STATE OF OKLAHOMA  
 DEPARTMENT OF HIGHWAYS  
 SURVEY DIVISION

FLOOD INFORMATION FORM

County Kay Date highwater occurred 1923  
 Highway number SH 11 Name of stream Spring Creek  
 Direction and distance from nearest town, village or store 1 mi. west of SH 11, US 77 Jct., west of Kildare.

Subject SWO 3115(1) - P.E.B. - SH 11 - Kay County  
Highwater at Spring Creek

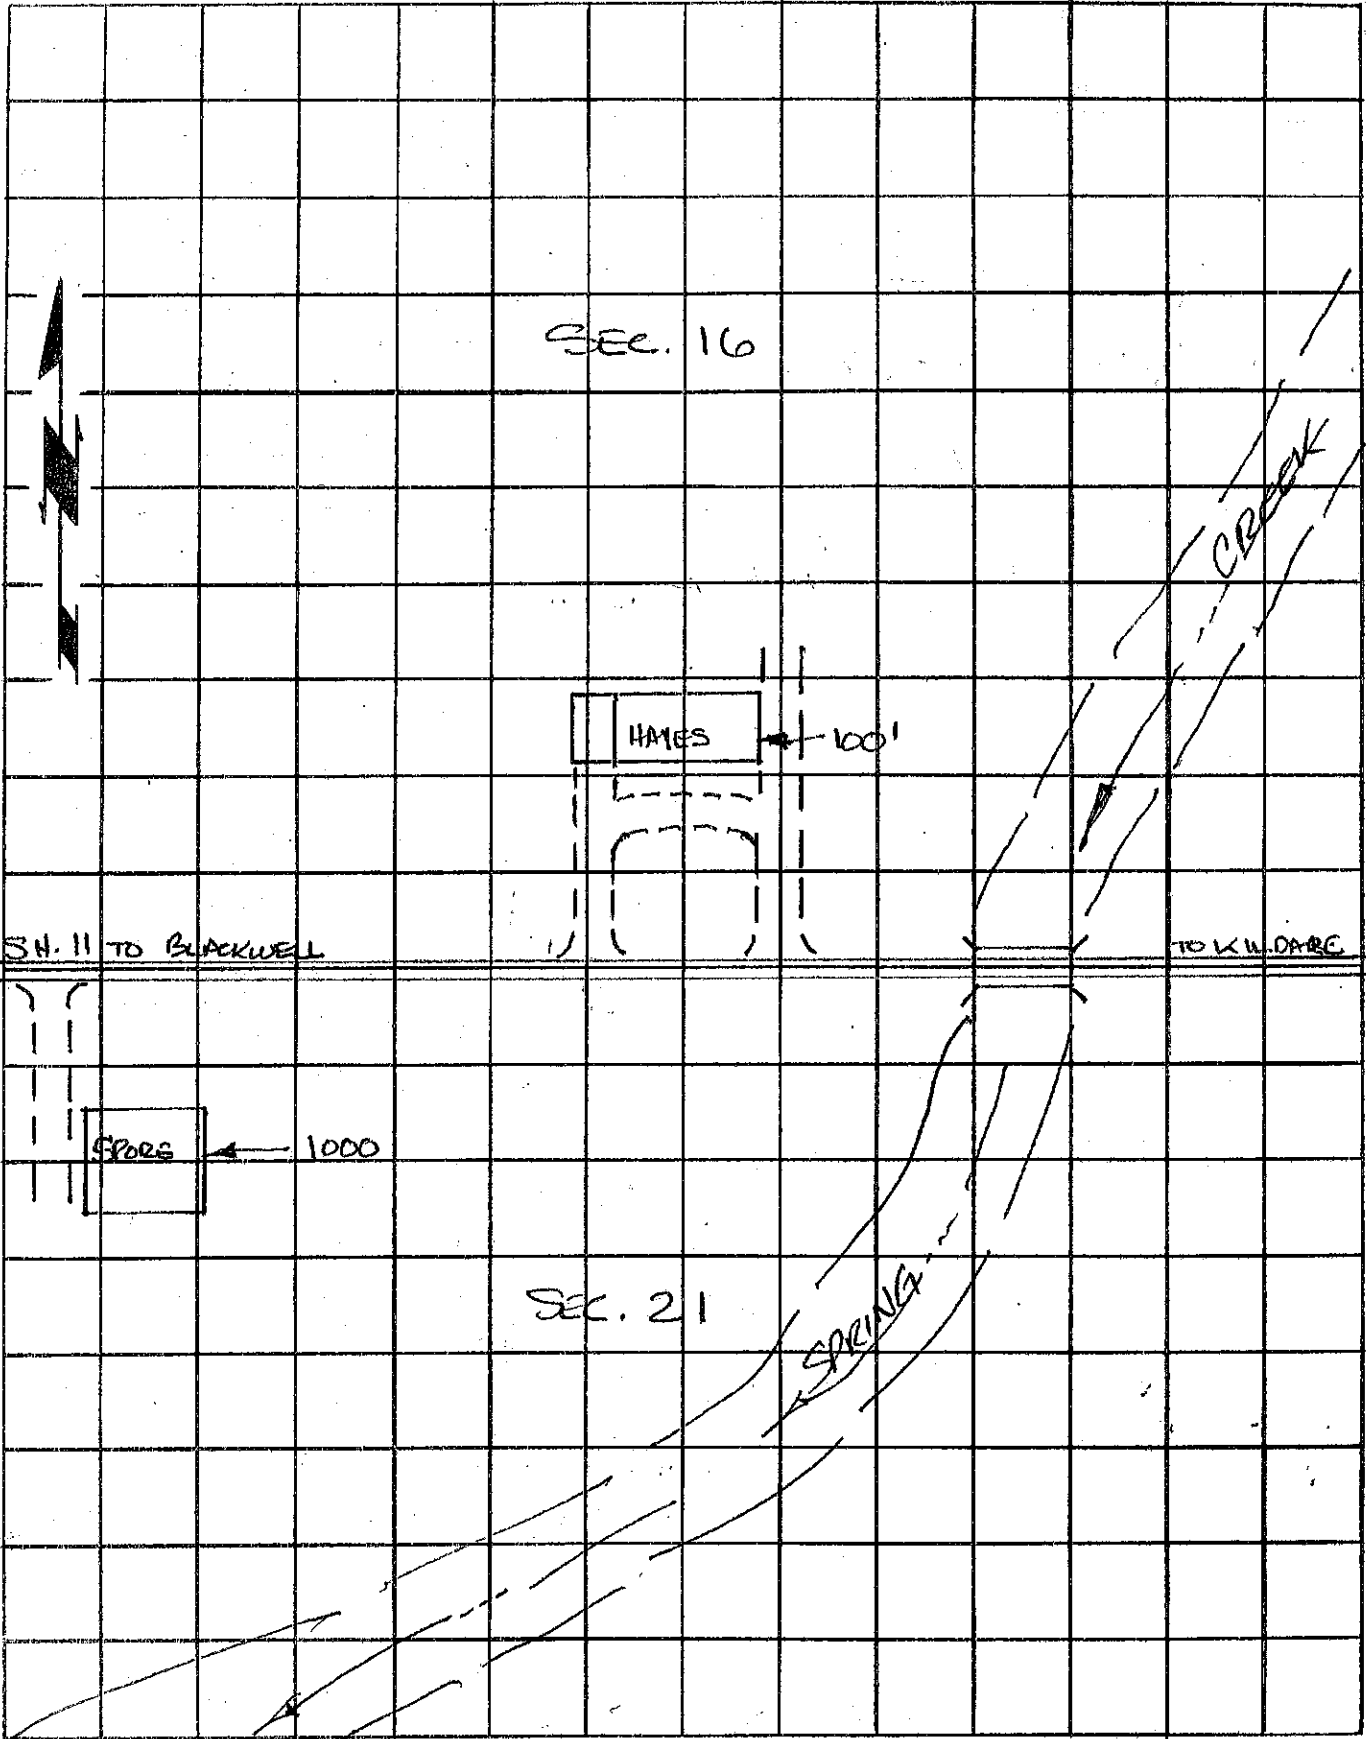
Location No. 31

Section, Township and Range Ret. Sec. 16 & 21, T27N-R2E, -300' W. of NE cor. of 21  
 Description of Location at Mr. Hayes residence water was in orig. has. when he was teenager. Estimated where water would be on new hse, to be porch floor

Was highwater mark obtained from actual water, drift, local resident, U. S. Engineers, etc.? Mr. sidney Spore, resident 1000' west of creek on south side of SH 11 & Mr. Lyle Hayes, resident 100' west on north side of hwy.

HMS 100'

SPRS 1000'
