## Oklahoma State Highway Dept.

Date August 31, 1970

From Oscar C. Curnutt, Ground Survey Engineer

Subject SWO 2154(1) - I-35 - From 2.5 miles north of US 60 west of Blackwell northerly to the Oklahoma-Kansas State Line, Kay County.

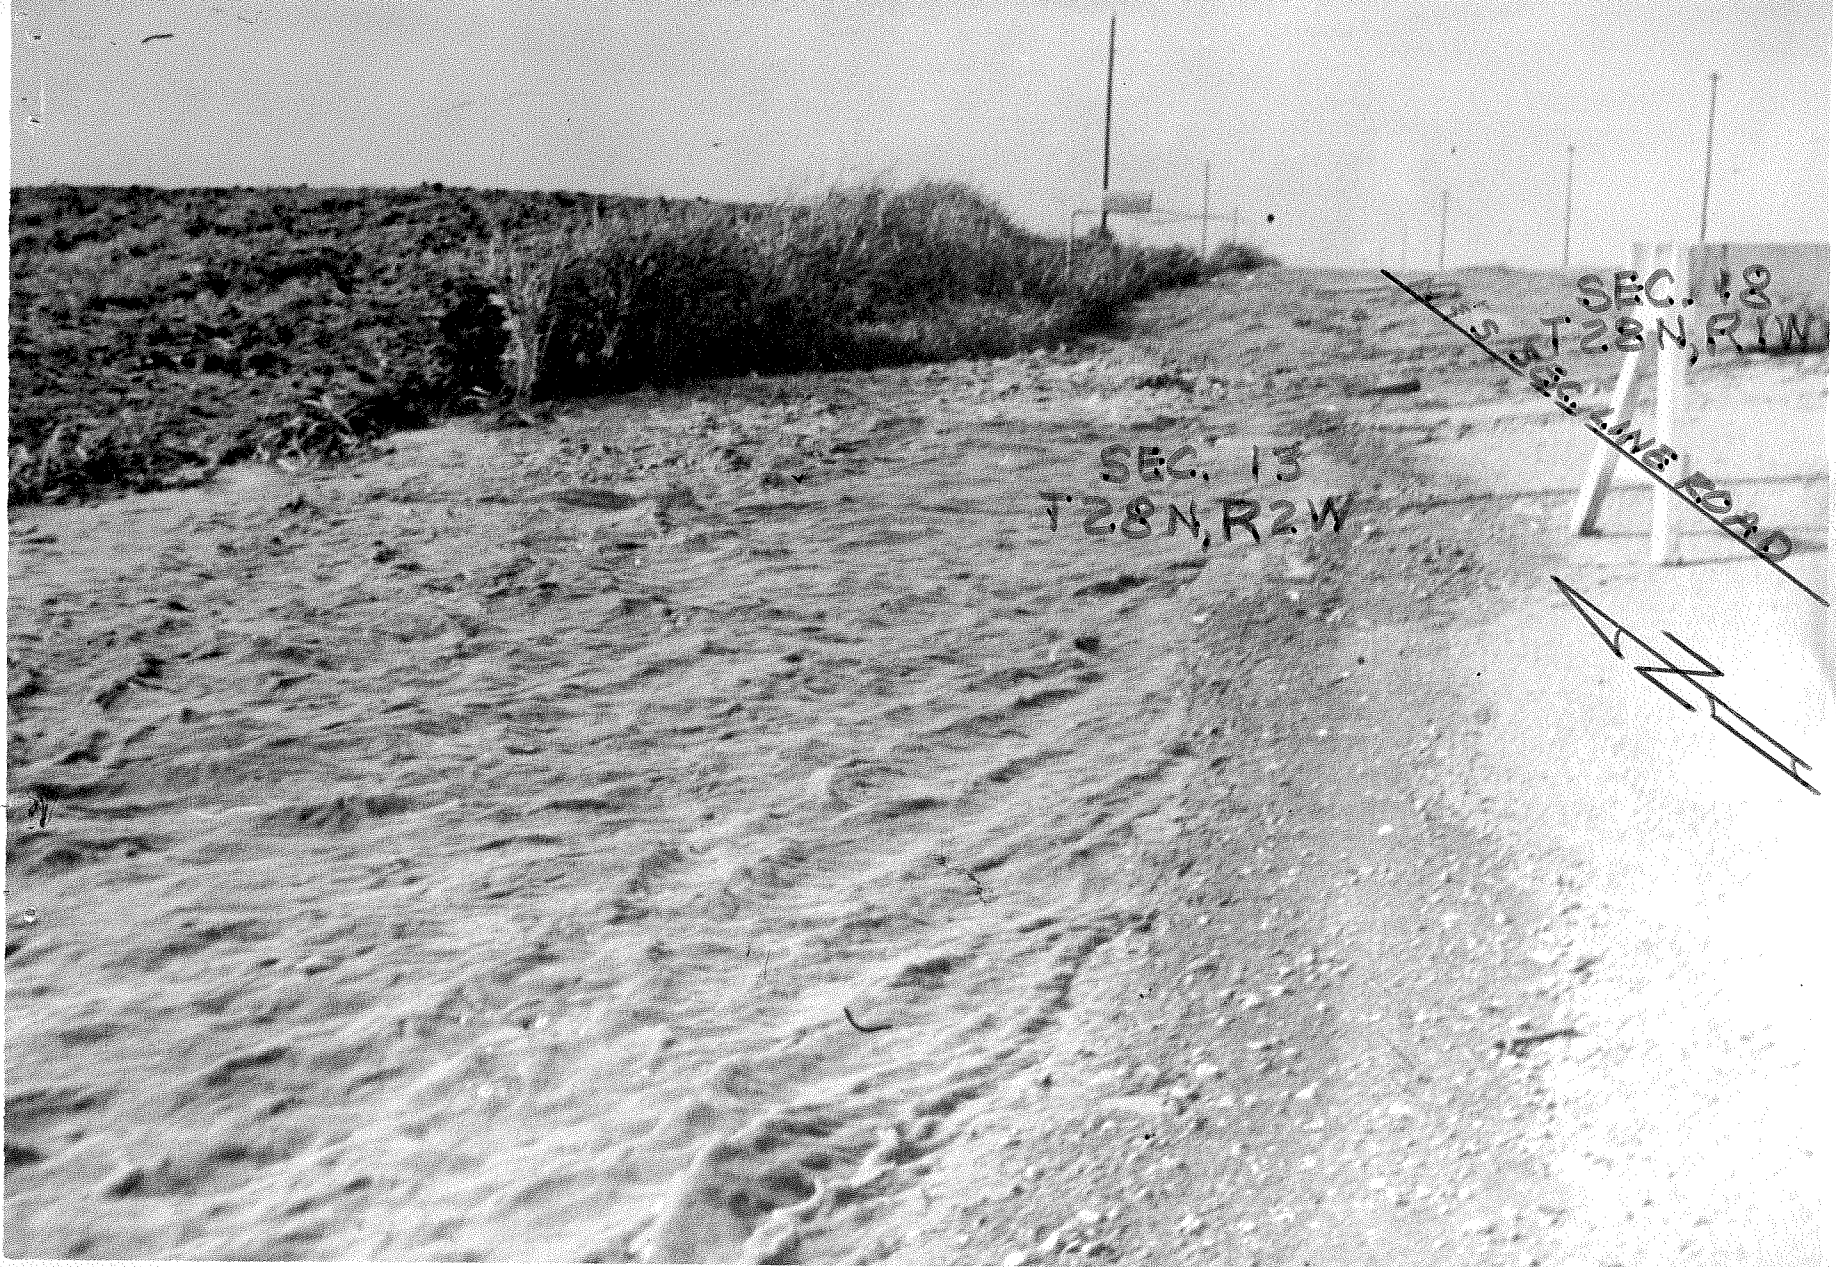
LOCATION NO. 5

5. History and Explanations This photograph was obtained from  
Mrs. Lawrence Scott, the location is just west of her residence  
looking north up the N&S section line road, showing damage to  
the road after highwater had receded. The date of the highwater  
was 1964 and was caused by overflow of Shoo-fly and Dry Creeks  
and not by the Chickaskia River.

Mrs. Scott stated that the highwater also overflowed the fields north of her residence, came behind her residence and into the Chickaskia River which is approximately 1000' south of this location.

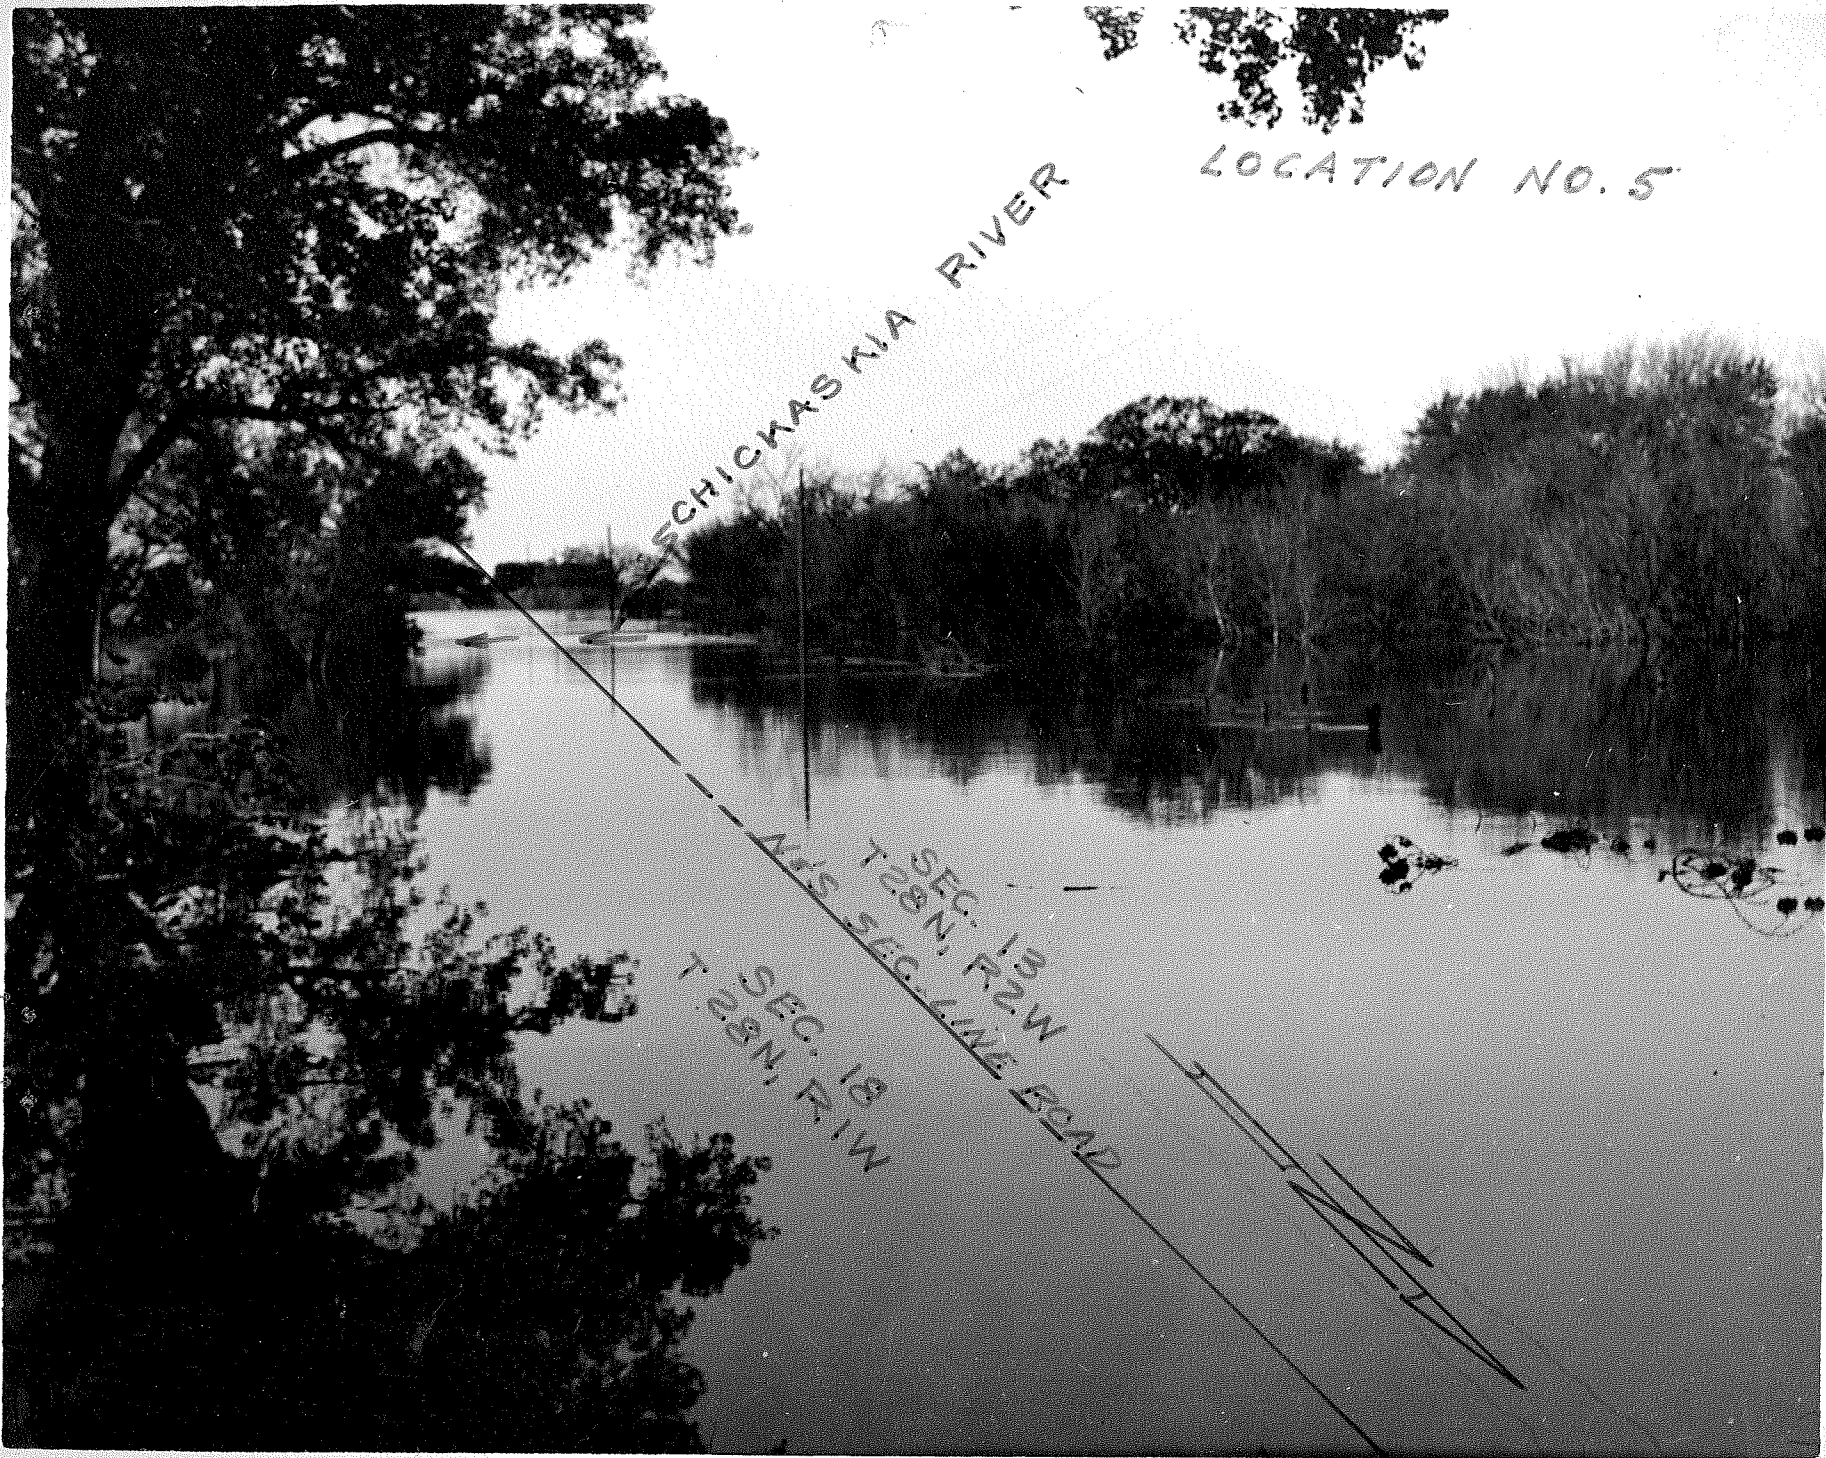
LOCATION NO. 5

5. History and Explanations Photograph was obtained from Mrs.  
Lawrence Scott. The location is on the east side of the N&S  
section line road just south of residence looking south.

The Chickaskia River is in background. The highwater occurred  
in 1957 and caused by Chickaskia River overflow and does not  
depict the maximum elevation water reached.

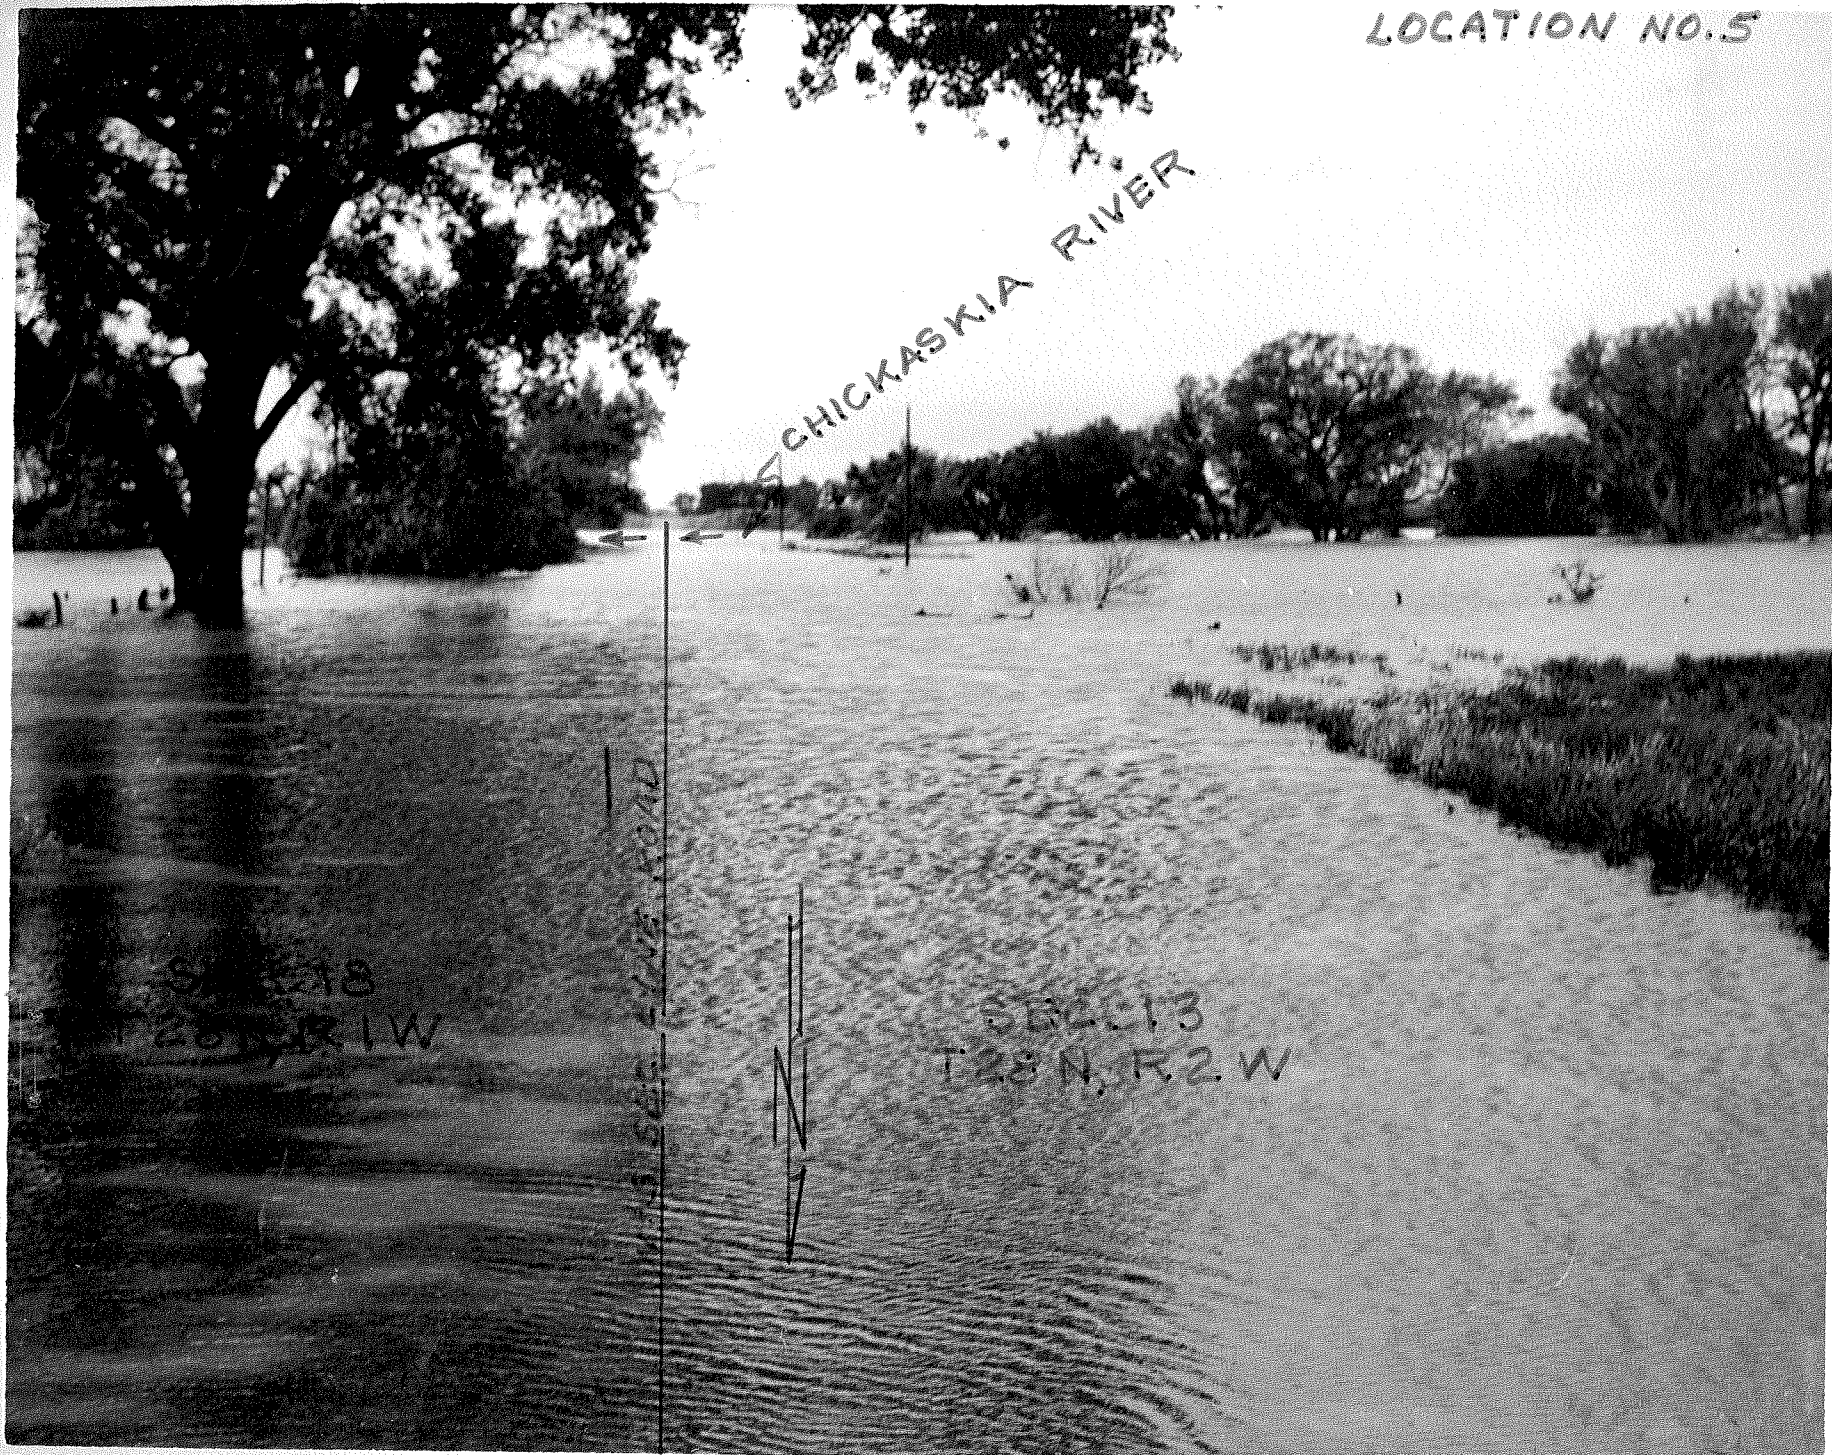
LOCATION NO. 5

1. Location At Mrs. Lawrence Scott residence located in the  
NW/4 Sec. 18, T-28-N, R-1-W, approximately 1.0 Mi. W. and 1.2  
Mi. S. of Braman, Kay County.
2. Subject Highwater on the Chickaskia River in the Braman, Kay  
County area.
3. Purpose To record and preserve highwater information.
4. For Use SWO 2154(1), I-35-4(4)225, Flood information on the  
Chickaskia River, Shoo-fly and Dry Creeks in the vicinity of  
Braman.
5. History and Explanations Photograph was obtained from Mrs.  
Lawrence Scott. The location is on the N&S section line road,  
just west of residence looking south.

The Chickaskia River is in the background.

The highwater occurred in 1957 and was caused by Chickaskia  
River overflow.

Photograph does not depict the maximum elevation water reached.

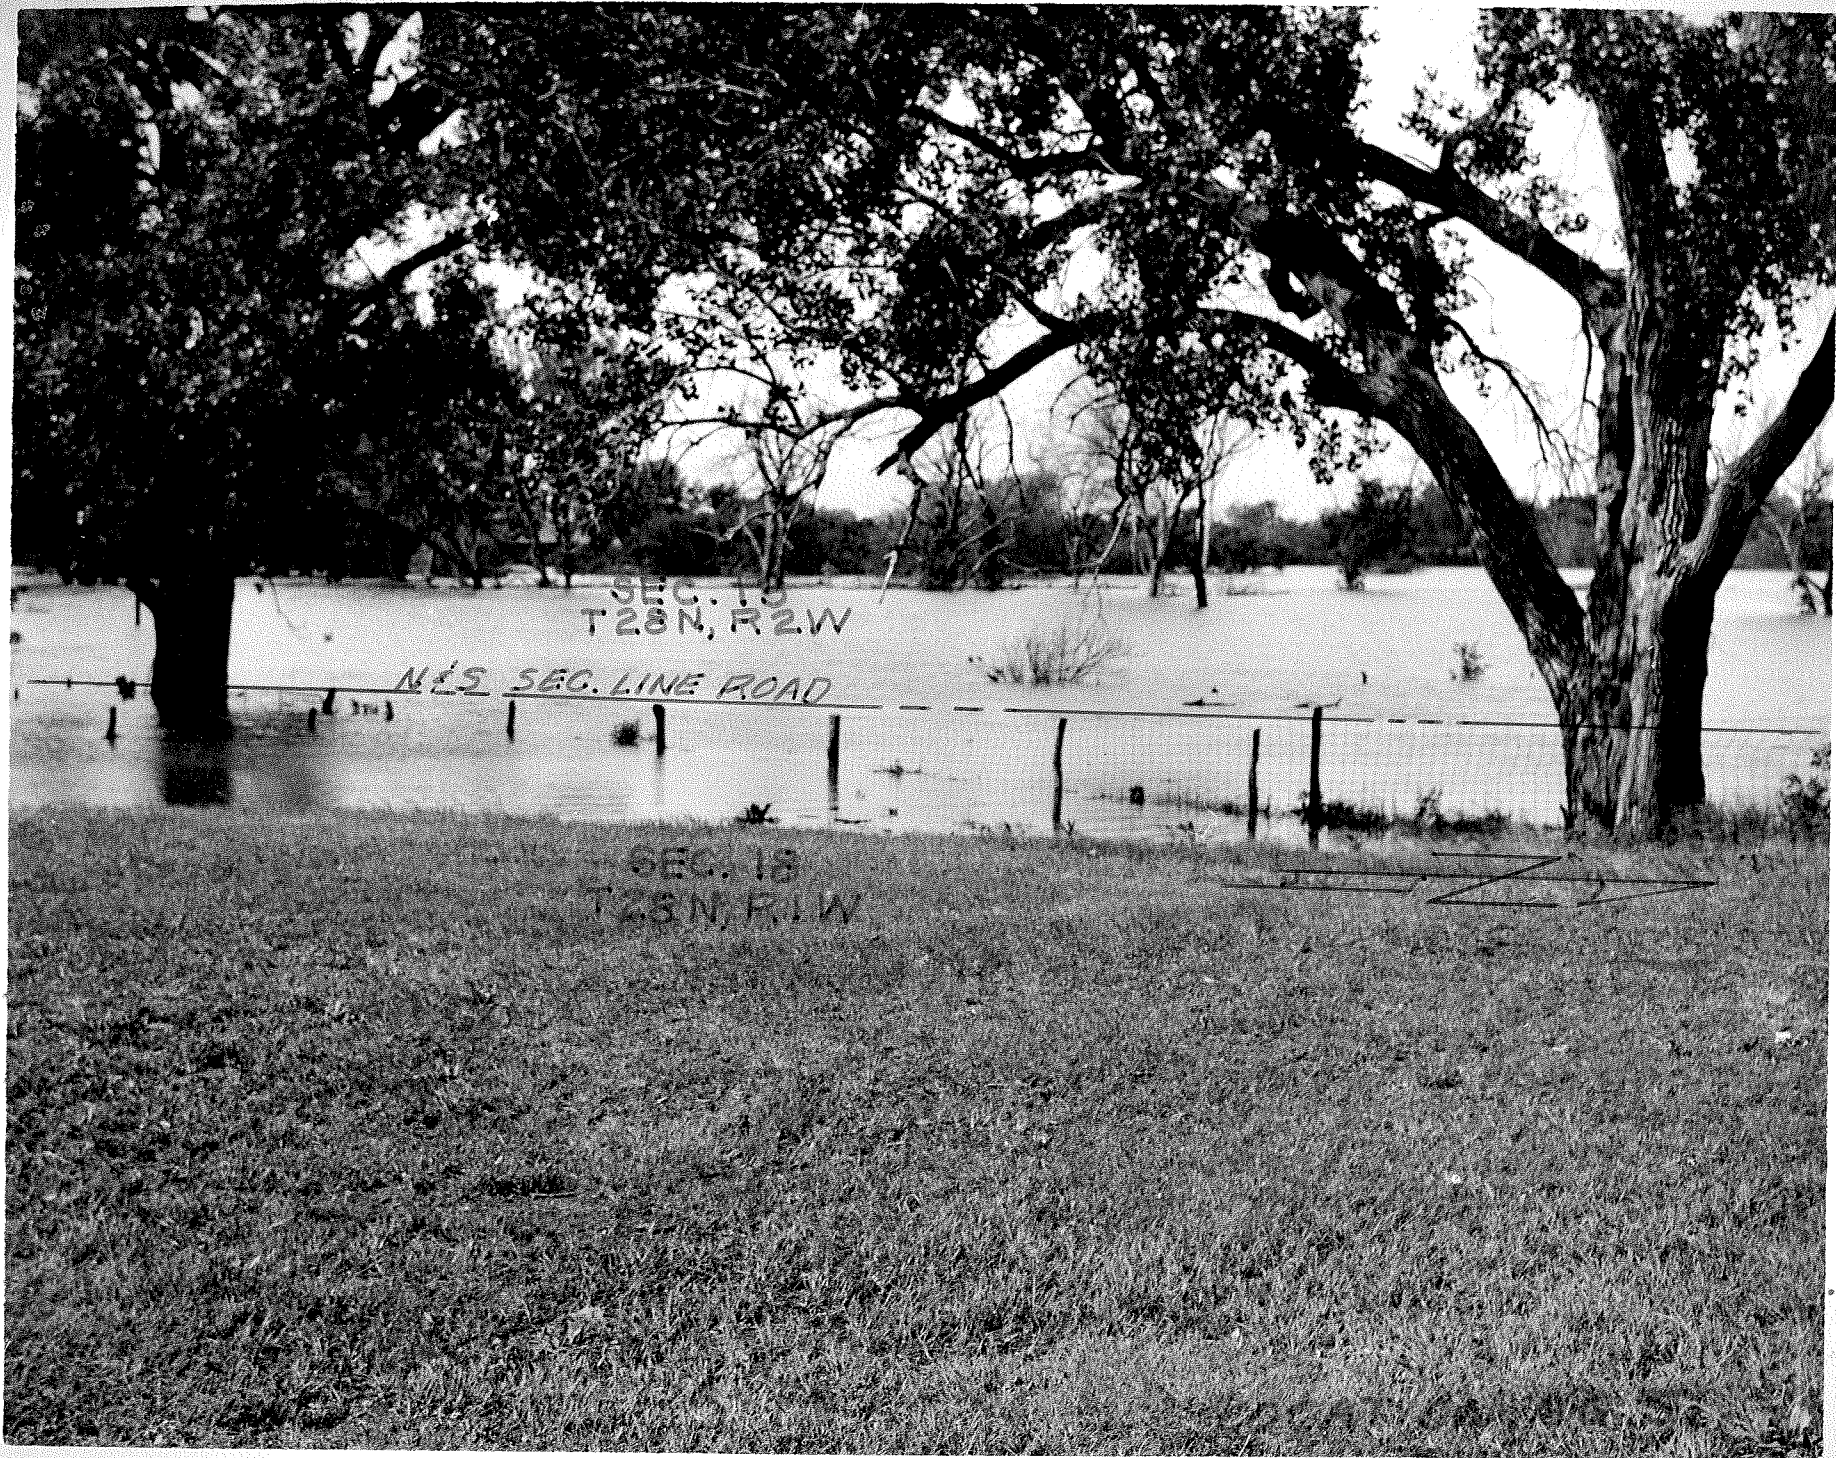
1. Location At Mrs. Lawrence Scott residence located in the NW/4  
Section 18, T-28-N, R-1-W, approximately 1.0 Mi. W. and 1.2  
Mi. S. of Braman, Kay County.
2. Subject Highwater on the Chickaskia River in the Braman, Kay  
County area.
3. Purpose To record and preserve highwater information.
4. For Use SWO 2154(1), I-35-4(4)225, Flood information on the  
Chickaskia River, Shoo-fly and Dry Creeks in the vicinity of  
Braman.
5. History and Explanations Photograph was obtained from Mrs.  
Lawrence Scott. The location is just south of her residence  
looking southwest.

The highwater occurred in 1957 and was caused by Chickaskia River overflow, it does not depict the maximum elevation the water reached.

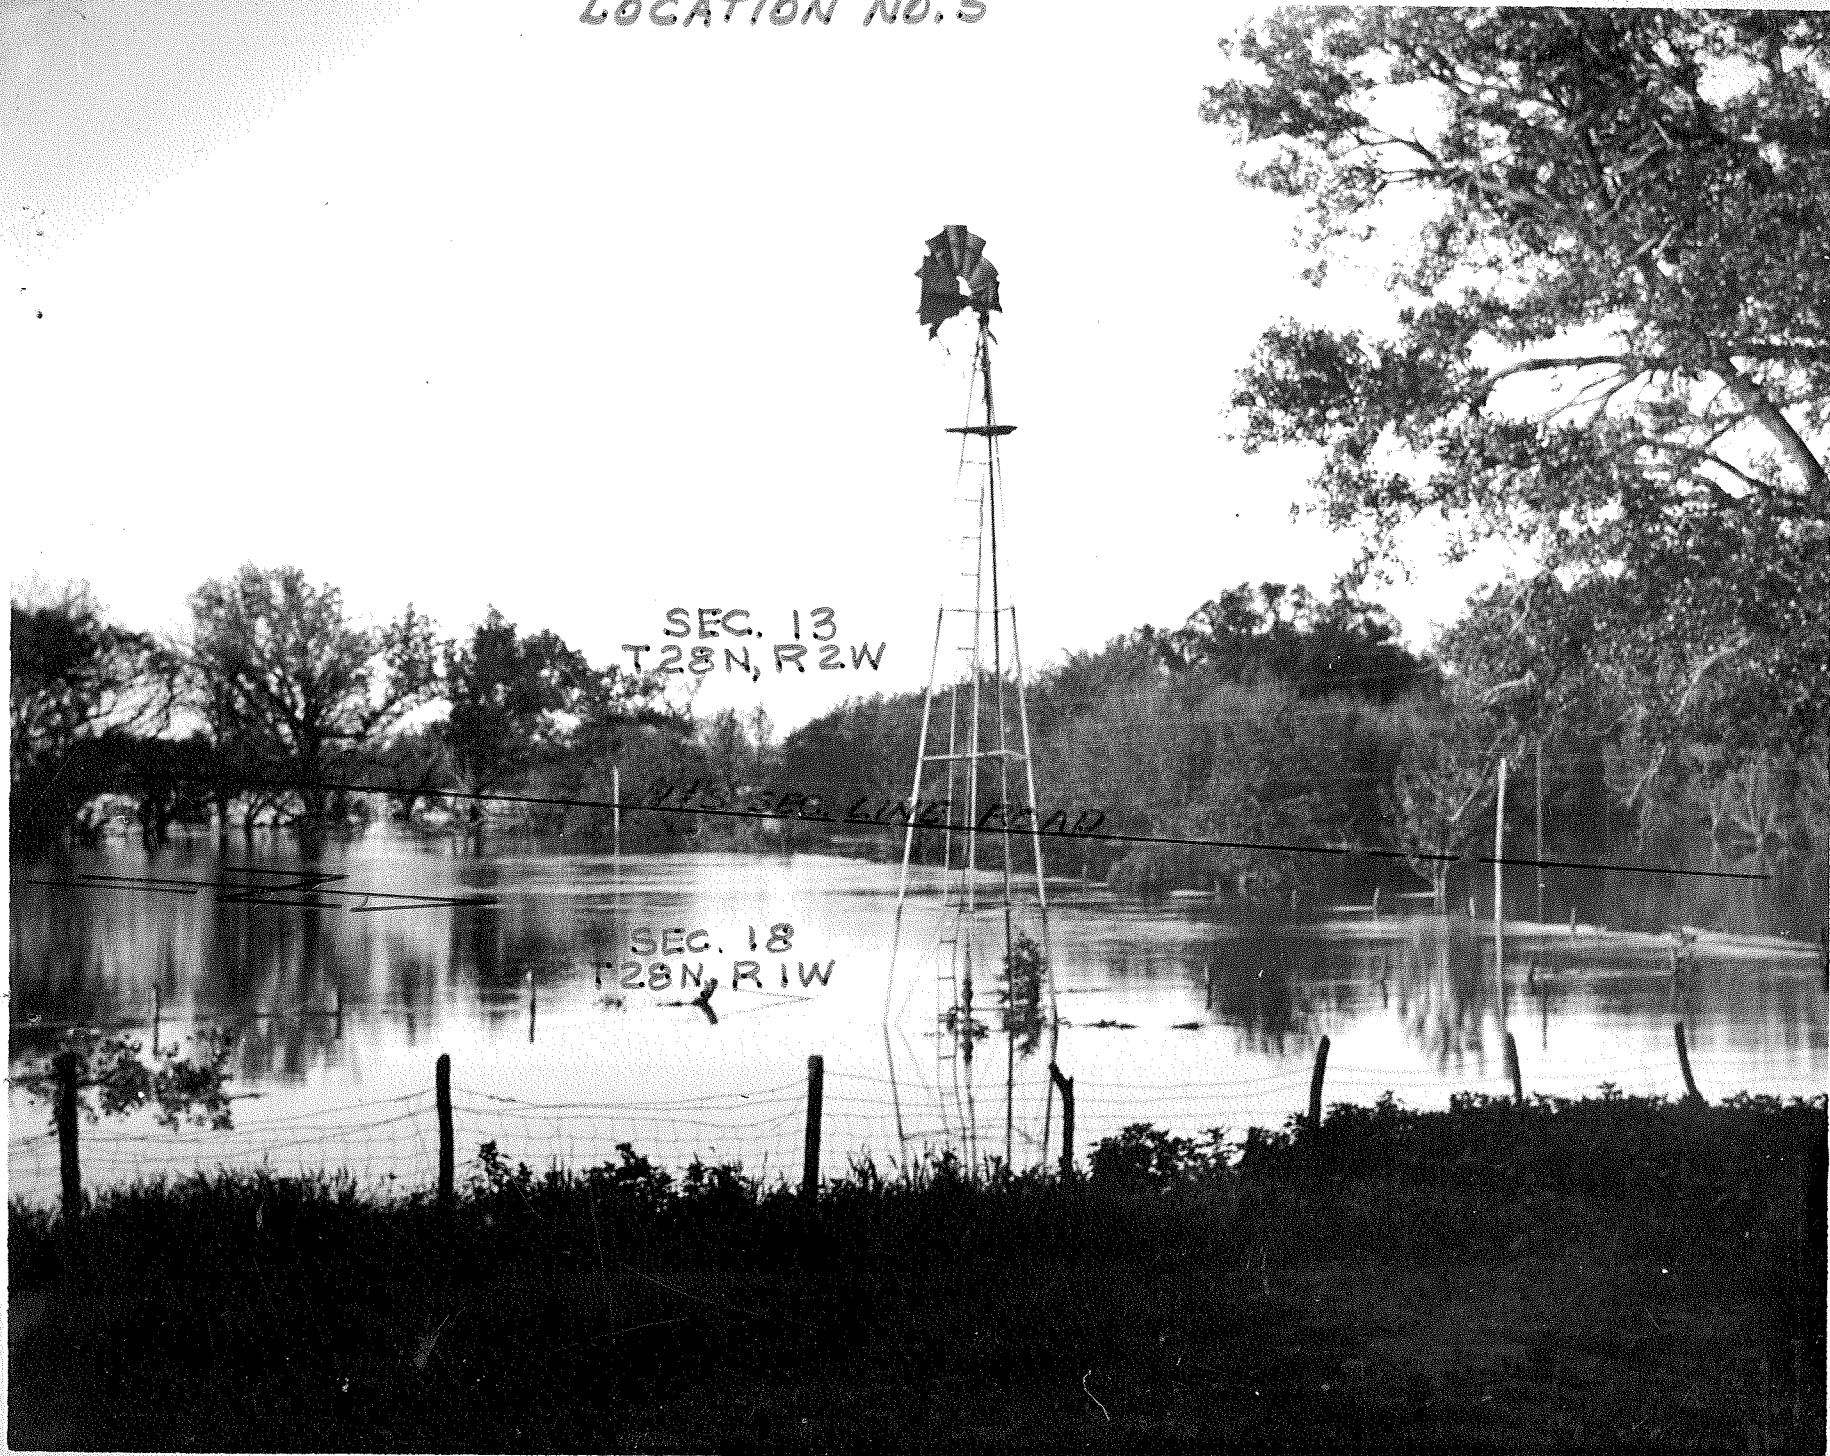
LOCATION NO. 5

1. Location At the Mrs. Lawrence Scott residence located in the NW/4 Sec. 18, T-28-N, R-1-W approximately 1.0 Mi. West and 1.0 Mi. South of Braman, Kay County, Oklahoma
2. Subject Highwater on the Chickaskia River in the Braman, Kay County area.
3. Purpose To record and preserve highwater information.
4. For Use SWO 2154(1), I-35-4(4)225, Flood information on the Chickaskia River, Shoo-fly and Dry Creeks in the vicinity of Braman.
5. History and Explanations Photograph was obtained from Mrs. Lawrence Scott. The location is just south of residence looking southwest. The large tree at right is southeast corner of yard. The windmill has been removed but concrete foundation still in place.

The highwater occurred in 1957 and caused by the Chickaskia River overflow.

The photograph does not depict the maximum elevation water reached.

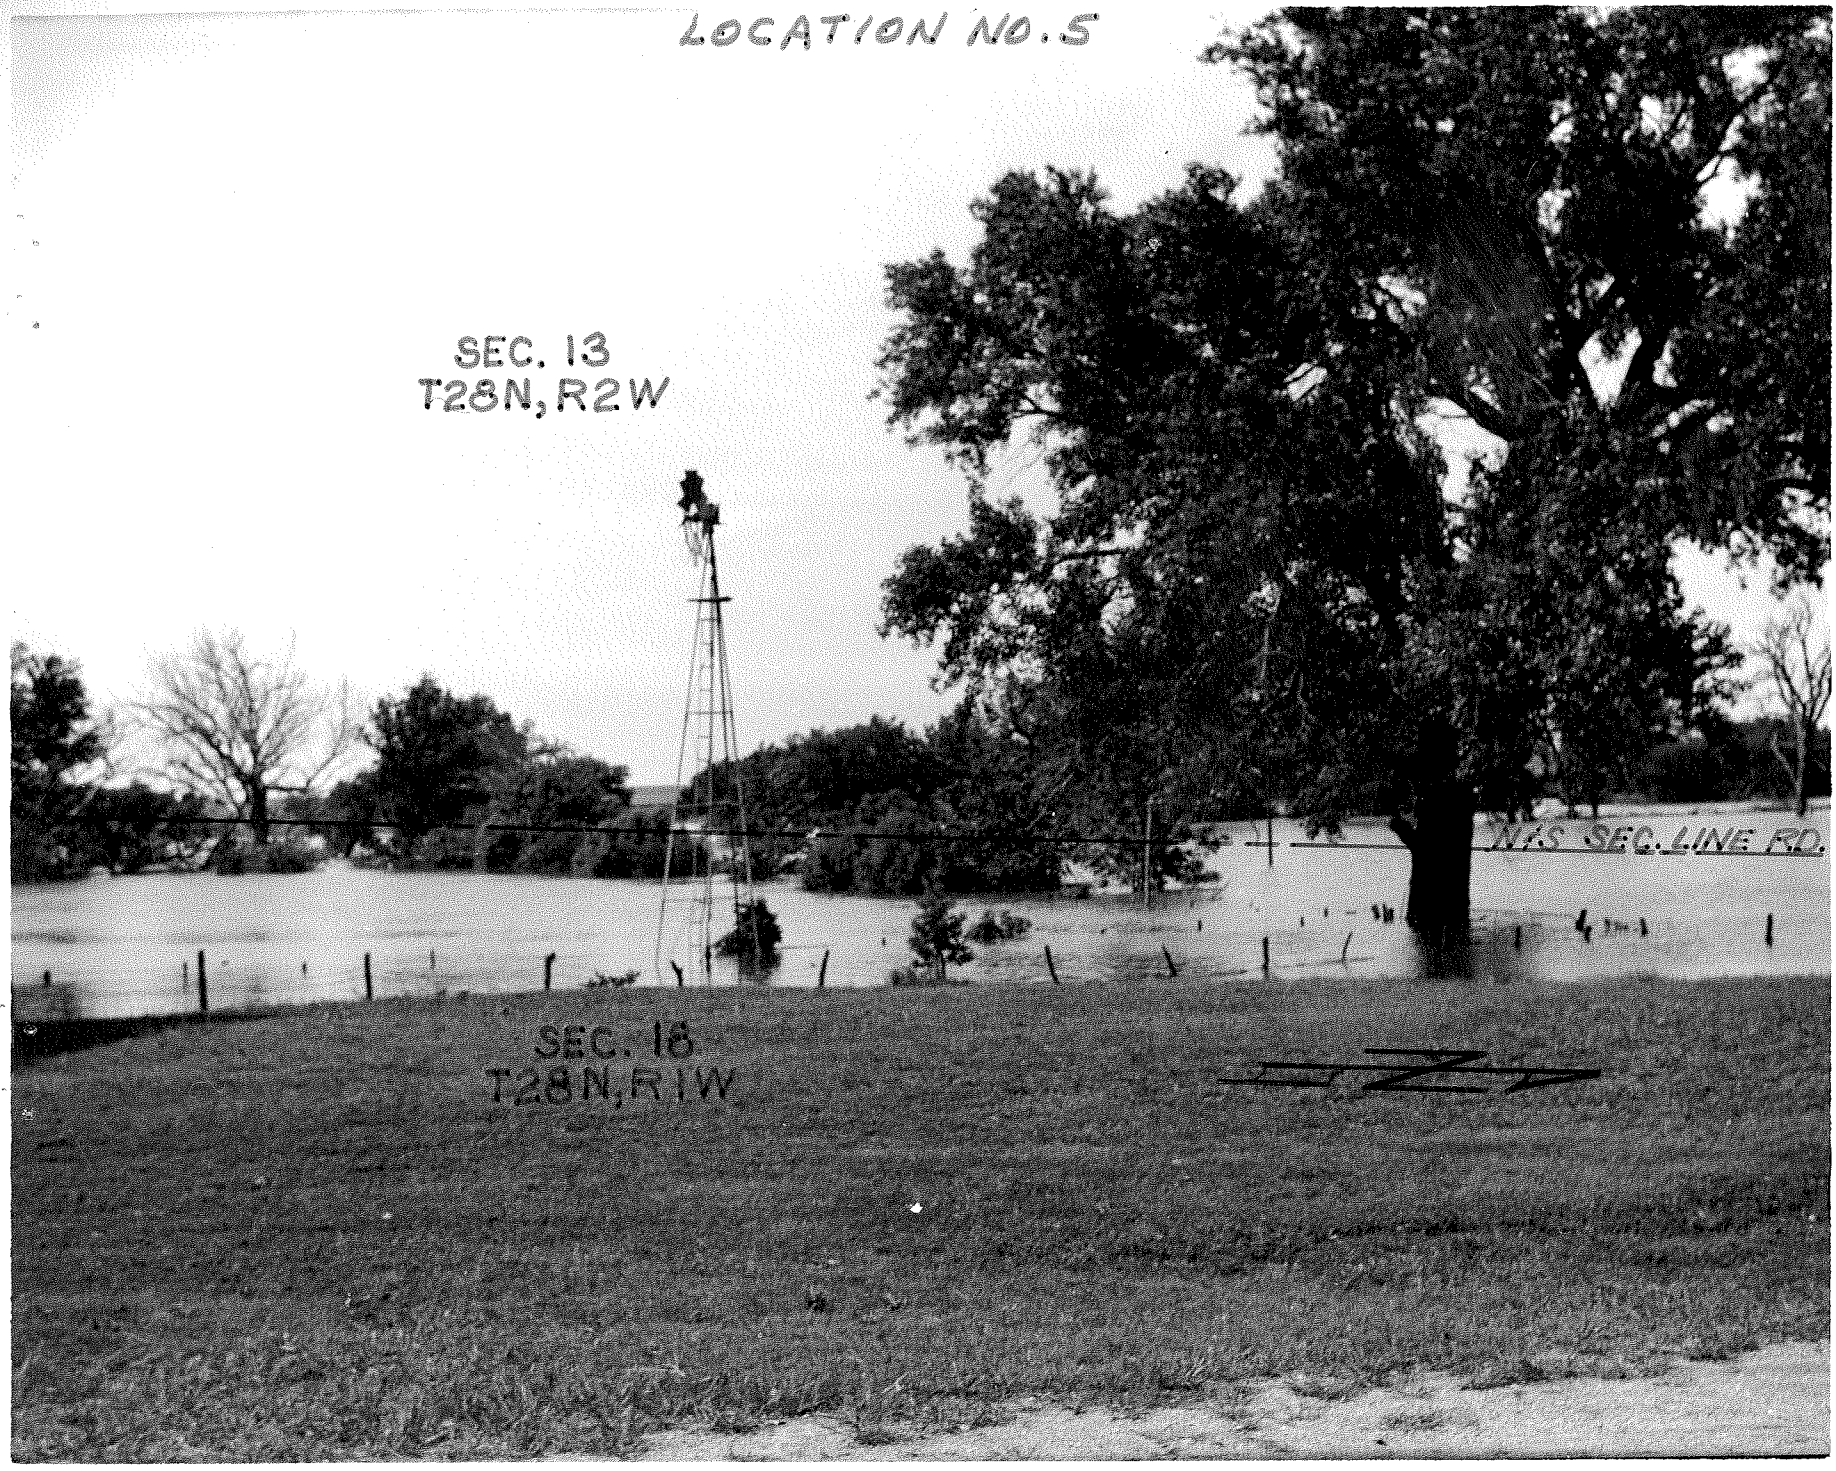
LOCATION NO. 5

5. History and Explanations Photograph was obtained from Mrs. Lawrence Scott. The location of the photograph is in the S.E. corner of Mrs. Scott's yard. The large tree at the right is the southeast corner of the yard. The windmill has been removed but concrete foundation is still in place.

The photograph was taken from highground just southwest of Scott Residence looking southwest.

This highwater occurred in 1957 and is caused by Chickaskia River overflow, while on water was on the rise and does not depict the maximum elevation the water reached. The Chickaskia River County road crossing is approximately 1000' south of this location.

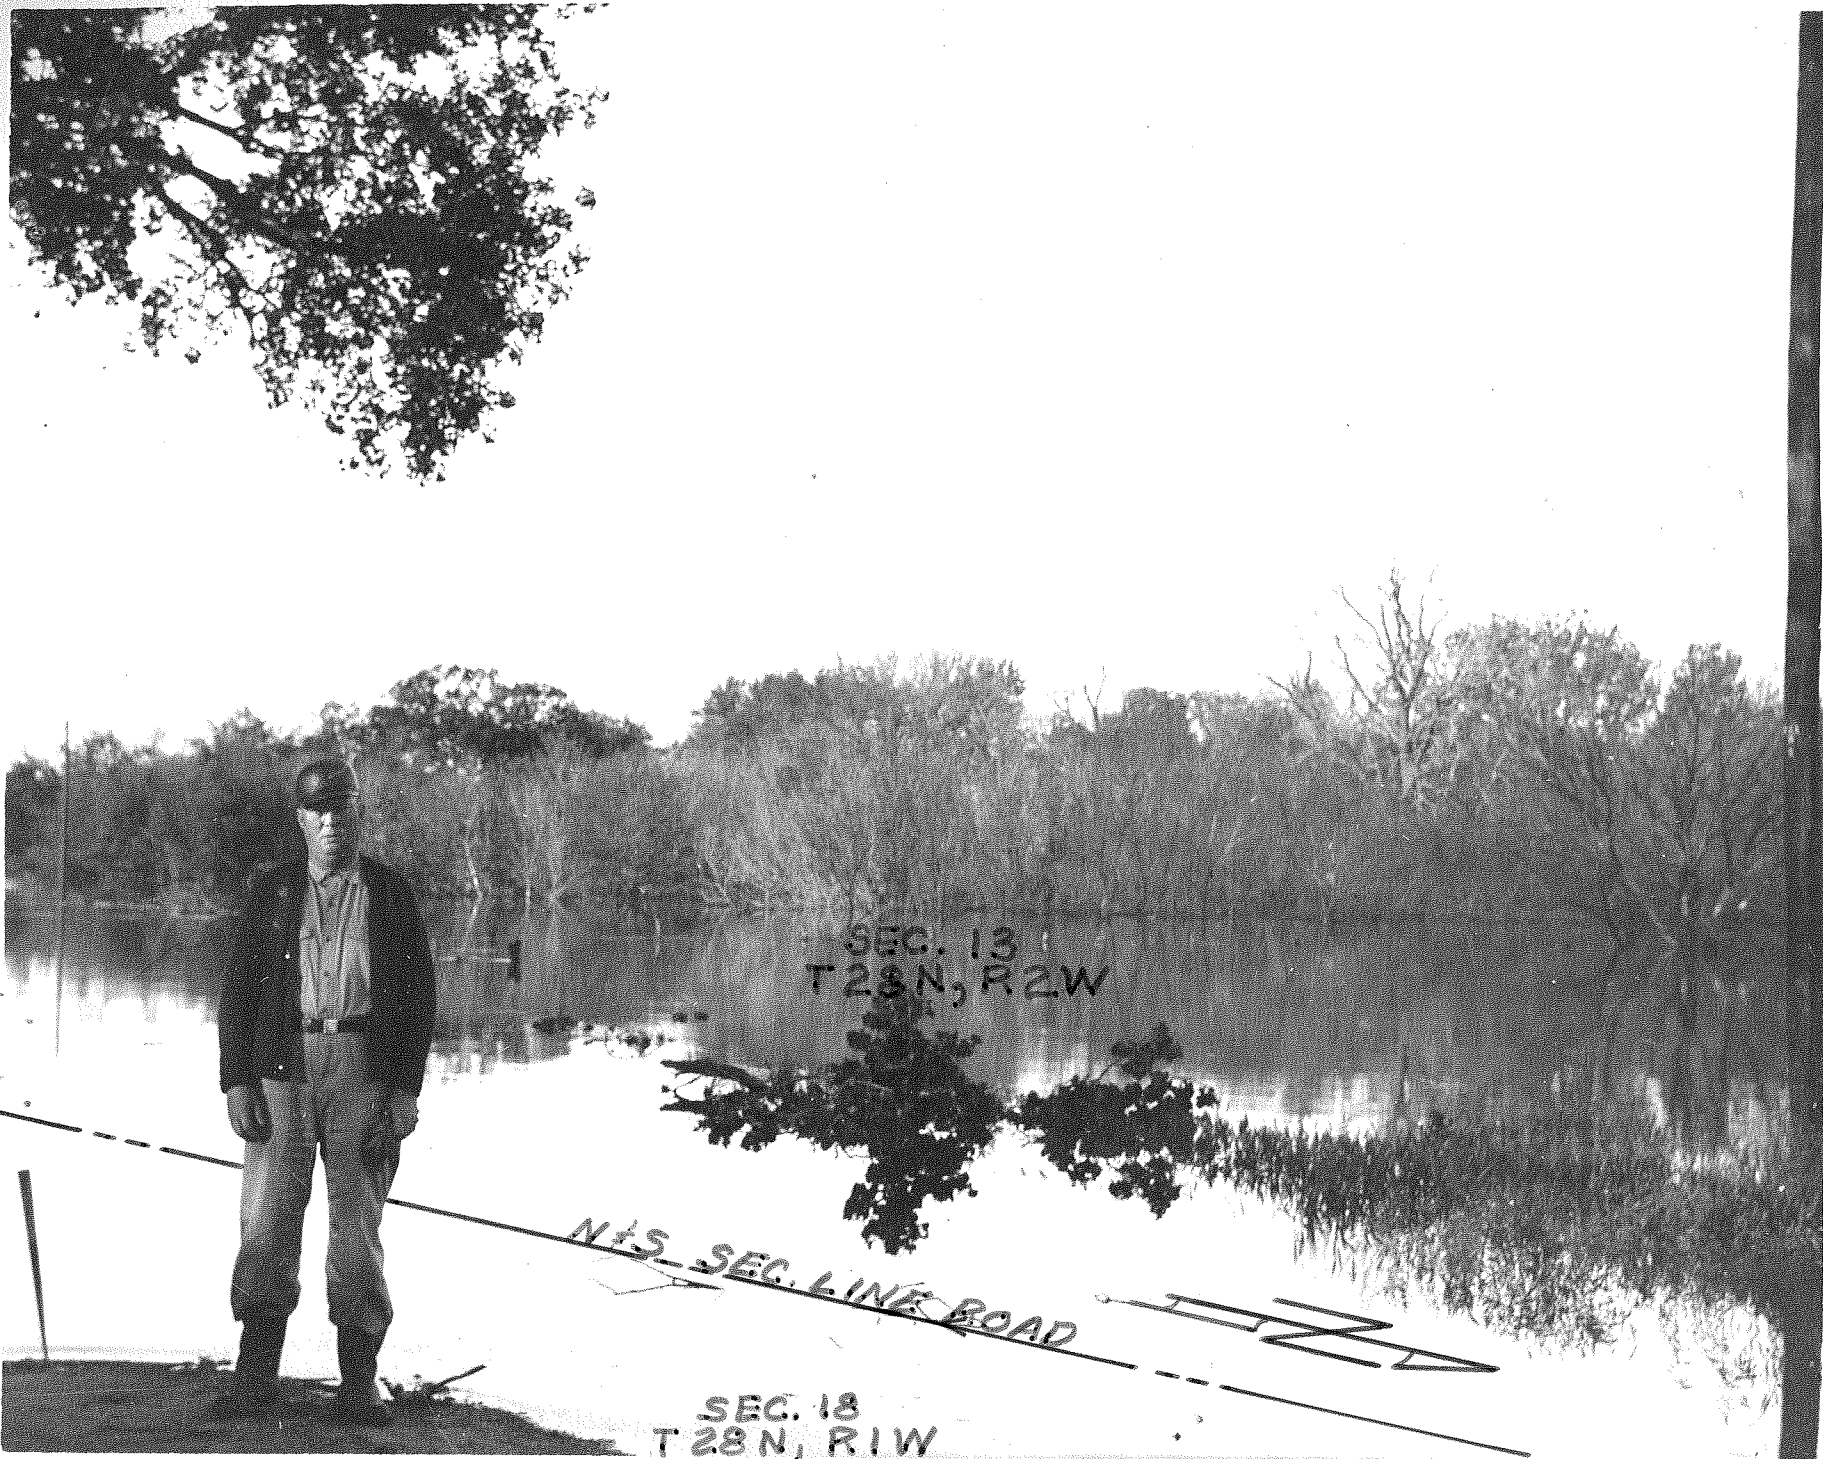
LOCATION NO. 5

1. Location At Mrs. Lawrence Scott Residence located in the NW/4  
Sec. 18, T-28-N, R-1-W, approximately 1.0 mile W. and 1.2 miles  
S. of Braman, Kay County.
2. Subject Highwater on the Chickaskia River in the Braman, Kay  
County area.
3. Purpose To record and preserve highwater information.
4. For Use SWO 2154(1), I-35-4(4)225, Flood information on the  
Chickaskia River, Shoo-fly and Dry Creeks in the vicinity of  
Braman.
5. History and Explanations Photograph was obtained from Mrs.  
Lawrence Scott, the location is at the entrance to driveway to  
her residence, on east side of N.&S. section line road looking  
southwest.

The highwater occurred in 1957 and is caused by Chickaskia River overflow as it was on the rise and does not depict the maximum elevation water reached. The Gentlemen in the photograph is Mr. Lawrence Scott, deceased.

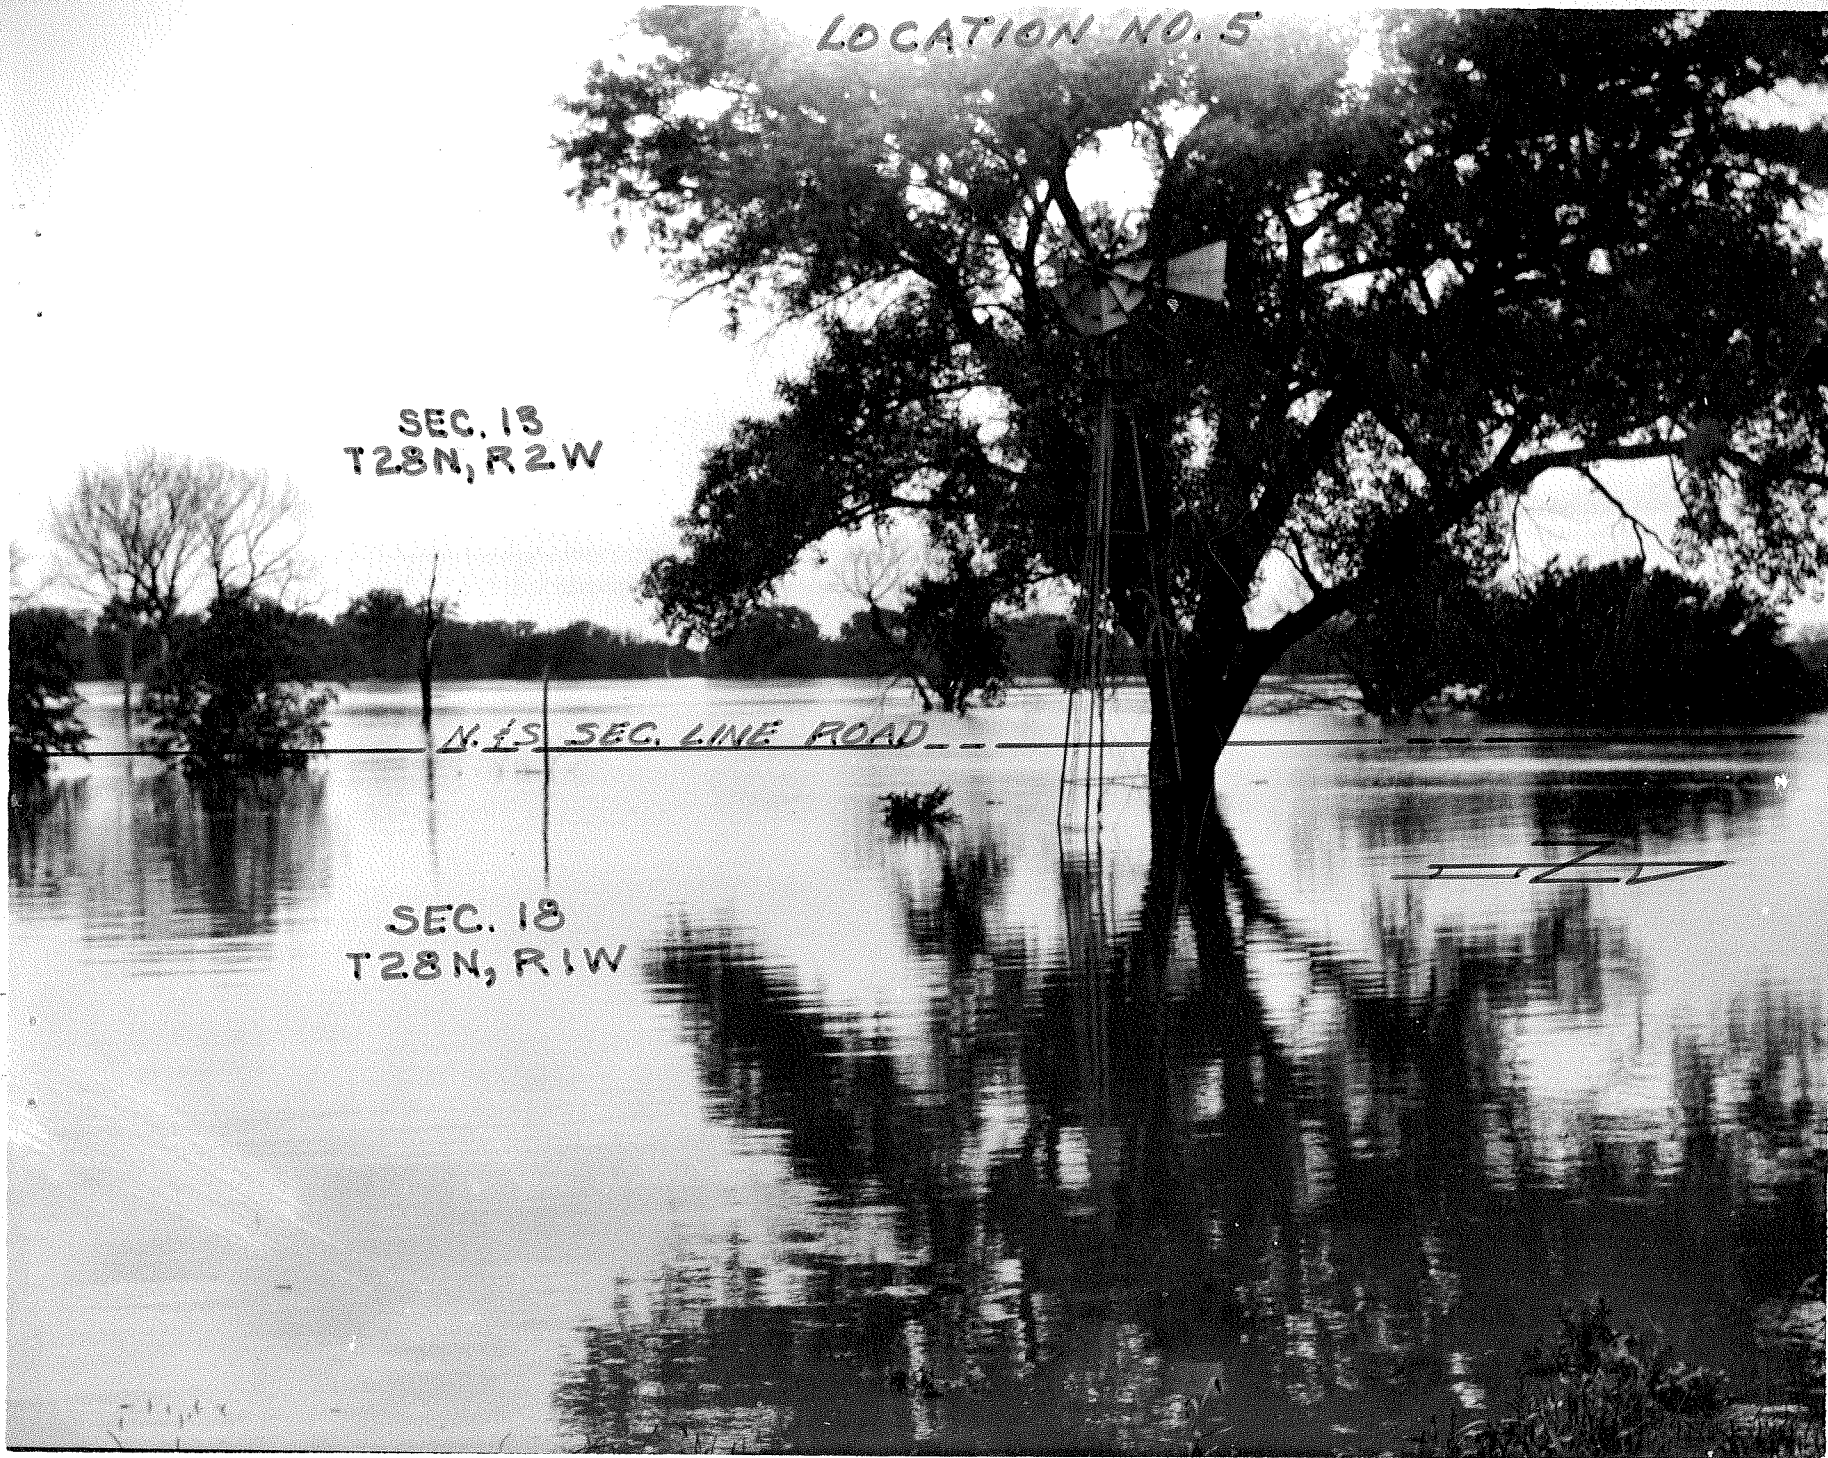
LOCATION NO. 5

1. Location At Mrs. Lawrence Scott Residence located in the NW/4 Sec. 18, T-28-N, R-1-W, approximately 1.0 Mi. W. and 1.2 Mi. S. of Braman, Kay County.
2. Subject Highwater on the Chickaskia River in the Braman, Kay County area.
3. Purpose To record and preserve highwater information.
4. For Use SWO 2154(1), I-35-4(4)225, Flood information on the Chickaska River, Shoo-fly and Dry Creeks in the vicinity of Braman.
5. History and Explanations Photograph was obtained from Mrs. Lawrence Scott. The location of the photograph is south side of yard looking west.

The large tree on right is the southeast corner of yard. The windmill has been removed but concrete foundation is still in place. This photograph was taken late in evening and highwater was near maximum flood stage. Highwater occurred in 1957 and was caused by Chickaskia River overflow.
