## Oklahoma State Highway Dept.

Date August 31, 1970

From Oscar C. Curnutt, Ground Survey Engineer

Subject SWO 2154(1) - I-35 - From 2.5 miles north of US 60 west of Blackwell northerly to the Oklahoma-Kansas State Line, Kay County.

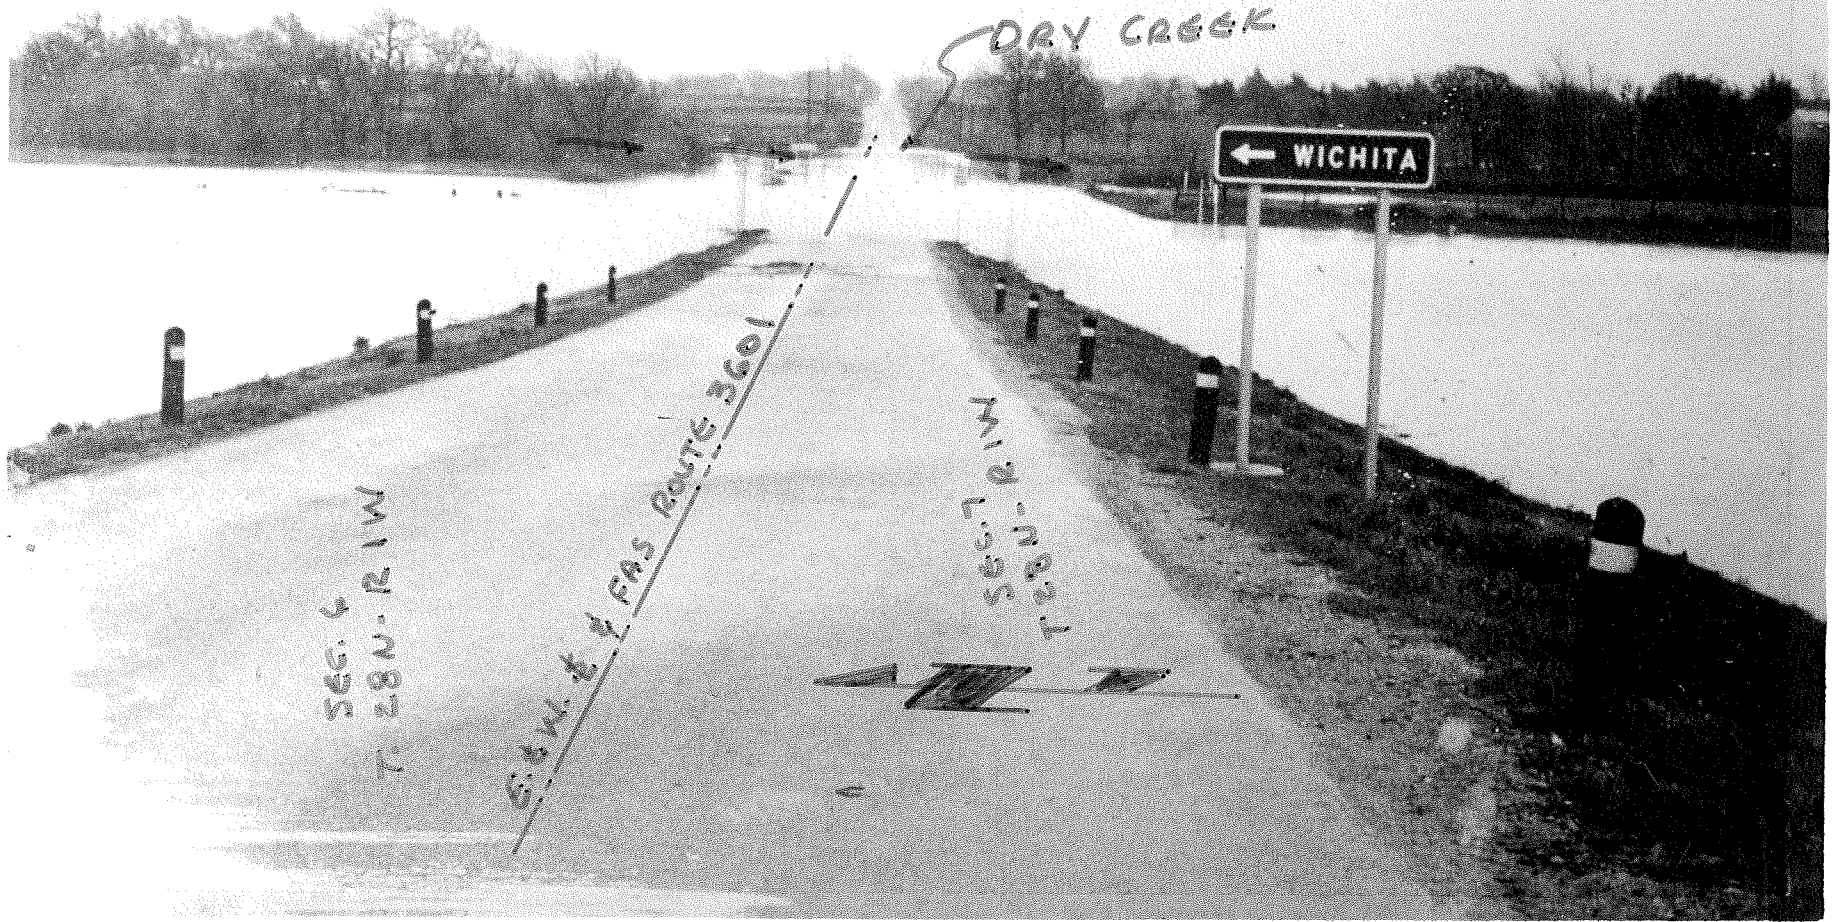
LOCATION NO. 9

1. Location I-35 and FAS Route 3601 Interchange 0.75 mile west of Braman, Kay County.
2. Subject Highwater on the Chickaskia River, Shoo-fly and Dry Creeks in the Braman, Kay County Area.
3. Purpose To record and preserve highwater information.
4. For Use SWO 2154(1), I-35-4(4)225, Flood information on the Chickaskia River, Shoo-fly and Dry Creeks in the vicinity of Braman.
5. History and Explanations This photograph was taken by Mr. R. C. Poage, Construction Engineer, in company of Mr. Gaines H. Stout, Survey Engineer and O. C. Curnutt, Ground Survey Engineer, at approximately 2:50 P.M. on November 17, 1964.

At this time all four quadrants of the interchange was partially inundated.

Intersection Station on I-35-4(4)225 is Station 715+30.72. Flooding was caused by overflow of Shoo-fly and Dry Creeks.

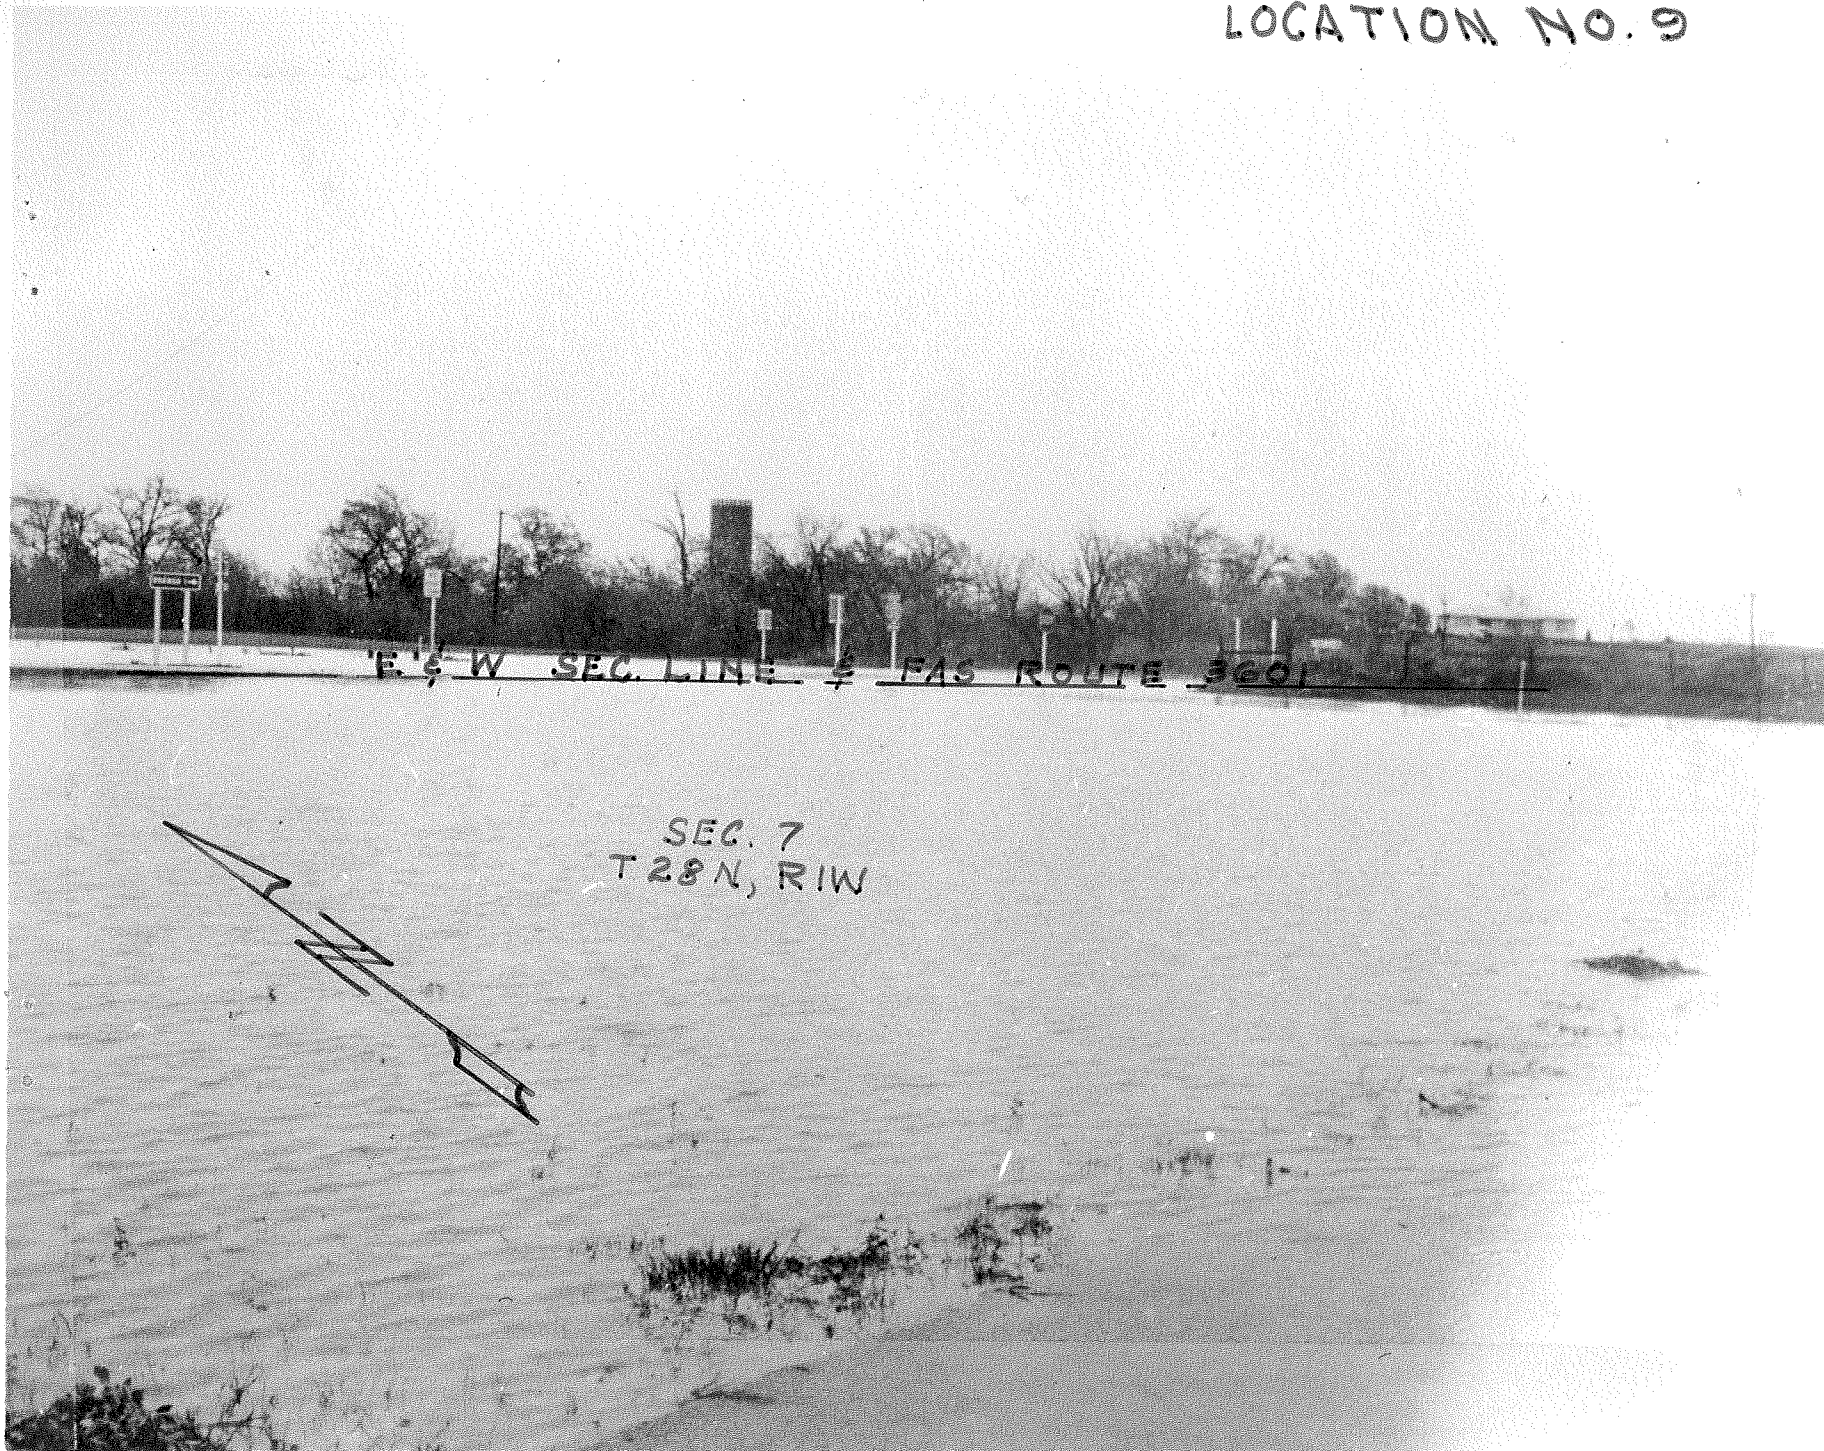
LOCATION NO. 9

Flooding was caused by overflow from Shoo-fly and Dry Creeks.
