Consultation on fish passage at San Acacia Diversion Dam on the Middle Rio Grande River

July 26, 2002

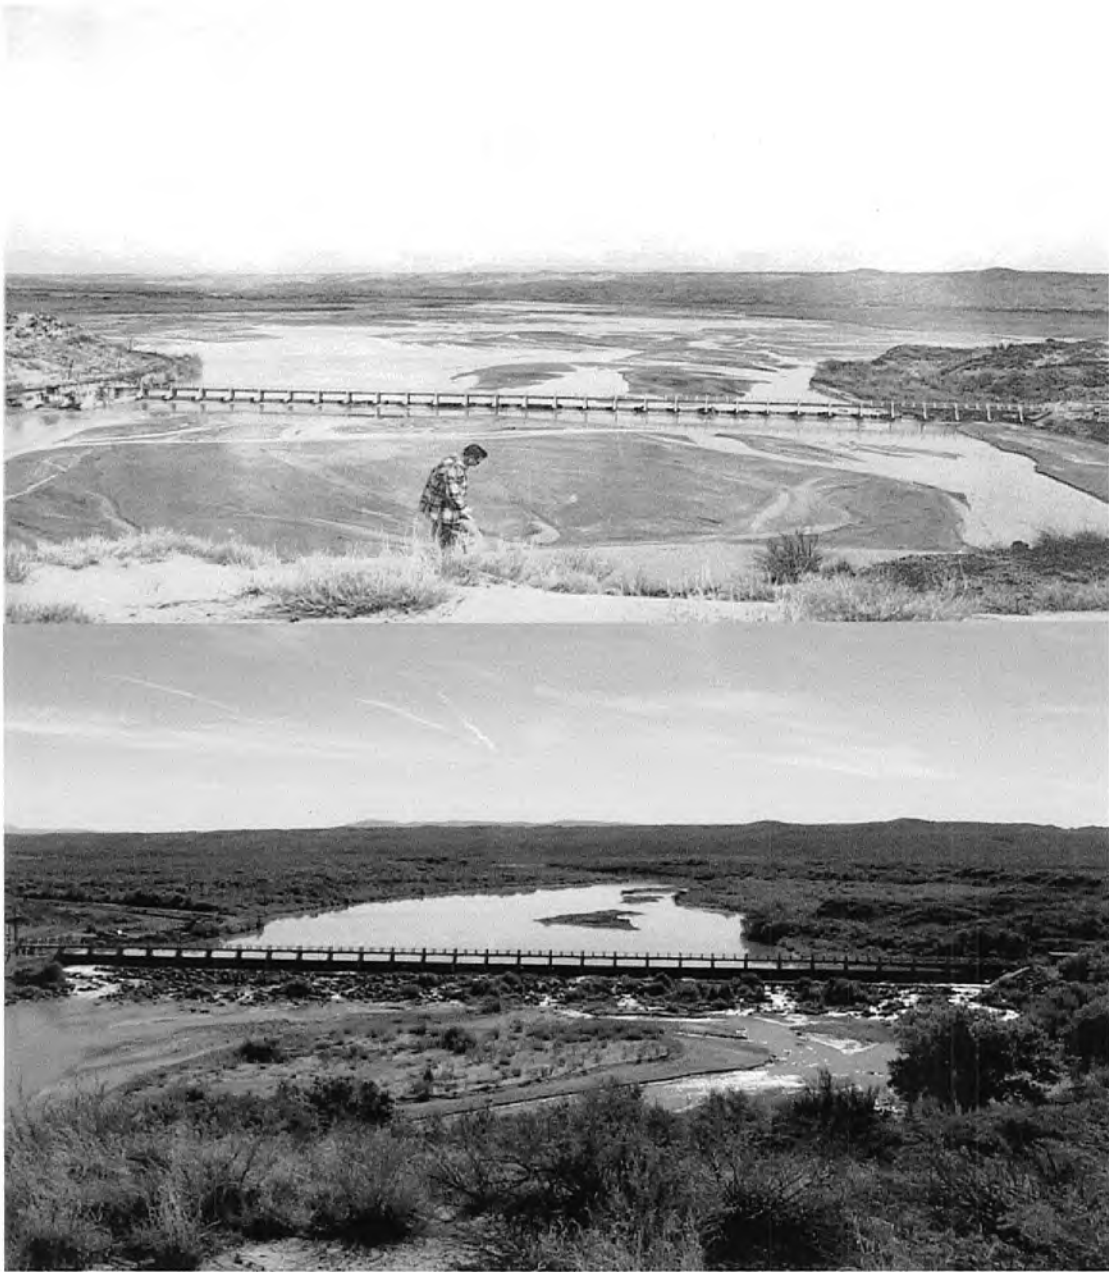
Figure 2: View of San Acacia dam 1952 and 2002 that shows how strongly the channel has been narrowed in last 50 years.

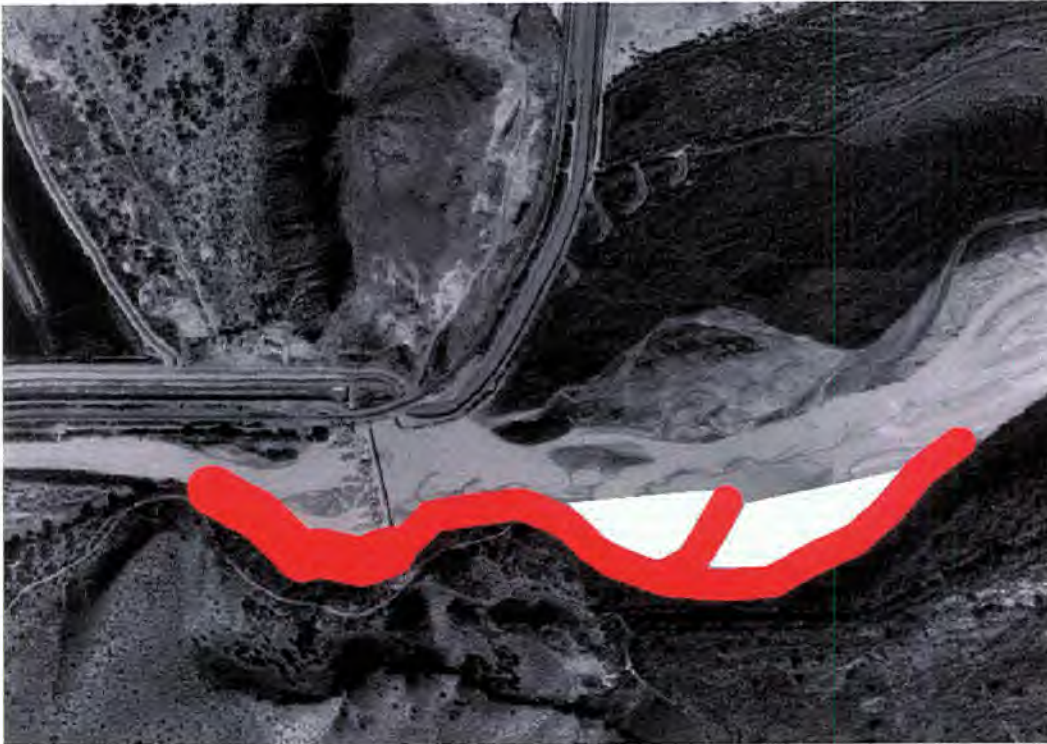
Figure 4: Proposed location of bypass channel sketched on aerial photograph. The red line shows proposed alignment and approximate size of the channel. The white hatch symbolizes the backwater/side arm area, presently covered with mature vegetation.
