2019 Annual Monitoring Results and Maintenance Plan for San Acacia Reach Restoration Sites

Prepared for:
New Mexico Interstate Stream Commission
5550 San Antonio
Albuquerque, New Mexico 87109

Prepared by:
GeoSystems Analysis, Inc.
3150 Carlisle Blvd. NE,
Albuquerque, NM 87110
www.gsanalysis.com

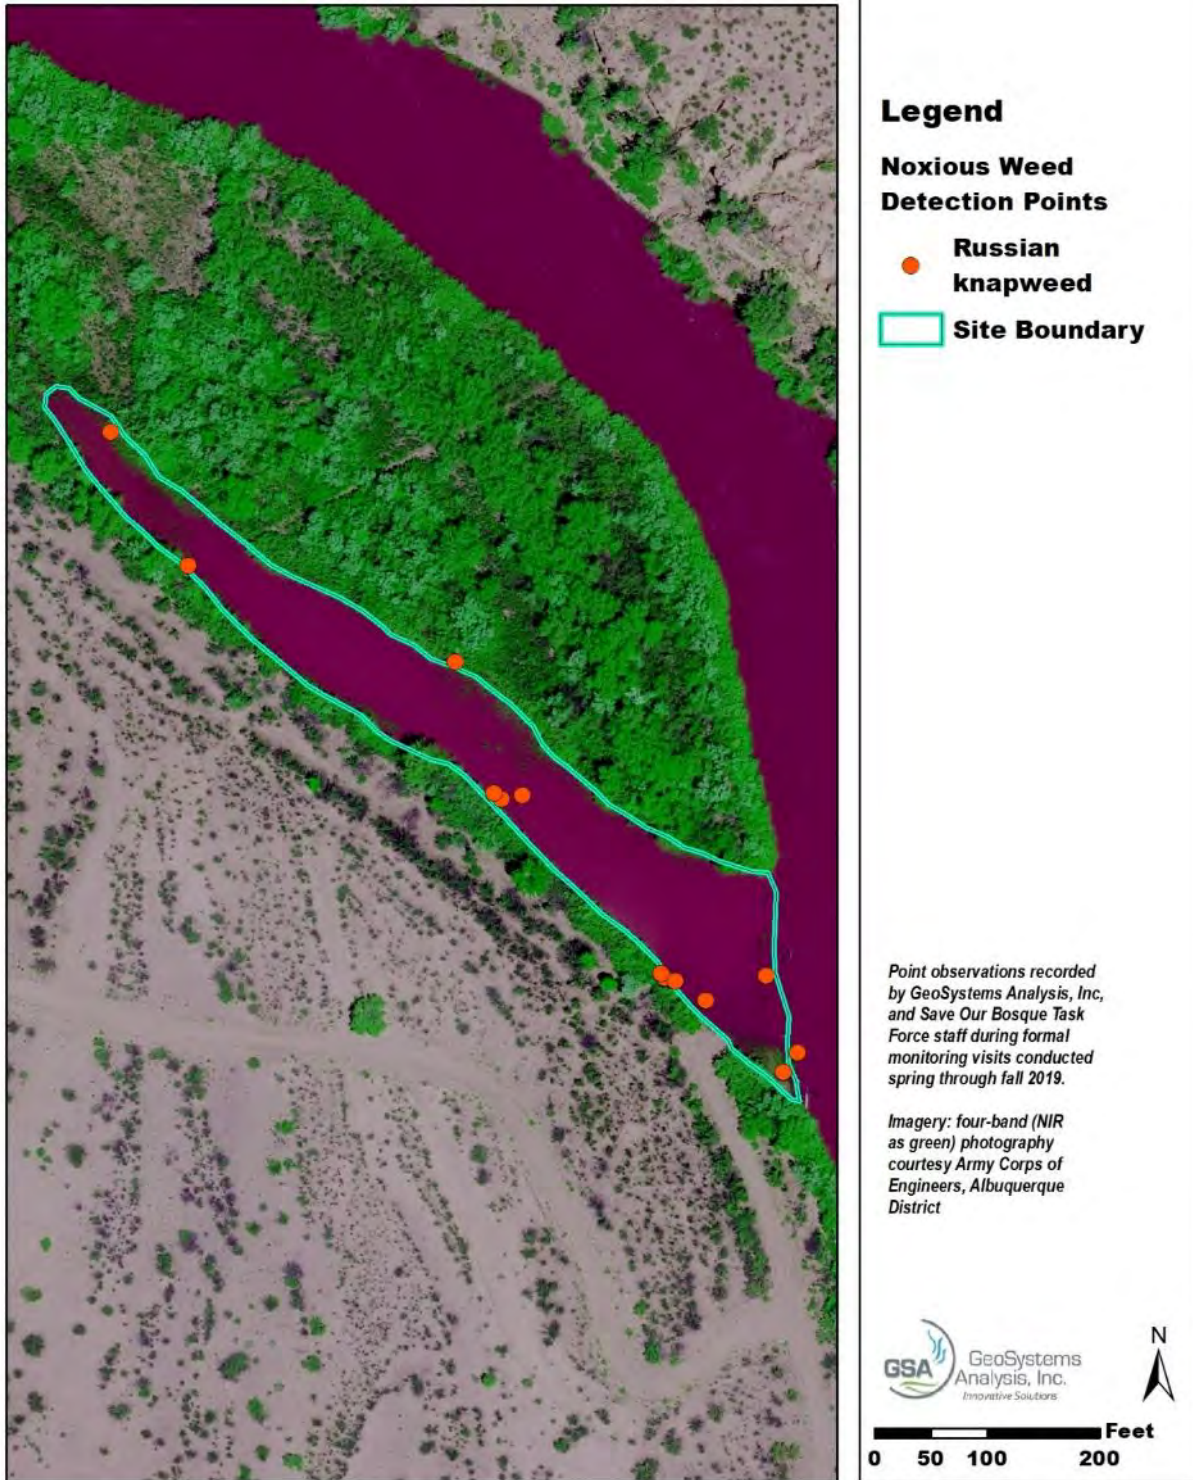
**Noxious Weed Detections through October 2019:
Site RM 112**

Figure D-1. Noxious weed species populations documented at RM 112.

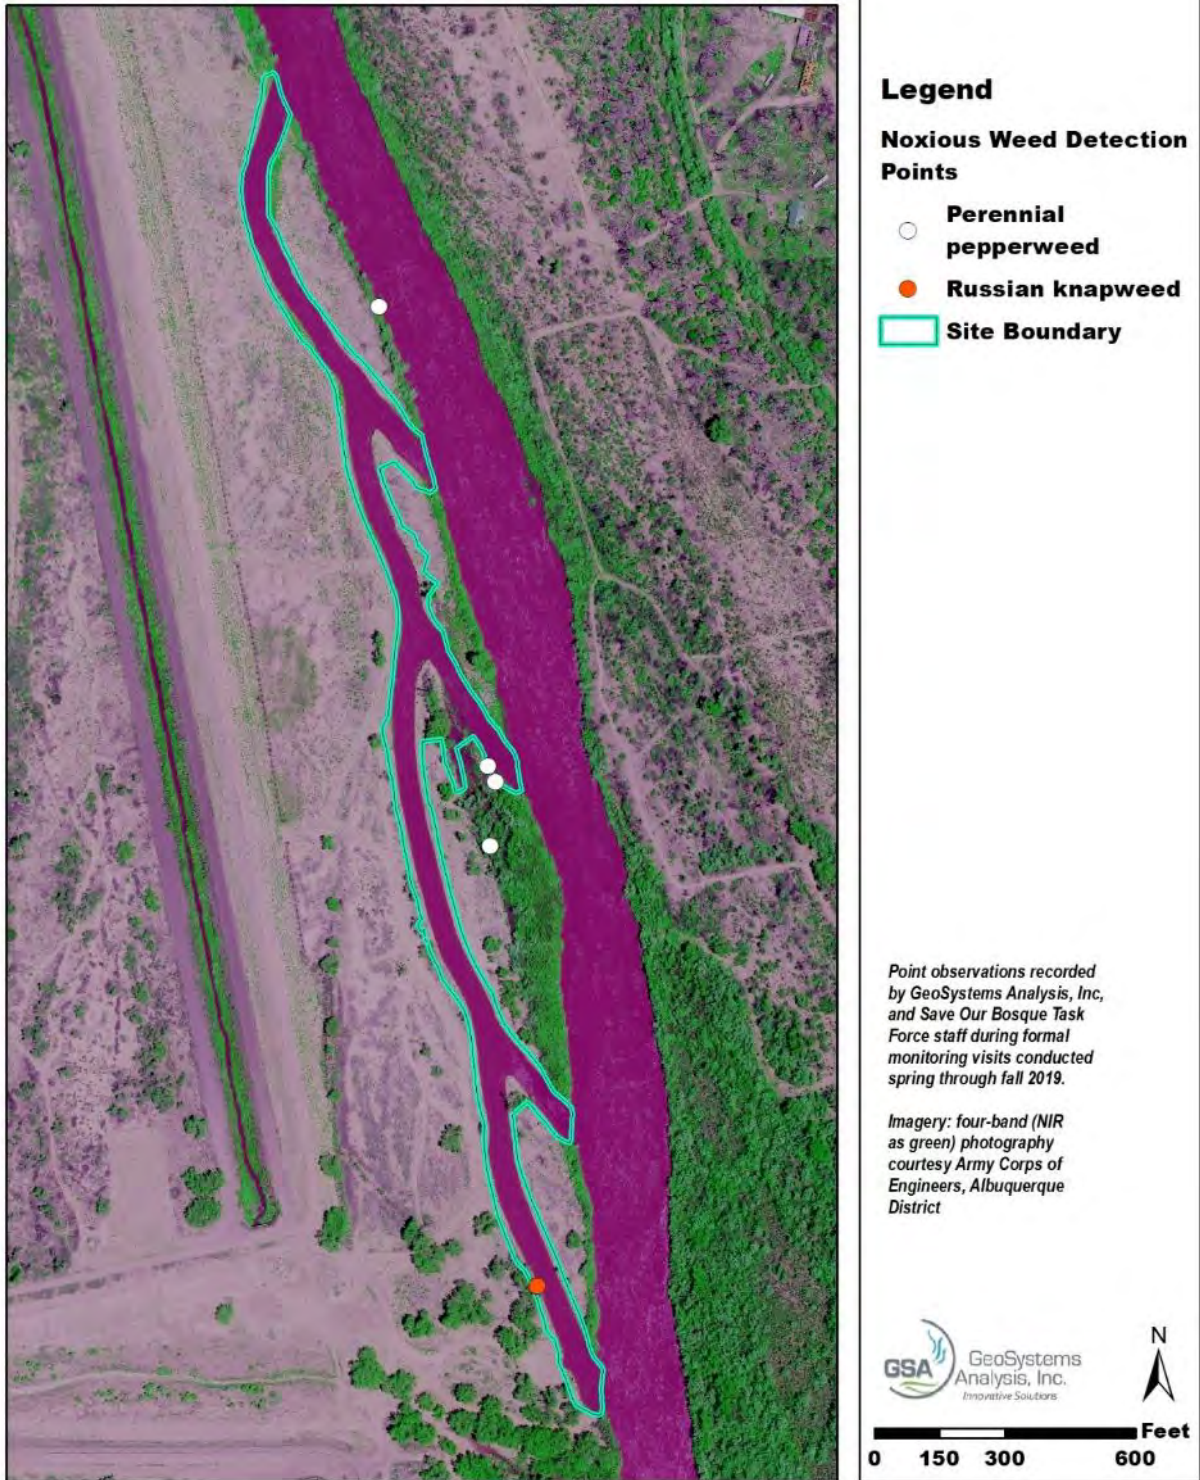
**Noxious Weed Detections through October 2019:
Site RM 103 (Escondida West)**

Figure D-3. Noxious weed species populations documented at RM 103.

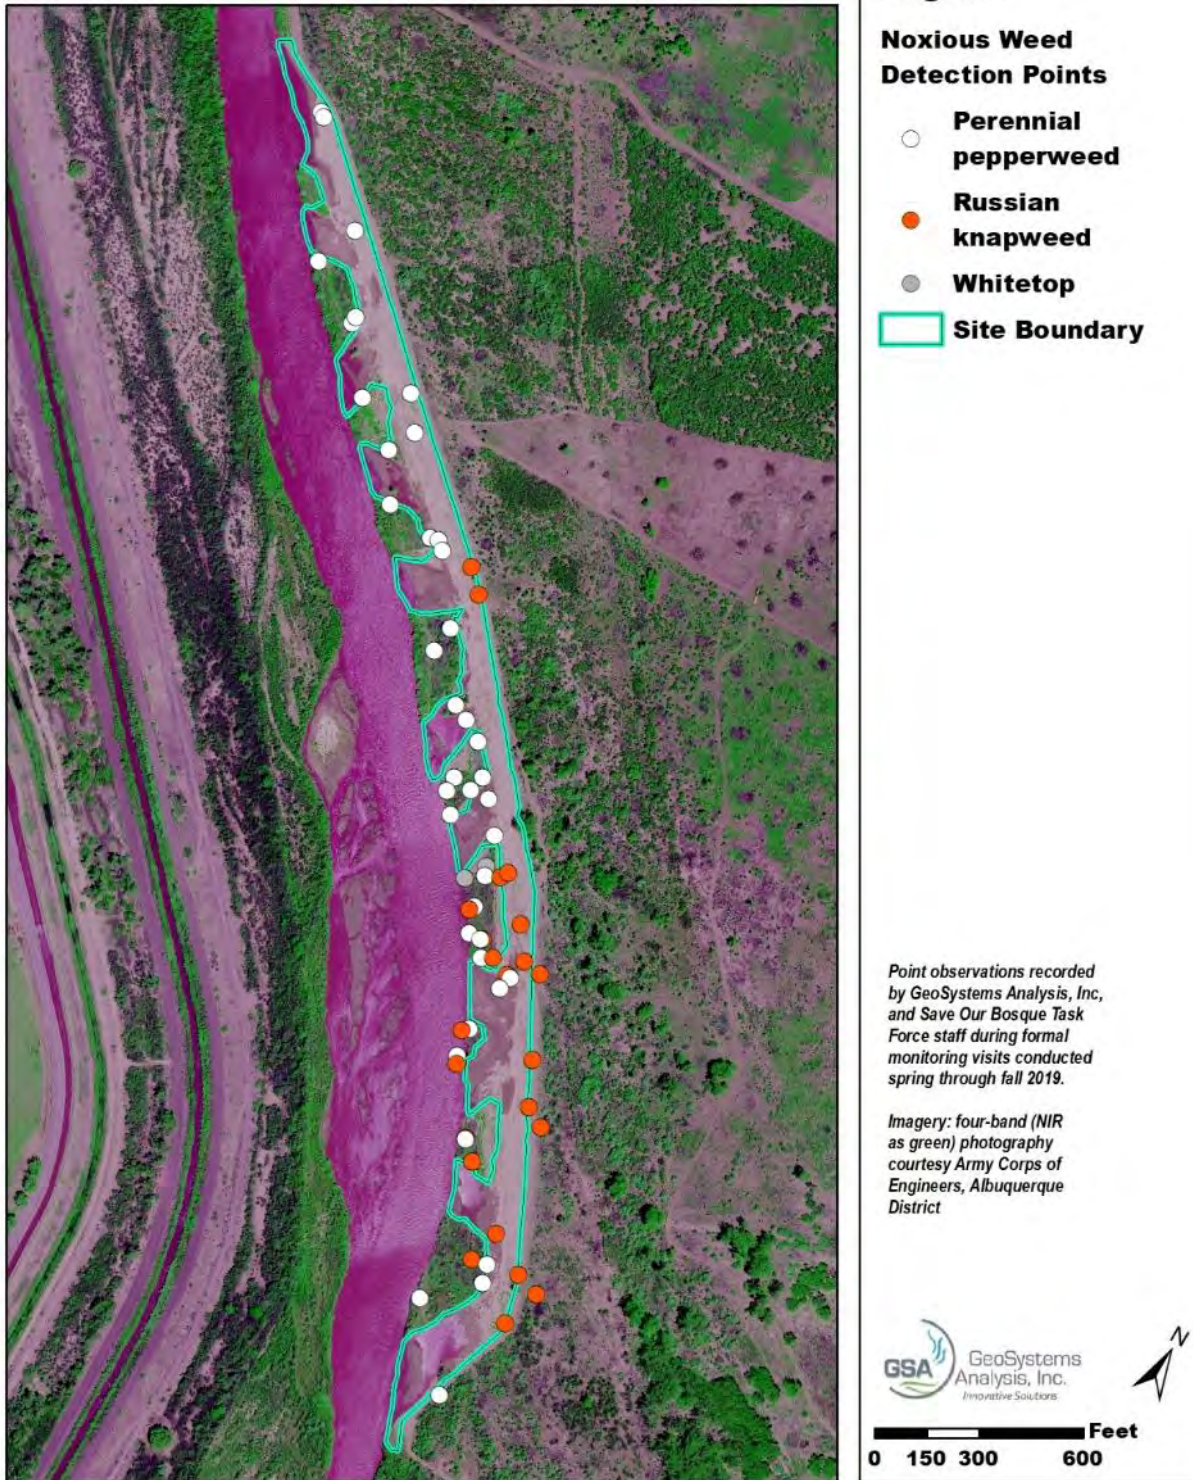
**Noxious Weed Detections through October 2019:
Site RM 93**

The greatest number of noxious weed populations (a total of 66) were documented at the RM 93 (Rhodes) project site. The RM 93 site also contained the highest number of noxious weed species observed (3). The most common noxious weed recorded at RM 93 was perennial pepperweed (*Lepidium latifolium*). This species was also documented at restoration sites RM 104.5, RM 103, and RM 100.5 (**Table 8**). The next most common was Russian knapweed (*Acroptilon repens*), which was recorded at restoration sites RM 112, RM 103.0 and RM 93. Twelve Ravenna grass (*Saccharum ravennae*) plants were observed at RM 99.5. Six of the Ravenna grass plants were in the rosette stage while the other six were mature plants with seed heads. Two populations of whitetop (*Cardaria draba*) were identified at RM 93 (**Table 8**).

Figure D-6. Noxious weed species populations documented at RM 93.

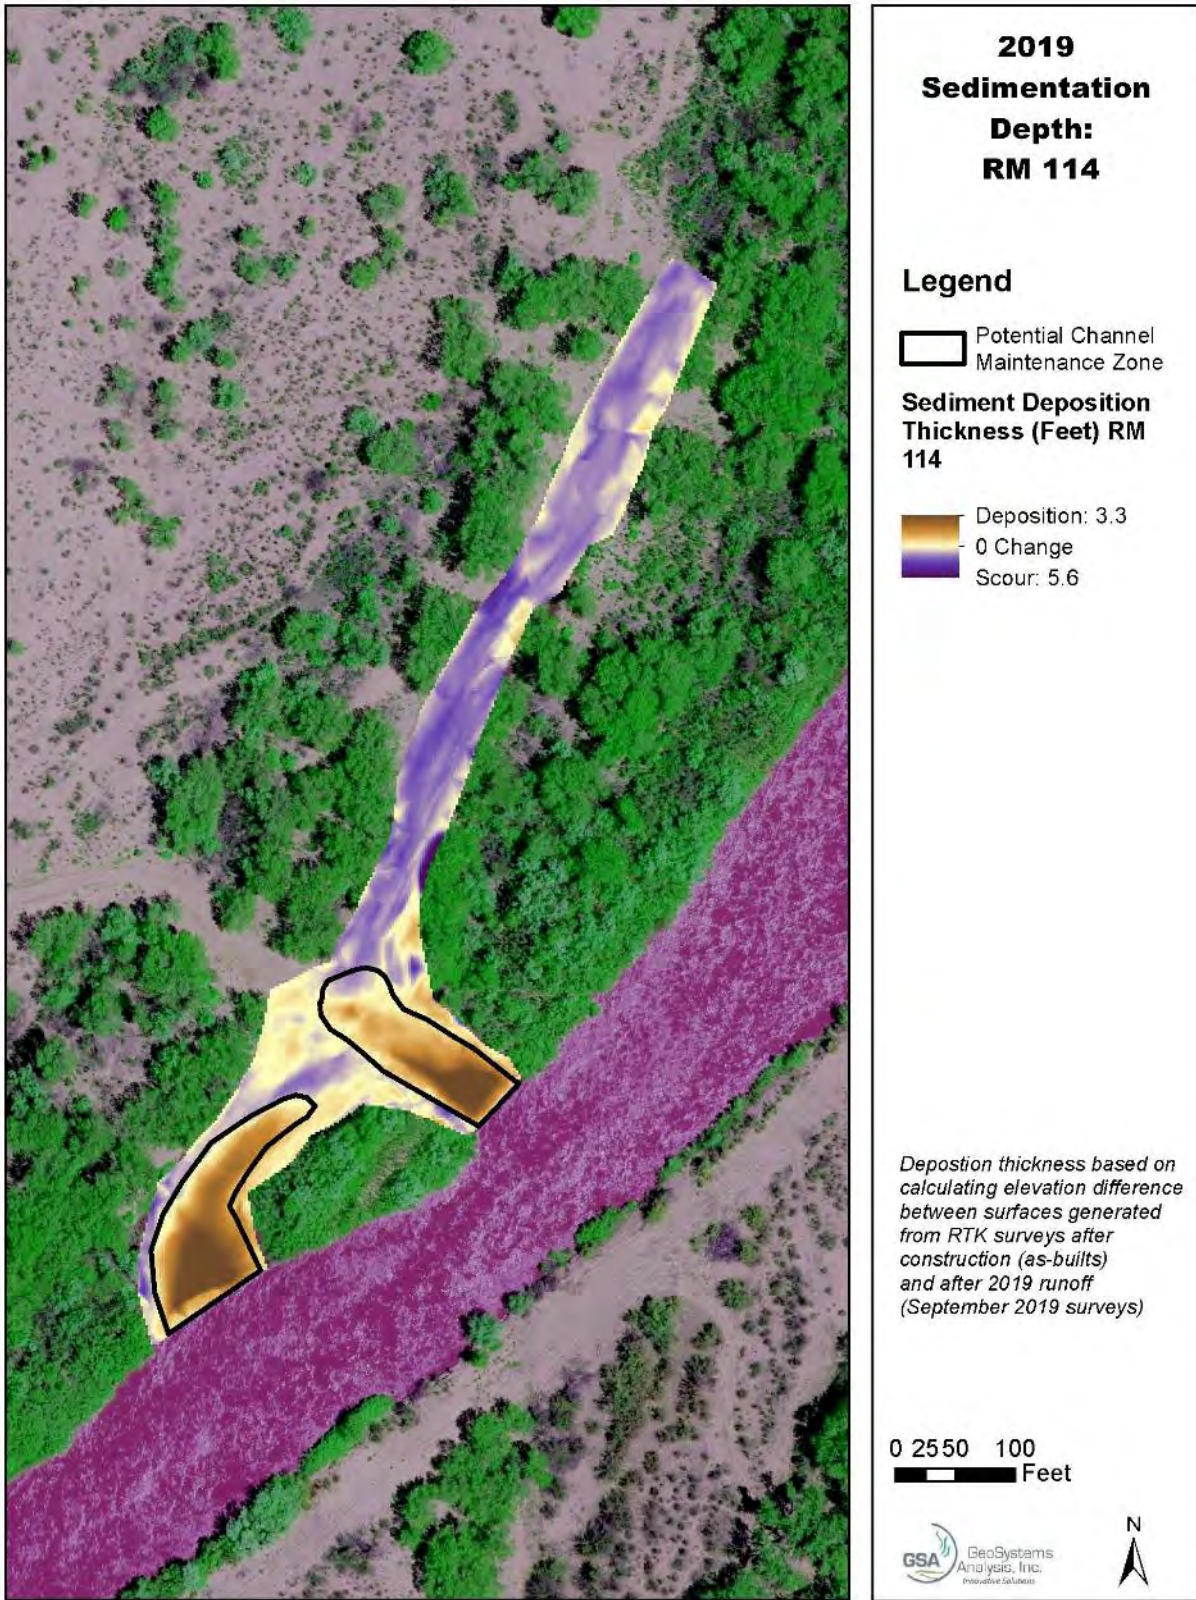
Figure G-1. Post-runoff sediment deposition and scour at project site RM 114.

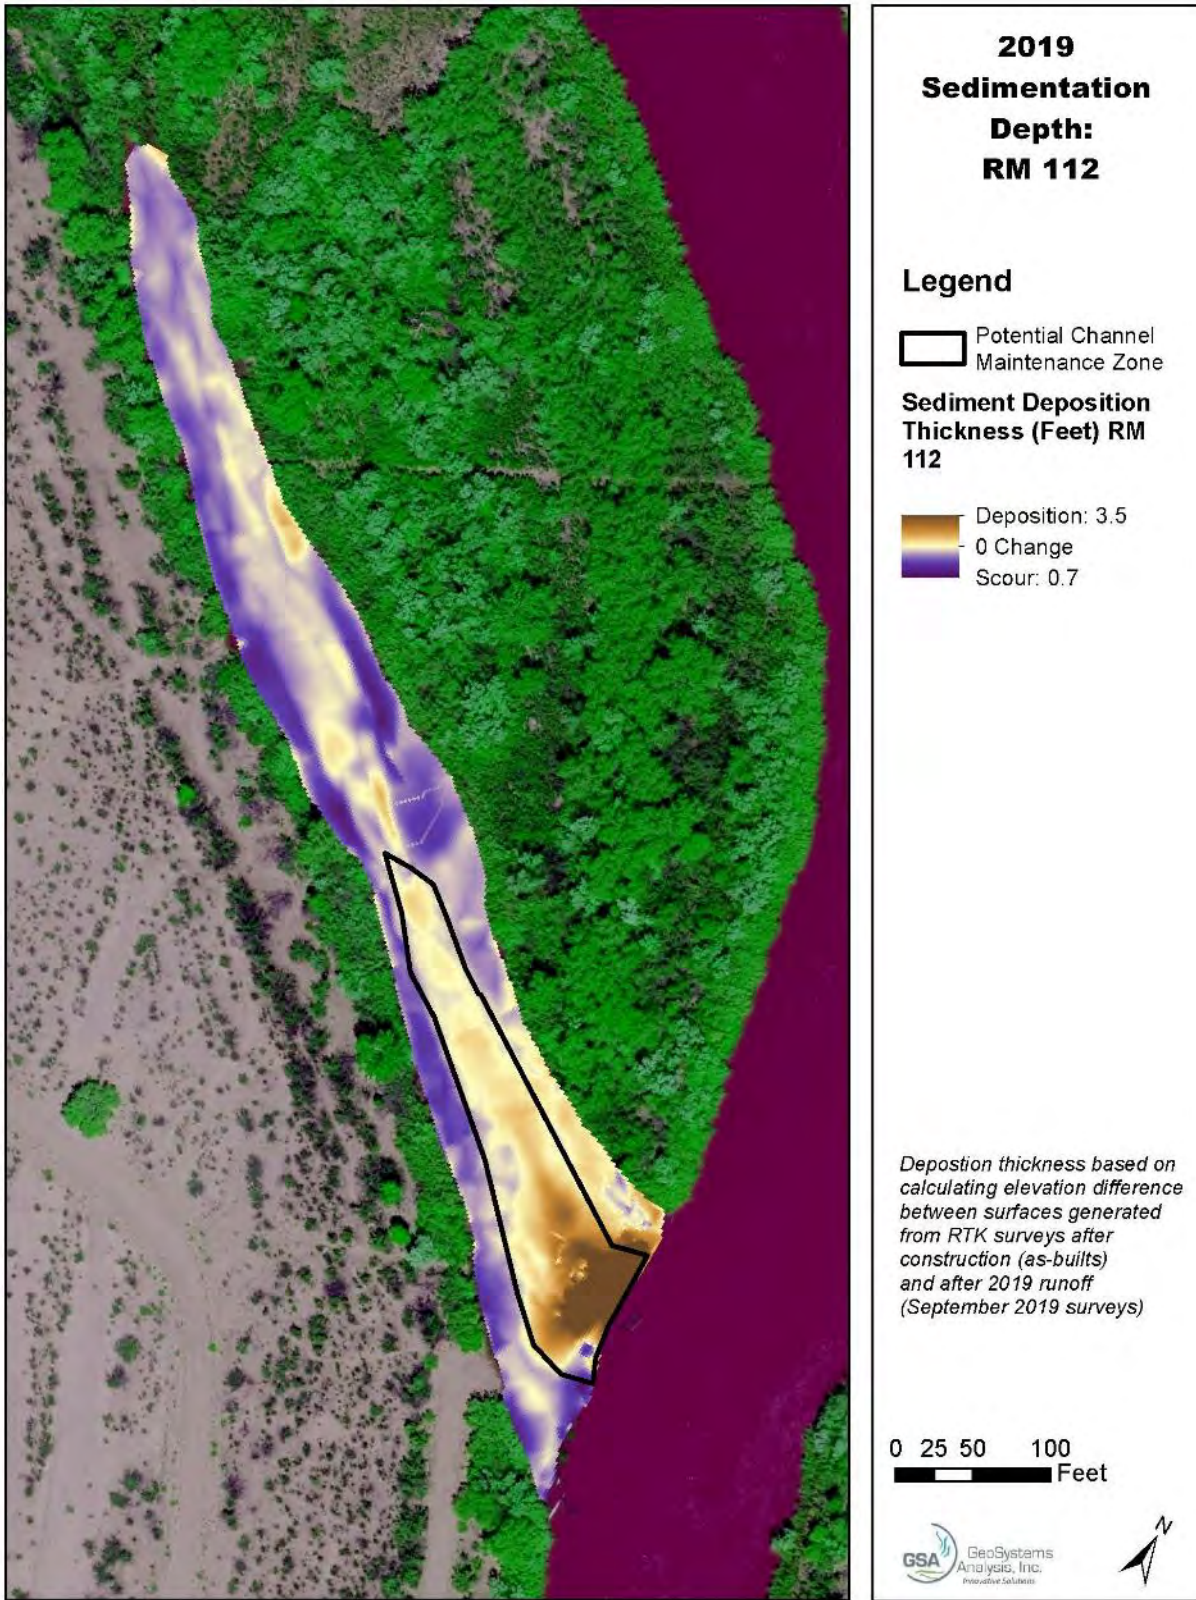
Figure G-2. Post-runoff sediment deposition and scour at project site RM 112.

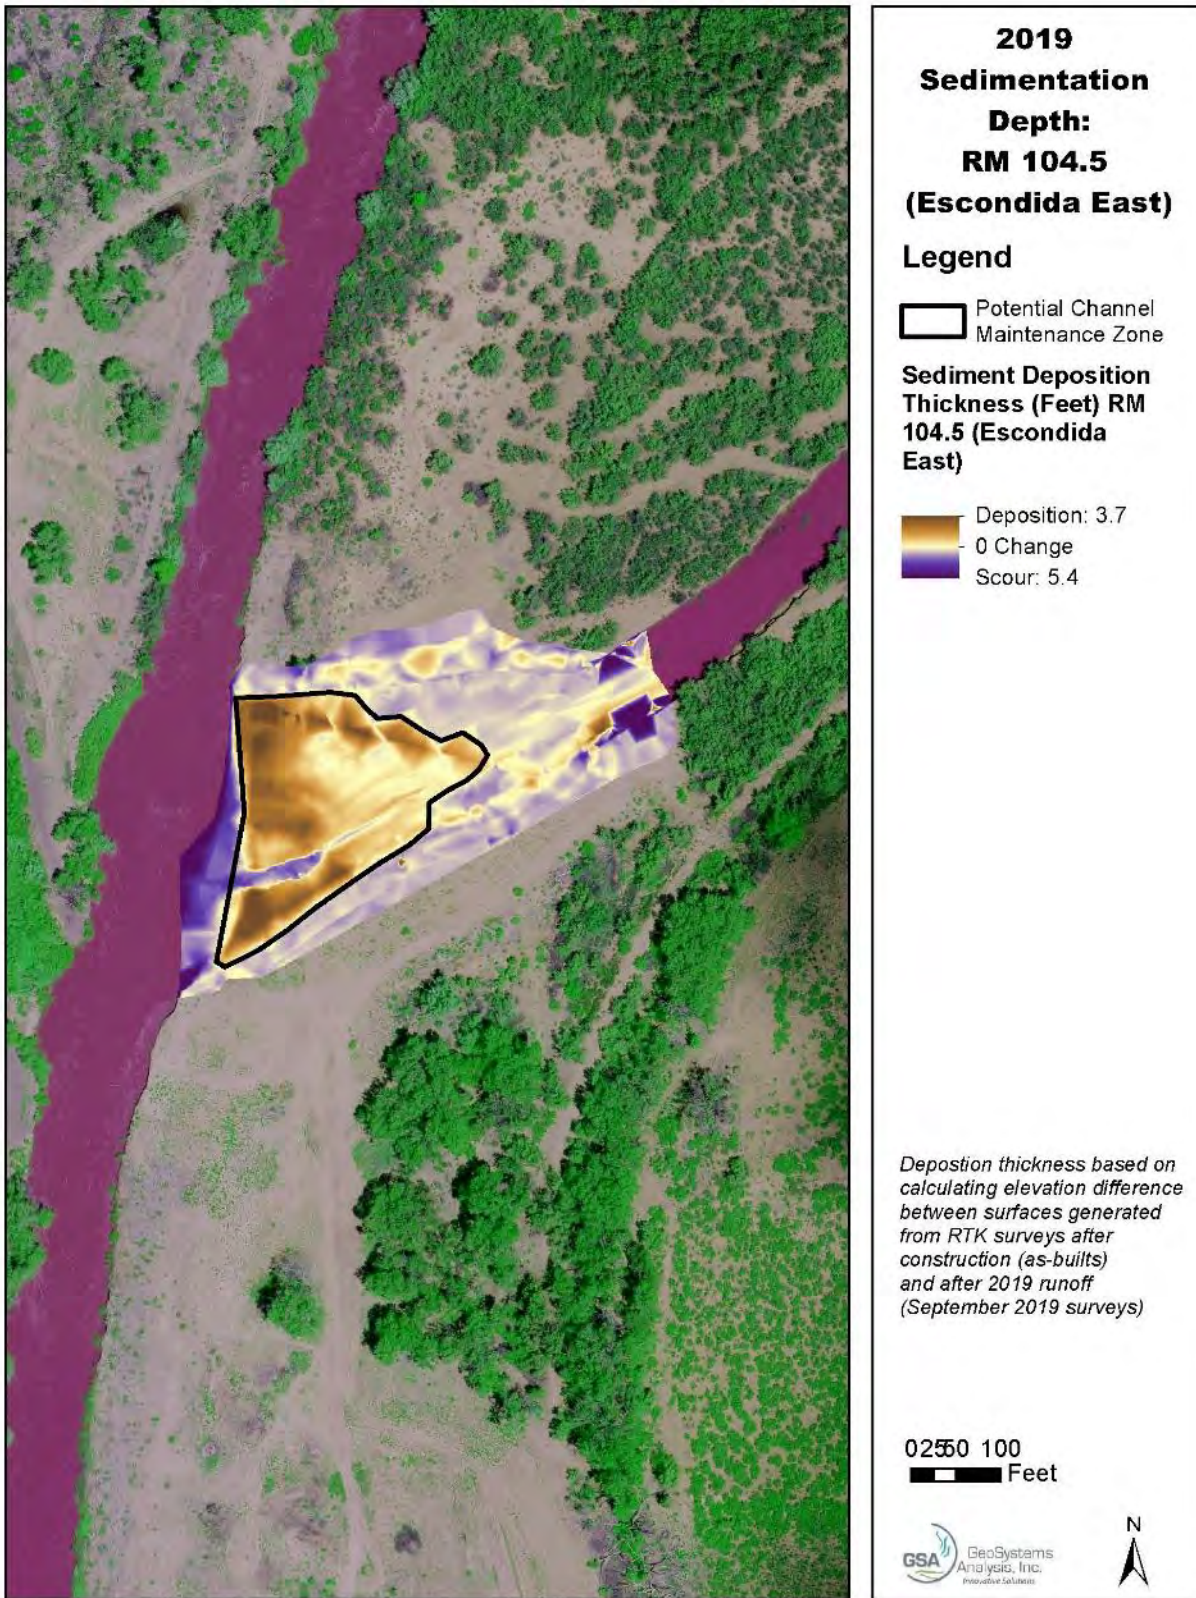
Figure G-3. Post-runoff sediment deposition and scour at project site RM 104.5.

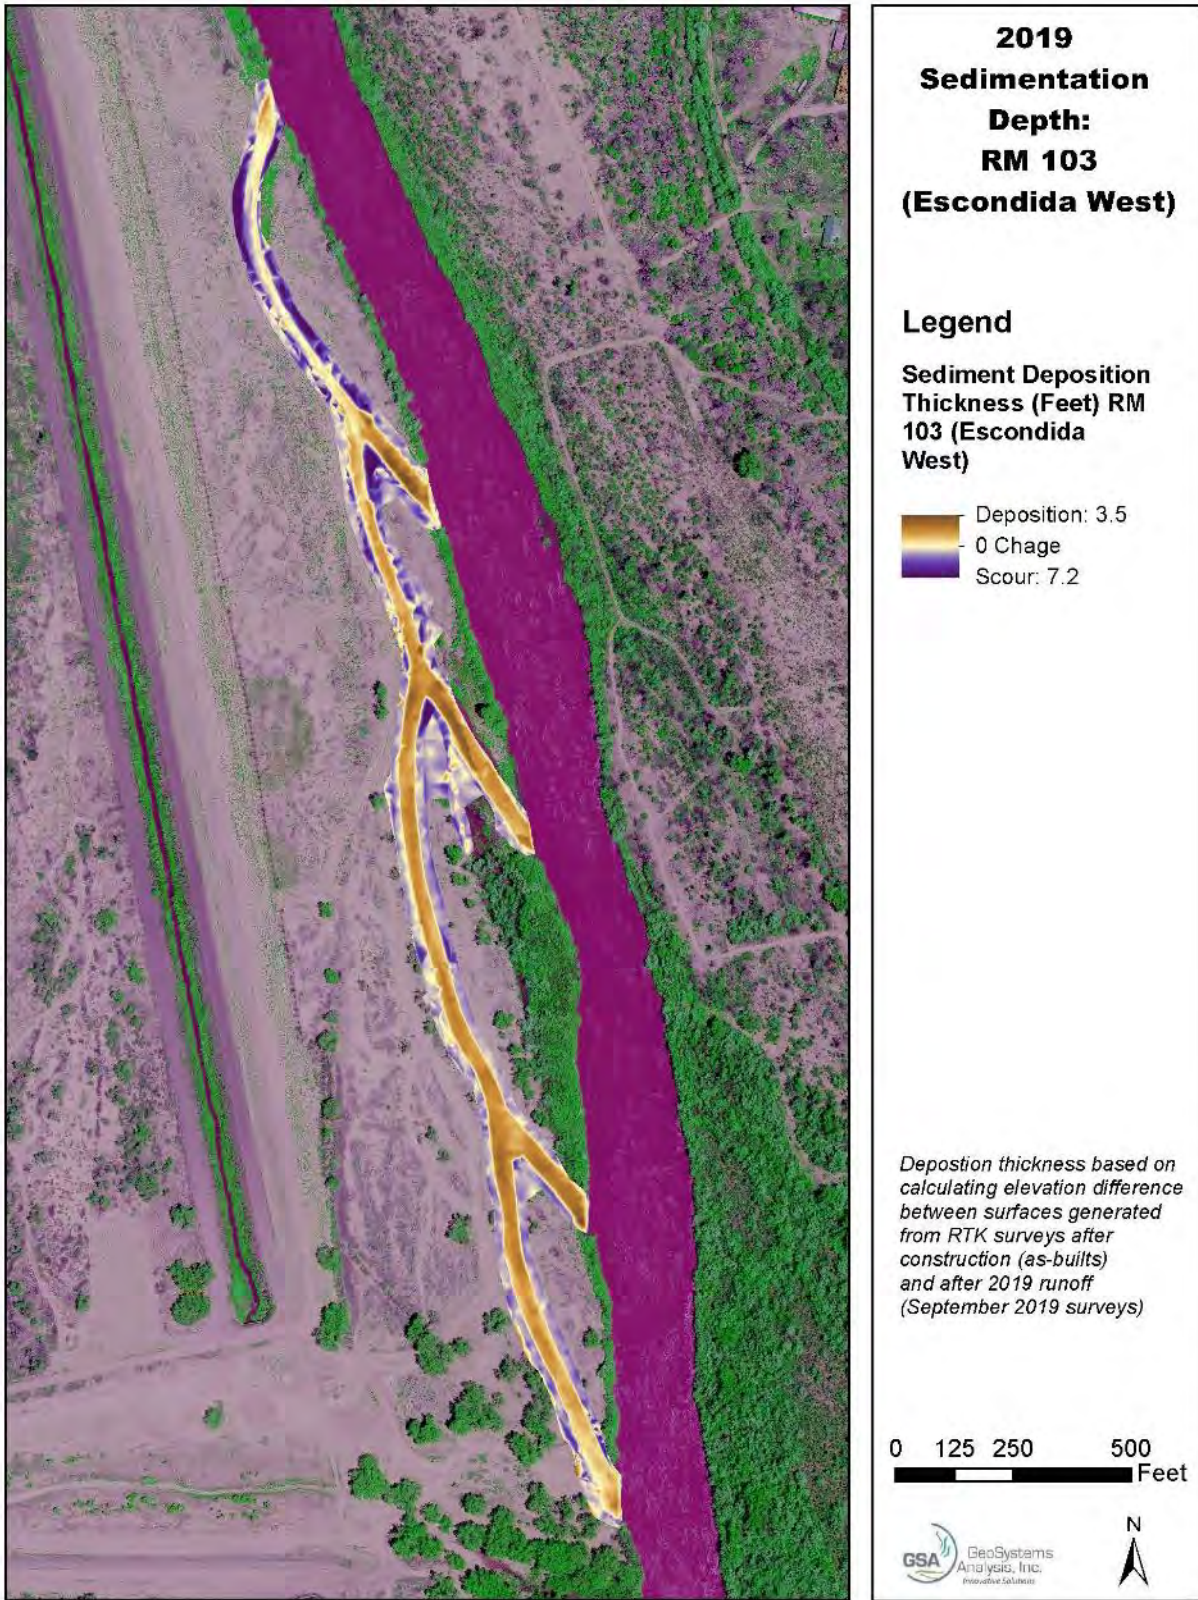
Figure G-4. Post-runoff sediment deposition and scour at project site RM 103.

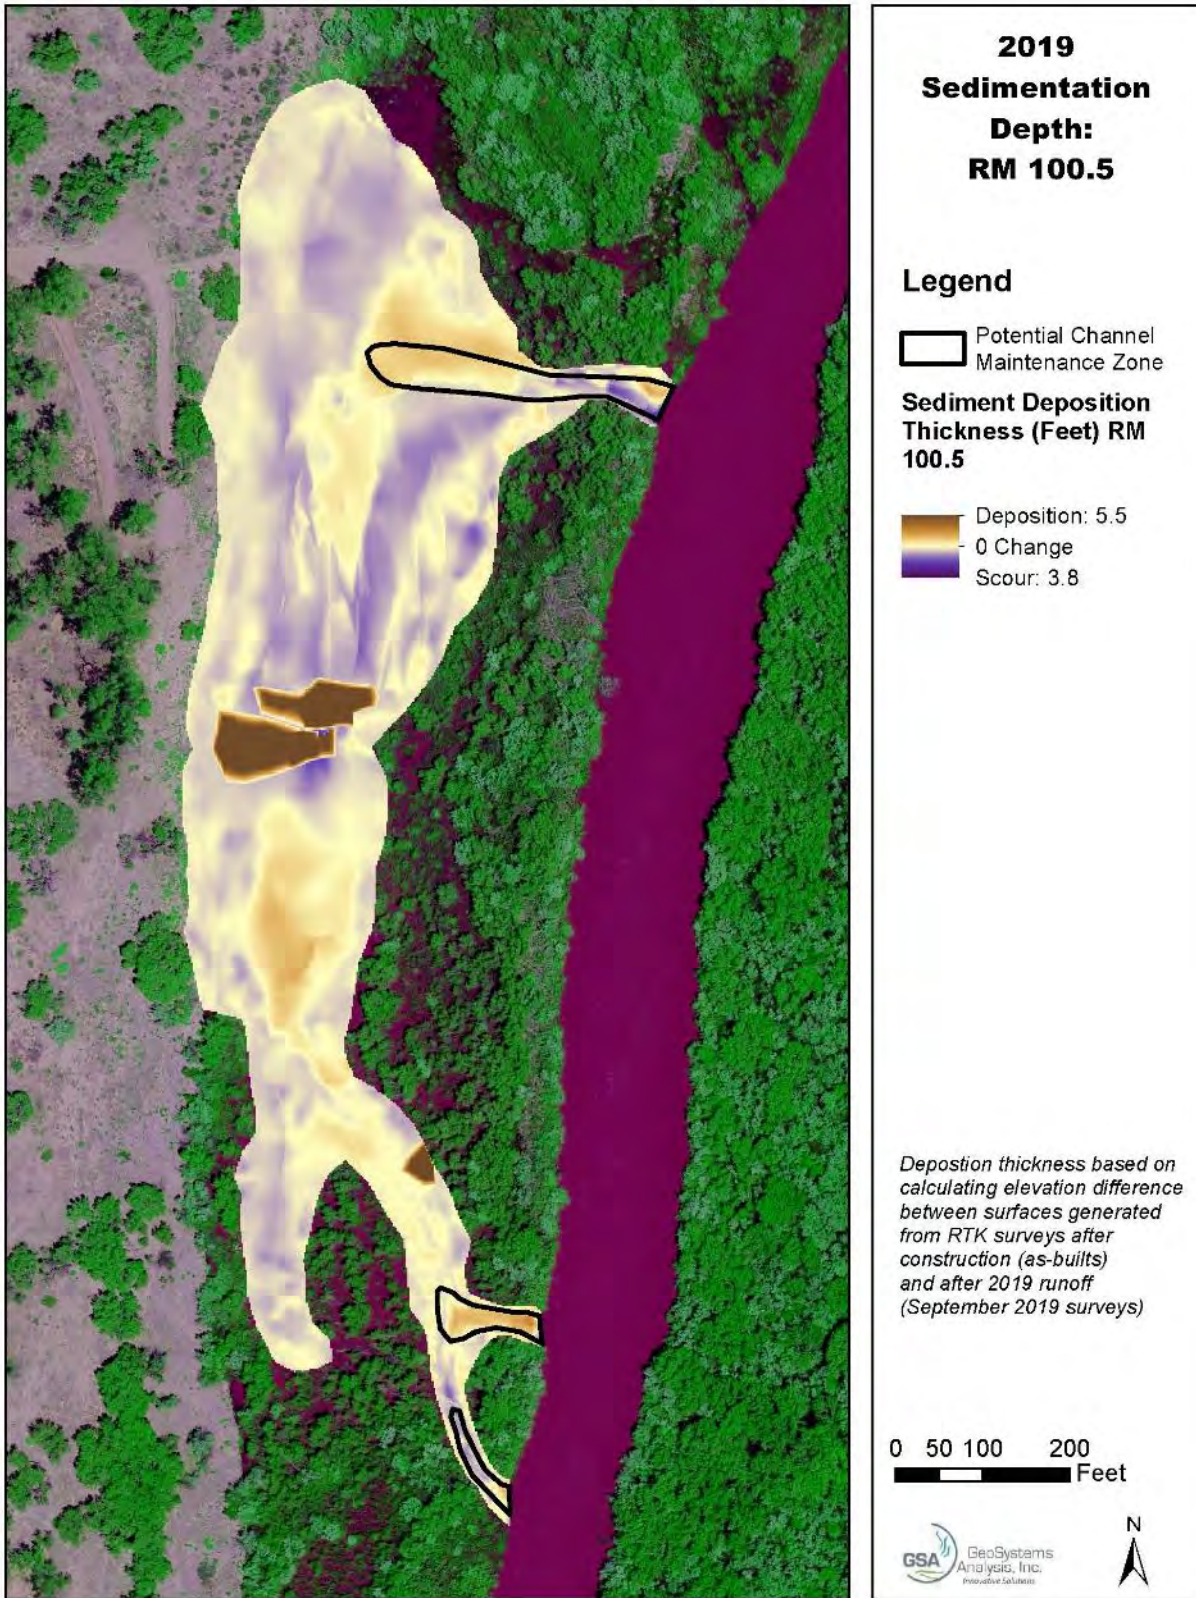
Figure G-5. Post-runoff sediment deposition and scour at project site RM 100.5.

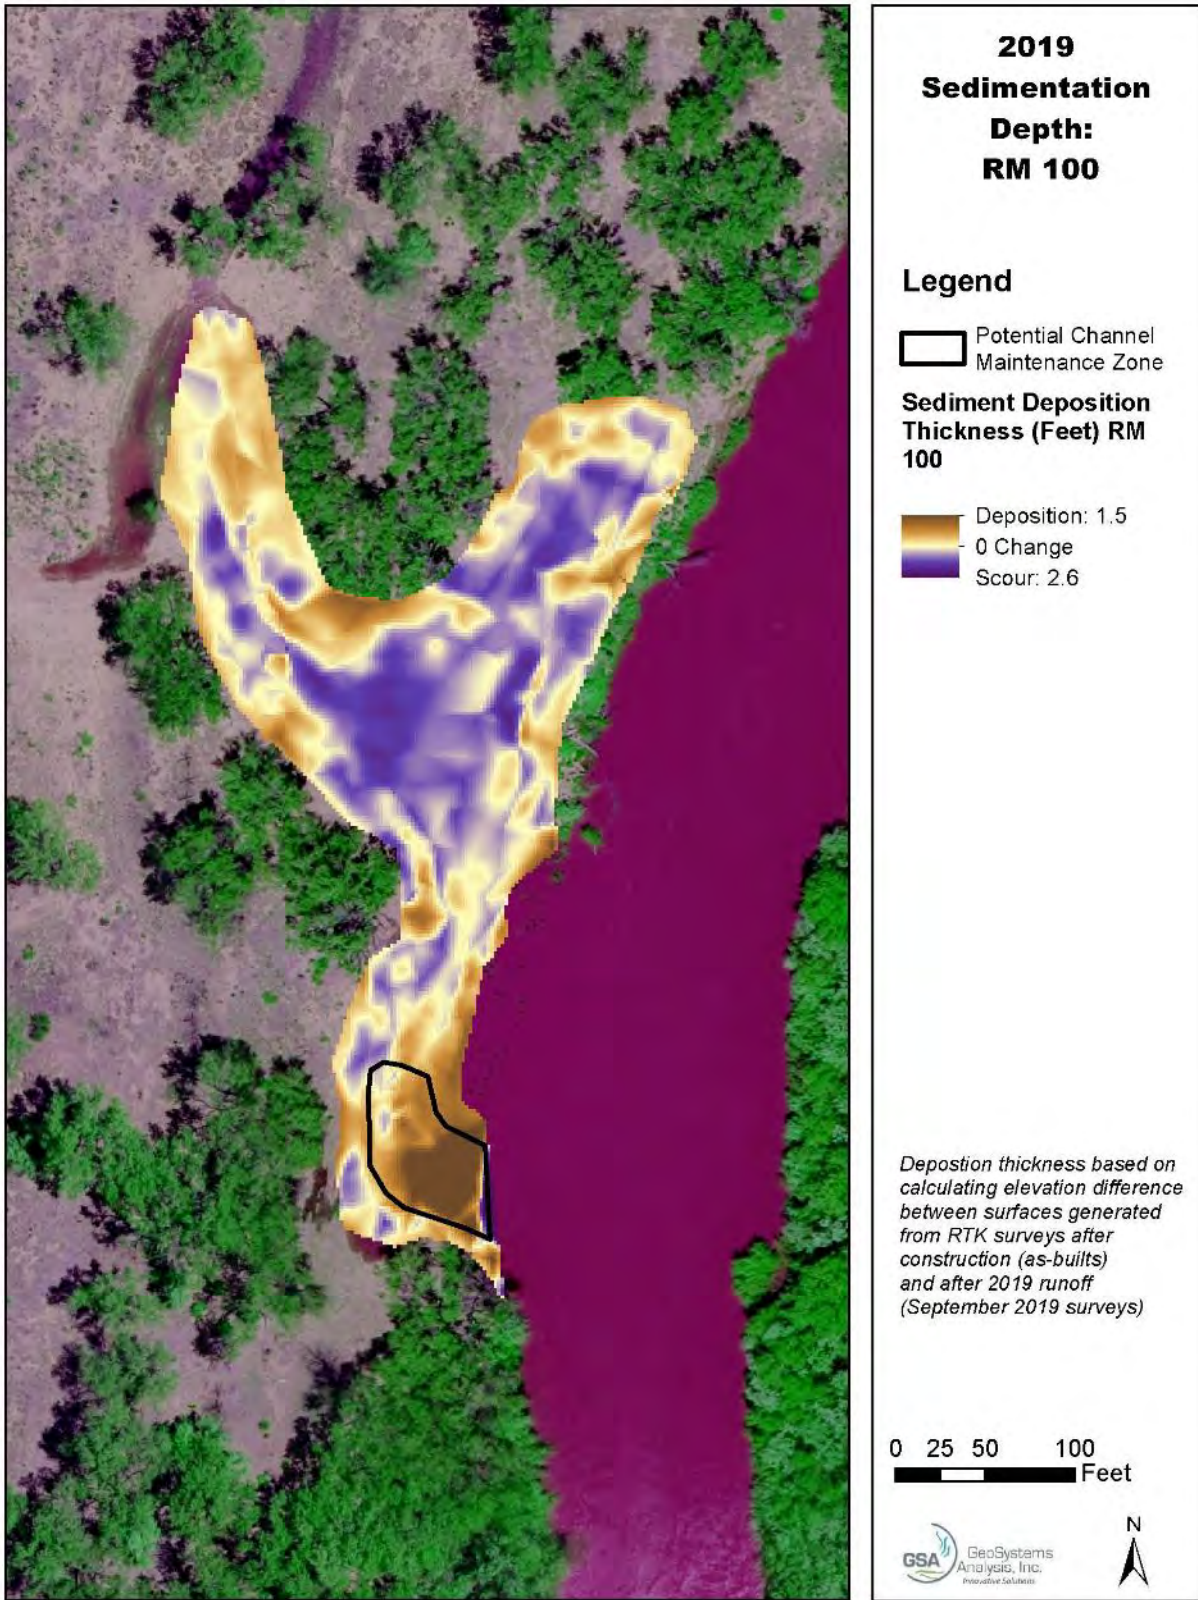
Figure G-6. Post-runoff sediment deposition and scour at project site RM 100.

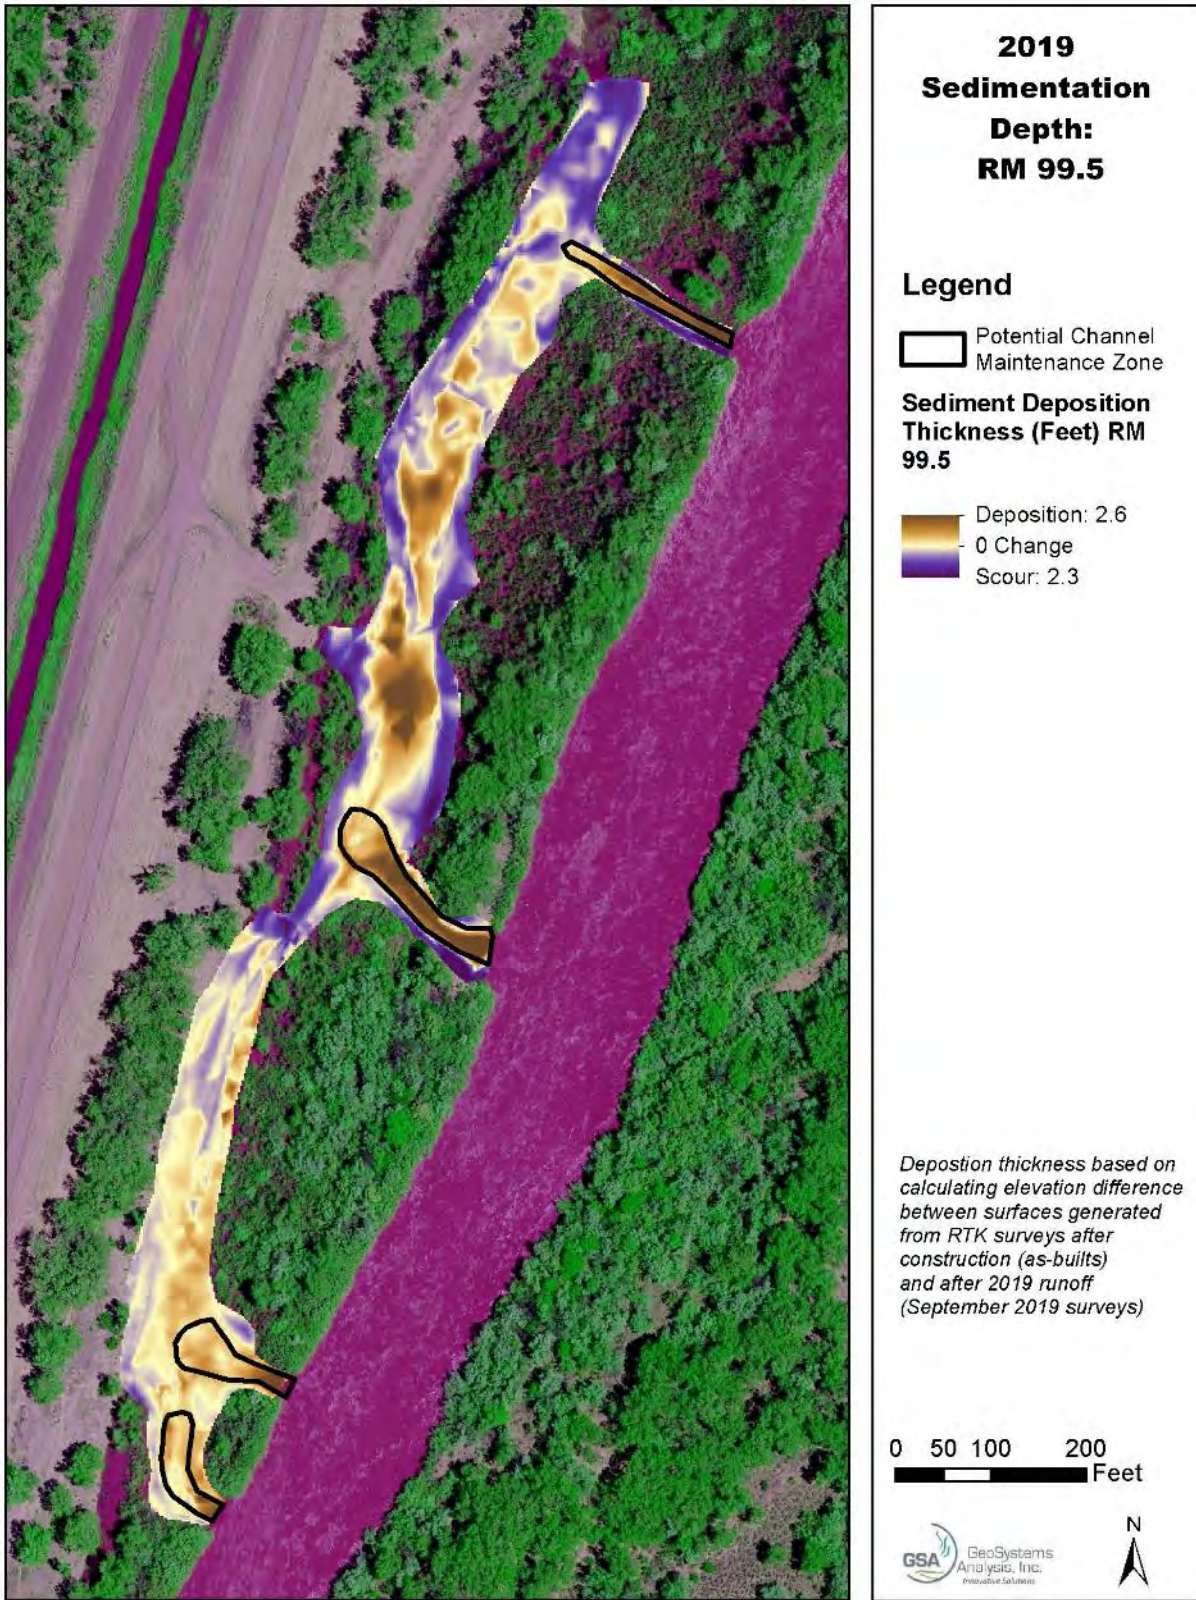
Figure G-7. Post-runoff sediment deposition and scour at project site RM 99.5.

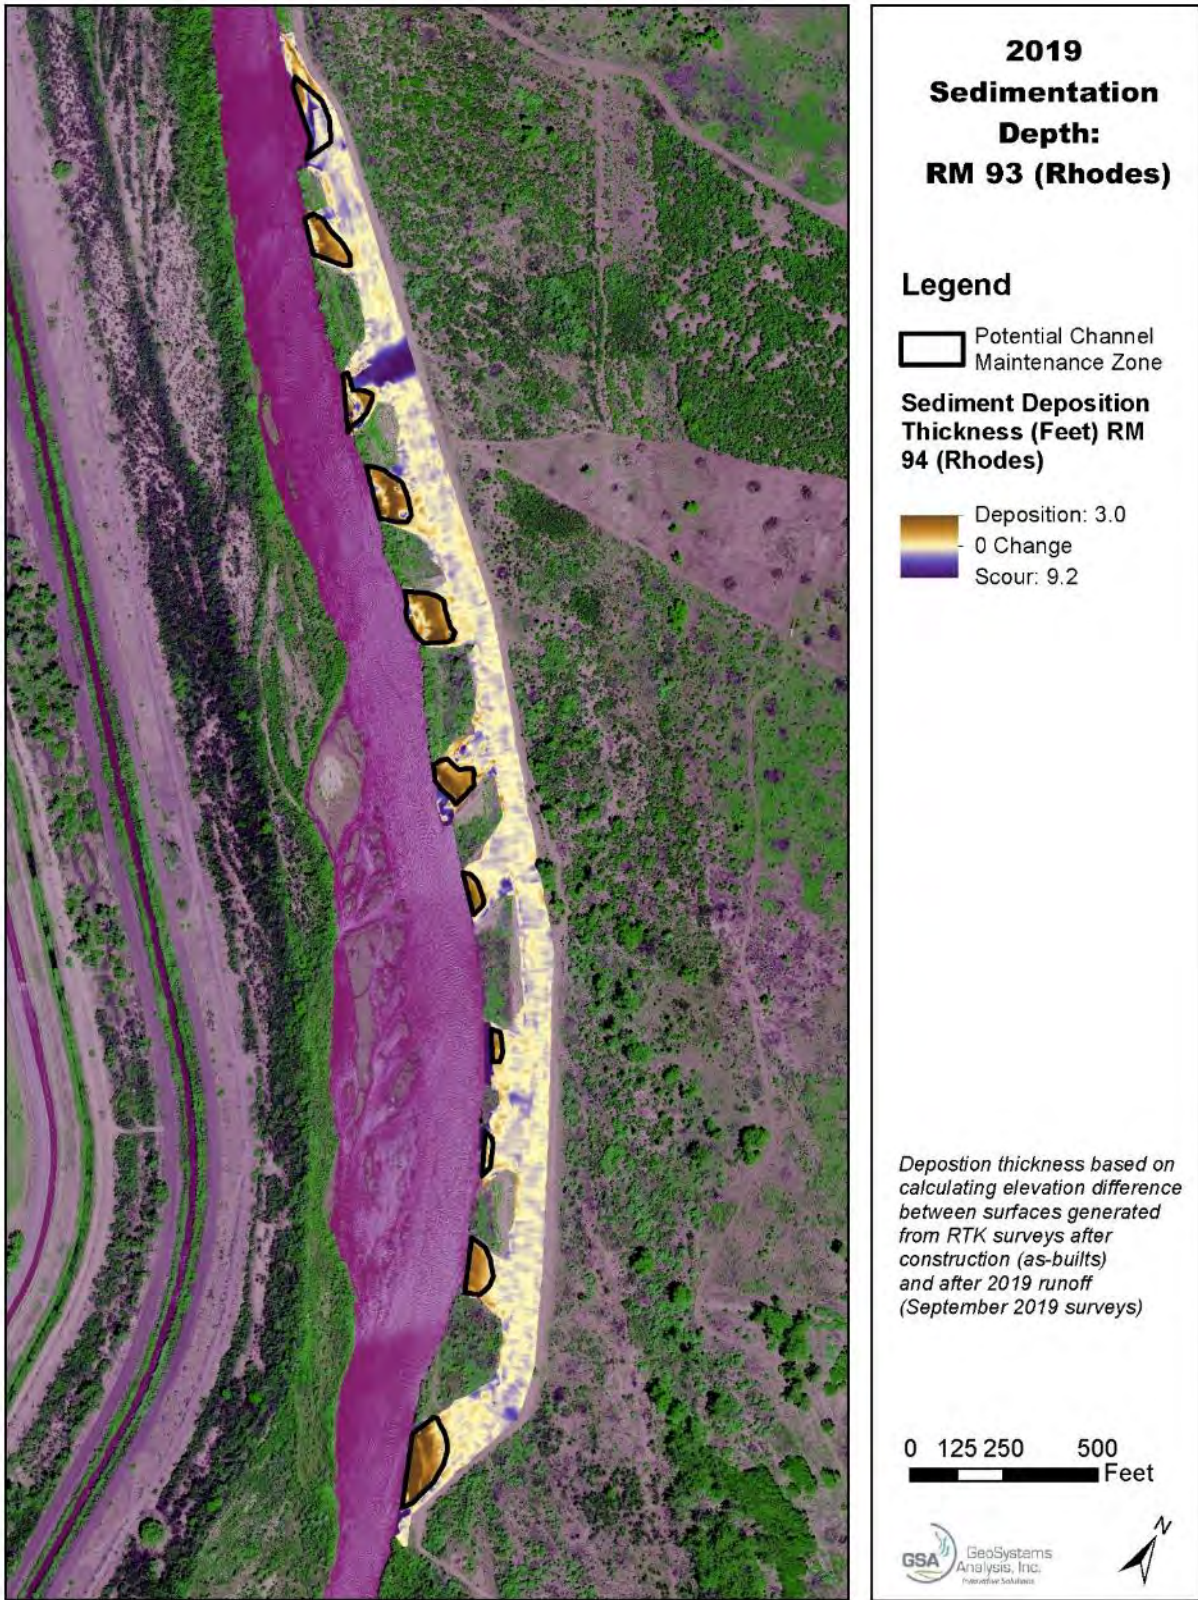
Figure G-8. Post-runoff sediment deposition and scour at project site RM 93.
