**MIDDLE RIO GRANDE  
ISLETA REACH PHASE II  
RIVERINE HABITAT RESTORATION PROJECT  
BIOLOGICAL ASSESSMENT**

**U.S. BUREAU OF RECLAMATION, ALBUQUERQUE AREA OFFICE**  
555 Broadway NE, Suite 100  
Albuquerque, New Mexico 87102

**SWCA ENVIRONMENTAL CONSULTANTS**  
5647 Jefferson Street NE  
Albuquerque, New Mexico 87109  
Telephone: 505-254-1115; Fax: 505-254-1116  
[www.swca.com](http://www.swca.com)

April 1, 2010

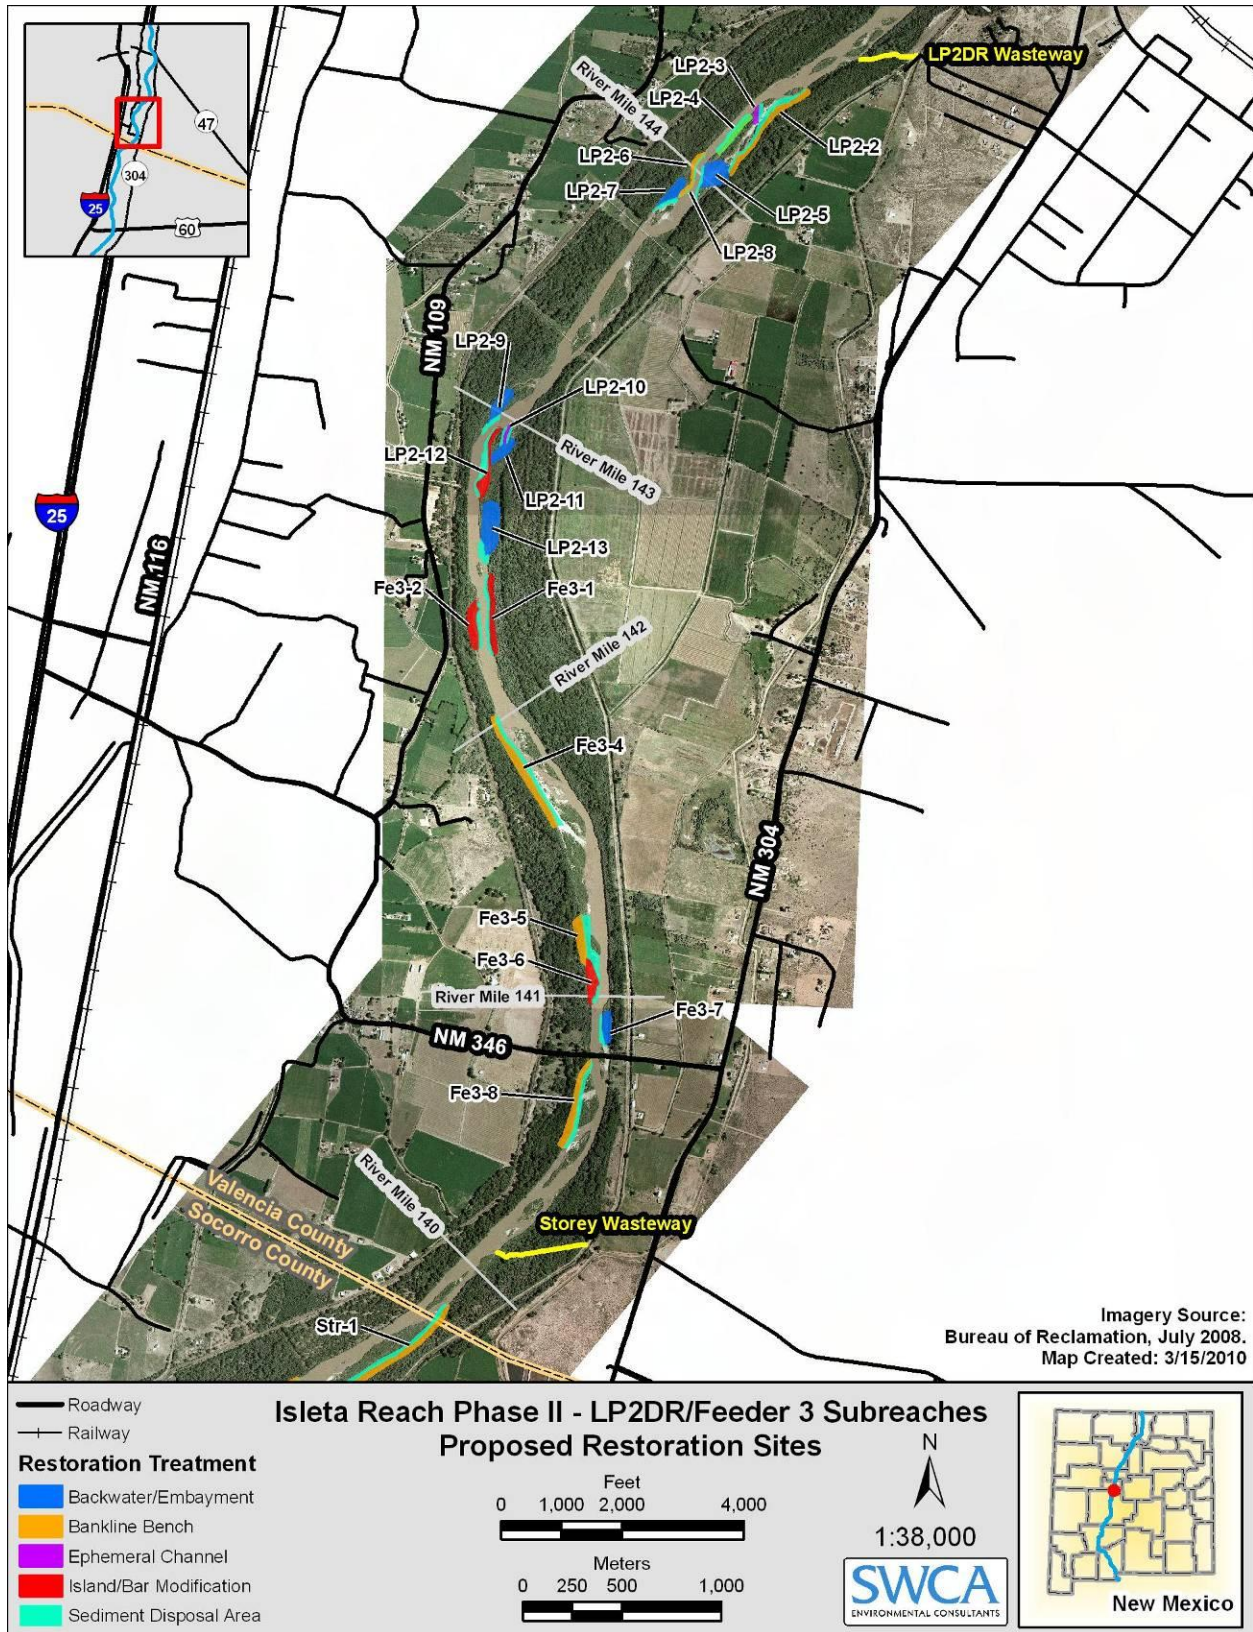
Figure 1.3. LP2DR and Feeder 3 Subreach restoration sites.

The LP2DR Subreach (see Figure 1.3) is demarcated by the LP2DR outfall at River Mile 144.7 (River Kilometer 232.9) to the north and the Feeder #3 outfall at River Mile 142.8 (River Kilometer 229.8) to the south. The approximate subreach length is 1.9 miles (3.1 km). The Feeder 3 Subreach is demarcated by the Feeder #3 outfall at River Mile 142.8 (River Kilometer 229.8) to the north and the Storey outfall at River Mile 140.1 (River Kilometer 225.5) to the south. The subreach is 2.7 miles (4.3 km) long.

As shown in Figure 1.2 through Figure 1.4, the four subreaches of the Isleta Reach proposed for restoration/rehabilitation techniques are the Belen, Lower Peralta #2 Riverside Drain (LP2DR), Feeder 3, and Storey subreaches. These subreaches lie within the Los Lunas Subreach and the Belen Subreach as defined in the *Restoration Analysis and Recommendations for the Isleta Reach of the Middle Rio Grande, NM* (Parametrix et al. 2008). Brief descriptions of the existing conditions in the Belen, LP2DR, Feeder 3, and Storey subreaches are contained in Sections 1.1.2 through 1.1.4.

The project consists of the application of several alternative restoration/rehabilitation techniques designed to create aquatic habitat in the four subreaches: Belen, LP2DR, Feeder 3, and Storey (see Figure 1.2–Figure 1.4). The goal of the project is to enhance the availability and condition of spawning and egg retention, larval rearing, young-of-year, and over-wintering habitat for the silvery minnow in support of Element S of the RPA in the March 2003 Biological Opinion (USFWS 2003). The objective of the restoration process is to increase measurable habitat complexity in support of various life stages of the silvery minnow by providing slackwater habitat and facilitating lateral migration of the river across bars and riverbanks during various mid-level and high-flow stages. The project will be implemented with construction from September 1, 2010, through April 15, 2011. Specific restoration treatments will be implemented, monitored, and evaluated to inform the restoration plans of future phases. Phase I of the NMISC Isleta Reach Riverine Habitat Restoration Project was implemented in the Peralta and LP1DR subreaches during spring 2009 (Reclamation 2008).

Approximately 148 acres (60 ha) of islands and riverbank will be modified to create slackwater mesohabitat features to increase the spawning and larval fish habitat within the Belen, LP2DR, Feeder 3, and Storey subreaches of the Isleta Reach. Table 2.2 provides a summary of the number of sites and the area affected for each restoration technique by subreach. The areas provided in Table 2.2 also include sediment disposal locations. Maps indicating the location of proposed restoration sites are found in Figure 1.2 through Figure 1.4 above.

A summary of the proposed techniques, their acreage impacted by each restoration technique (including sediment disposal locations), and the target flows for the inundation of the area after construction can be found in Table 3.1 through Table 3.4. Table 3.5 summarizes the treatment acres in each subreach. Refer to Figure 1.2 through Figure 1.4 for site locations. The restoration

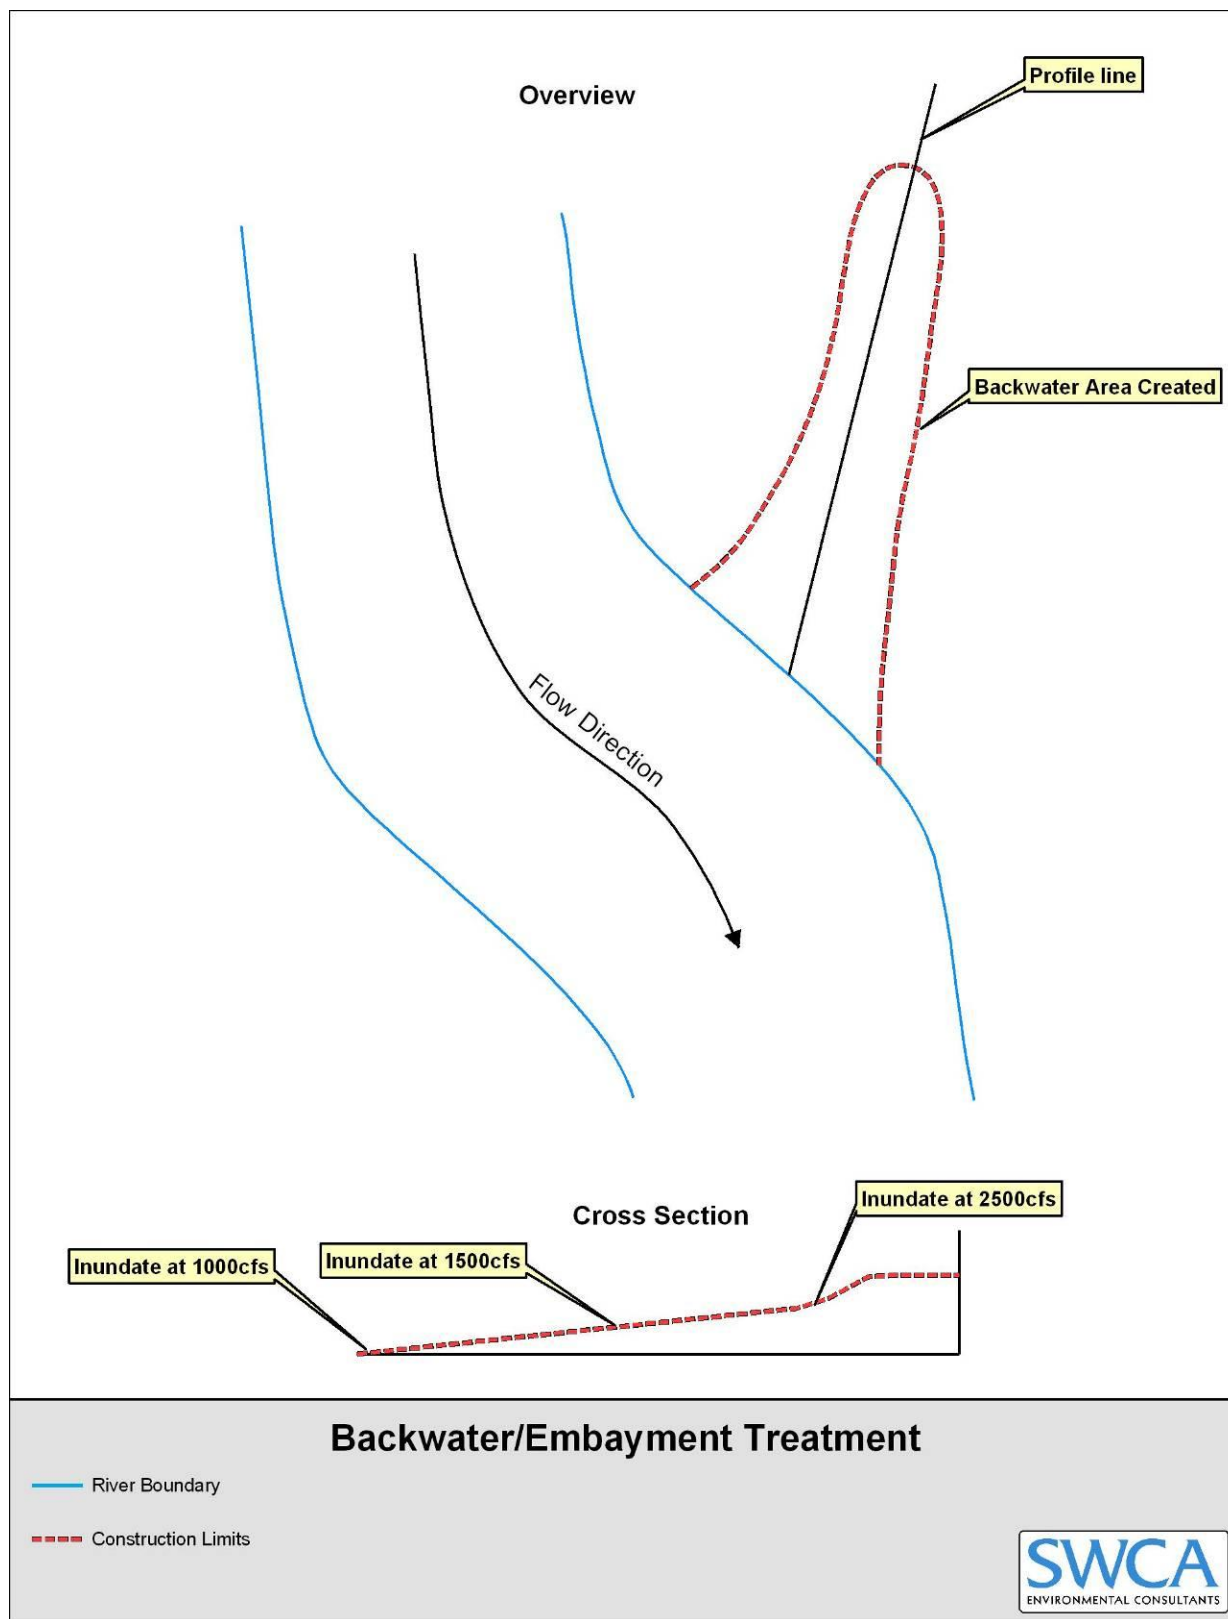
Figure 3.1. Backwater/Embayment schematic design.

The creation of moderate- to high-flow backwater and embayment areas will involve the removal of riverbank and island vegetation and the excavation of soils to prescribed depths. Backwater areas (e.g., no upstream inlet) will be constructed on the downstream end of large point bars, already low-velocity areas, at a range of elevations. This allows for inundation at a range of river flows (Figure 3.1 and Figure 3.2). Backwater areas will slope slightly, with the downstream end lower in elevation than the upstream end, increasing the amount of habitat opportunities at a range of river flows. Backwaters can also be terraced to create two distinct target inundation discharges.

This treatment is being used to increase the amount of shallow, low-velocity habitat. The creation of backwaters and embayments are intended to retain drifting silvery minnow eggs and provide habitat for developing silvery minnow larvae.

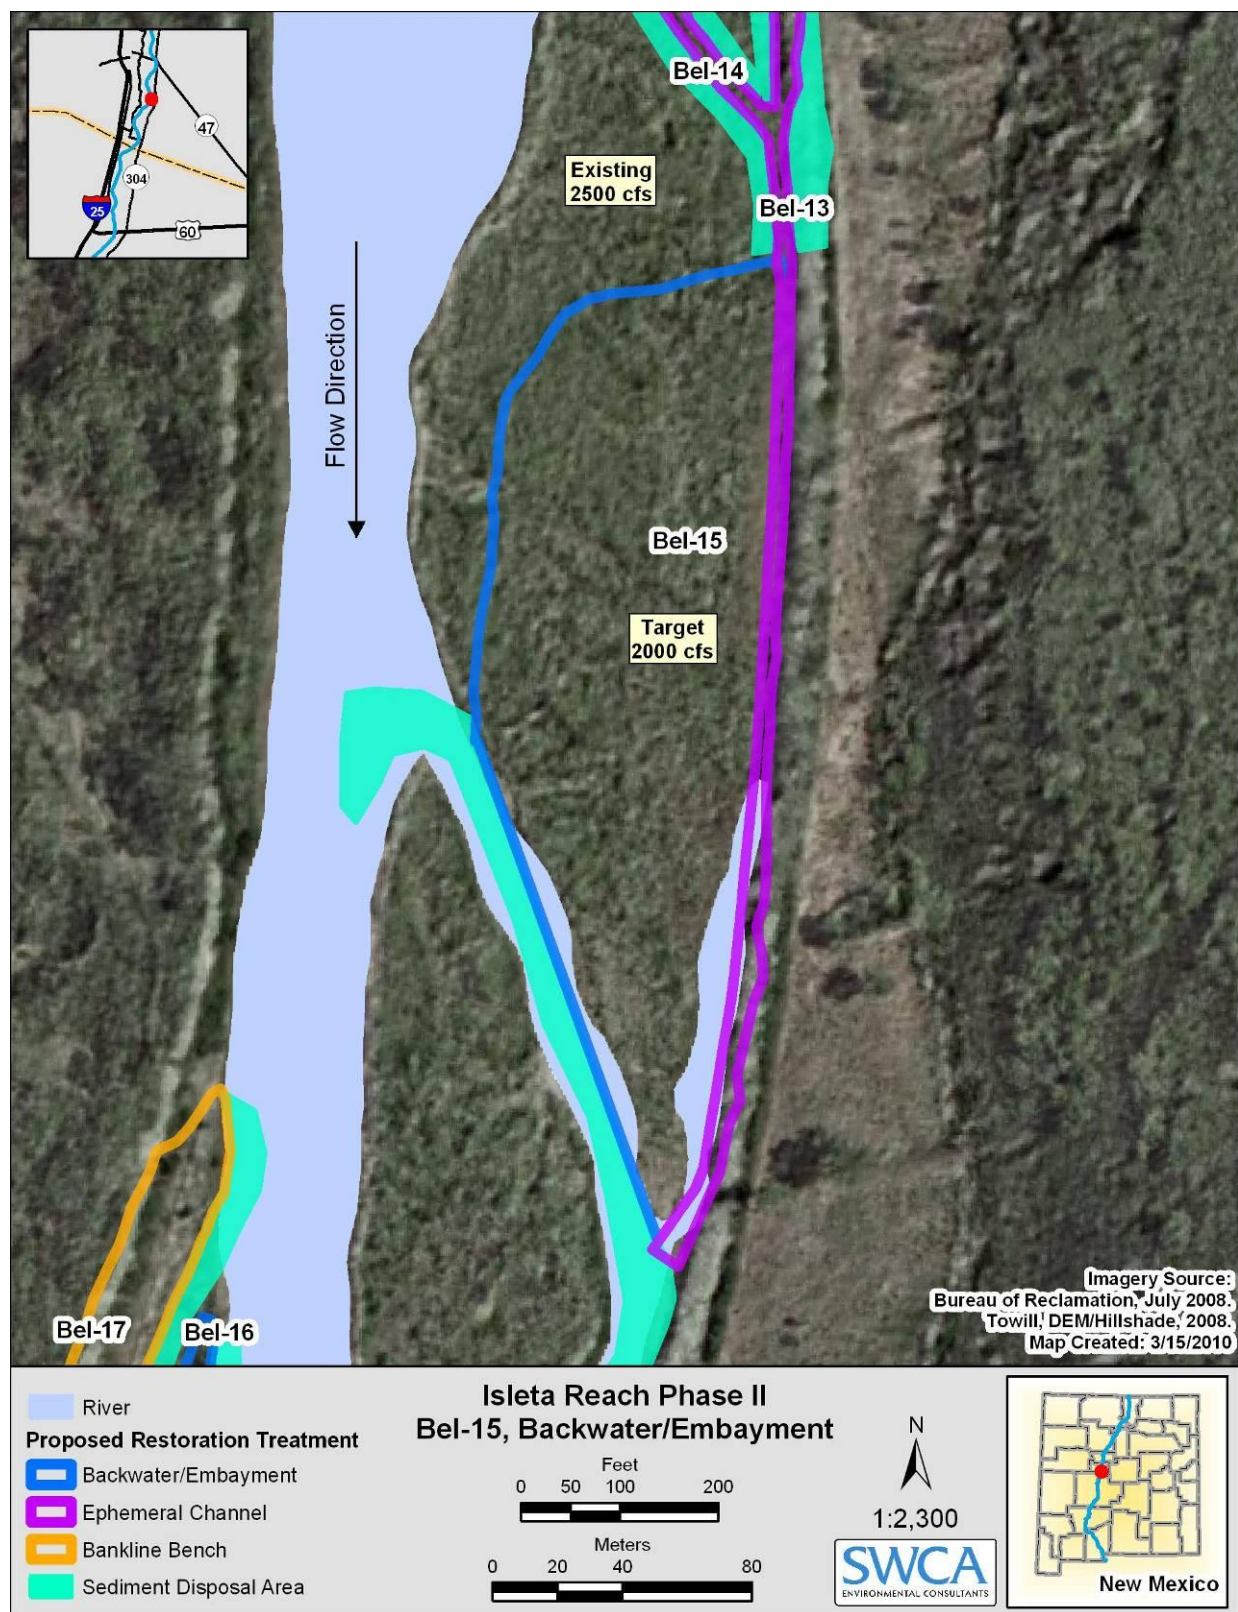
Figure 3.2. Backwater/Embayment example.

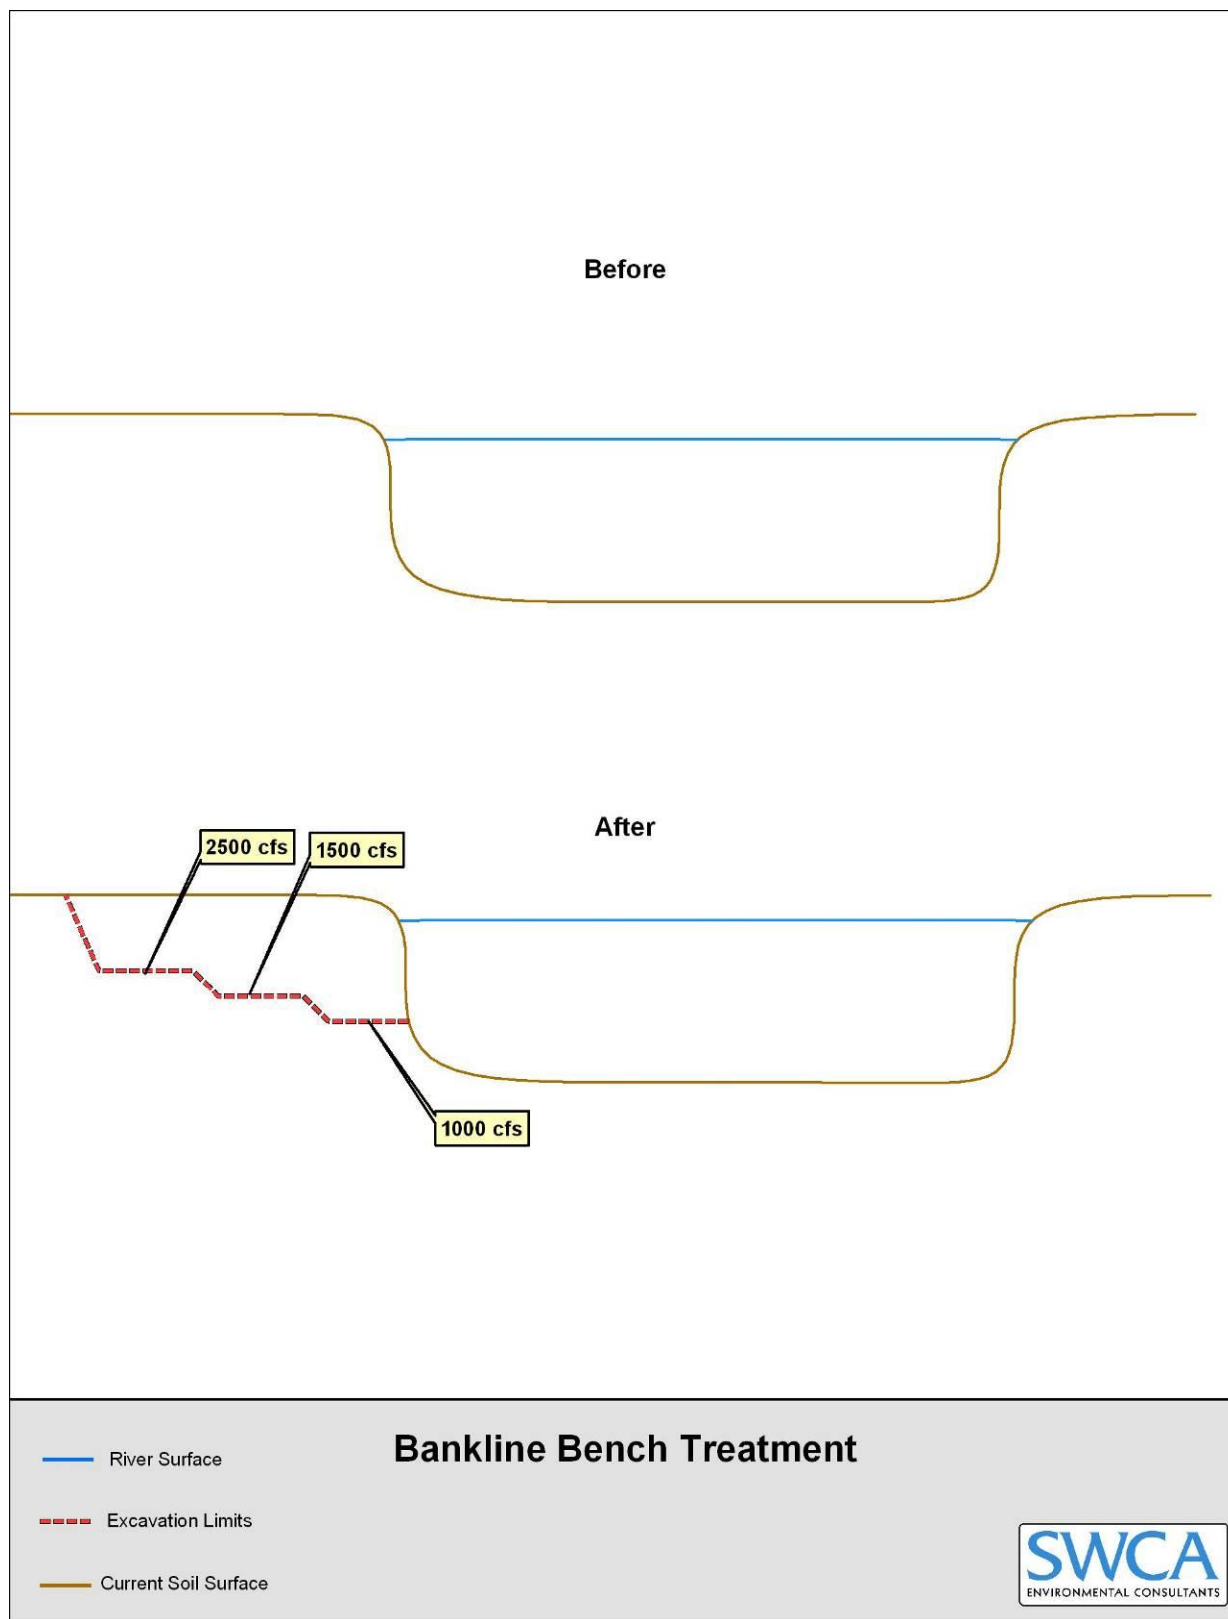
**Figure 3.3. Bankline bench schematic design.**

The creation of bankline benches involves lowering the bank through the removal of bankline vegetation and the excavation of soils to increase the potential for overbank flooding (Figure 3.3 and Figure 3.4). The target elevation for excavated and terraced banks varies depending on the height of the bank, the bank-full level, and the target inundation discharge frequency and duration. Bankline benches will be created in areas where the removal of the naturally formed berms that often exist along the banks could increase inundation in the overbank areas.

Bankline benches will be inundated during different stages of moderate to high flows (non-annual events) and will increase the frequency and duration of inundation. However, the overbank areas will not remain flooded for significant periods of time and will not be intended to provide mesohabitat for adult silvery minnow. Conversely, bankline benches are expected to provide additional low-velocity habitat, resulting in improved egg retention and larval fish development during periods of high river flow.

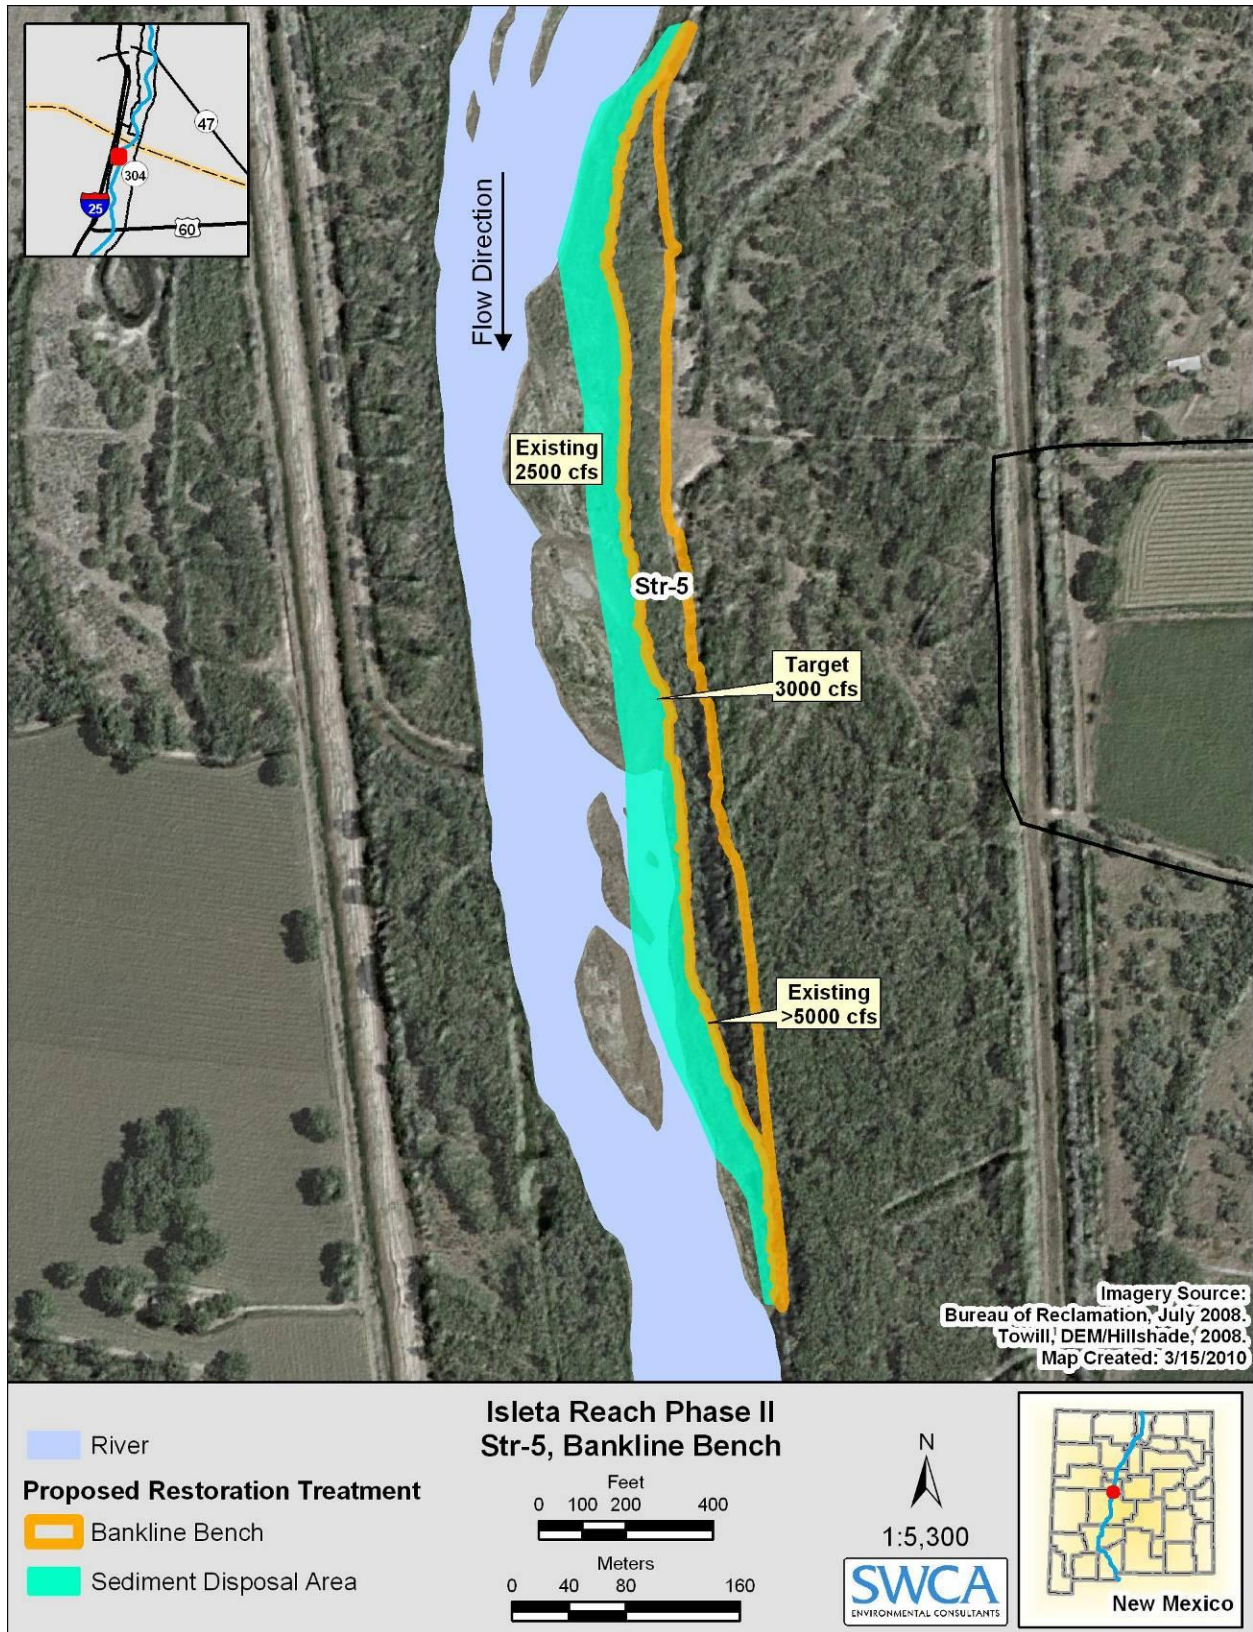
Figure 3.4. Bankline bench example.

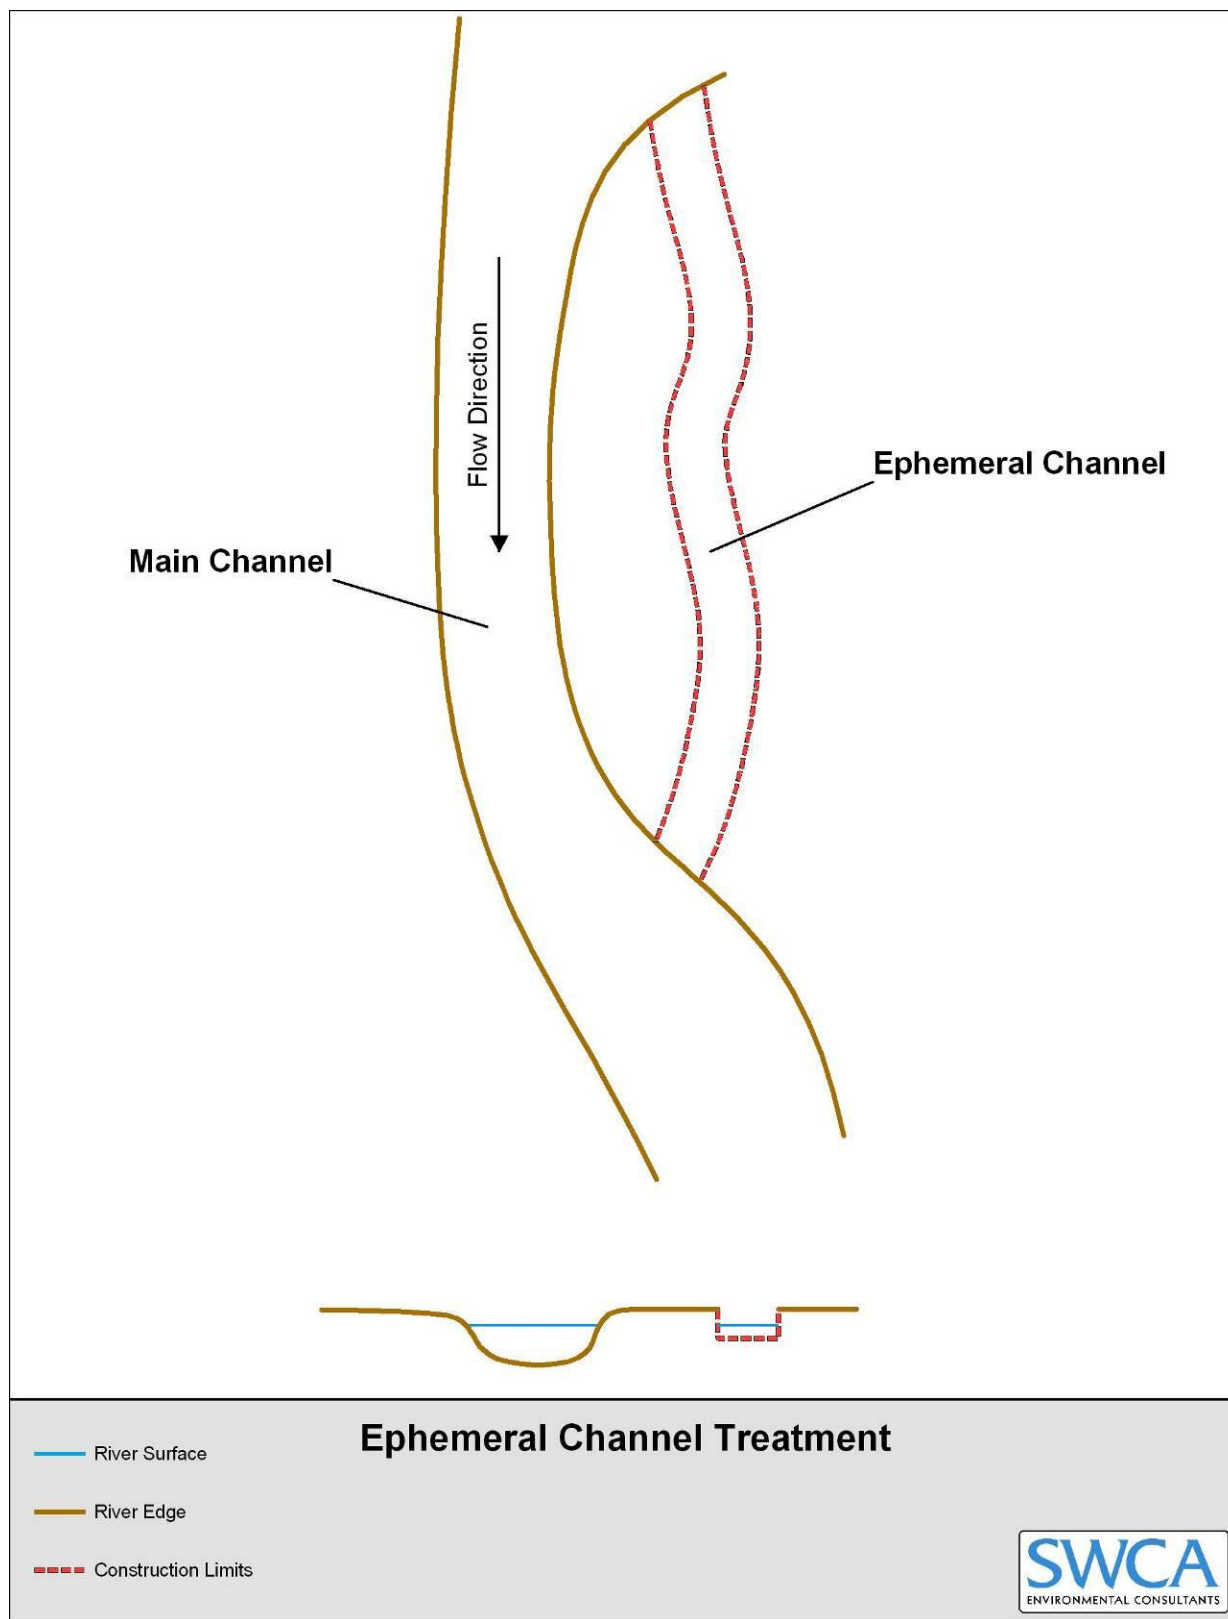
**Figure 3.5. Ephemeral channel schematic design.**

Ephemeral channels are low-velocity, flow-through channels that are connected to the main river channel across bars and islands. These channels are normally dry but carry high-discharge flow from the main channel during spring snowmelt and summer monsoon events. The channels carry water at lower velocities than the main channel and may include mesohabitats, such as pools and backwaters with little to no flow. Ephemeral channels are not intended to provide for overbank flooding. Construction of an ephemeral channel requires removal of existing vegetation and will cause the disturbance of some sediment or soil. The channels will be cut through islands, banks, and bars to a depth that will allow water to flow at moderate to high river flows (Figure 3.5 and Figure 3.6). The design of the ephemeral channels will consider the river height and velocity at which water enters the channel and water retention times.

Ephemeral channels create aquatic habitat beneficial to the silvery minnow. The target inundation elevations will accommodate flows to encourage silvery minnow recruitment each year. Ephemeral channels could provide sufficient periods of inundation for larval development and refugia for young silvery minnow. These side channels will dry during lower flows and will not be designed to provide habitat for adult silvery minnow. While channels of this kind are proposed primarily to enhance silvery minnow habitat, they also promote riparian functionality and interconnectedness.

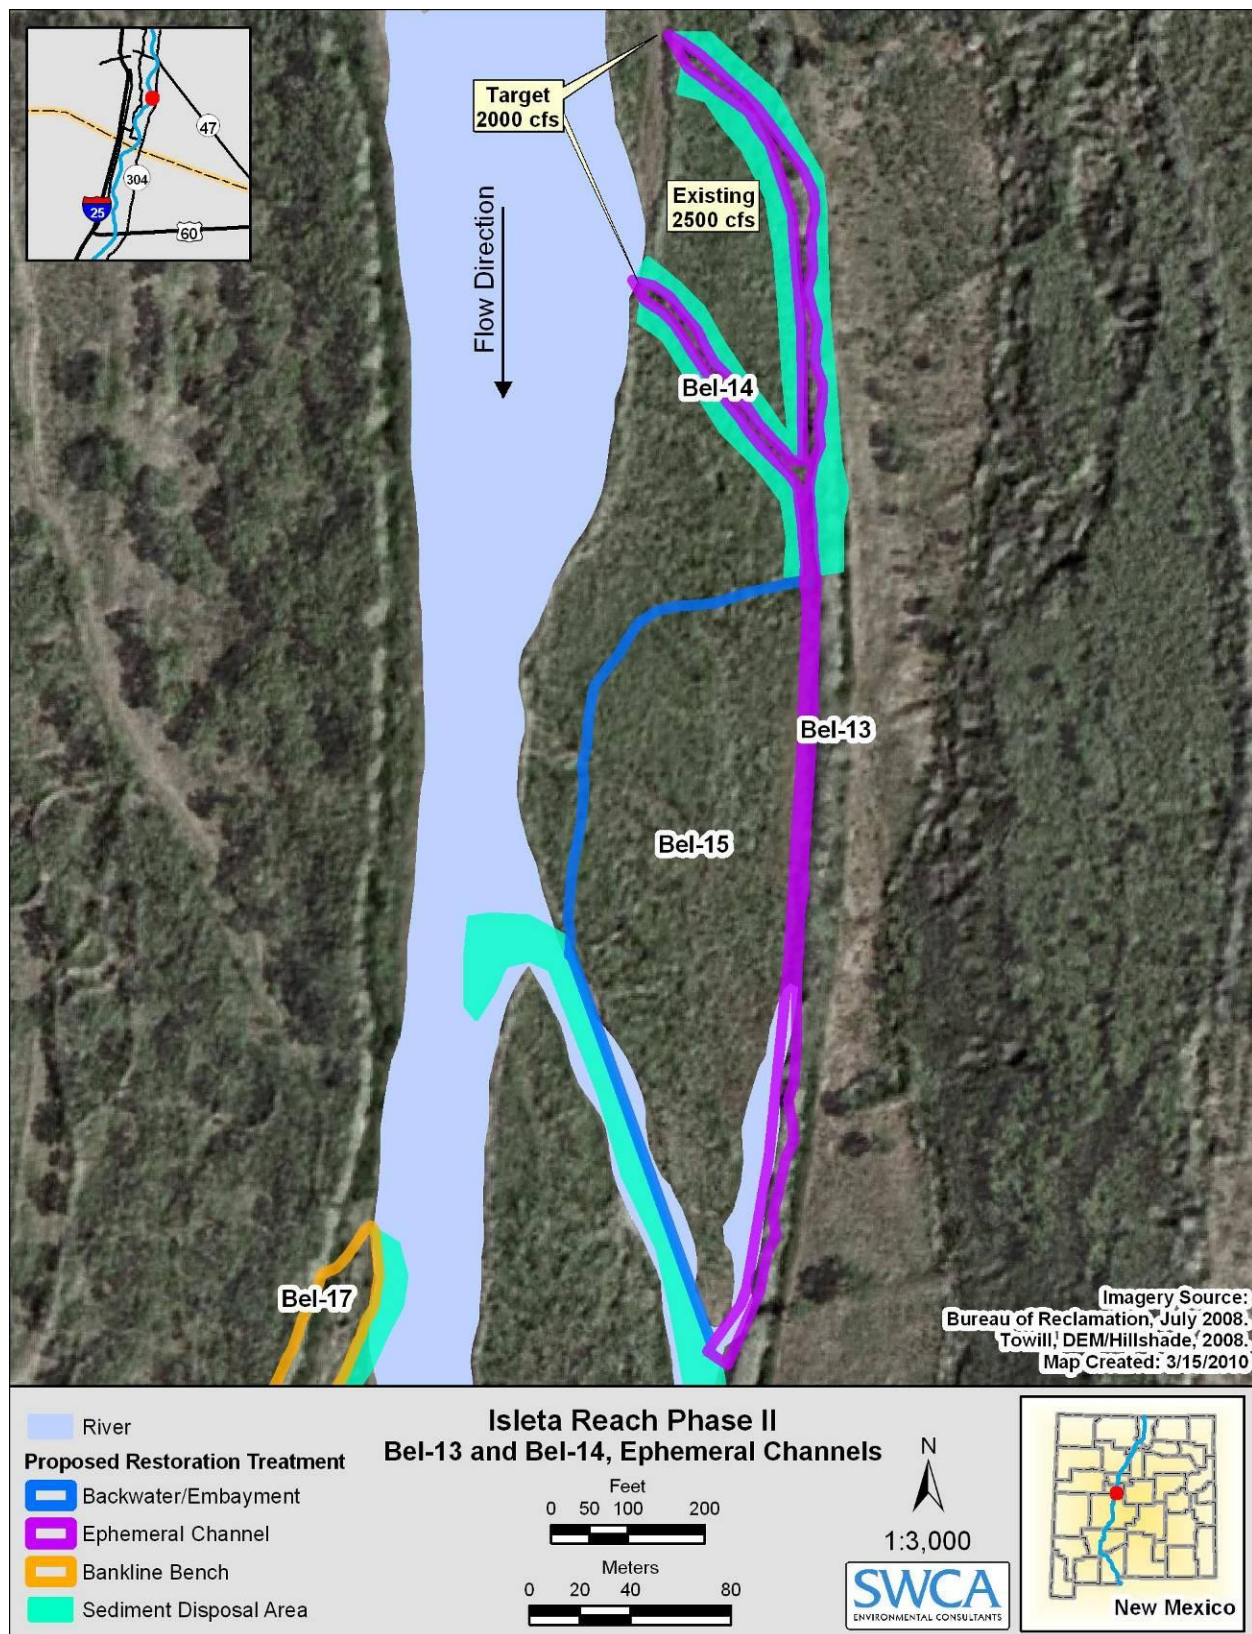
Figure 3.6. Ephemeral channel example.

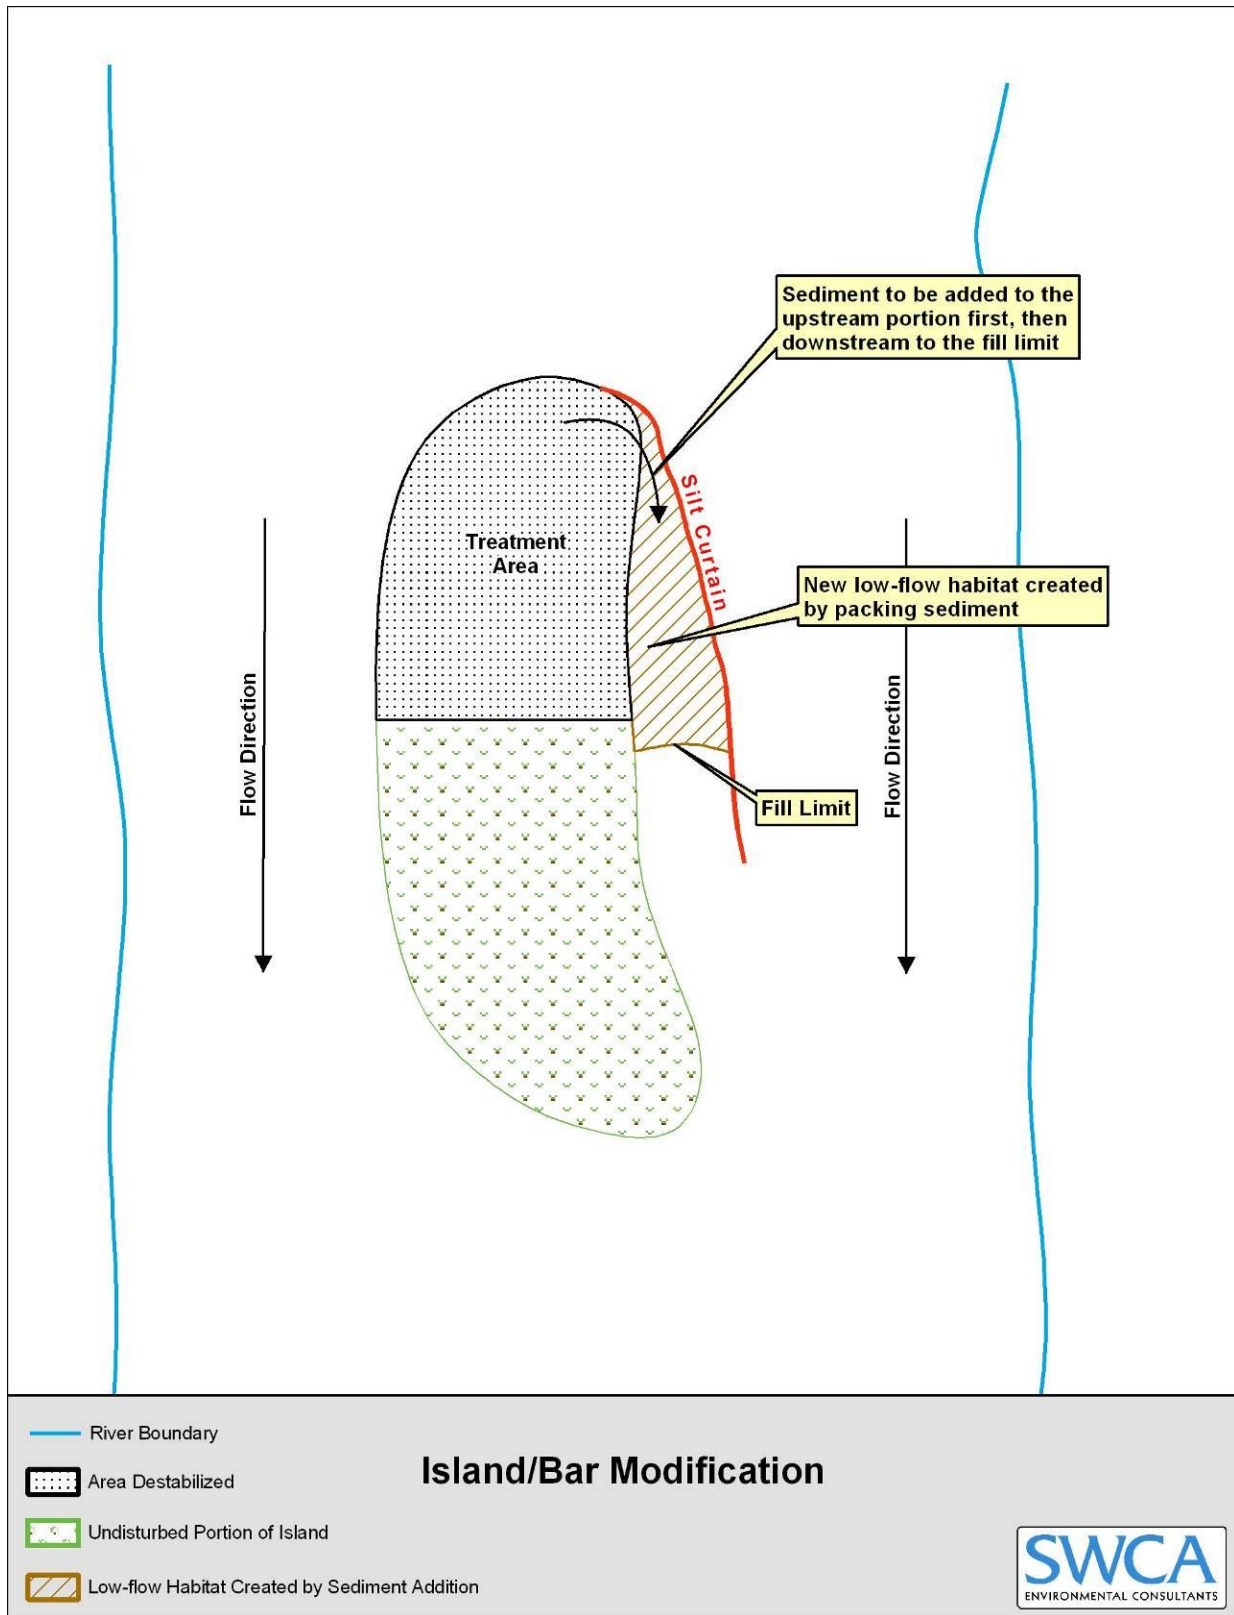
**Figure 3.7. Island/Bar modification schematic design. Schematic illustrates sediment dispersal contained within silt curtains installed into the channel.**

The island/bar modification technique will be targeted to those features that are infrequently inundated, are stabilized by vegetation, or otherwise are armoring and thus are resistant to sediment mobilization. These bank-attached bars and islands have the potential to become or have already become permanent channel features. Modifying these features may assist in alleviating adverse changes to silvery minnow critical habitat and improving the quality and quantity of available habitat (USFWS 2003). Islands will be modified by planned physical disturbance, such as removing vegetation (including the root mass) and destabilizing soil (Tetra Tech 2004) or through creating shelves that are inundated at a lower discharge. Treated islands will be allowed to naturally expand or contract in response to flows and available sediment load. Island/bar modification will also increase the potential for redeposition of sediment in downstream subreaches of the Rio Grande. Sediment removed as a result of the modification may be placed in the river behind silt fences (Figure 3.7 and Figure 3.8). Reclamation will collaborate with the USACE for island modifications to ensure all 401 and 404 permits are obtained and the proposed actions comply with all elements of the Clean Water Act (CWA).

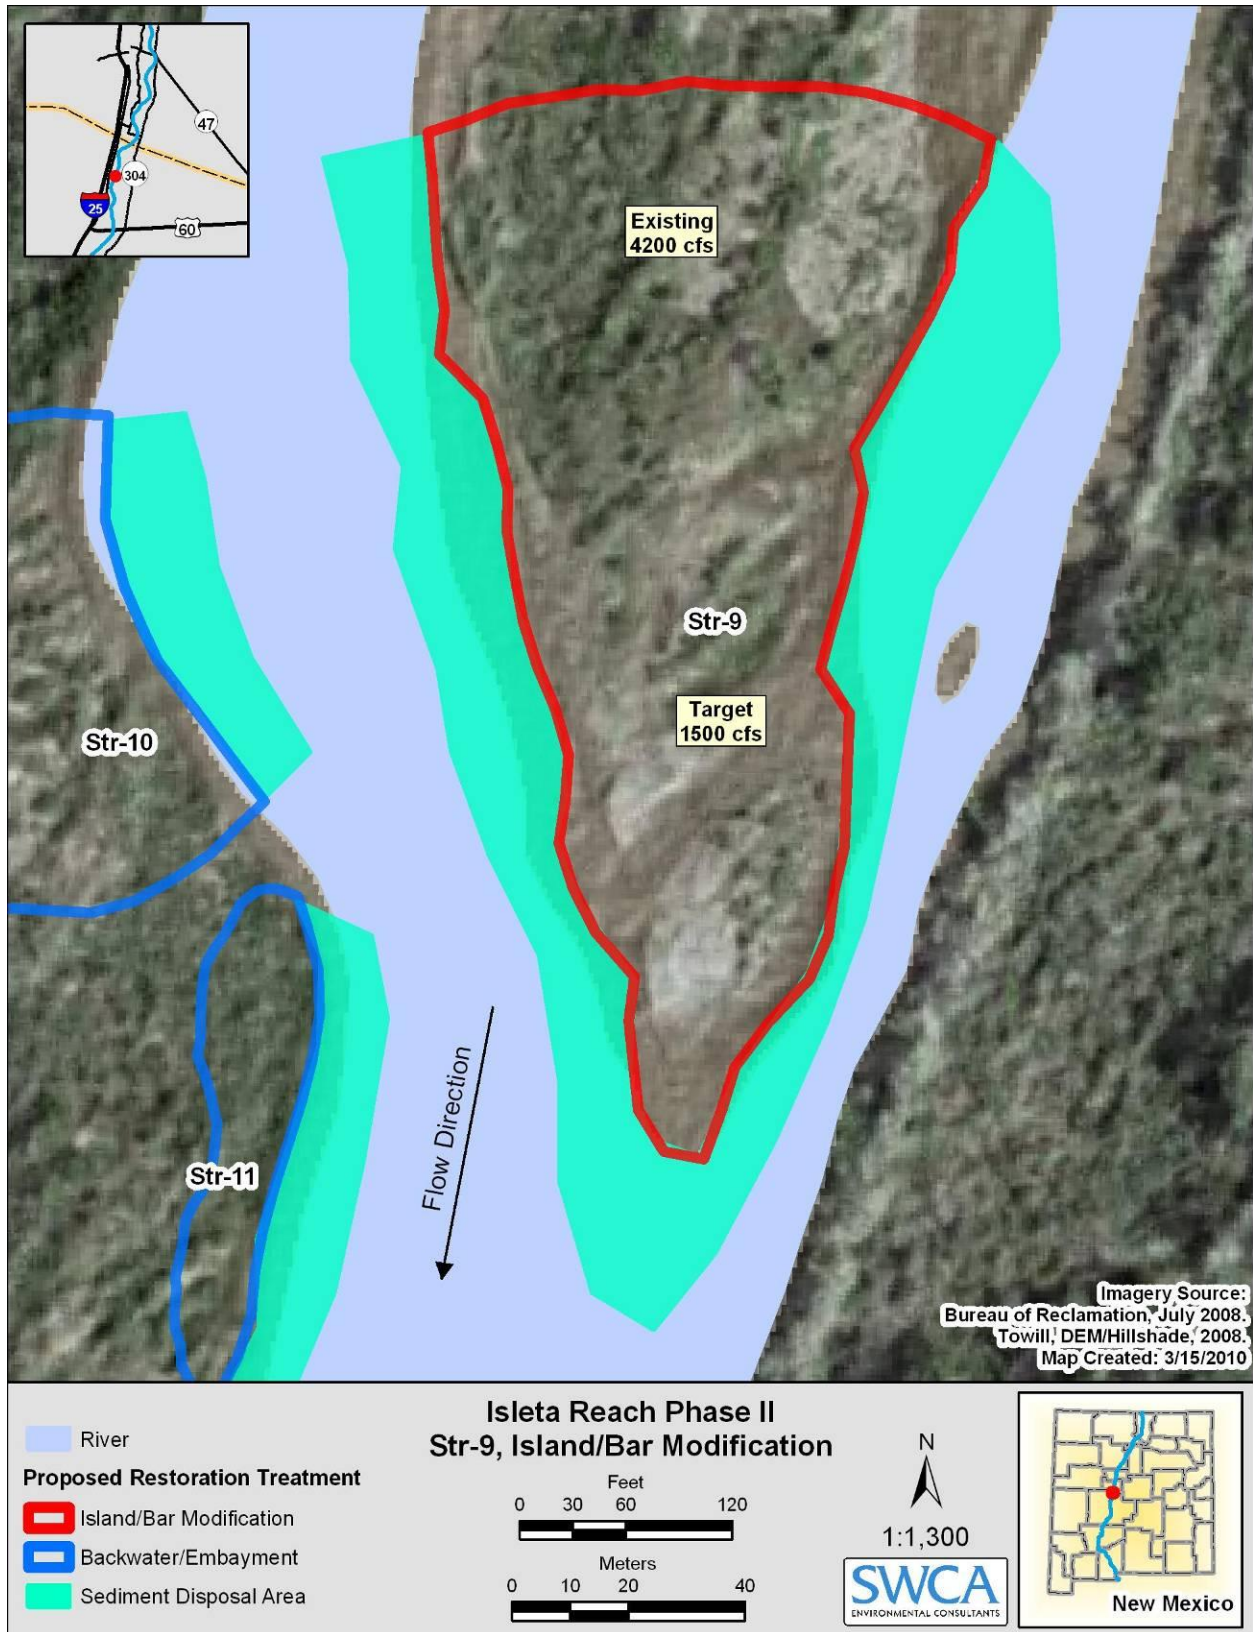
**Figure 3.8. Island/Bar modification example.**

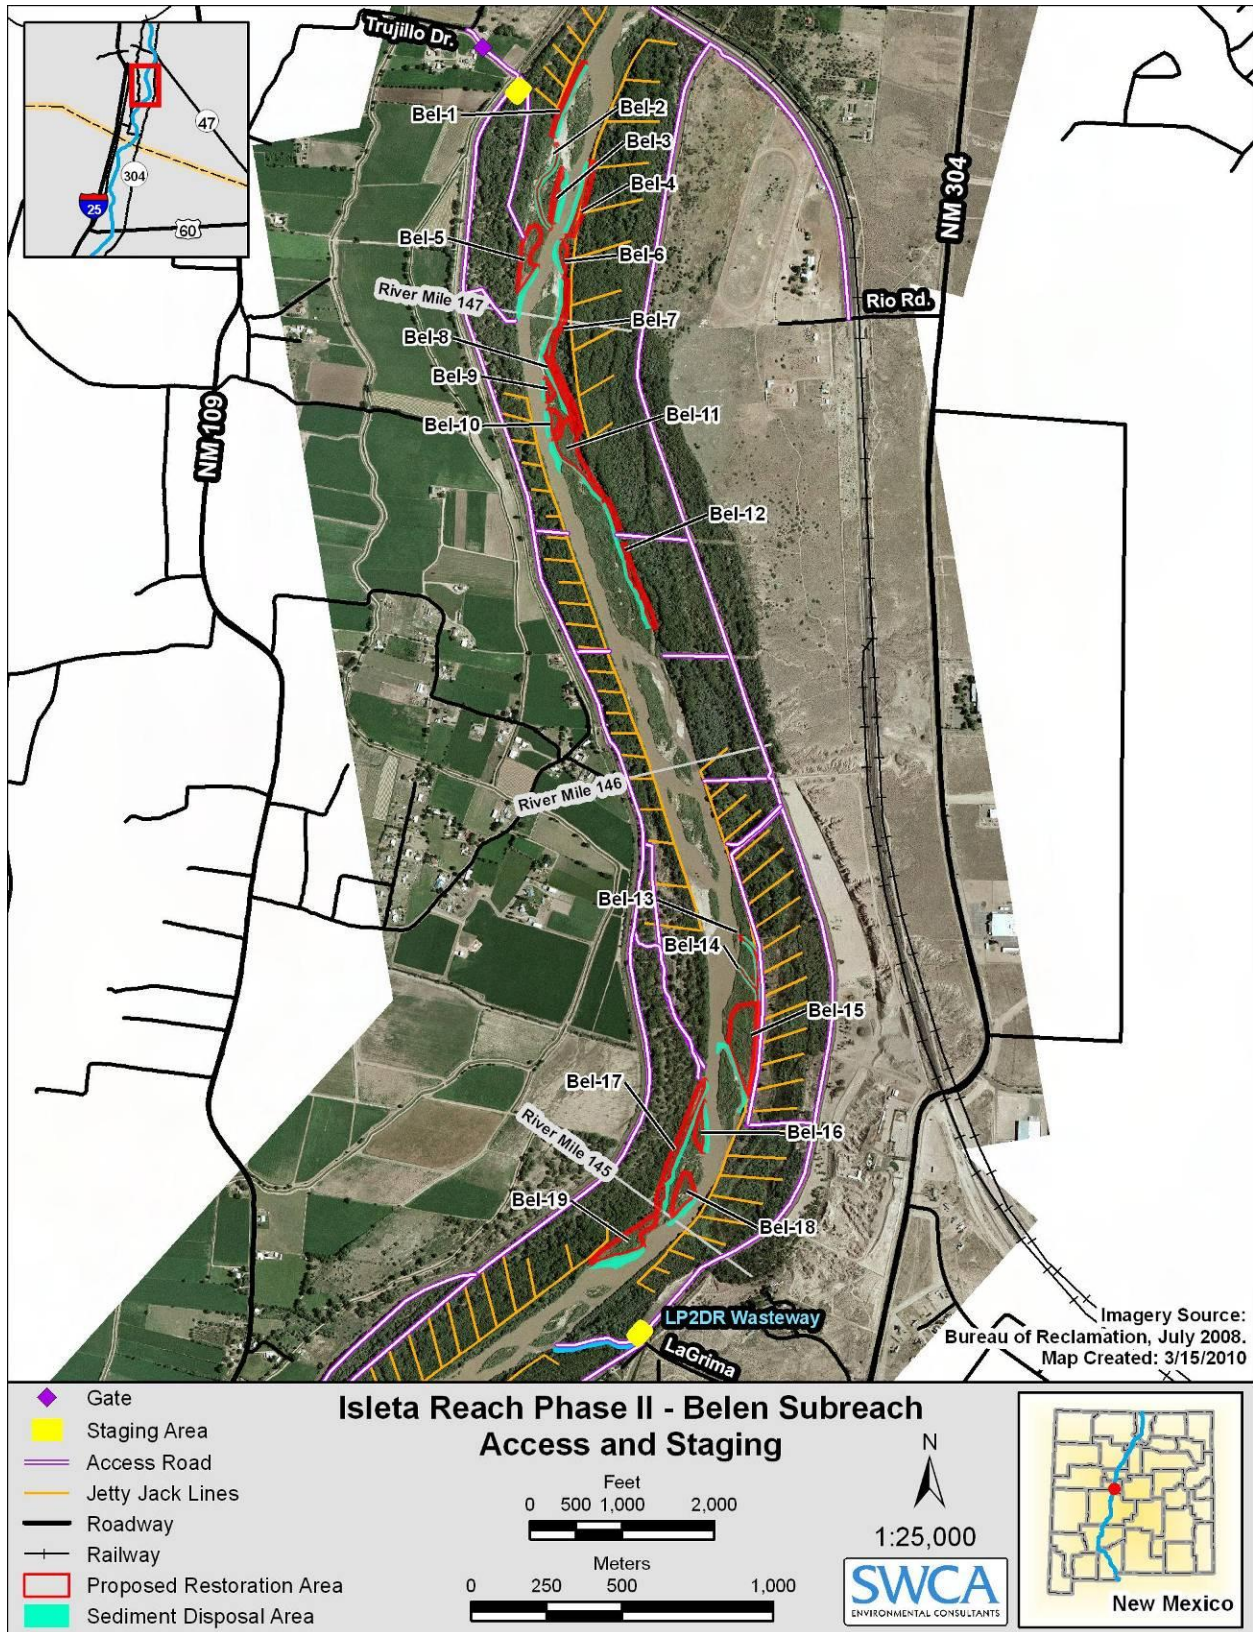
**Figure 4.1. Belen Subreach access and staging.**

Equipment and personnel staging and access locations for the four subreaches are shown in Figure 4.1 through Figure 4.3. Designated access routes will be over existing roads and trails; no new roads will be constructed. No mature native vegetation will be removed and construction will occur outside the flycatcher breeding season. All wetlands will be avoided by construction equipment. Work will be scheduled to minimize crossing the river channel. To prevent the mixing of sediments with surface pools and runoff in each of the subreaches, access paths that minimize travel distances in wetted pools or flowing water will be predetermined. Water quality parameters, primarily turbidity, will be measured prior to and after river crossing.
