**MIDDLE RIO GRANDE  
ISLETA REACH PHASE II  
RIVERINE HABITAT RESTORATION PROJECT  
BIOLOGICAL ASSESSMENT**

**U.S. BUREAU OF RECLAMATION, ALBUQUERQUE AREA OFFICE**  
555 Broadway NE, Suite 100  
Albuquerque, New Mexico 87102

**SWCA ENVIRONMENTAL CONSULTANTS**  
5647 Jefferson Street NE  
Albuquerque, New Mexico 87109  
Telephone: 505-254-1115; Fax: 505-254-1116  
[www.swca.com](http://www.swca.com)

April 1, 2010

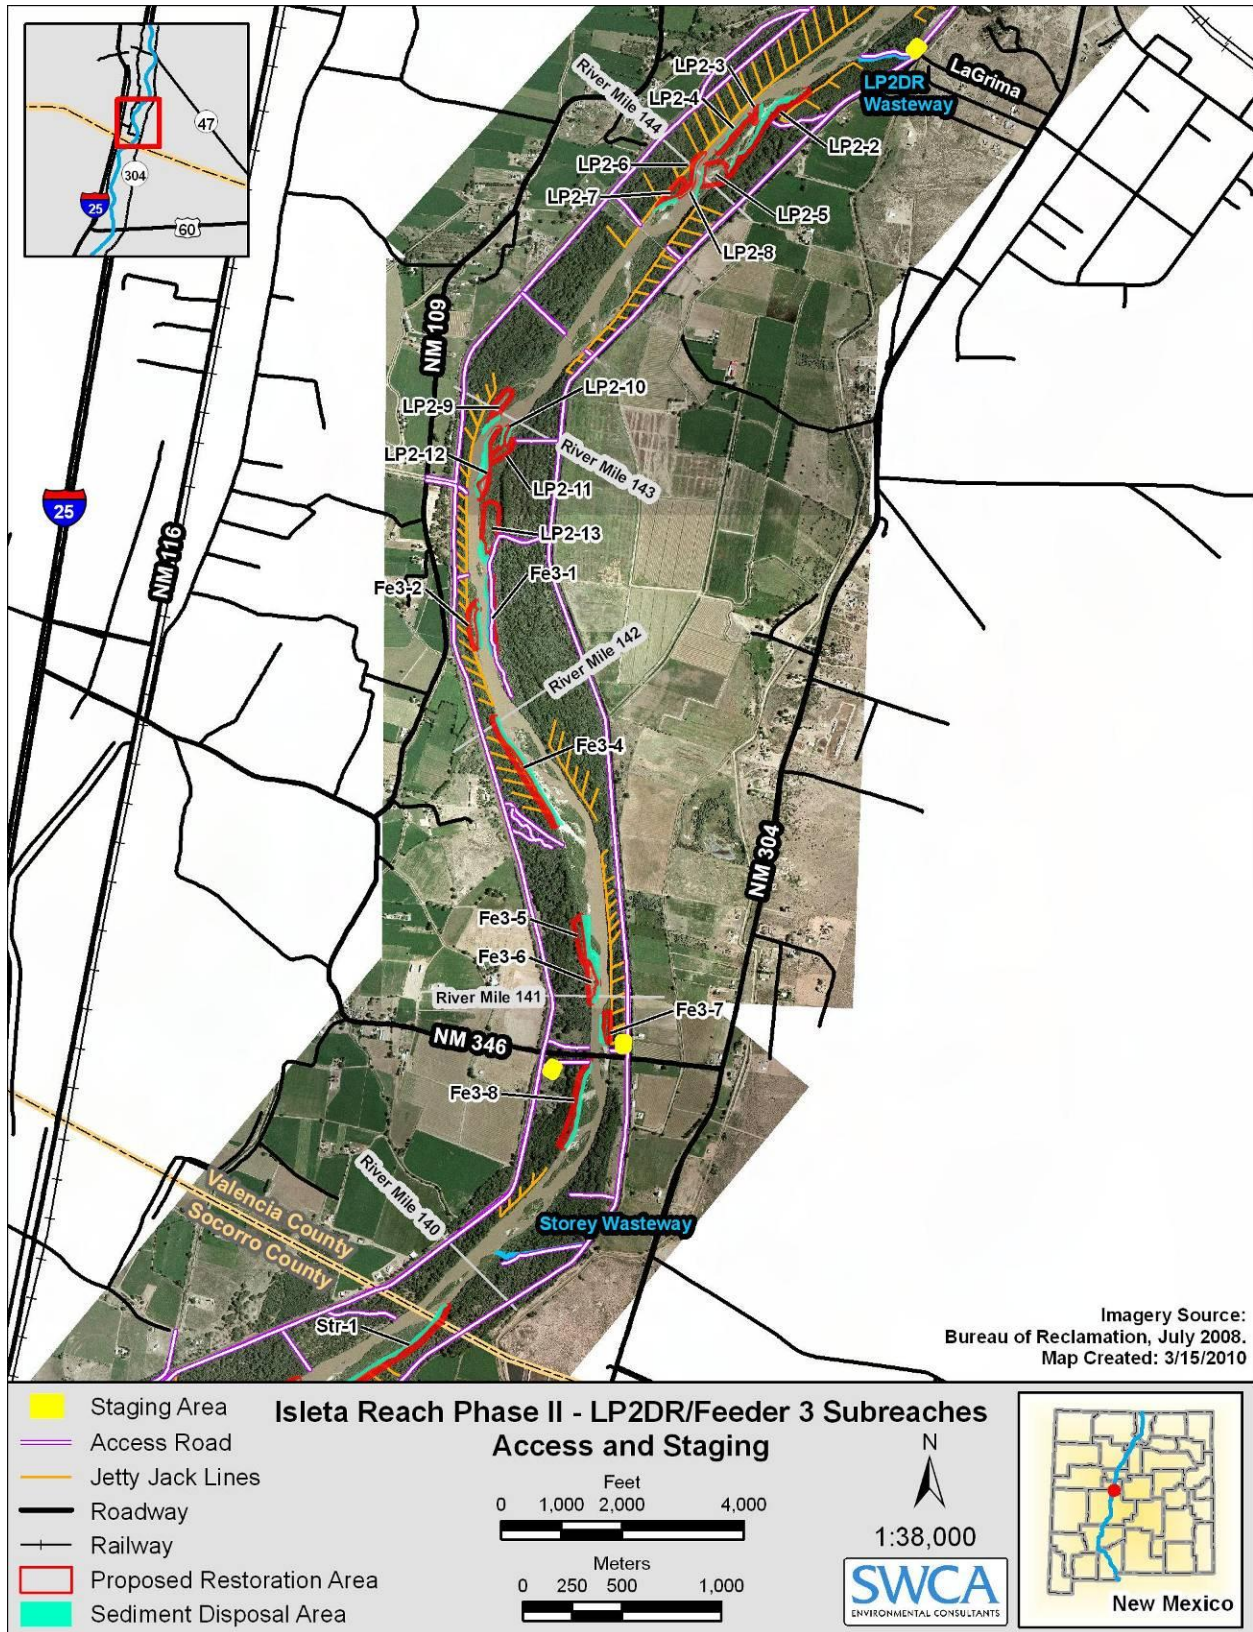
Figure 4.2. LP2DR and Feeder 3 Subreach access and staging.

Equipment and personnel staging and access locations for the four subreaches are shown in Figure 4.1 through Figure 4.3. Designated access routes will be over existing roads and trails; no new roads will be constructed. No mature native vegetation will be removed and construction will occur outside the flycatcher breeding season. All wetlands will be avoided by construction equipment. Work will be scheduled to minimize crossing the river channel. To prevent the mixing of sediments with surface pools and runoff in each of the subreaches, access paths that minimize travel distances in wetted pools or flowing water will be predetermined. Water quality parameters, primarily turbidity, will be measured prior to and after river crossing.

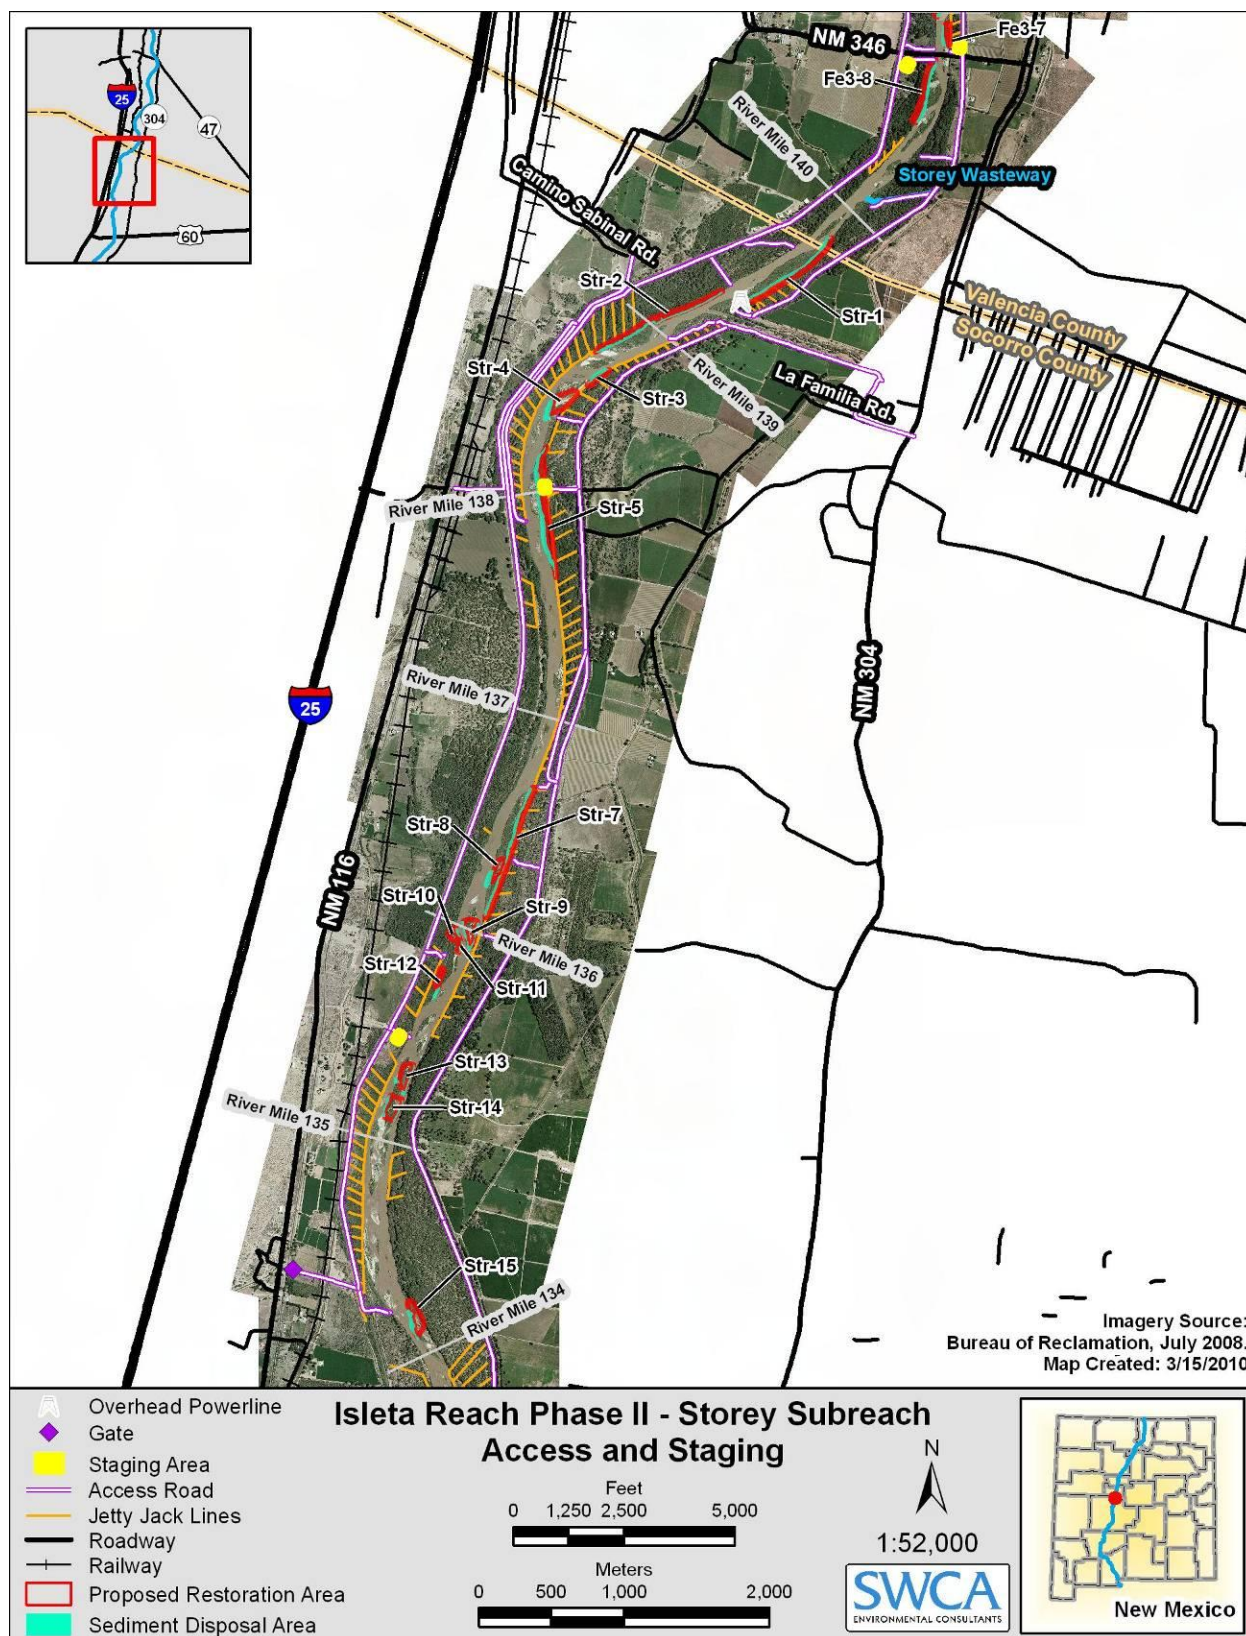
Figure 4.3. Storey Subreach access and staging.

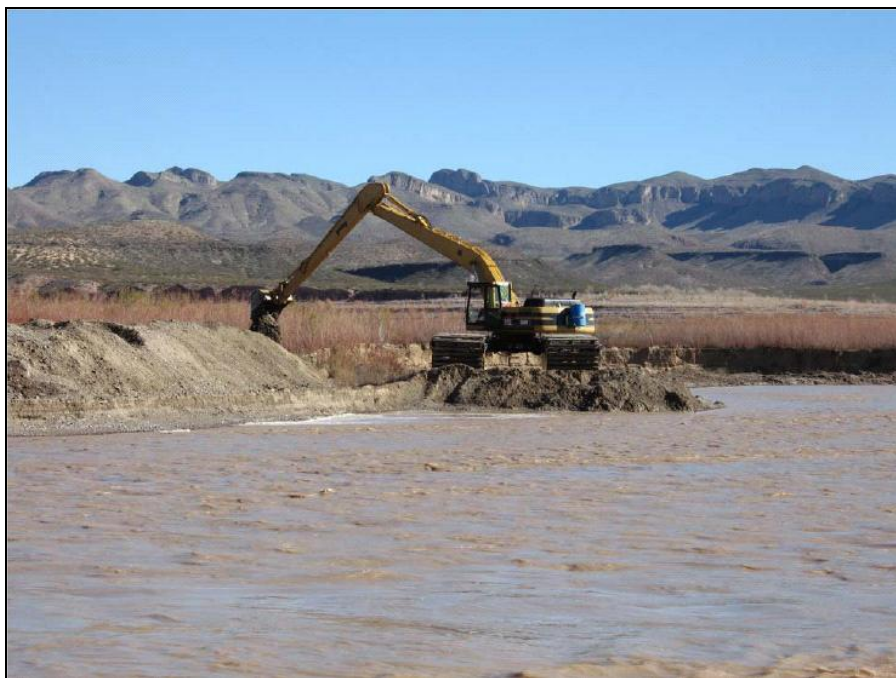
**Figure 4.4.** Example of amphibious-type excavation equipment.

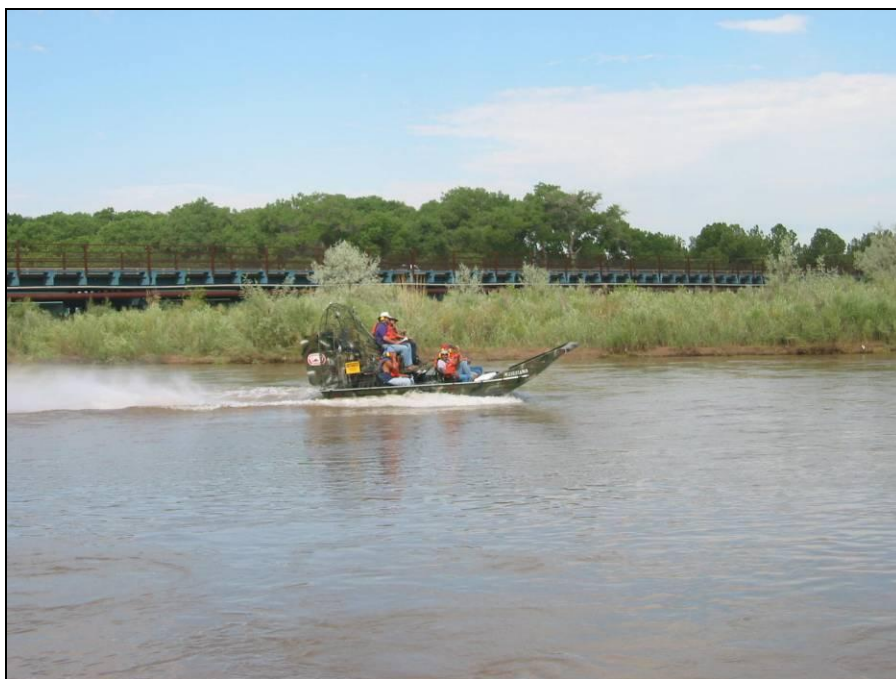
Equipment proposed for construction on point bars and banks accessible from the shore may include a dozer, an excavator, or a backhoe. For islands and less accessible banks and bars, an amphibious-type excavator capable of crossing the river at low flows will be used (Figure 4.4). Personnel and other equipment may be transported using air boats (Figure 4.5). It is preferable to use low-impact amphibious equipment for work in the river, wetlands, and other sensitive aquatic sites where ecological disturbance, including disturbance to the silvery minnow, must be kept to a minimum. The preferred amphibious equipment is designed to disperse weight and minimize impact of the treads when operating in water. The amphibious excavator is about 18 feet (5.5 m) wide and 34 feet (10 m) long, and is equipped with a 60-foot (18-m) boom, allowing the machine to perform extensive work with a minimal footprint. The gross pressure of the excavator is 1.7 pounds per square inch (psi) and the maximum speed of the machine is 1.2 miles per hour (mph) (1.9 km per hour) on level ground and 1 mph (1.6 km per hour) in water.

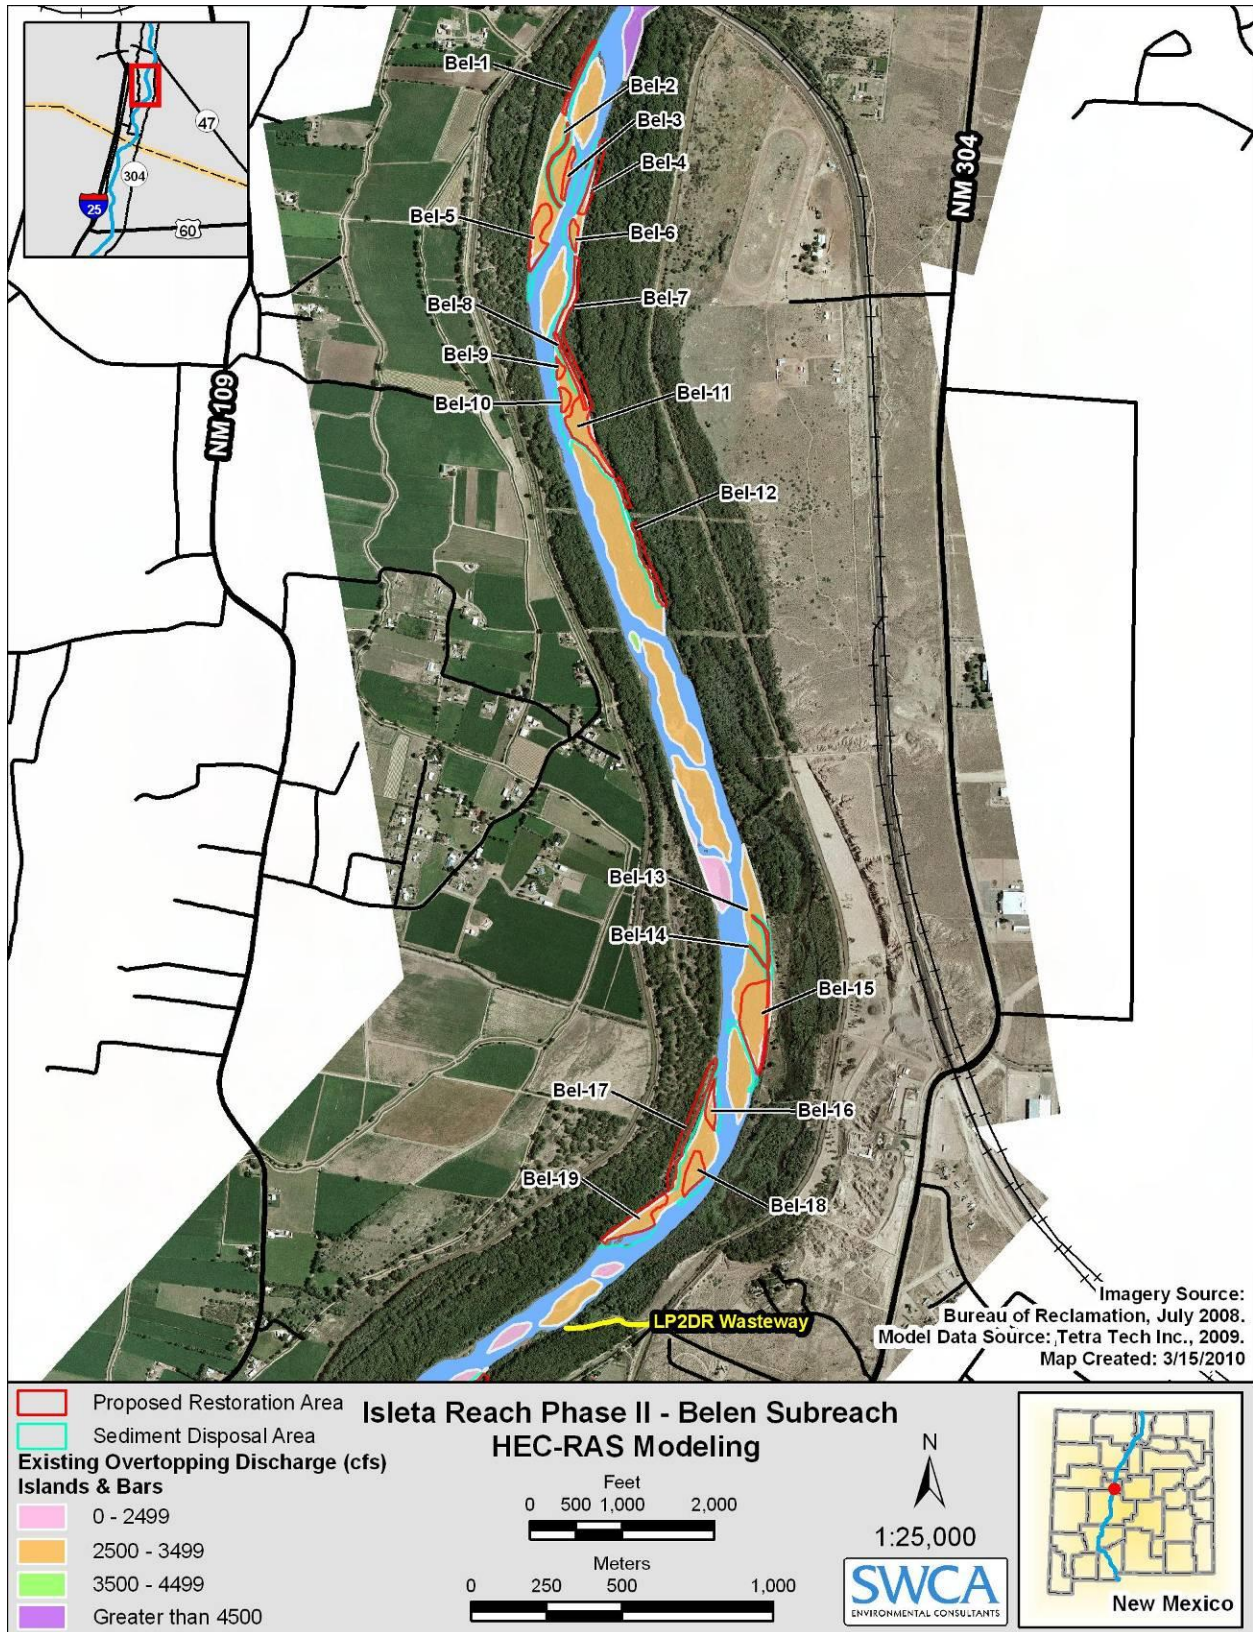
**Figure B.1. Belen Subreach HEC-RAS modeling with island/bar and restoration site delineation.**

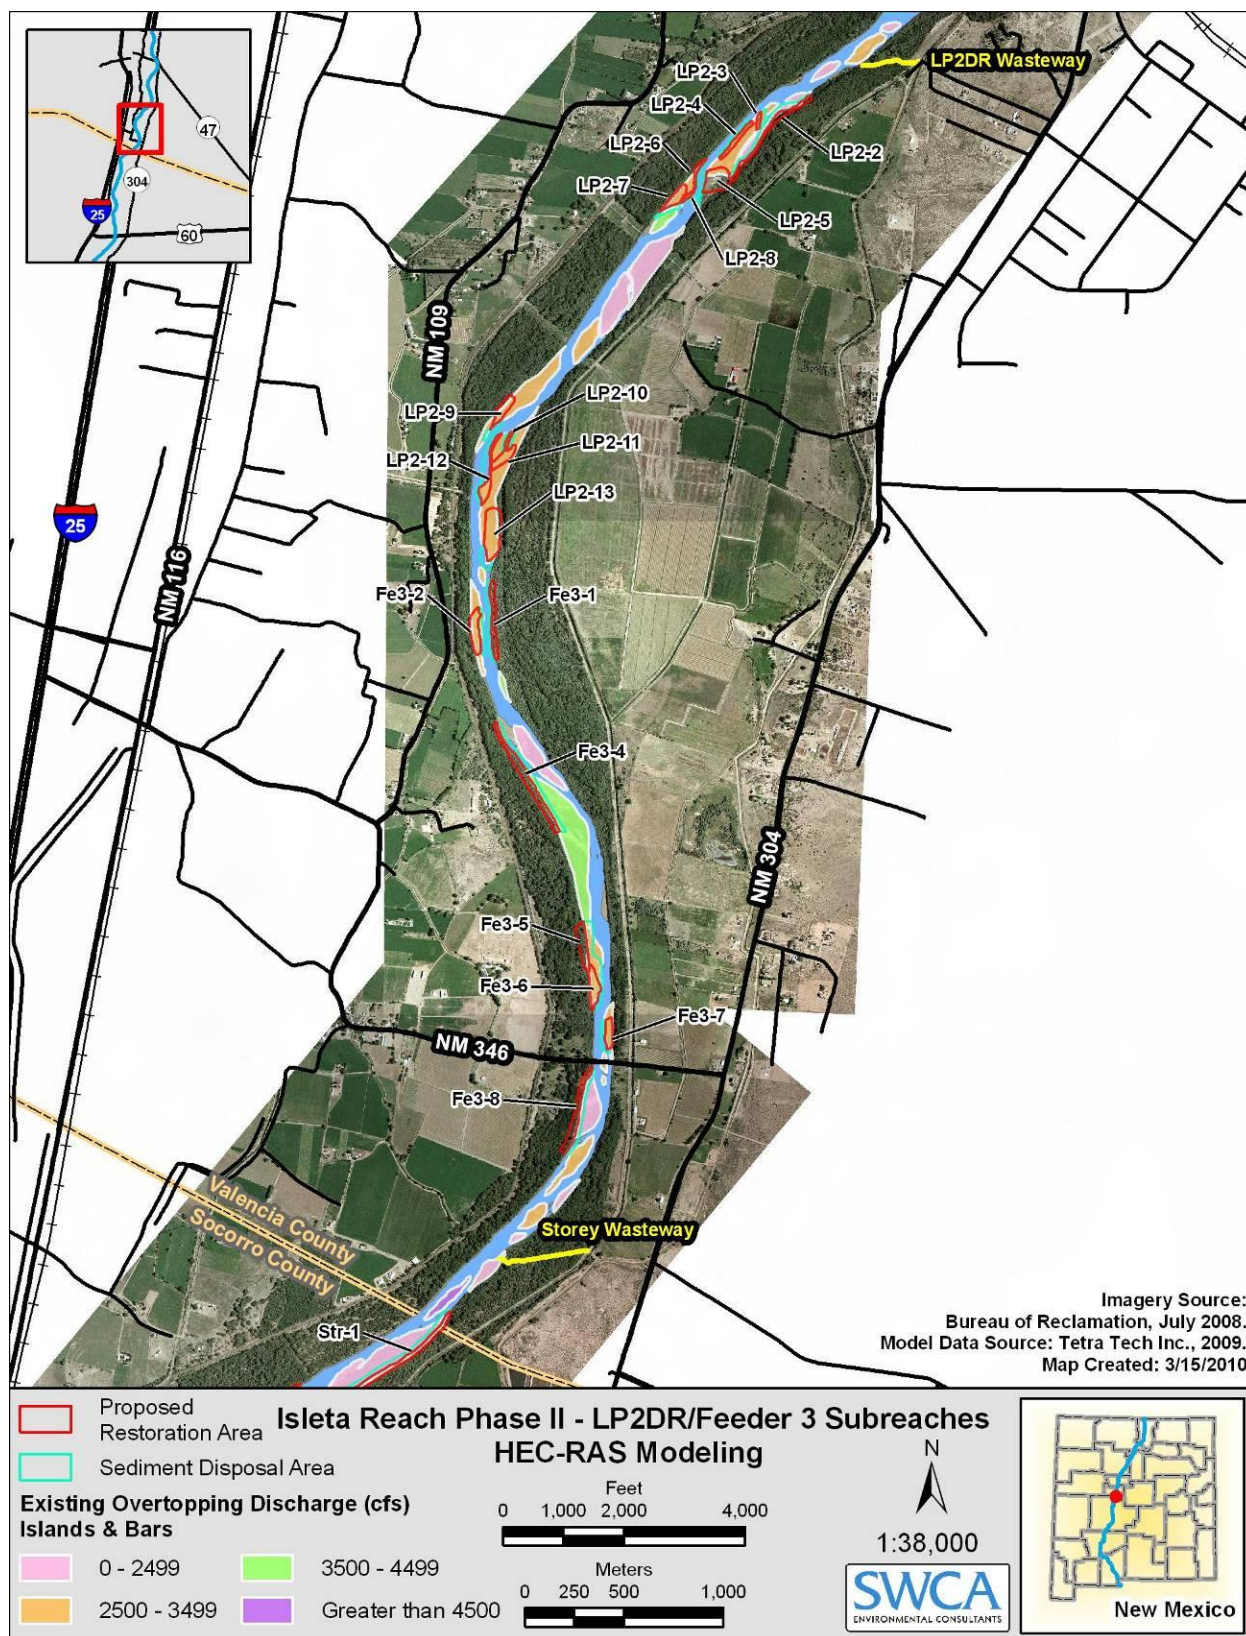
**Figure B.2. LP2DR and Feeder 3 Subreaches HEC-RAS modeling with island/bar and restoration site delineation.**

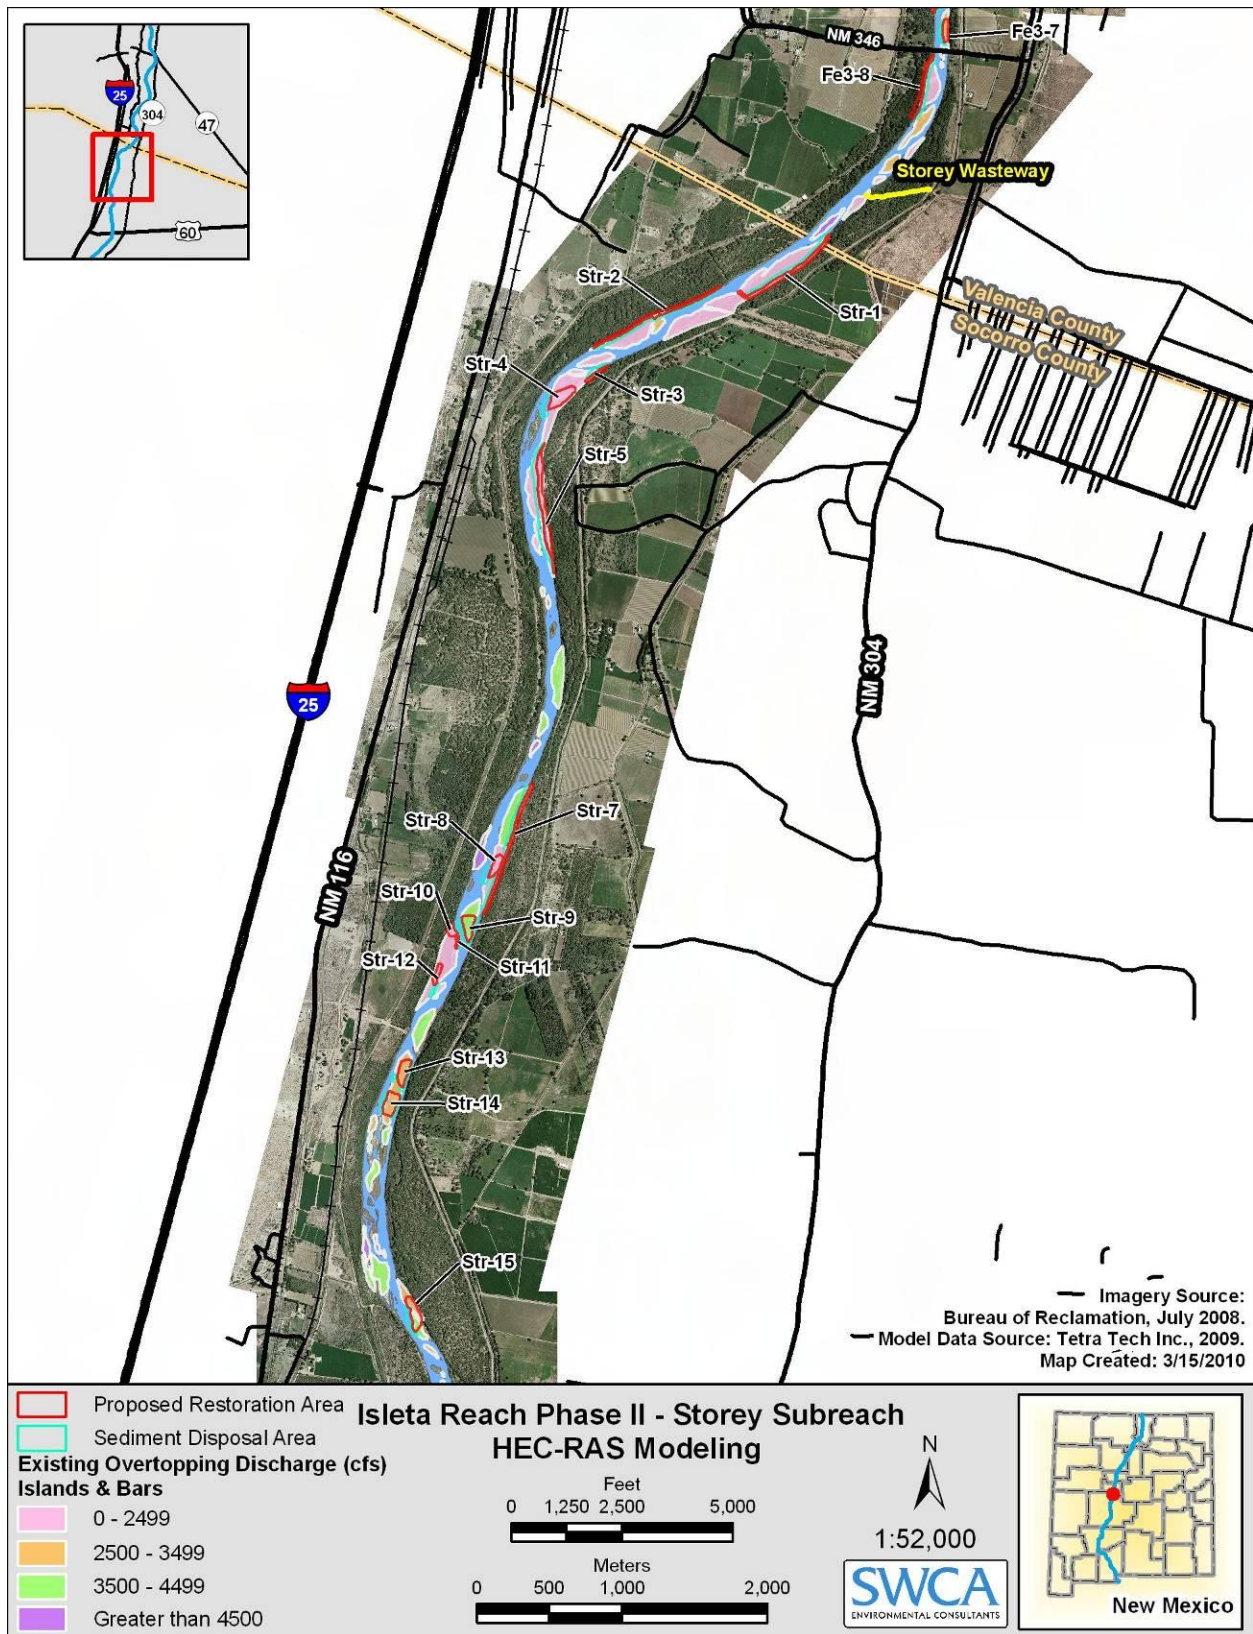
**Figure B.3. Storey Subreach HEC-RAS modeling with island/bar and restoration site delineation.**

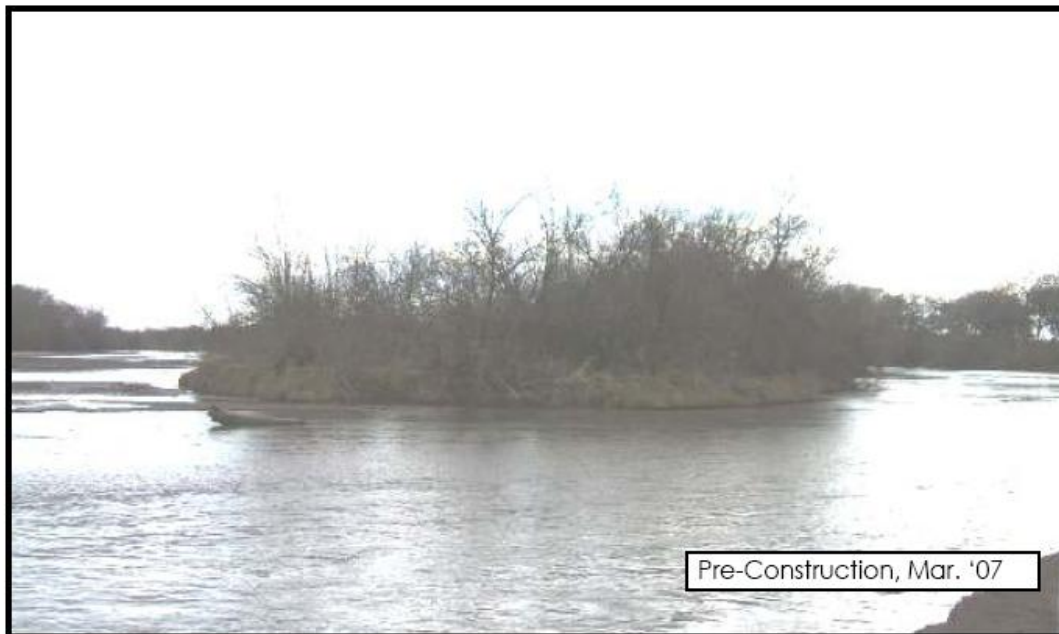
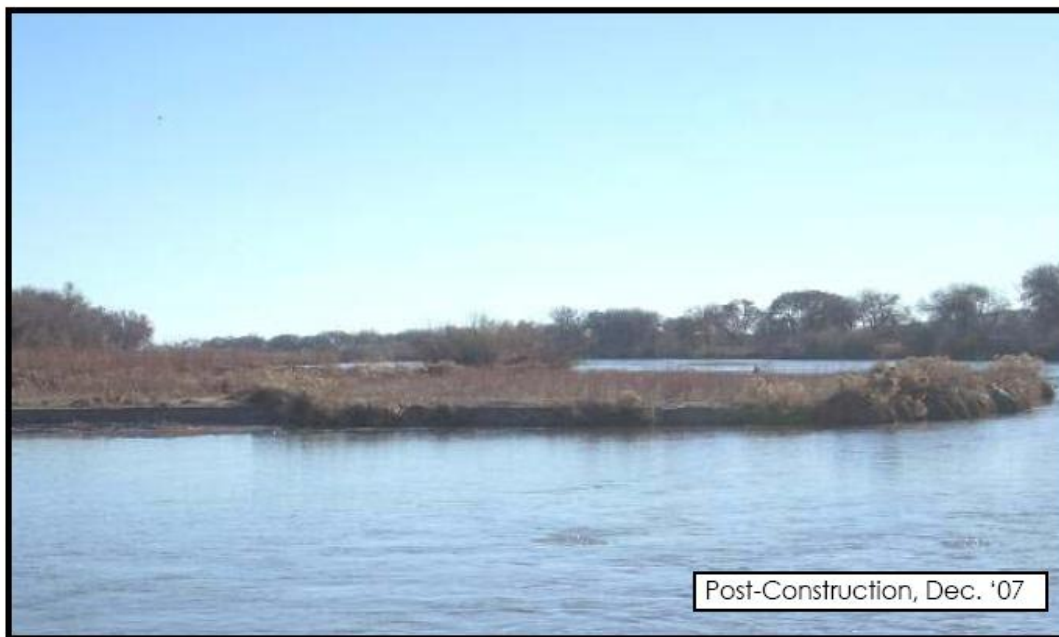
**Figure 1.** Photo point example for SDC\_1i, SSW aspect.

All field monitoring activities will include taking photo point documentation of HR project sites (Figure 1). When applicable, digital photos will be taken at established photo point locations for each monitoring site. Typically individual photos are recorded in the four cardinal directions for each established photo point. The exact photo point protocol will be tailored to the specific goal of each monitoring activity. This provides visual evidence of changes in vegetation, geomorphology and hydrology for each site over time and allows for the NMISC to convey those changes to people not intimately involved in the project.

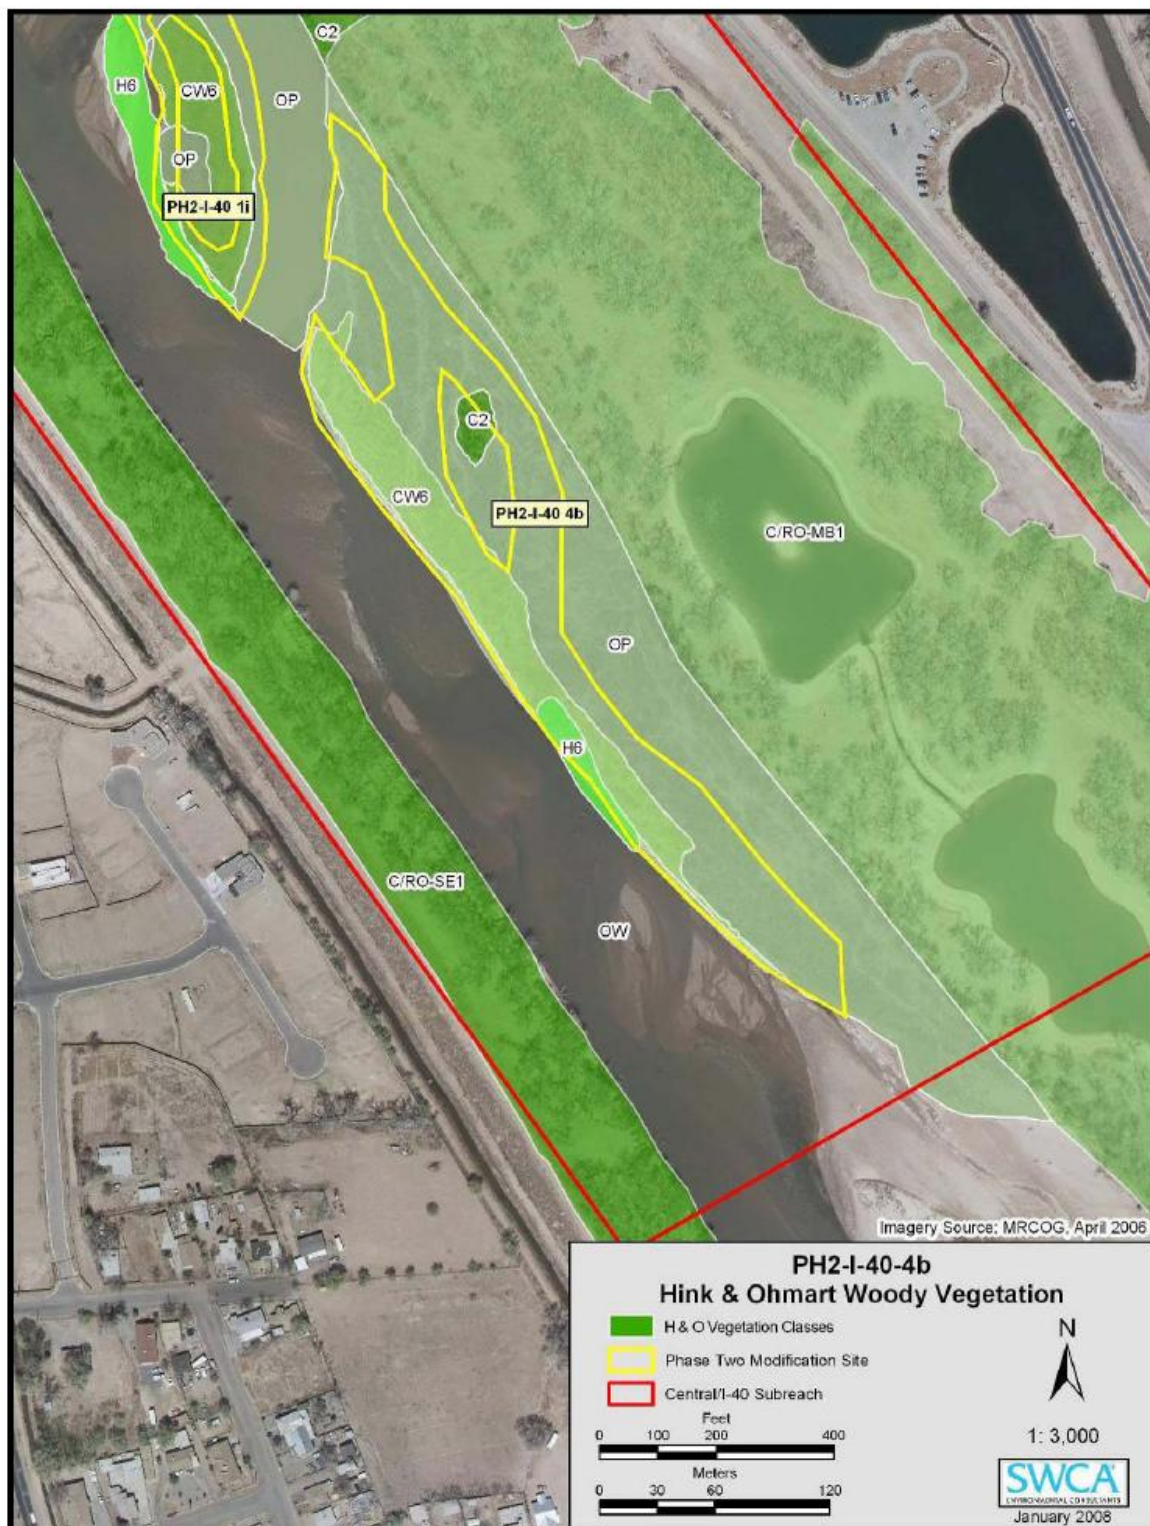
Figure 2. Hink and Ohmart Vegetation Classes for I-40\_4b.

The NMISC proposes to monitor vegetation changes once in 2009 and once 2010. Vegetation monitoring would characterize species composition and community types, including grasses, shrubs, and trees. The Hink and Ohmart (1984) classification system would be used to classify structure (Figure 2). Wetlands and associated species would be identified and mapped to assess overall vegetation changes due to the project as well as for 404 Clean Water Act (CWA) permit compliance. GPS units would collect points and polygons of vegetation at project sites. Any evidence of disturbance, natural or anthropogenic, would be recorded. All data compiled would be stored and analyzed in Excel format and would be submitted to the Collaborative Program.

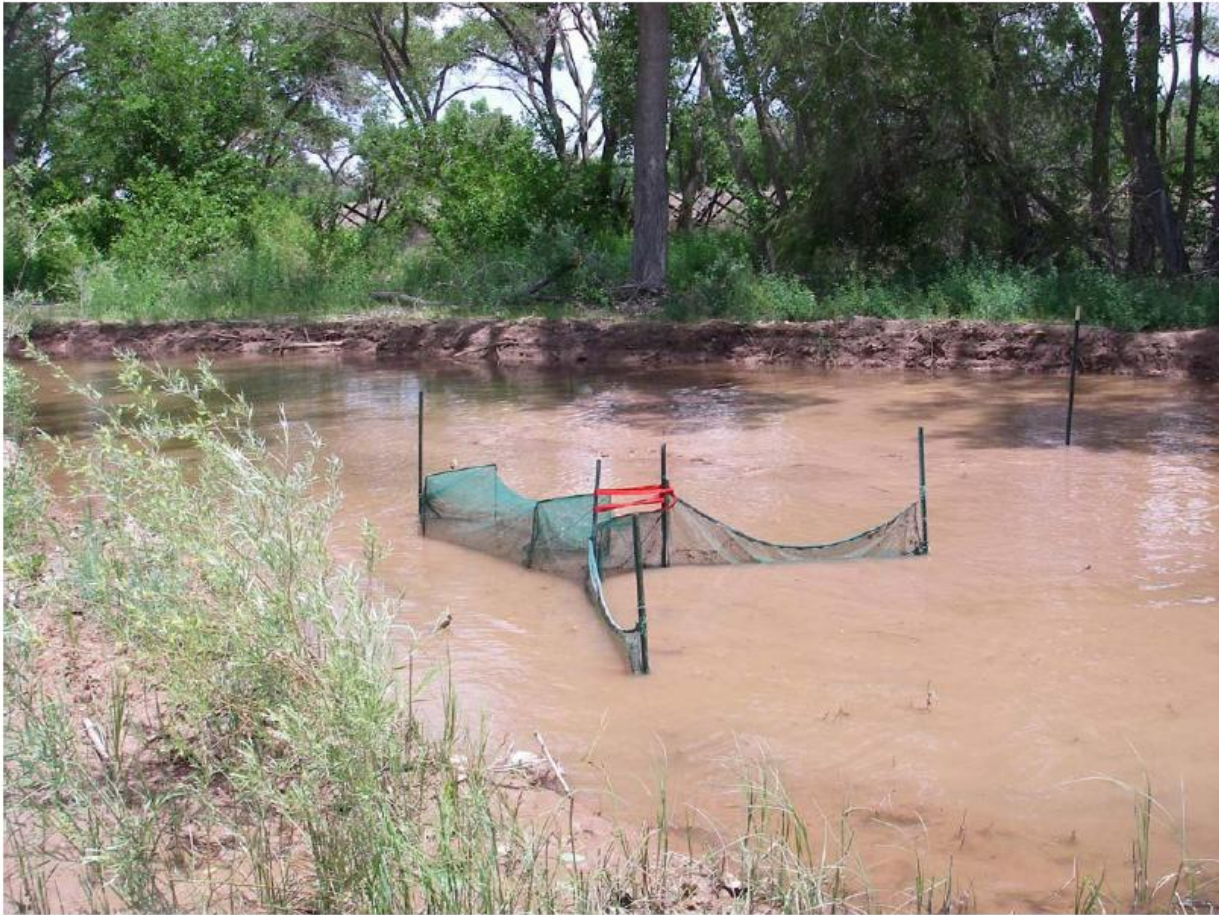
**Figure 3.** Fyke net installation at NMISC habitat restoration site.

Fyke nets will be deployed at multiple locations within the sites in an effort to document floodplain occupancy and spawning of silvery minnow (Figure 3). Depending on the site and topography, individual fyke nets, paired fyke nets (stretched across a narrow channel), one of which will be orientated with the flow and one against the flow, and fyke nets arranged as an enclosure will be set up.

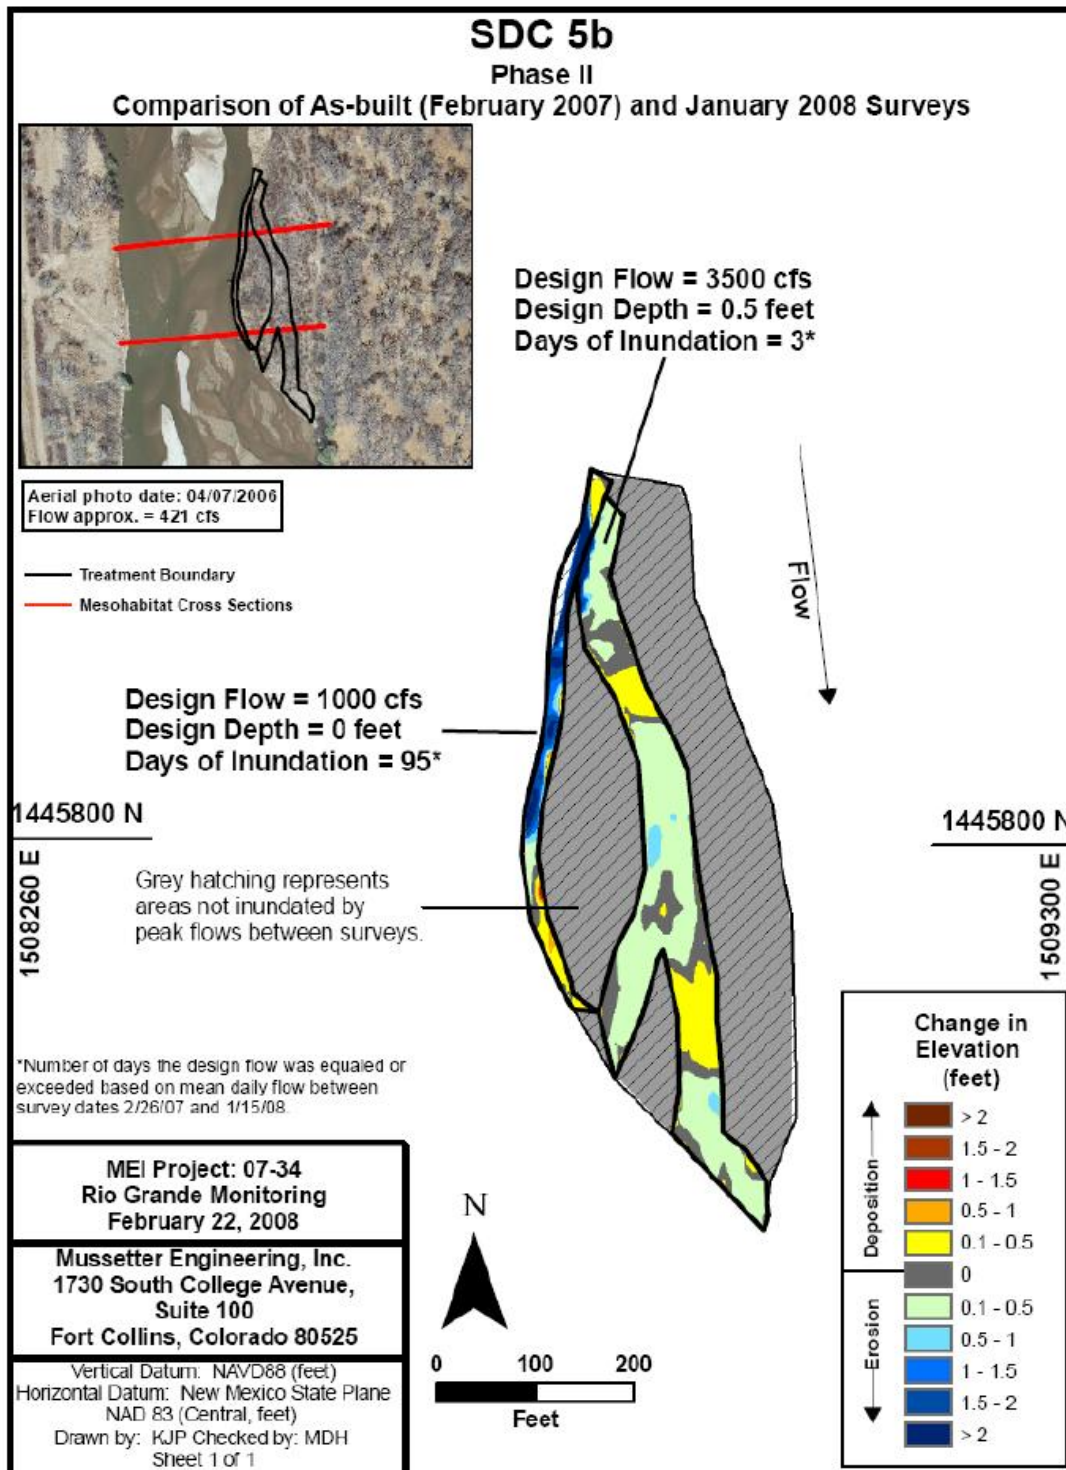
**Figure 4.** Visual output product for topographic survey comparison of NMISC habitat restoration site.

Survey results will be compared through time to determine the changes in elevation at the project sites (see Figure 4). The NMISC is interested in site wide aggradation and degradation to determine the sustainability and longevity of the project techniques. The NMISC is also interested in creating and maintaining a diversity of habitat characteristics across individual sites. Determining the isolated scouring and deposition of sediments within a site using the topographic surveys will help characterize that diversity.

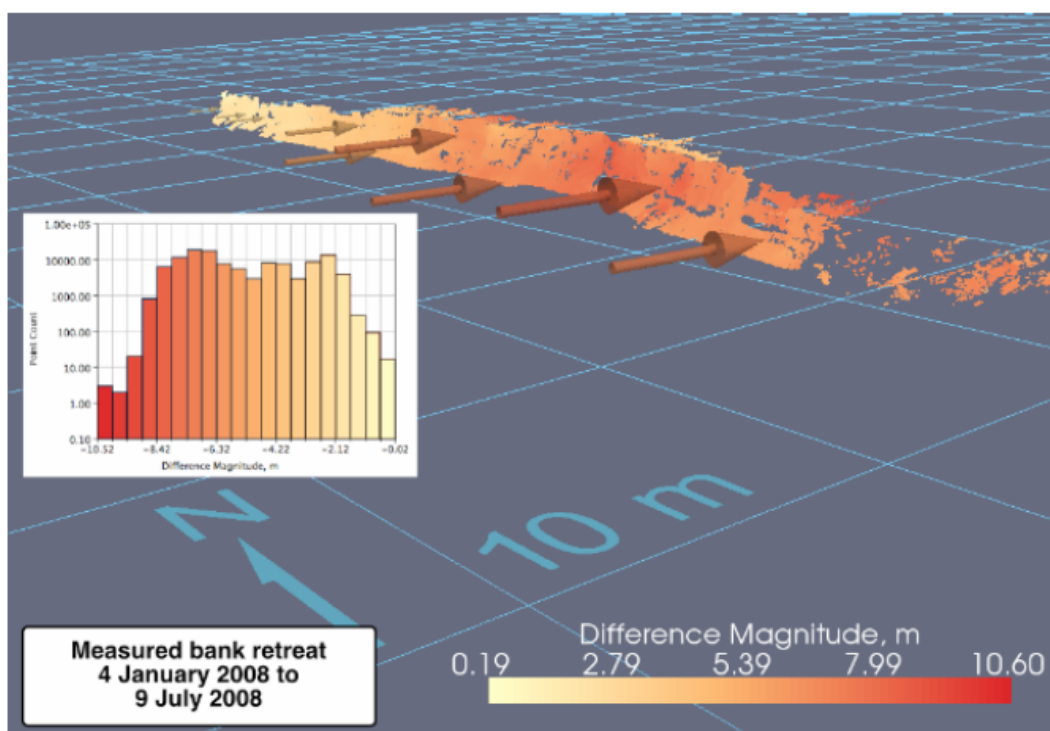
**Figure 5.** Visual output of changes in geomorphology between pre and post-2008 spring runoff for HR site PH1-I40-1b.

Additionally, the NMISC will utilize the University of New Mexico LiDAR Lab to produce DEMs of at least 2-4 HR sites to provide higher resolution analysis of the changes in geomorphology. The LiDAR lab has imaged and cataloged point in time DEMs for the Phase I I40-1ch bankline cut in January 2008 and July 2008 (see Figure 5). The initial analysis of bankline retreat at this site indicates that over this time period, the bankline has retreated on the order of 10 meters in some locations. The use of LiDAR based DEMs allow for cubic centimeter scale mass balance analysis. Although it is not realistically feasible to perform such analysis for every HR site, results from this type of analysis performed on a representative subset of sites can be correlated to sites not monitored this intensively. Given conditions on the ground, the NMISC would like to use LiDAR to conduct geomorphic monitoring at sites that represent each of the HR modification techniques.

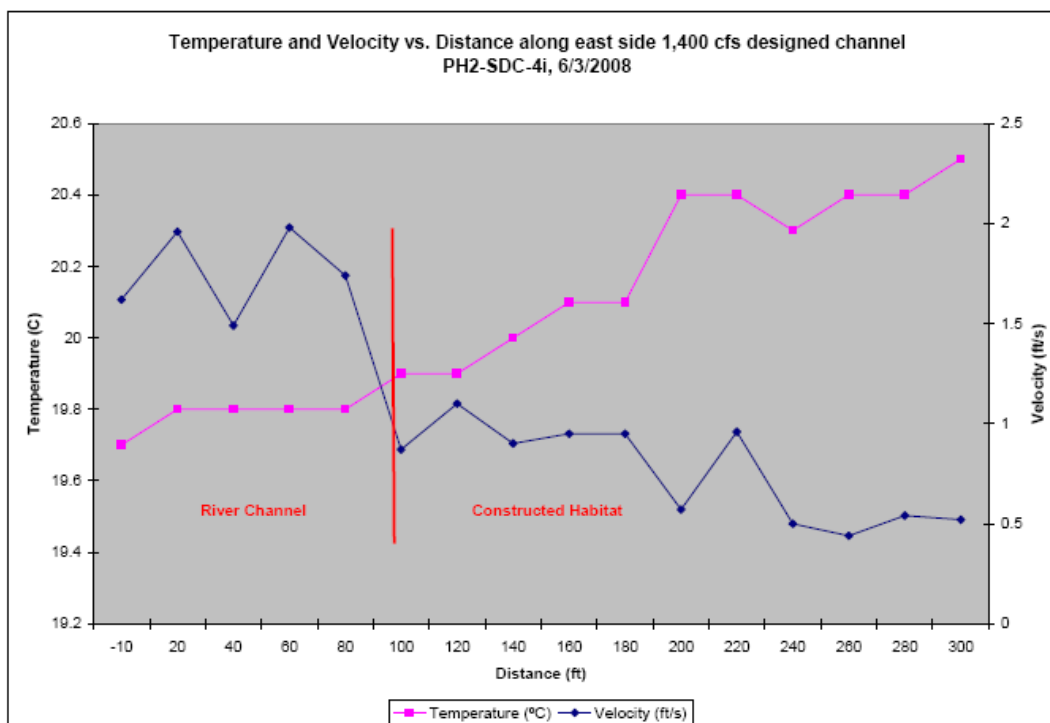
**Figure 6.** Graphed data results from 2008 hydrological monitoring of NMISC HR sites, notice the values and trends of the data between the river channel and the constructed habitat.

characteristic ranges, the NMISC will be able to make defensible arguments as to the success of the project in terms of the amount of suitable habitat that was created. Temperature is another variable that affects biological productivity of aquatic habitat and thus will be measured during hydrologic monitoring. In particular the NMISC is interested in distinguishing the hydrologic characteristics of existing in-channel habitat versus created effective floodplain habitats (see Figure 6).

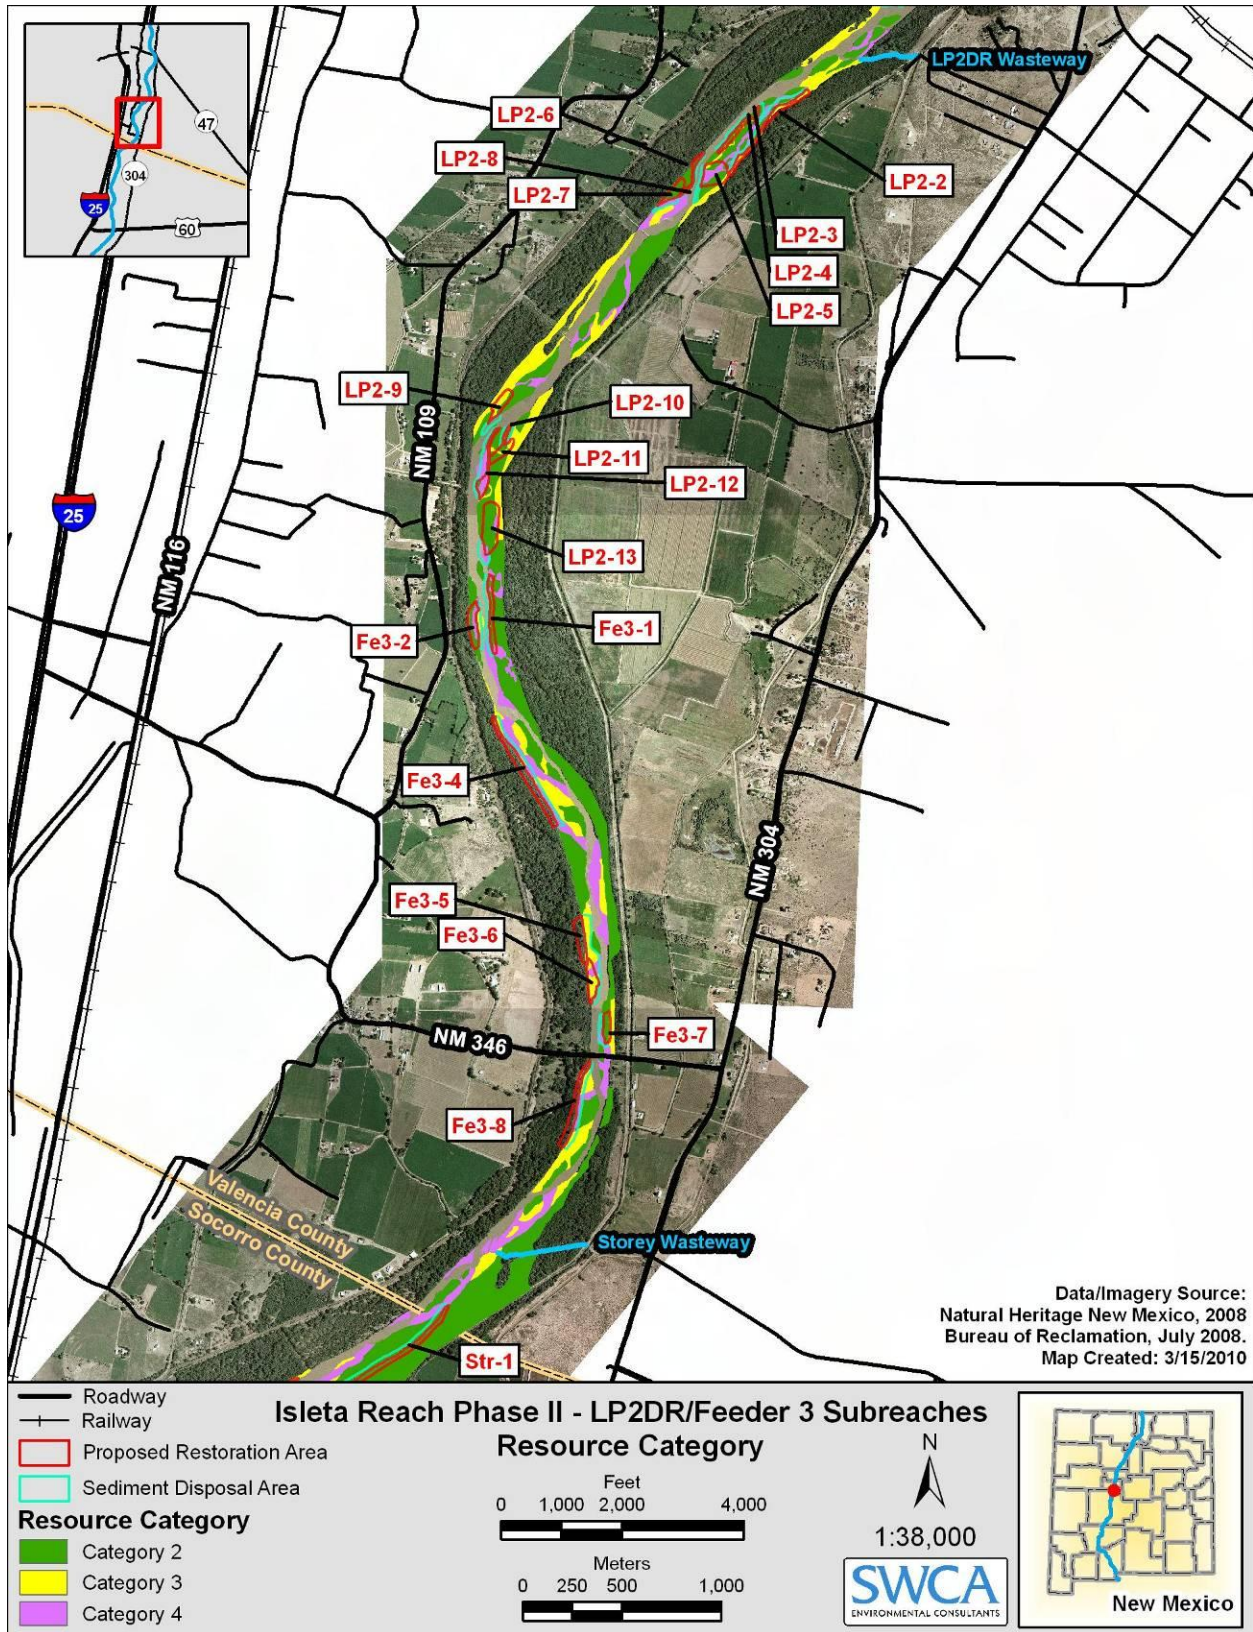
Figure F.2. LP2DR/Feeder 3 Subreach Resource Categories.

Dominant Strata Class Code: F = forest, S = Shrub, B = bare.

Dominant Vegetation Cover Code: h = high, m = moderate, s = sparse, b = bare.
