Oklahoma State Highway Dept.

From Oscar C. Curnutt, Ground Survey Engineer

Subject SWO 2154(1) - I-35 - From 2.5 miles north of US 60 west of Blackwell northerly to the Oklahoma-Kansas State Line, Kay County.

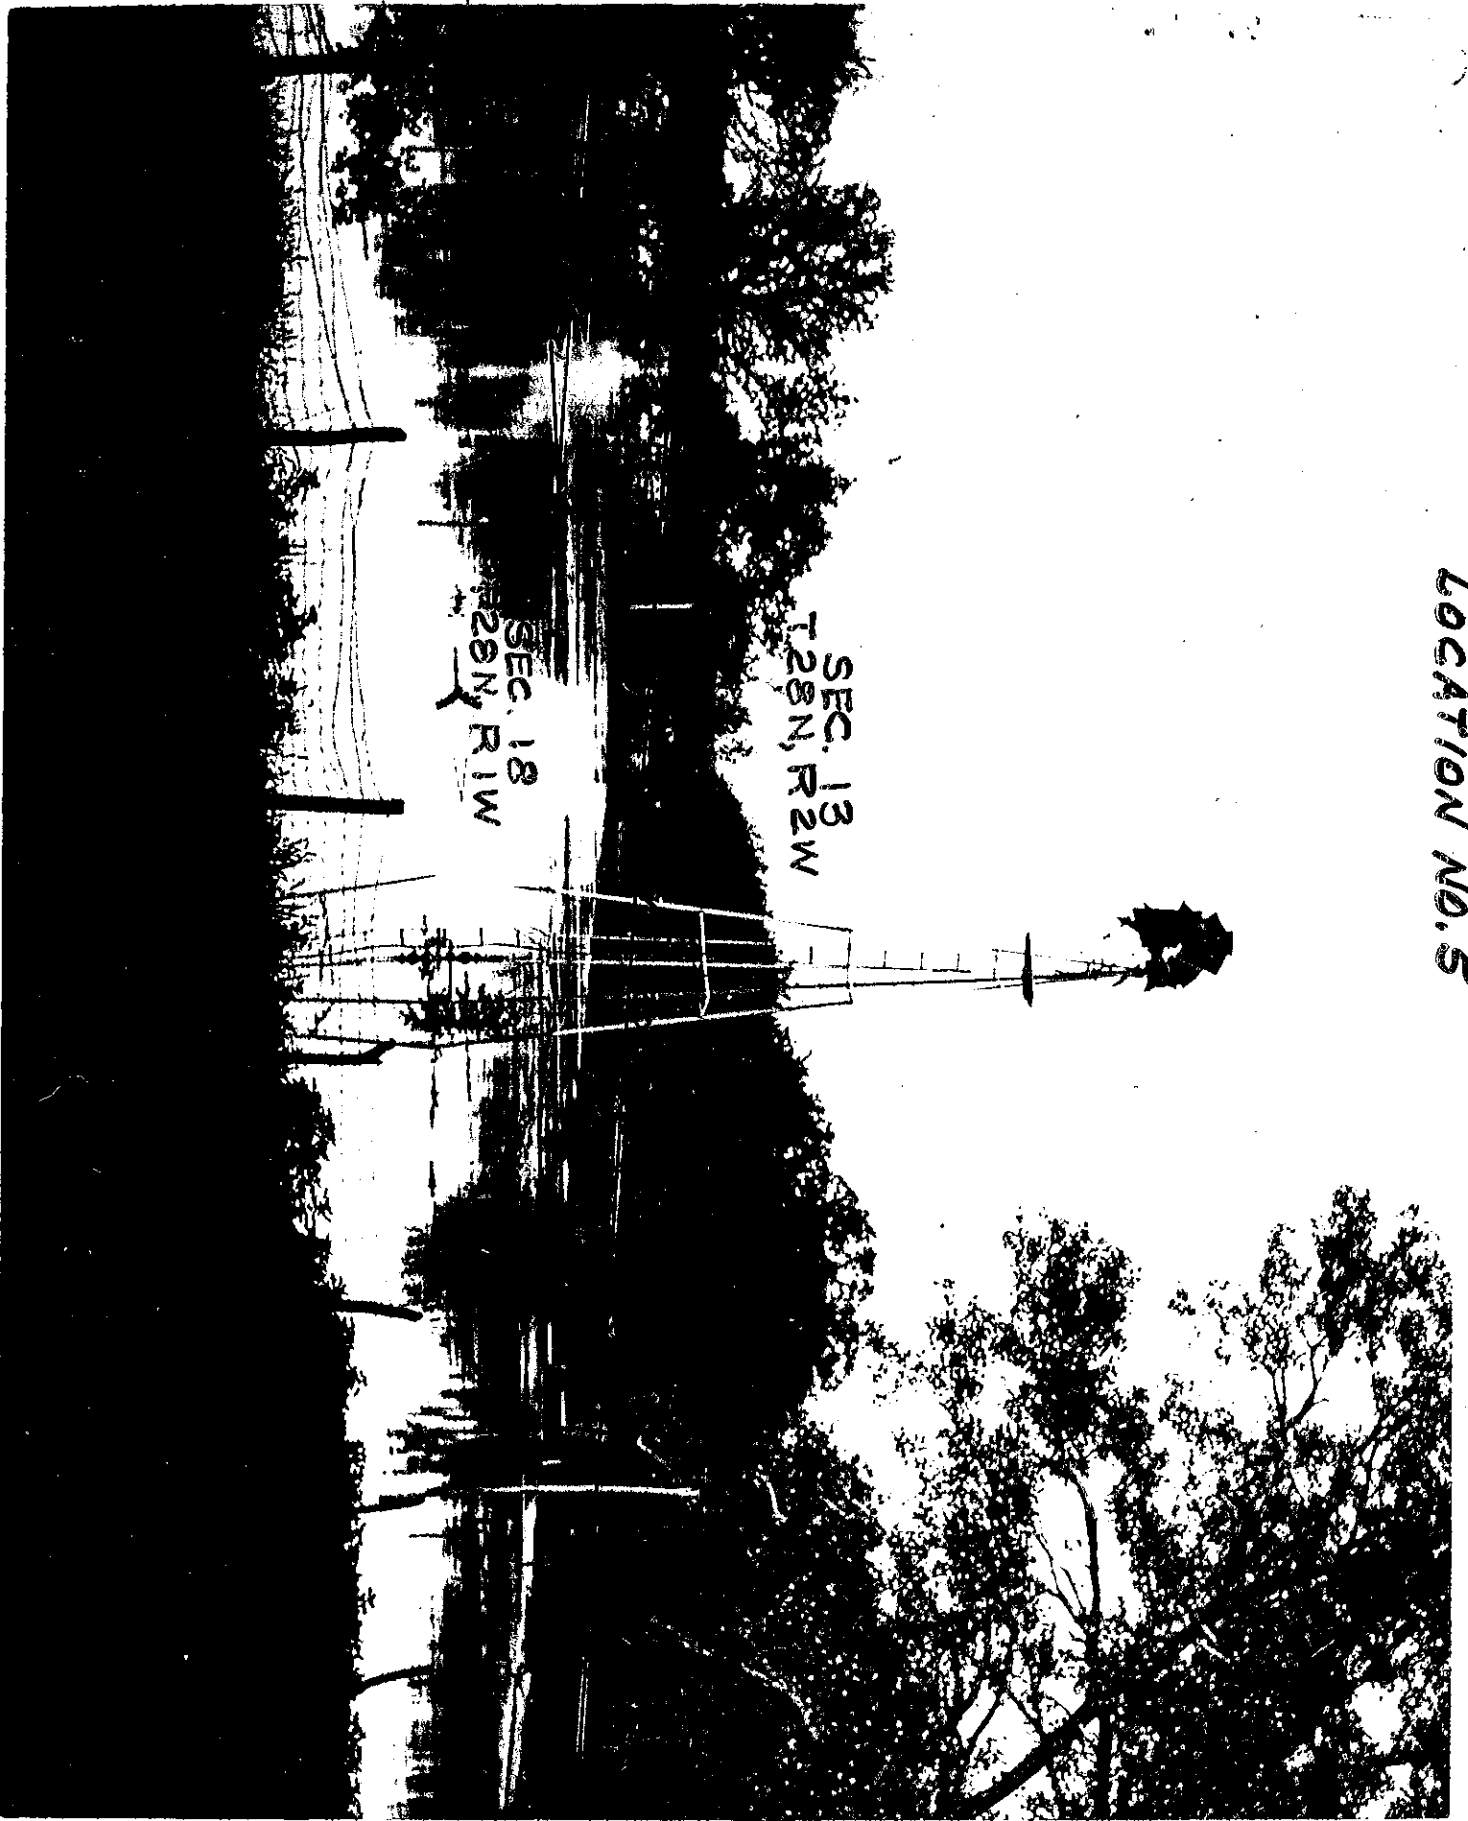
LOCATION NO. 5

1. Location At the Mrs. Lawrence Scott residence located in the NW/4 Sec. 18, T-28-N, R-1-W approximately 1.0 Mi. West and 1.0 Mi. South of Braman, Kay County, Oklahoma
2. Subject Highwater on the Chickaskia River in the Braman, Kay County area.
3. Purpose To record and preserve highwater information.
4. For Use SWO 2154(1), I-35-4(4)225, Flood information on the Chickaskia River, Shoo-fly and Dry Creeks in the vicinity of Braman.
5. History and Explanations Photograph was obtained from Mrs. Lawrence Scott. The location is just south of residence looking southwest. The large tree at right is southeast corner of yard. The windmill has been removed but concrete foundation still in place.

The highwater occurred in 1957 and caused by the Chickaskia River overflow.

The photograph does not depict the maximum elevation water reached.

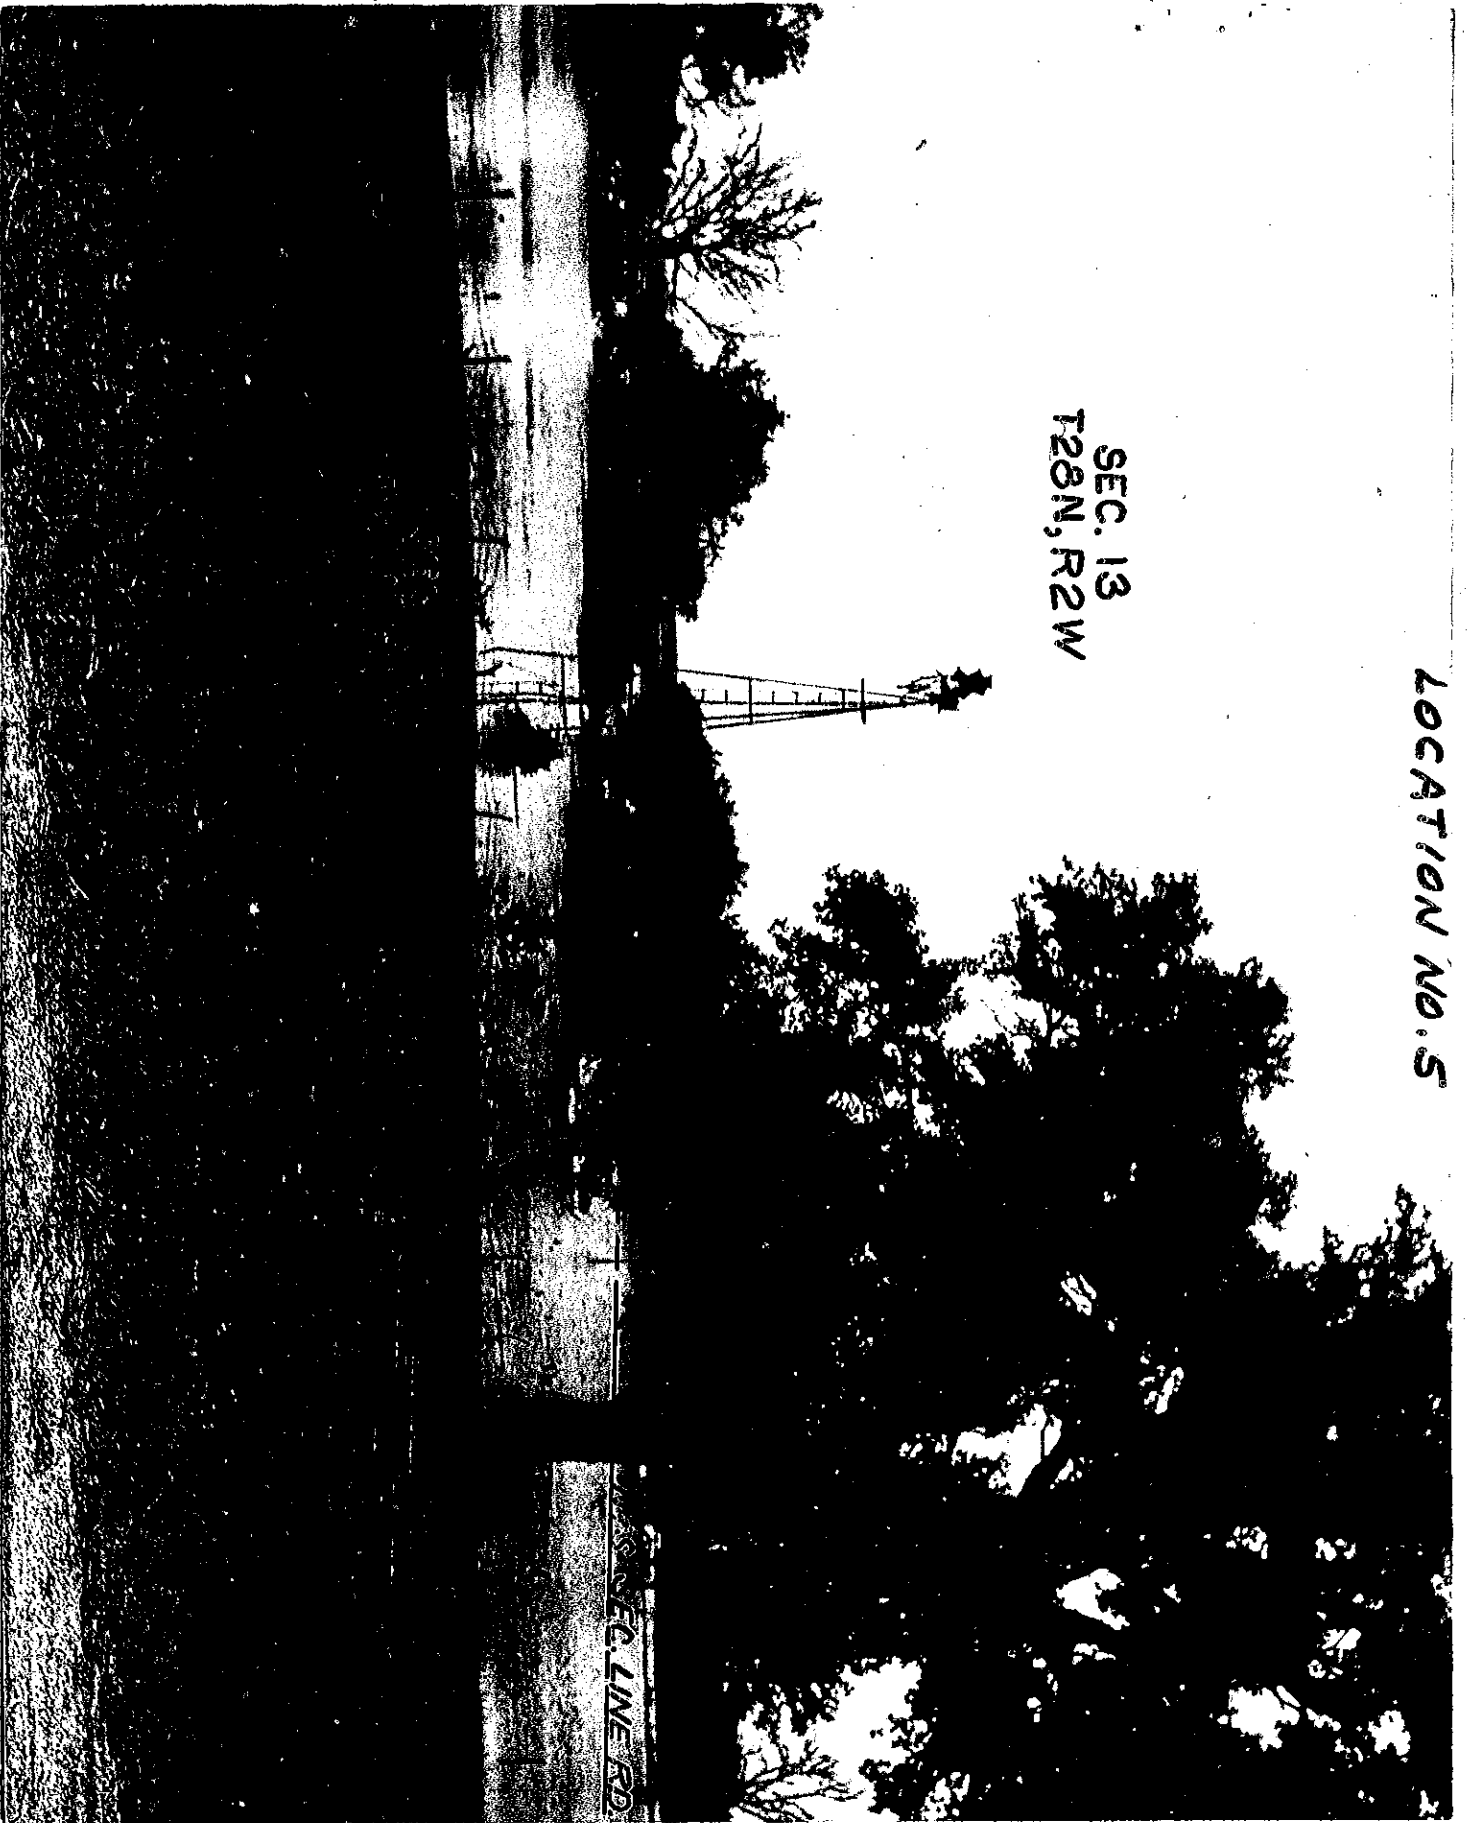
LOCATION NO. 5

5. History and Explanations Photograph was obtained from Mrs. Lawrence Scott. The location of the photograph is in the S.E. corner of Mrs. Scott's yard. The large tree at the right is the southeast corner of the yard. The windmill has been removed but concrete foundation is still in place.

The photograph was taken from highground just southwest of Scott Residence looking southwest.

This highwater occurred in 1957 and is caused by Chickaskia River overflow, while on water was on the rise and does not depict the maximum elevation the water reached. The Chickaskia River County road crossing is approximately 1000' south of this location.

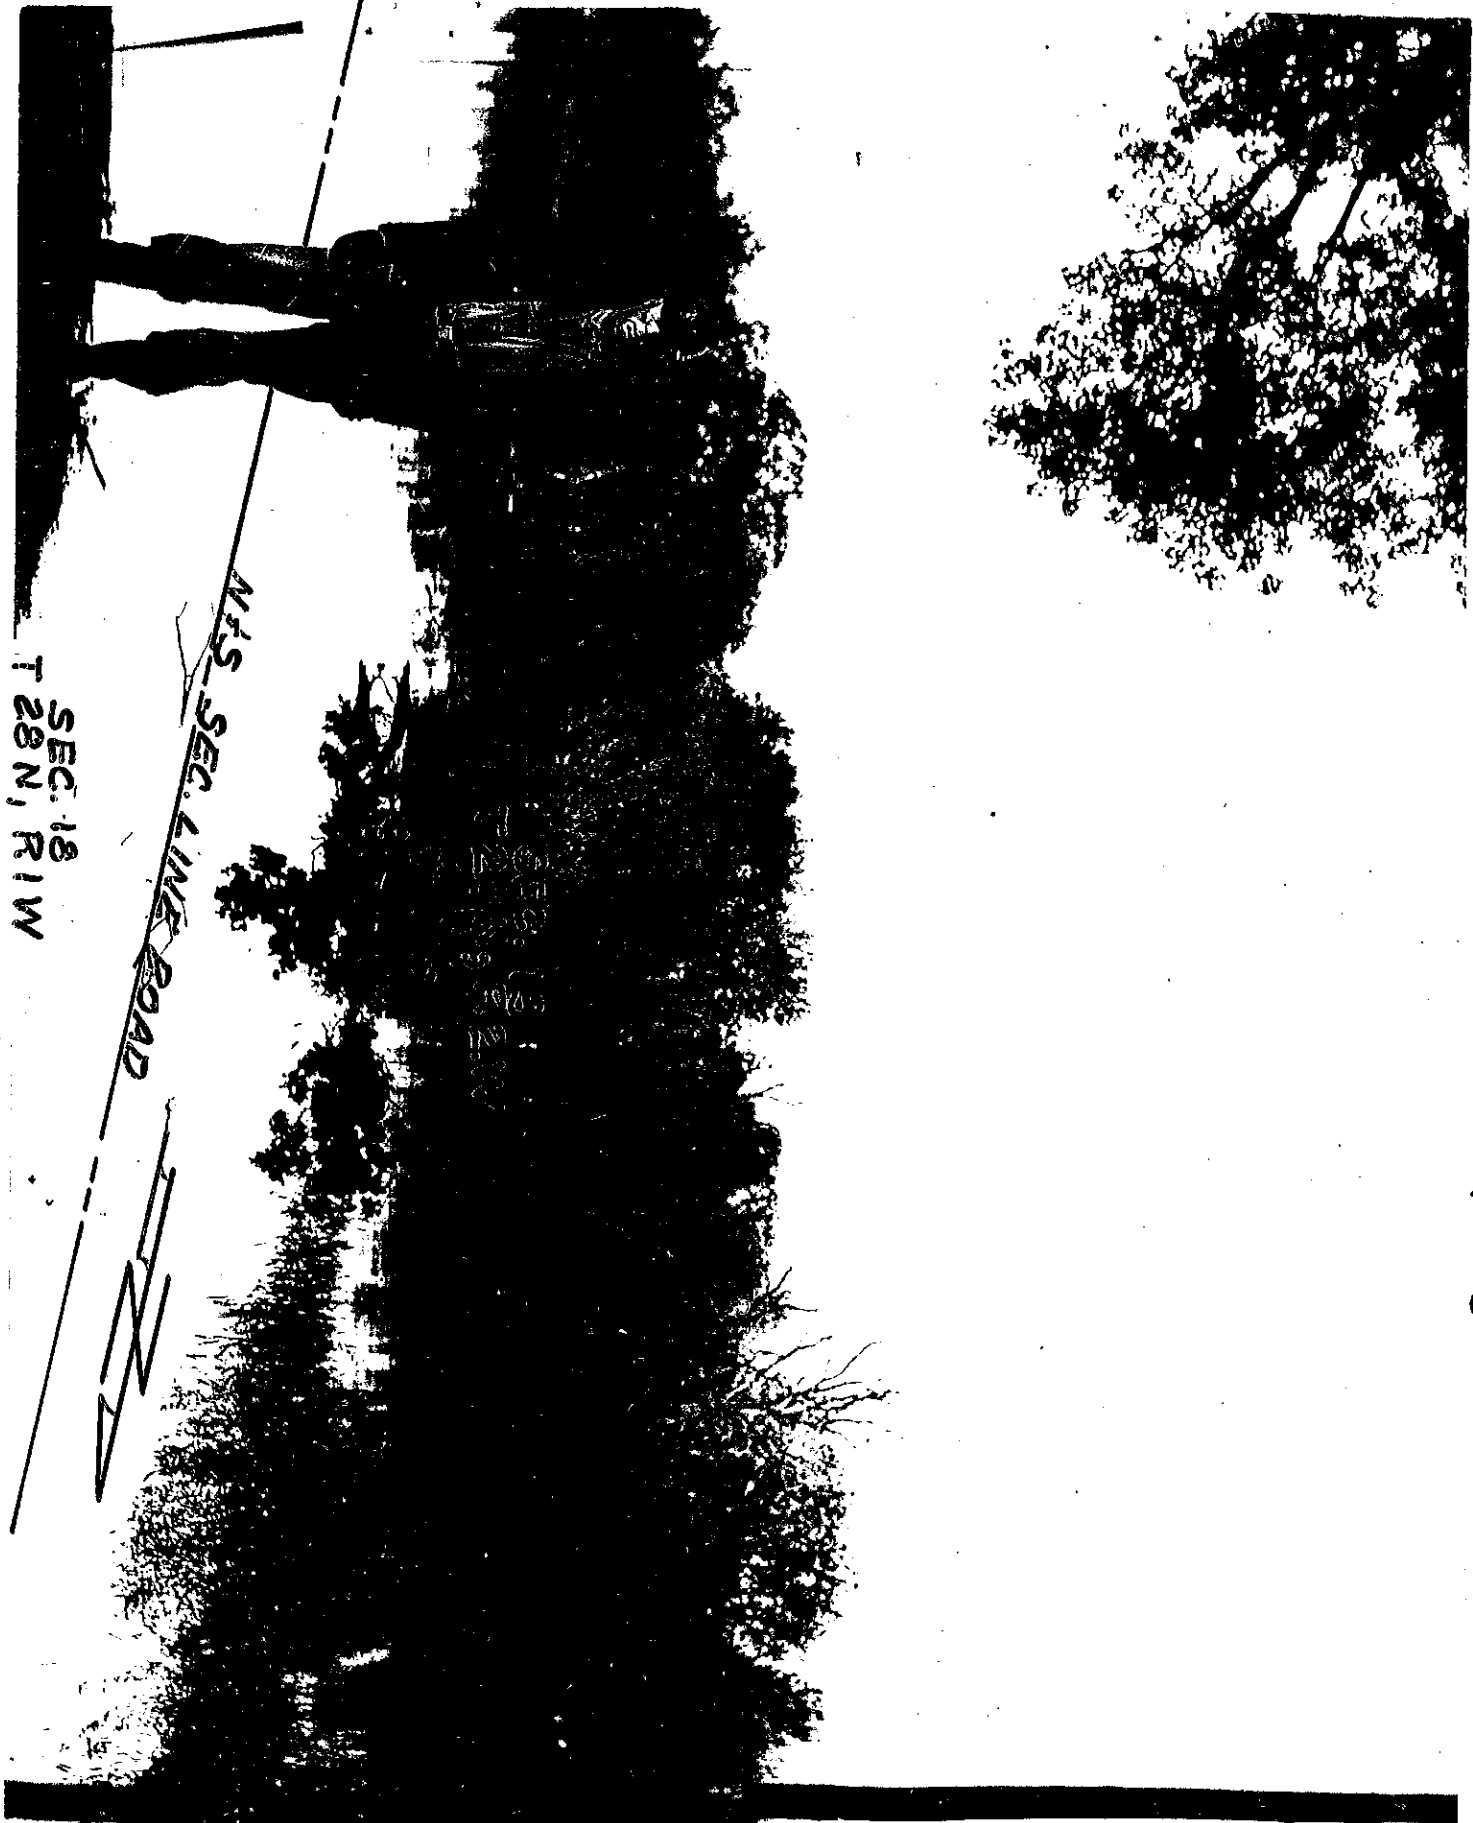
LOCATION NO. 5

1. Location At Mrs. Lawrence Scott Residence located in the NW/4
Sec. 18, T-28-N, R-1-W, approximately 1.0 mile W. and 1.2 miles
S. of Braman, Kay County.
2. Subject Highwater on the Chickaskia River in the Braman, Kay
County area.
3. Purpose To record and preserve highwater information.
4. For Use SWO 2154(1), I-35-4(4)225, Flood information on the
Chickaskia River, Shoo-fly and Dry Creeks in the vicinity of
Braman.
5. History and Explanations Photograph was obtained from Mrs.
Lawrence Scott, the location is at the entrance to driveway to
her residence, on east side of N.&S. section line road looking
southwest.

The highwater occurred in 1957 and is caused by Chickaskia River overflow as it was on the rise and does not depict the maximum elevation water reached. The Gentlemen in the photograph is Mr. Lawrence Scott, deceased.

The Chickaskia River section line road crossing is approximately 1000' south from this location.
