Subject SWO 2329 (1) - US 271 - Pushmataha-LeFlore Counties
FAP 126 (4) (5) - US 271 - Talihina south to the LeFlore-Pushmataha County Line

Additional Information - Rock Creek Flood of September 27, 1964, approximately 1.5 miles south of Talihina.

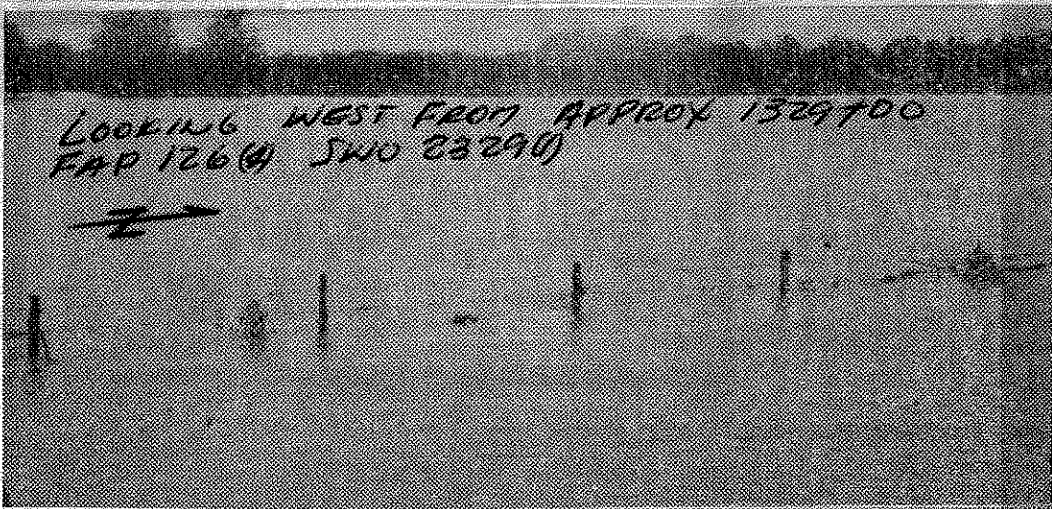
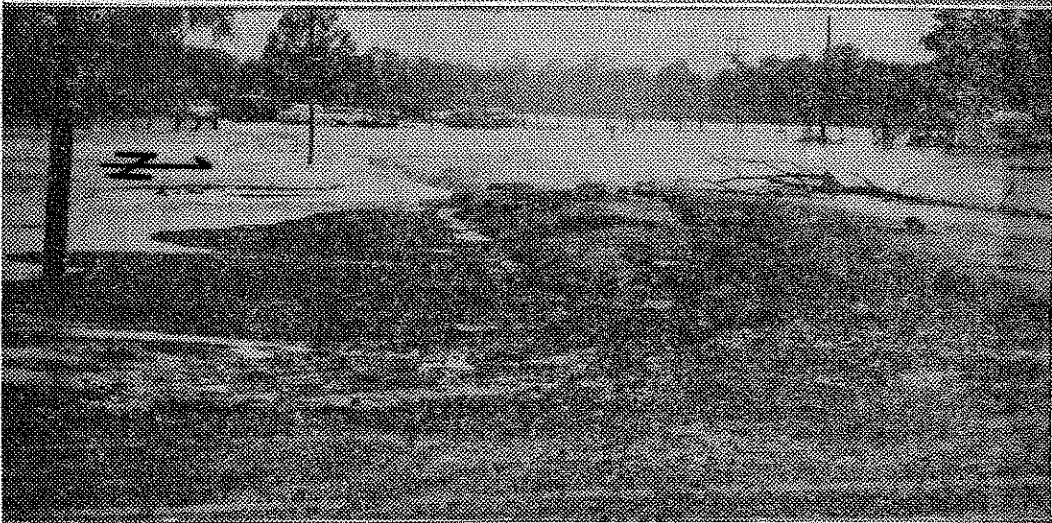
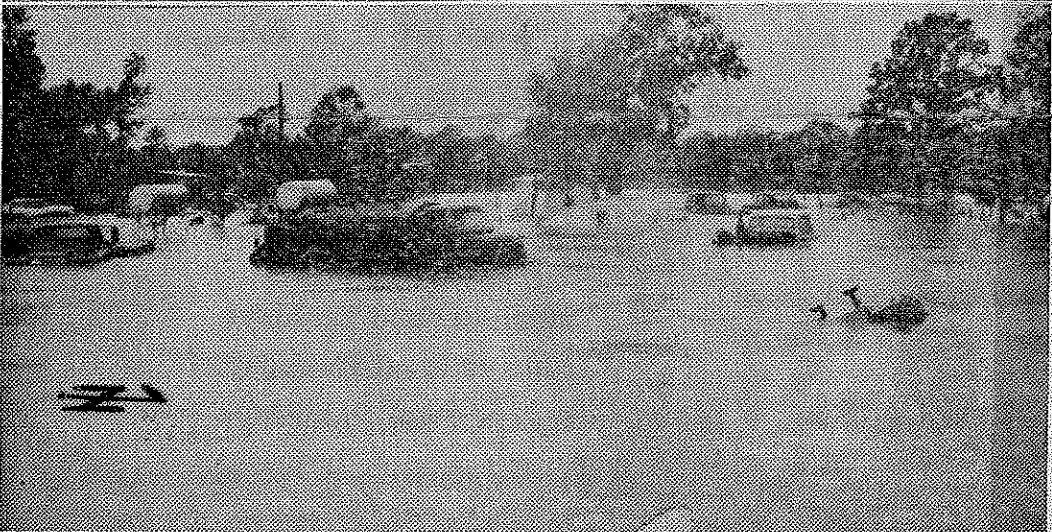
The attached Talihina American paper dated Thursday, October 1, 1964, has three pictures of the flood which were taken from US 271, looking westerly from approximately Sta. 1329+00 after the water started receding.

PICTURES TAKEN FROM US 271
LOOKING WEST AT APPROXIMATE
STA. 1327 AFTER WATER STARTED RECEDED.

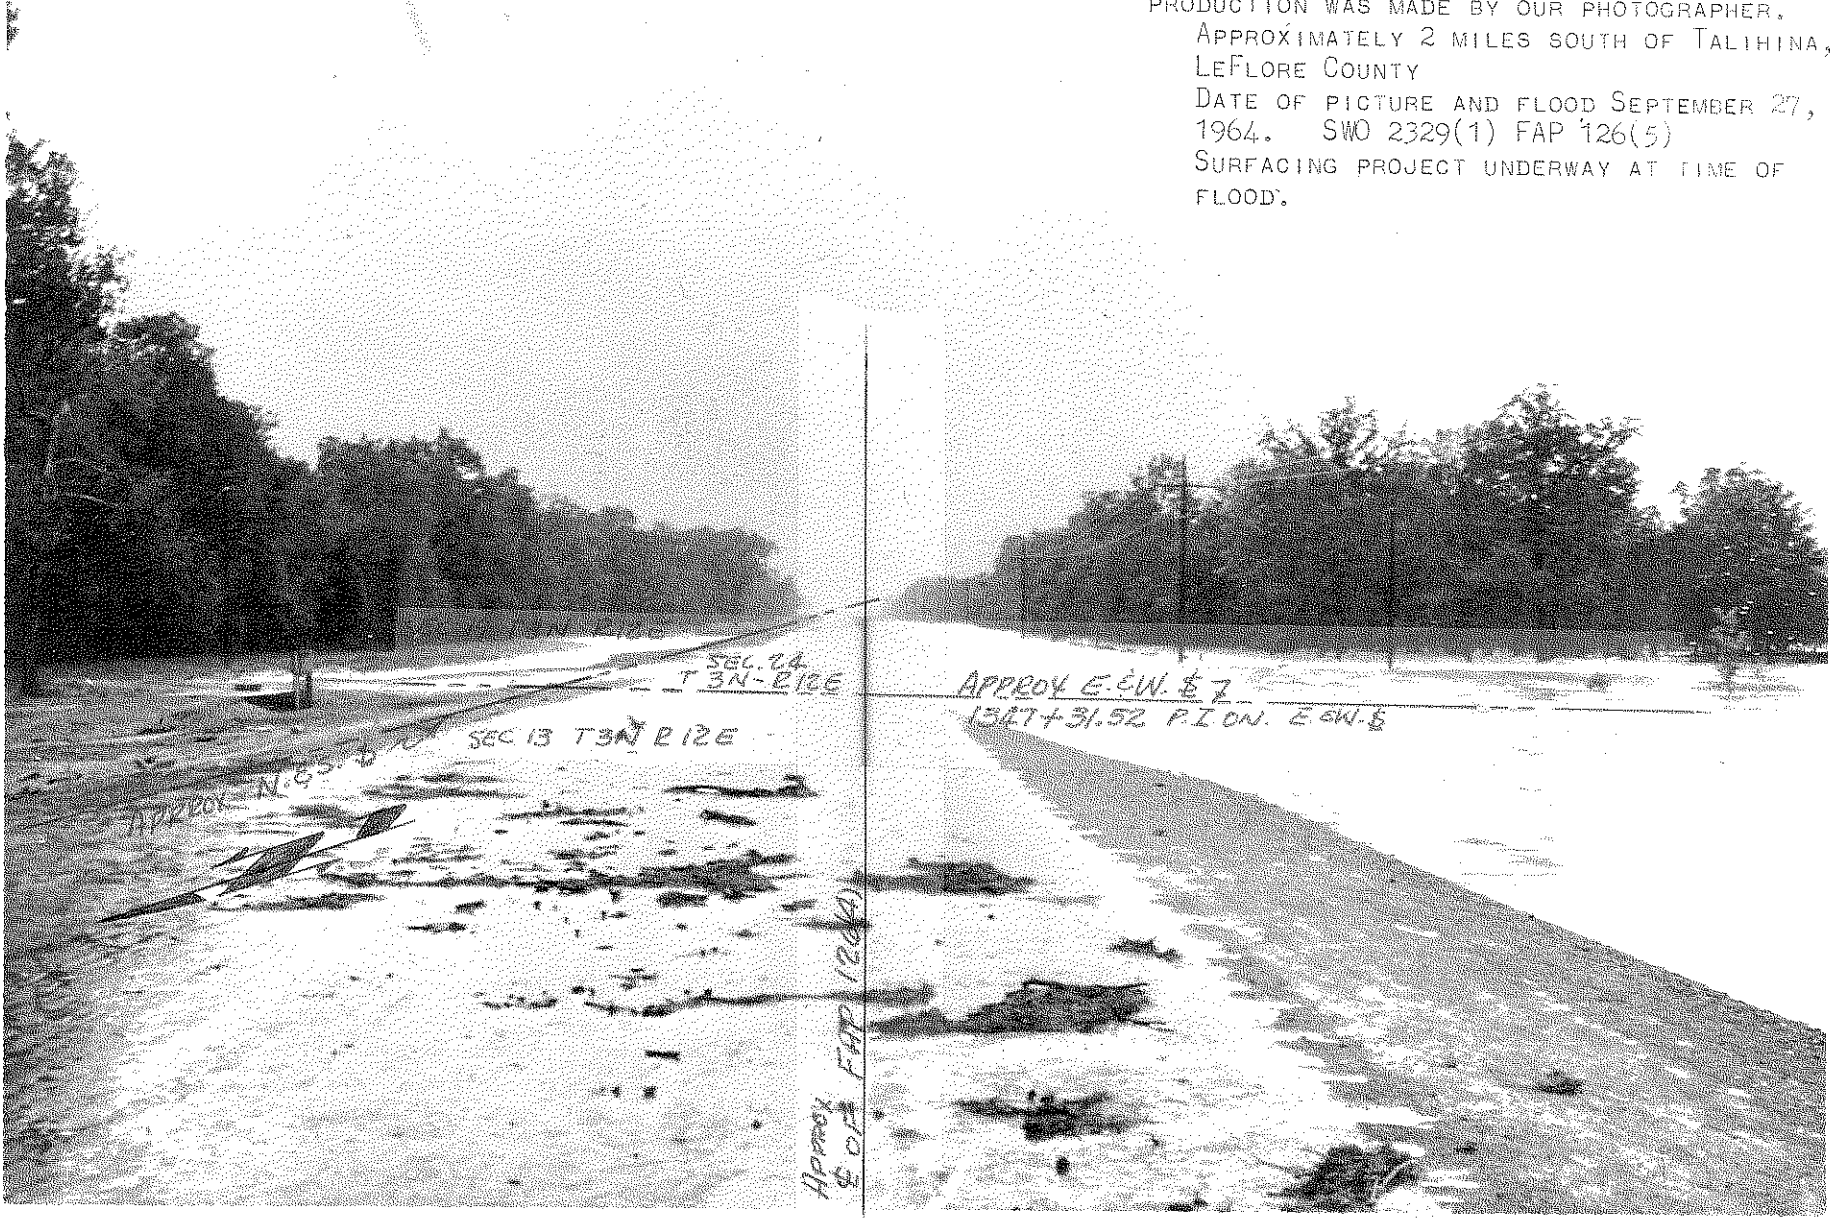
SEPT. 27, 1964 - LOOKING SOUTH - WATER
CROSSING NEW US 271 SOUTH OF TALIHINA.
NOTE WATER MOVING SWIFTLY AT THE RT. SIDE
OF ROAD. THE NEW ROAD FILL DIVERTED WATER
SOUTH FROM ROCK CREEK TO JACKSON CREEK.
PICTURE BORROWED FROM SOIL CONSERVATION
SERVICE AT TALIHINA. FROM WHICH THIS RE-
PRODUCTION WAS MADE BY OUR PHOTOGRAPHER.

APPROXIMATELY 2 MILES SOUTH OF TALIHINA,
LEFLORE COUNTY

DATE OF PICTURE AND FLOOD SEPTEMBER 27,
1964. SWO 2329(1) FAP 126(5)

SURFACING PROJECT UNDERWAY AT TIME OF
FLOOD.

Mr. George Farrar, Junior Resident Engineer, on construction of this new US 271 highway said the flood occurred at 6:00 AM, Sunday morning on September 27, 1964 and washed out the road fill between Sta. 1338+00 and Sta. 1352+00. The high water was caused by a flash flood which lasted only a few hours.

A 5 1/4 inch rain fell in the water shed area of Rock Creek during the night of September 26, 1964. The water overflowed a bend in the creek approximately 1200 feet west of Sta. 1374+00 and flowed south easterly on the west side of US 271 into Jackson Creek, also across US 271 between Stations 1338+00 and 1352+00 where it washed out the fill.

The attached kodak picture was taken with a Polaroid Camera, looking south on US 271. I borrowed this picture from the Talihina Soil and Water Conservation District Office at Talihina, which I am to return.
