Habitat Restoration Work Group Meeting  
*October 21, 2014*

**Corrales Siphon Presentation to  
Habitat Restoration Workgroup  
Michael Scialdone – Bosque Project  
Manager  
October 21, 2014**

## The Corrales Siphon

Overview of issues related to its possible exposure

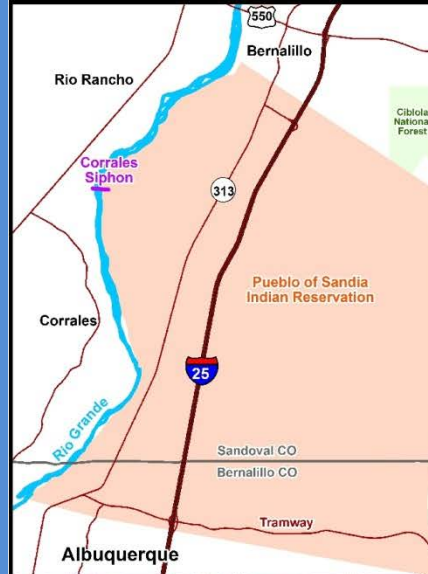
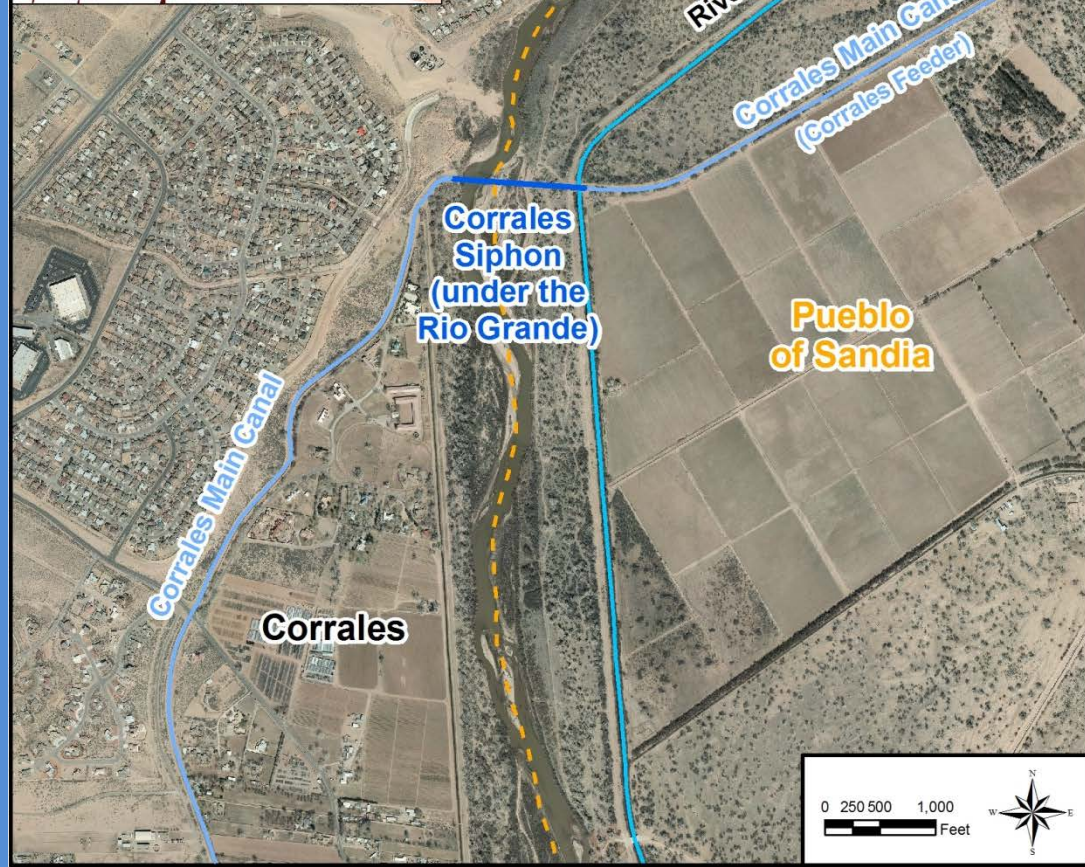
# The Corrales Siphon Regional Overview

Water is taken from the Rio Grande at the Angostura Diversion Dam, about 10 miles north of Corrales. All of this water goes to the east side of the river, with some ending up in the Albuquerque Main Ditch.

Toward the north end of the Pueblo of Sandia, it connects with the Corrales Main Canal, often called the Corrales Feeder on the Pueblo side. This is the beginning of the irrigation system for all the farms on the west side of the Rio Grande from Corrales down to Montañito.

Just before the Riverside Drain, water drops into the Corrales Siphon, which takes it under the Rio Grande and back up into the ditch on the Corrales side.

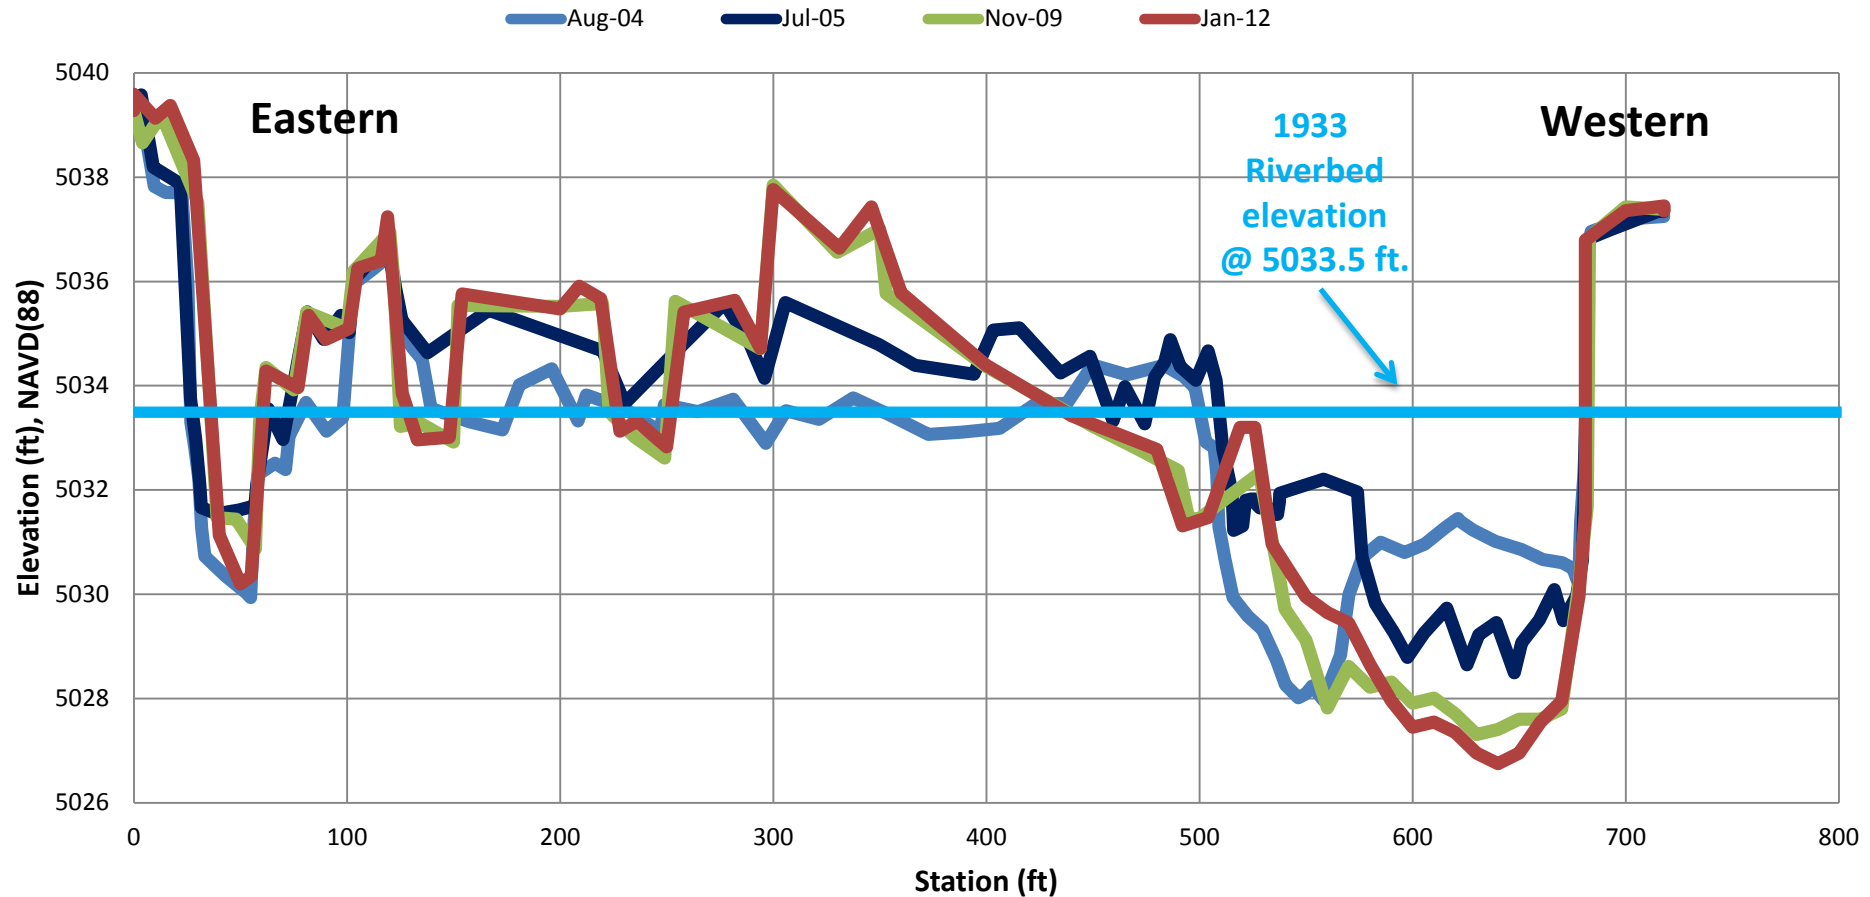
# River Cross Section near Corrales Siphon (2004-2012)

- River bed has lowered near western bank almost 4 feet just in the last 9 years
- Image taken from BoR presentation to Corrales Village Council on Nov 12, 2013

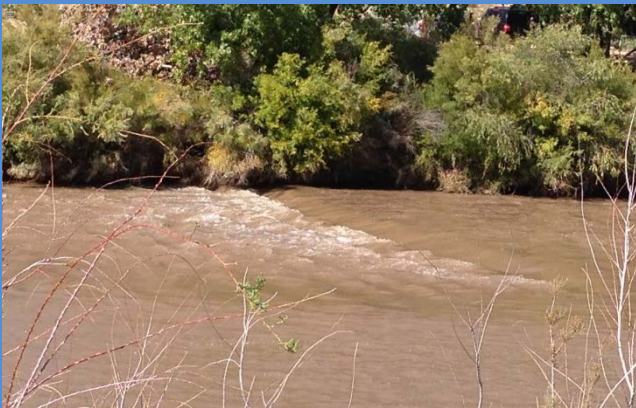
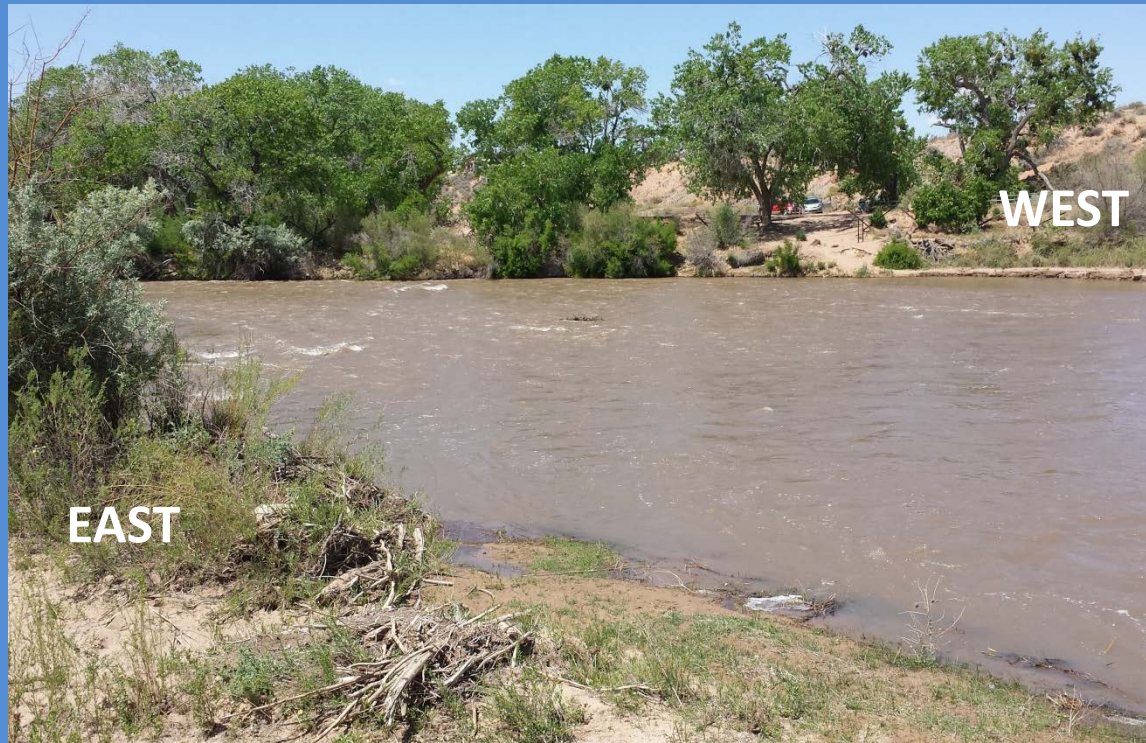
- A gravel bar coming out of Arroyo de la Baranca, just upstream of the Siphon directed the Rio Grande to the west side
  - The Siphon is two feet deeper on the east side and rises to the west
  - The down-cut river is now directly over the most shallow part of the Siphon and the river is now pouring over it
- The Siphon now begins to act as a weir, pushing water toward the bank that is already up near its exit on the Corrales side

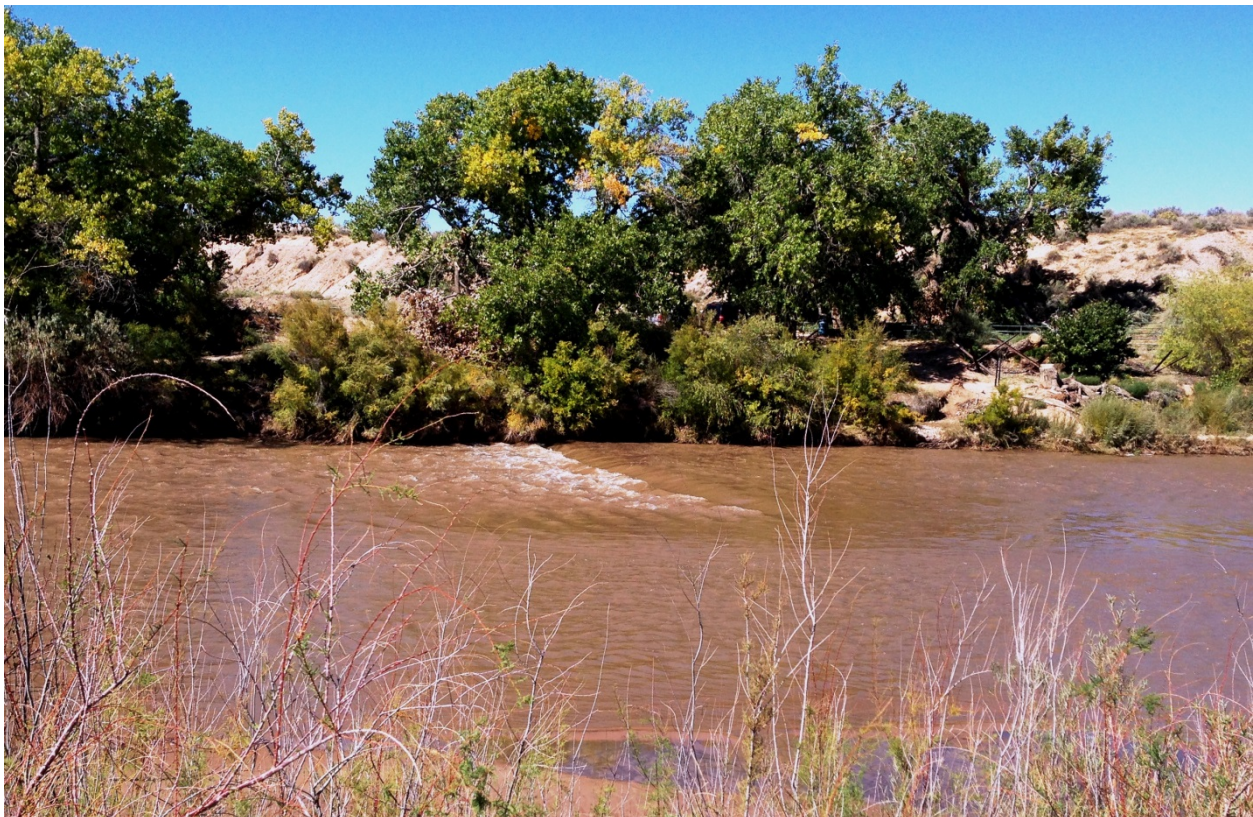
The Rio Grande flowing over the Corrales Siphon.

Looking at the Rio Grande where the Corrales Siphon goes under it, one can “see” its location (see photo on p. 4 below). It is not directly exposed yet. A hump or wave in the river shows where it is pouring over the Corrales Siphon. Reports on the Corrales Siphon note that as long as it stays wet, it is safe. However, nothing is stated about how long it can retain its structural integrity with the river pushing directly into it, regardless if this keeps it wet. Going through the trouble to put the top of a 6ft structure 8ft below the riverbed when it was it was built, it seems clear the original designers planned not just for it to stay wet but protected from direct contact with the river’s flow. This protection is gone and time is of the essence for a solution.

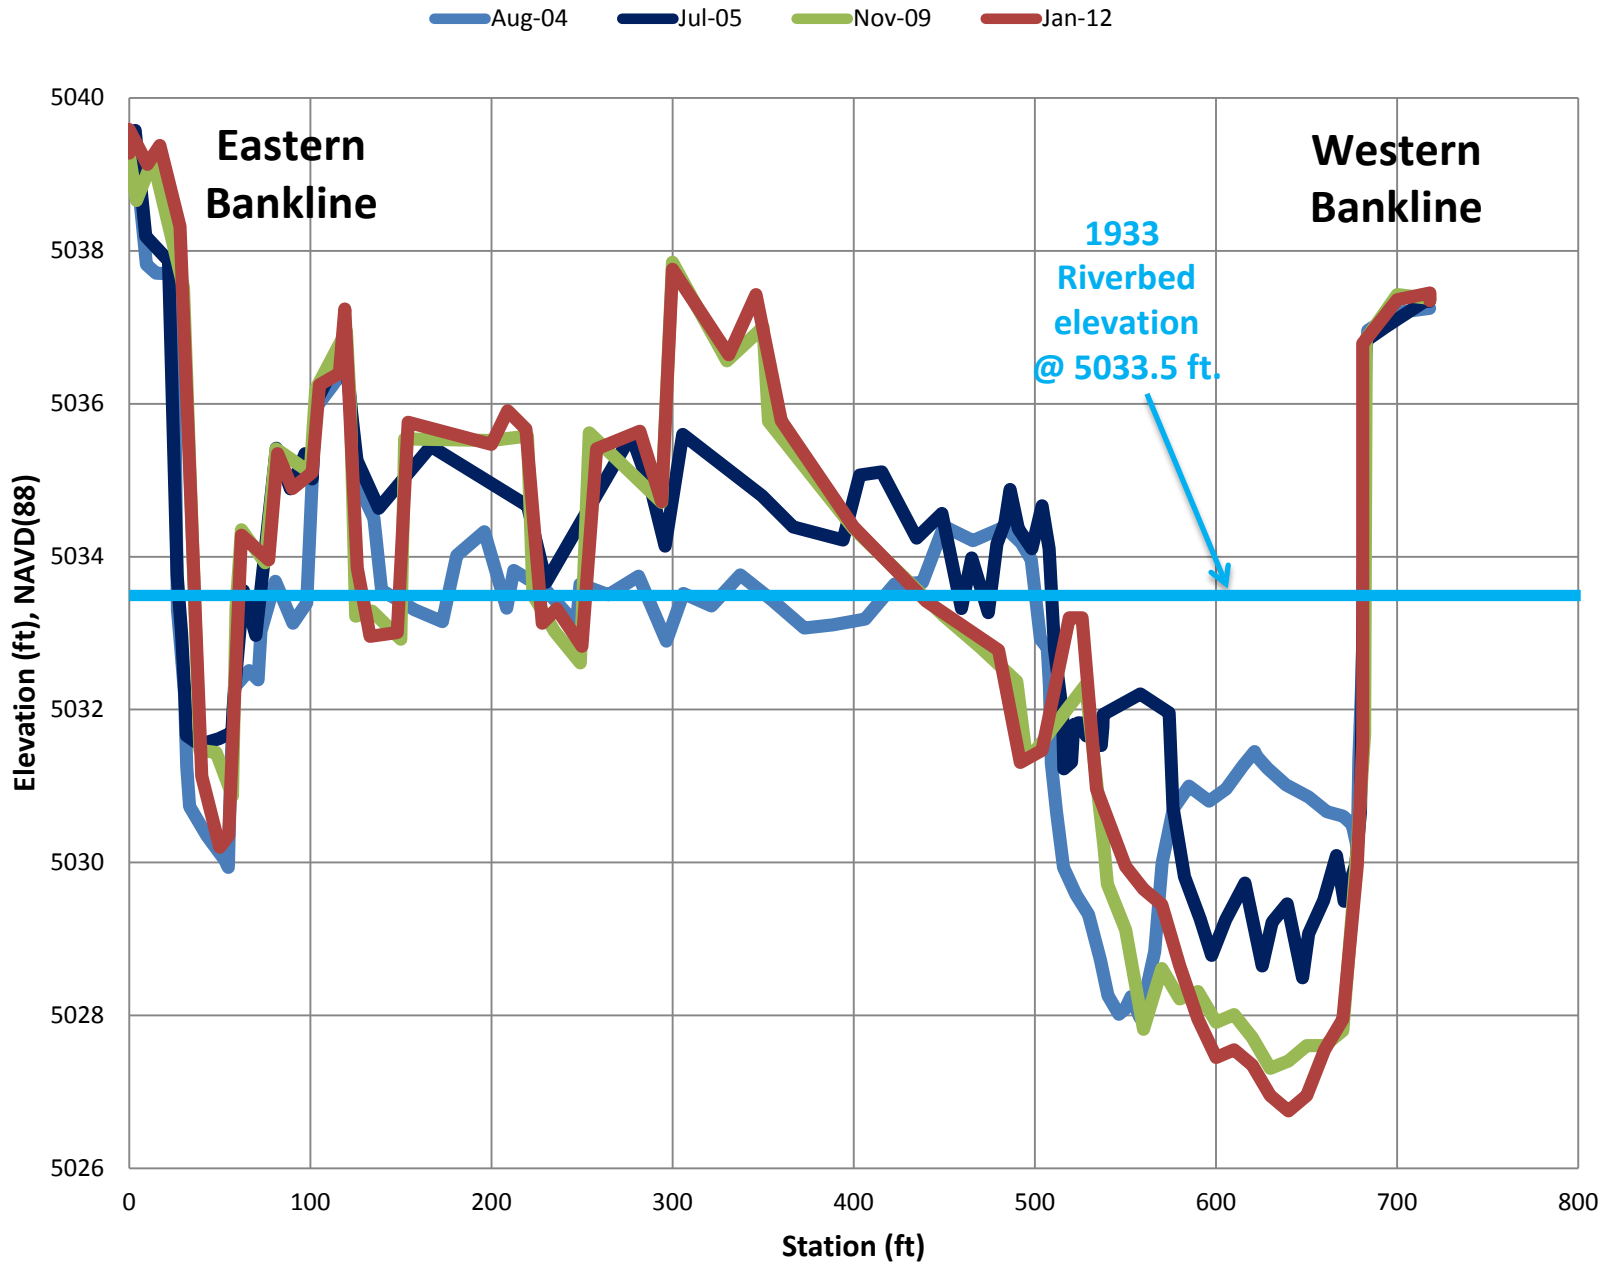
# Cross Section 350 Feet Downstream of Corrales Siphon

- **River Cross Section 350 Feet Downstream of Siphon Crossing (2004-2012).**
- **River bed has lowered near western bank almost 4 feet in last 9 years.**
- **Image taken from presentation to Corrales Village Council on Nov 12, 2013.**

A further complication is that as the Corrales Siphon is pushed on by the river, it starts to act like a weir. This means that it will push water toward the banks, potentially compromising them. At the Corrales Siphon, the Rio Grande is at the far right (west) bank, not far from where irrigation water leaves the Corrales Siphon and continues in the Corrales Main. In other words, it would not take much bank-line erosion to reach and cut into the Corrales Main. See graph on p. 7 showing how much the river has dropped on the western bank.
