EVALUATION OF SEDIMENT DYNAMICS IN HABITAT RESTORATION FEATURES IN ALBUQUERQUE

Kyle Stark
Jonathan AuBuchon
Lynette Giesen

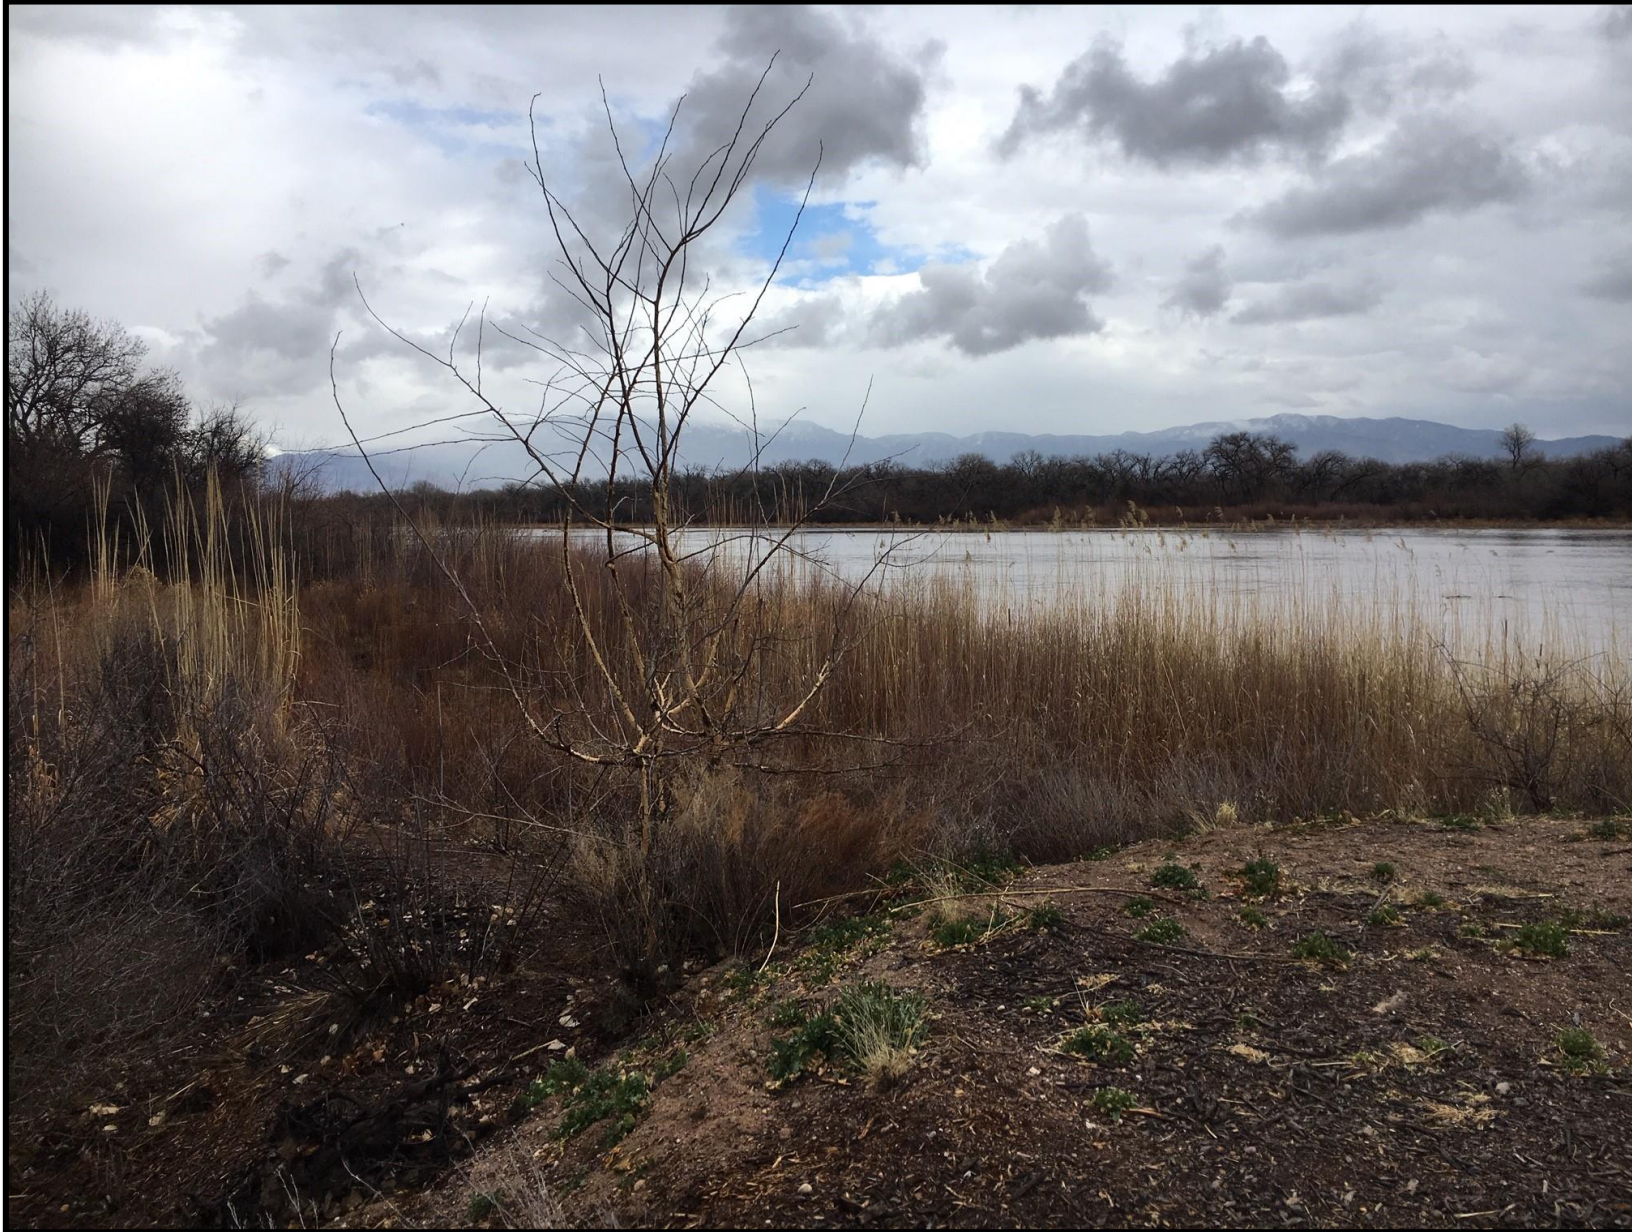
- Channelize flow
 - high flow channels
 - Backwater embayments
- Create inland depressions
 - Swales
 - Constructed ponds
- Modify banklines through terracing and grading

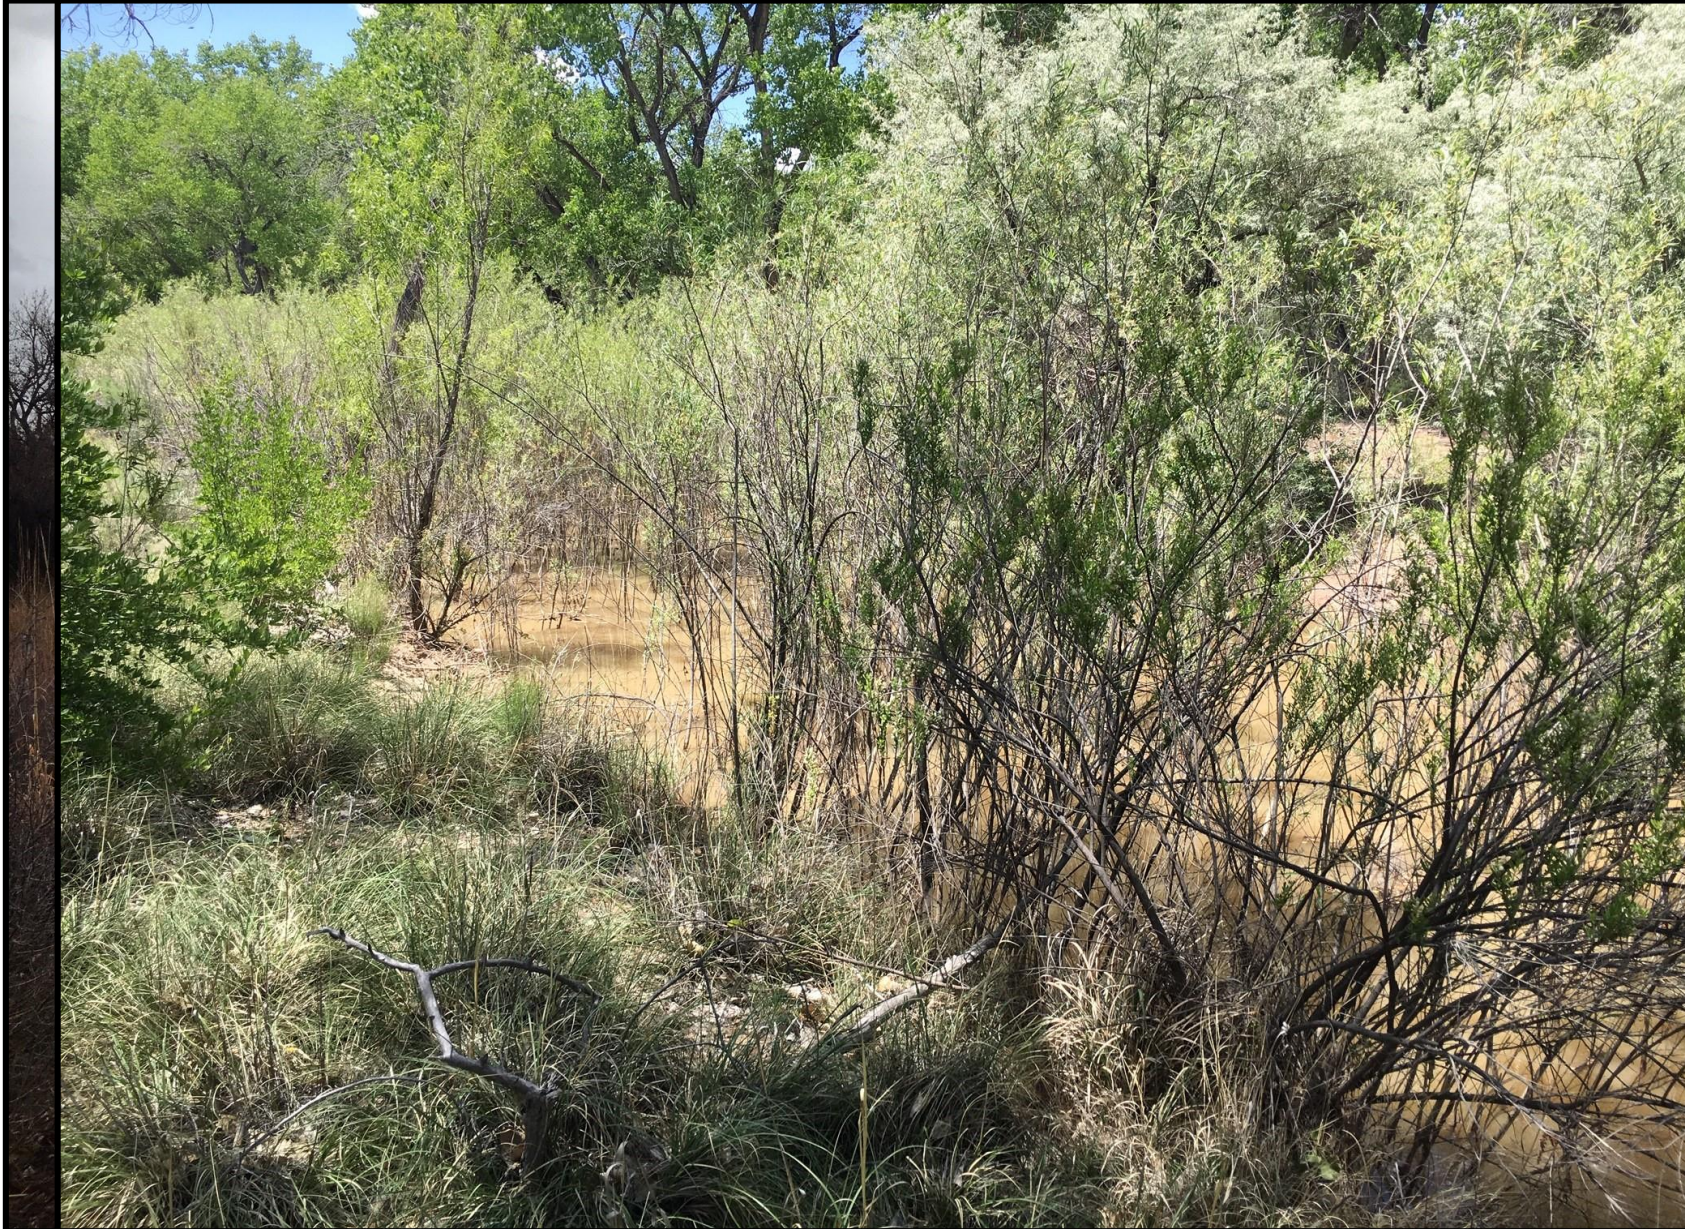
5

- Channelize flow
 - high flow channels
 - Backwater embayments
- Create inland depressions
 - Swales
 - Constructed ponds
- Modify banklines through terracing and grading

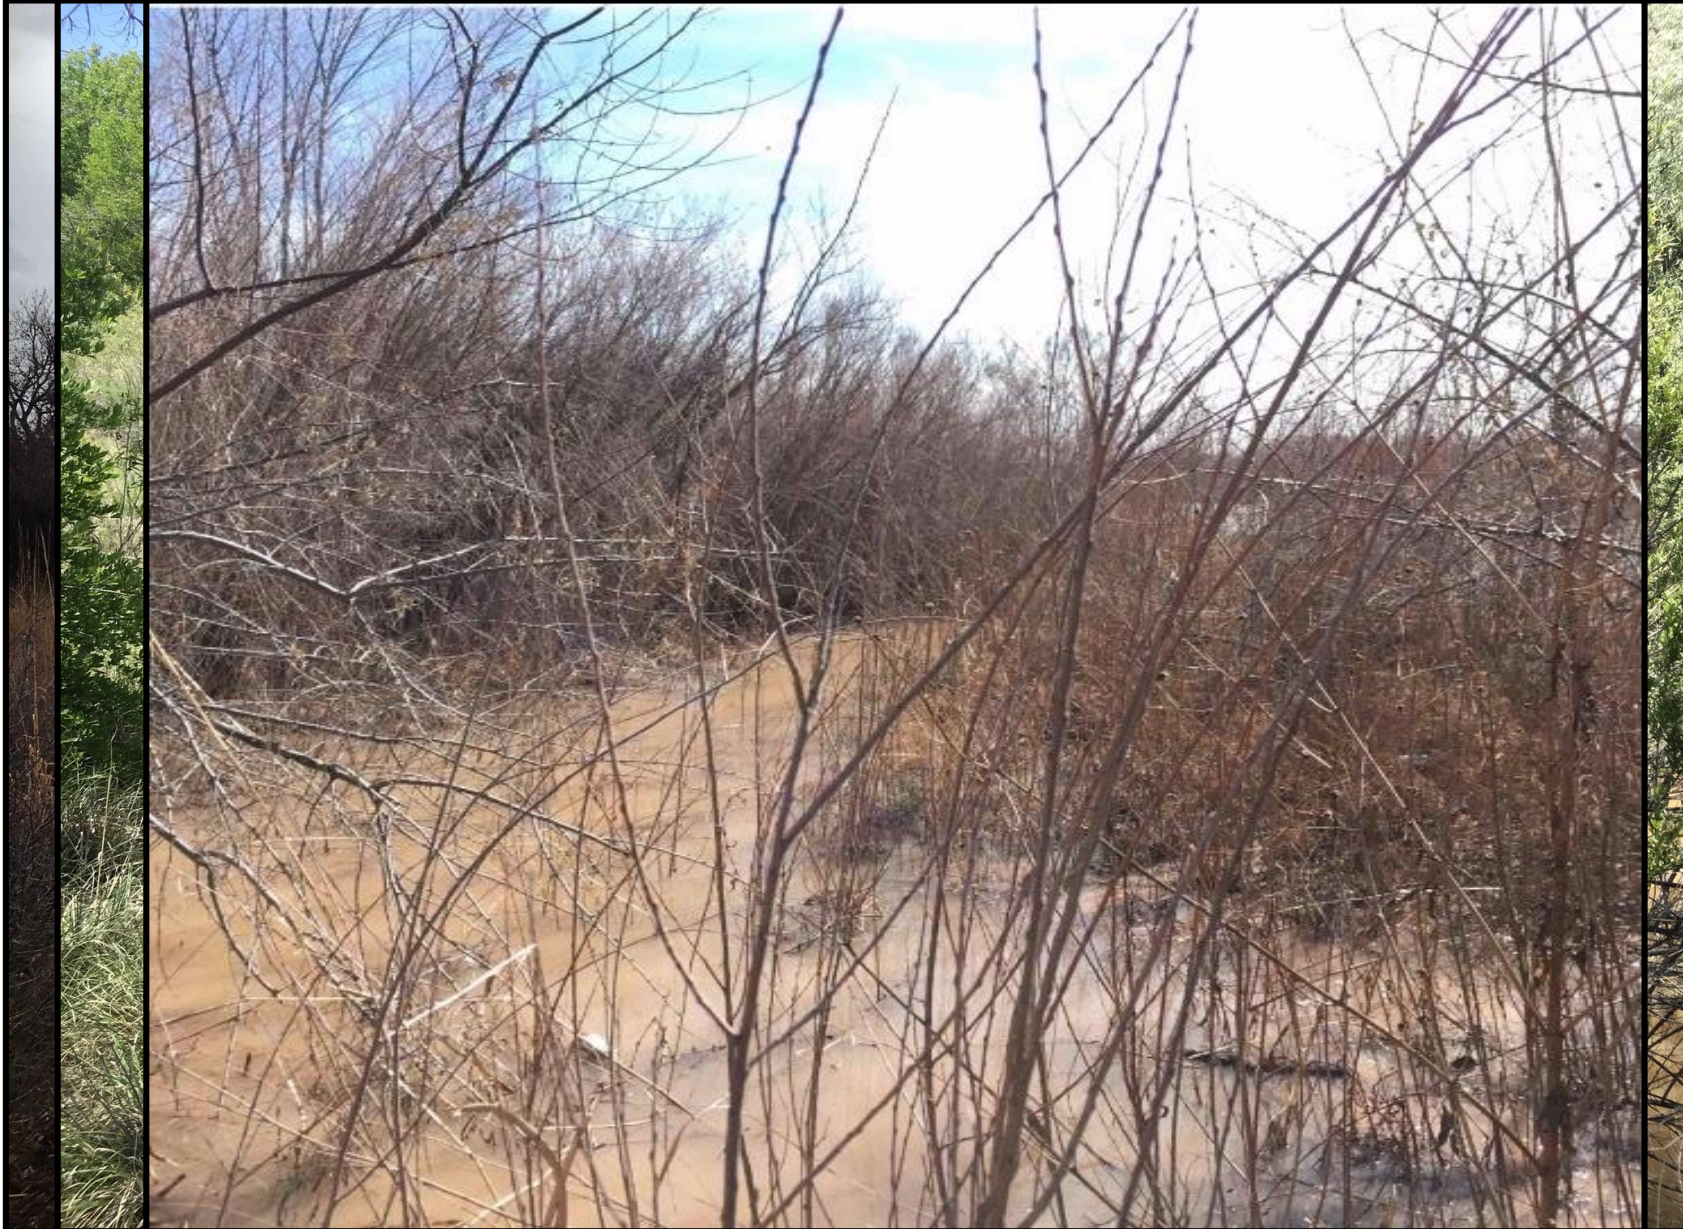
6

- Channelize flow
 - high flow channels
 - Backwater embayments
- Create inland depressions
 - Swales
 - Constructed ponds
- Modify banklines through terracing and grading

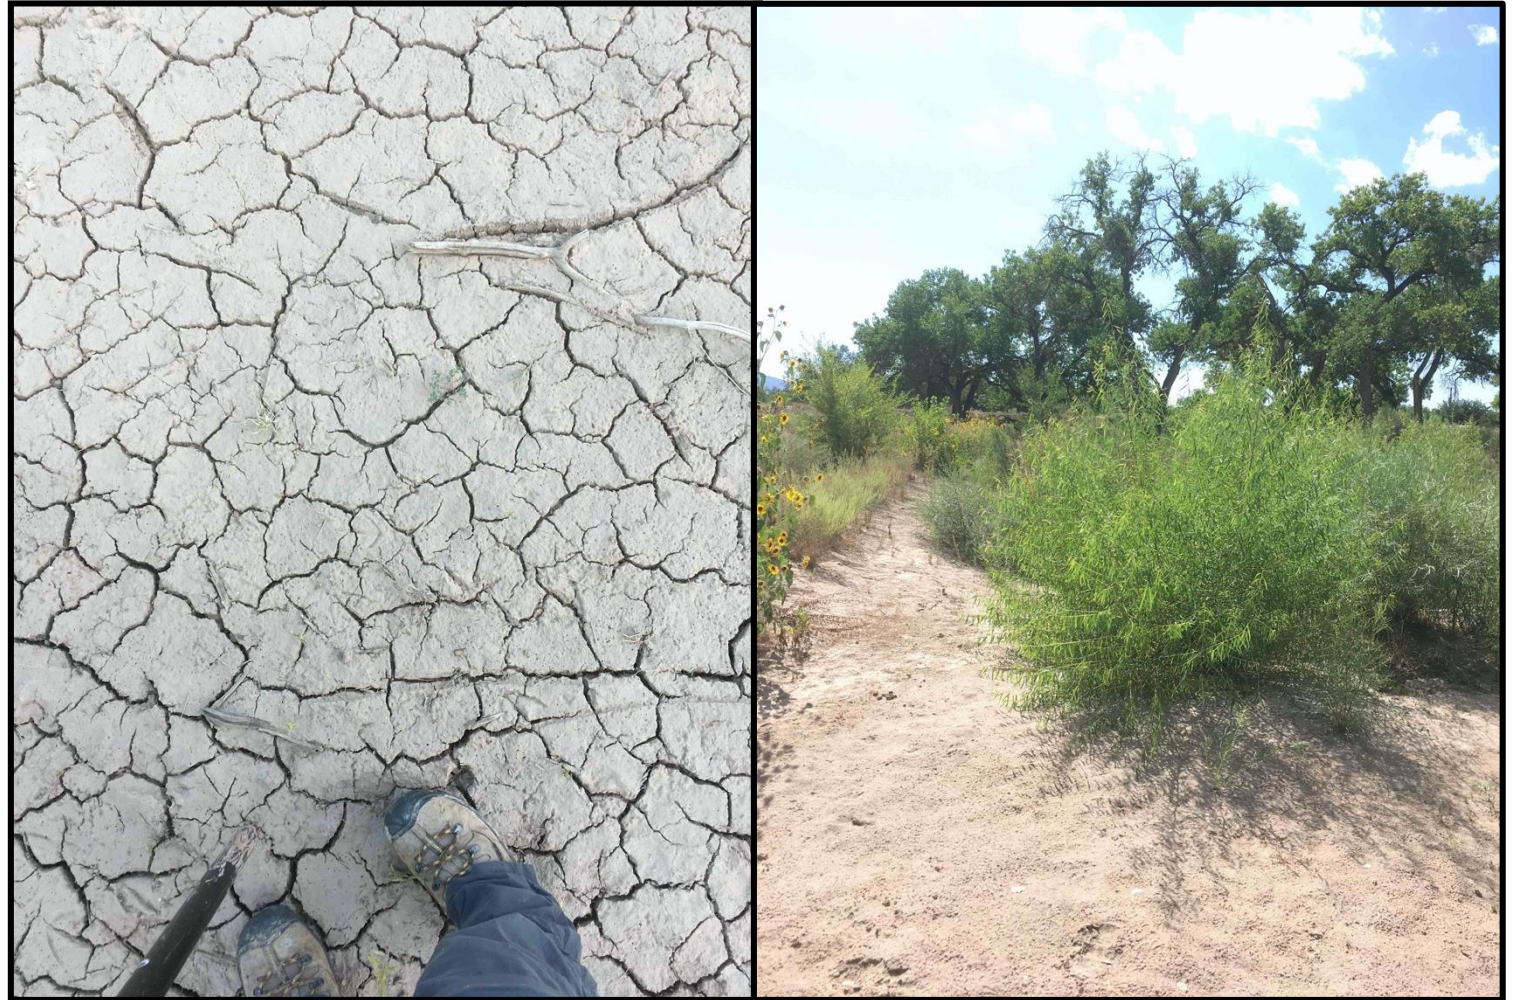
ONGOING MONITORING: SEDIMENTATION ISSUES

- During high runoff, the Rio Grande overbanks and deposits sediment into constructed features
- Deposition is observed to varying degrees, depending on the feature and flow
- Survey-grade surface measurements are compared to assess the health of the feature

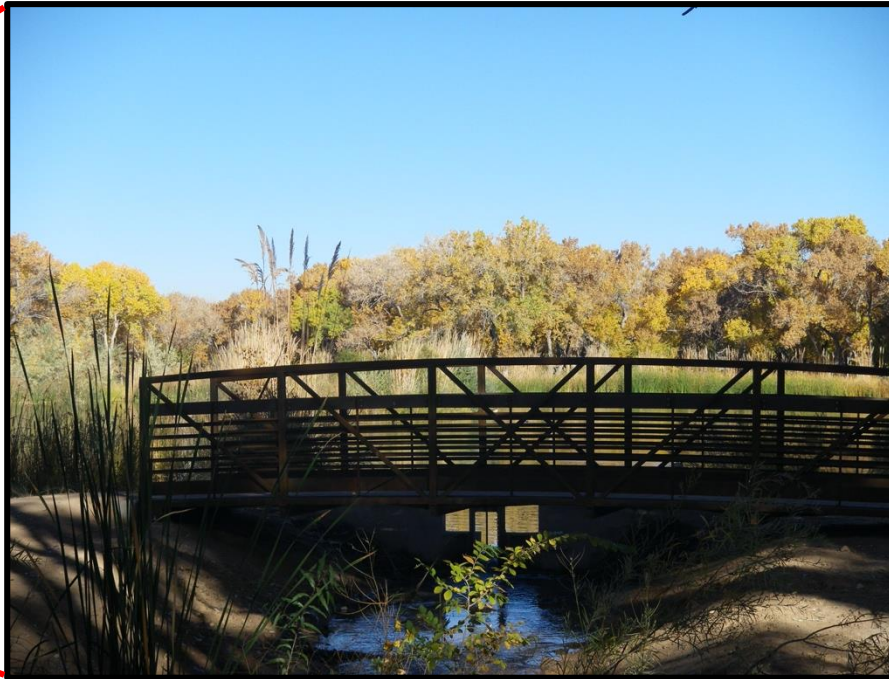
RIO GRANDE NATURE CENTER: HIGH FLOW CHANNEL

- Constructed in 2008
- One of three sites with routine monitoring (2012 – 2019).
- One high-flow channel with backwater embayments constructed
- High foot traffic within restoration feature

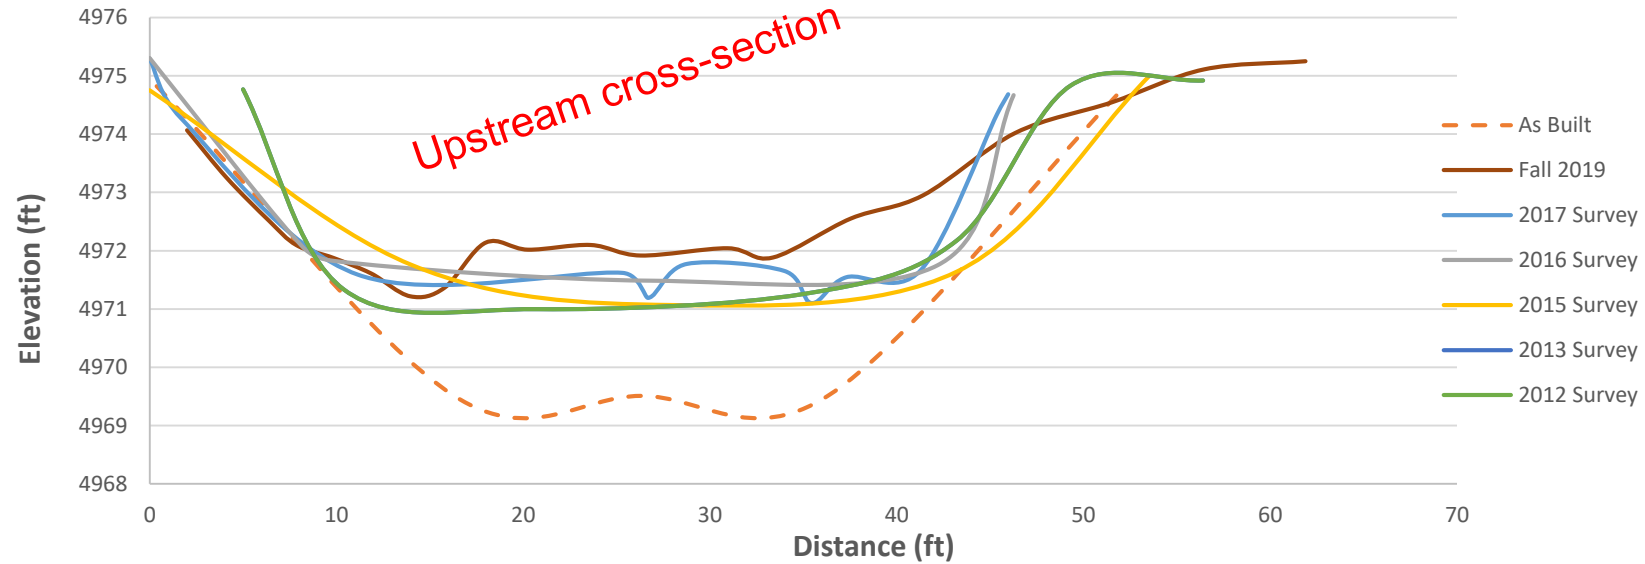
RIO GRANDE NATURE CENTER: HIGH FLOW CHANNEL

- High flow channel inlet see the most sedimentation (2x as much aggradation when compared to the channel center)
- Prevents flows from efficiently entering the channel

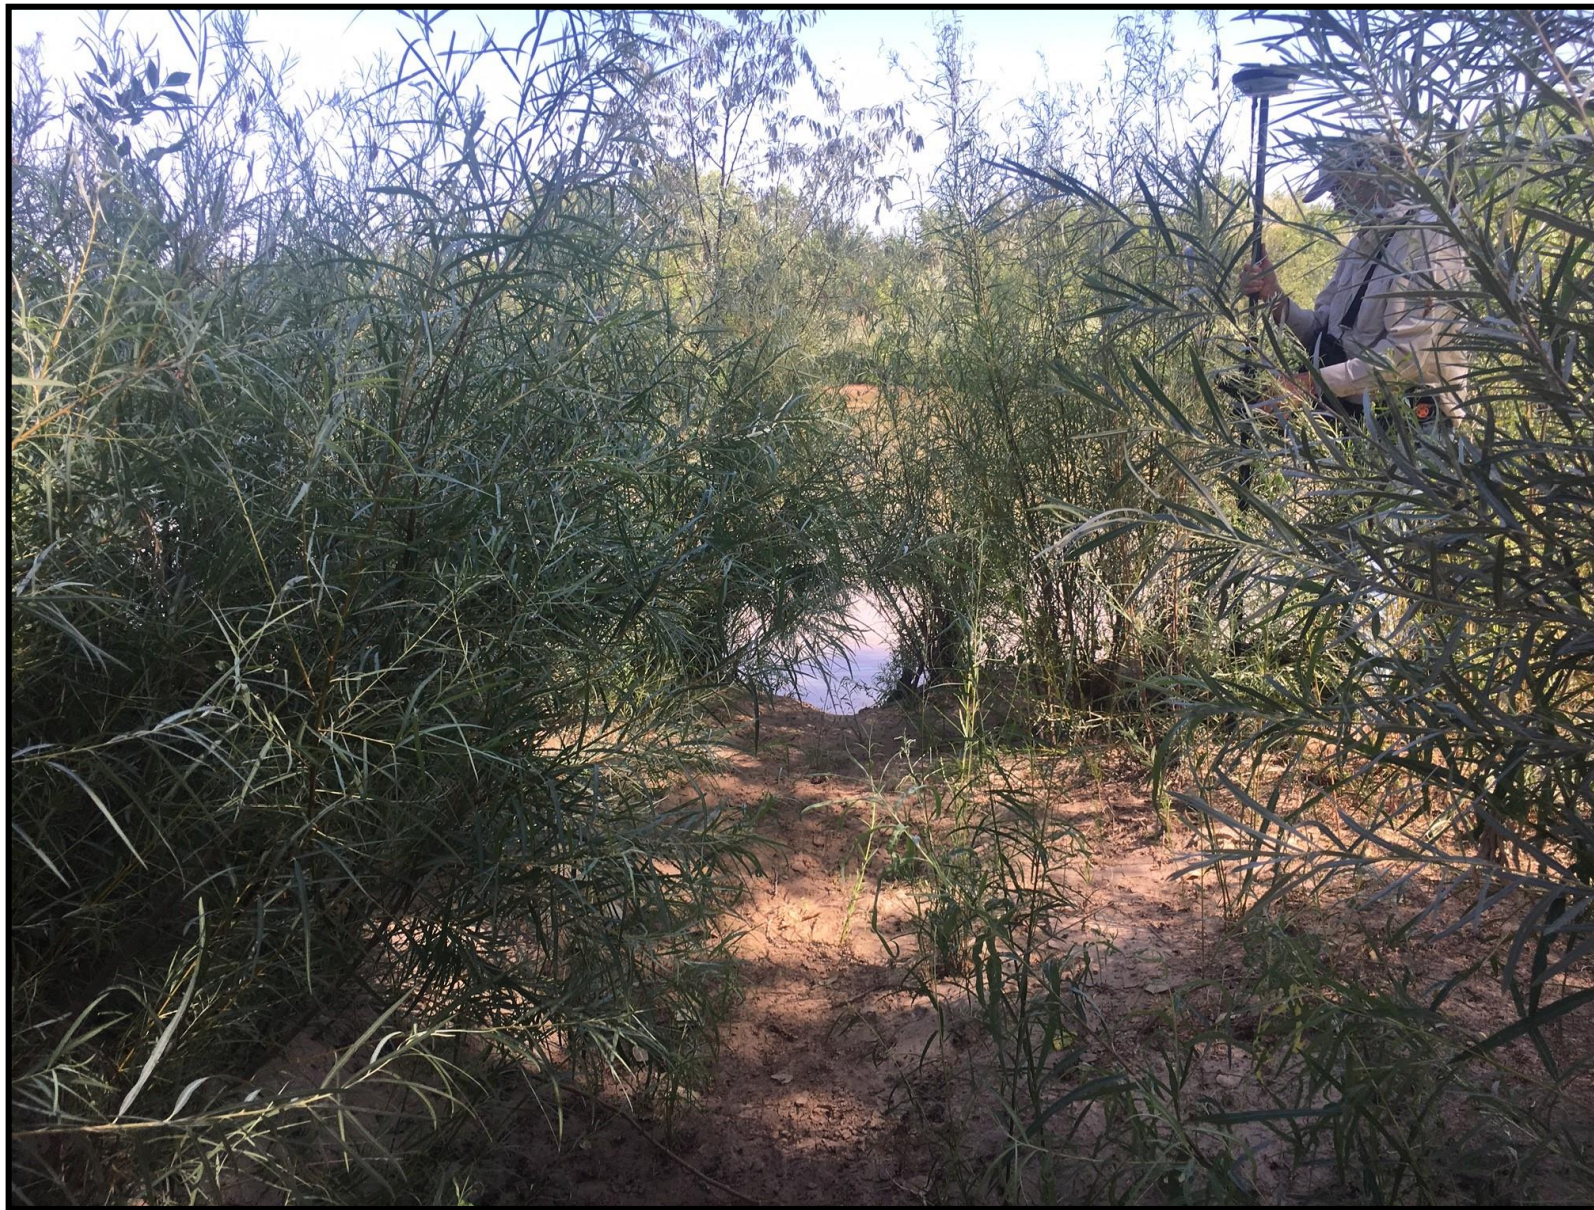
RIO GRANDE NATURE CENTER: HIGH FLOW CHANNEL

- High flow channel inlet see the most sedimentation (2x as much aggradation when compared to the channel center
- Prevents flows from efficiently entering the channel

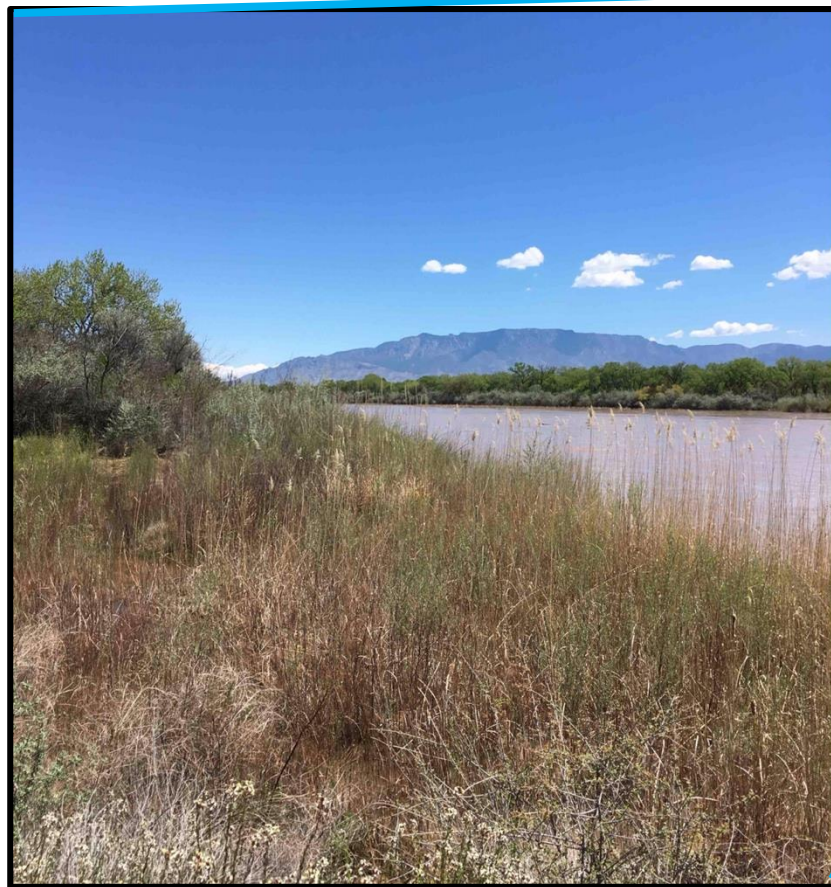
SITE 3A: BANK TERRACING

- Constructed in 2016.
- Many different features used, including bank terracing.
- Limited surveys; only pre and post 2019 floods.

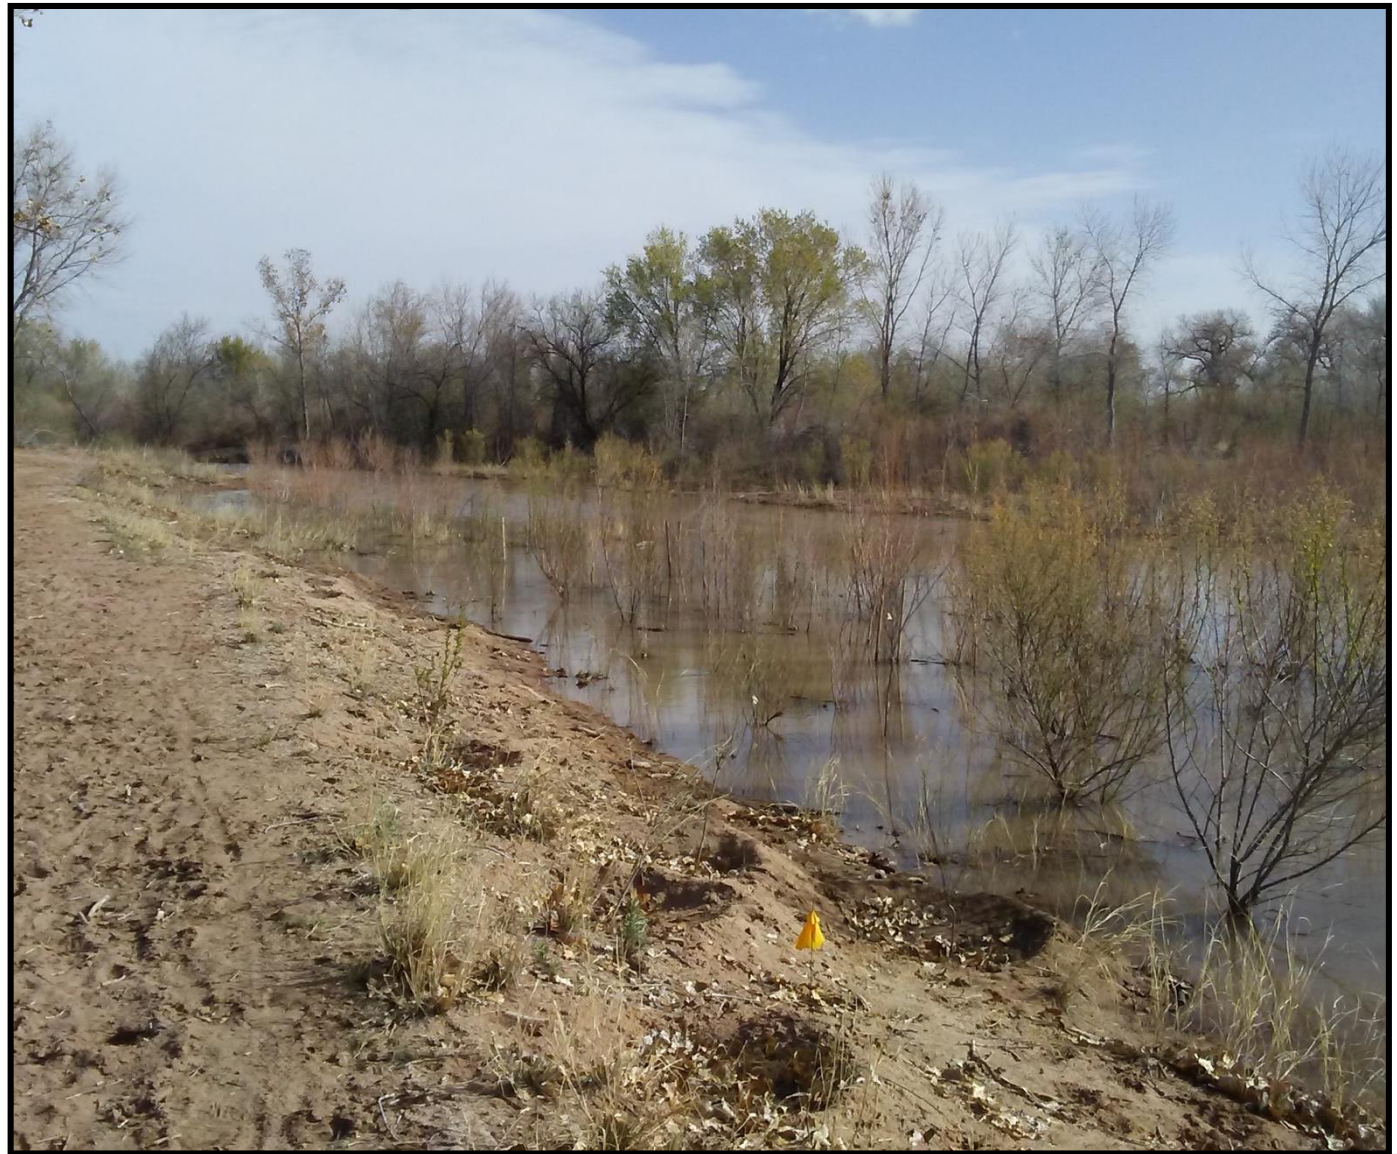
SITE 1H: SWALES

- Ubiquitous throughout restoration sites.
- Two types of swale construction: river-connected and unconnected.
- Often groundwater fed.
- Thought to be more stable flycatcher habitat.
