# EVALUATION OF HISTORICAL ALLUVIAL CHANNEL CROSSINGS

Prepared by:  
Jonathan AuBuchon  
Deanna Wilson

14 February 2024

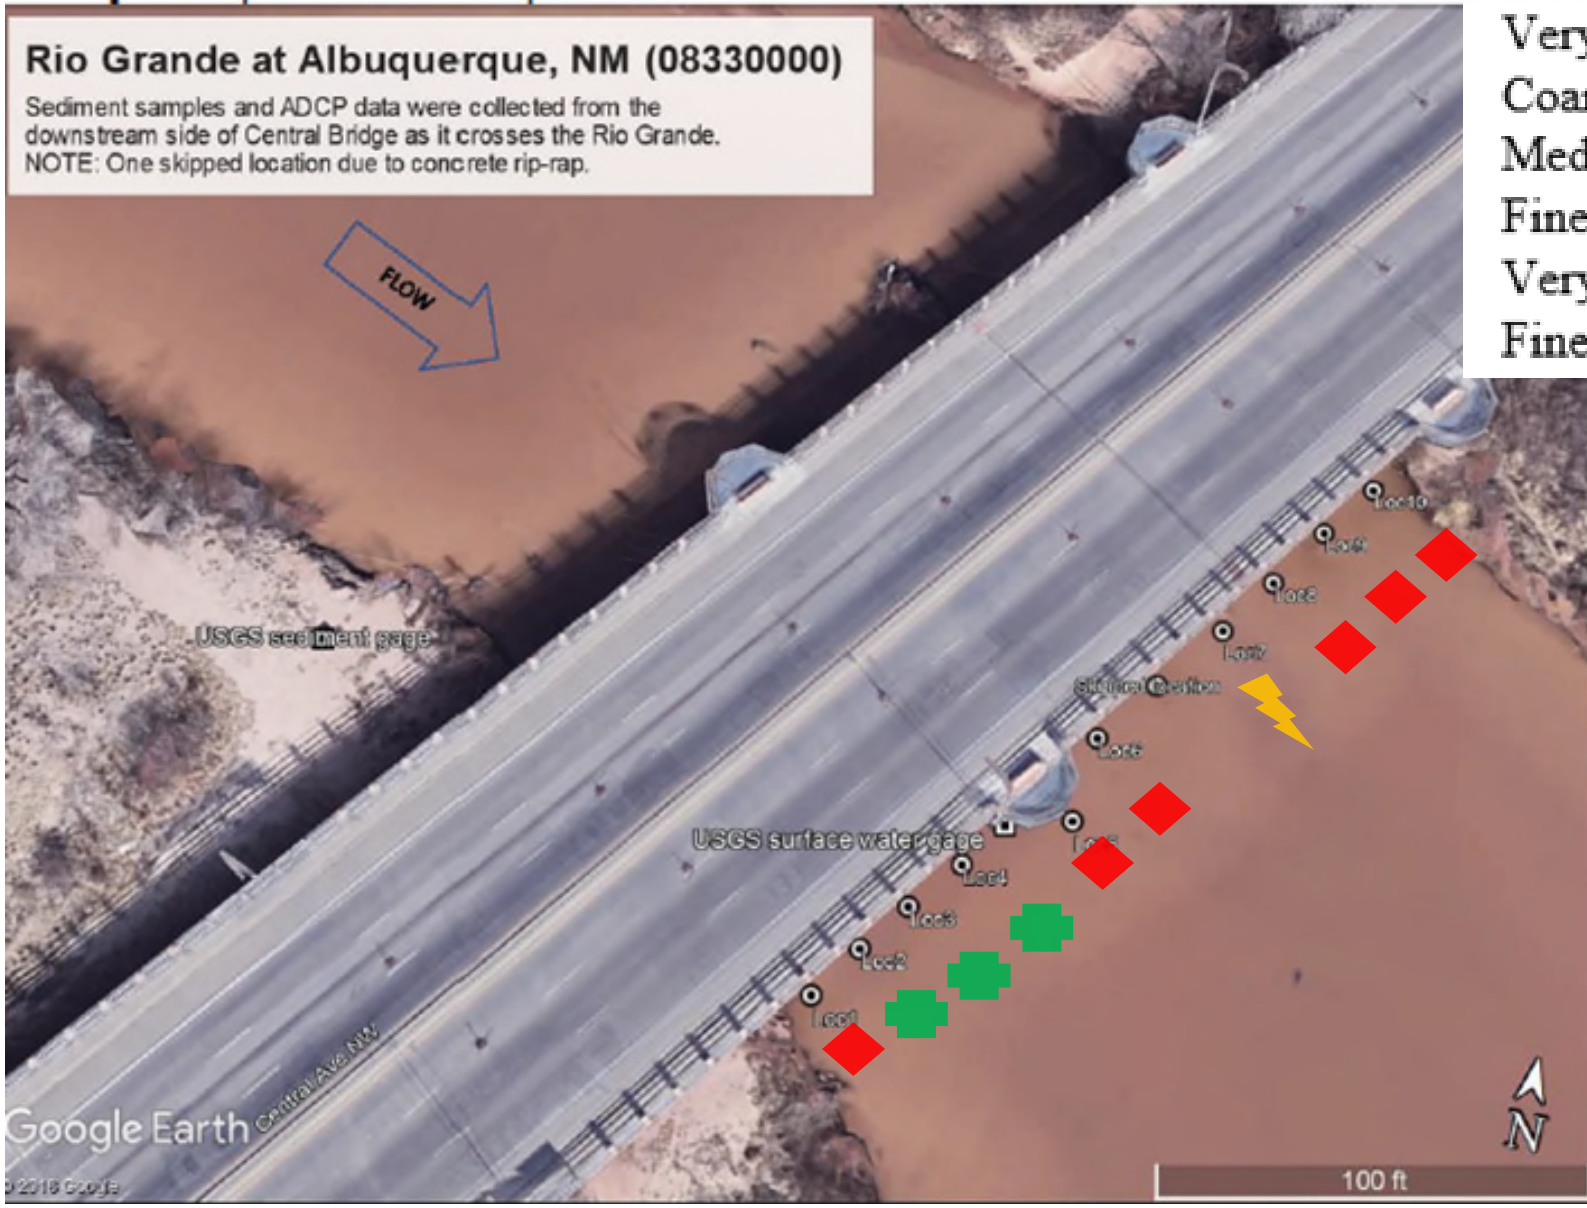
**Rio Grande at Albuquerque, NM (08330000)**  
Sediment samples and ADCP data were collected from the downstream side of Central Bridge as it crosses the Rio Grande.  
NOTE: One skipped location due to concrete rip-rap.

- Very Coarse Sand (VCS): 1-2 mm ⚡
- Coarse Sand (CS): 1-0.5 mm: ■
- Medium sand (MS): 0.5-0.25 mm ◆
- Fine sand (FS): 0.25 – 0.125 mm
- Very fine sand (VFS): 0.125 – 0.0625 mm
- Fines (silts and clays): < 0.0625 mm

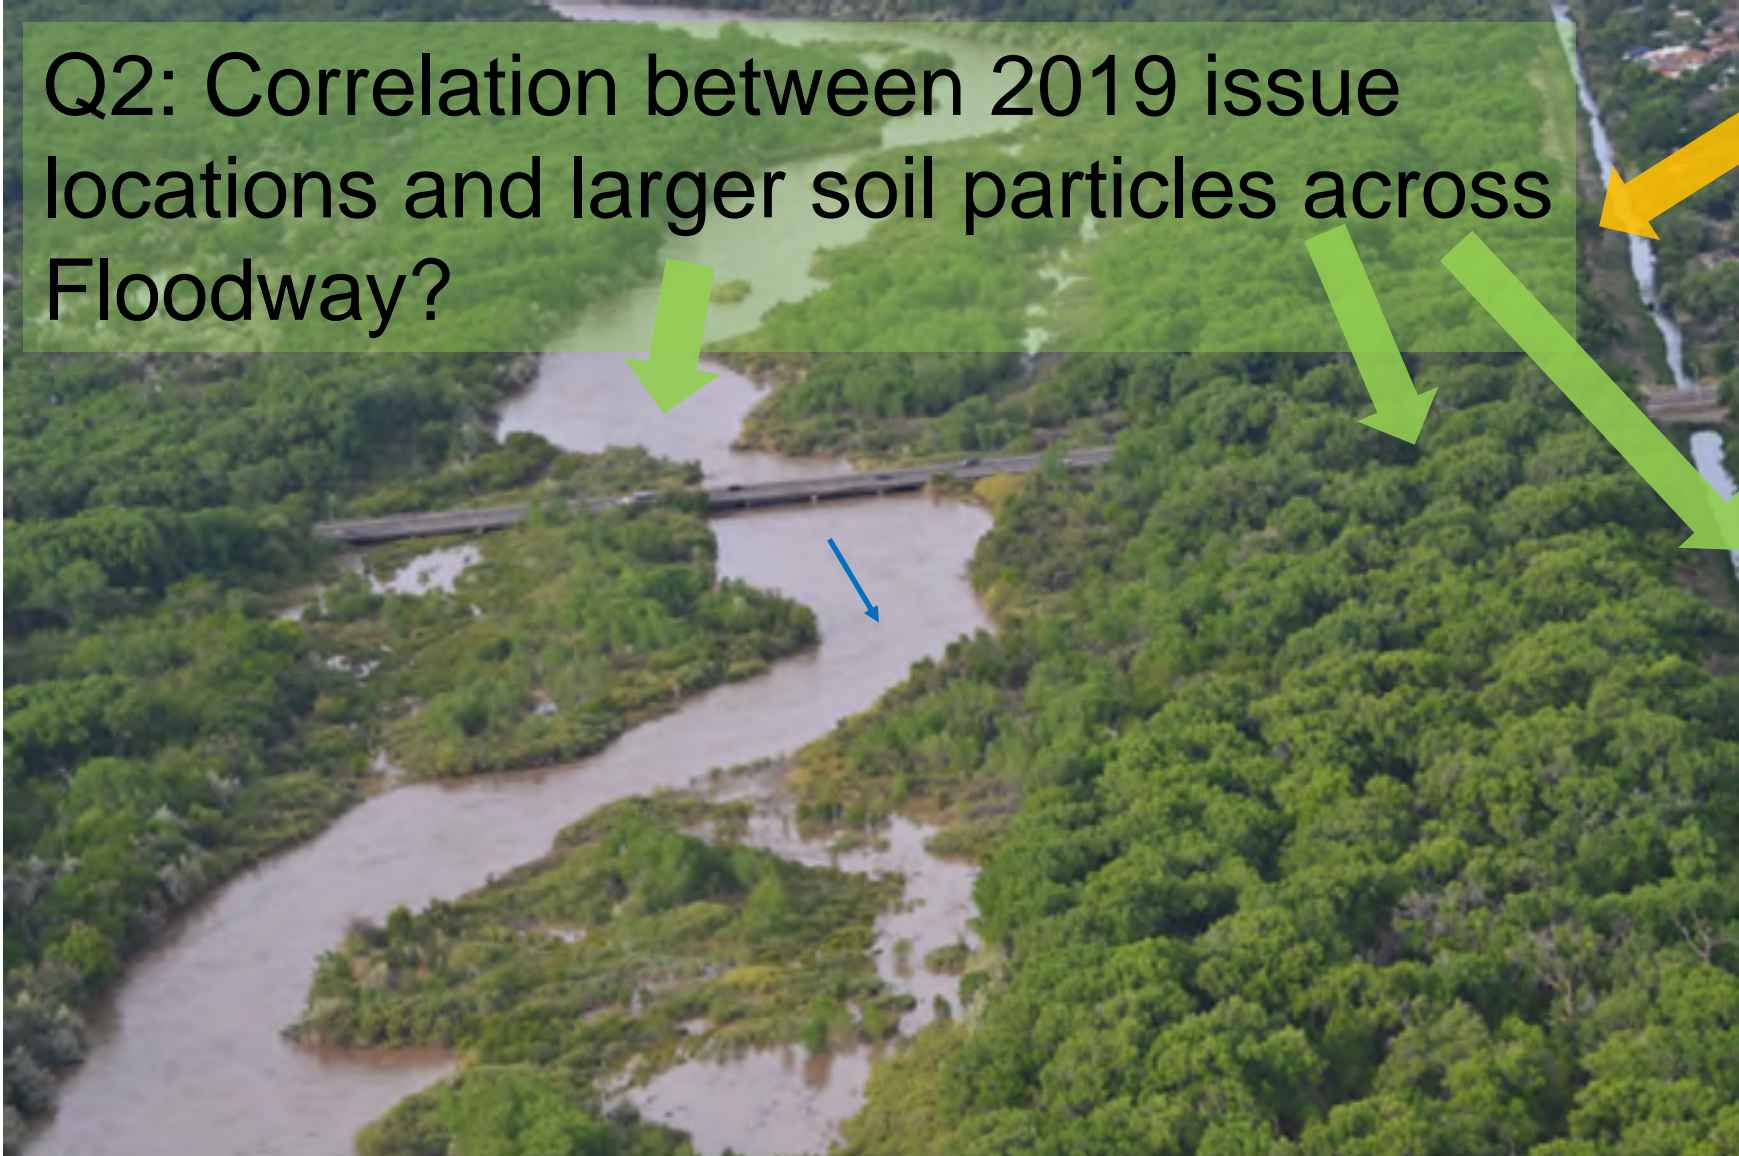
Q2: Correlation between 2019 issue locations and larger soil particles across Floodway?

Q1: Correlation between 2019 issue locations and historical alluvial channels?
