Arroyo de las Cañas Geomorphic, Hydraulic, and Sediment Transport Analysis

**Middle Rio Grande Project, New Mexico
Albuquerque Area Office**

September 2016

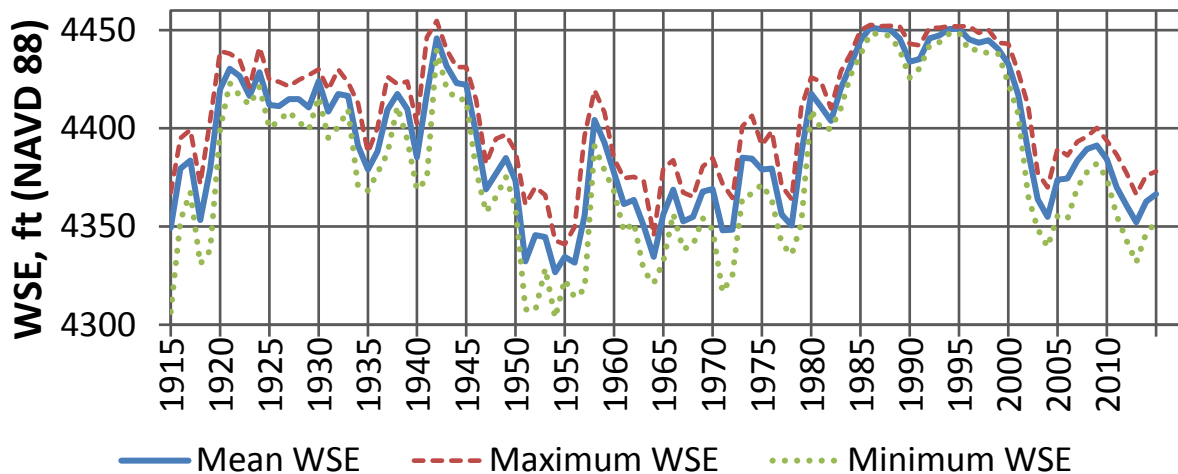
Figure 4 Annual average, maximum and minimum Elephant Butte Reservoir levels over time (modified from Owen et al, 2012)

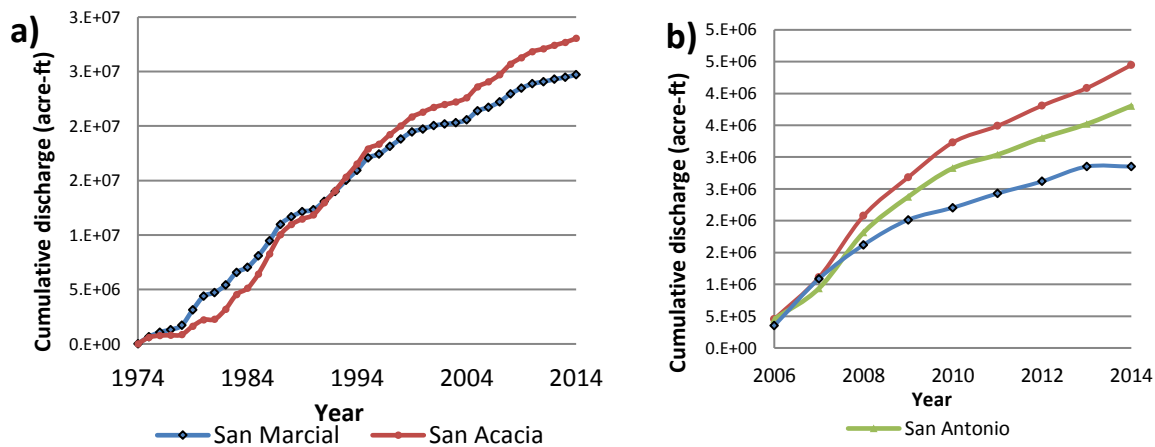
It was found that from 1974 to 1991, the USGS gage at San Marcial (USGS 08358400) had greater cumulative discharge than the upstream gage at San Acacia (USGS 08354900). At this period, flow was diverted to the LFCC above the San Acacia gage and returned downstream of the San Marcial gage. The flows at this time period may indicate that arroyos, drains, and/or groundwater base flow were contributing water at a greater rate than evaporation losses and the cumulative diversion at the LFCC. In 1982, the annual discharge at San Acacia begins to exceed that of San Marcial, and by 1991 the cumulative discharge at San Acacia exceeds that of San Marcial, as observed by a higher value in cumulative discharge in Figure 6. There appears to be three different time periods during the analysis period where the slope of cumulative discharge at San Acacia is steeper than at San Marcial (Figure 6). While the slope increases for both of the gaging stations, the larger increase at the San Acacia gage than the San Marcial gage is likely associated with evaporation, transpiration, or groundwater losses between the gage stations. The slope shift beginning in 1982 at San Acacia is probably due to the change in LFCC operations (Reclamation, 1985; Reclamation, 2000), where diversions were curtailed due to environmental concerns and eventually suspended in 1985. The inclusion of San Juan –Chama waters into the Rio Grande may have been a possible contributor to a slight increase of flows through this reach during this time period as well.

Figure 6 Cumulative water discharge at USGS water gages in San Acacia (USGS 08354900), San Antonio (USGS 08355490), and San Marcial (USGS 08358400).

After 1993, the upstream gage, San Acacia (USGS 08354900), has a cumulative discharge that exceeds the cumulative discharge at San Marcial (USGS 08358400) indicating that losses from evapotranspiration or groundwater infiltration are greater than contributing flows. Figure 6b shows the three USGS gages within the study area, the third one being the San Antonio gage, about six miles downstream from the Arroyo de las Cañas, which began operation in 2006. The San Antonio gage is about 24 miles downstream from the San Acacia gage and 21 miles upstream from the San Marcial gage. The San Antonio gage is 57% of the distance between San Acacia gage and San Marcial gage, but on average over the 8 year data period, it had 53% of the discharge, with some years varying to be 12% more than the expected discharge or 16% less.

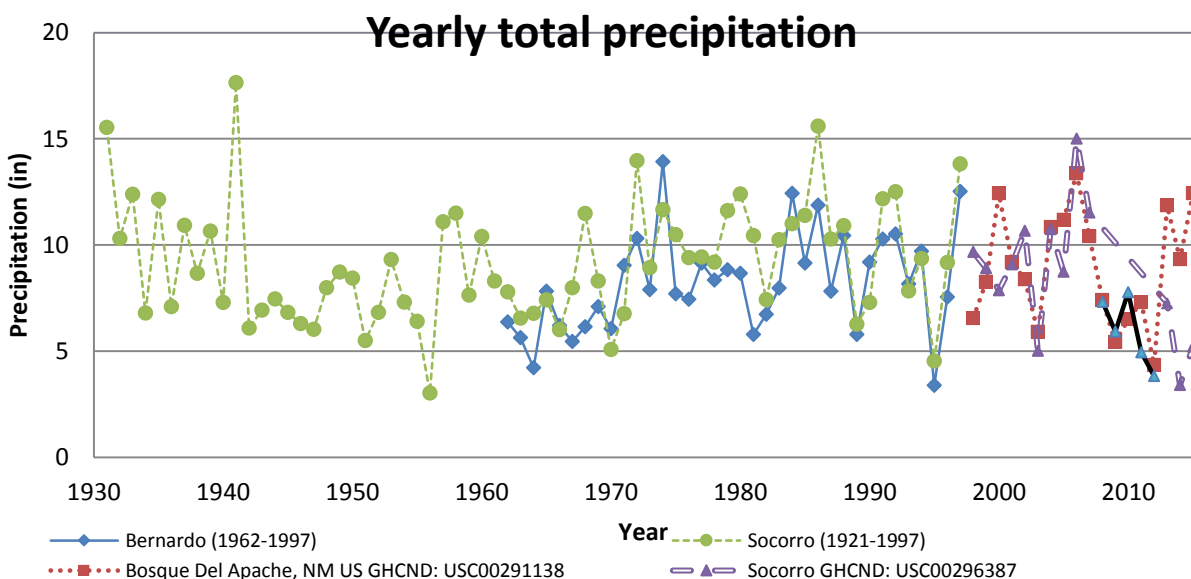
From 1962 to 1997, the average precipitation at Bernardo was about 8.2 inches per year, with the highest annual amount at 13.74 inches in 1974. At the Socorro gages, the trend was a general decrease in average annual precipitation by a rate of 0.10 inches per year, with rainfall exceeding 13 inches in 1986, 1997, and 2006 (Figure 7).

Figure 7 Total annual precipitation from gage sites near the study area.

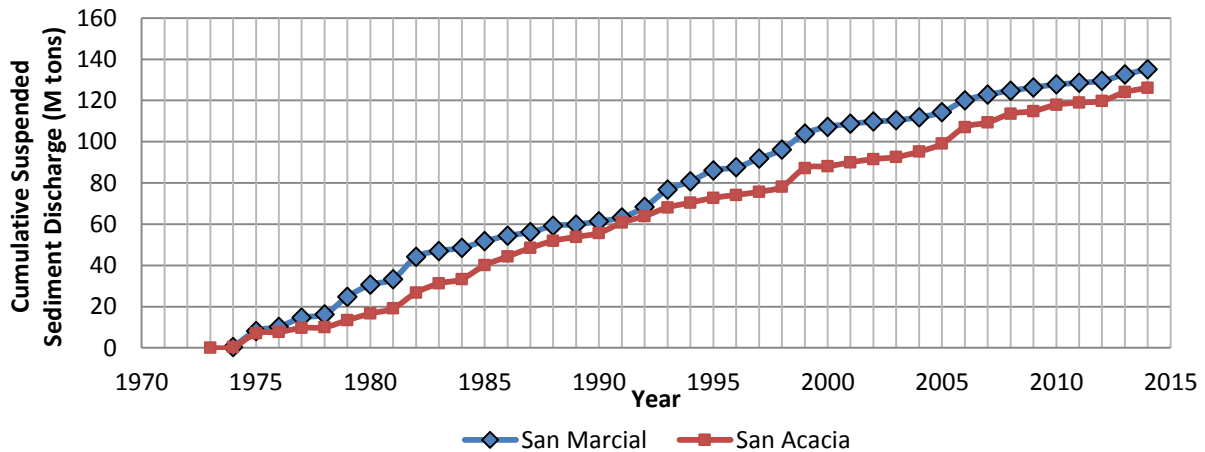
floods. There appears to be a similar trend of an increasing gap that started in 1991 and went to about 1999. Since 1999 the gap between the two lines seems to be decreasing. This is interesting since it seems to correlate with the drought that occurred in the late 1990s. In general, the USGS gage at San Marcial (08358400) experiences a greater suspended load than at San Acacia (USGS 08354900).

Figure 12 Cumulative sediment discharge according to USGS water gages at San Acacia (USGS 08354900) and San Marcial (USGS 08358400).

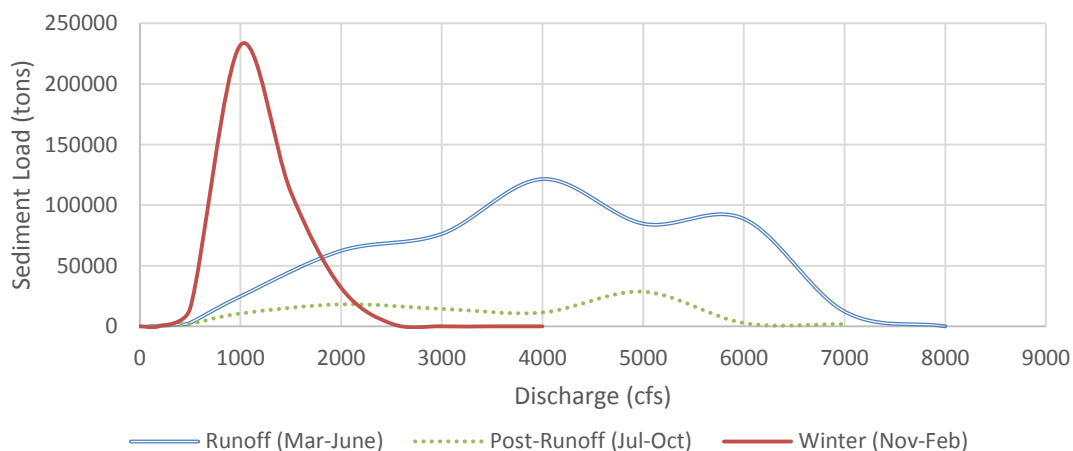
The suspended sediment field-measured discharge was averaged for each discharge interval, for each hydrologic season. A suspended sediment discharge rating curve was created to estimate the sediment discharge per discharge interval, which was then multiplied by the annual frequency of these events, according to the Bui (2014) flow duration frequency analysis. For San Acacia (Figure 17) it was found that in the winter months, the effective discharge is 1,000 cfs. As shown in Figure 15, this time of year has a range of 500 to 2,000 cfs, with 1,000 cfs being nearly the median discharge. The run off is a season with a higher cumulative sediment transport, with a longer range of possible discharges than the winter months, the most effective discharge occurring at 4,000 cfs.

Figure 17 Effective sediment discharge for different discharge intervals for the Rio Grande at the USGS San Acacia (USGS 08354900) from 1993 to 2013.

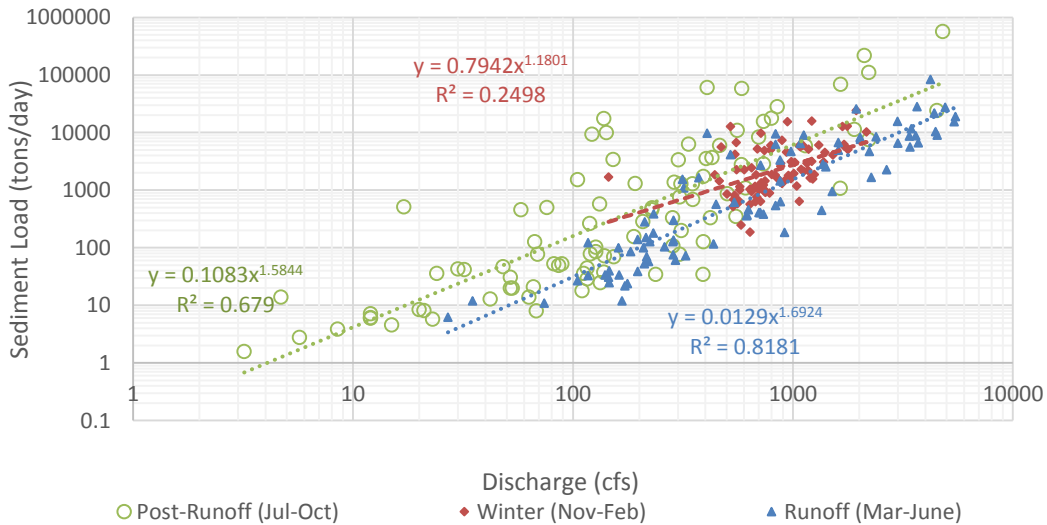
The four hydrologic seasons were plotted in Figure 19 to compare sediment load to discharge. These demonstrate the magnitude of sediment discharge at each USGS measured field event. Generally, post runoff discharge has a higher sediment load per discharge interval. The winter events generally have a smaller range of discharges throughout the season but with a sediment load similar or a littler greater than the runoff season.

Figure 19 Field samples at San Acacia (USGS 08354900) separated by hydrologic season, instantaneous discharge. Sample dates from 1993 to 2013.

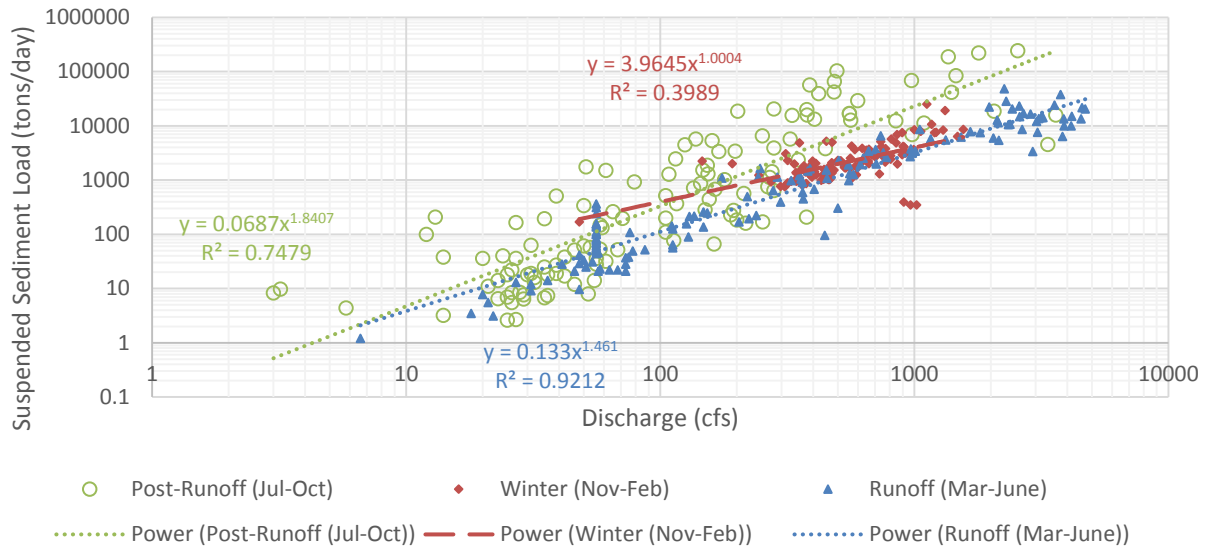
Figure 20 Field samples at San Marcial (USGS 08358400) separated by hydrologic season, instantaneous discharge. Sample dates from 1993 to 2013.

The distribution of sediment and discharge at the San Marcial gage (USGS 08358400) is more uniform across the seasons (Figure 20) than observed at the San Acacia gage (USGS 08354900) over the same time period as shown by a thinner distribution of points over time. Again, post run-off shows higher sediment load at a particular discharge. The range of discharges is less for winter months than of the other hydrologic seasons. The San Marcial gage shows lower discharges during the runoff season than San Acacia.

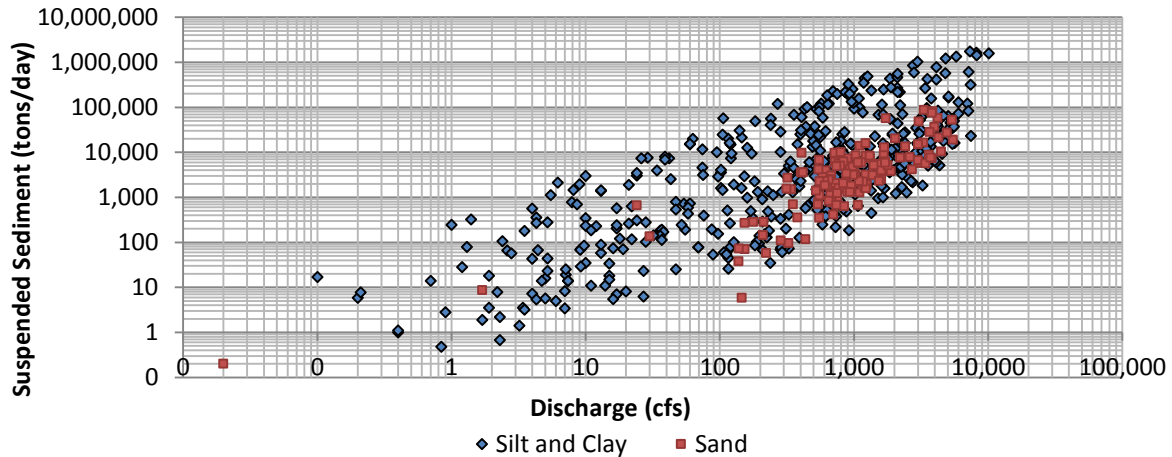
Sediment gradation is based on the standard USGS-accepted Wentworth grade scale (Wentworth 1922). These characterizations were applied in order to distinguish between a dominantly fine suspended sediment load and a dominant suspended sand load. The sediment type in the suspended load may indicate seasonal variations in the types of suspended sediment loads, different effective discharges for transporting varying sediment types, or increased seasonal sediment transport capacity. From the analysis at the San Acacia gage (Figure 21), it was found that discharge rates less than 100 cfs predominantly transport fines in the suspended sediment load. Also, for a particular discharge, when silt and clay is the predominant sediment type, the amount of suspended sediment transported is greater.

Figure 21 Suspended sediment discharge for different dominant sediment size ranges: sand dominate, silt and clay dominate. Data from San Acacia gage (USGS 08354900) field measurements by the USGS from 1960 to 2015.

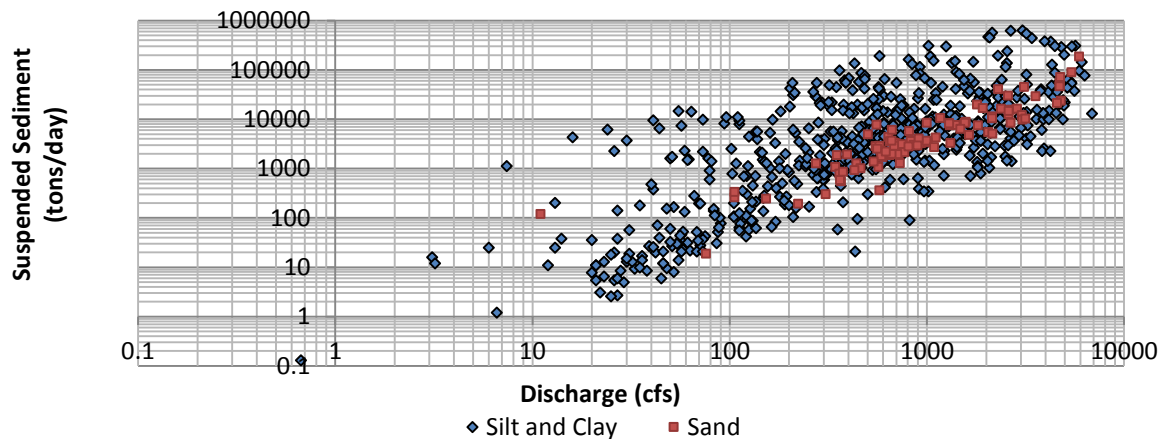
Figure 22 Suspended distribution of different sediment types: sand, clay, silt and loam. Data from San Marcial gage (USGS 08358400) field measurements from 1960 to 2015.

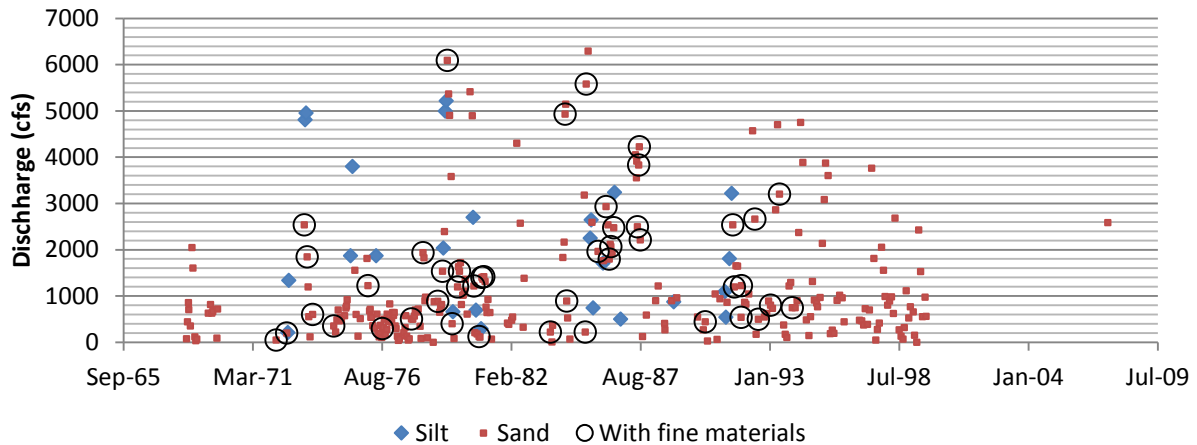
Figure 27 Bed sediment sizes from field measurements at San Marcial (USGS 08358400) from 1966 to 2015.

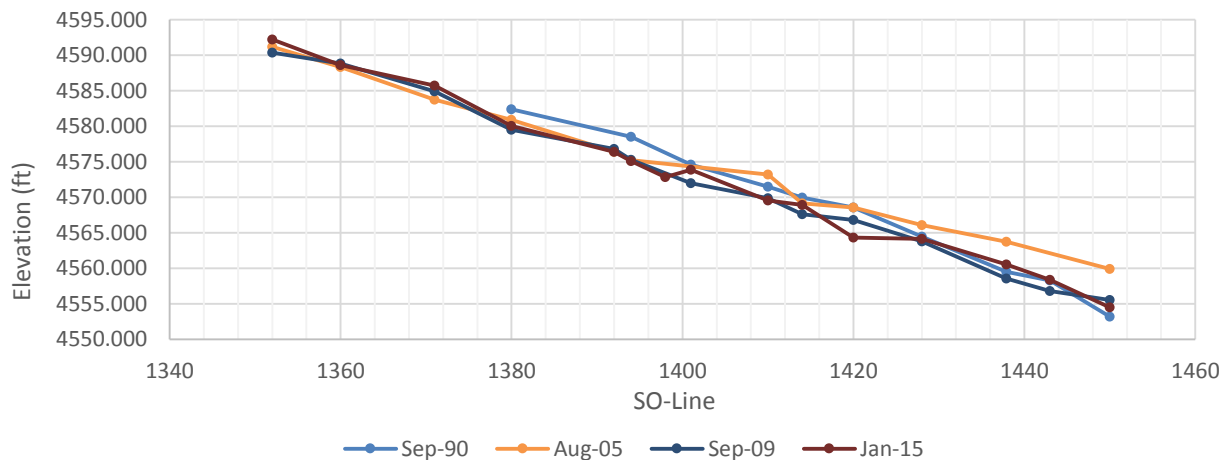
Figure 42 Thalweg elevation of SO lines within the study area in 1990, 2005, 2009 and 2015.

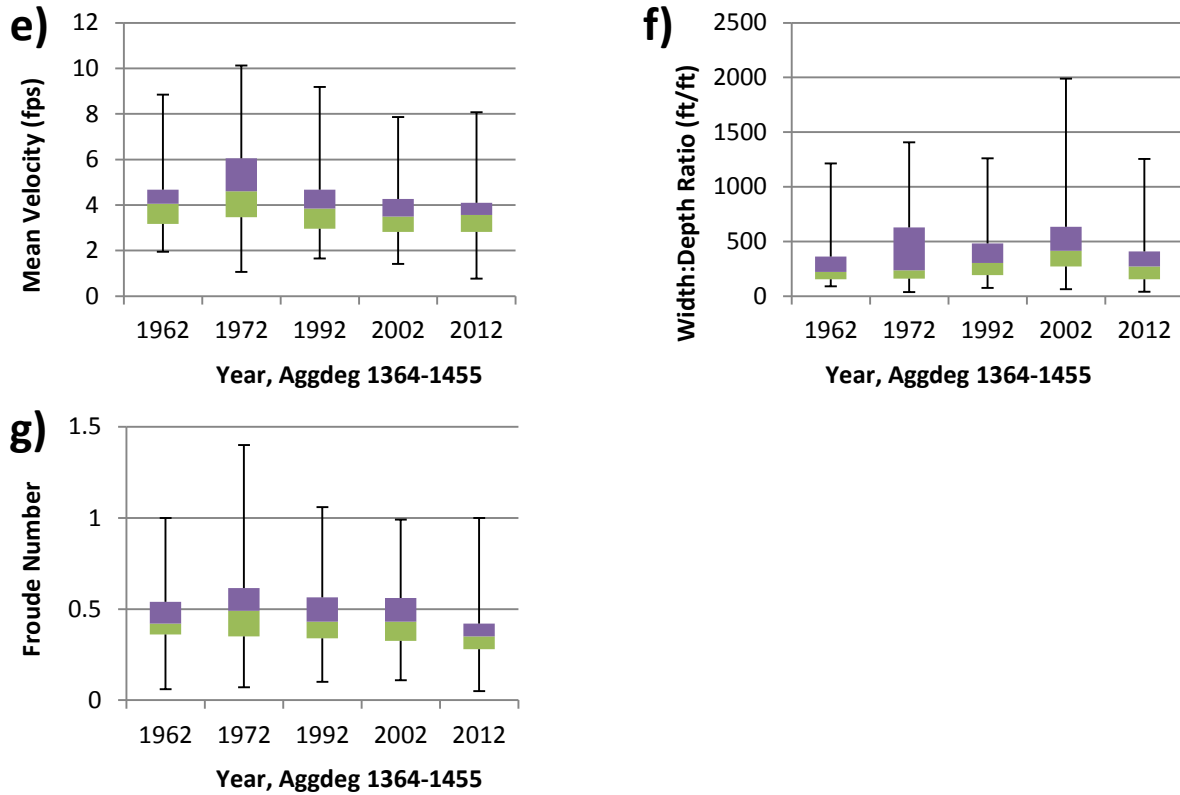
Figure 48 Channel geometry parameters which are weight-distance -averaged for HEC-RAS models of the study area from 1962 to 2012.

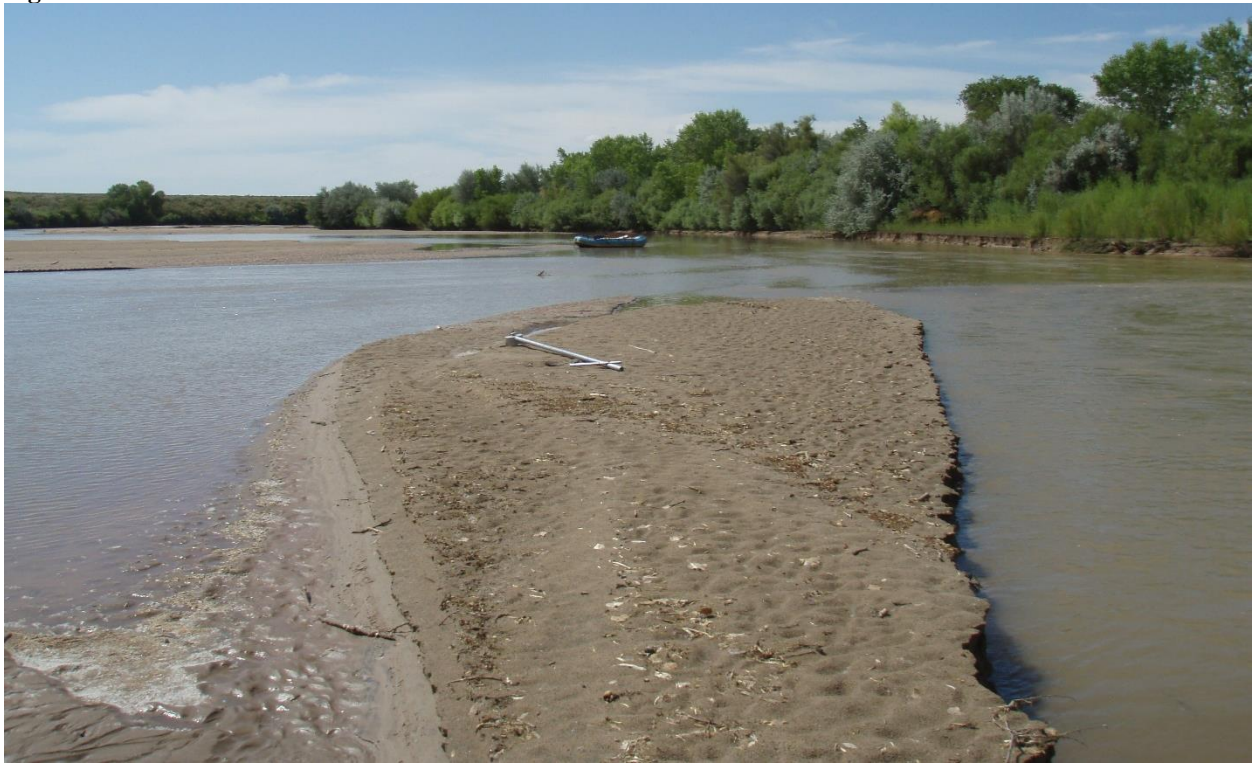
Figure 64 Near CA-2, red silty clay can be seen on the side channel bars. Likely the clay is attributed to monsoonal rain events.

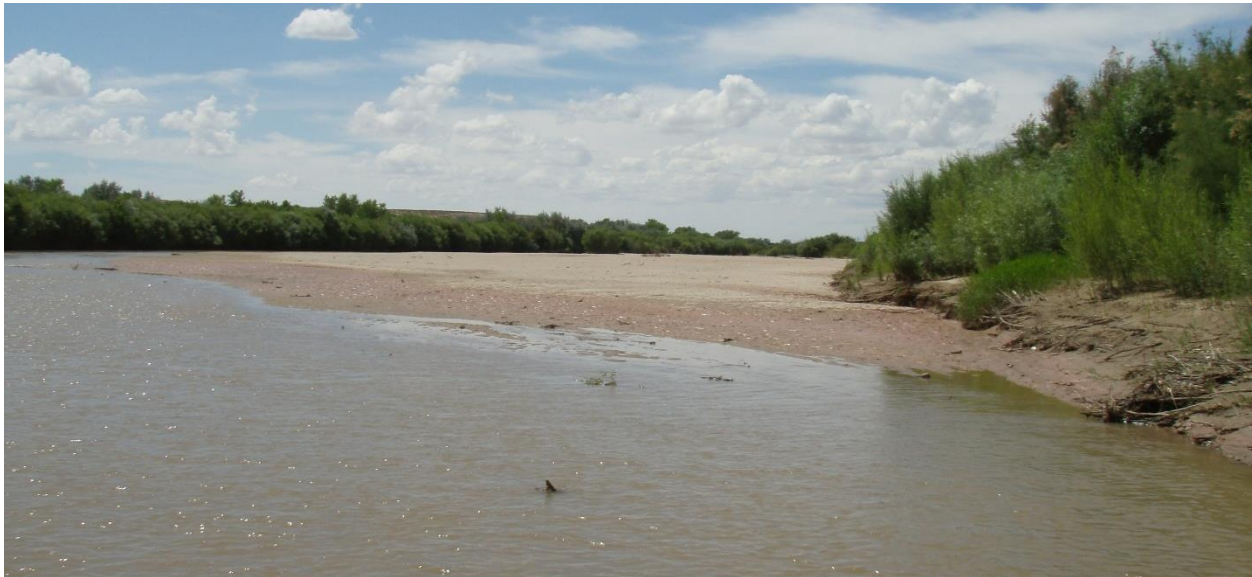
Figure 65 Near CA-2, high water mark and clay deposits can be seen on the river bank.

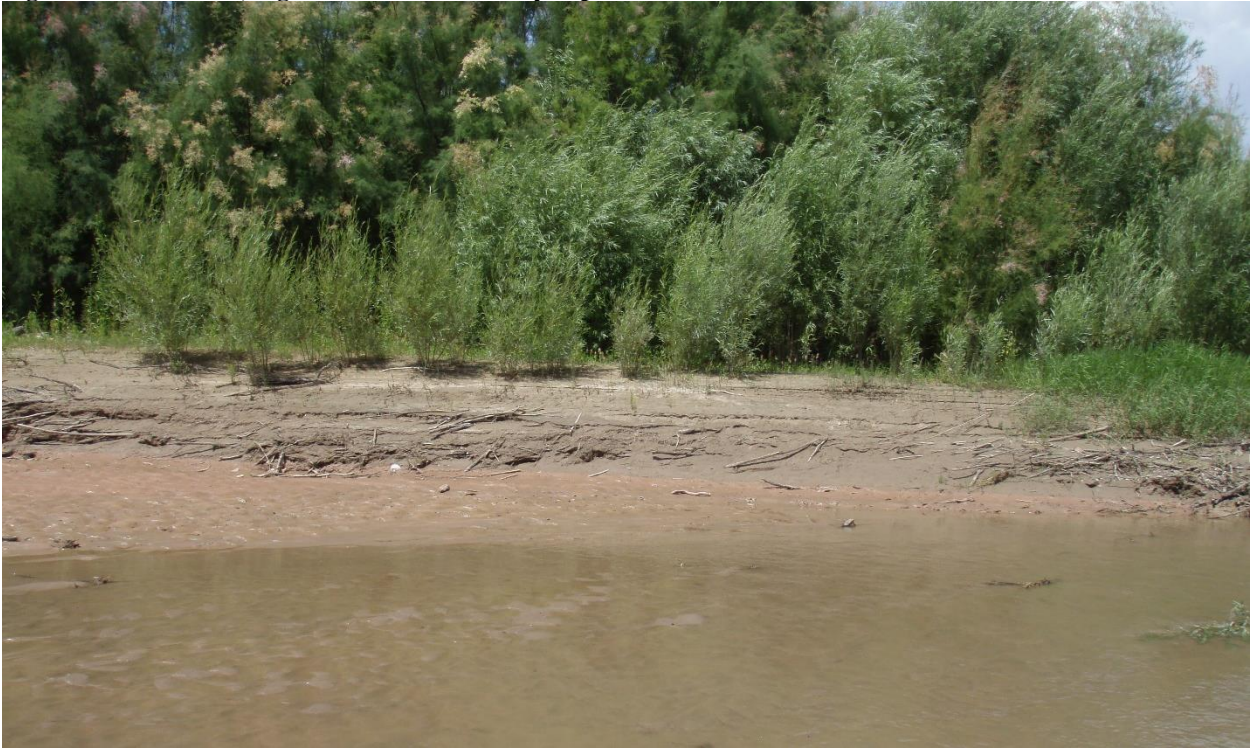
Figure 66 Gravelly sediment deposition found at the Arroyo de las Cañas confluence.

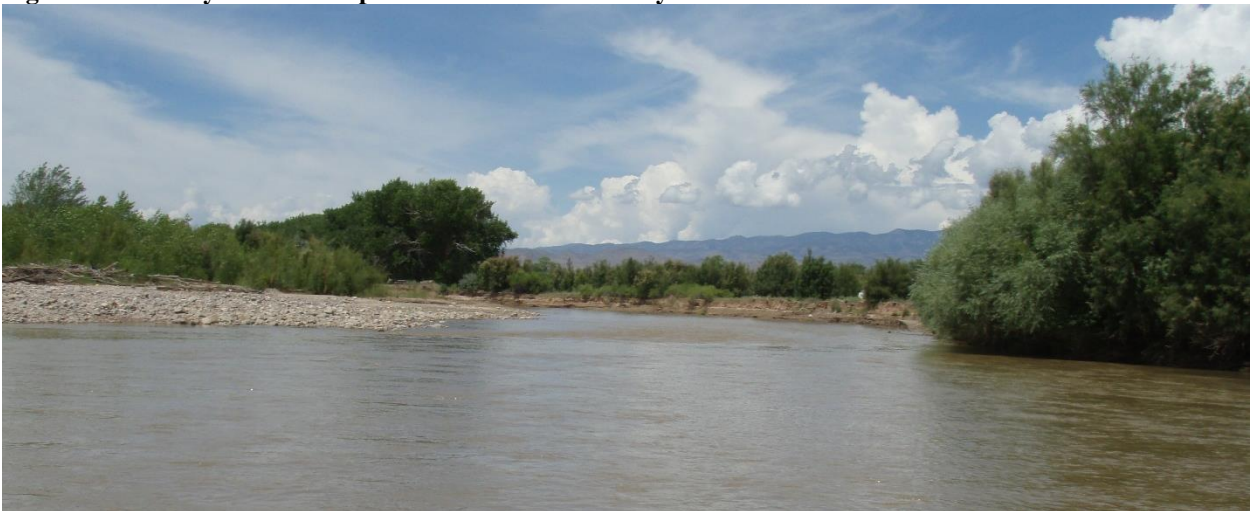
Figure 67 looking upstream, on the alluvial fan of the rocky Arroyo de las Cañas confluence.

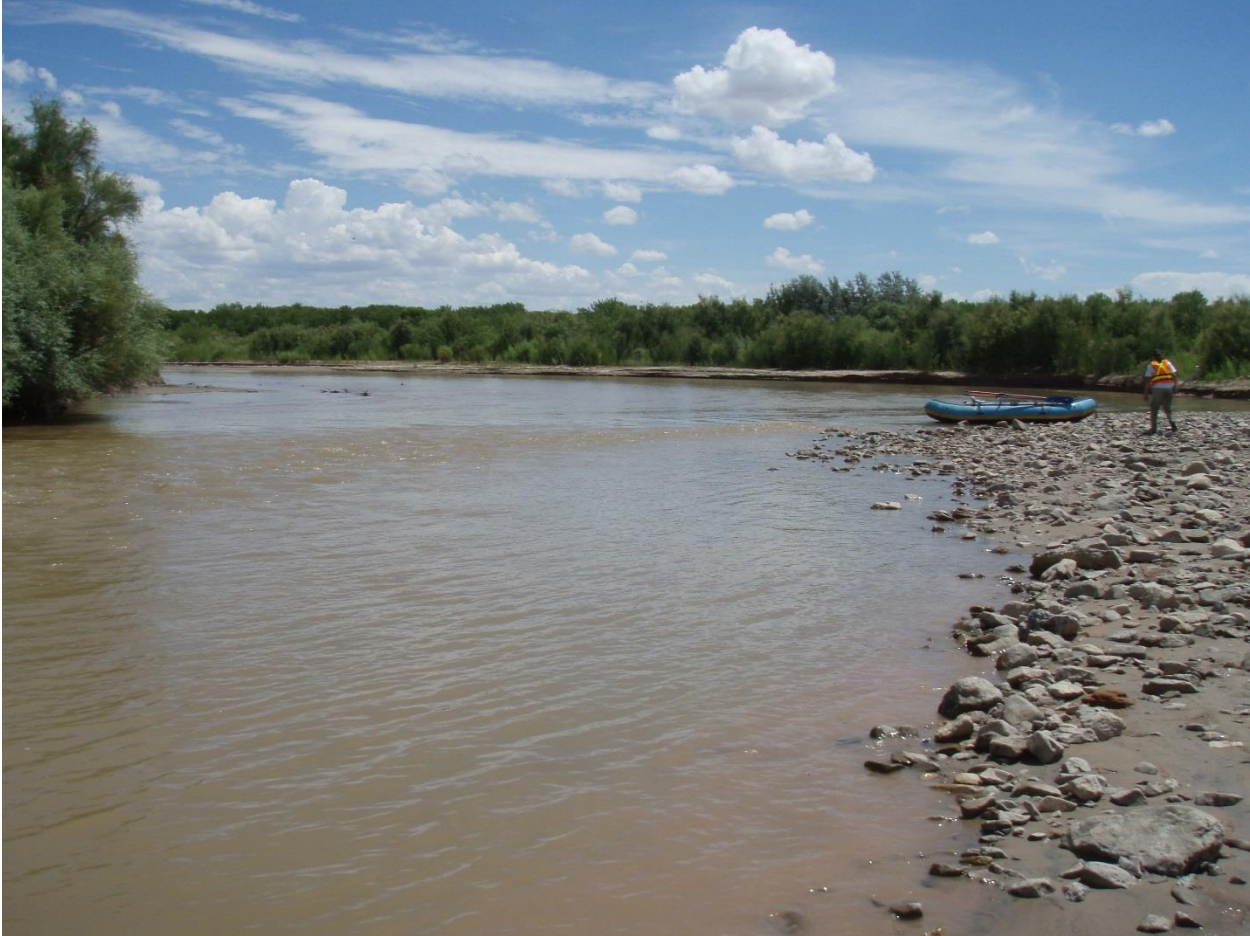
Figure 68 From the Arroyo de las Cañas alluvial fan, looking across stream at the erosion occurring at the banks of the Rio Grande.

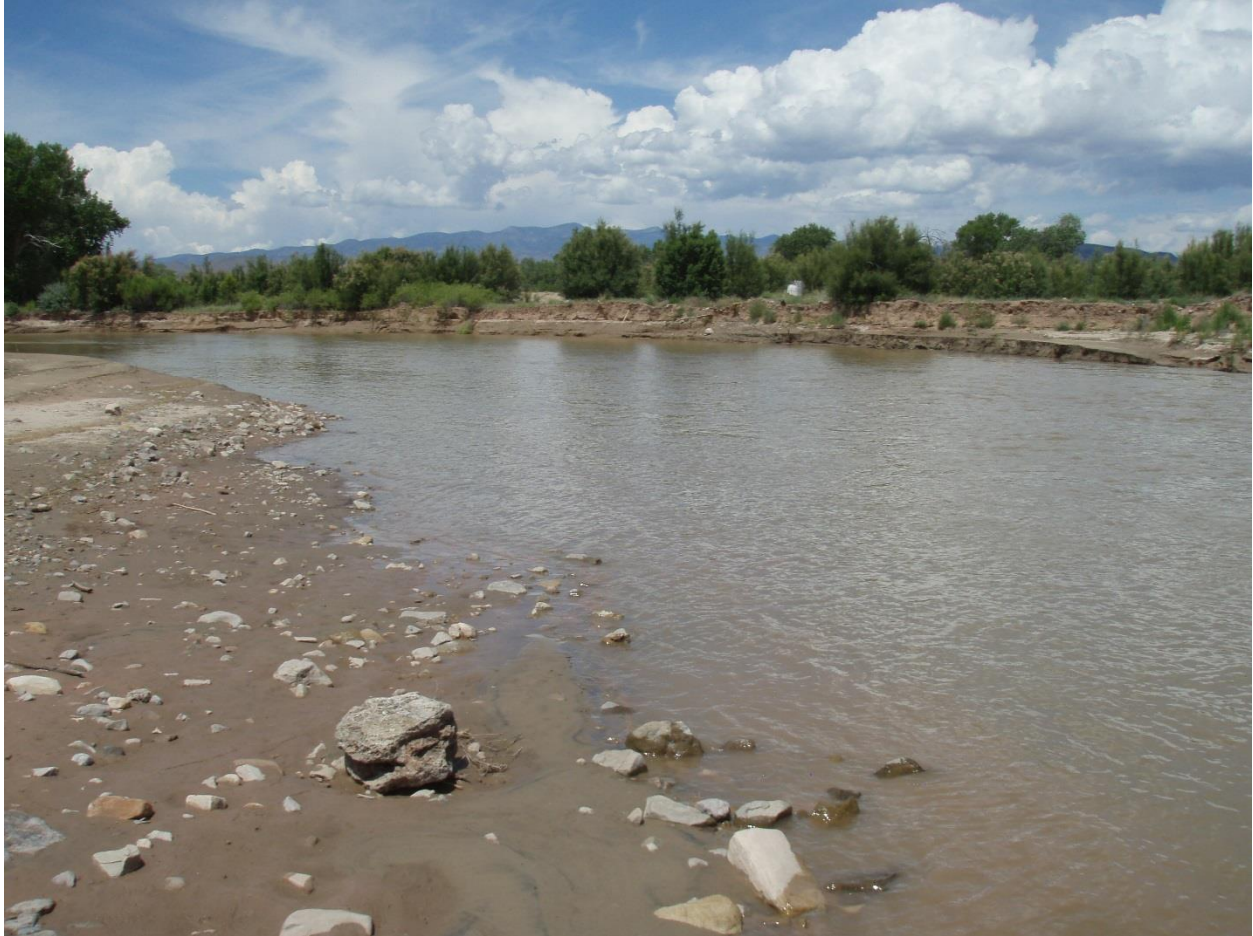
Figure 69 Eroding side bar opposite the Arroyo de las Cañas confluence (near the collection site for CA-3 and CA-4)

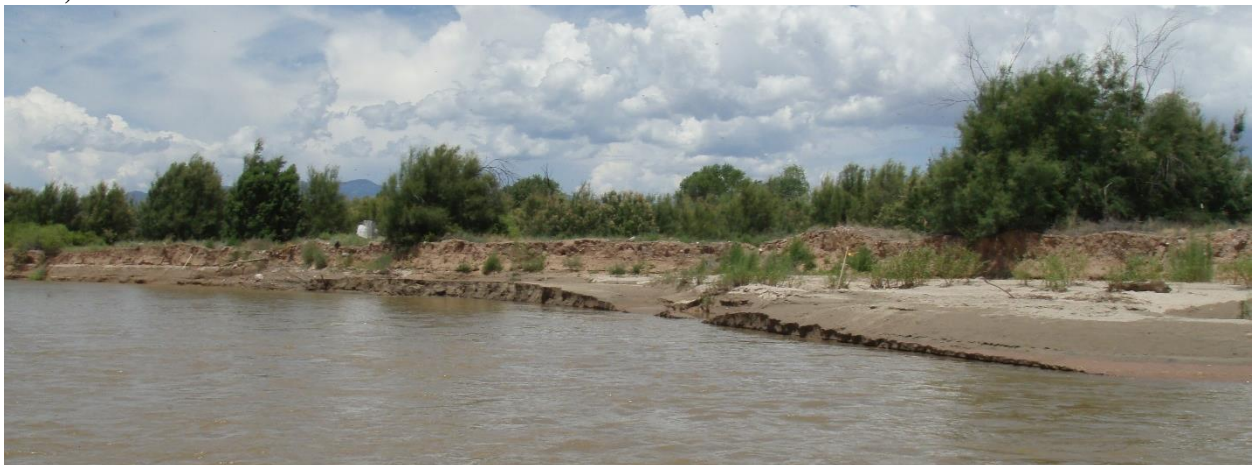
Figure 70 Eroding bank of the Rio Grande, opposite the confluence of the Arroyo de las Cañas

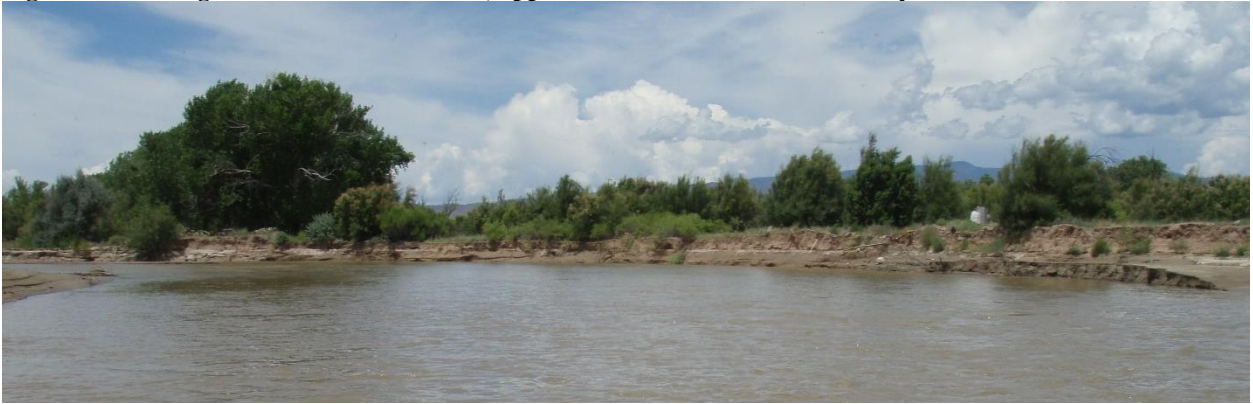
Figure 71 Eroding bank of the Rio Grande, near the confluence of the Arroyo de las Cañas.

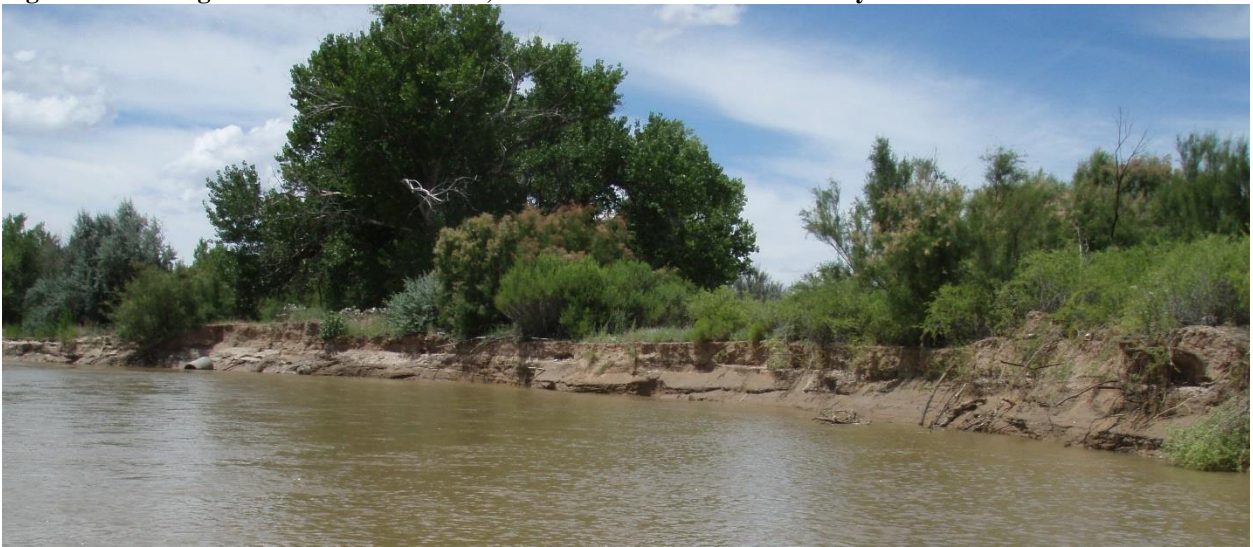
Figure 72 High water mark and the eroding bank of the Rio Grande near the Arroyo de las Cañas confluence.

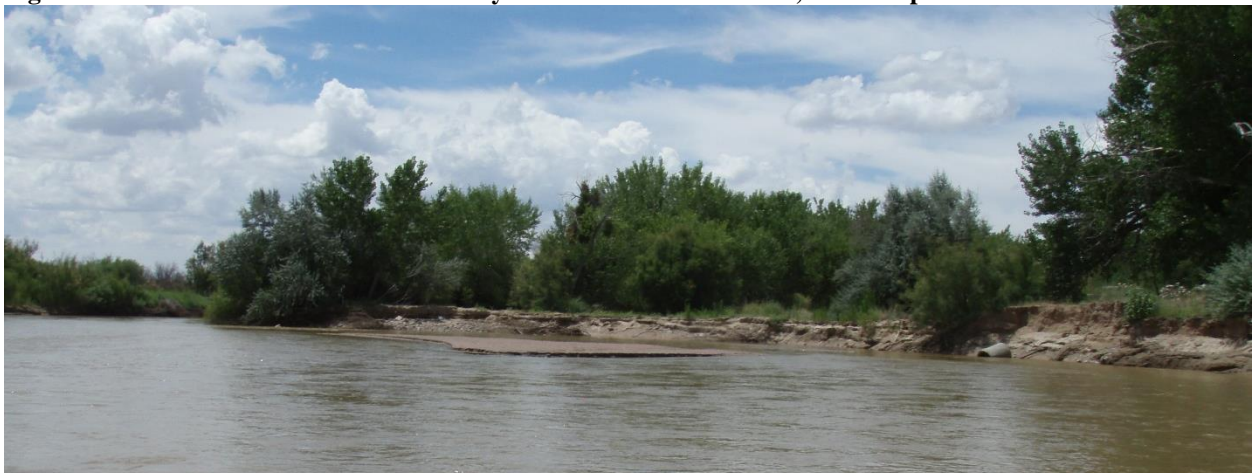
Figure 74 Sand bar near the CA-5 data collection location.

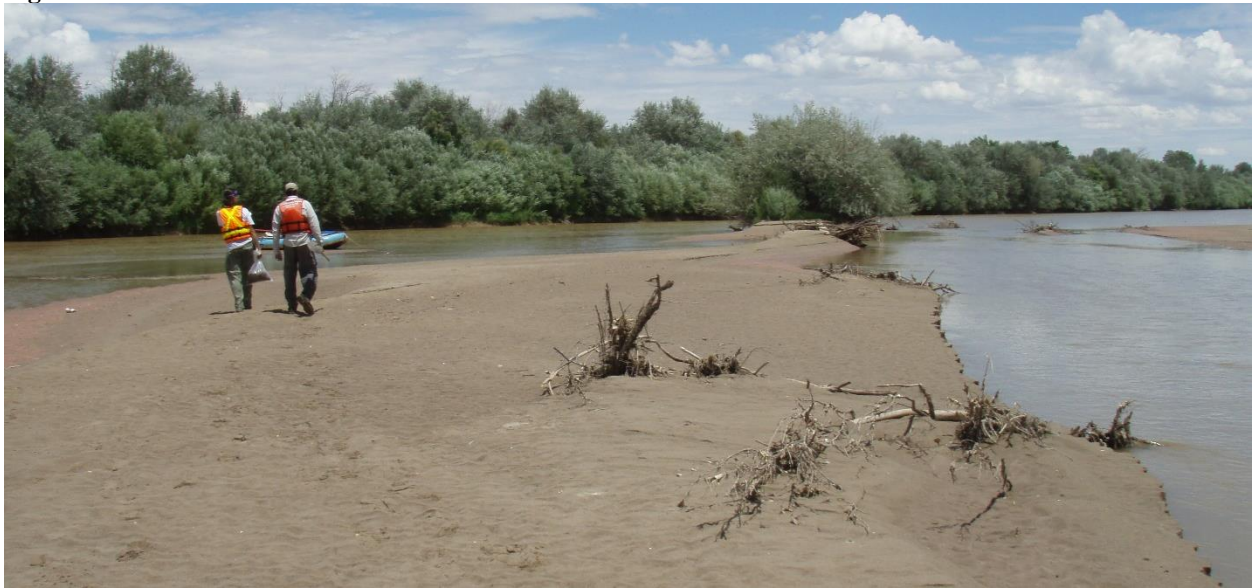
Figure 75 Photograph of the braided channel occurring due to several sand bar and debris near the CA-5 location.

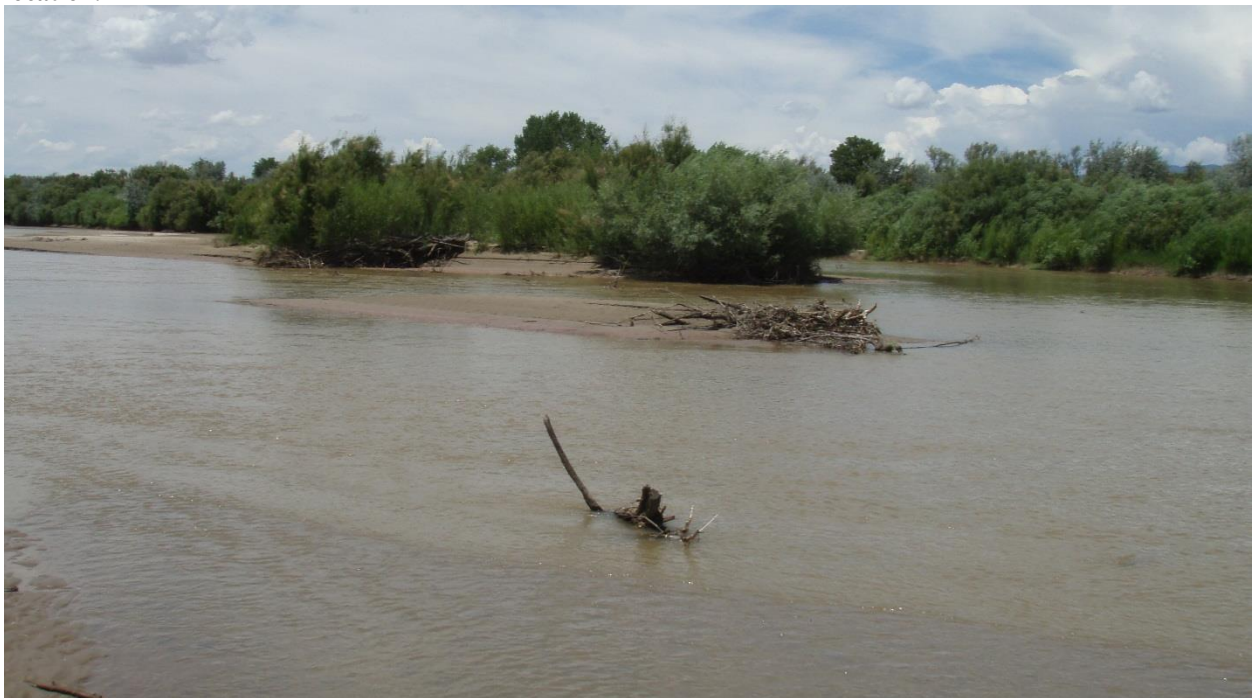
Figure 76 Photograph of the silty clay attributed to monsoon flows on a sand bar. Location is near CA-6 and CA-7.

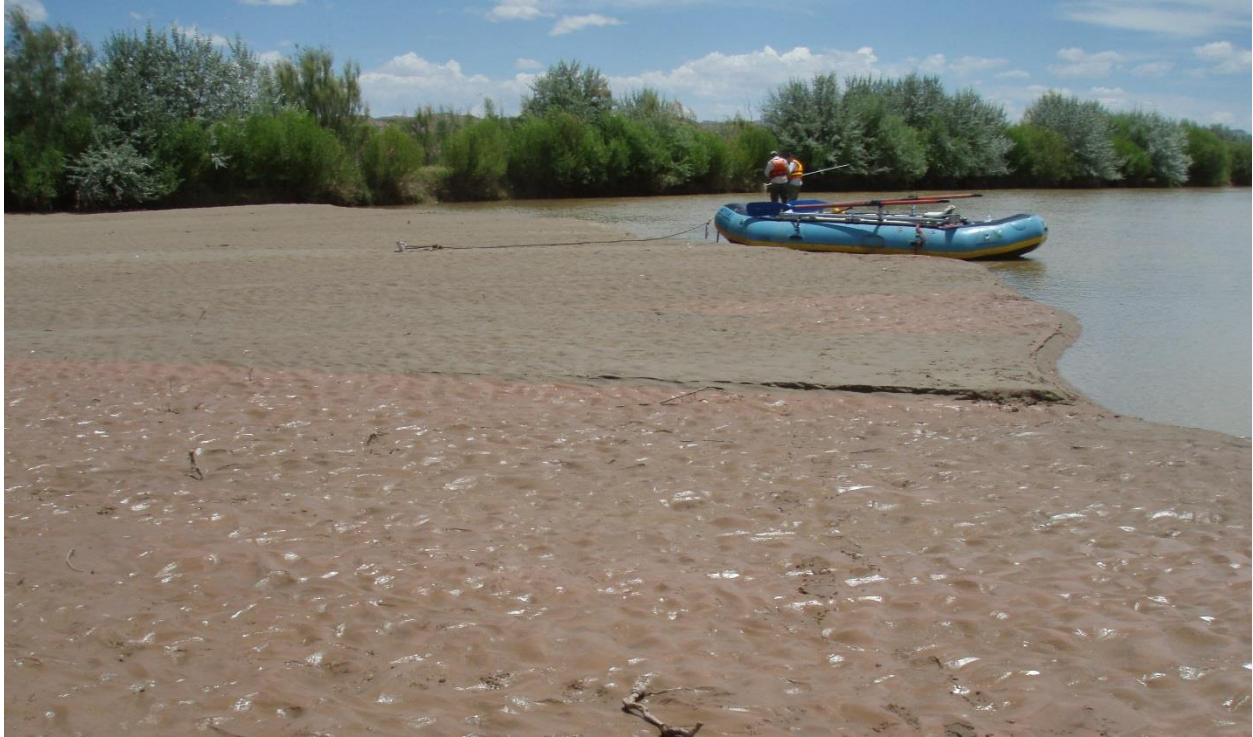
Figure 77 Eroding sand bar at the CA-8 through CA-10 data collection location.

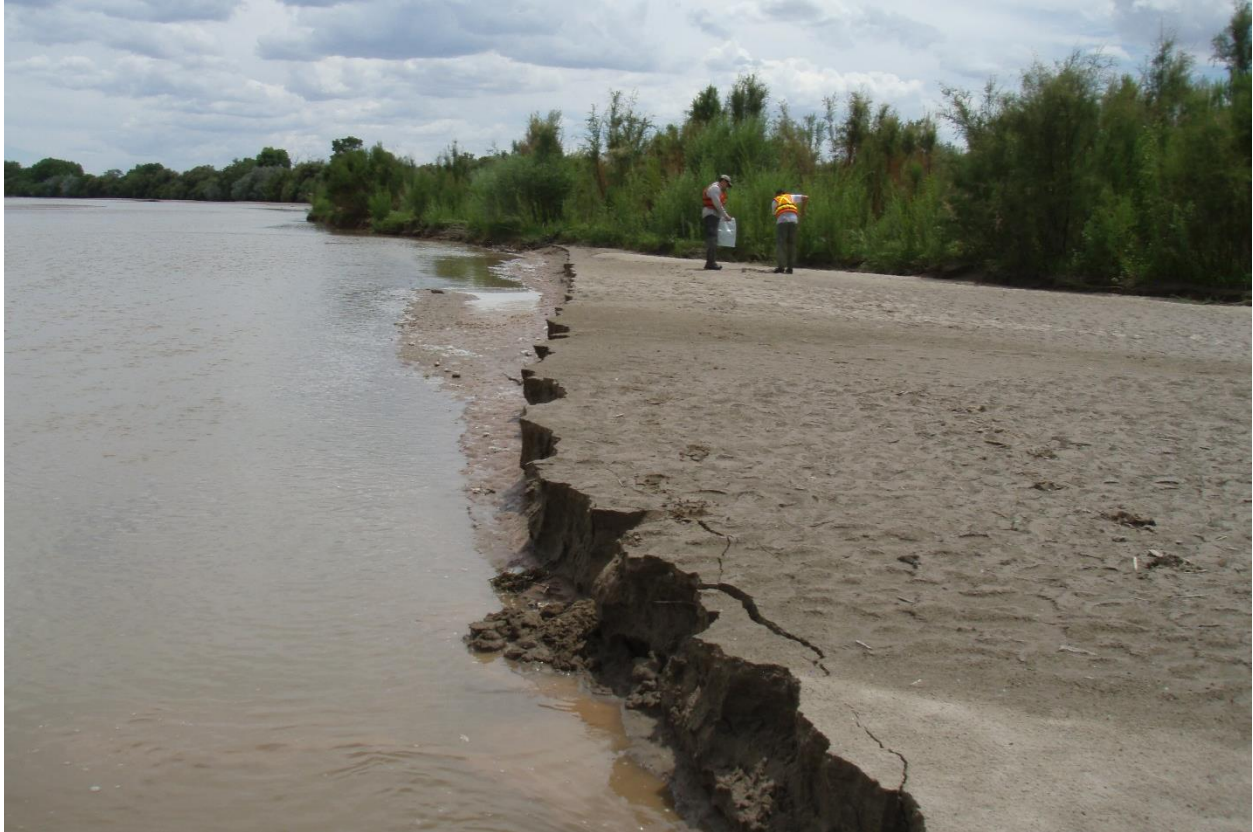
Figure 78 Approximate location of the sediment samples in the study reach.
