# HYDRAULIC HABITAT SUITABILITY FOR RIO GRANDE SILVERY MINNOW AT SAN ACACIA RESTORATION SITES

PREPARED FOR THE BUREAU OF RECLAMATION

SEPTEMBER 2021

US ARMY CORPS OF ENGINEERS  
ALBUQUERQUE DISTRICT  
HYDROLOGY AND HYDRAULICS SECTION

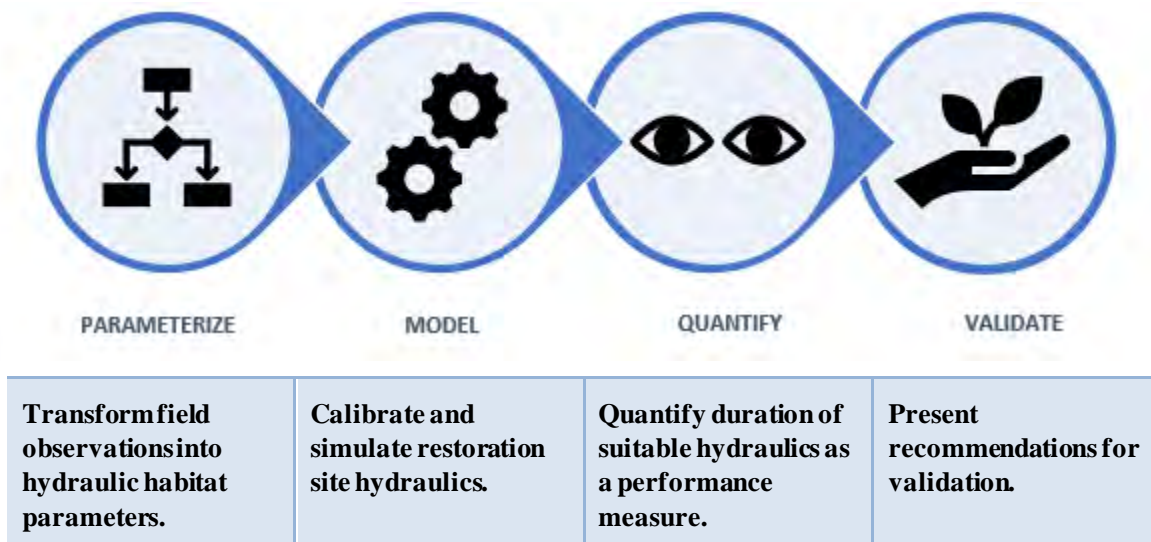
Figure 1. Process diagram for this study.

These analyses present acreages of suitable hydraulic habitat for various life stages of the RGSM. Hydrologic and hydraulic analyses were conducted with various software applications in the Hydrologic Engineering Center’s River Analysis System (HEC-RAS) version 5.0.6, Ecological Function Model (HEC-EFM) version 5.0.1, and ArcMap version 10.4. A schematic of the methodology is shown in Figure 1.

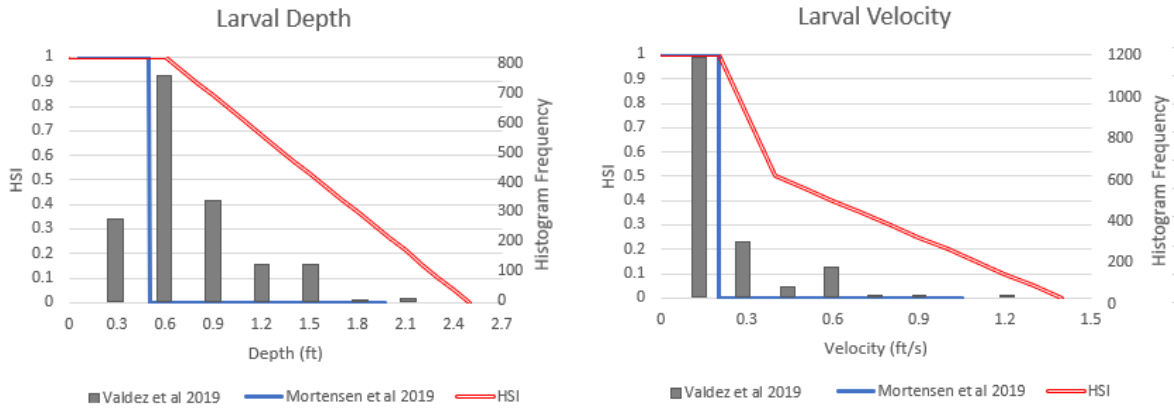
Figure 3. Larval depth and velocity hydraulic-suitability indices based on Valdez et al (2019) and Mortensen et al (2019).

Raw data from publications provided the average velocities, water depths, and counts of RGSM in these areas. Valdez et al (2019) was used for the larval RGSM metrics (Figure 3), and Braun et al (2015) was used for the adult RGSM metrics (Figure 4). Two studies were used because each studied a different life stage of RGSM. Generally, the data presented in these two studies represent a small sample size. The data were collected over the course of 1 year and particularly in Braun (2015), the RGSM population was small relative to other years. It is recommended that as more monitoring data becomes available, that it is added to the HSI curve to improve its statistical relevance.

The data were used to generate histograms of fish population frequency versus both hydraulic parameters (shown as bar graphs in Figure 3 and 4). The histograms were then translated to a 0 to 1 index by using a line graph to bound the population distribution (double red line in Figures 3 and 4). An HSI of 1 is associated with the depths and velocities where most fish were found, and gradual slopes to 0 to the bounds where fish were not detected. Depths and velocities where fish were captured were set to a minimum HSI of 0.1, as fish were found in these locations but in a much lower frequency than most of the other fish captured. The larval velocity HSI has an inflection at 0.3 feet/second because an overwhelming proportion of the silvery minnow larvae are captured at velocities from 0 to 0.15 feet/second. The shape of these lines were reviewed by fisheries biologists in a meeting facilitated by BOR in 2020. Based on uncertainties in capturing adult stage fish at deeper areas, fisheries biologists (BOR and ISC, personal comm. 2020) recommended the index of adult depth should be extended to 4 feet. Literature cited in Mortensen et al. (2019) was used as the initial bounds for the maximum index output (HSI = 1).

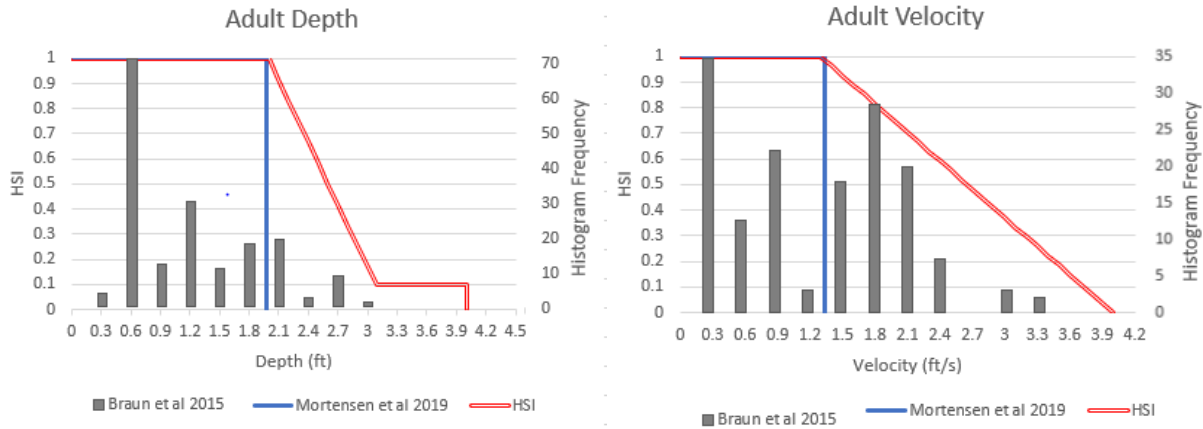
**Figure 4. Adult depth and velocity hydraulic suitability indices based on Braun et al 2015 and Mortensen et al 2019.**

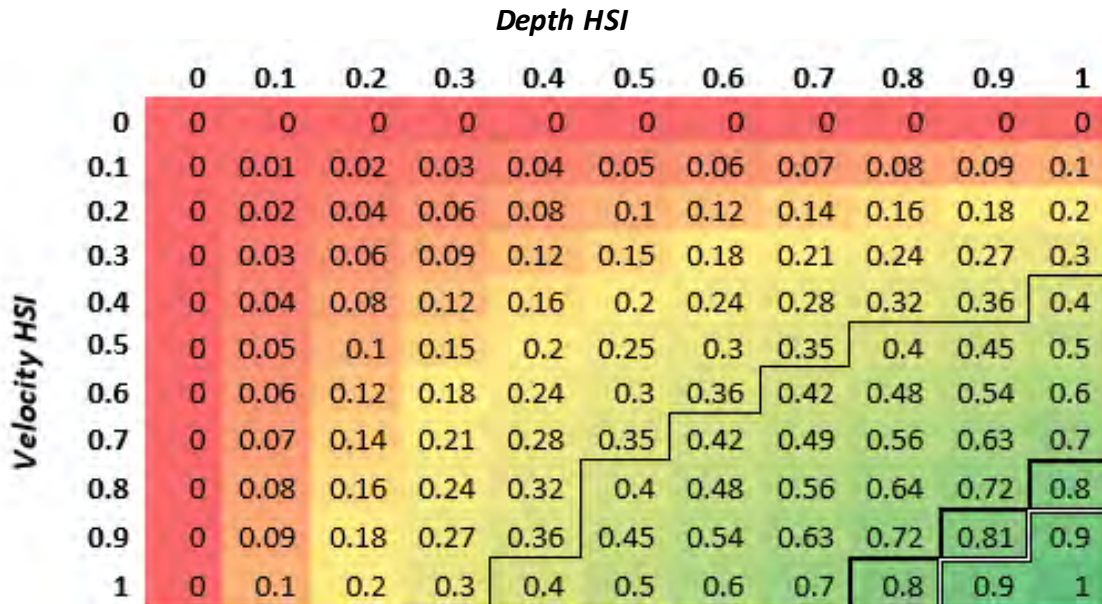
**Figure 5. Matrix of HSI results from velocity and depth sub-parameters. Scores are demarcated from least to most preferred hydraulic habitat “bins” used for visualizing results on a site-by-site basis.**

The bins used for visualization of the HSI results for each restoration site and both life stages are presented in Figure 5. The bins are: 0-0.4 HSI, 0.4-0.8 HSI, 0.8-0.9 HSI, and 0.9-1 HSI. Higher scores indicated more highly preferred conditions for RGSM. The bin extents were selected by using the Natural Breaks (Jenks) method (Smith et al, 2018). Under this method, a set number of breaks (4) are selected, and the breaks are determined by natural groupings where large changes in raster values occur. Though Natural Breaks may vary per dataset, the same bins were applied across all figures for comparison. The selected Natural Breaks (from RM 100.5) provides higher resolution at the higher HSI scores.

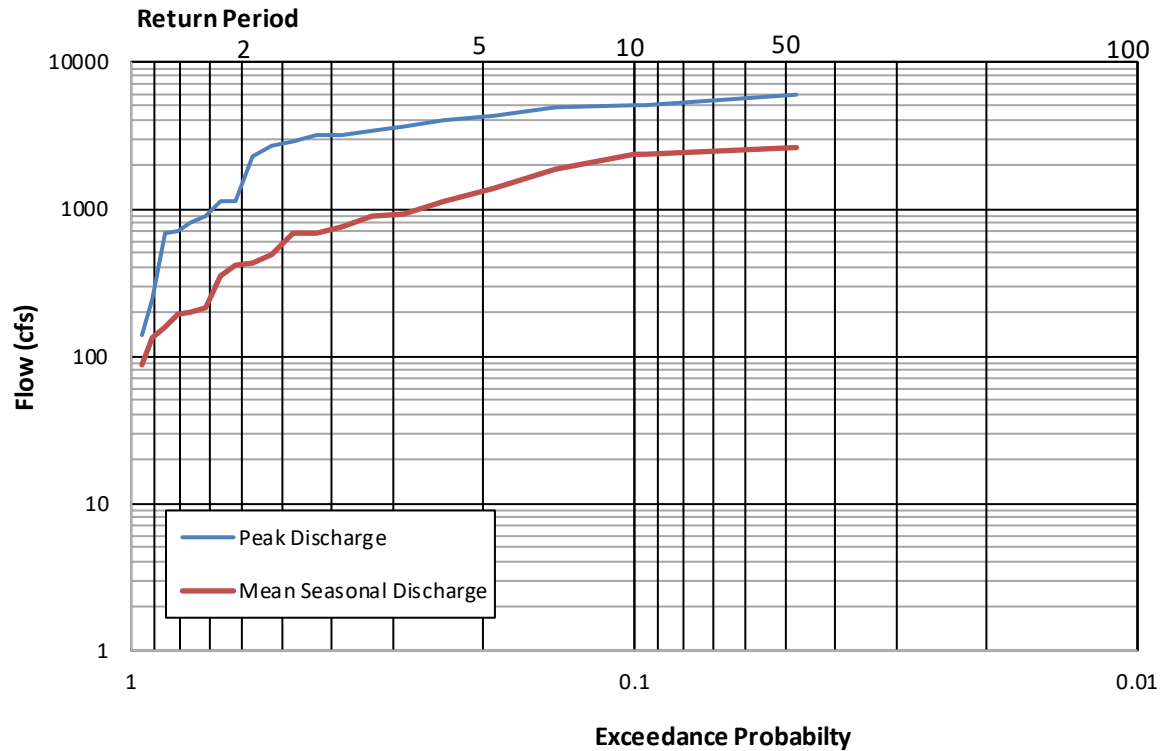
**Figure 6. San Acacia peak and mean seasonal discharges for the spring runoff (April through June) from 2000 to 2019.**

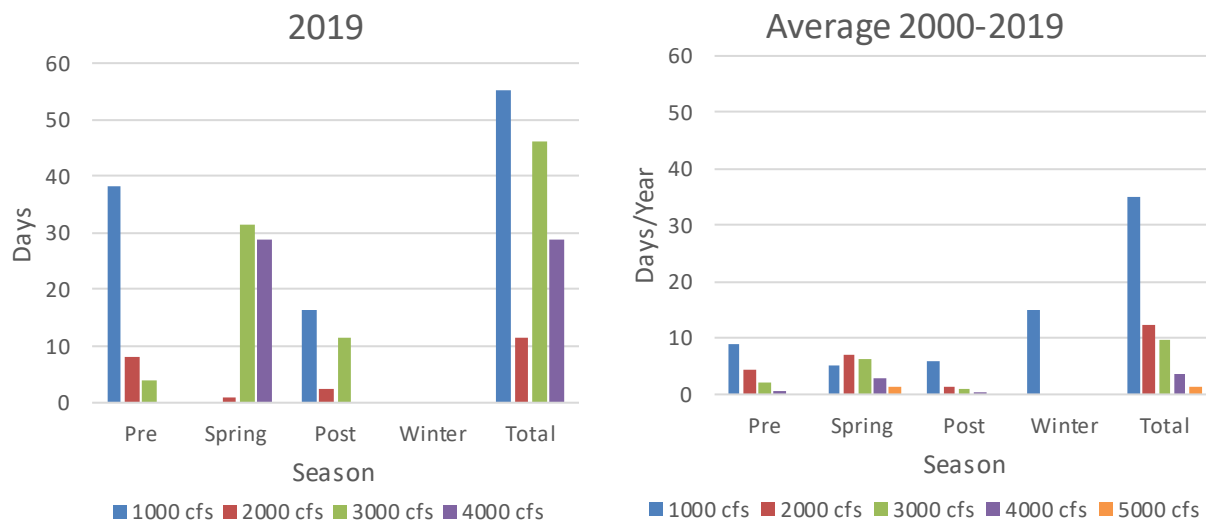
**Figure 7. Hydrology from San Acacia gage USGS 08354900 daily data, presenting occurrence frequency in terms of days per season in a year for 1) 2019; and 2) from 2000-2019. Bars indicate duration of hydrology from 1000-1999 cfs, 2000 -2999 cfs, etc. Hydrologic seasons were based on Bui (2014)**

Season (Name in Figure 7)	Duration
Pre-Runoff (Pre)	March to April
Spring Runoff (Spring)	May to June
Post-Runoff (Post)	July to October
Winter (Winter)	November to February

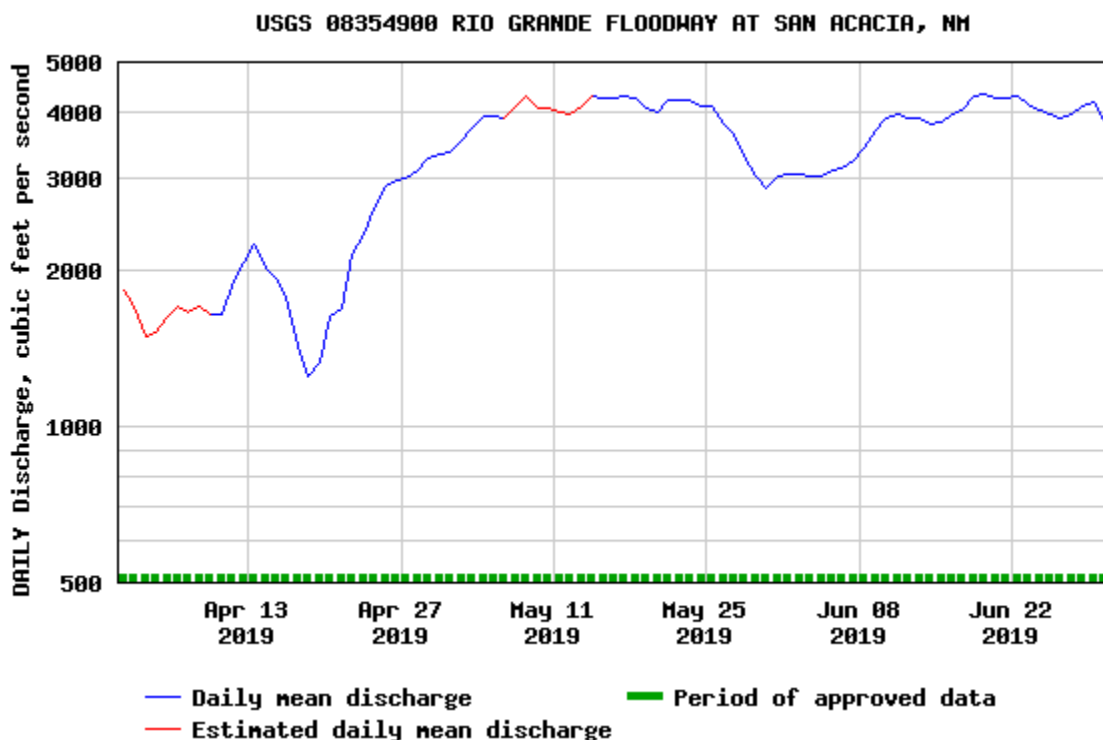
Figure 11. Discharge hydrograph used in the Percent Time Inundated (PTI) simulations.

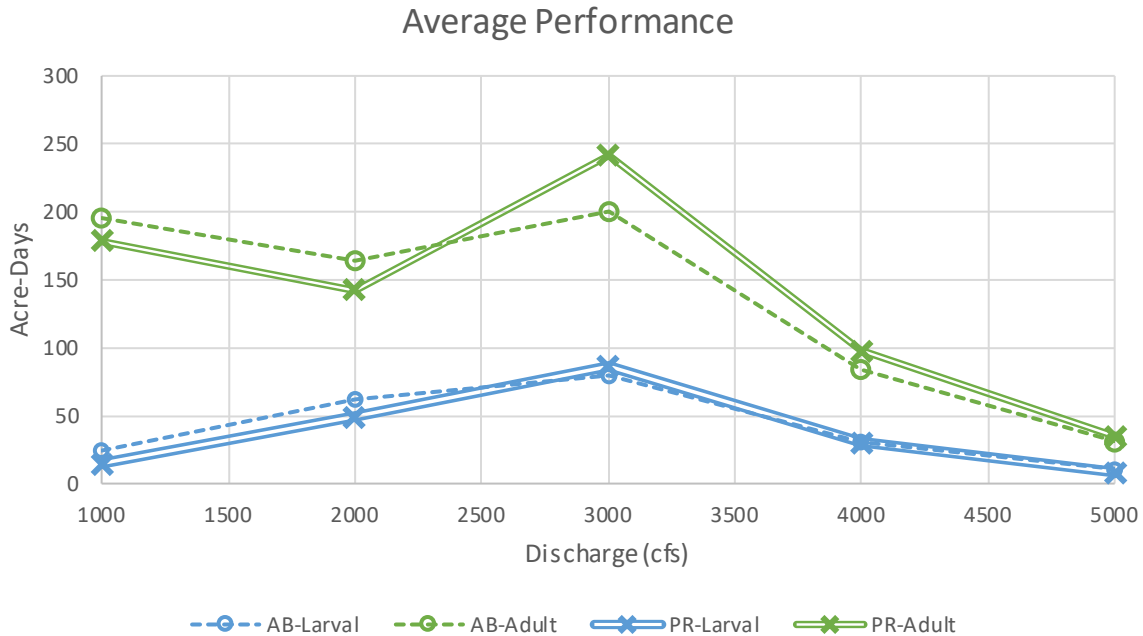
**Figure 12. Cumulative effective hydraulic habitat for all restoration sites in this study. (AB= As-Built; PR = Post-Runoff models)**

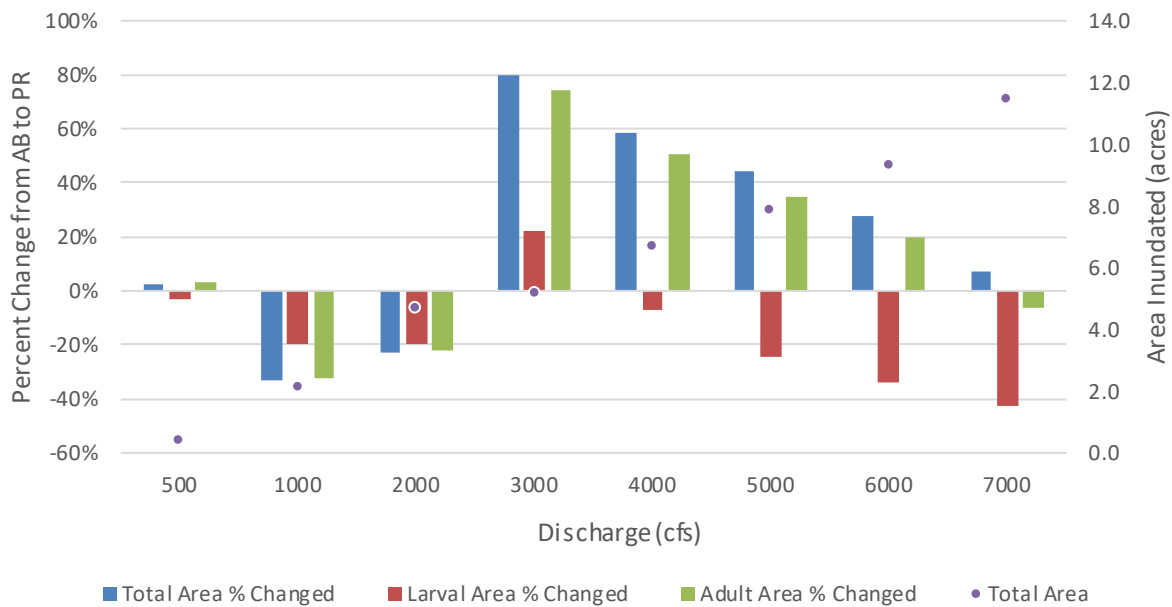
**Figure 16. RM93 percent change in inundation areas in the PR and AB suitable hydraulics for larval and adult life stages of RGSM within the restoration construction footprint.**

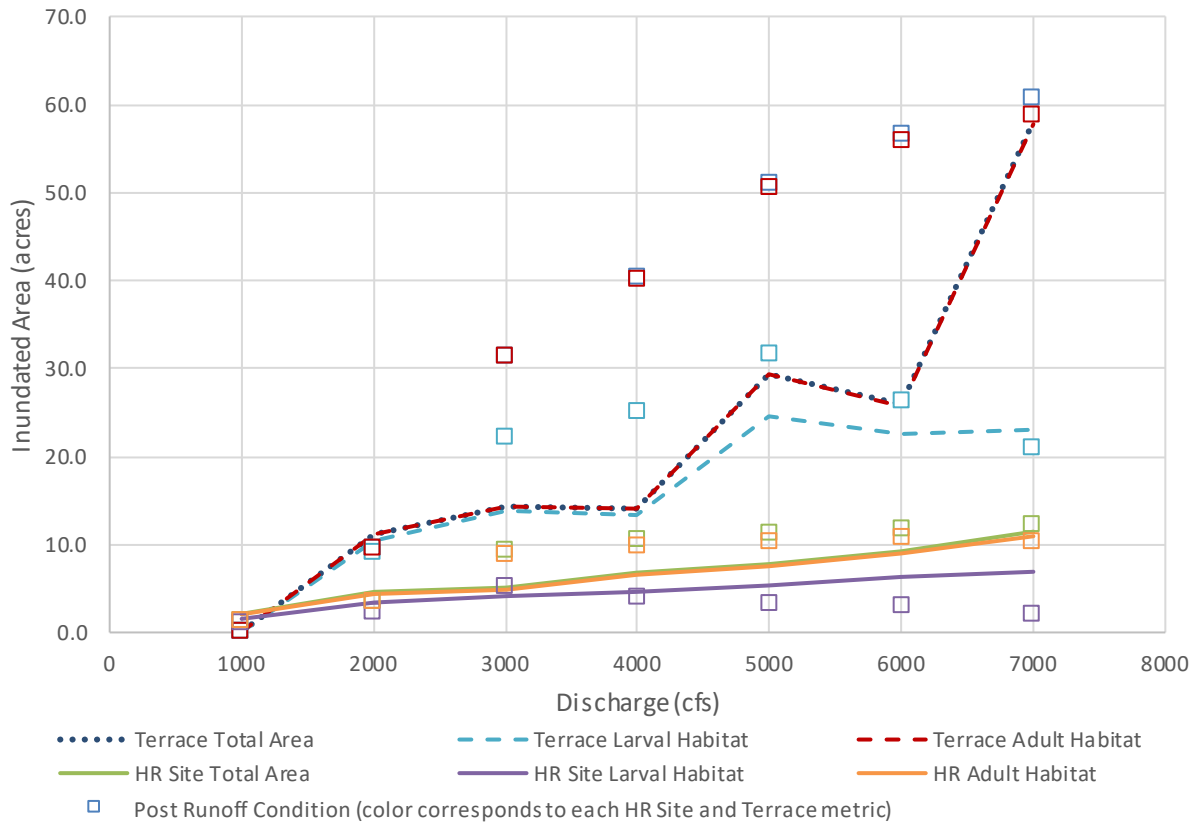
**Figure 18. RM93 Areal results for AB (shown as line graphs) and PR (shown as square points) scenarios for adult and larval life stages of the RGSM on constructed habitat restoration (HR) site footprint and the adjacent floodplain (Terrace).**

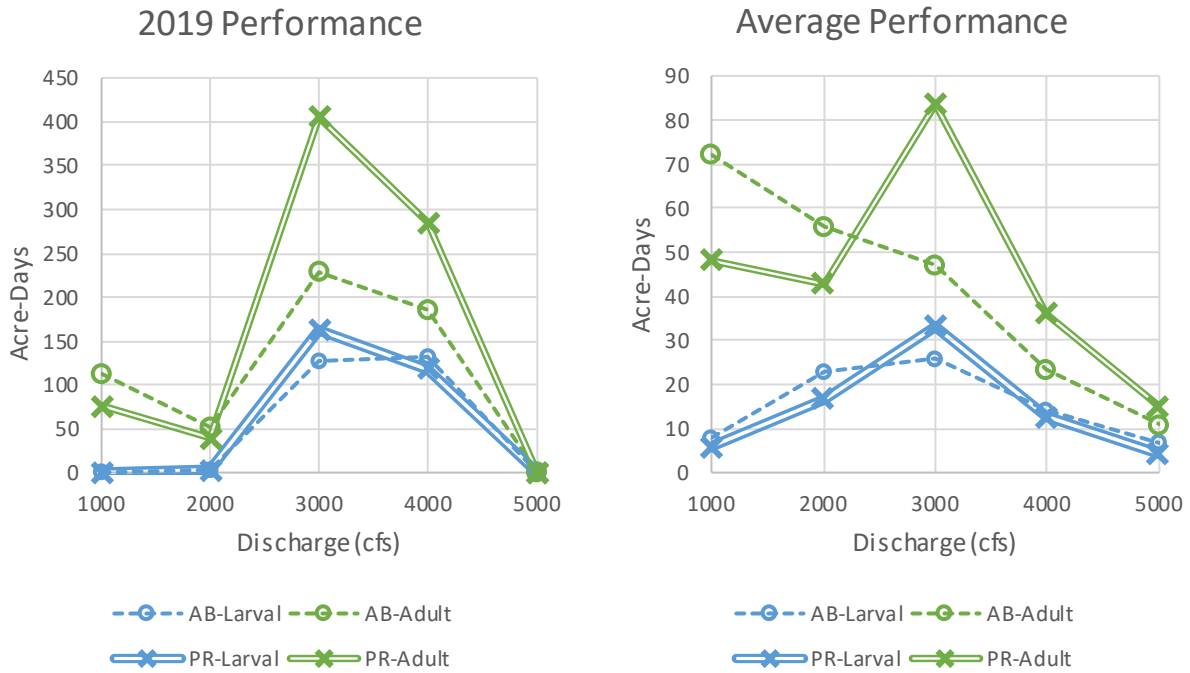
**Figure 19. Hydraulic habitat effectiveness curve based on frequency of discharge events from 1000 to 5000 cfs. Note the difference in scale on the y-axis for the two figures.**

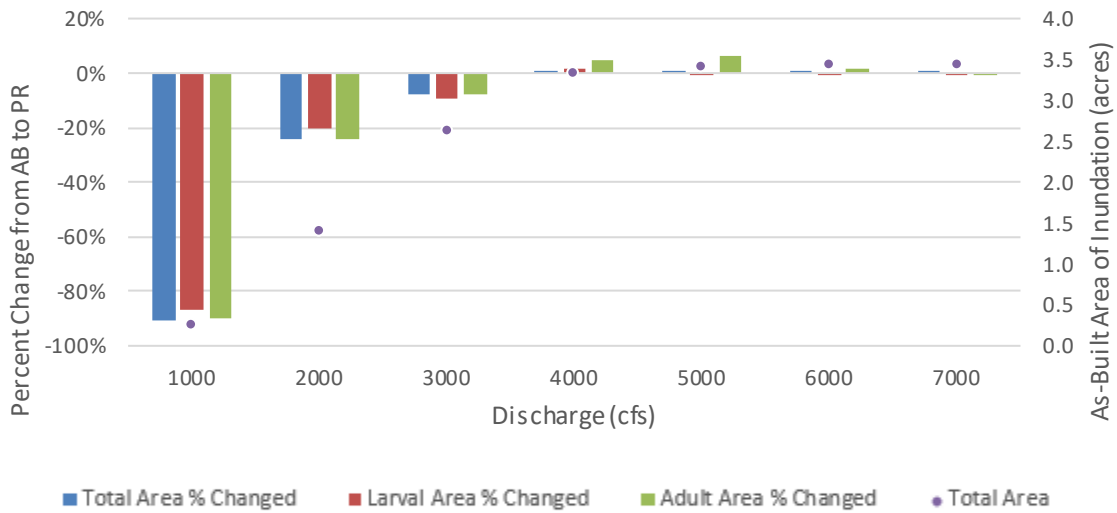
**Figure 22. RM99.5 percent change in inundation areas in the PR and AB suitable hydraulics for larval and adult life stages of RGSM within the restoration construction footprint.**

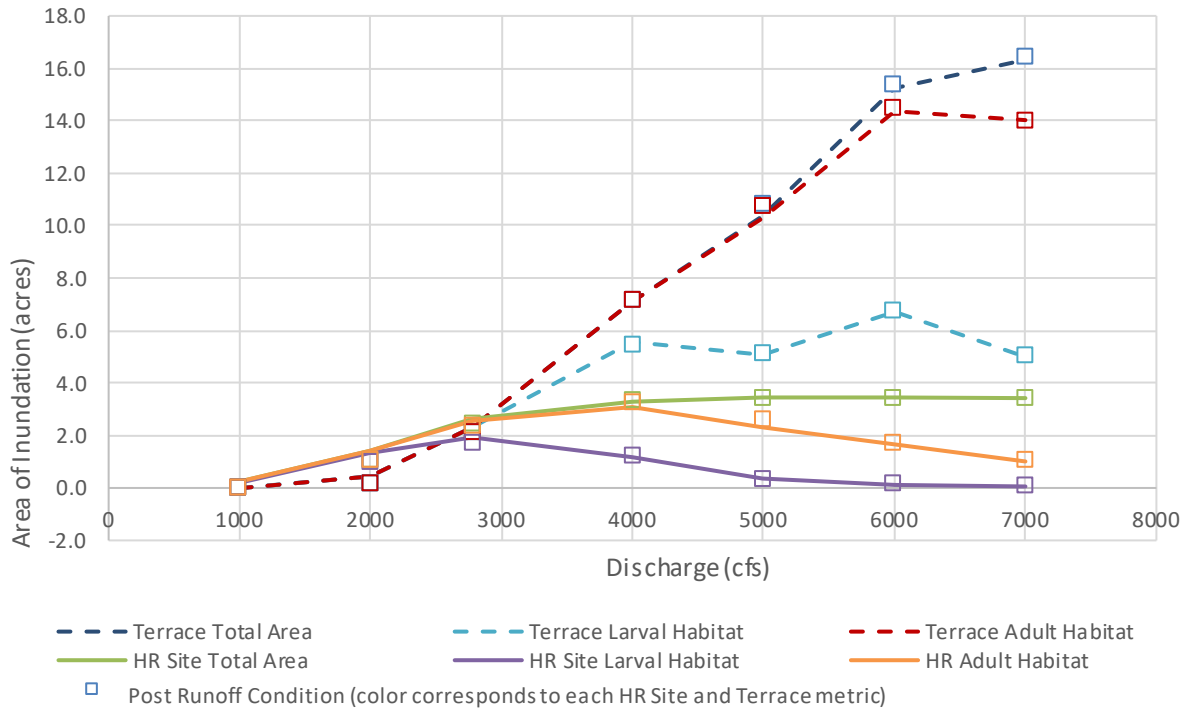
**Figure 23. RM99.5 Areal results for AB (shown as line graphs) and PR (shown as square points) scenarios for adult and larval life stages of the RGSM on constructed habitat restoration (HR) site footprint and the adjacent floodplain (Terrace).**

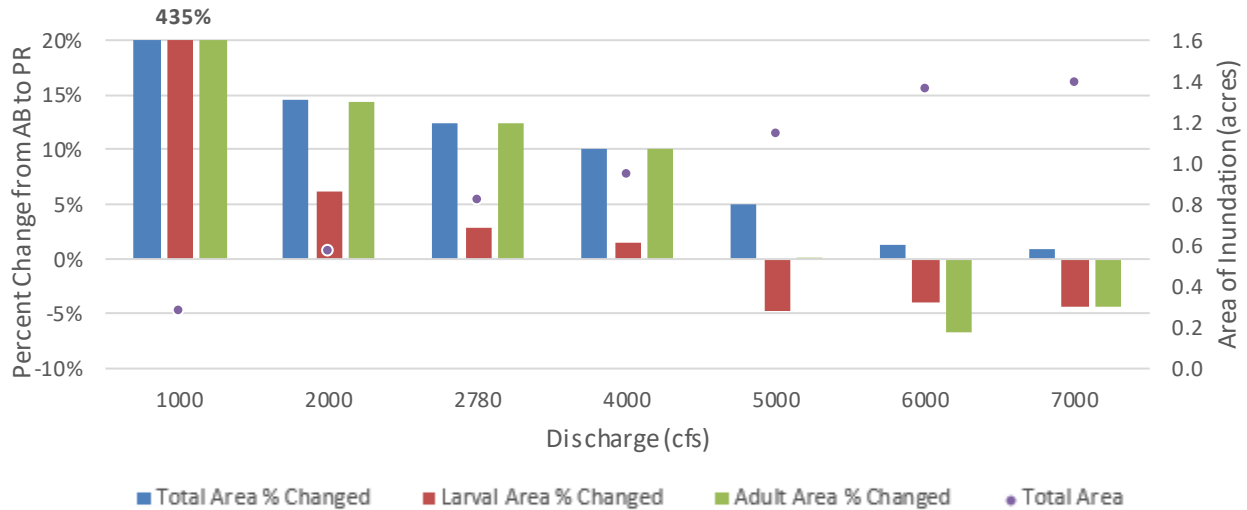
**Figure 27. RM 100 percent change in inundation areas in the PR and AB suitable hydraulics for larval and adult life stages of RGSM within the restoration construction footprint.**

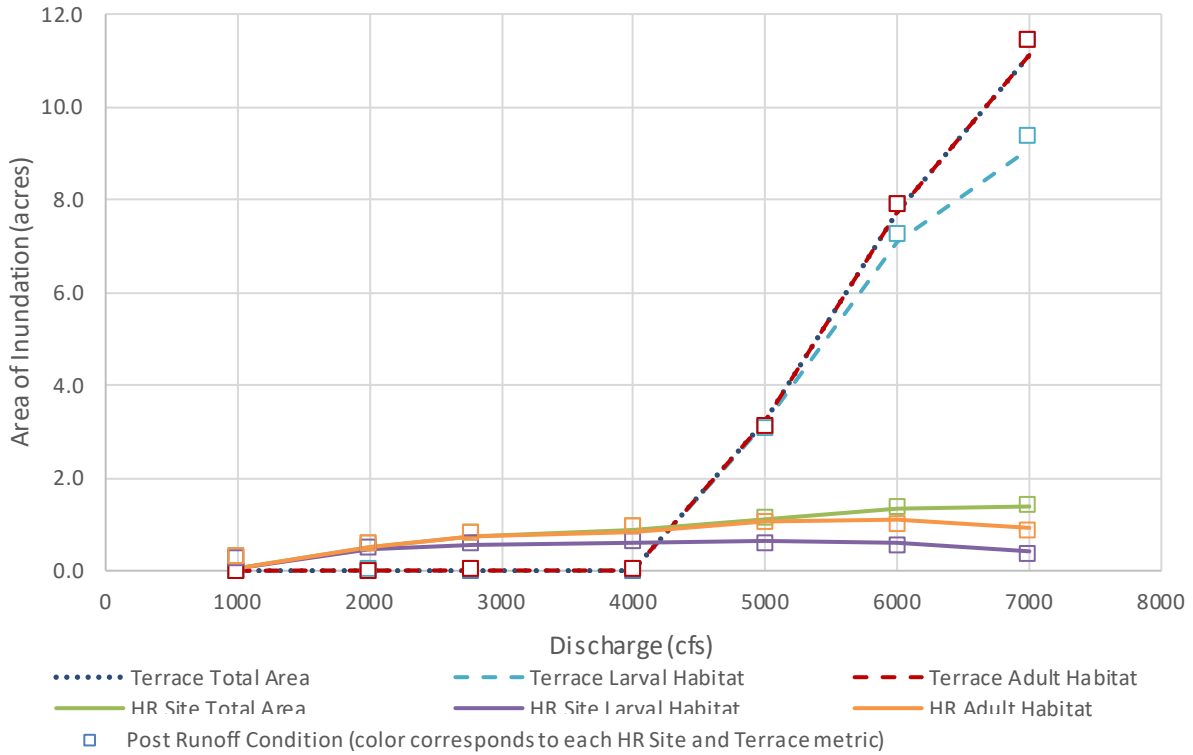
**Figure 28. RM100 Areal results for AB (shown as line graphs) and PR (shown as square points) scenarios for adult and larval lifestages of the RGSM on constructed habitat restoration (HR) site footprint and the adjacent floodplain (Terrace).**

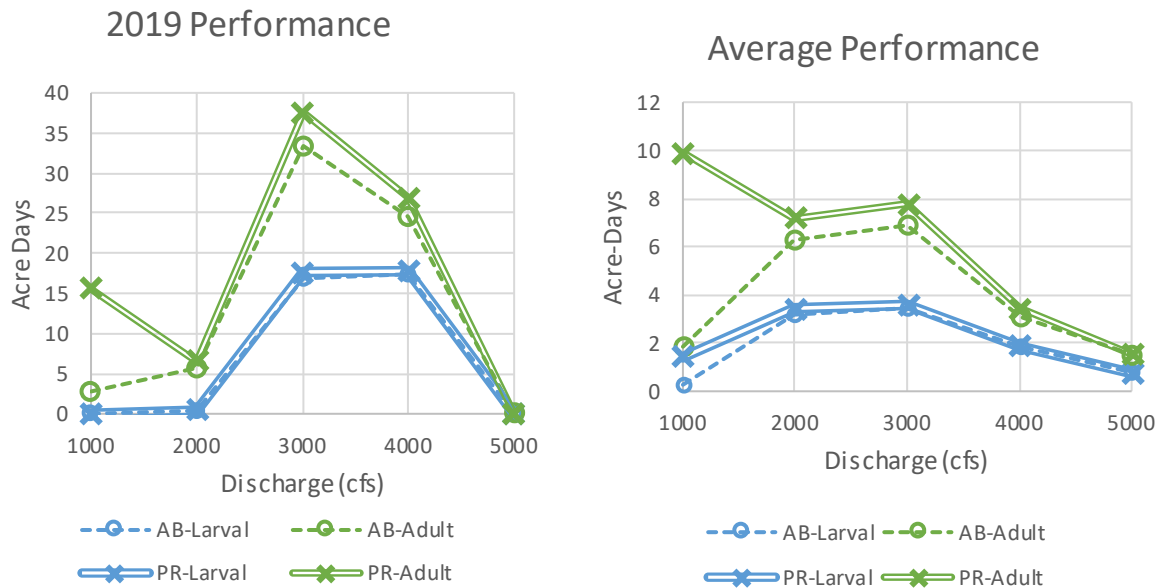
**Figure 29. Hydraulic habitat effectiveness curve based on frequency of discharge events from 1000 to 5000 cfs. Note the difference in scale on the y-axis for the two figures.**

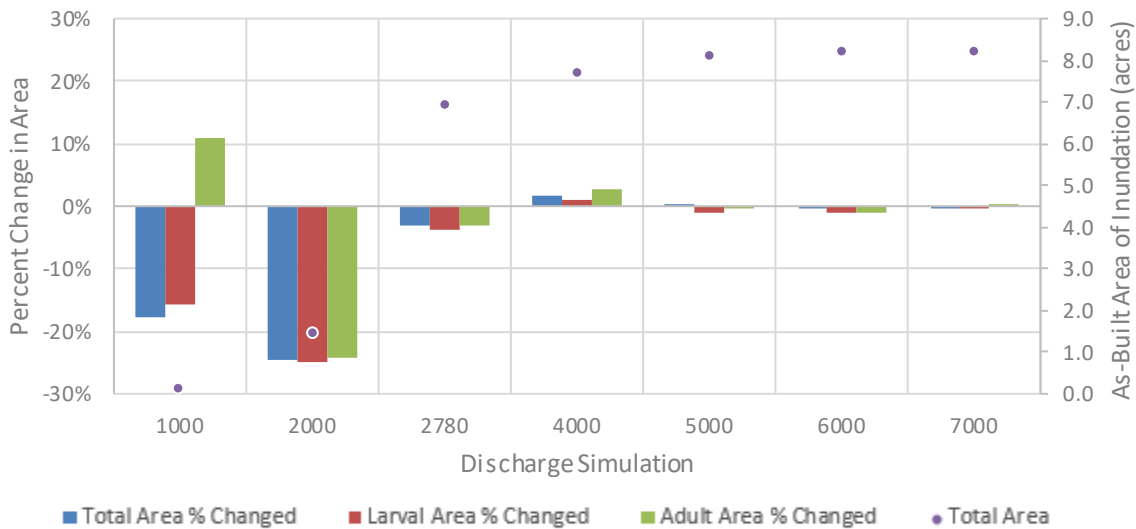
**Figure 32. RM 100.5 percent change in inundation areas in the PR and AB suitable hydraulics for larval and adult life stages of RGSM within the restoration construction footprint.**

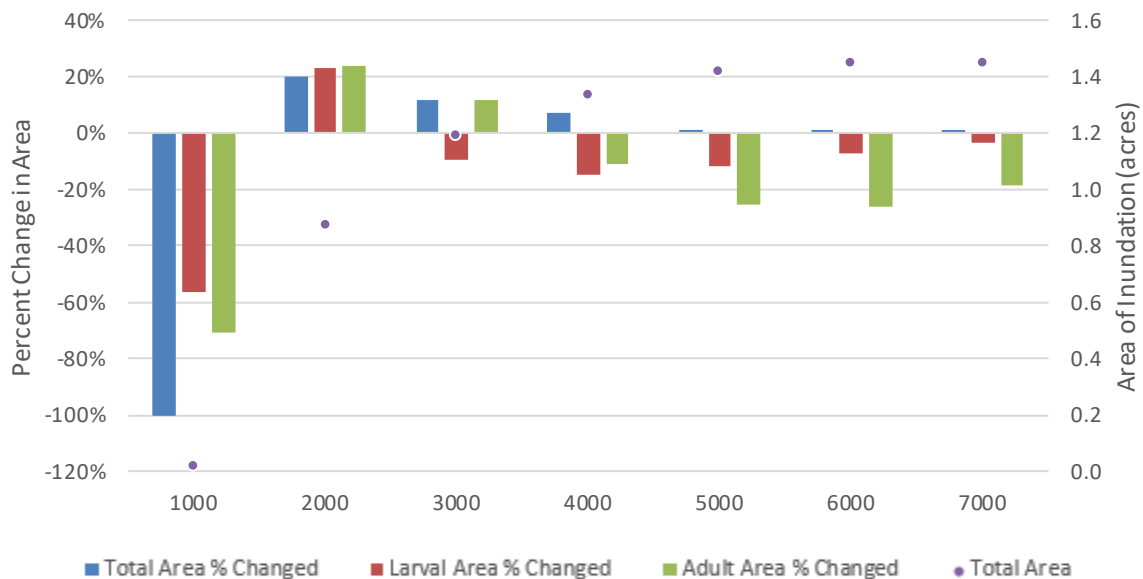
**Figure 48. RM 112 percent change in inundation areas in the PR and AB suitable hydraulics for larval and adult life stages of RGSM within the restoration construction footprint.**

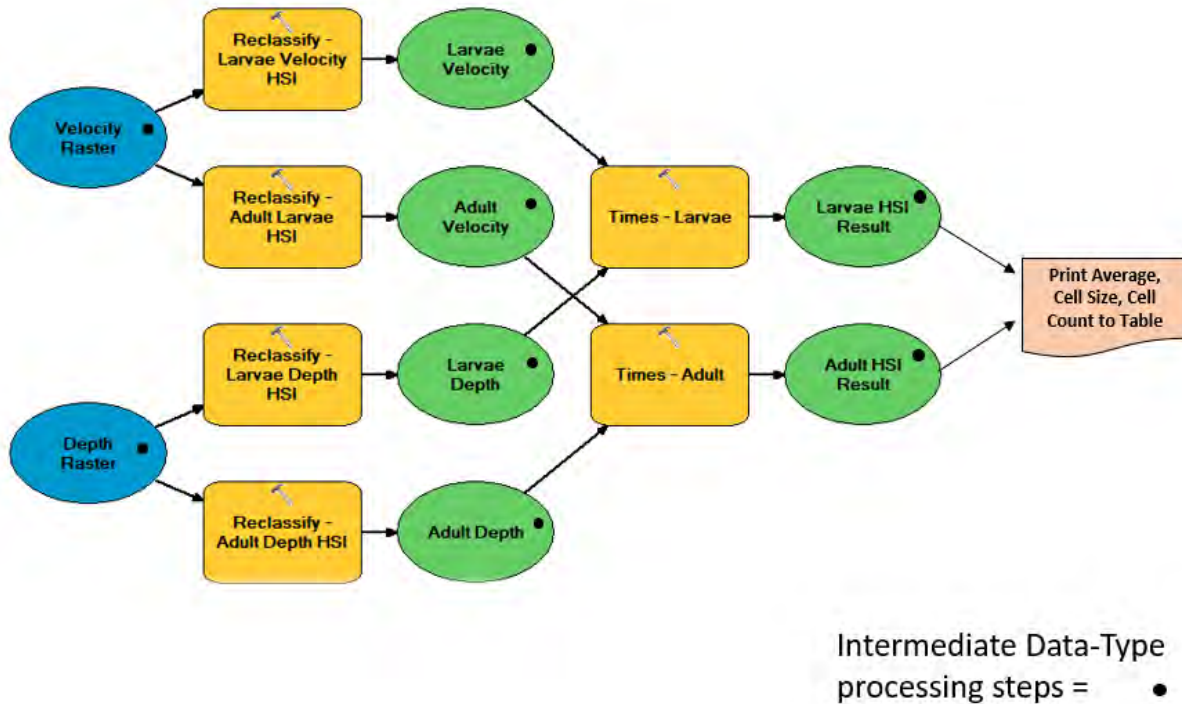
**Figure 58. Module Builder representation of the workflow. Intermediate data-type processing involves changing the data to Integer, Float, or Script to be used in subsequent ArcMap Tools.**

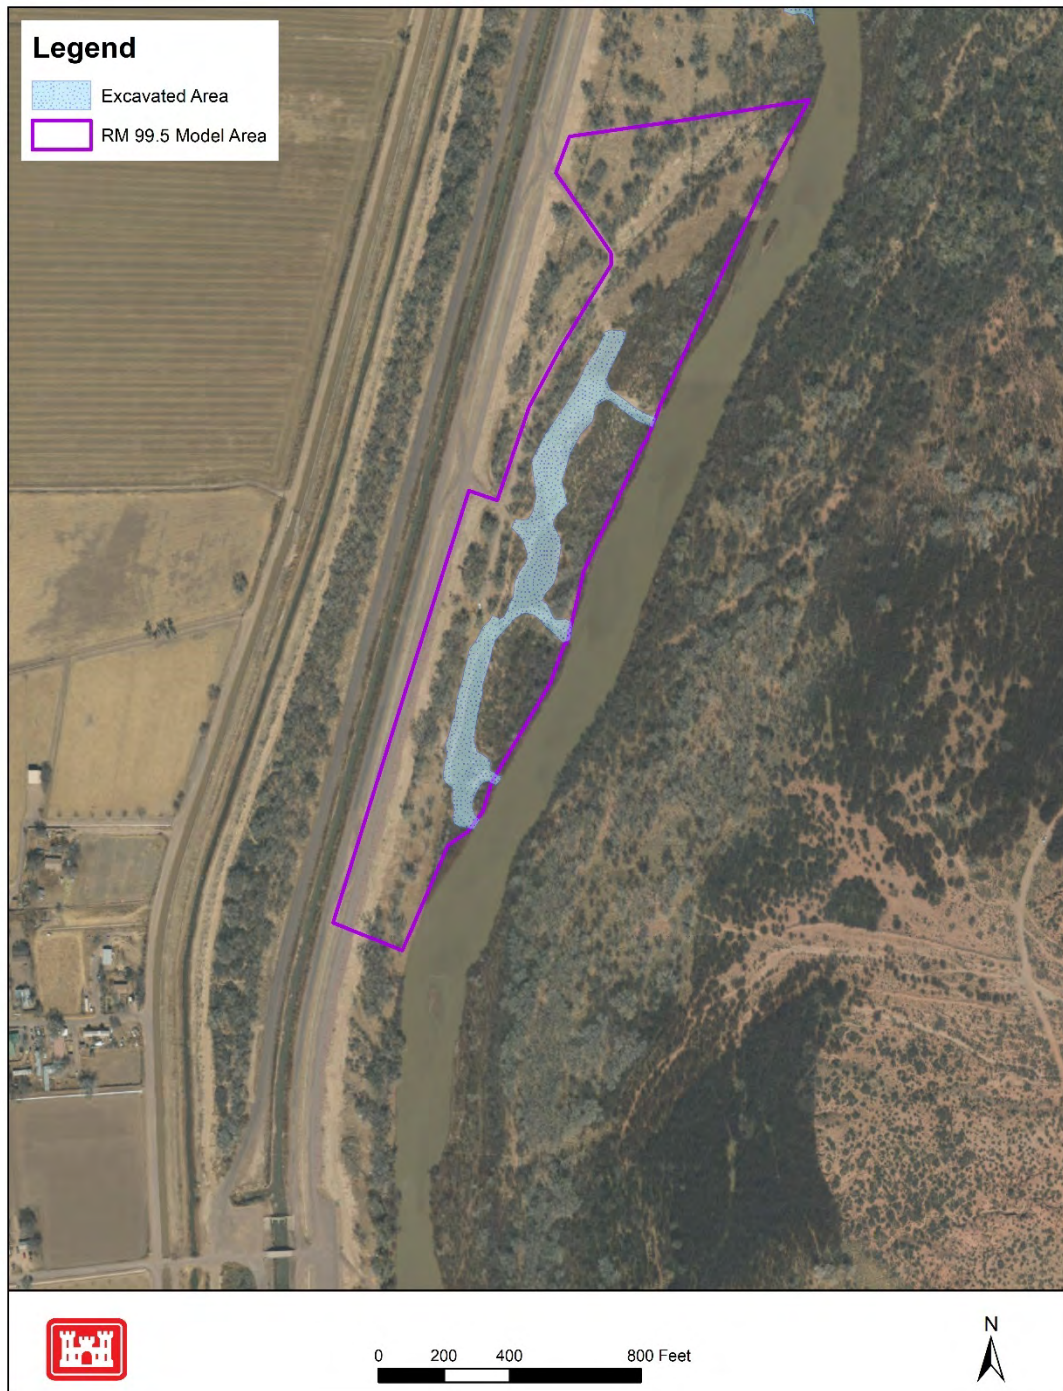
**Figure 61. Extents of the 2D model area (evaluated as the adjacent floodplain or “terrace” – geomorphic terrace shown as well) and the RM 99.5 excavated area (HR site).**

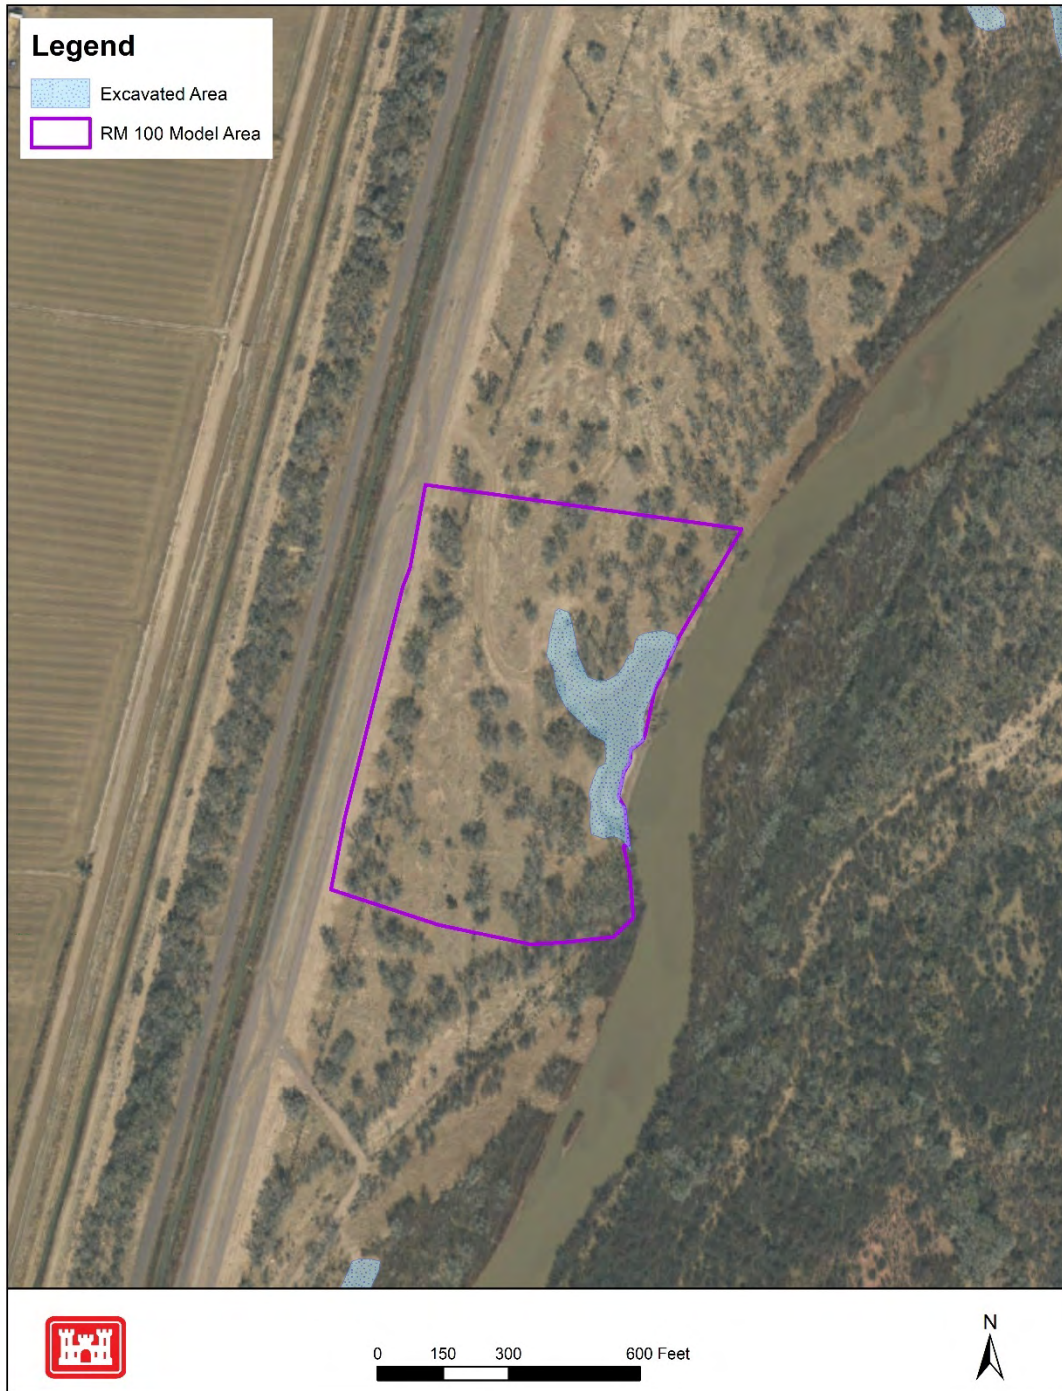
**Figure 62. Extents of the 2D model area (evaluated as the adjacent floodplain or “terrace”) and the RM 100 excavated area (HR site).**

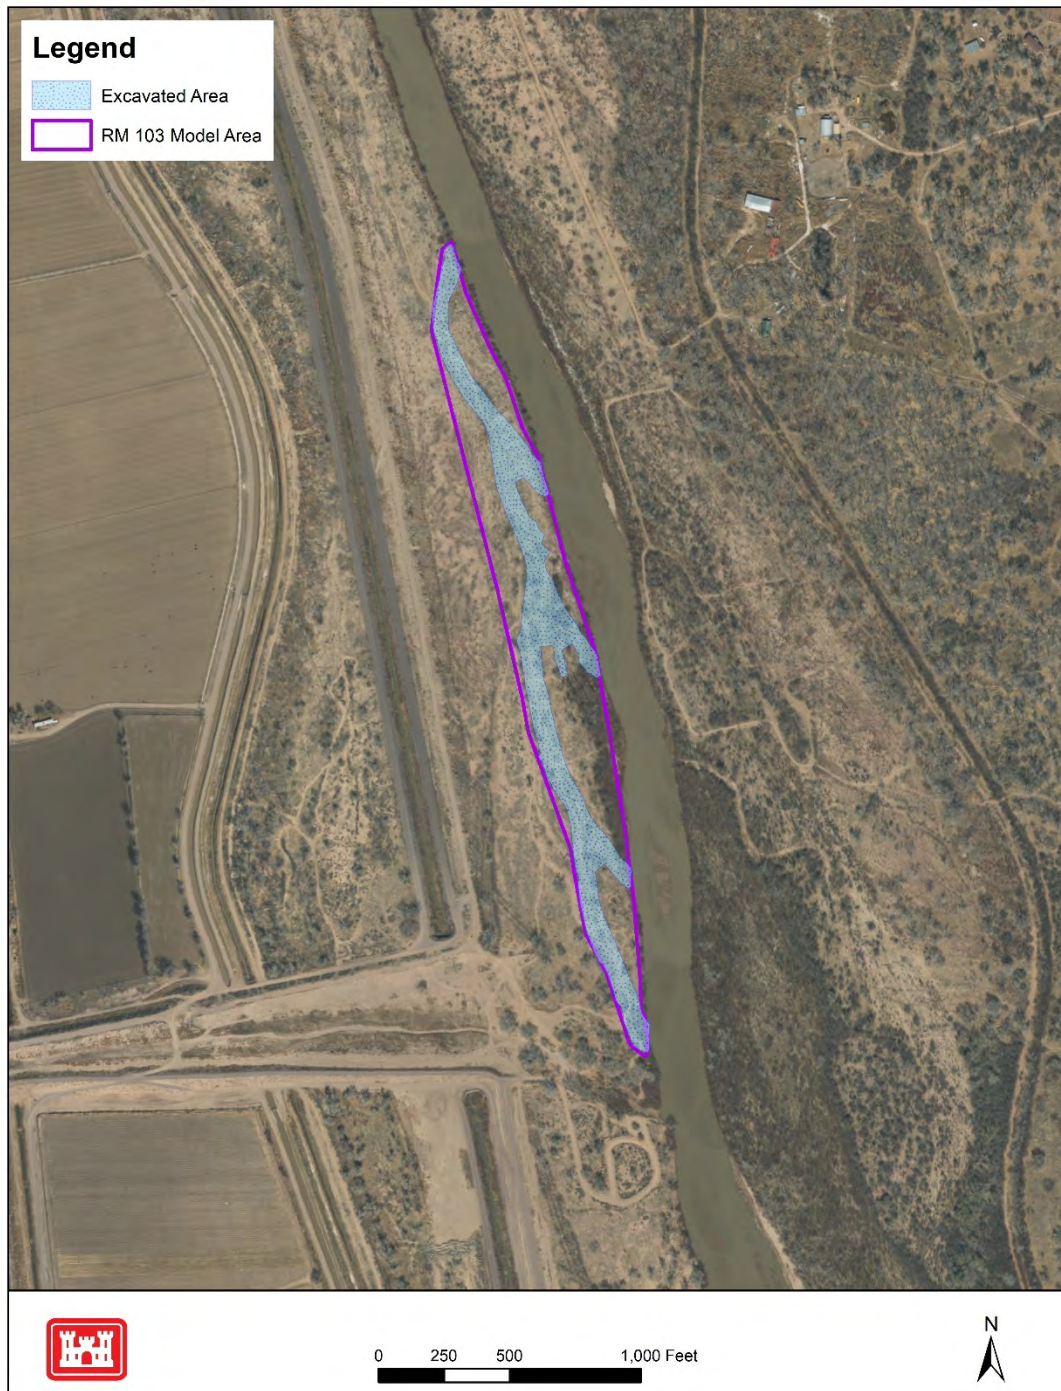
**Figure 64. Extents of the 2D model area (evaluated as the adjacent floodplain or “terrace”) and the RM 103 excavated area (HR site).**

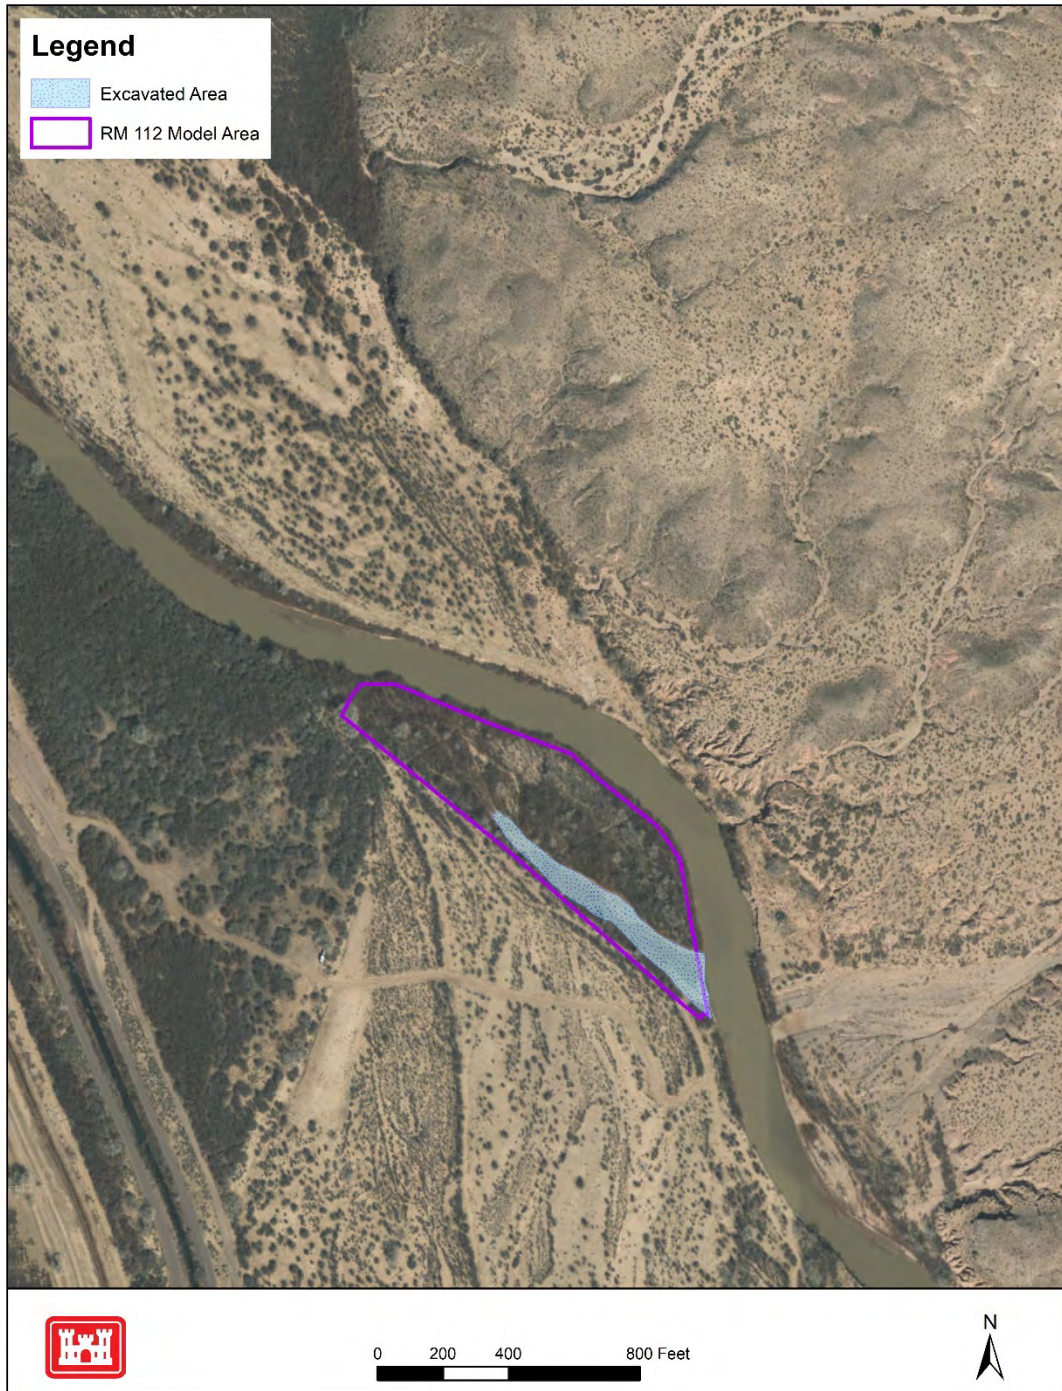
**Figure 66. Extents of the 2D model area (evaluated as the adjacent floodplain or “terrace”) and the RM 112 excavated area (HR site).**

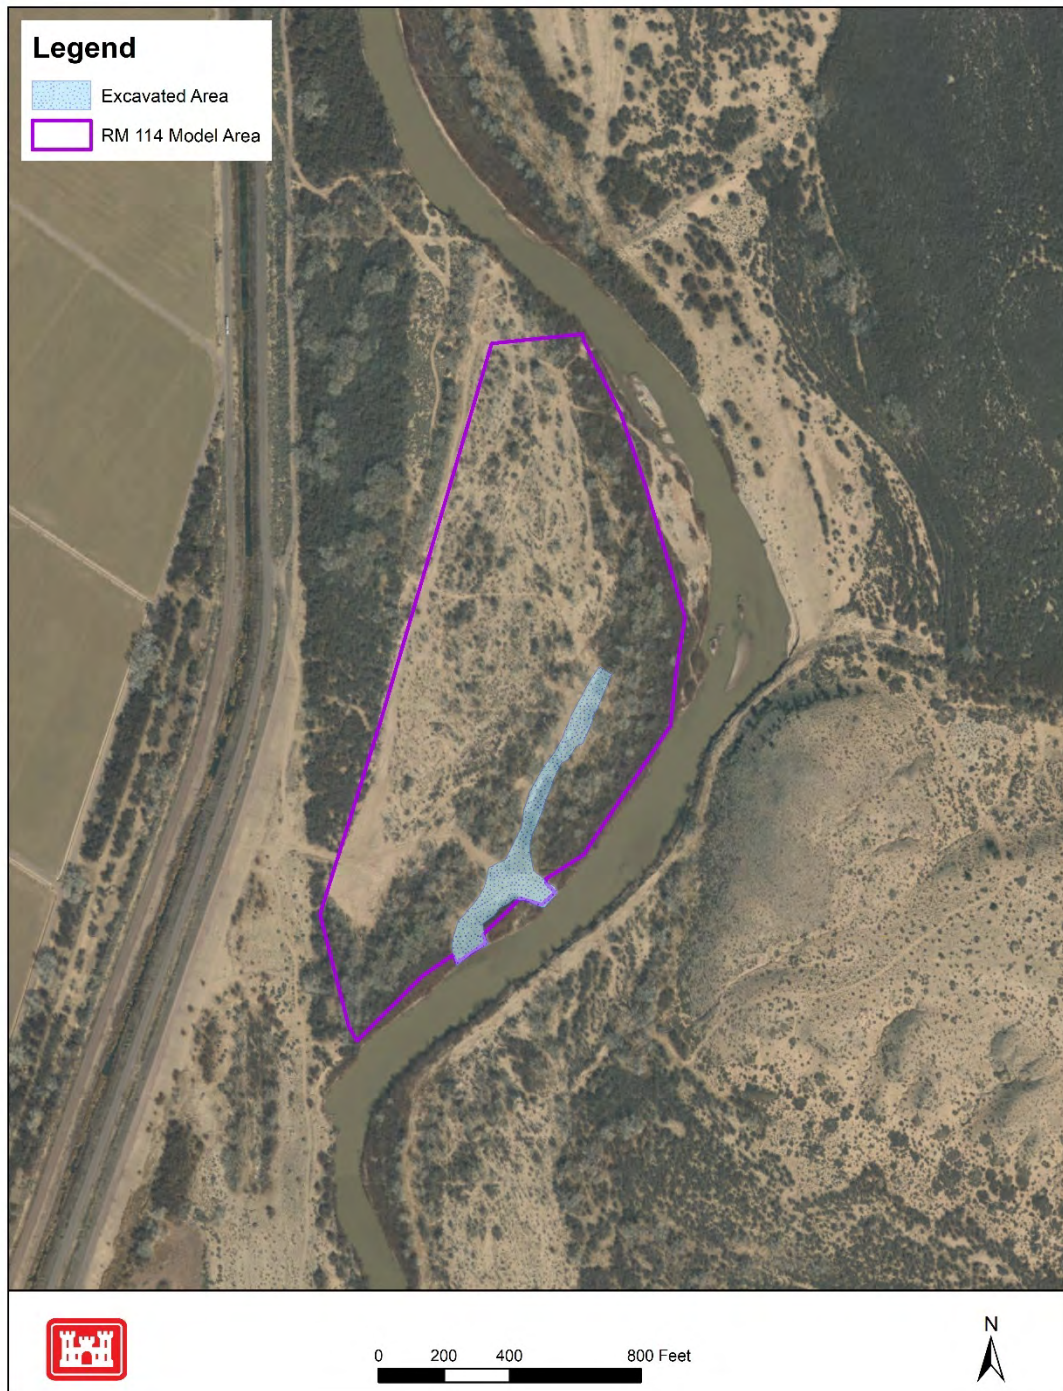
**Figure 67. Extents of the 2D model area (evaluated as the adjacent floodplain or “terrace”) and the RM 114 excavated area (HR site).**
