Low Intensity Monitoring 2010 Water Year

MRGESCP Monitoring Plan Team

March 11, 2011

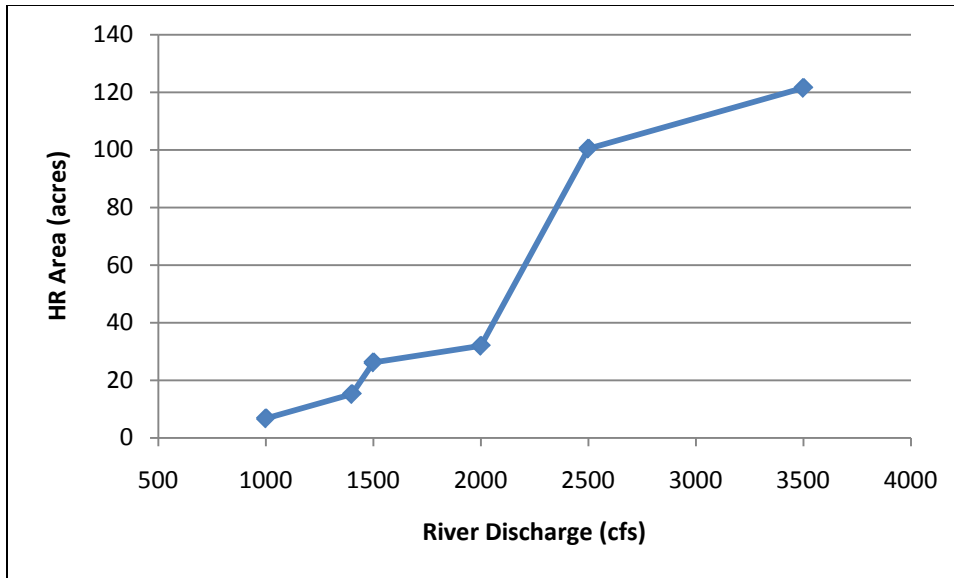
Figure 1. Projected cumulative inundation curve for Program habitat restoration (HR) sites within the MRG determined from project-specific target inundations and acreages.

For each of the 20 study areas monitored in 2010, inundation evaluation used hydrograph data to estimate the area and duration of inundation at different flood stages. Inundation evaluation is a MRG-scale analysis of the extent and duration of inundation on HR sites designed as floodplain habitats. It is assumed that the first order definition of floodplain habitat as it pertains to these Program projects is the periodic inundation of land surfaces adjacent to the active river channel. As such, this analysis evaluates the proof of concept that lowering pre-existing land surface elevations results in the creation of floodplain habitat and since both extent and duration of inundation are theoretically important in the function of floodplain, this analysis provides a basic indication as to the potential function of the combination of all Program projects in area inundated (acres) per unit time (days). This concept is referred to as “acre/days” in this analysis and is the MPT’s current metric for evaluation first order project effectiveness. Figure 1 presents the total area of Program-funded HR projects that will be inundated at a given river discharge.

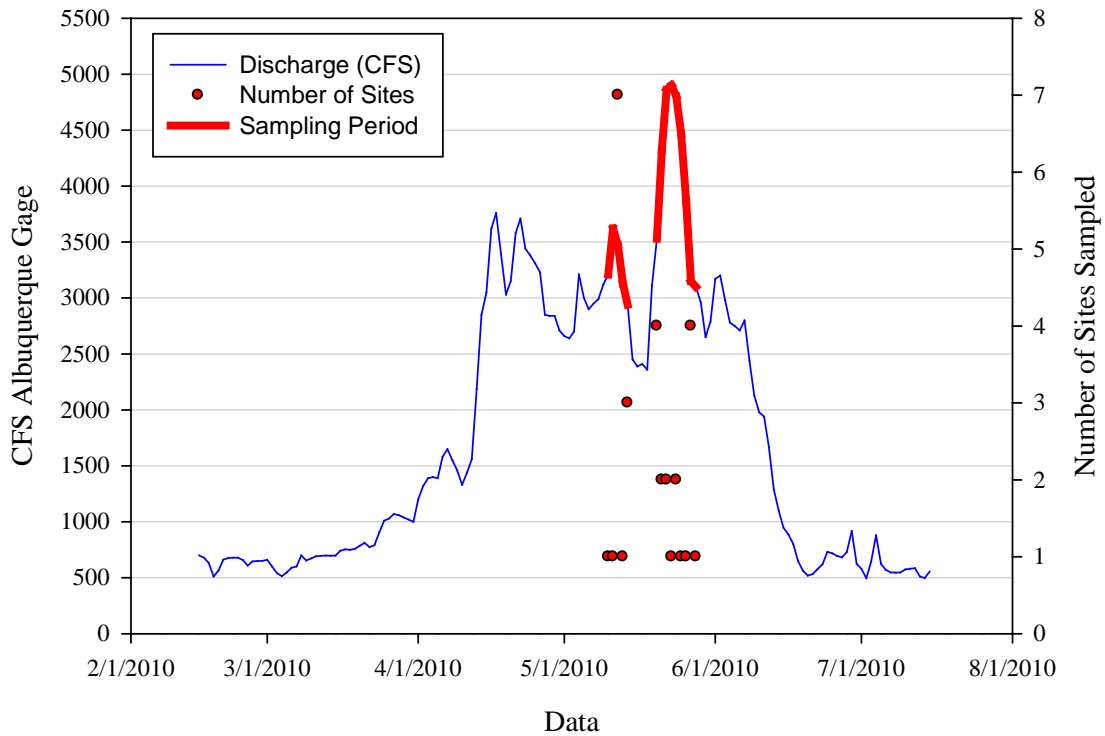
Figure 5. Spring hydrograph for Central Avenue Gage (USGS 08330000, Albuquerque, NM) and silvery minnow sampling dates for habitat restoration sites.

Sampling was initiated approximately “mid-peak” and conducted into the tail off of the spring runoff hydrograph (Figure 5). Most sites were sampled while the discharge was above the target flow for the habitat site though a few samples were taken below target inundation levels in adjacent habitats.

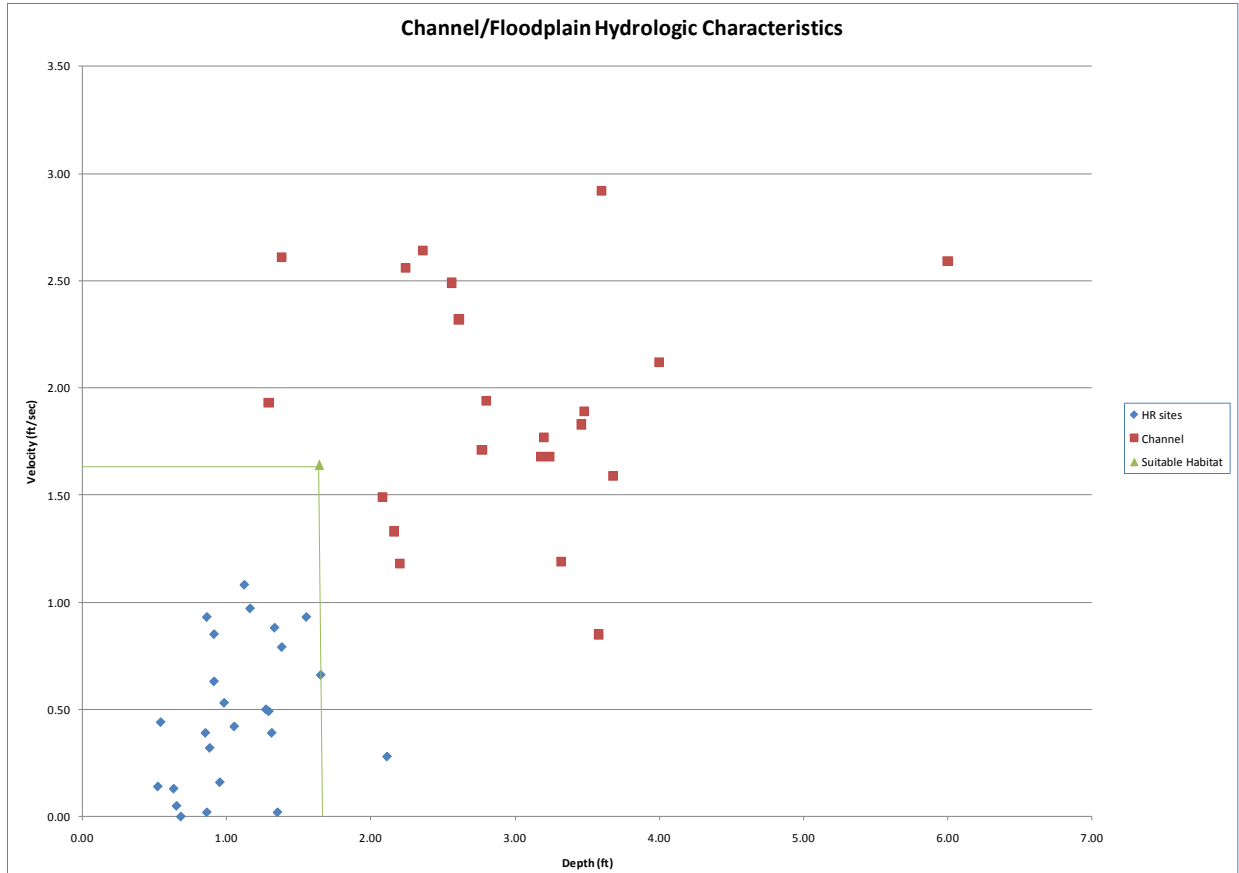
Figure 7. Scatter plot of site specific and adjacent channel average velocity and depth measurements with established suitable habitat boundaries included.

Hydrological characterization of habitat conditions on HR sites was conducted on 13 of the 20 representative sites and included 29 individual monitoring transects. Results for site specific average water depths and velocities on floodplain HR project sites ranged from 0.52-2.11 ft and 0.00-1.19 ft/sec respectively. Taken as a whole across all representative sites and monitored flow conditions, the average water depth of HR sites was 1.08 ft and the average water velocity was 0.53 ft/sec. For 23 of the 29 monitoring transects, adjacent active river channel conditions were also monitored resulting in the ability to compare these two distinct habitat types. HR and adjacent river channel averages plot relatively neatly in two distinct clusters as shown in Figure 7 with HR conditions consistently within the range of both variables of suitable habitat conditions and adjacent river channel conditions consistently falling outside these ranges. Comparing to the HR site averages above, the average conditions in the adjacent river channel across all monitored flow conditions were a depth of 2.95 ft and velocity of 1.87 ft/sec, an overall increase in average depth of 1.87 ft and an overall increase in average velocity of 1.35 ft/sec.

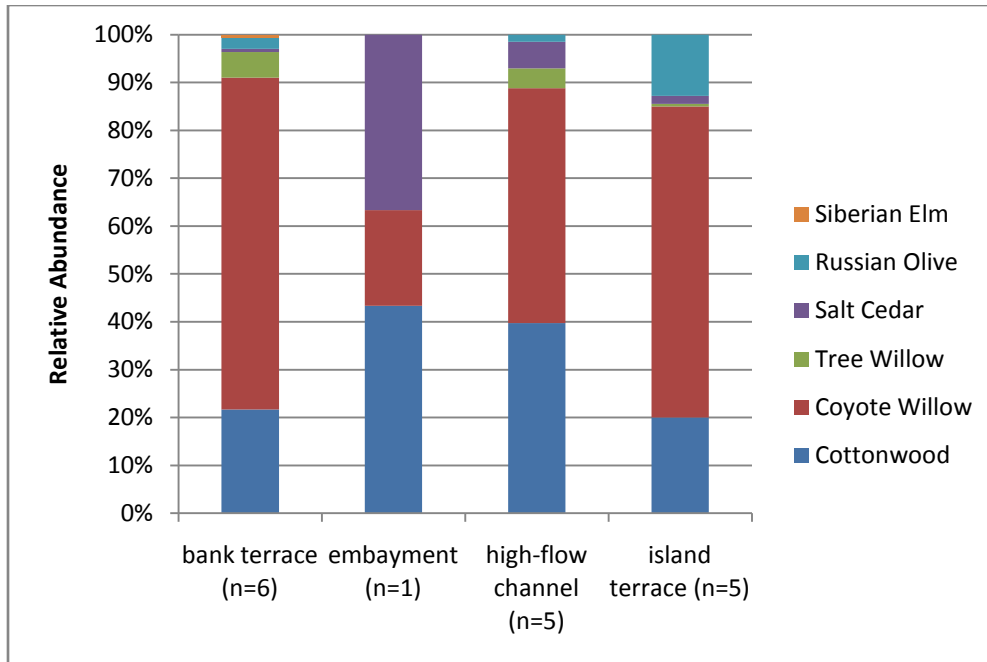
Figure 8. Relative abundance of woody species by habitat restoration feature type.

Seventeen of the 20 HR sites were surveyed for woody vegetation and digitized patch maps are presented in Appendix D. A total of 46 vegetation type patches were identified (totaling 289,000 m² or 71.4 acres) and only two lacked woody species. Each HR site contained between one and six different vegetation type patches that ranged from approximately 300 to 63,000 m² (0.07 to 15.5 acres) in size. All maps are presented in Appendix E. Native vegetation dominated sites sampled (Figure 8). Coyote willow was the dominant woody species (encountered in 41 of the 46 patches) and had a mean relative abundance of 64%. Because only the relative abundance of each woody species was noted, but not the absolute density of species, it is not possible to quantify in absolute terms the amount of each woody species present at HR sites.
