# 2020 Annual Monitoring Results and Maintenance Plan for San Acacia Reach Restoration Sites

*Prepared for:*  
New Mexico Interstate Stream Commission  
5550 San Antonio  
Albuquerque, New Mexico 87109

*Prepared by:*  
GeoSystems Analysis, Inc.  
6300 Riverside Plaza Lane NW  
Ste. 100/PMB 1019  
Albuquerque, NM 87120  
[www.gsanalysis.com](http://www.gsanalysis.com)

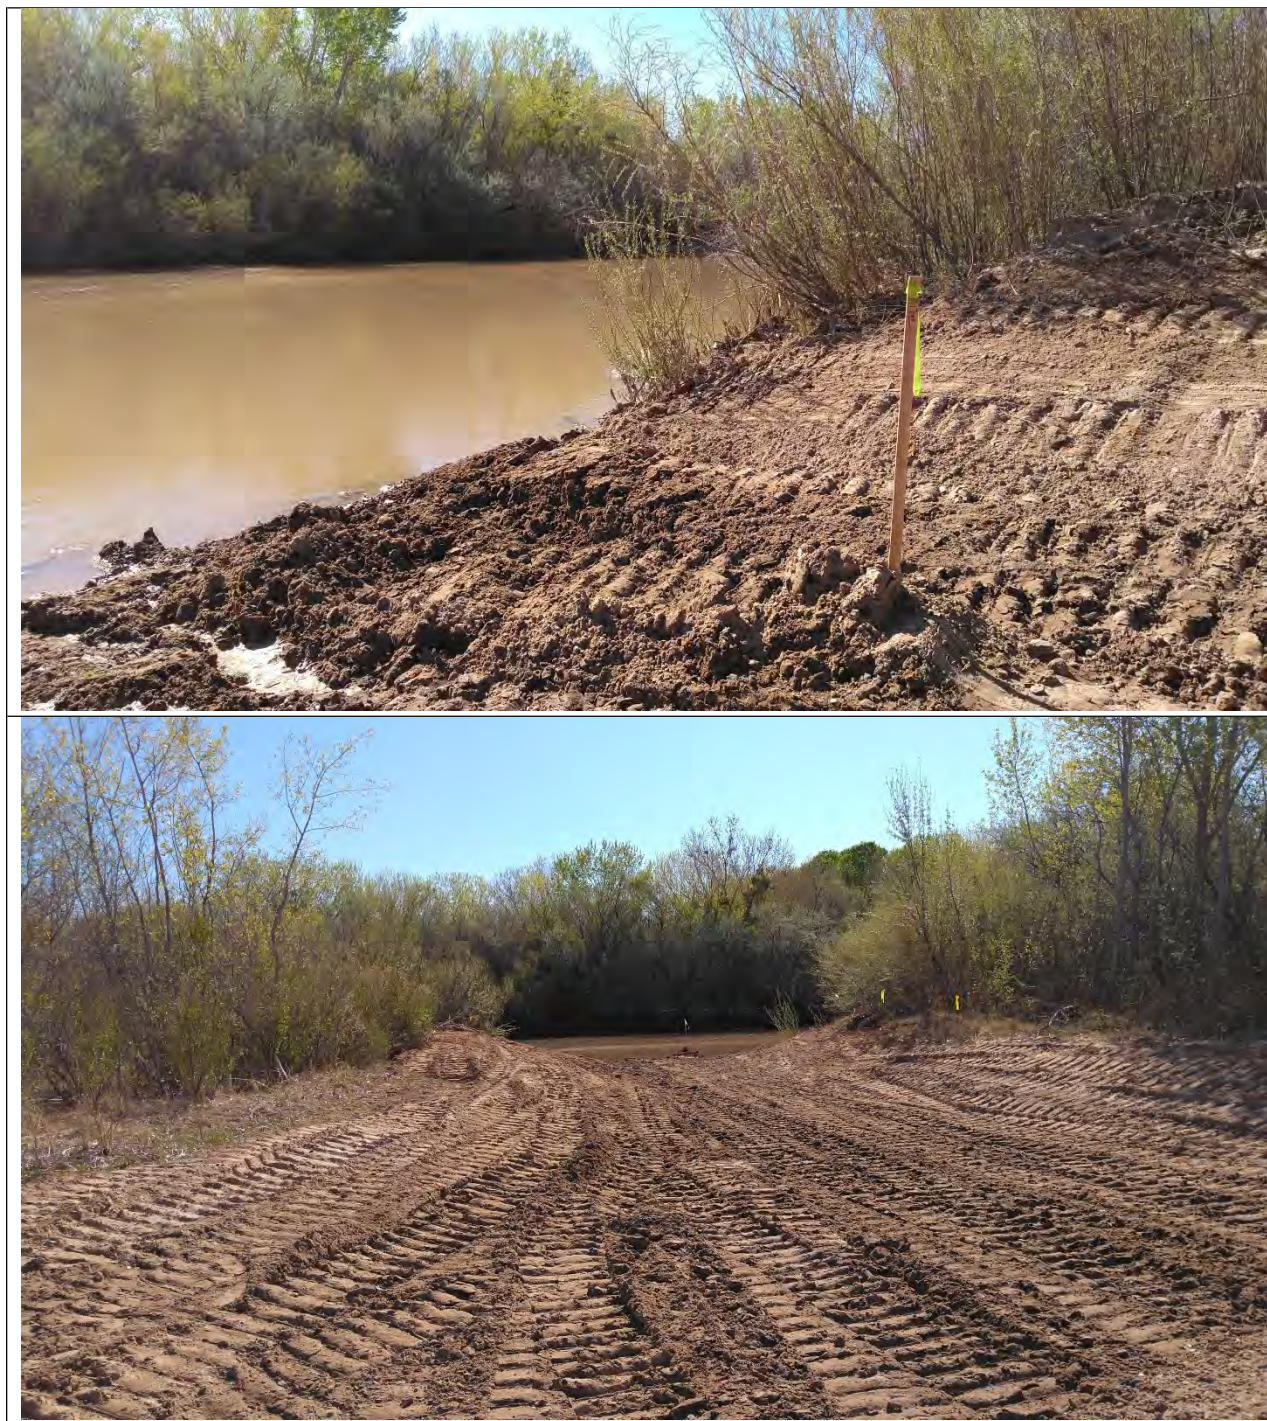
Figure 5. Representative photos of sediment removal within channel maintenance zones. These photographs were taken immediately after sediment removal at RM 100.5

Given the dry conditions spring and summer months of 2020, no additional sediment removal will be required prior to 2021 snowmelt runoff.

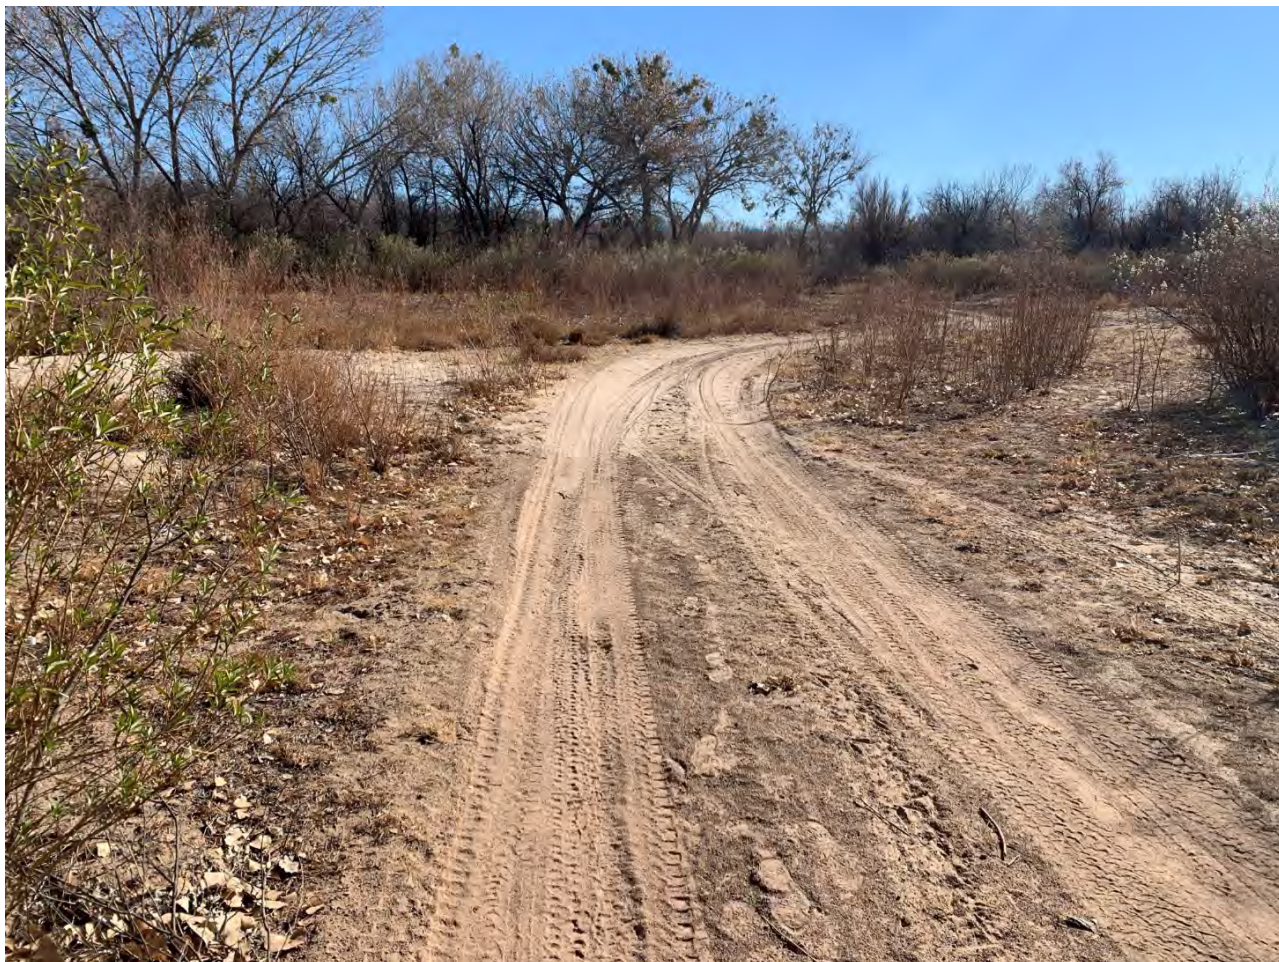
Apart from RM 93, off-road four-wheel drive vehicles (to include both trucks and all-terrain vehicles) continue to utilize the inlets at most project sites as river access locations for fishing and recreating. The vehicles are creating varying degrees of ground disturbance that create topographic depressions, alter drainage patterns, and destroy or damage young native vegetation. Most of the inlets (e.g. sites RM 114, 112, 100.5, 100, 99.5) now have well-established two-track roads to the bank of the river. In some locations (e.g., RM 100) the topographic depressions are significant and have potential to promote ponding and fish entrapment following flow recession. We recommend the project adaptive management team discuss potential opportunities to restrict trespass vehicle entry into the various project sites.

Figure 6. Well used two track road through the RM 99.5 site. Most of the features now have similar heavily used roads down to the river.

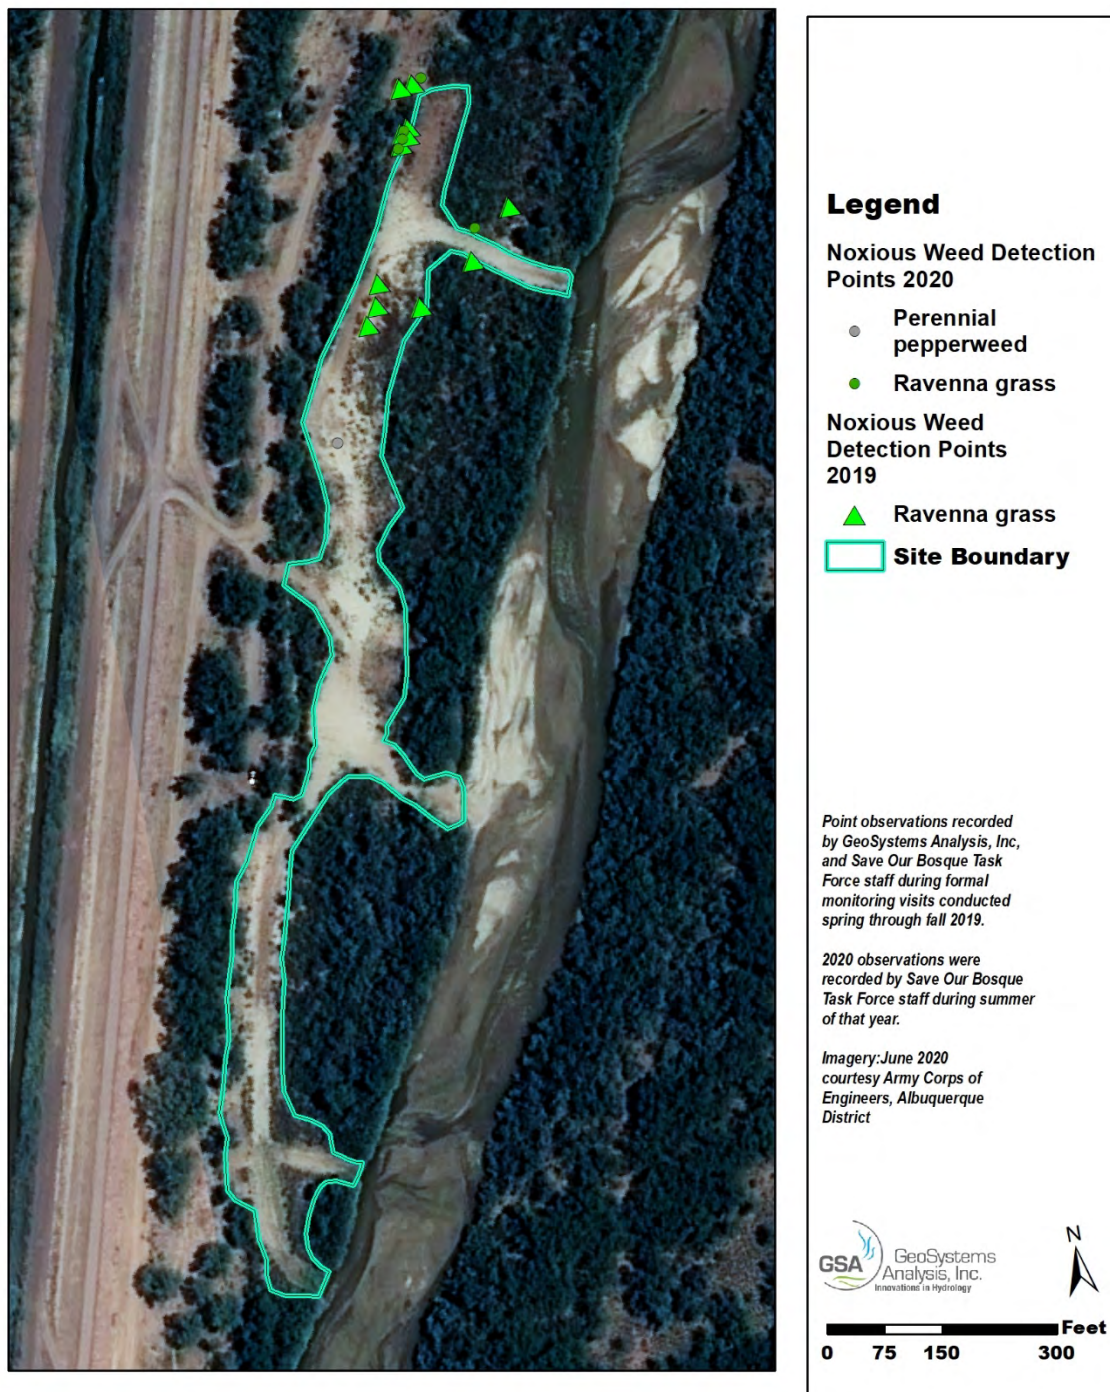
**Noxious Weed Detections through August 2020:  
Site RM 99.5**

Figure A-2. Noxious weed species populations documented at RM 99.5.

Additional herbicide applications are recommended in spring/summer 2021 for treating perennial pepperweed and Russian knapweed. Ravenna grass plants identified at RM 99.5 and RM 93 should be removed using shovels. **Tables 9** summarize treatment approach, timing, and location for noxious weeds. Maps showing location of noxious weed species detections are provided in **Appendix A**.

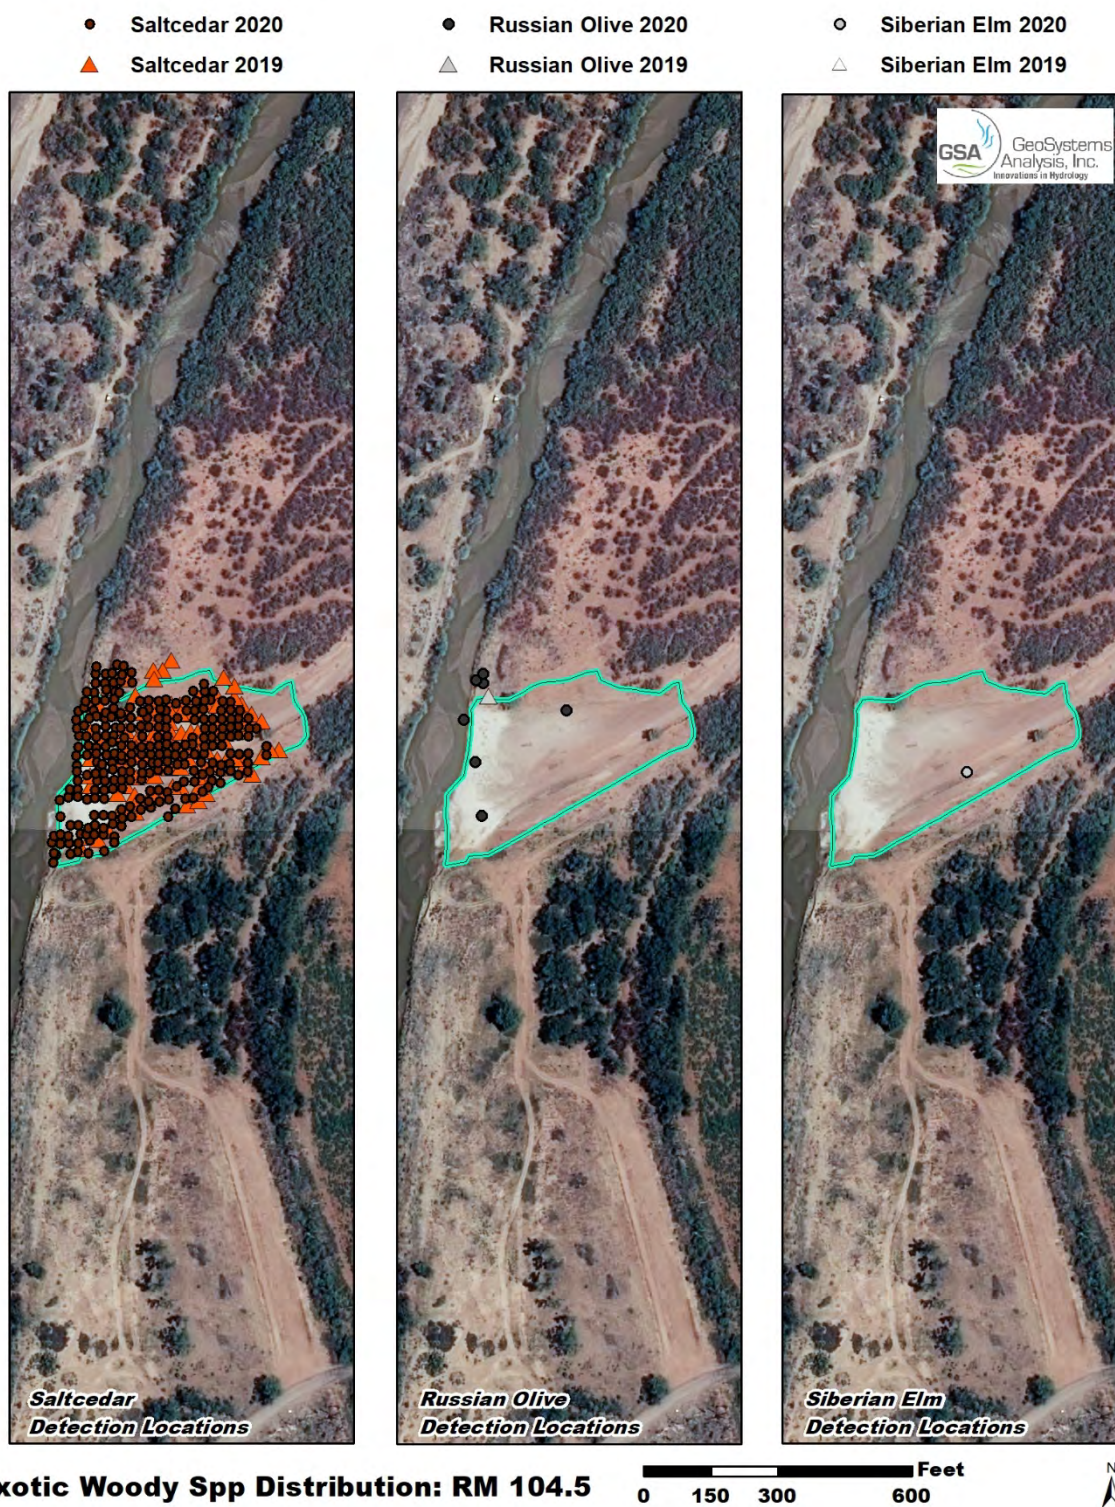
Figure D-3. Distribution of non-native saltcedar (left), Russian olive (center) and Siberian elm (right) plants recorded in 2019 and 2020 at RM 104.5.

Herbicide applications will be required for treating Russian olive and saltcedar plants documented at all project sites. All non-native woody plants should be treated using a cut-stump or foliar herbicide treatment of an aquatic approved herbicide such as Habitat (active ingredient imazapyr) or Rodeo, AquaMaster (active ingredient glyphosate). We recommend that cut stump application be used on individuals with greater than one-inch basal stem diameter (bsd) and could be implemented year-round (as allowable per environmental compliance guidelines). A July-September foliar application is recommended for smaller individuals (i.e. seedlings with <1 inch bsd). An SOP for implementing and documenting non-native plant control treatments is provided in **Appendix E**.
