2017 RiverEyes Monitoring Report

Prepared for:
US Bureau of Reclamation,
Albuquerque Area Office
555 Broadway NE, Suite 100
Albuquerque, NM 87102

Prepared by:
GeoSystems Analysis
3150 Carlisle Blvd. NE,
Albuquerque, NM
87110
www.gsanalysis.com

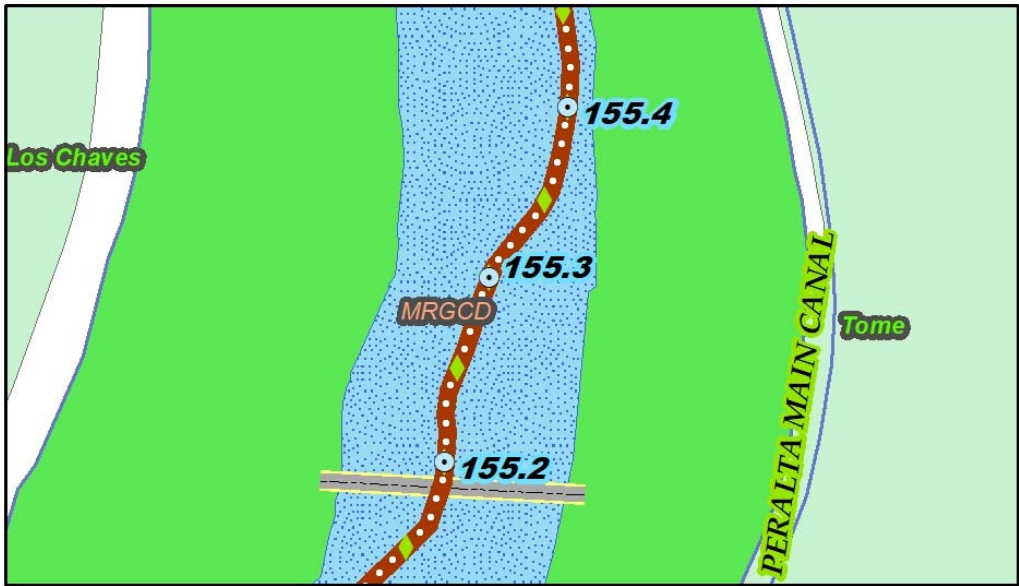
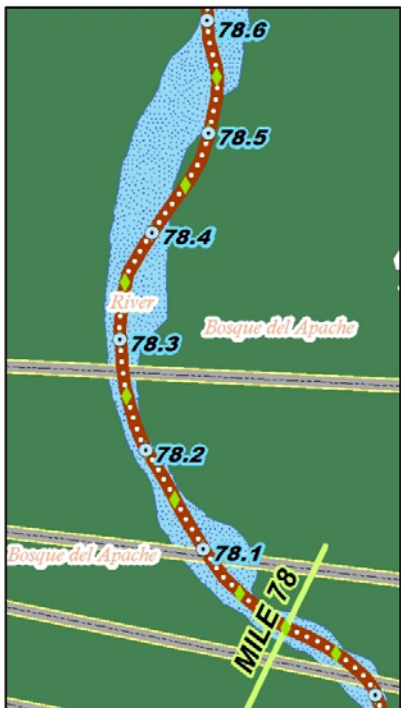
Figure 2. Sample RiverEyes field maps from the 2017 monitoring season. Maps were spatially-referenced electronic files that could be used to precisely determine a field location to the nearest 0.01 river mile.

Reconnaissance observations were documented in the field on an iPad tablet with a Bluetooth connection to a Garmin Glo Global Positioning System (GPS) to improve locational accuracy (consistently ~5-foot accuracy) over the iPad's GPS chip. River mile proximity was determined to the nearest 0.01 of a mile using a spatially-referenced .pdf file opened in the Avenza Maps app (<https://www.avenza.com/avenza-maps/>). To enable placement to this precision, we segmented the 2012 USBR RM Geographic Information System (GIS) file into symbolized half-mile, tenths, and hundredths of a mile on the electronic field map (Figure 2).

River segments with a historically high probability for drying were denoted on the map with a red-colored river centerline to assist field staff with targeting "hot spots" to check during intermittent periods. The map also enabled field staff to see adjacent land ownership,

irrigation infrastructure, flow metering priorities, municipalities, arroyos, USBR range lines, roads, etc. Locating nearby range lines was especially important when surveying by foot because dense vegetation was recently cleared along the cross-sections from the levee to river.
