## ***2018 RiverEyes Monitoring Report***

*Prepared for:*  
*US Bureau of Reclamation,*  
*Albuquerque Area Office*  
*555 Broadway NE, Suite 100*  
*Albuquerque, NM 87102*

*Prepared by:*  
*GeoSystems Analysis*  
*3150 Carlisle Blvd. NE, Suite 203*  
*Albuquerque, NM 87110*  
*[www.gsanalysis.com](http://www.gsanalysis.com)*

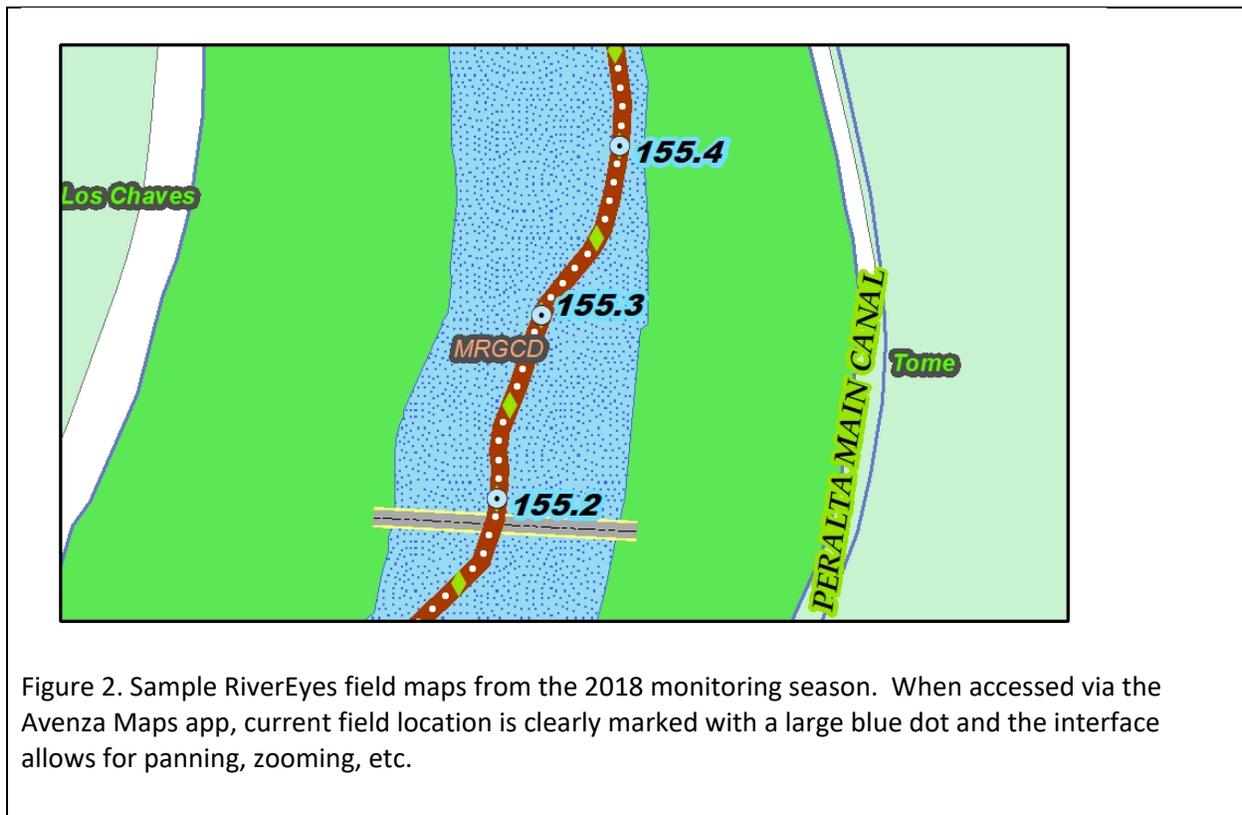
Reconnaissance observations were documented in the field on an iPad tablet connected with a Bluetooth Global Positioning System (GPS; Garmin Glo, consistently ~5-foot accuracy). Field proximity was determined to the nearest 0.01 river mile using a spatially-referenced .pdf base map accessed via Avenza Maps (<https://www.avenza.com/avenza-maps/>). To enable placement to this precision, we utilized various utilities and addons to ESRI ArcMap to clean and re-segment the 2012 Reclamation RM Geographic Information System (GIS) file into symbolized half-mile, tenths, and hundredths of a mile on the electronic field map (Figure 2).

Field crews recorded daily field observations into a customized mobile app specially developed for storing RiverEyes data. All field observations were registered with underlying GPS coordinates (automatically marked by the app), as well as the nearest 0.01 RM, which was keyed in by the field observer. At times, the crew also drove the intermittent riverbed segment to check for presence of remnant pools, if the bed was navigable, but determining the dry length was the main priority each day.
