2019 RiverEyes Monitoring Report

Prepared for:
US Bureau of Reclamation,
Albuquerque Area Office
555 Broadway NE, Suite 100
Albuquerque, NM 87102

Prepared by:
GeoSystems Analysis
3150 Carlisle Blvd. NE, Suite 203
Albuquerque, NM 87110
www.gsanalysis.com

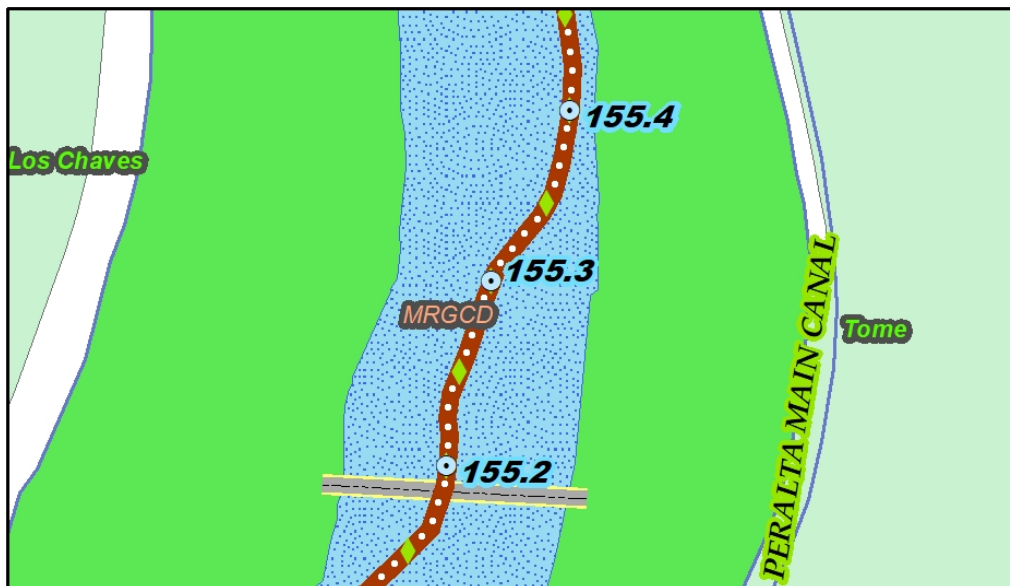
Figure 2. Sample RiverEyes field maps from the 2019 monitoring season. When accessed via the Avenza Maps app, current field location is clearly marked with a large blue dot and the interface allows for panning, zooming, etc.

Field observations were documented on an iPad tablet connected to a Bluetooth Global Positioning System (GPS; Garmin Glo, consistently ~10-foot accuracy). Field proximity was determined to the nearest 0.01 river mile using a spatially referenced .pdf base map accessed via Avenza Maps (<https://www.avenza.com/avenza-maps/>). To enable placement to this precision, various utilities and addons to ESRI ArcMap were utilized to clean and re-segment the 2012 Reclamation RM Geographic Information System (GIS) file into half-mile, tenths, and hundredths of a mile symbols on the electronic field map (Figure 2).

River segments with a historically high drying probability were denoted on the electronic field map with a red-colored river centerline to assist field staff with targeting “hot spots” to check during low flow conditions. The map also displayed adjacent land ownership, irrigation

infrastructure, landmarks, wasteways, interior drains, municipalities, arroyos, rangelines, roads, streamflow gages, important river access locations, etc. Locating nearby rangelines (Reclamation's long-term hydrographic survey cross-sections) was especially important when surveying by foot because dense vegetation may have been recently cleared along the rangeline from the levee to river, which improved accessibility.
