Los Lunas Habitat Restoration

17 Years of Monitoring

Los Lunas Restoration Site

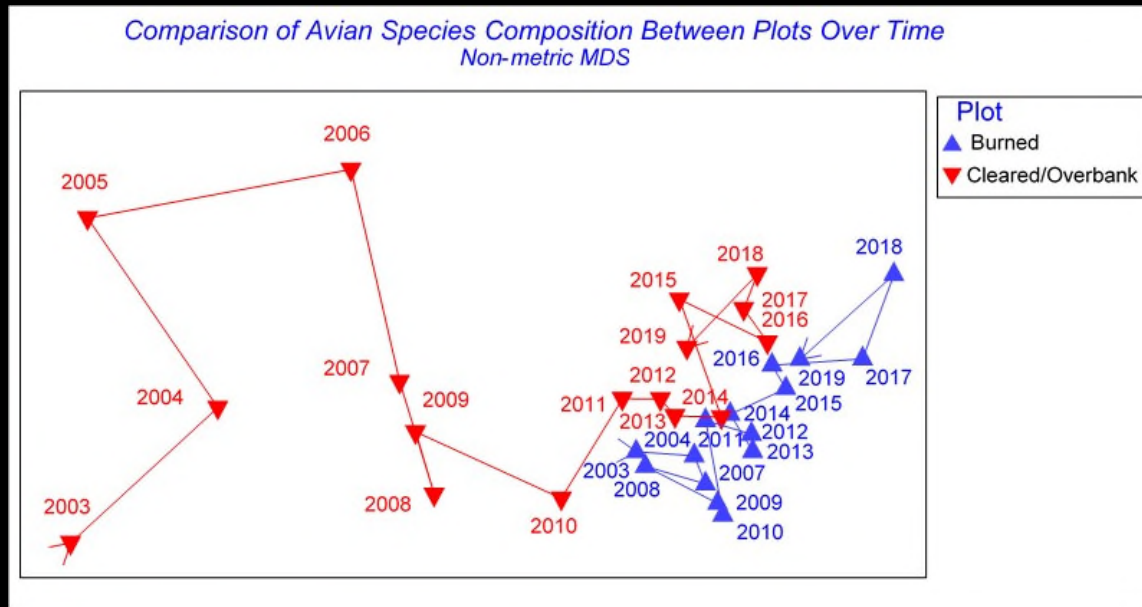
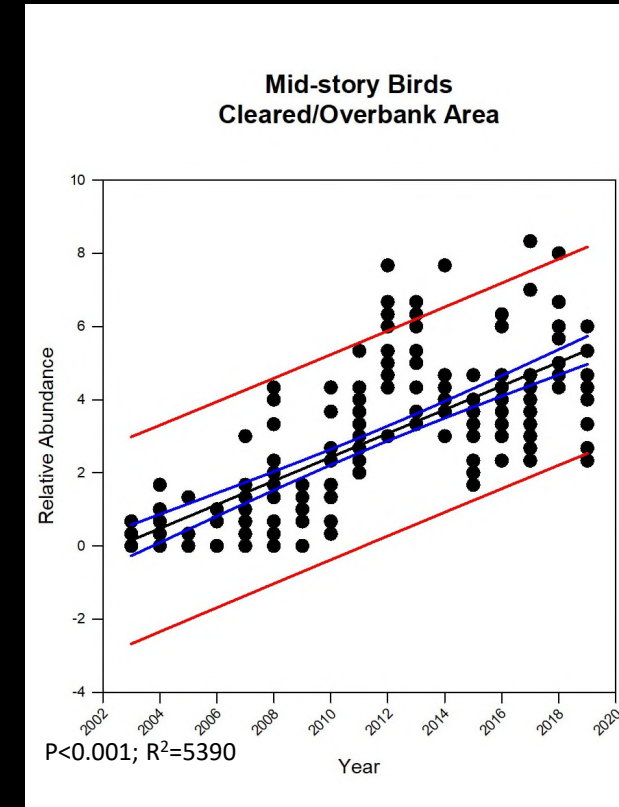
Avian Point Counts

- There was a moderately strong relationship between relative abundance of Midstory birds and time in Cleared/Overbank Area
- When comparing species composition, avian community in Cleared/Overbank Area became similar to Burned Area in 2012

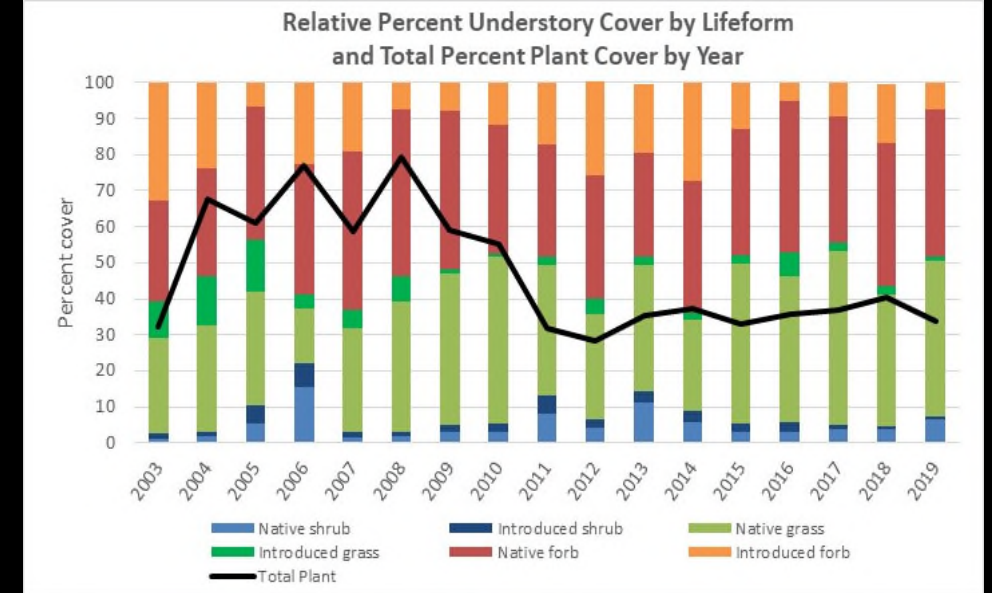
Understory

- Plant cover significantly higher 2004-2010 than other years
- Native grasses and forbs were dominant lifeforms over study period

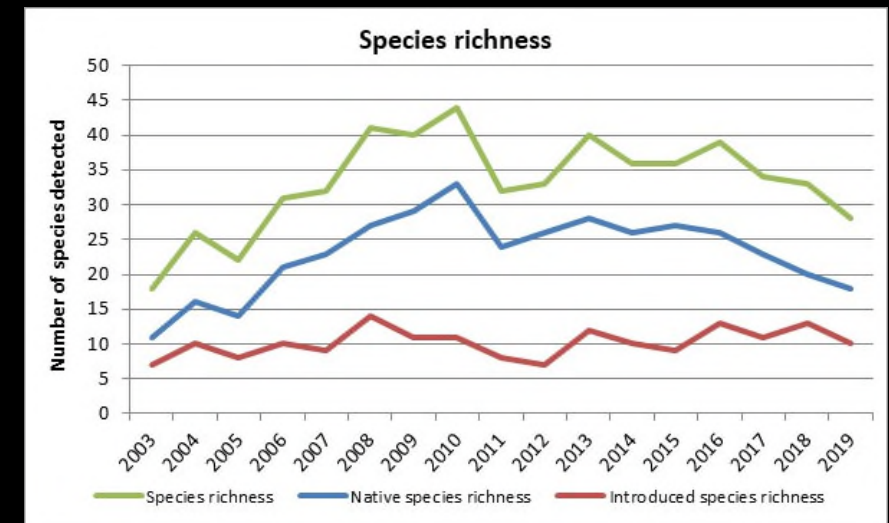
Species richness

- 82 plant species detected in both under and overstory throughout monitoring period

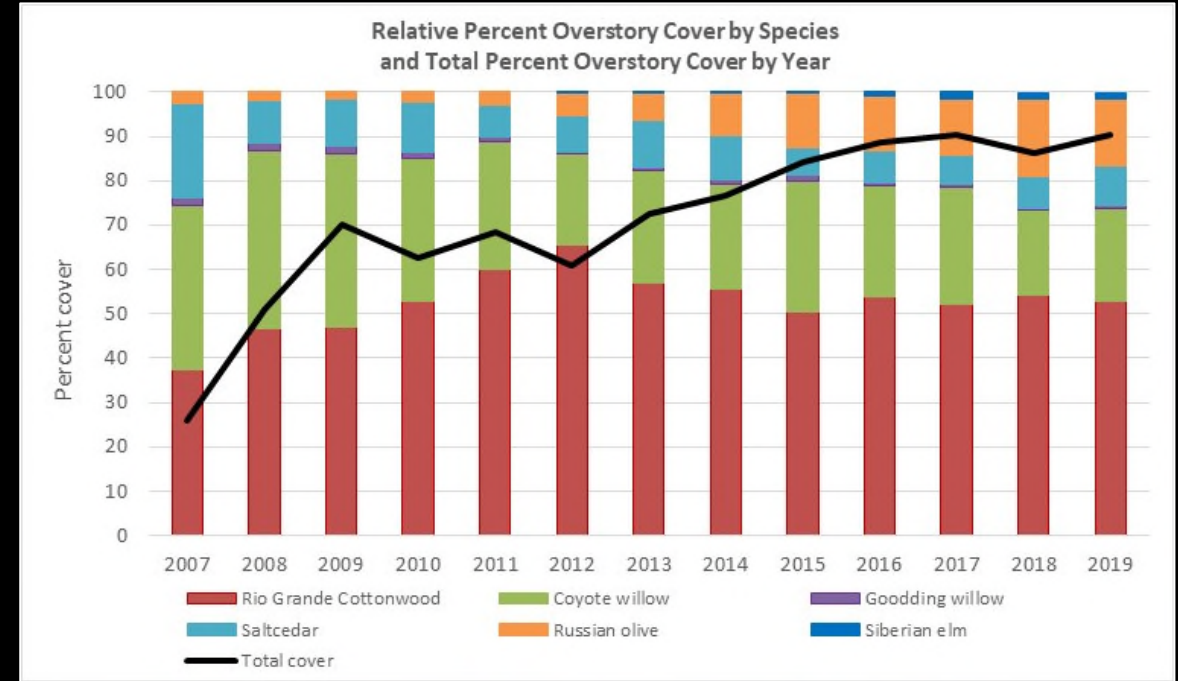
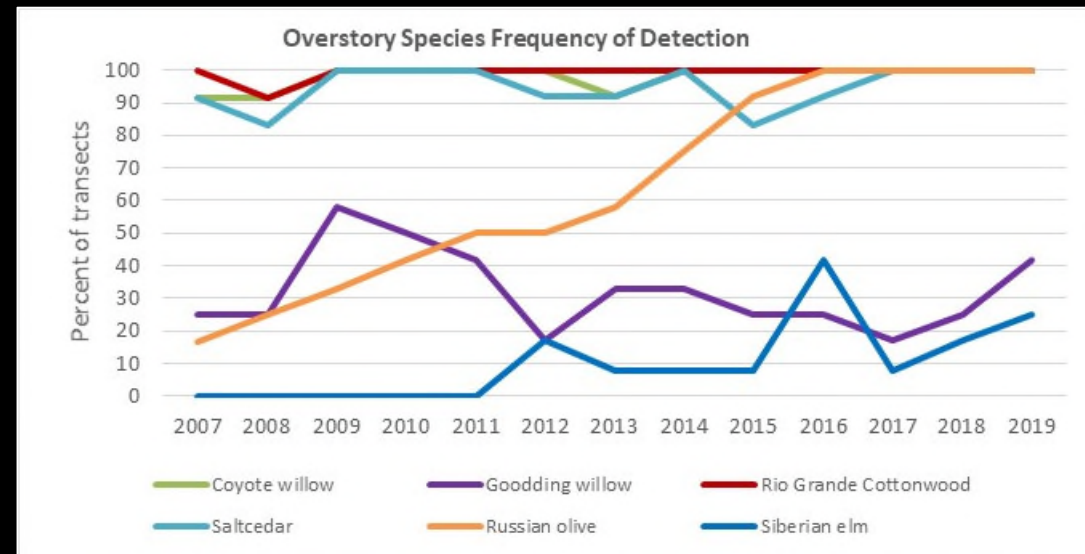
Overstory Vegetation

- Overstory cover significantly increased since 2007
- Cottonwood and coyote willow dominant based on cover

- Cottonwood, coyote willow, and saltcedar have been detected in most plots since 2007
- Russian olive was found in 17% of plots in 2007 and in 100% of plots by 2016

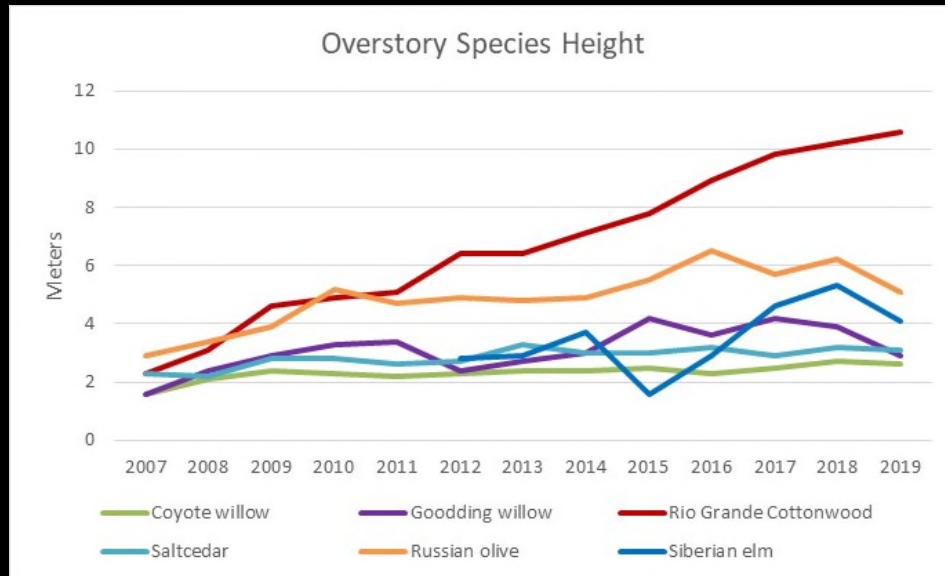
Woody species composition

- Highest similarities in the woody species composition from about 2013 through 2019
- Saltcedar cover has increased less than other species

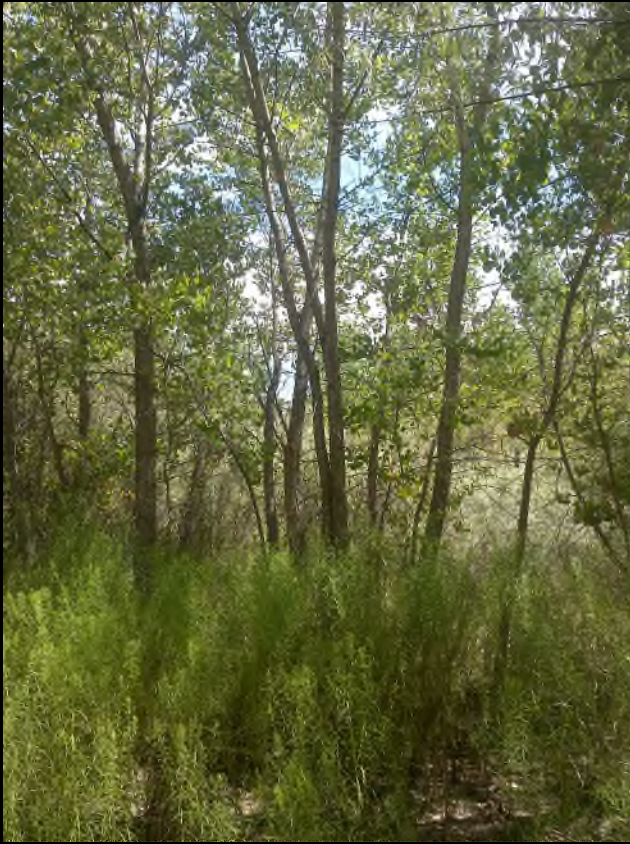
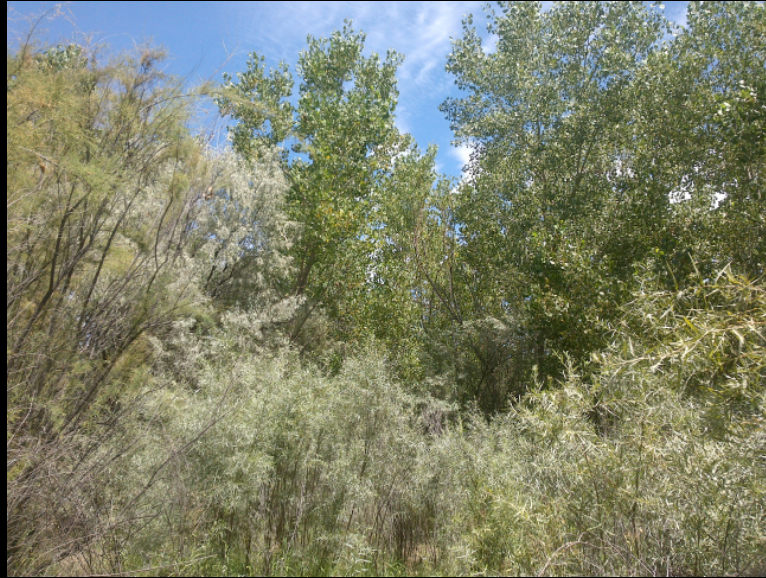
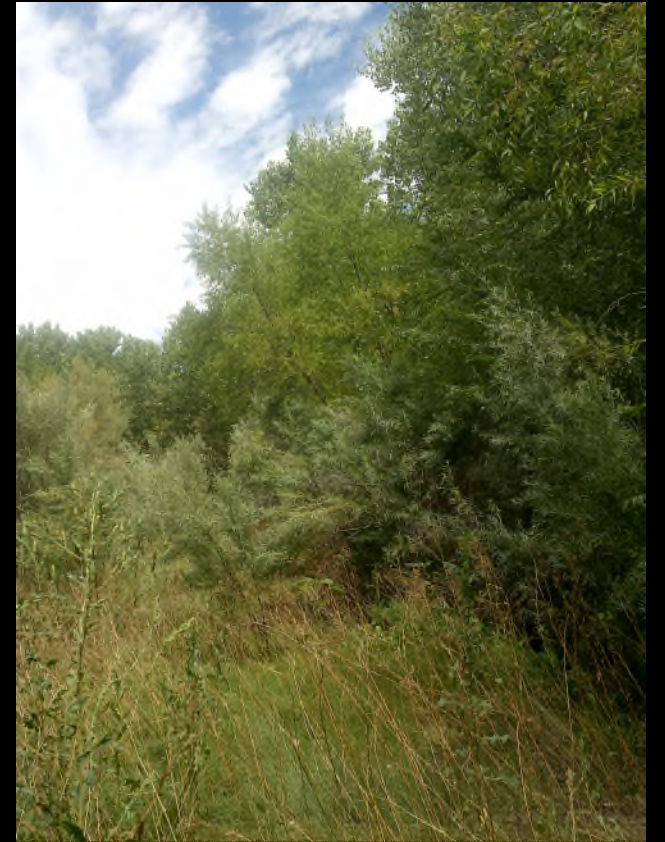
Overstory Height by Species

- Cottonwood has grown to > 10 m

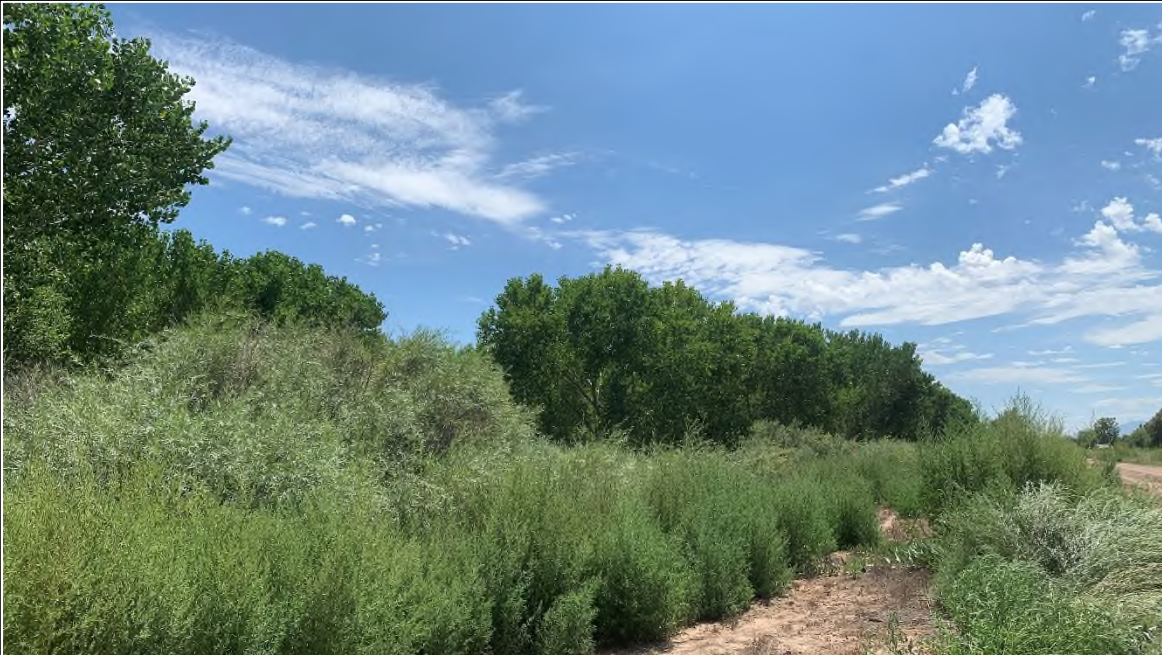
Cottonwood poles planted along west side of project

- 54 % of potted mixed shrubs survived from 2005 to 2006 (n=160)
 - New Mexico olive and Gooddings willow most successful
- 38 % of Cottonwood poles survived from 2005 to 2006 (n=47)
 - Root sprouts most successful

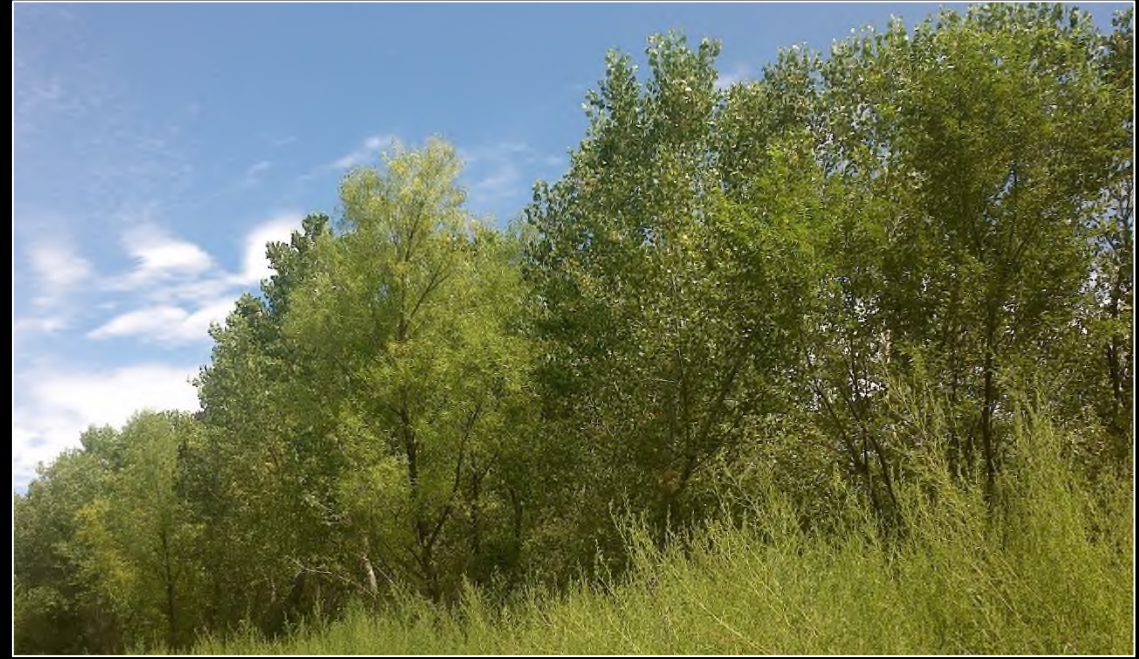
Goodding's willow planted just east of rootwad berm matured to create a willow and cottonwood stand

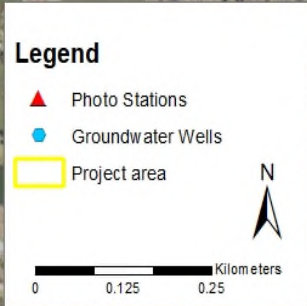
Los Lunas Restoration Site Groundwater Well and Photo Station Locations

- 9 shallow groundwater wells
 - 3 across North, Middle, and South sections of project area
 - Depths averaged 5 ft
 - HOBO loggers installed in 2011

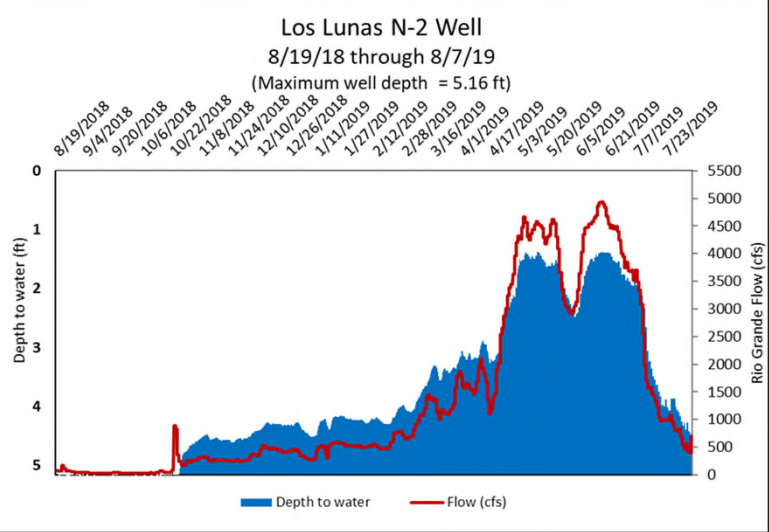
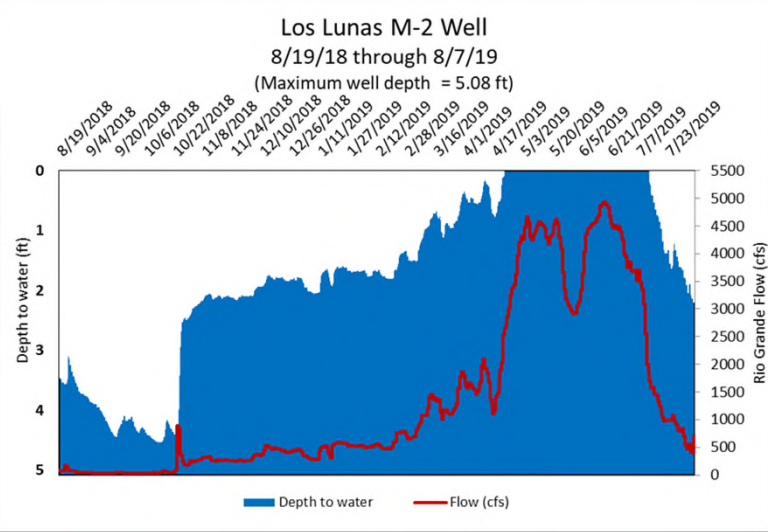
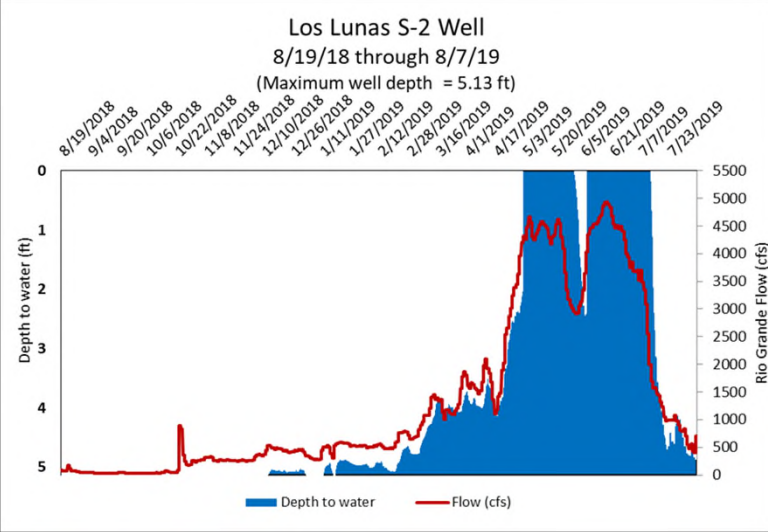
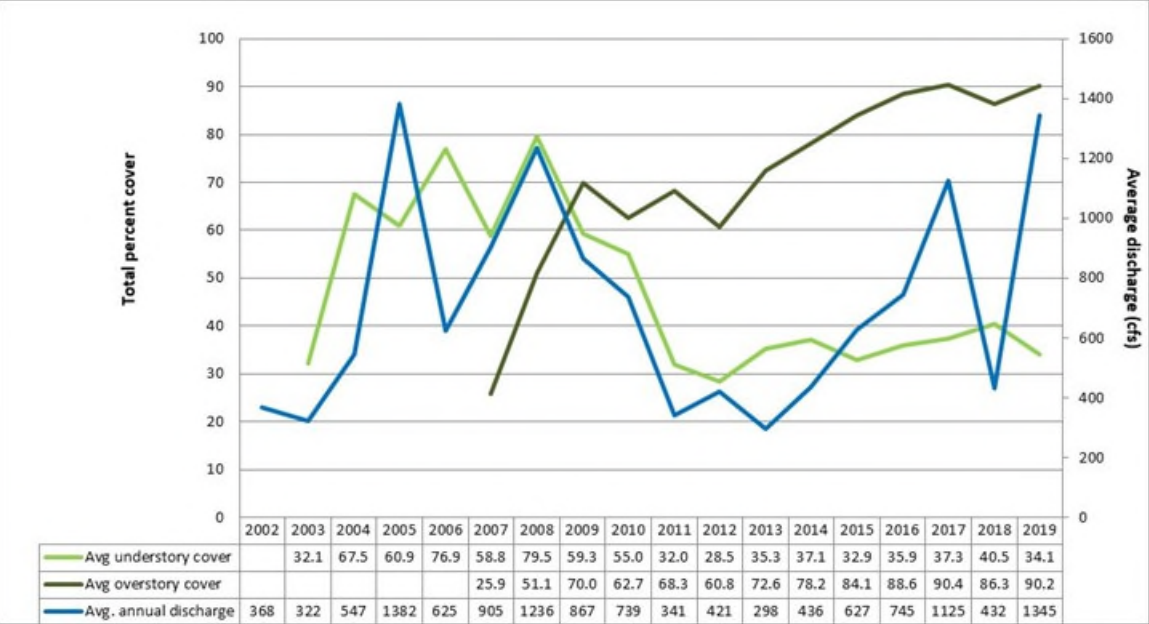
Groundwater Wells

- Water table levels have been closely linked to river flows, indicating connectivity
- Groundwater is shallow enough to support recruitment and establishment of cottonwood and willow stands
