Middle Rio Grande
Endangered Species Collaborative Program

Restoration Analysis and Recommendations for the Isleta Reach of the Middle Rio Grande, NM

**Middle Rio Grande
Endangered Species Collaborative Program**

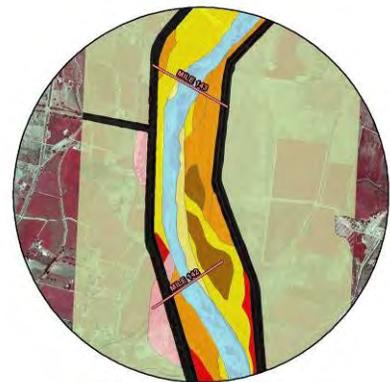
Surficial geology map at RM 142. Unfortunately, this dataset was not useful for determining the soil salinity of the various surficial geologic features.

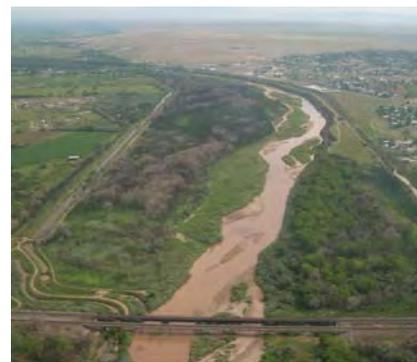
*Belen burn site which burned in spring 2007. Photo taken facing northeast.
(Photo Credit: Parametrix)*

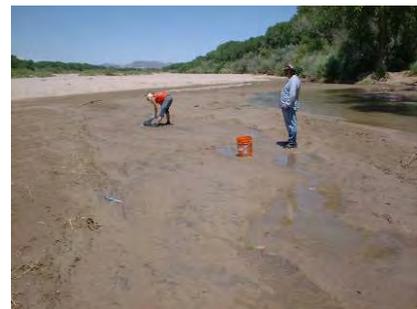
Drying channel.
(Photo Credit: Michael Hatch)

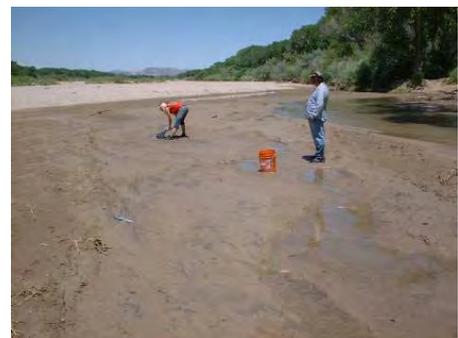
*Photo of dry channel near Bosque del Apache.
(Photo Credit: Michael Hatch)*

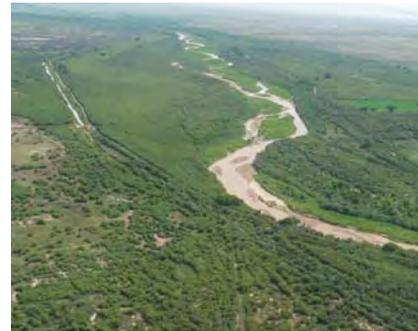
Looking northeast at RM 128 and RM 129, it is possible to see the large number of vegetated bars and islands. (Photo Credit: Parametrix)

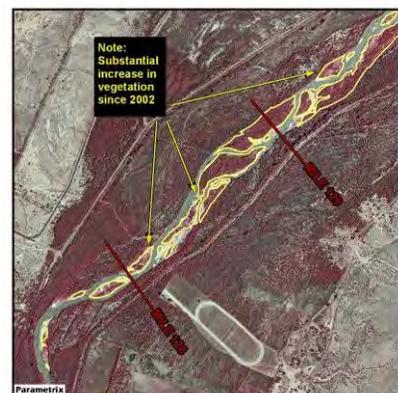
Vegetated channel bars and islands at RM 128 in June 2006.

The decrease in the active channel width in the Isleta Reach is widespread. Program projects funded to enhance aquatic habitat should strongly consider approaches that expand and sustain the active channel within targeted project segments. The recommended restoration techniques were selected to improve both “reach-wide” fluvial processes and to promote site-specific habitat enhancements. We suggest that this combined restoration approach has greater potential for realizing short-term and long-term habitat benefits than either approach alone. Success of these techniques requires rigorous monitoring and a commitment by the Program for adaptive management (see Chapter 6). Monitoring is critical for evaluating if project objectives have been achieved and to inform follow-up maintenance requirements. Maintenance could be in the form of periodic mechanical treatments or could involve implementing managed flows to maintain the active channel.

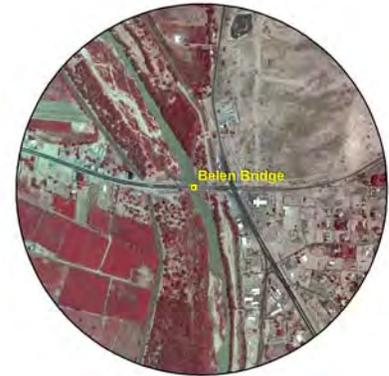
Example of constricted channel segment immediately upstream and downstream of the Belen Bridge. Areas like this are excluded from bar destabilization and lowering treatments to avoid negative impacts to the bridges.

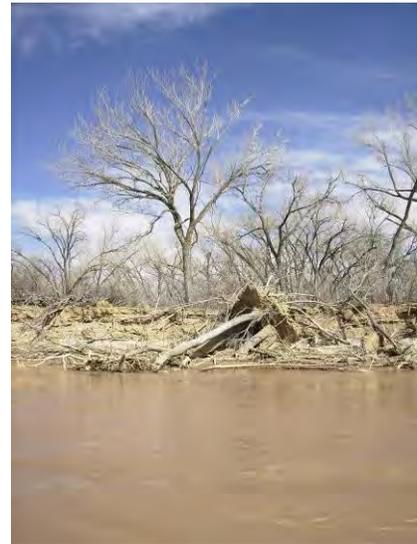
Photo showing bank erosion and cottonwood trees falling into the river near RM 102 in the San Acacia Reach. Bank-line destabilization treatments are recommended to achieve this result in select locations within the Isleta Reach (Photo Credit: Parametrix)

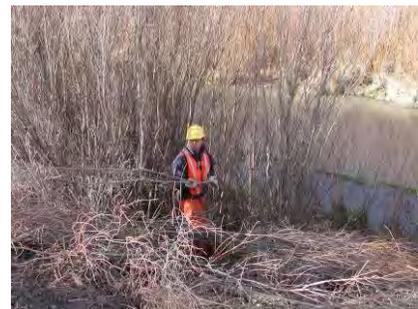
Coyote willow plants were harvested from the Low Flow Conveyance Channel for previous willow-swale restoration projects at the Pueblos of Santa Ana and Cochiti. These willow “cuttings” were harvested and planted during winter months when the plants were dormant.

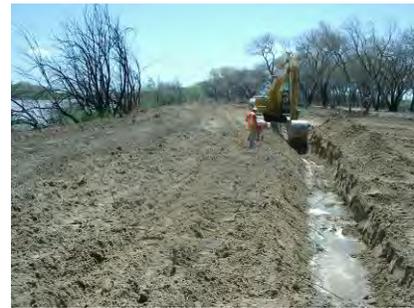
*Swale construction in the Albuquerque bosque in 2005.
(Photo Credit: Parametrix).*

- Removing existing non-native vegetation from the site. This can be accomplished using mowing tractors.
- Creating the swale by lowering the floodplain grade. This serves the dual purpose of removing unwanted plant roots and bringing the ground surface closer to the water table. The soil and root spoil will be spread on-site to avoid excessive hauling costs.

- Excavating parallel, linear trenches within the swale until groundwater begins flowing into the trenches.
- Purchasing and/or collecting willow material. Previous projects requiring large quantities of coyote willow (e.g., Santa Ana and Cochiti Pueblos) have coordinated with the BOR to collect coyote willow cuttings along the LFCC. Bosque del Apache has collected large numbers of Goodding's willow tree poles from the Elephant Butte delta, although it may be more cost effective in some situations to coordinate with a qualified local plant nursery to grow and deliver the tree poles.

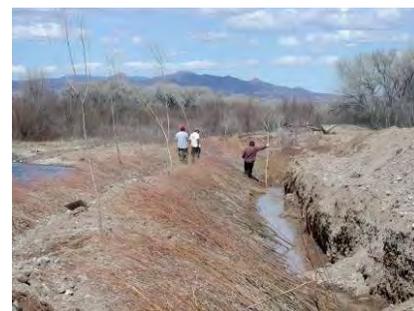
*Willow installation at a swale constructed at Cochiti Pueblo.
(Photo Credit: Parametrix)*

- While the plants are dormant (December–February), cuttings are installed vertically in the exposed trenches with their butt-ends in standing water. The coyote willow cuttings are spaced approximately 3 to 5 feet apart. Goodding’s willow and cottonwood tree poles should be added to the trenches to add structural diversity to the restoration project. Bosque del Apache has planted Goodding’s willow poles as close as 10 feet apart at some of their restoration sites (G. Dello Russo, Bosque del Apache NWR, personal communication, 2007). Although, wider planting distances may be more appropriate if planted in combination with coyote willow shrubs because coyote willows tend to be more robust when the overstory tree canopy is relatively open. To reduce potential beaver damage to tree poles, it may be desirable to install devices to minimize beaver damage to the poles.

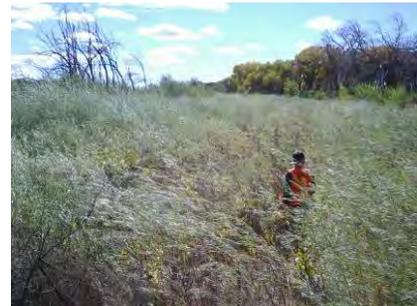
*If conditions are suitable, willow canopy cover can exceed 100 percent after only two growing seasons. This photo was taken at the Albuquerque bosque site shown in the photo above.
(Photo Credit: Parametrix)*

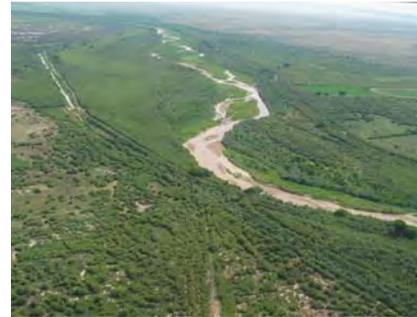
*Looking northeast at RM 128 and RM 129
(Photo Credit: Parametrix)*

Restoration treatments to promote an active channel and enhance aquatic habitat diversity are proposed as experimental treatments to be tested between RM 128 and RM 153. The proposed restoration treatments are designed to improve aquatic habitat by restoring channel dynamics associated with an active channel and a highly mobile bed condition. The proposed treatments include:

- Destabilizing accreted bars by removing vegetation and mechanically reworking bar alluvium so that it can become re-mobilized during subsequent snowmelt runoff.
- Mechanically uprooting vegetation from the edge of channel banks and reworking the bankline to initiate some channel widening and migration, and facilitate deposition of large woody debris into the channel.

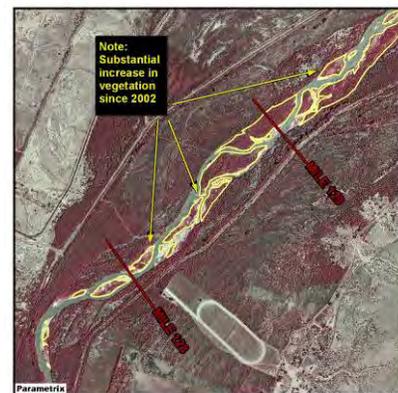
Vegetated channel bars and islands at RM 128 in June 2006.

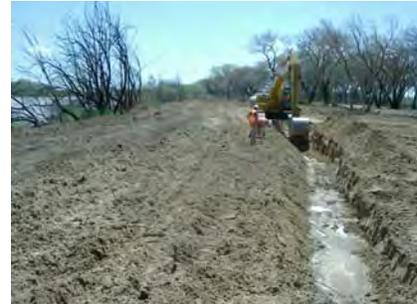
*Willow swale construction near Albuquerque.
(Photo Credit: Parametrix)*

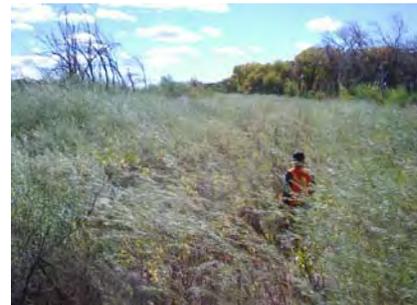
*Same location as above 18 months after construction.
(Photo Credit: Parametrix)*
