**ANNUAL MONITORING REPORT FOR THE CITY OF ALBUQUERQUE'S RIO
BRAVO NORTH AND SOUTH HABITAT RESTORATION PROJECTS: 2009**

SWCA Project No. 15479

May 3, 2010

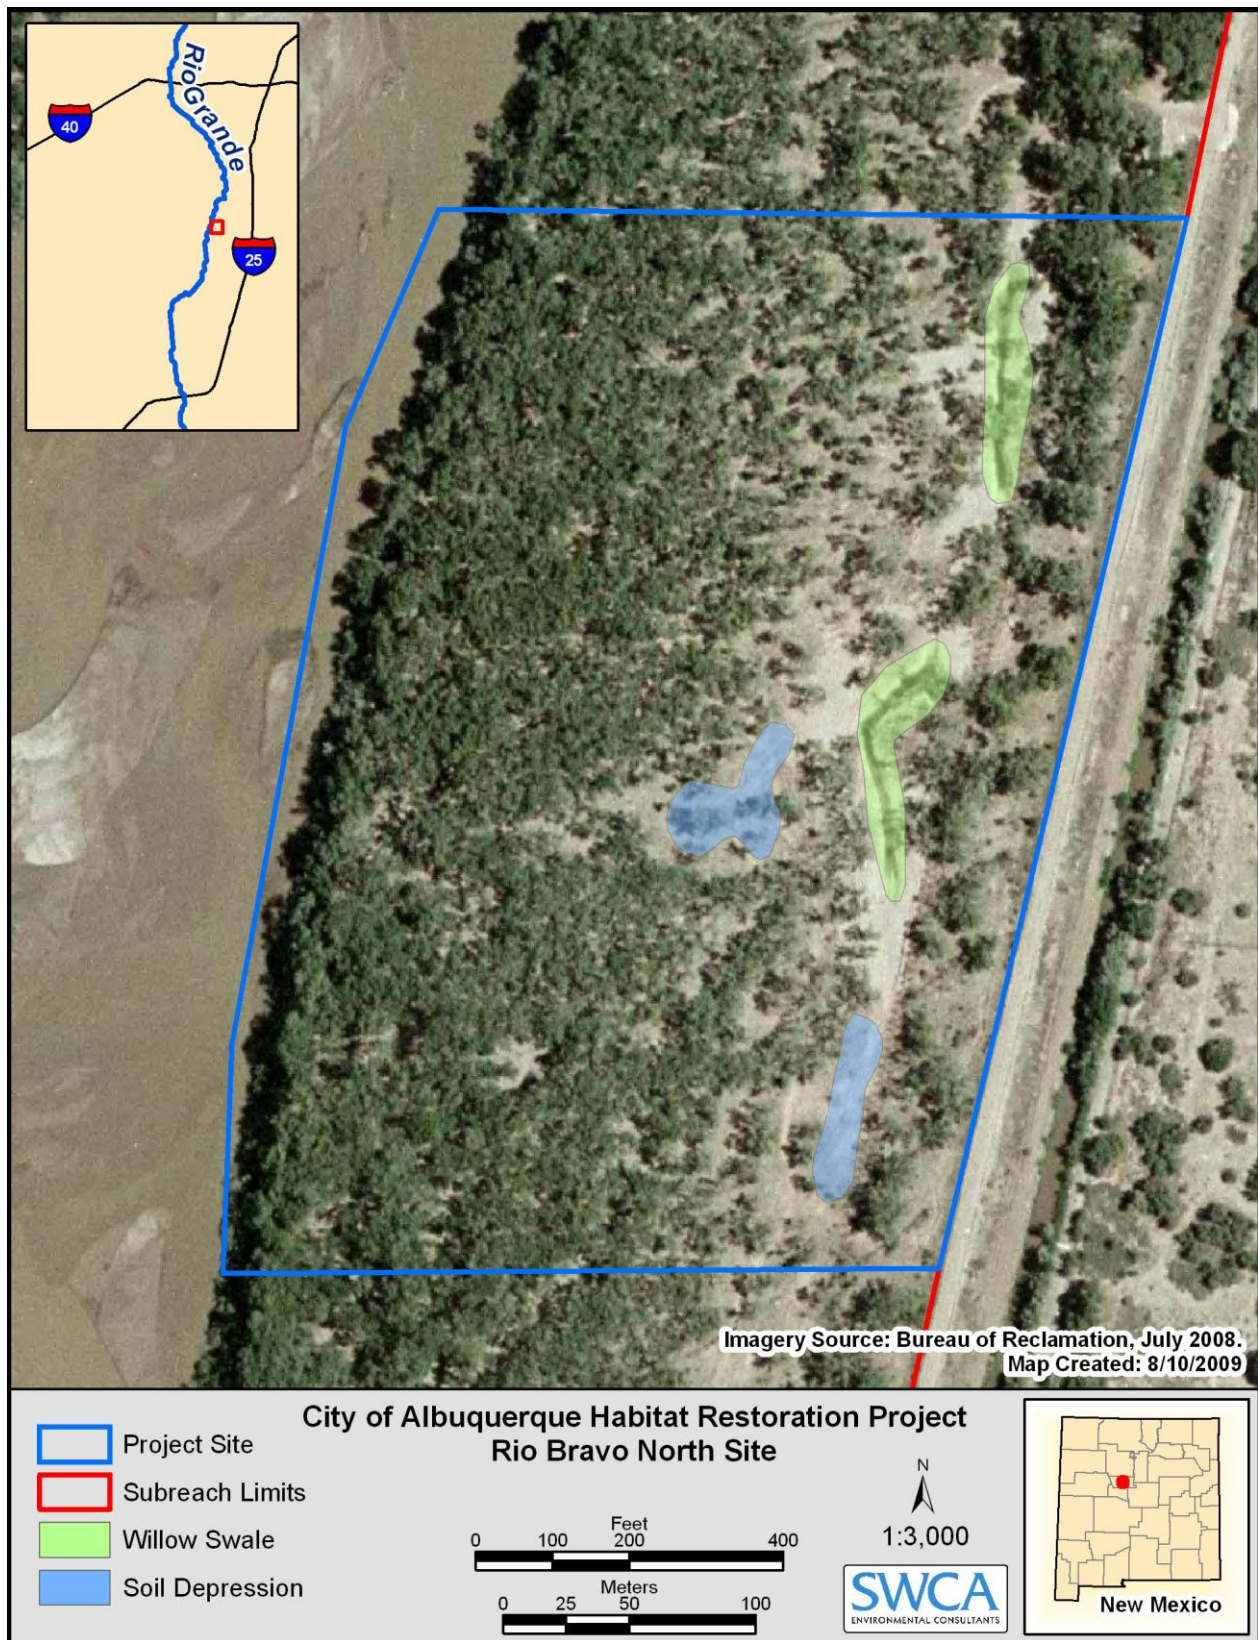
Figure 2. RBN site restoration features.

The RBN site covers 33 acres (12.7 ha) on the east side of the channel, approximately 0.5 mile north of the Rio Bravo Bridge (Figure 2). The site was characterized by mixed native and non-native riparian vegetation; however, the majority of the area was cleared of non-native vegetation and is now an open Rio Grande cottonwood (*Populus deltoides*) bosque with scattered New Mexico olive (*Forestiera pubescens*) and black willow (*Salix nigra*). The bankline vegetation within the project area was left undisturbed and remains characterized by a cottonwood canopy with an understory dominated by Russian olive (*Elaeagnus angustifolia*) and saltcedar (*Tamarix ramosissima*). Within the bosque, four depressions—two approximately 0.75 acre (0.3 ha) each and two approximately 0.30 acre (0.12 ha) each—were excavated to function as surface water catchments that will encourage the recruitment of native vegetation for the benefit of flycatcher. In addition, 120 jetty jacks were removed from this location to improve access in the event of wildfire. A proposed channel was eliminated at the RBN site due to complications with depletions.

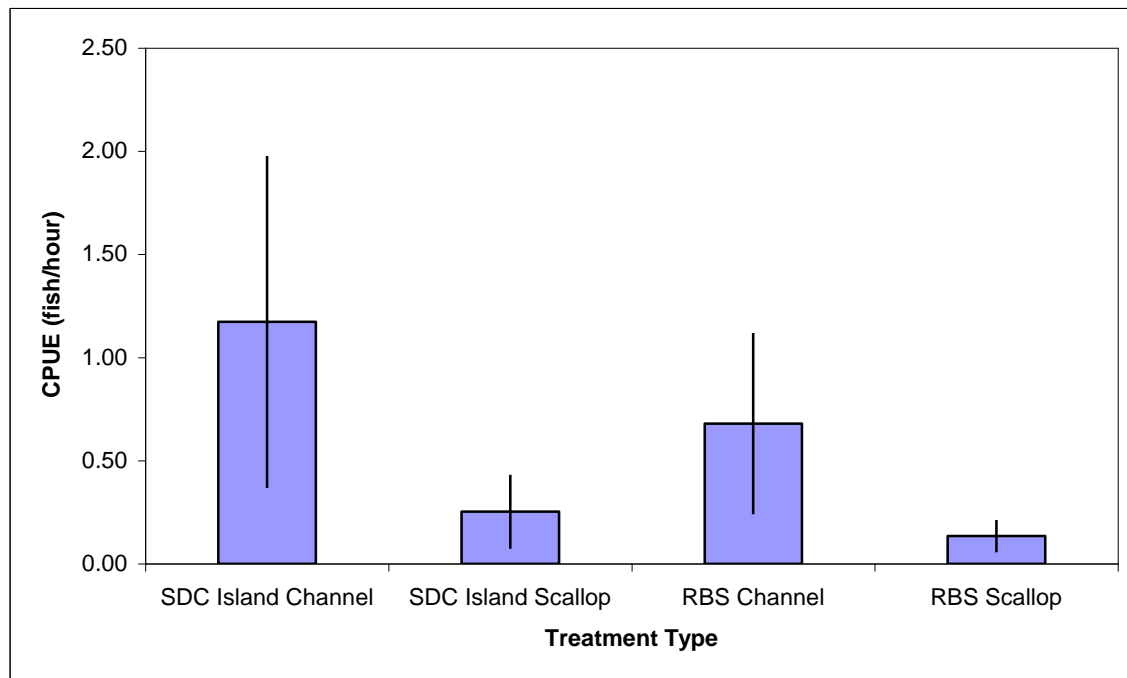
Silvery minnow CPUE did not differ among habitat restoration sites (Kruskal-Wallis single-factor analysis of variance $P = 0.48$), among sampling dates (Kruskal-Wallis single-factor analysis of variance $P = 0.28$), or between treatment types (Wilcoxon rank-sum test $P = 0.39$). The highest CPUE value was observed at the SDC Island (3.41 fish/hour) on May 21, 2009, and was qualitatively greatest at channel treatment types (Figure 6). Among dates CPUE was qualitatively highest on May 21 and lowest on May 29, 2009 (Figure 7). The channels constructed at SDCI are low velocity and shallow relative to main channel flow and have undergone a substantial amount of sediment deposition since construction which may have resulted in a greater amount of suitable habitat for silvery minnow than anticipated.

Figure 6. Mean CPUE values at each fyke net site. Error bars represent plus or minus one standard error from the mean.

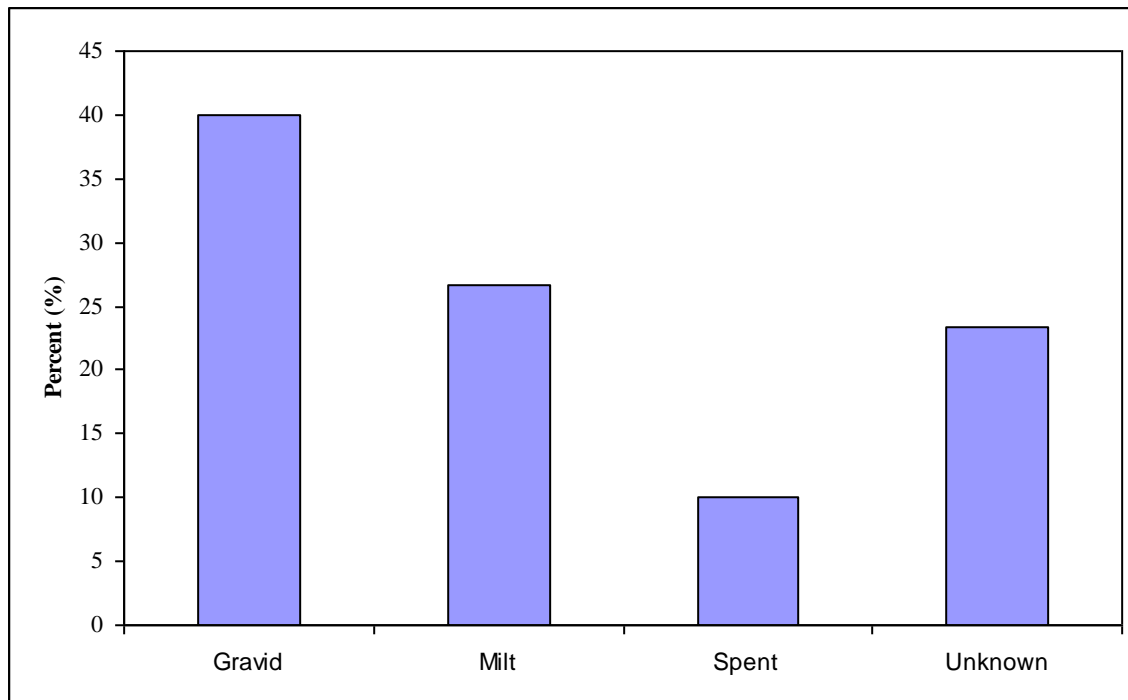
A total of 30 silvery minnow were observed for signs of reproductive maturity. Gravid females (40%) and males issuing milt (27%) comprised the largest fractions of collected silvery minnow. Two silvery minnow, including the largest fish collected (66 mm) were observed issuing eggs during processing. Seven silvery minnow were classified as unknown and three were classified as spent females (Figure 9).

Figure 9. Percent of silvery minnow by reproductive classification observed during monitoring.

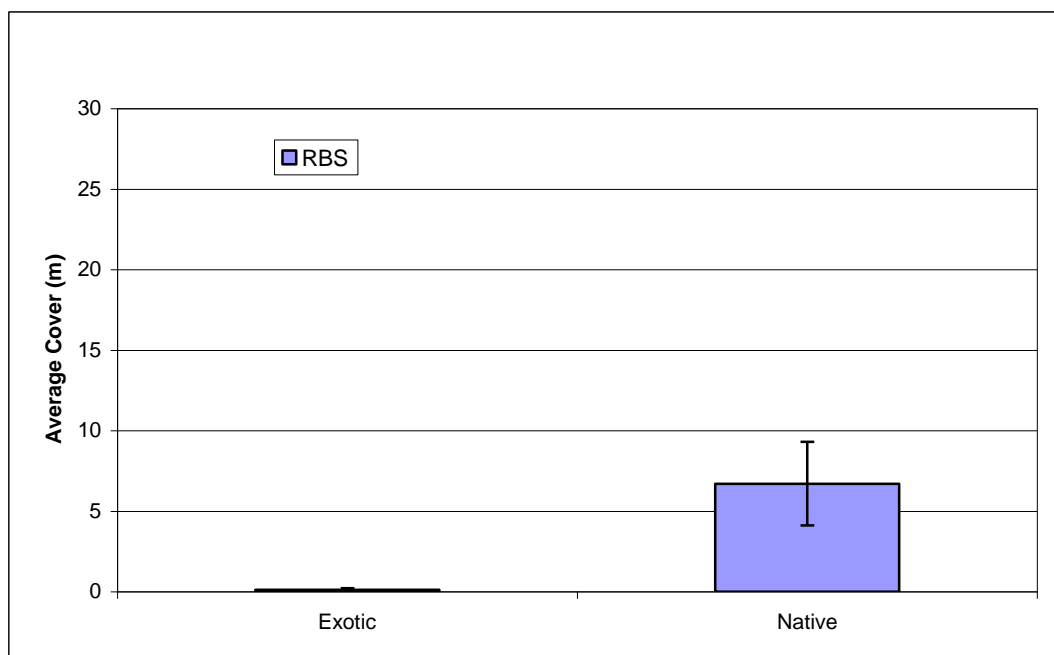
For both sites combined native vegetation was more abundant than exotic vegetation (Wilcoxon rank sum test $P < 0.0001$) (Figure 13 and Figure 14). Between sites cover of exotic vegetation did not differ (Wilcoxon rank sum test $P = 0.2$), however cover of native vegetation did (Wilcoxon rank sum test $P = 0.04$). Cover of native vegetation was greatest at the SDCI site averaging three times that of native cover at the RBS site. Native species were found within all of the four Hink and Ohmart classifications, while exotic vegetation was found within three of the four Hink and Ohmart classifications (Figure 15 and Figure 16).

Figure 13. Average cover (m) of native and exotic vegetation estimated from line-intercept data collected at the RBS site.

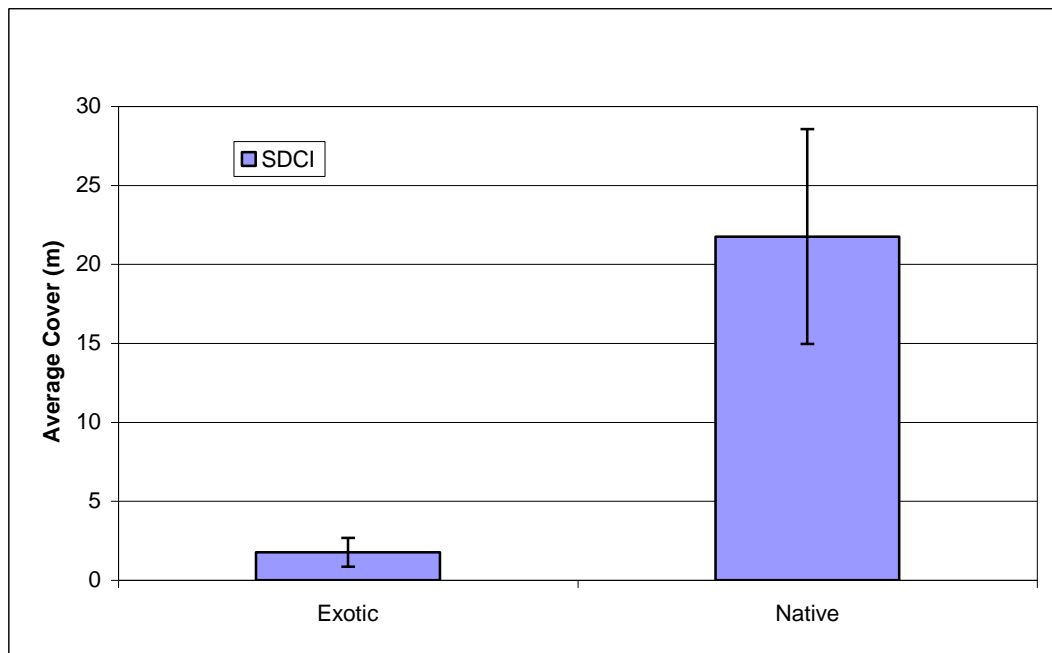
Figure 14. Average cover (m) of native and exotic vegetation estimated from line-intercept data collected at the SDCI site.

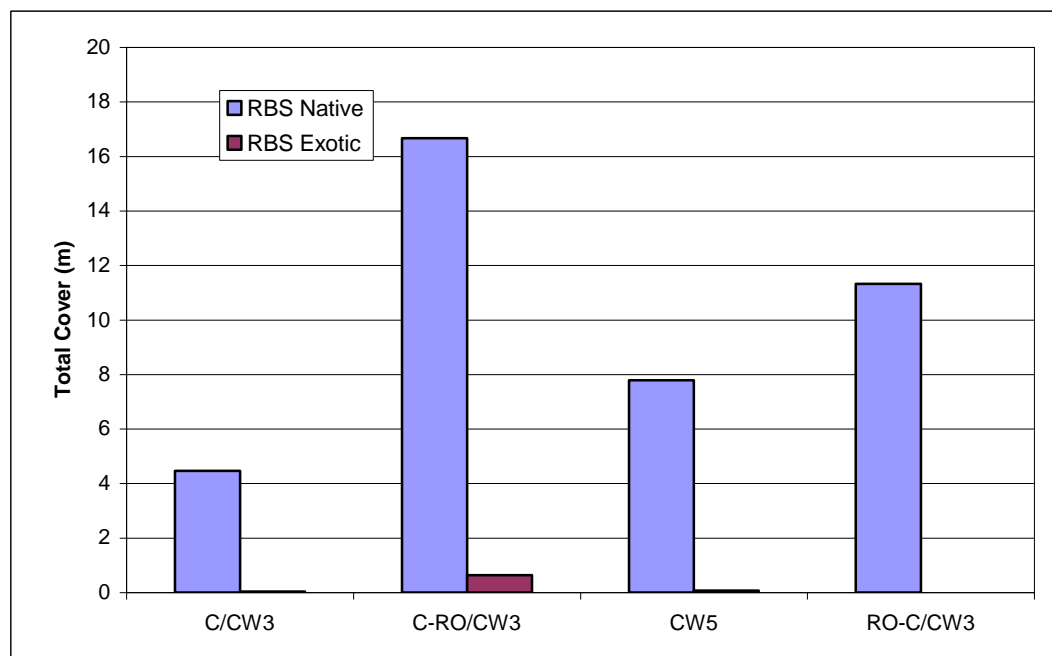
Figure 15. Total cover (m) of native and exotic vegetation within Hink and Ohmart classification types from line-intercept data collected at the RBS site.

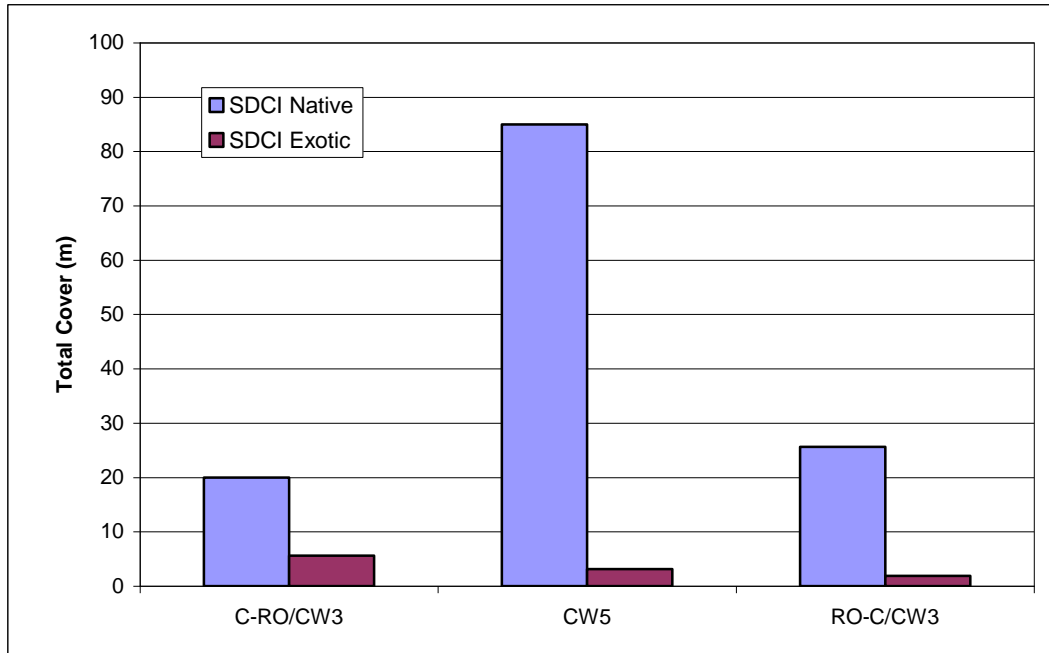
Figure 16. Total cover (m) of native and exotic vegetation within Hink and Ohmart classification types from line-intercept data collected at the SDCI site.

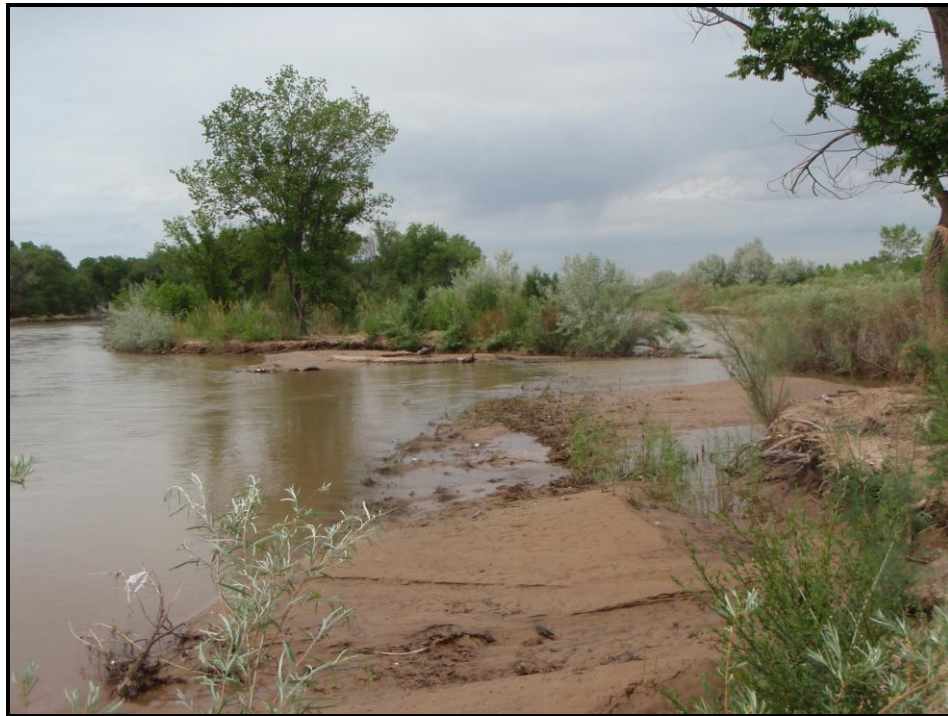
Three flow-through channels were constructed at RBS and SDCI. The two channels at SDCI experienced some level of deposition, while the channel at RBS eroded greatly vertically and laterally. This is likely a function of hydrology. The channels at SDCI have a tremendous amount of vegetation, mostly coyote willow. The constructed channel at the RBS site has become the main thalweg of the Rio Grande. The channel had a design width of 30 feet and at the time of the survey has extended to approximately 50-60 feet. The existing channel on the east side of the river has accumulated sediment deposition in which inundation only occurs with flows greater than 2,500 cfs. Six scallops were constructed at RBS and SDCI. The scallops experienced varying levels of erosion and deposition. Scallop #1 has eroded away with the widening of the channel at RBS. The remaining scallops have experienced some deposition along their eastern edge allowing for a backwater environment to exist and creating suitable habitat for silvery minnow. The back edge of Scallop #2 at RBS however, has been eroded and is connected to the constructed channel at high flows (Figure 19). Similarly at the SDCI site, the scallops have had some deposition and backwater environment also exist. The RBN site was also surveyed, but post-construction surveys were not completed. The channel planned for RBN was eliminated from the project. Geomorphology maps are located in Appendix G.

Figure 19. The effect of erosion at Scallop #2 at the RBS site. This scallop is now connected to the constructed channel at high flows (south orientation).

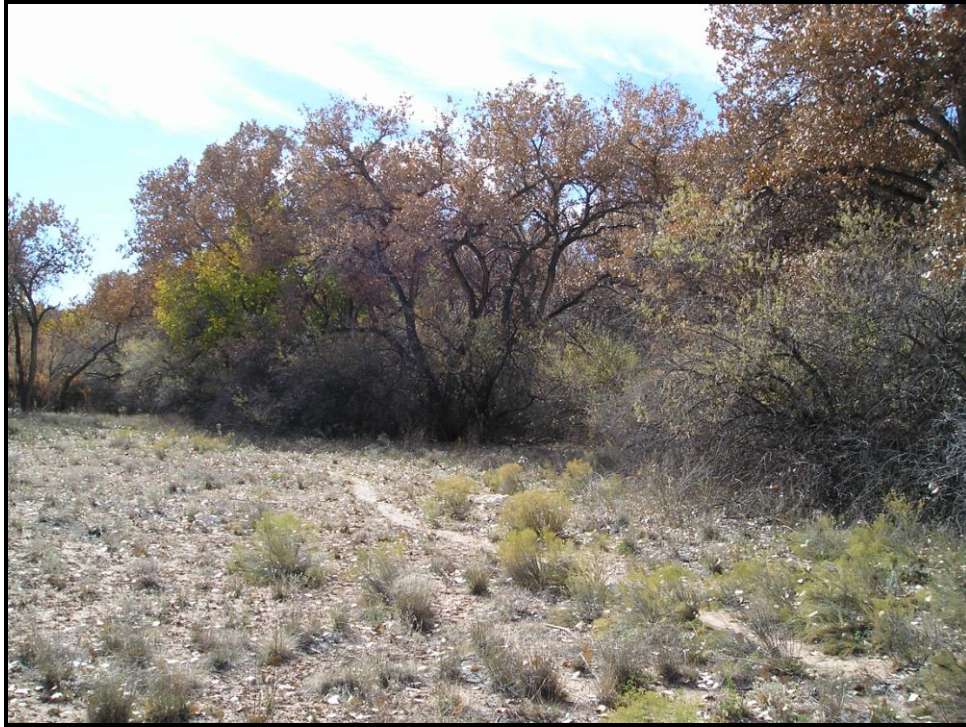
Figure A1. Bosque area of RBN site before construction. Taken from within the site at 12:16 hours on November 16, 2005; southwest orientation.

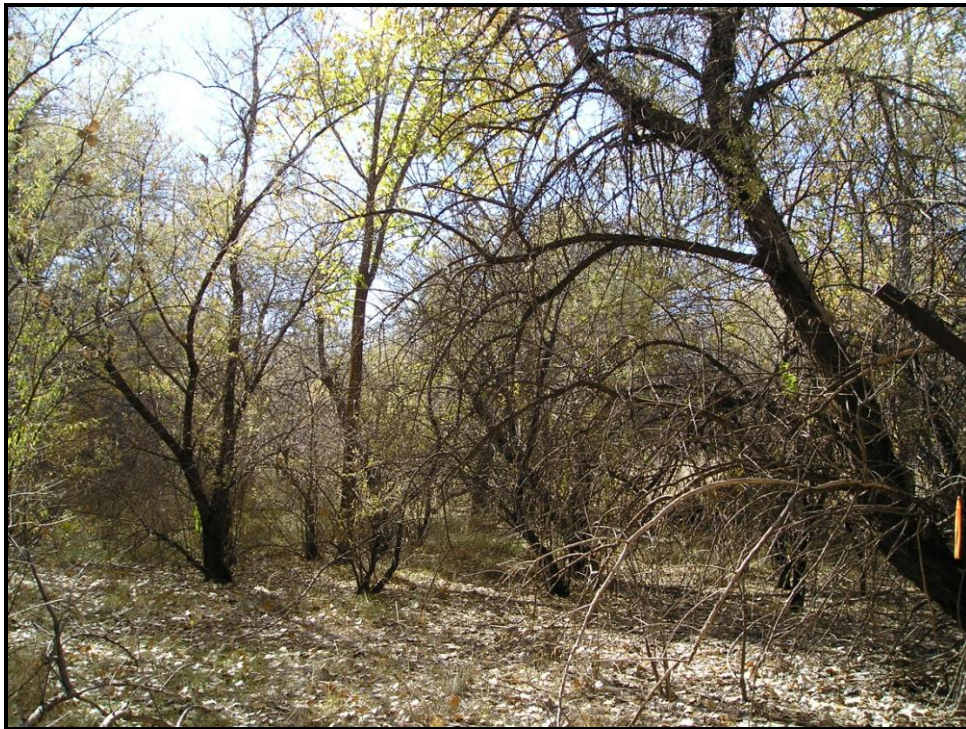
Figure A2. Bosque area of RBN site before construction. Taken from within the site at 13:11 hours on November 16, 2005; south orientation.

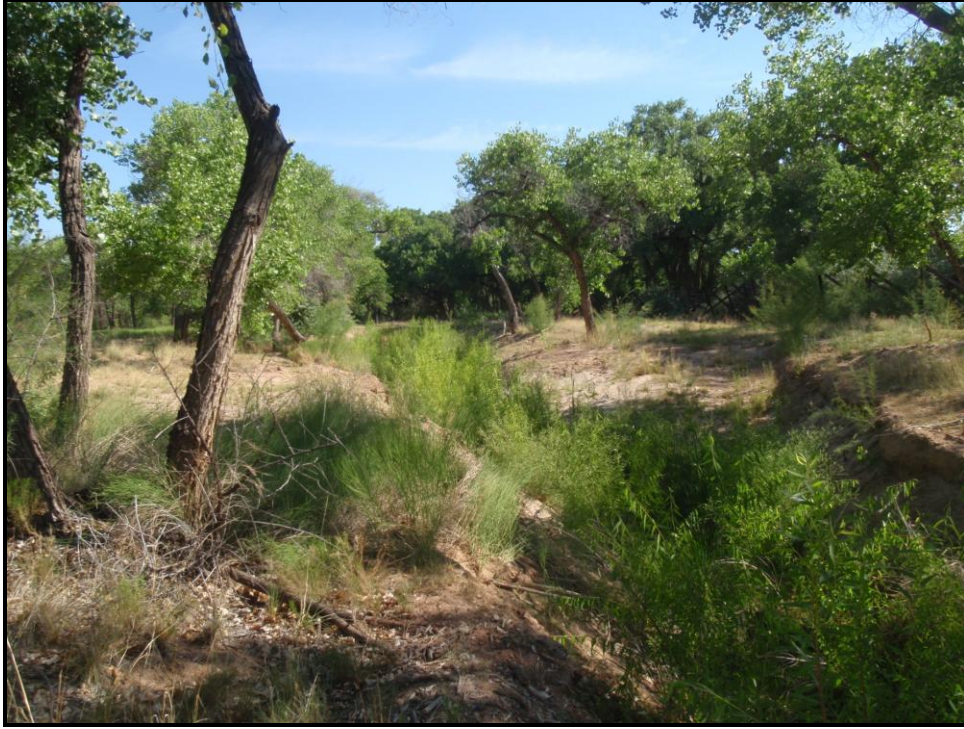
Figure A3. Near south end of Willow Swale #1 at RBN site after construction. Taken from within Willow Swale #1 at 09:39 hours on July 24, 2009; northeast orientation.

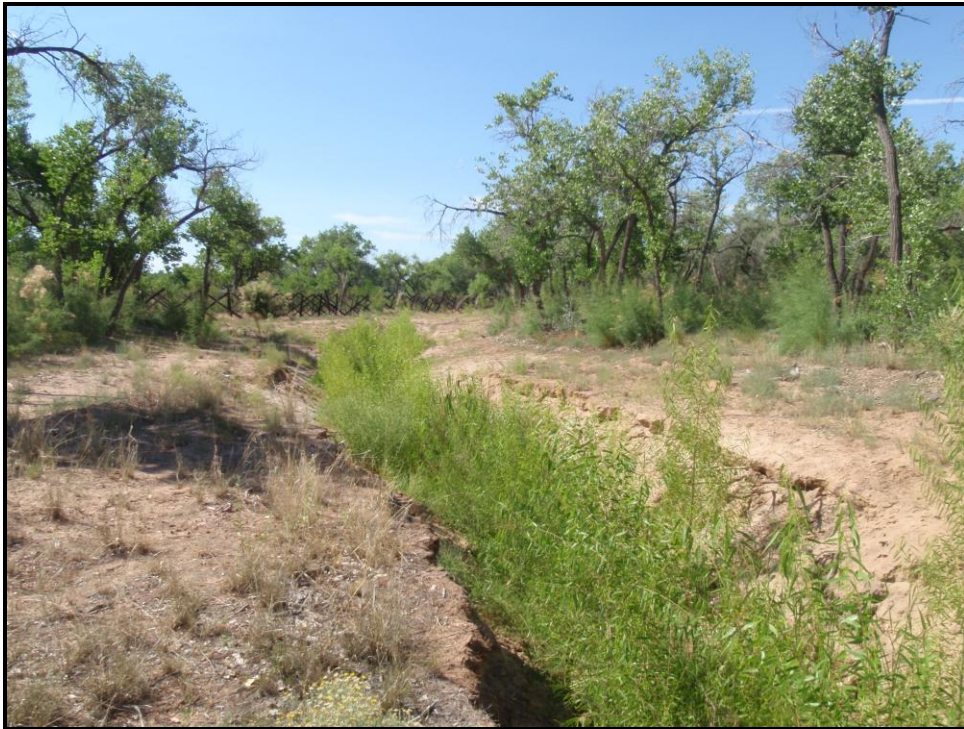
Figure A4. The mid-section of Willow Swale #2 at RBN site after construction. Taken from within Willow Swale #2 at 10:14 hours on July 24, 2009; southeast orientation.

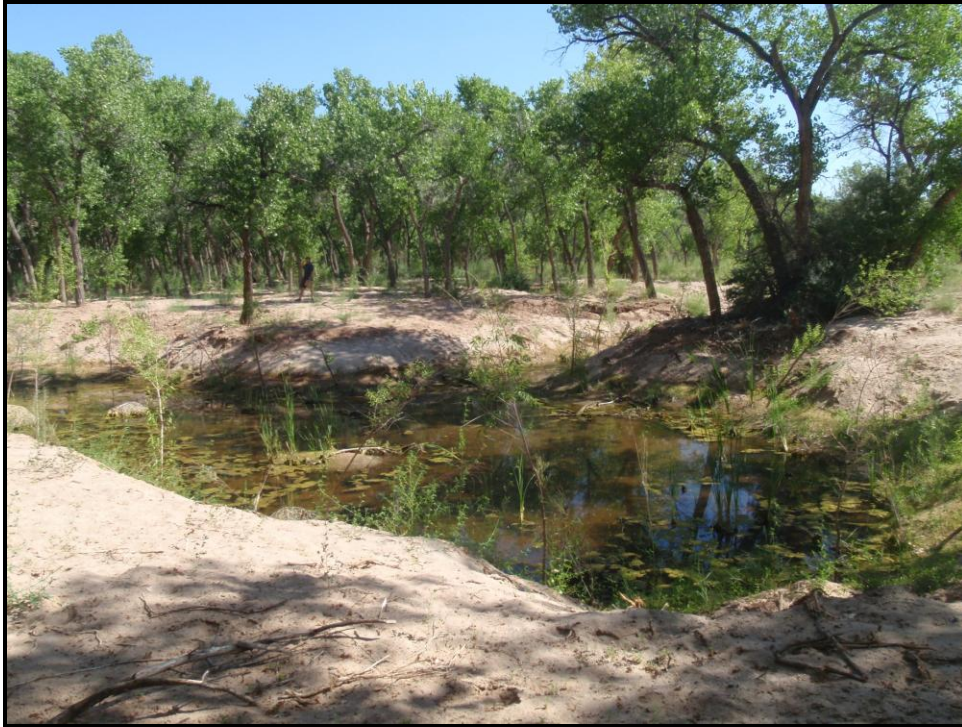
FigureA5. Soil Depression #1 in bosque area of RBN site after construction. Taken at 08:57 hours on July 24, 2009; northeast orientation.

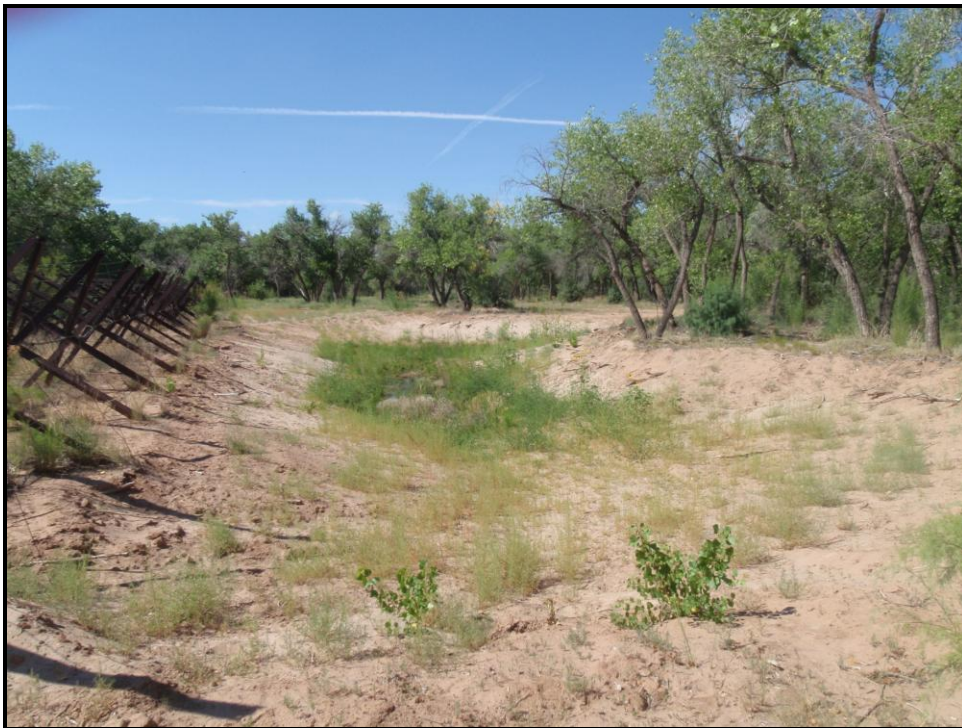
FigureA6. Soil Depression #2 in bosque area of RBN site after construction. Taken at 09:19 hours on July 24, 2009; south orientation.

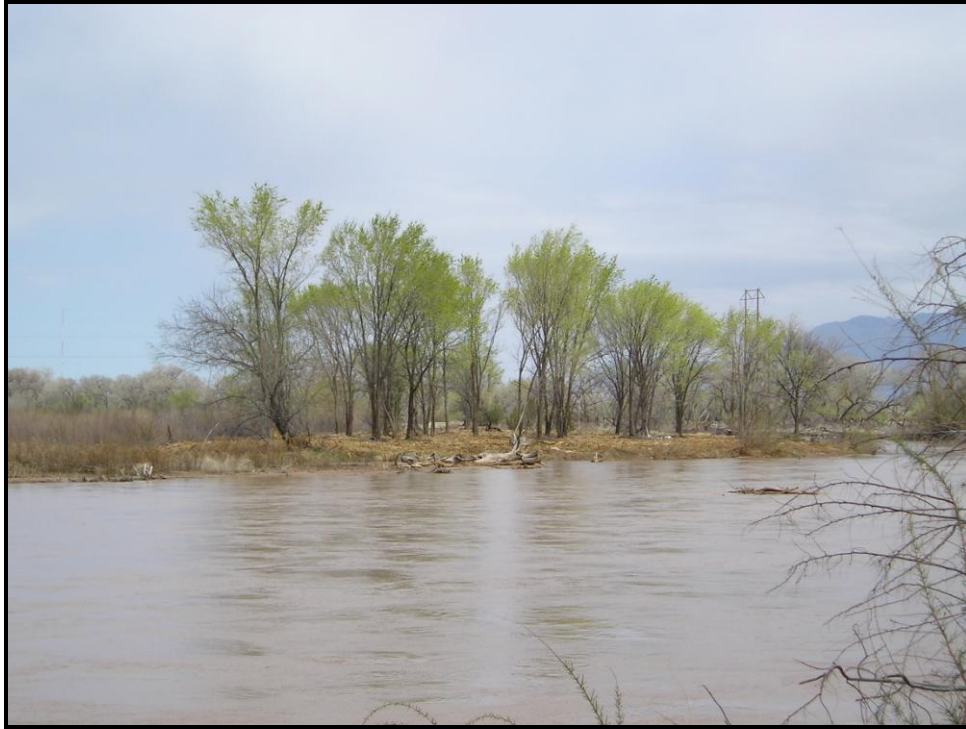
Figure A7. Southeast bank of RBS before construction. Taken from east bank at 12:29 hours on March 28, 2007; north orientation.

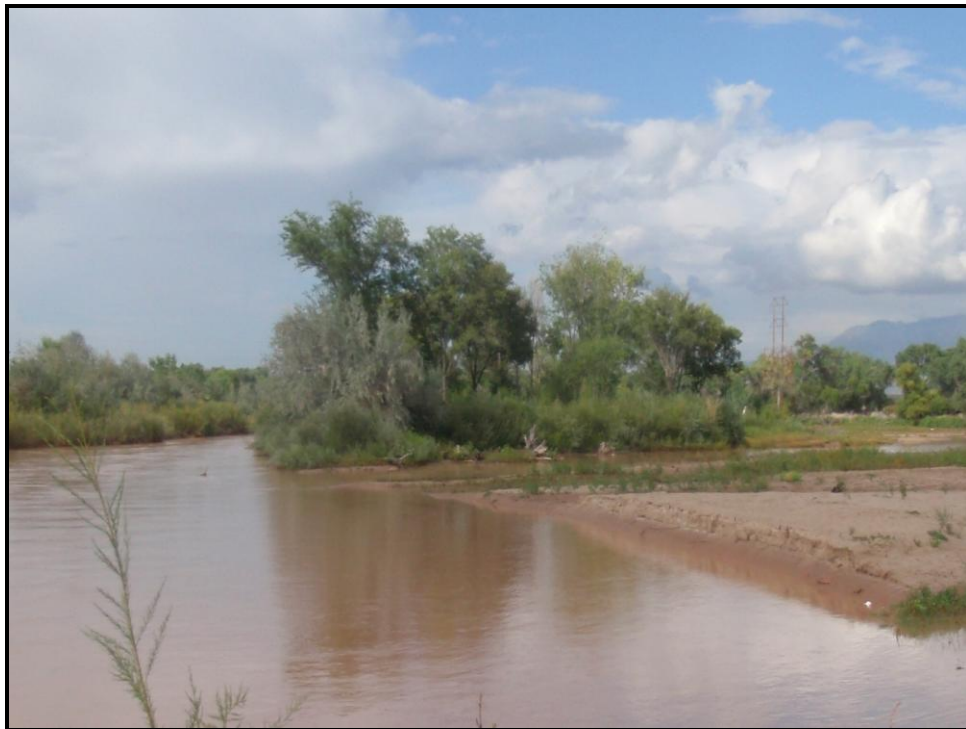
Figure A8. Southeast bank of RBS after construction. Taken from east bank at 13:03 hours on March 28, 2007; southwest orientation.

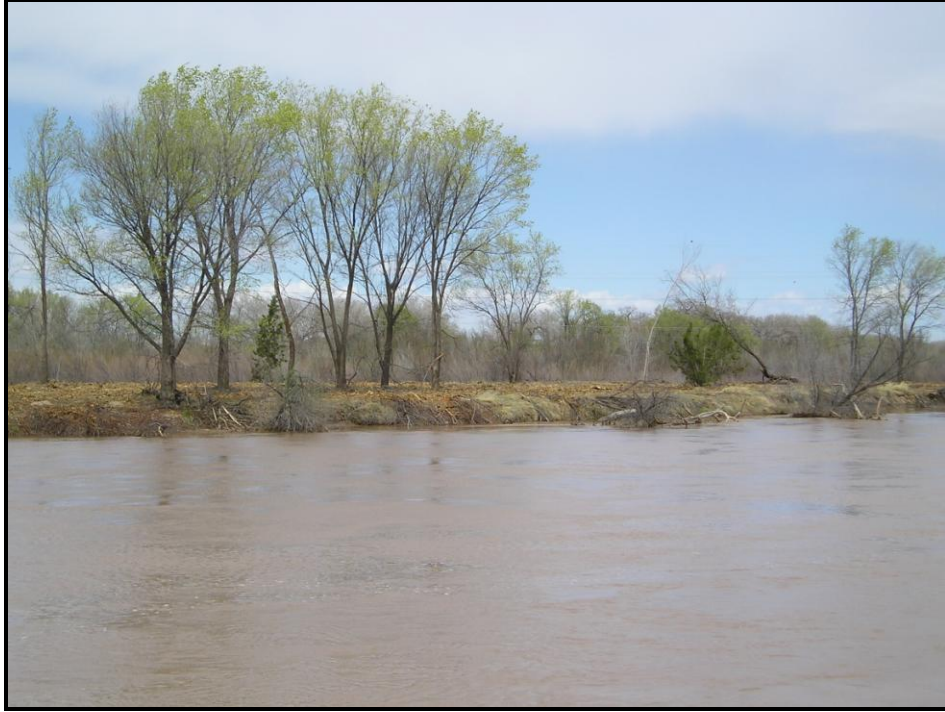
Figure A9. East bank of RBS before construction. Taken from the east bank at 12:38 hours on March 28, 2007; southwest orientation.

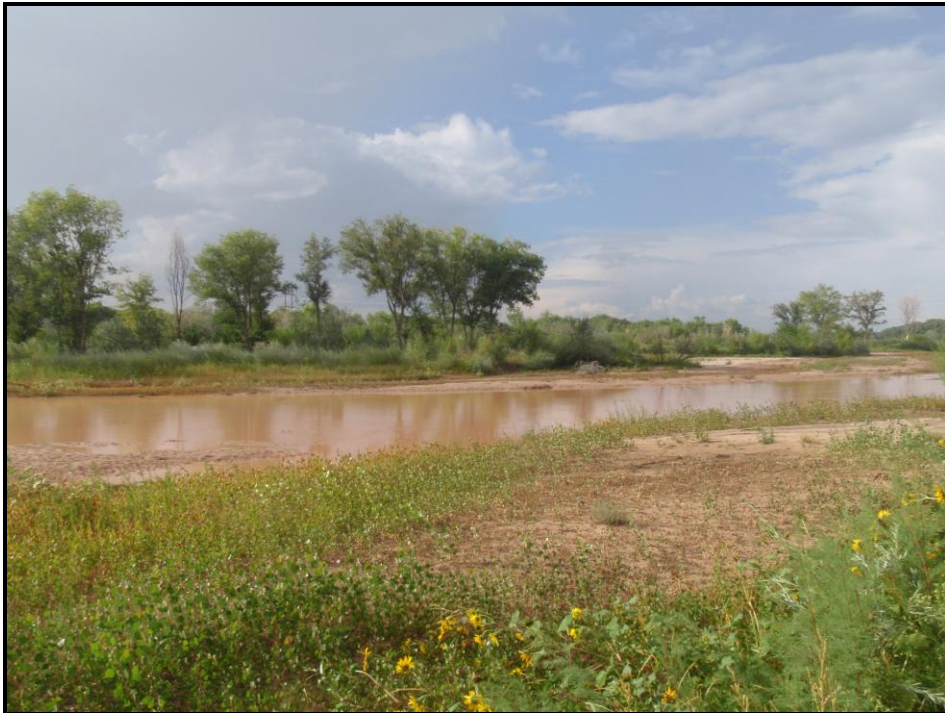
Figure A10. East bank of RBS after construction. Taken from the east bank at 16:50 hours on September 9, 2009; southwest orientation.

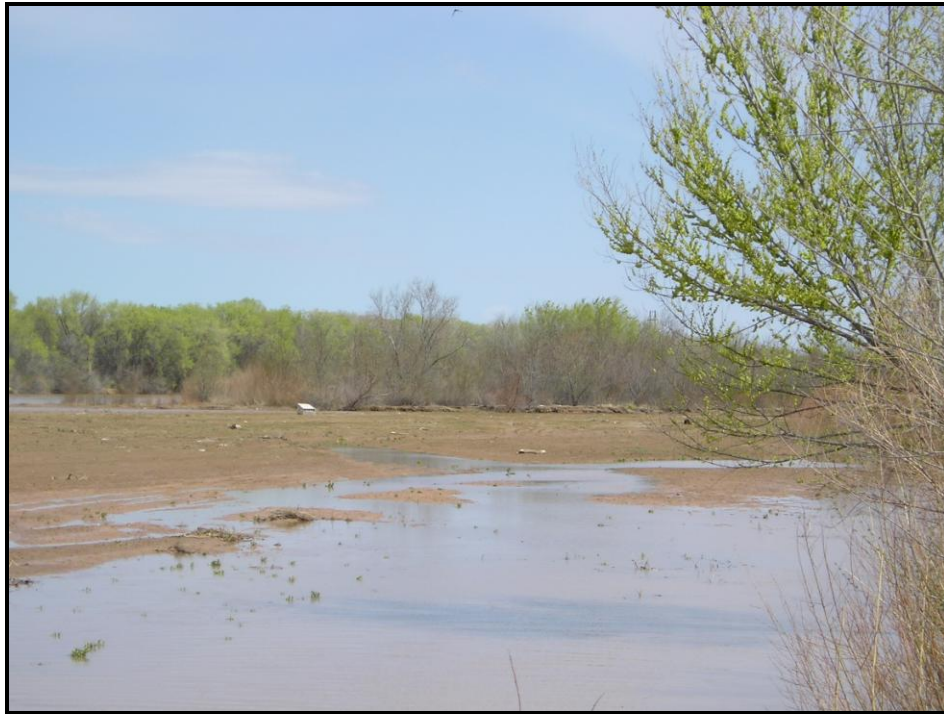
Figure A11. Southern tip of SDC Island before construction. Taken from the east bank at 12:26 hours on March 28, 2007; north orientation.

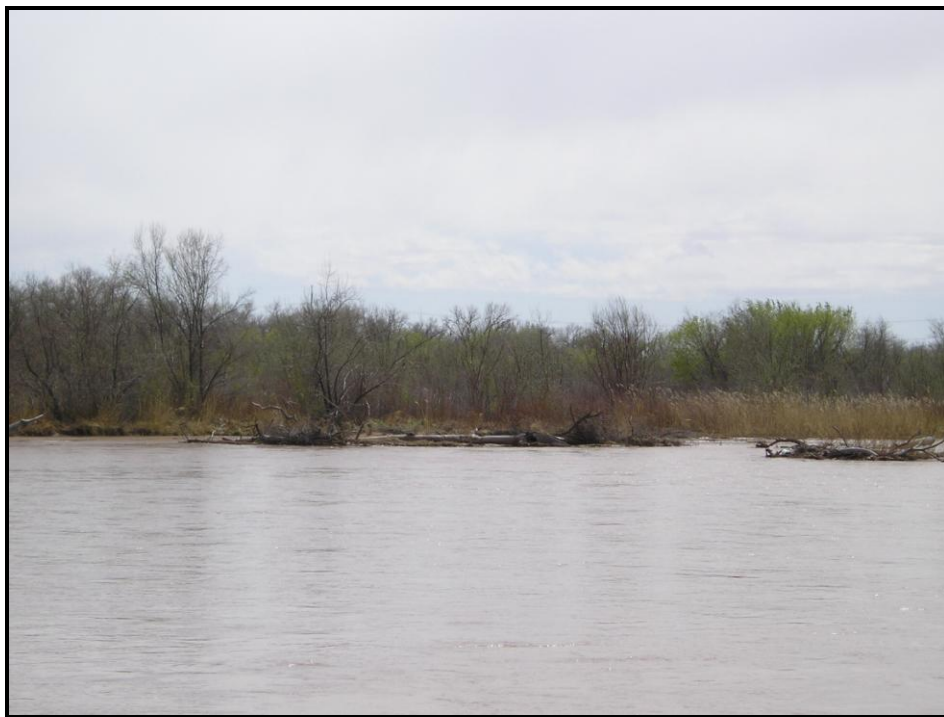
Figure A12. West bank of SDC Island before construction. Taken from the west bank at 14:22 hours on March 28, 2007; south orientation.

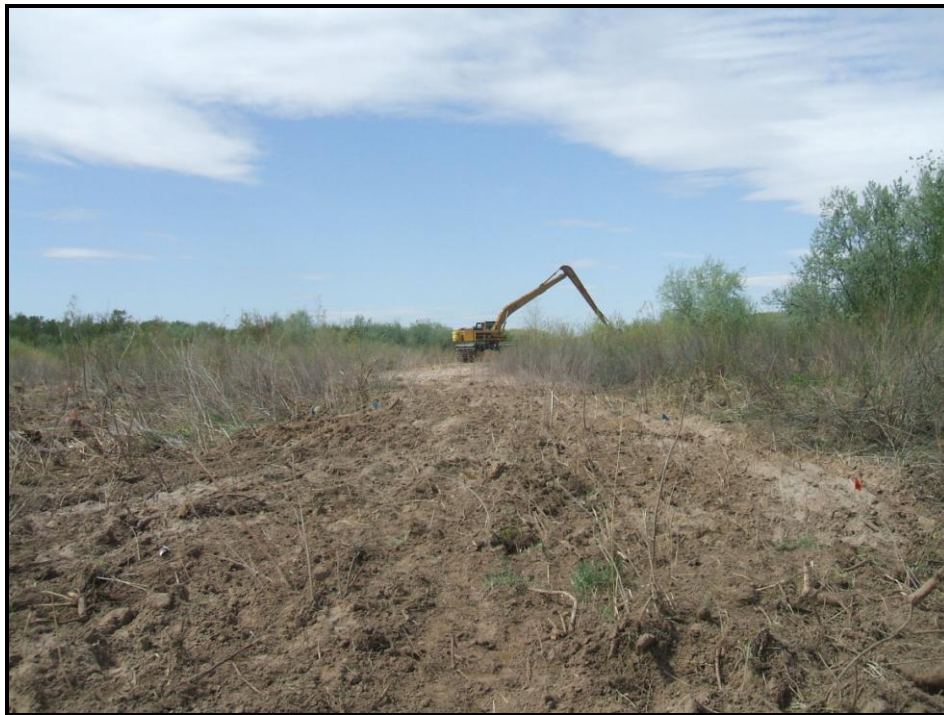
Figure A14. Channel #1 and #2 on SDC Island during construction. Taken from north end of Channel #1 at 11:00 hours on April 23, 2007; southwest orientation.

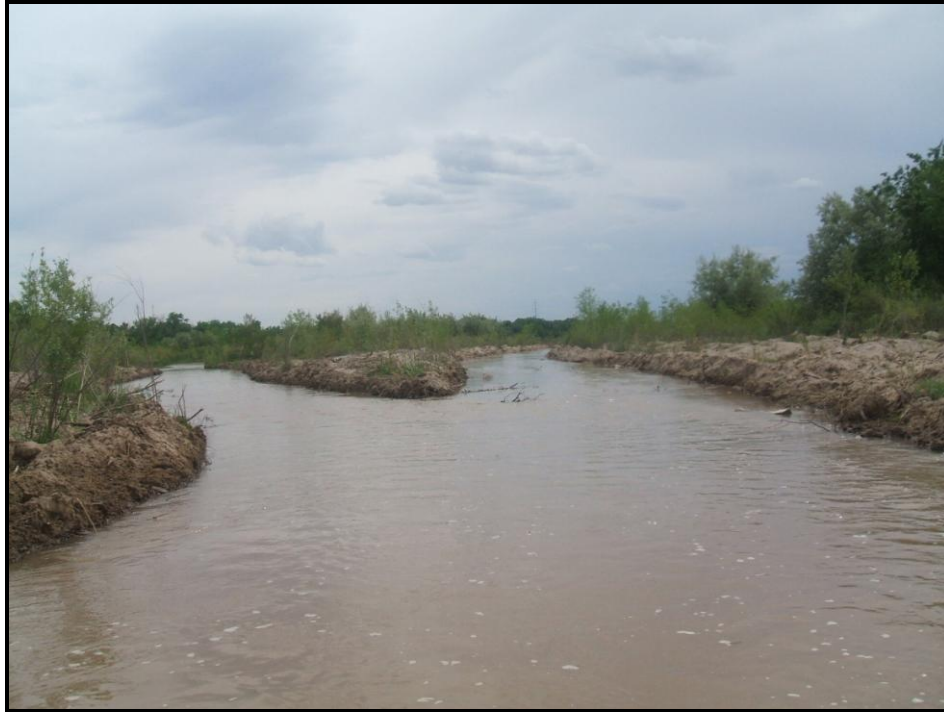
Figure A15. Channel #1 and #2 of SDC Island after construction. Taken from the north end of Channel #1 at 15:04 hours on May 14, 2007; southwest orientation.

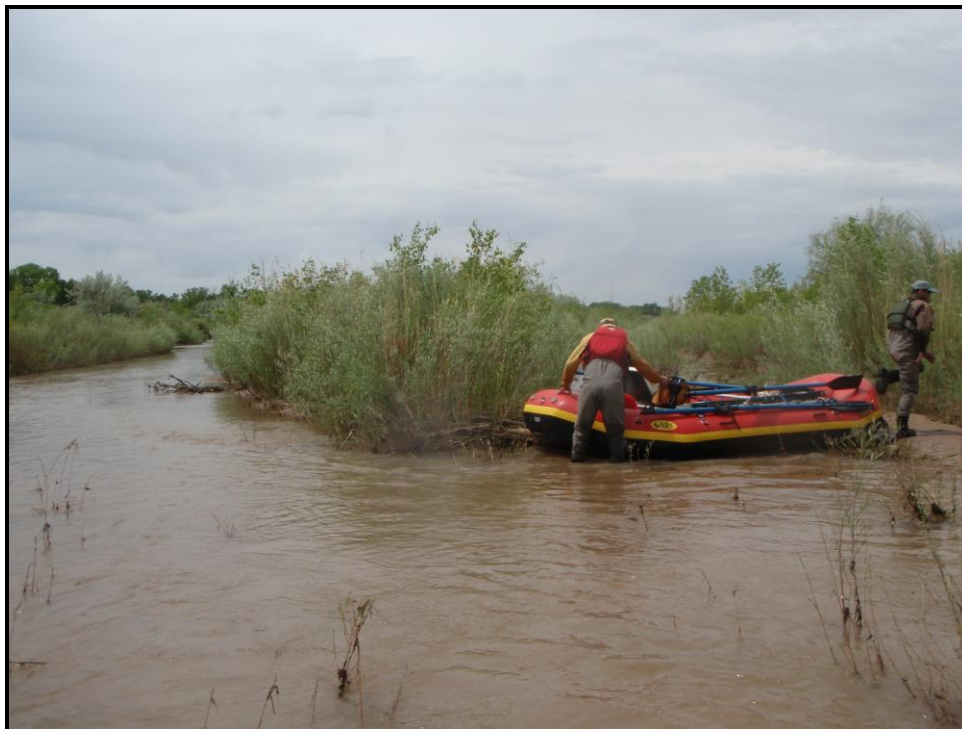
Figure A16. Channel #1 and #2 of SDC Island during fish monitoring. Taken from the north end of Channel #1 at 10:31 hours on May 21, 2009; southwest orientation.

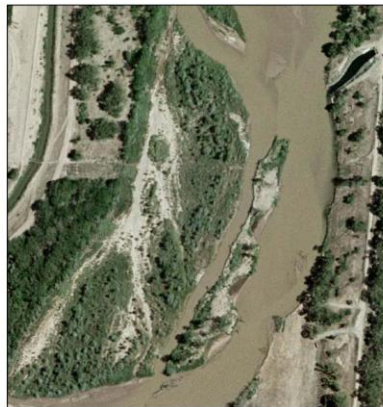
Figure G.2. Geomorphology at the RBS site.

COMPARISON MAP : PRE PROJECT (2005/2006) => WITH PROJECT(2008-2009)

LOOKING D/S AT CONSTRUCTED CHANNEL
