# MIDDLE RIO GRANDE ENDANGERED SPECIES COLLABORATIVE PROGRAM

2017 Topographic Data Collection of  
Three High Flow Channels  
Located in Albuquerque, New Mexico

US Army Corps of Engineers  
Albuquerque District

September 2020

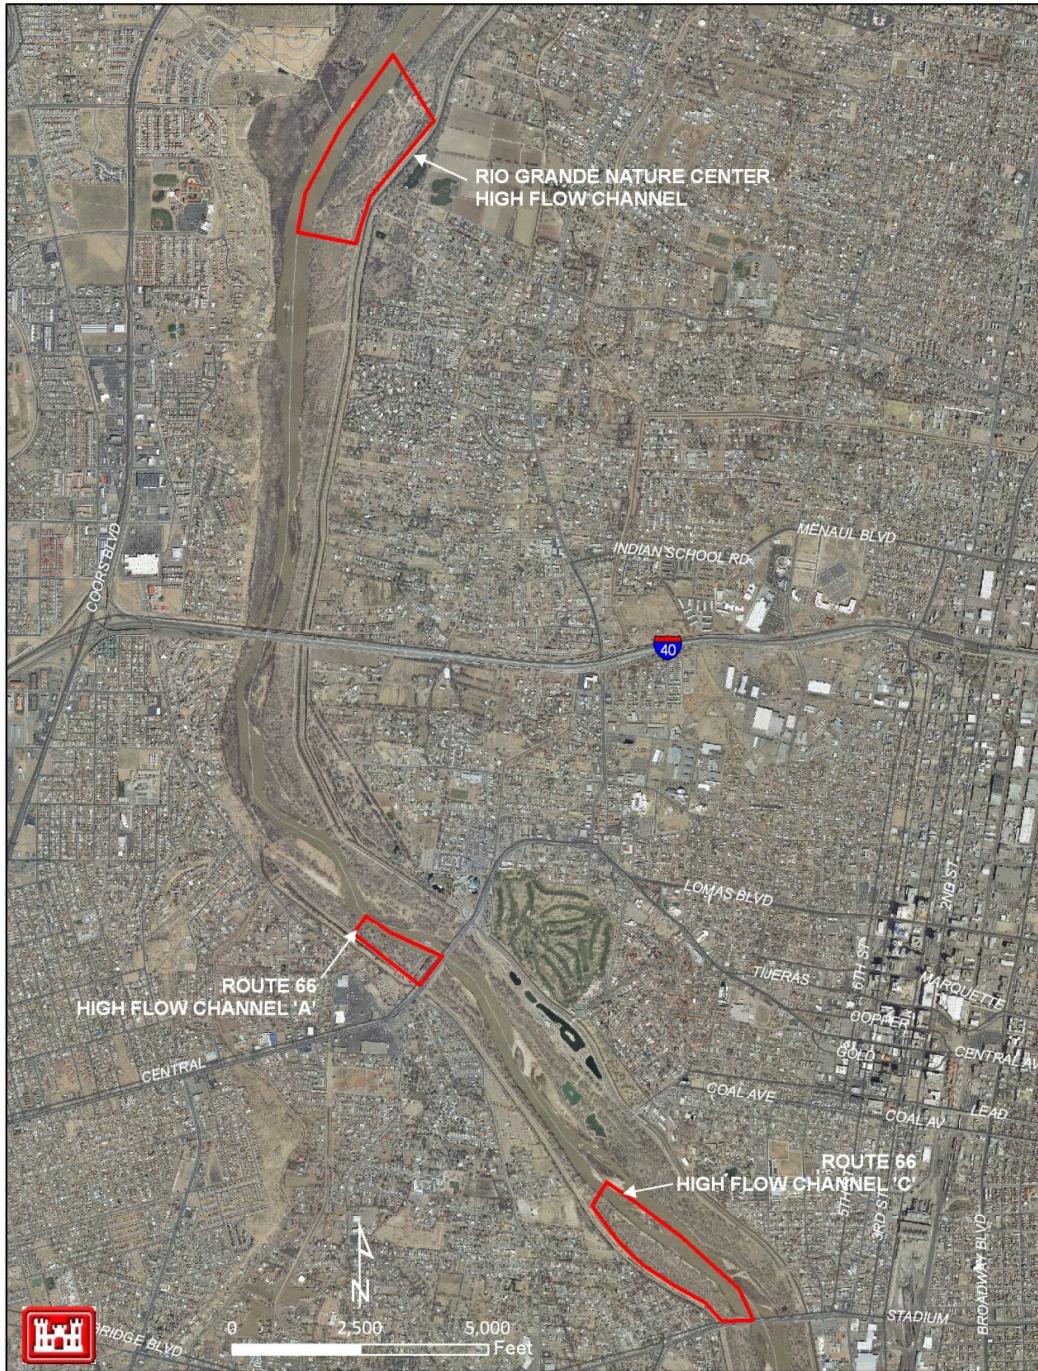
**Figure 1 – Site Map for surveys conducted on the high flow channels at the Rio Grande Nature Center and the Route 66 habitat restoration projects.**

general aggradation and degradation trends within the channels. This information provides insight into the development of general design guidelines that may promote desirable silvery minnow habitat. The topographic data were collected between March 7 and March 8 2017. This is the fifth year in which these specific geomorphic aspects were measured for these particular channels. All sites are accessible through current agreements with the Middle Rio Grande Conservancy District and through the City of Albuquerque (COA) Open Space Division Special Use Permits. Additional access agreements are not required, though updated permits are required on a yearly basis from the COA. The channels selected for survey are shown in Figure 1. The channels selected for the year 2017 survey are described as:

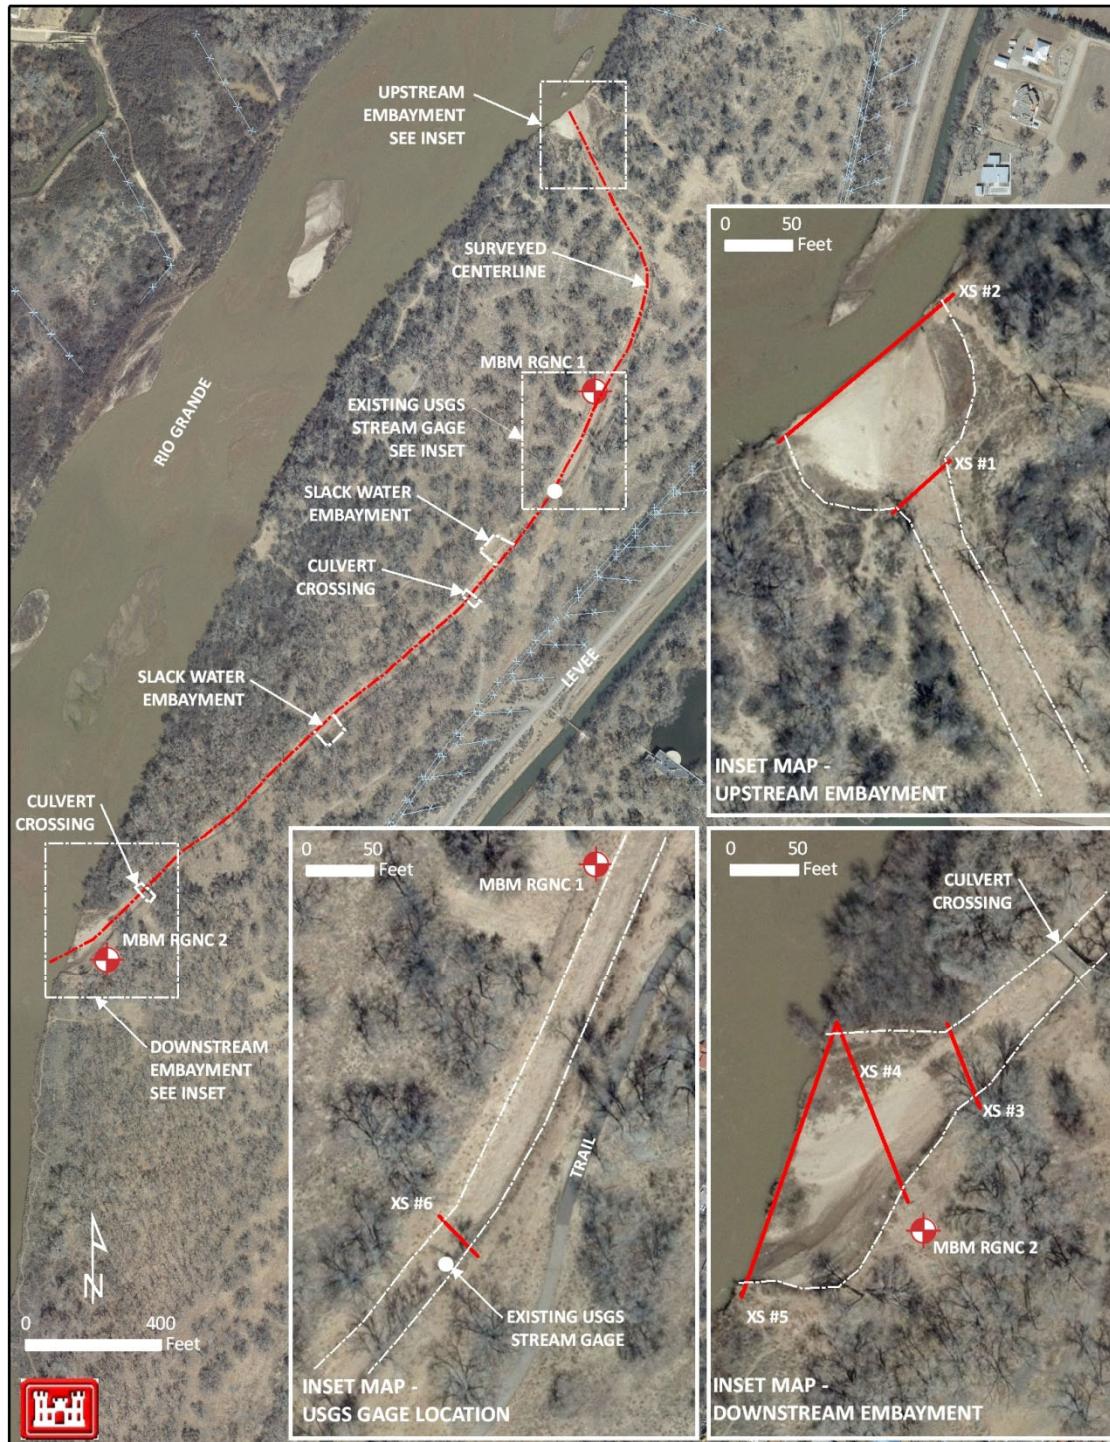
Figure 2 – RGNC HFC Site Layout.

The channel was created as part of the Rio Grande Nature Center Habitat Restoration Project, with construction completed in March 2008. The Site Layout for the RGNC HFC plan view is shown as Figure 2. The channel is earth lined and is approximately 3,300 feet long and 20 feet wide. The channel was designed as trapezoidal in shape, with 3H to 1 V side slopes. The channel was designed to flow at a depth of 1 foot across the high point, when the Rio Grande is flowing at ~3,000 cfs. However, it has been observed to begin flowing when the Rio Grande flows at ~1,500 cfs. The channel was originally constructed with two slack-water embayments that are intended to promote fish spawning. A third slack-water embayment about 100 yards downstream of the inlet was added in 2013. There is also a USGS stream gage located in the upper half of the channel. An upstream and downstream embayment was included, as well as two culvert crossings for pedestrian access.

The benchmarks are shown for each respective channel in Figures 2 thru 4. The monuments were installed two per site, near the upstream and downstream ends of each channel, this allowed for ease in finding a known elevation virtually at all locations within each channel. Installing two per site also allowed for ease in confirming level loops and determining survey error. Each installed benchmark, along with their associated coordinates, is noted in Table 2. Northing and Easting are shown in the New Mexico State Plane Central Zone NAD83 horizontal datum while the elevations are shown in the NAVD88 vertical datum.

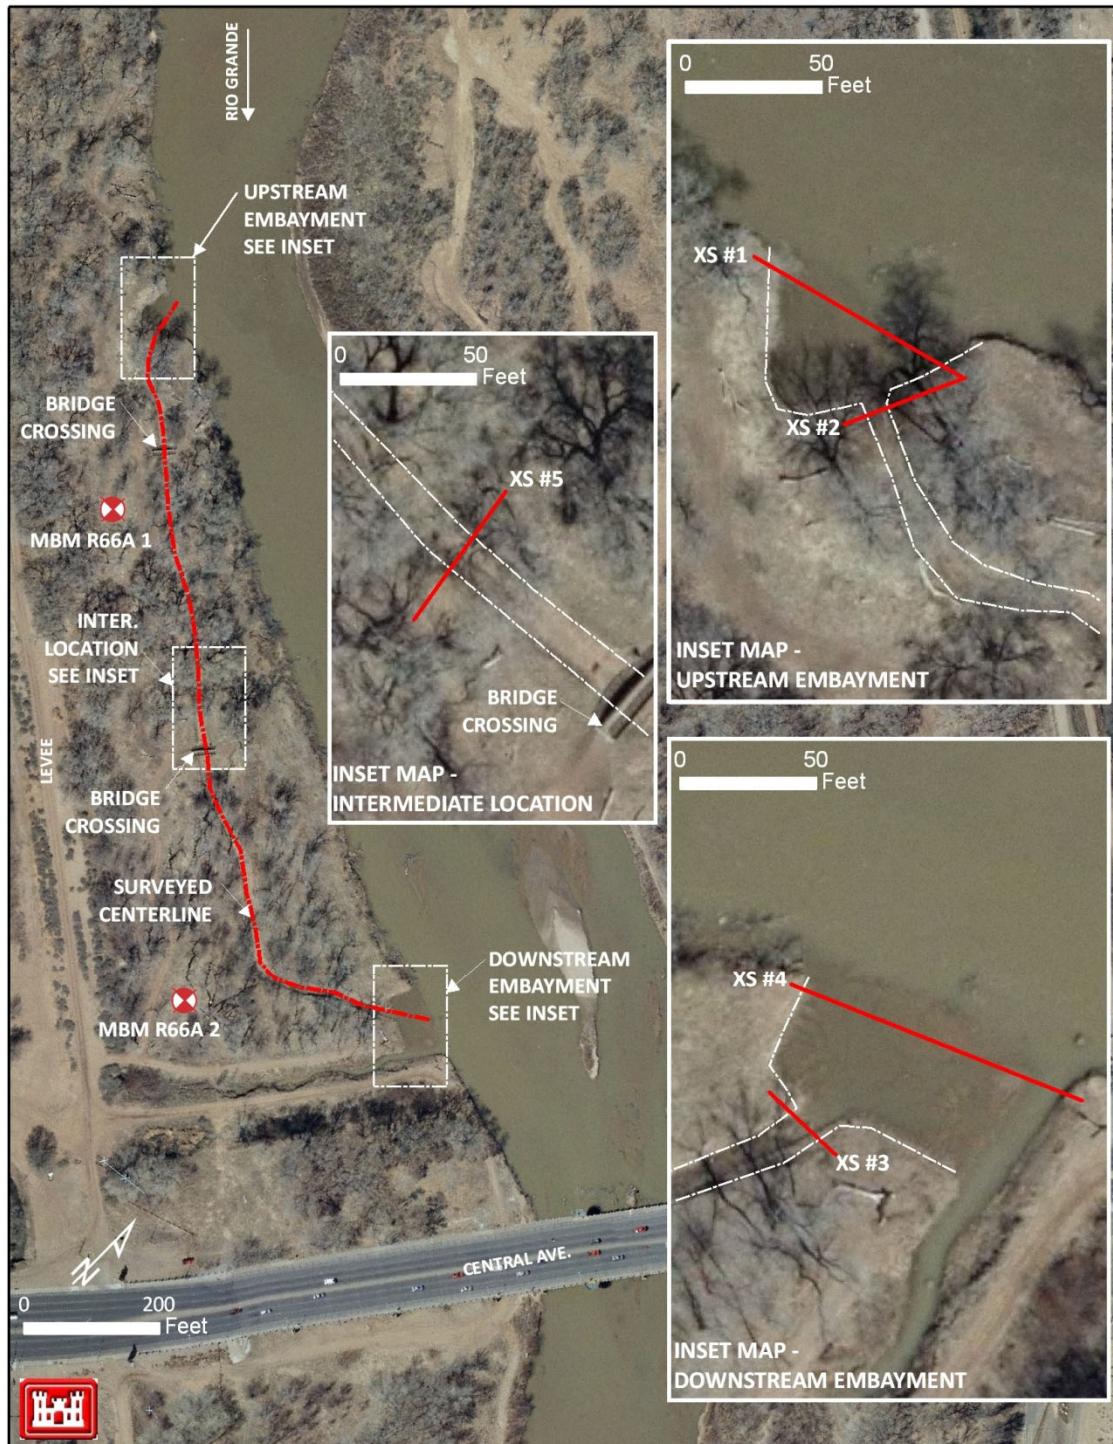
Figure 3 – Route 66 HFC ‘A’ Site Layout.

The channel was created as part of the Bosque Revitalization @ Route 66 project. This channel was completed in 2009. The Site Layout for the R66 HFC ‘A’ is shown as Figure 3. The channel is earth lined and is approximately 1,230 feet long and 10 feet wide. The channel was designed as trapezoidal in shape, with 3H to 1V side slopes. The channel is designed to flow at a depth of 0.5 feet across the high point, when the Rio Grande is flowing at ~3,000 cfs. The channel begins flowing when the Rio Grande

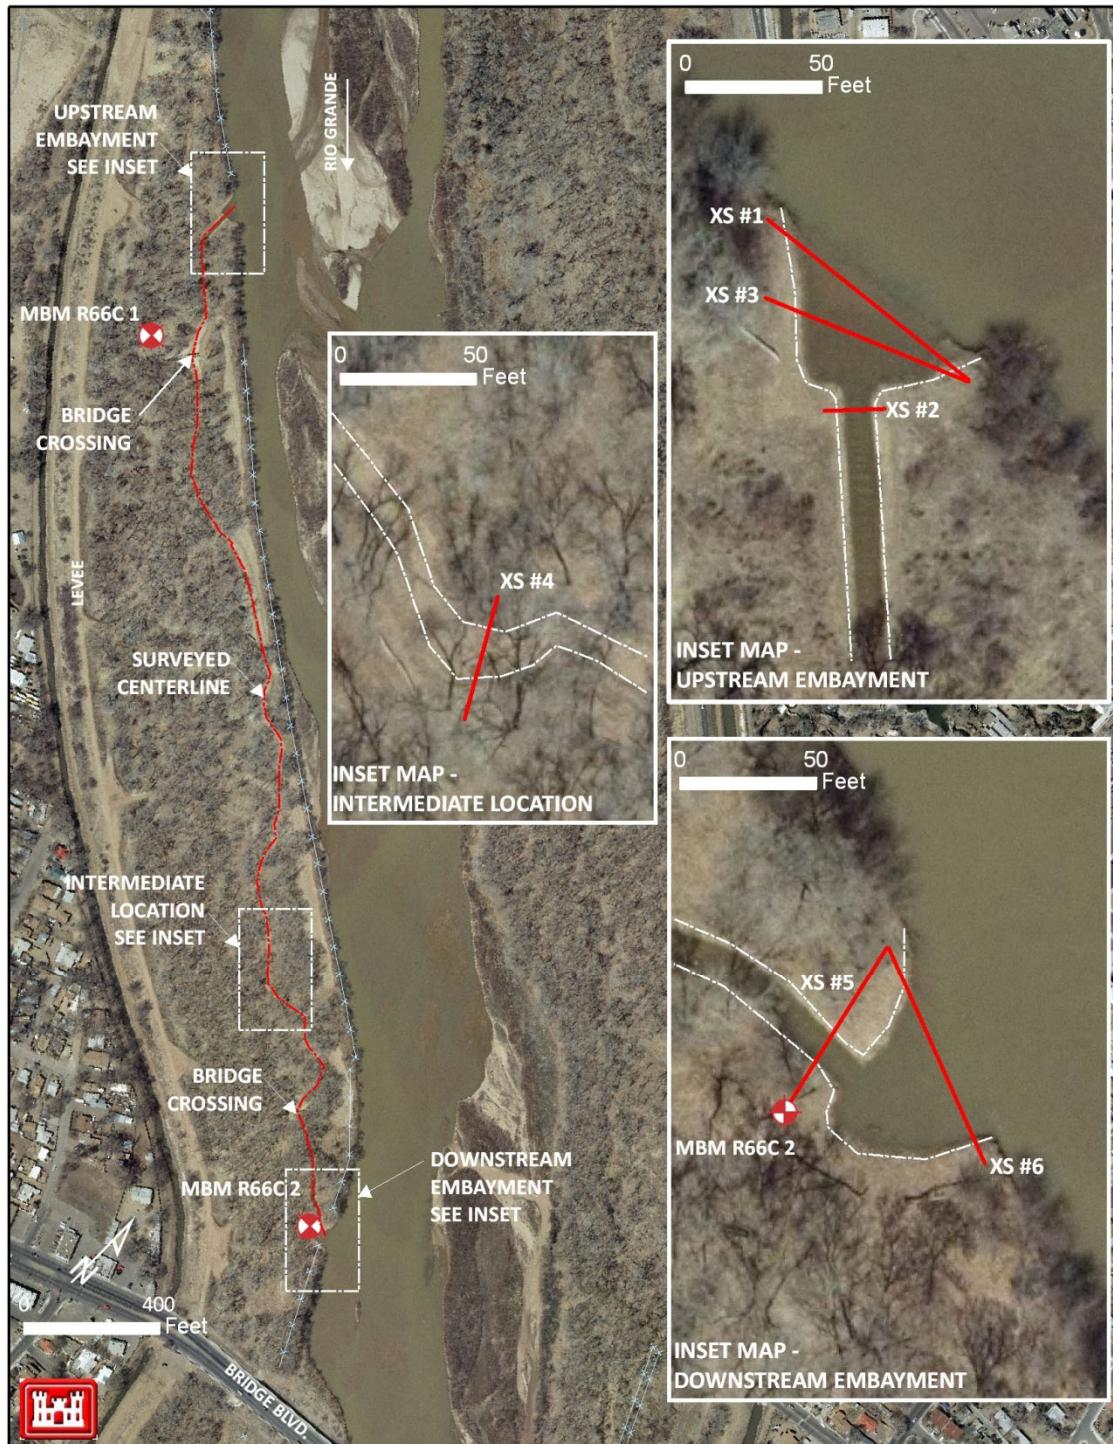
Figure 4 - Route 66 HFC 'C' Site Layout.

The channel was created as part of the Bosque Revitalization @ Route 66 project. This channel was completed in 2009. The Site Layout for the R66 HFC ‘C’ is shown as Figure 4. The channel is earth lined and is approximately 3,330 feet long and 10 feet wide. The channel was designed as trapezoidal in shape, with 3H to 1 V side slopes. The channel is designed to flow at depth of 0.5 feet across the high point, when the Rio Grande is flowing at ~3,000 cfs. The channel begins flowing when the Rio Grande flows at ~ 2,000 to 2,500 cfs. An upstream and downstream embayment was included as well as multiple bridge crossings for pedestrian access.

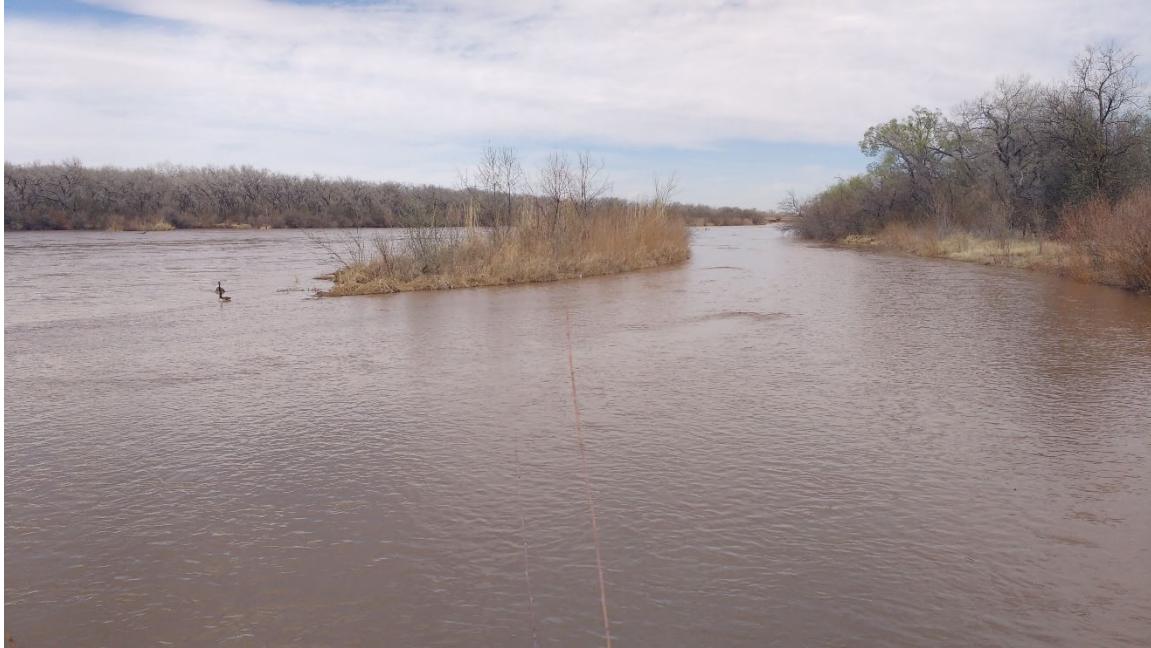
**Looking upstream at the Rio Grande River from the Rio Grande Nature Center HFC inlet (Photograph taken 22 March 2017).**

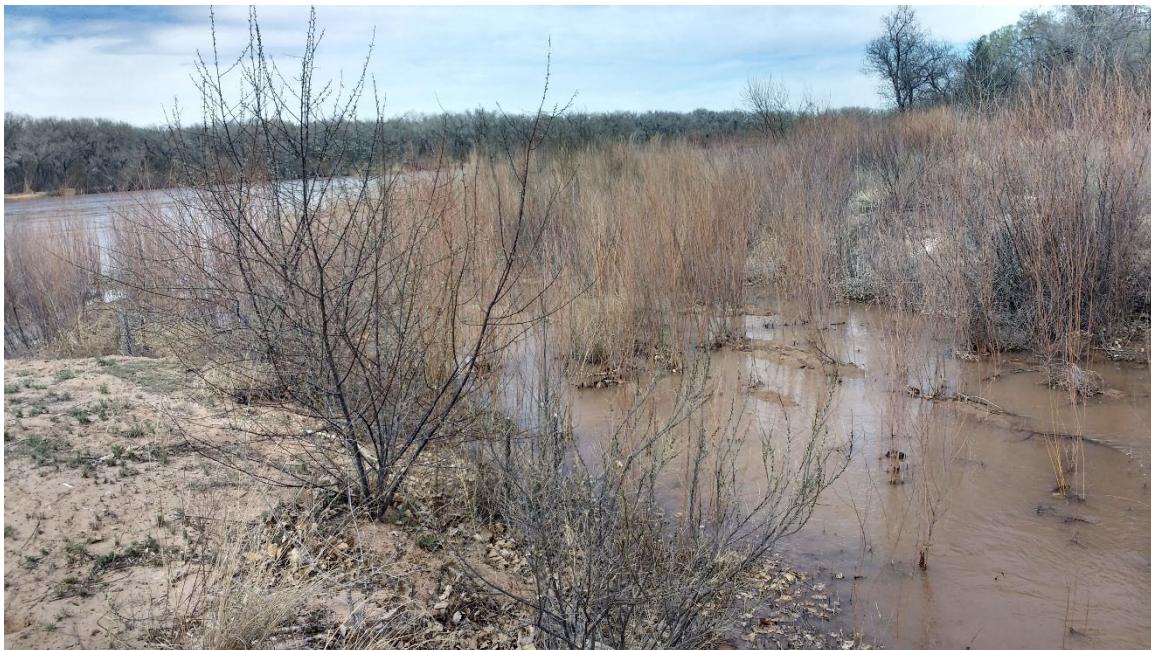
**Looking at the Rio Grande Nature Center HFC inlet (Photograph taken 22 March 2017).**

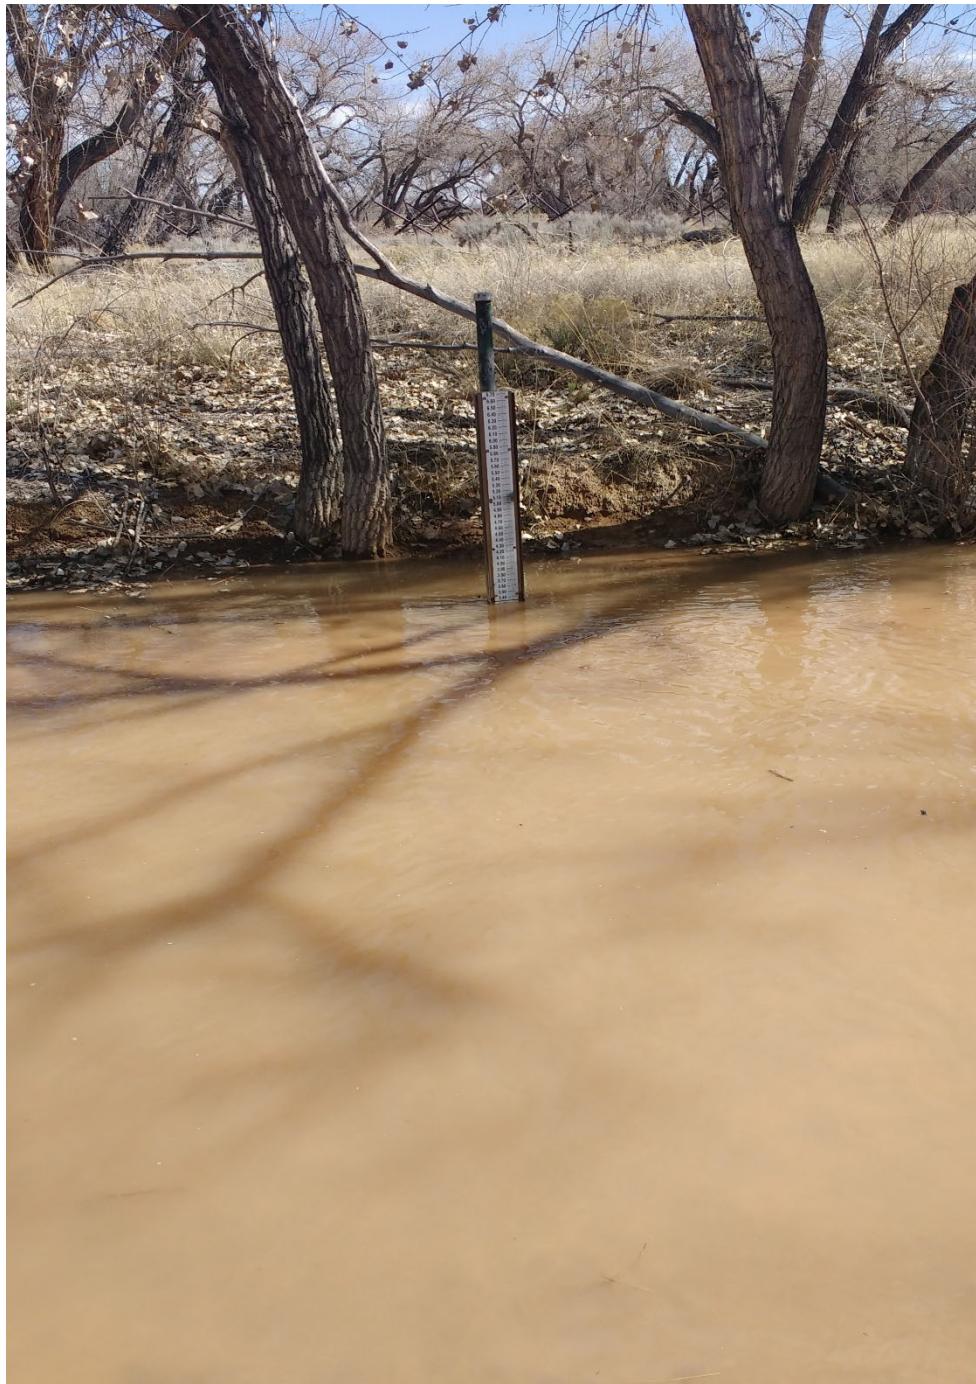
**Staff Gage at Rio Grande Nature Center HFC (Photograph taken 22 March 2017).**

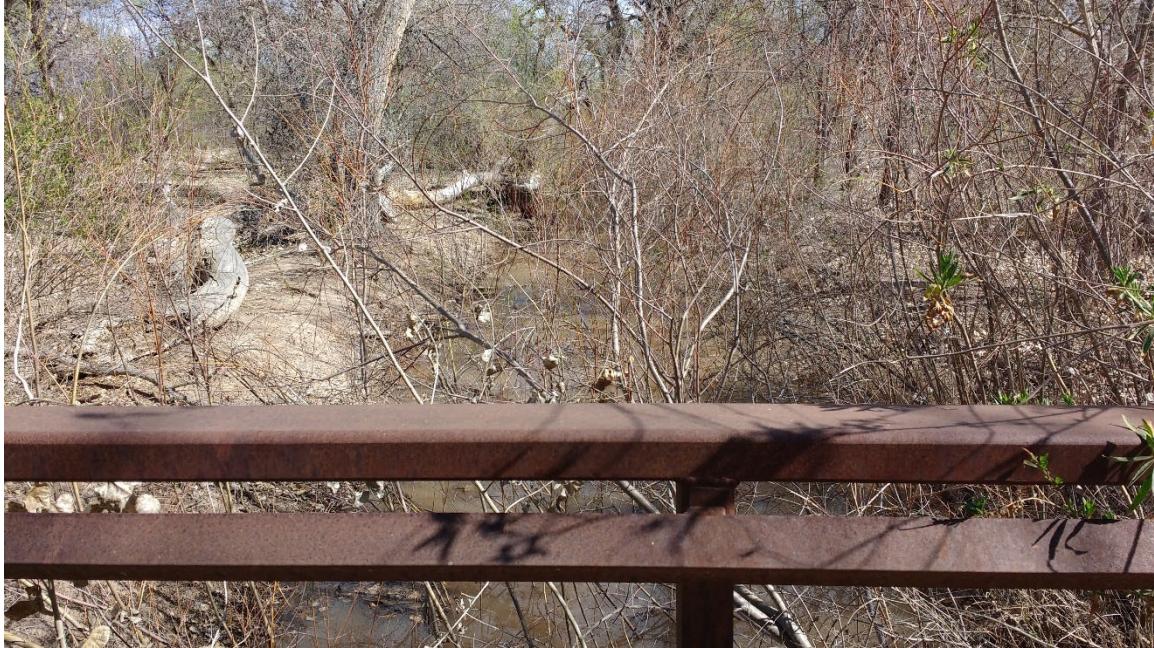
**Looking upstream from bridge at Route 66 HFC A (Photograph taken 22 March 2017).**

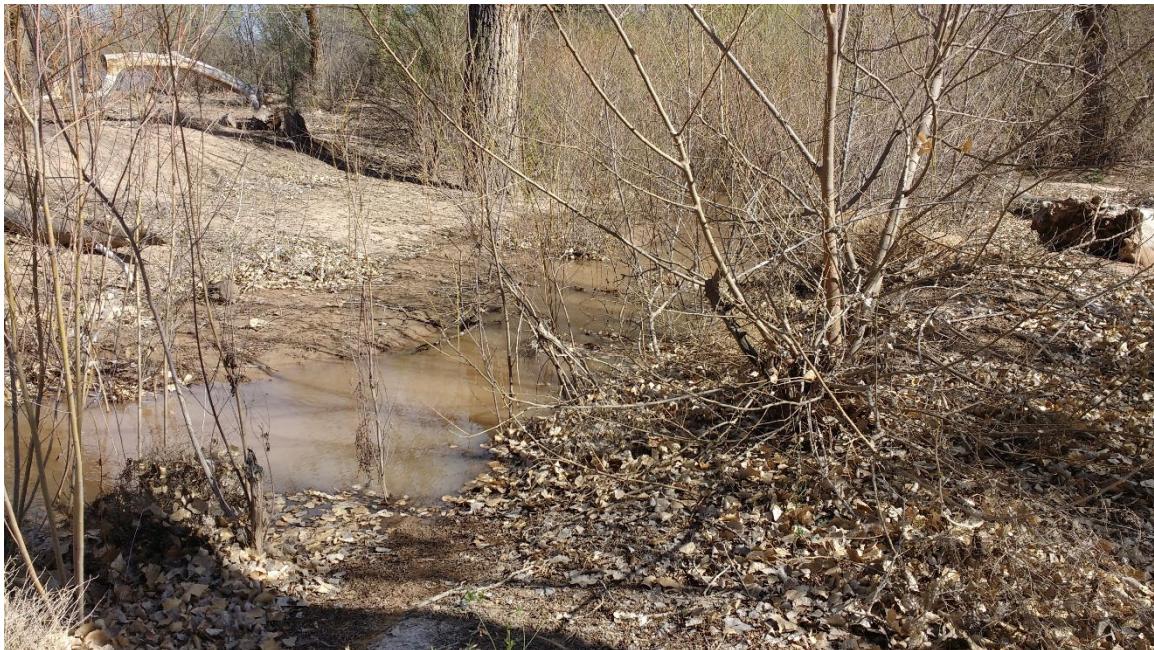
**Looking upstream at the Route 66 HFC A (Photograph taken 22 March 2017).**

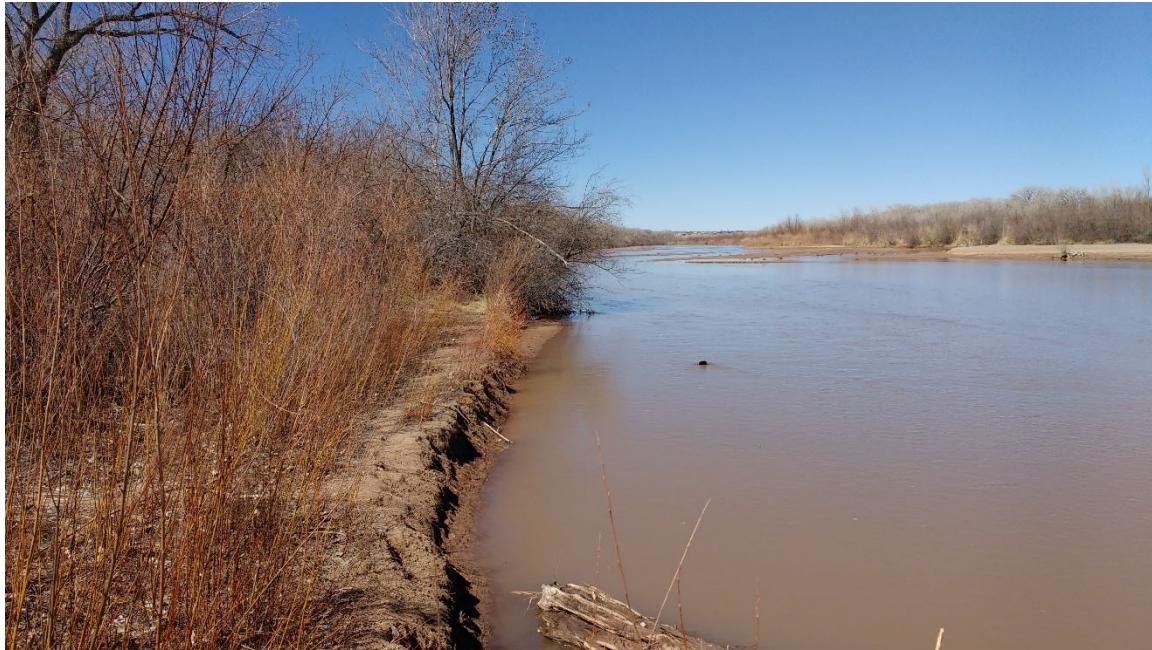
**Looking upstream on the Rio Grande at the Route 66 High Flow Channel 'C' from the downstream embayment (Photograph taken on 8 March 2017).**

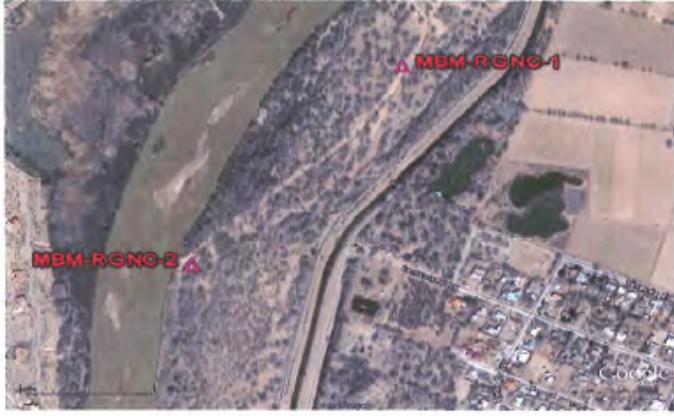
<b>Designation:</b> MBM RGNC 1 <b>Project:</b> RIO GRANDE RESTORATION SITE <b>Stamping:</b> MBM RGNC 1 <b>PID NGS:</b> _____ <b>COE:</b> _____ <b>State:</b> New Mexico <b>County:</b> BERNALILLO <b>District:</b> Albuquerque <b>Nearest Town:</b> ALBUQUERQUE <b>USGS Quad:</b> _____ <b>T.R.S.:</b> T11N, R2E, S36 <b>Nearest Hwy/Mi:</b> _____ <b>Date Recovered:</b> 04/12/2011 <b>By:</b> WILSON & COMPANY <b>Condition/Stability:</b> Good C <b>Setting/Monument Type:</b> BRASS CAP <b>Owner:</b> COE <b>GPS Suitable:</b> <input checked="" type="radio"/> Yes <input type="radio"/> No <b>Obstructions:</b> <input type="checkbox"/> N <input type="checkbox"/> E <input type="checkbox"/> S <input type="checkbox"/> W <b>Magnetic:</b> <input checked="" type="radio"/> Yes <input type="radio"/> No <b>Access:</b> Coordinate with the City of Albuquerque Open Space Division and the Rio Grande Nature Center

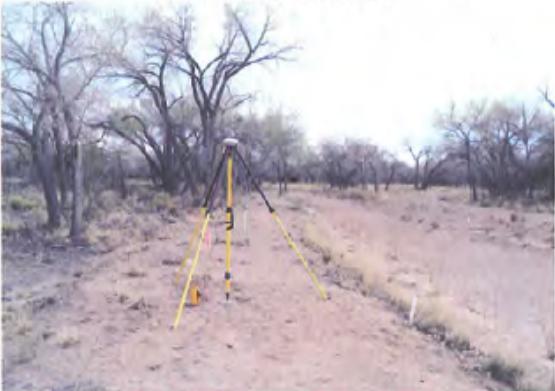
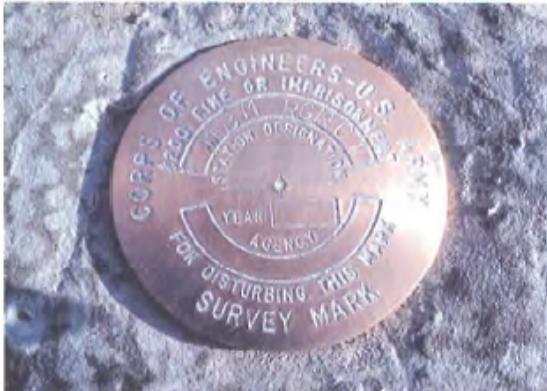
Owner:	Gage ID:	- Elevation -	- Datum -	Epoch:	_____	_____	_____	_____	_____	_____	_____	_____	_____	_____
Owner:	Gage ID:	- Elevation -	- Datum -	Epoch:													
_____	_____	_____	_____	_____													
_____	_____	_____	_____	_____													
<b>- State Plane Coordinates -</b> <b>Zone:</b> _____ <b>Northing:</b> _____ <b>USFT Easting:</b> _____ <b>USFT Convergence:</b> _____ <b>CSF:</b> _____																	
<b>- Horizon/Setup View -</b>

<b>- Close-Up View-</b>

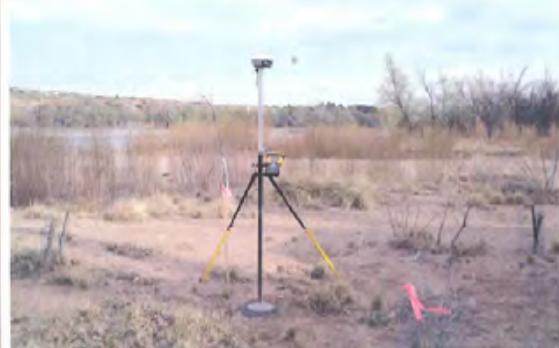
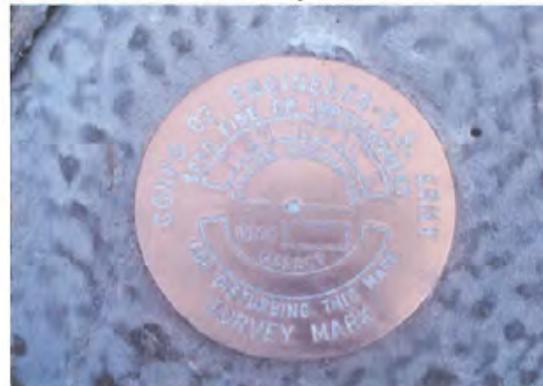
**- Horizon/Setup View -**

**- Close-Up View-**

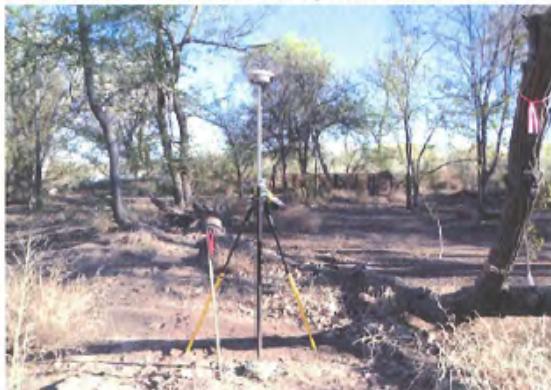
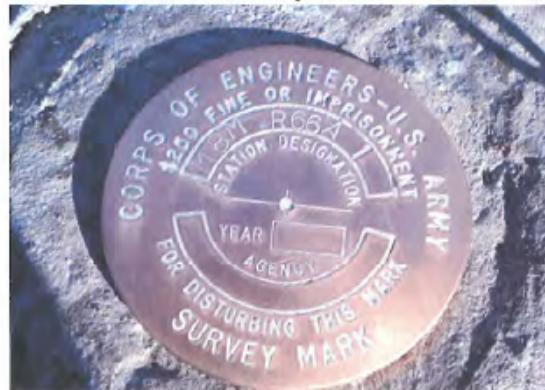
**- Horizon/Setup View -**

**- Close-Up View -**

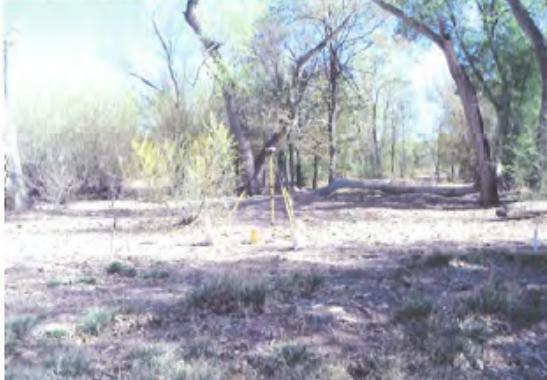
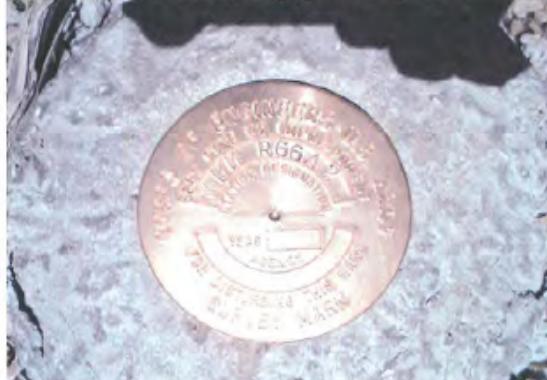
Owner:	Gage ID:	- Elevation -	- Datum -	Epoch:	_____	_____	_____	_____	_____	_____	_____	_____	_____	_____
Owner:	Gage ID:	- Elevation -	- Datum -	Epoch:														
_____	_____	_____	_____	_____														
_____	_____	_____	_____	_____														
<p><b>Description/Comments:</b> This station is located 467.72 feet northwest from the intersection of Central Ave. and the Albuquerque West Unit of the Middle Rio Grande Levee. 158.1 feet northeast of the centerline of the Middle Rio Grande Levee.</p>																		
<p><b>- State Plane Coordinates -</b></p> <p><b>Zone:</b> _____ <b>Northing:</b> _____ <b>USFT Easting:</b> _____ <b>USFT Convergence:</b> _____ <b>CSF:</b> _____</p>																		
<p><b>- Horizon/Setup View -</b></p>

<p><b>- Close-Up View -</b></p>

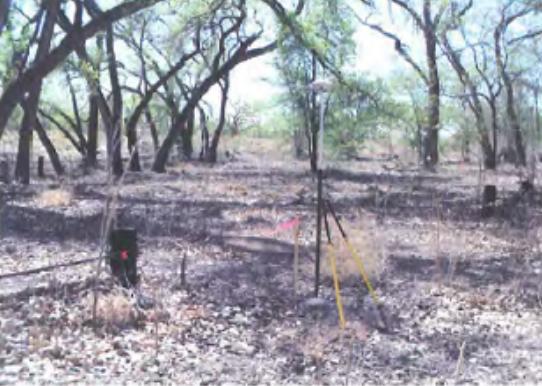
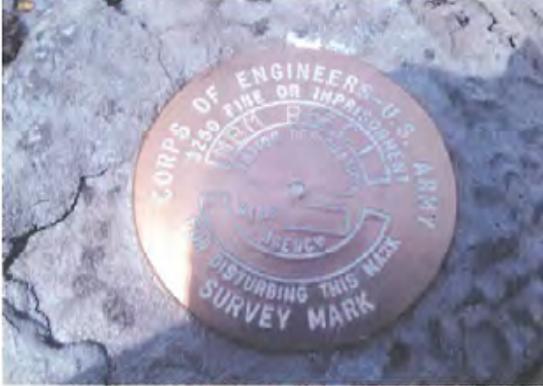
<p><b>- Horizontal -</b></p> <p>Datum: NAD83 ( 2002.0000 )            Lat: 35 04 30.29630 N            Lon: 106 40 12.14187 W</p> <p>Local Accuracy: _____            NSRS Accuracy: _____</p> <p><b>Survey/Computation Method:</b>            RTK  <b>Date Observed:</b> 04/14/2011</p> <p><b>- Vertical -</b></p> <p>Datum: NAVD83 ( )            Elevation Ht: 4,949.81            Ellip Ht: _____</p> <p>Local Accuracy: _____            NSRS Accuracy: _____</p> <p><b>Survey/Computation Method:</b>            Geodetic Levels  <b>Date Observed:</b> 04/14/2011</p> <p><b>- Tidal/Hydraulic Gage Relationships -</b></p> <table border="1" style="width: 100%; border-collapse: collapse;"> <thead> <tr> <th style="width: 25%;">Owner:</th> <th style="width: 25%;">Gage ID:</th> <th style="width: 25%;">- Elevation -</th> <th style="width: 25%;">- Datum -</th> </tr> </thead> <tbody> <tr> <td>_____</td> <td>_____</td> <td>_____</td> <td>_____</td> </tr> </tbody> </table> <p><b>Description/Comments:</b> This station is located 3007.9 feet northwest from the intersection of Bridge Ave. and the Albuquerque West Unit of the Middle Rio Grande Levee. 196.5 feet northeast of the centerline of the Middle Rio Grande Levee and 131.6 feet west of the center of a pedestrian bridge over the Route 66 High Flow Channel 'C'.</p>	Owner:	Gage ID:	- Elevation -	- Datum -	_____	_____	_____	_____	_____	_____	_____	_____	_____	_____	_____	_____	_____	_____	_____	_____
Owner:	Gage ID:	- Elevation -	- Datum -																		
_____	_____	_____	_____																		
_____	_____	_____	_____																		
_____	_____	_____	_____																		
_____	_____	_____	_____																		
<b>- State Plane Coordinates -</b> Zone: _____ Northing: _____ USFT Easting: _____ USFT Convergence: _____ CSP: _____																					
<b>- Horizon/Setup View -</b>

<b>- Close-Up View-</b>

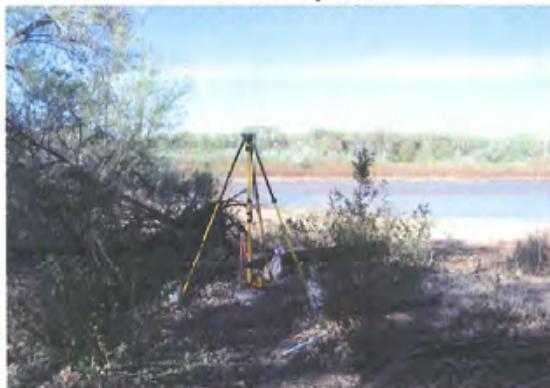
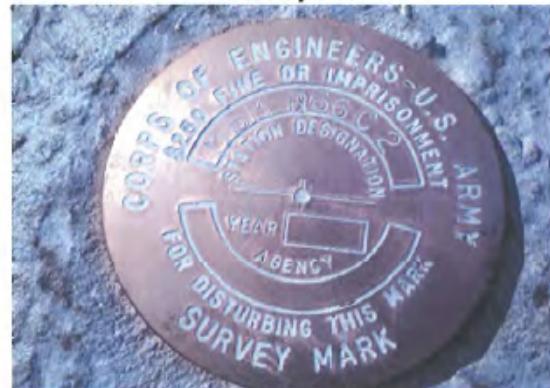
**- Horizon/Setup View -**

**- Close-Up View-**

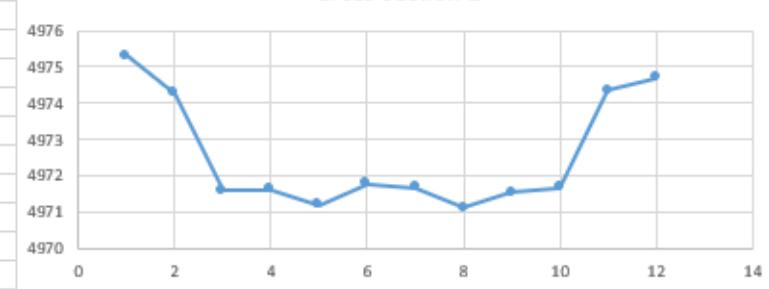
Number	Northing	Easting	Elevation	Description	Site	Type	Order_
12028	1504935	1510504	4975.29	REBAR L	Site 1	Cross Section 1	1
12027	1504936	1510503	4974.27	TOP	Site 1	Cross Section 1	2
12026	1504925	1510497	4971.58	TOE	Site 1	Cross Section 1	3
12025	1504910	1510497	4971.62	GROUND	Site 1	Cross Section 1	4
12024	1504909	1510496	4971.19	THLWG	Site 1	Cross Section 1	5
12023	1504908	1510493	4971.77	GROUND	Site 1	Cross Section 1	6
12022	1504905	1510487	4971.65	GROUND	Site 1	Cross Section 1	7
12021	1504905	1510484	4971.11	THLWG	Site 1	Cross Section 1	8
12020	1504904	1510482	4971.54	GROUND	Site 1	Cross Section 1	9
12019	1504904	1510476	4971.66	TOE	Site 1	Cross Section 1	10
12018	1504901	1510474	4974.34	TOP	Site 1	Cross Section 1	11
12017	1504900	1510473	4974.68	REBAR R	Site 1	Cross Section 1	12

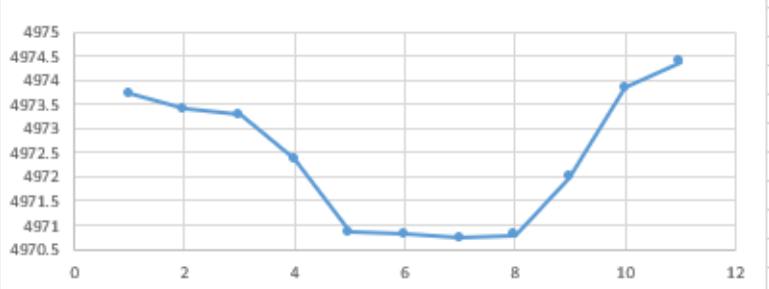
Number	Northing	Easting	Elevation	Description	Site	Type	Order_
12001	1505070	1510549	4973.73	REBAR L	Site 1	Cross Section 2	1
12002	1505062	1510542	4973.4	GROUND	Site 1	Cross Section 2	2
12005	1505046	1510523	4973.28	TOP	Site 1	Cross Section 2	3
12006	1505033	1510513	4972.37	TOE	Site 1	Cross Section 2	4
12007	1505030	1510508	4970.84	WATER	Site 1	Cross Section 2	5
12041	1504994	1510468	4970.82	SAND BAR	Site 1	Cross Section 2	6
12042	1504967	1510441	4970.72	SAND BAR	Site 1	Cross Section 2	7
12029	1504964	1510417	4970.79	SAND BAR	Site 1	Cross Section 2	8
12014	1504949	1510391	4971.99	TOE	Site 1	Cross Section 2	9
12015	1504942	1510380	4973.84	TOP	Site 1	Cross Section 2&2	127
12016	1504942	1510379	4974.37	REBAR R	Site 1	Cross Section 2&2	138

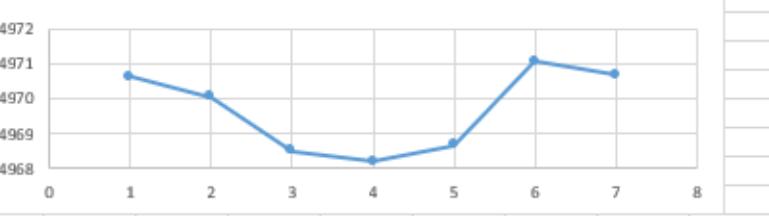
Number	Northing	Easting	Elevation	Description	Site	Type	Order_
24030	1502574	1509111	4970.62	REBAR L	Site 1	Cross Section 3	1
24031	1502575	1509111	4970.05	TOP	Site 1	Cross Section 3	2
24032	1502577	1509110	4968.5	TOE	Site 1	Cross Section 3	3
24033	1502587	1509102	4968.2	GROUND	Site 1	Cross Section 3	4
24034	1502602	1509097	4968.66	TOE	Site 1	Cross Section 3	5
24035	1502608	1509092	4971.07	REBAR R	Site 1	Cross Section 3	7
24036	1502607	1509092	4970.67	TOP	Site 1	Cross Section 3	6

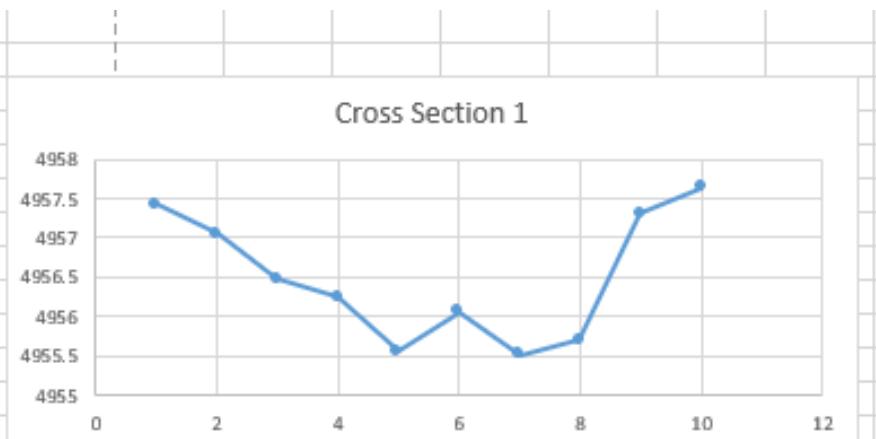
Number	Northing	Easting	Elevation	Description	Site	Type
11000	1488517	1510134	4957.42	REBAR L	Site 2	Cross Section 1
11001	1488524	1510123	4957.05	TOP	Site 2	Cross Section 1
11002	1488527	1510115	4956.48	GRND	Site 2	Cross Section 1
11003	1488527	1510106	4956.25	BRKLN	Site 2	Cross Section 1
11004	1488528	1510103	4955.56	TOE	Site 2	Cross Section 1
11005	1488531	1510087	4956.06	GRND	Site 2	Cross Section 1
11006	1488544	1510061	4955.52	GRND	Site 2	Cross Section 1
11007	1488557	1510050	4955.7	TOE	Site 2	Cross Section 1
11008	1488566	1510039	4957.3	TOP	Site 2	Cross Section 1
11009	1488569	1510042	4957.64	REBAR R	Site 2	Cross Section 1

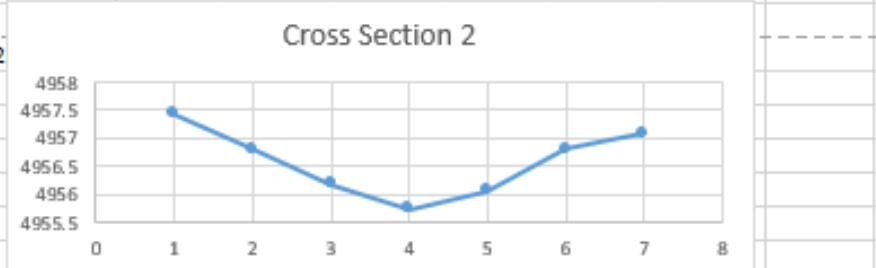
Number	Northing	Easting	Elevation	Description	Site	Type
11000	1488517	1510134	4957.42	REBAR L	Site 2	Cross Section 1&2
11012	1488520	1510117	4956.79	TOP	Site 2	Cross Section 2
11013	1488516	1510110	4956.17	TOE	Site 2	Cross Section 2
11014	1488510	1510102	4955.73	CENTER	Site 2	Cross Section 2
11015	1488505	1510096	4956.06	TOE	Site 2	Cross Section 2
11016	1488502	1510092	4956.8	TOP	Site 2	Cross Section 2
11017	1488504	1510079	4957.08	REBAR R	Site 2	Cross Section 2

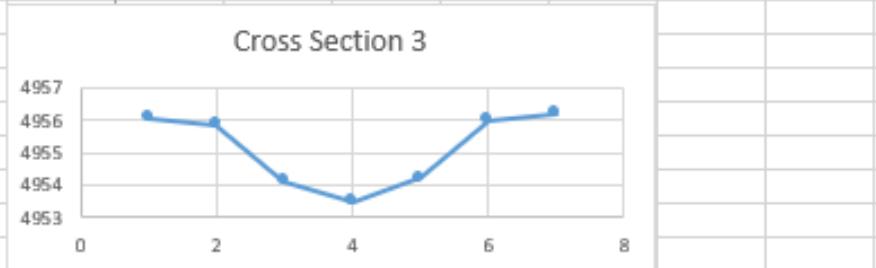
Number	Northing	Easting	Elevation	Description	Site	Type
22015	1488059	1511031	4956.07	REBAR L	Site 2	Cross Section 3
22016	1488056	1511032	4955.85	TOP	Site 2	Cross Section 3
22017	1488054	1511033	4954.1	TOE	Site 2	Cross Section 3
22018	1488048	1511038	4953.49	THLWG	Site 2	Cross Section 3
22019	1488043	1511039	4954.22	TOE	Site 2	Cross Section 3
22020	1488038	1511042	4955.99	TOP	Site 2	Cross Section 3
22021	1488033	1511046	4956.21	REBAR R	Site 2	Cross Section 3

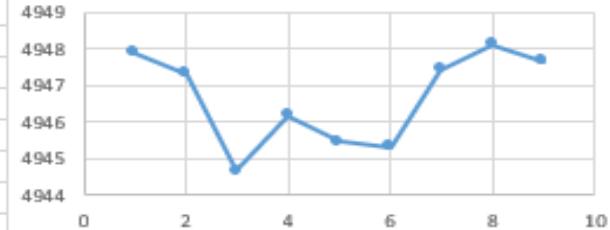
Cross Section 4												
Number	Northing	Easting	Elevation	Description	Site	Type						
20028	1481938	1516140	4947.9	GROUND	Site 3	Cross Section 4						
20026	1481922	1516130	4947.32	TOP	Site 3	Cross Section 4						
20027	1481918	1516130	4944.67	REBAR L	Site 3	Cross Section 4						
20024	1481914	1516128	4946.18	TOE	Site 3	Cross Section 4						
20025	1481907	1516128	4945.45	CENTER	Site 3	Cross Section 4						
20023	1481902	1516127	4945.32	TOE	Site 3	Cross Section 4						
20022	1481900	1516127	4947.44	TOP	Site 3	Cross Section 4						
20029	1481885	1516120	4948.13	REBAR R	Site 3	Cross Section 4						
20021	1481879	1516121	4947.67	GROUND	Site 3	Cross Section 4

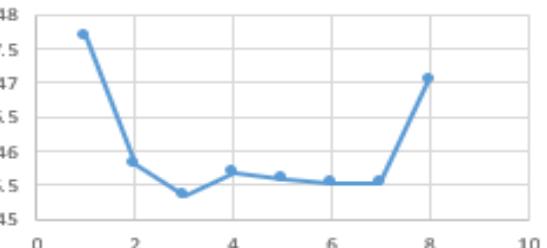
Number	Northing	Easting	Elevation	Description	Site	Type
10009	1481404	1516968	4947.68	REBAR L	Site 3	Cross Section 5&6
10008	1481396	1516976	4945.81	TOE	Site 3	Cross Section 6
10004	1481381	1516978	4945.35	GRND	Site 3	Cross Section 6
10005	1481375	1516984	4945.68	GRND	Site 3	Cross Section 6
20004	1481364	1516985	4945.61	GROUND	Site 3	Cross Section 6
10002	1481350	1516994	4945.54	GRND	Site 3	Cross Section 6
10001	1481340	1516995	4945.54	TOE	Site 3	Cross Section 6
10000	1481333	1516998	4947.05	REBARRIGHT	Site 3	Cross Section 6
