2019 Annual Monitoring Results and Maintenance Plan for San Acacia Reach Restoration Sites

Prepared for:
New Mexico Interstate Stream Commission
5550 San Antonio
Albuquerque, New Mexico 87109

Prepared by:
GeoSystems Analysis, Inc.
3150 Carlisle Blvd. NE,
Albuquerque, NM 87110
www.gsanalysis.com

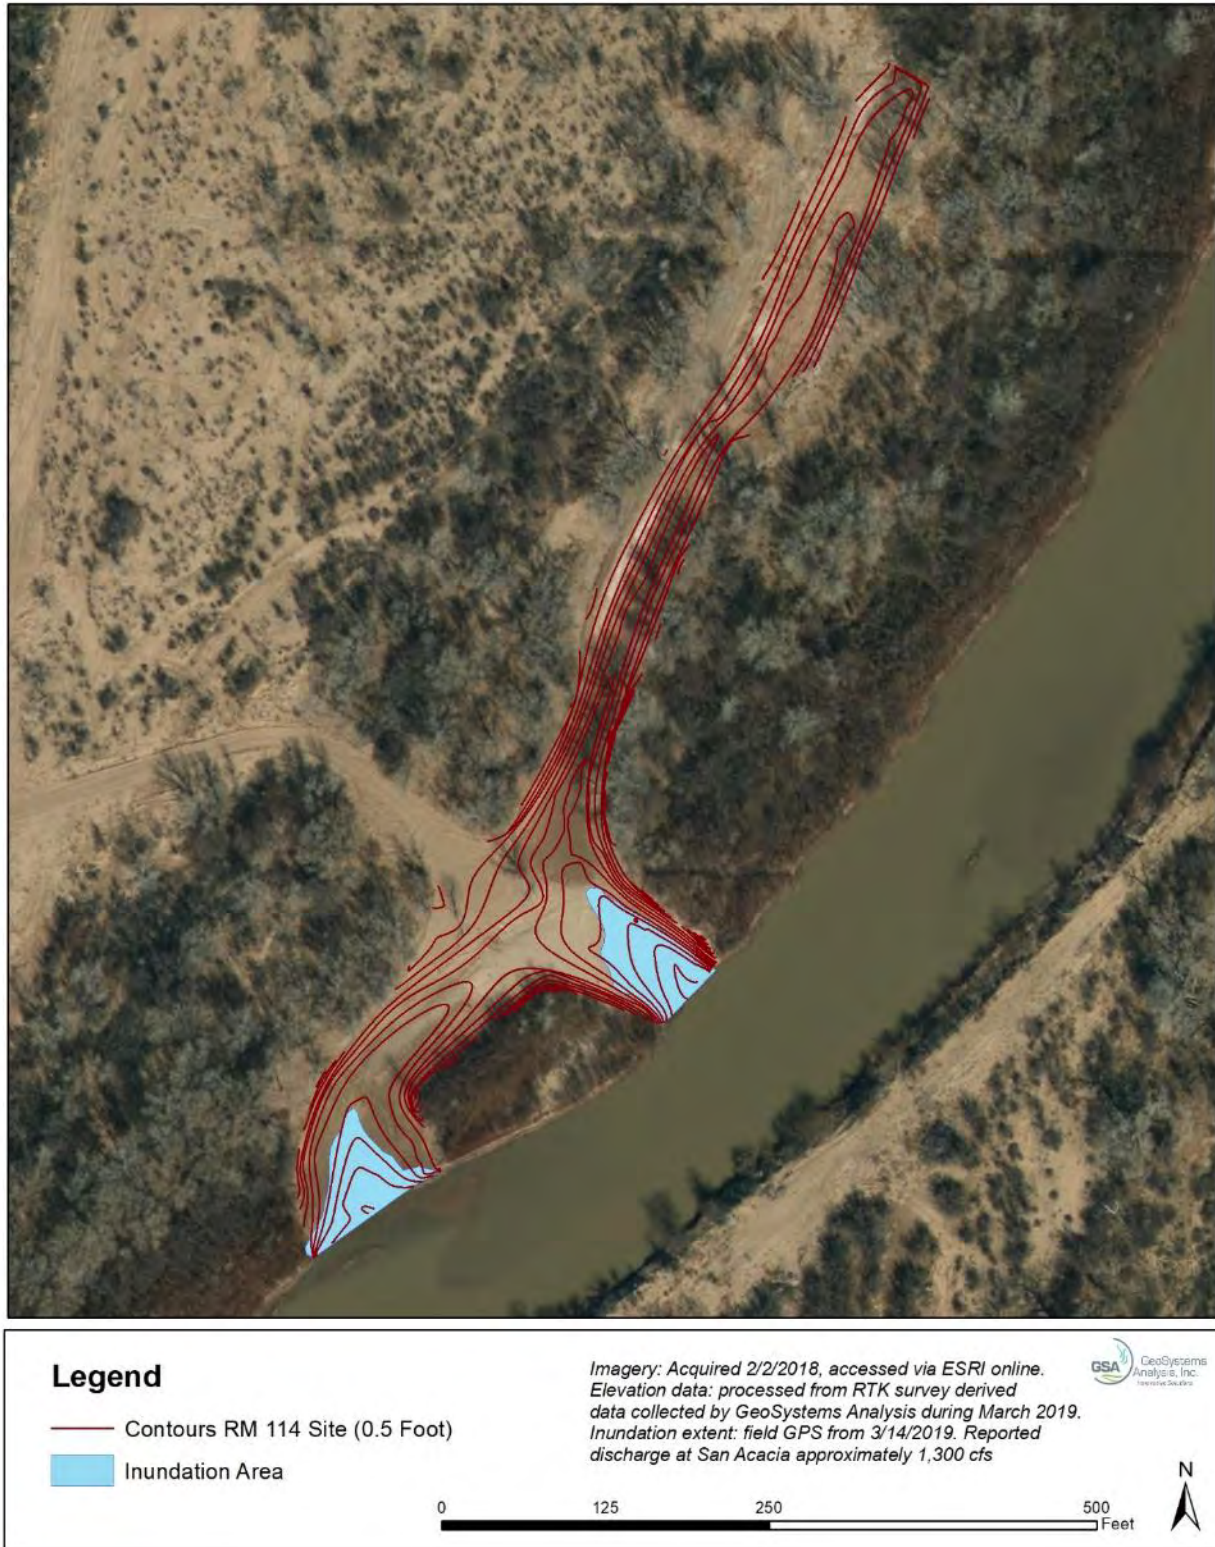
RM 114 March 14, 2019 Inundation Extent

Figure A-1. Inundation extent documented at RM 114 on March 14, 2019. Mean daily discharge at San Acacia gage was 1,310 cfs.

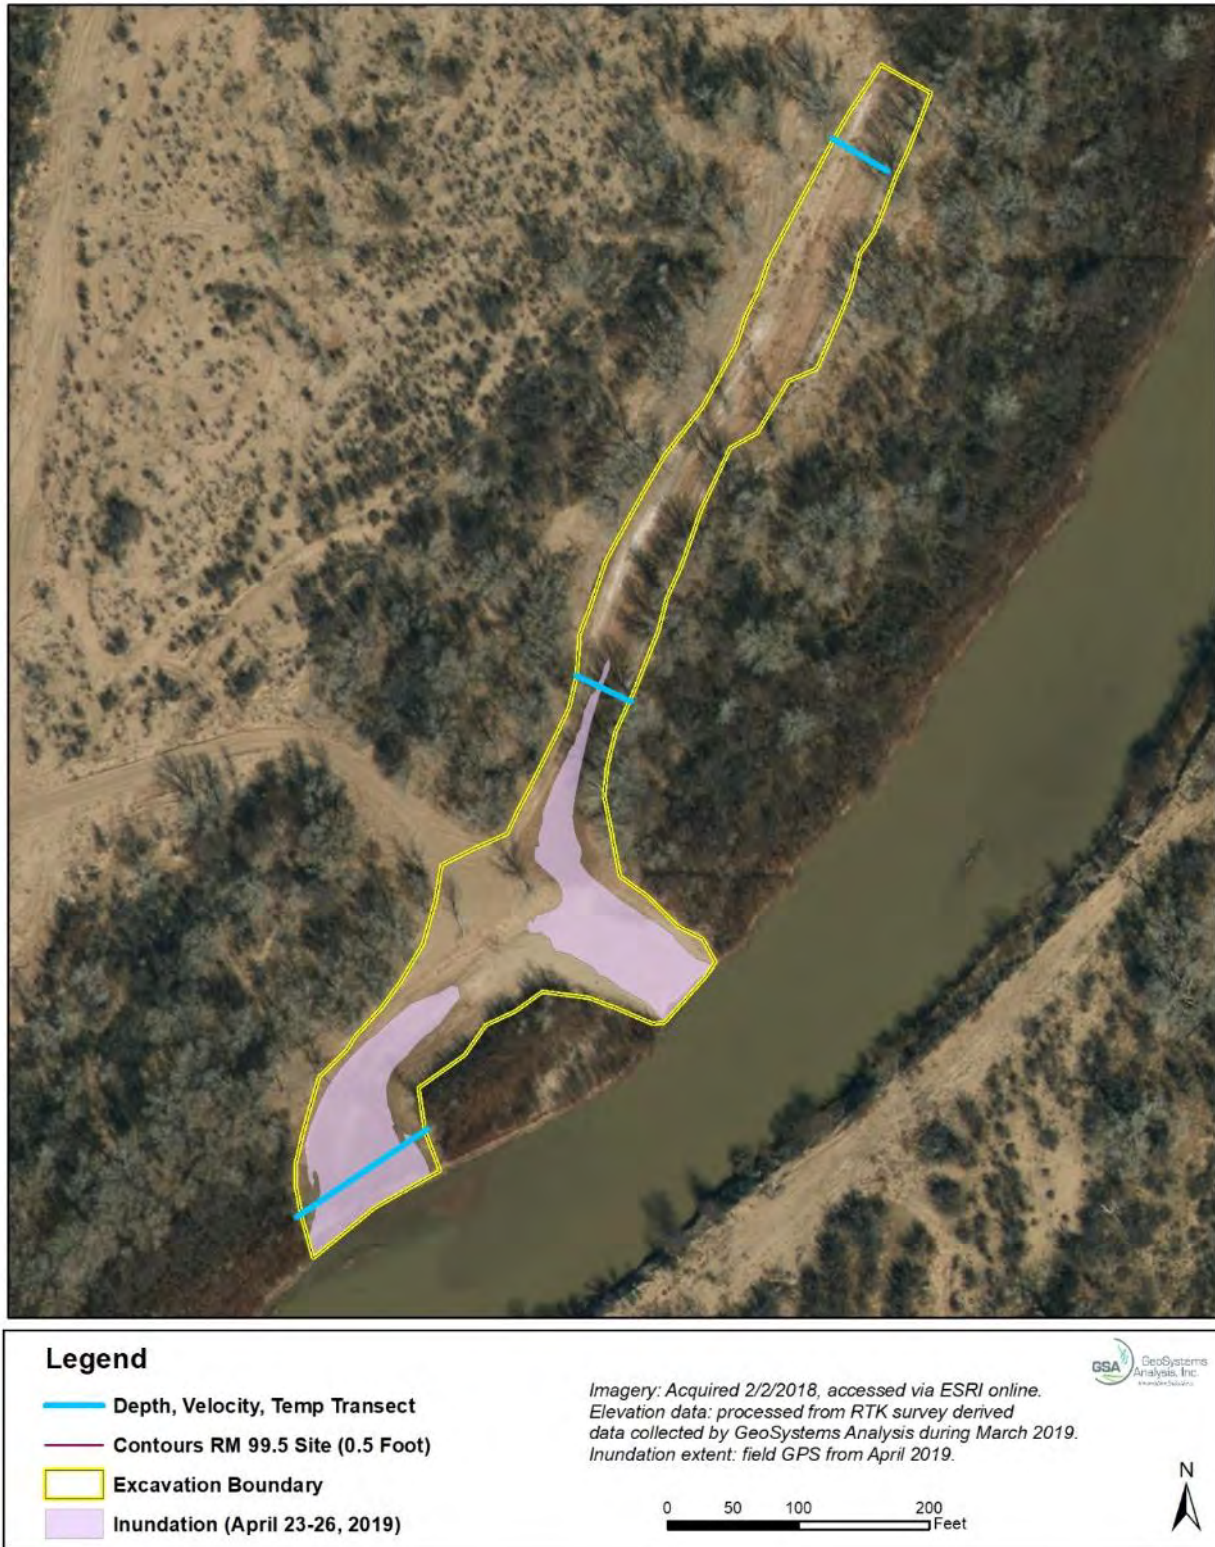
RM 114 April 23, 2019 Inundation Extent

Figure A-2. Inundation extent documented at RM 114 on April 23, 2019. Mean daily discharge at San Acacia gage was 2,530 cfs.

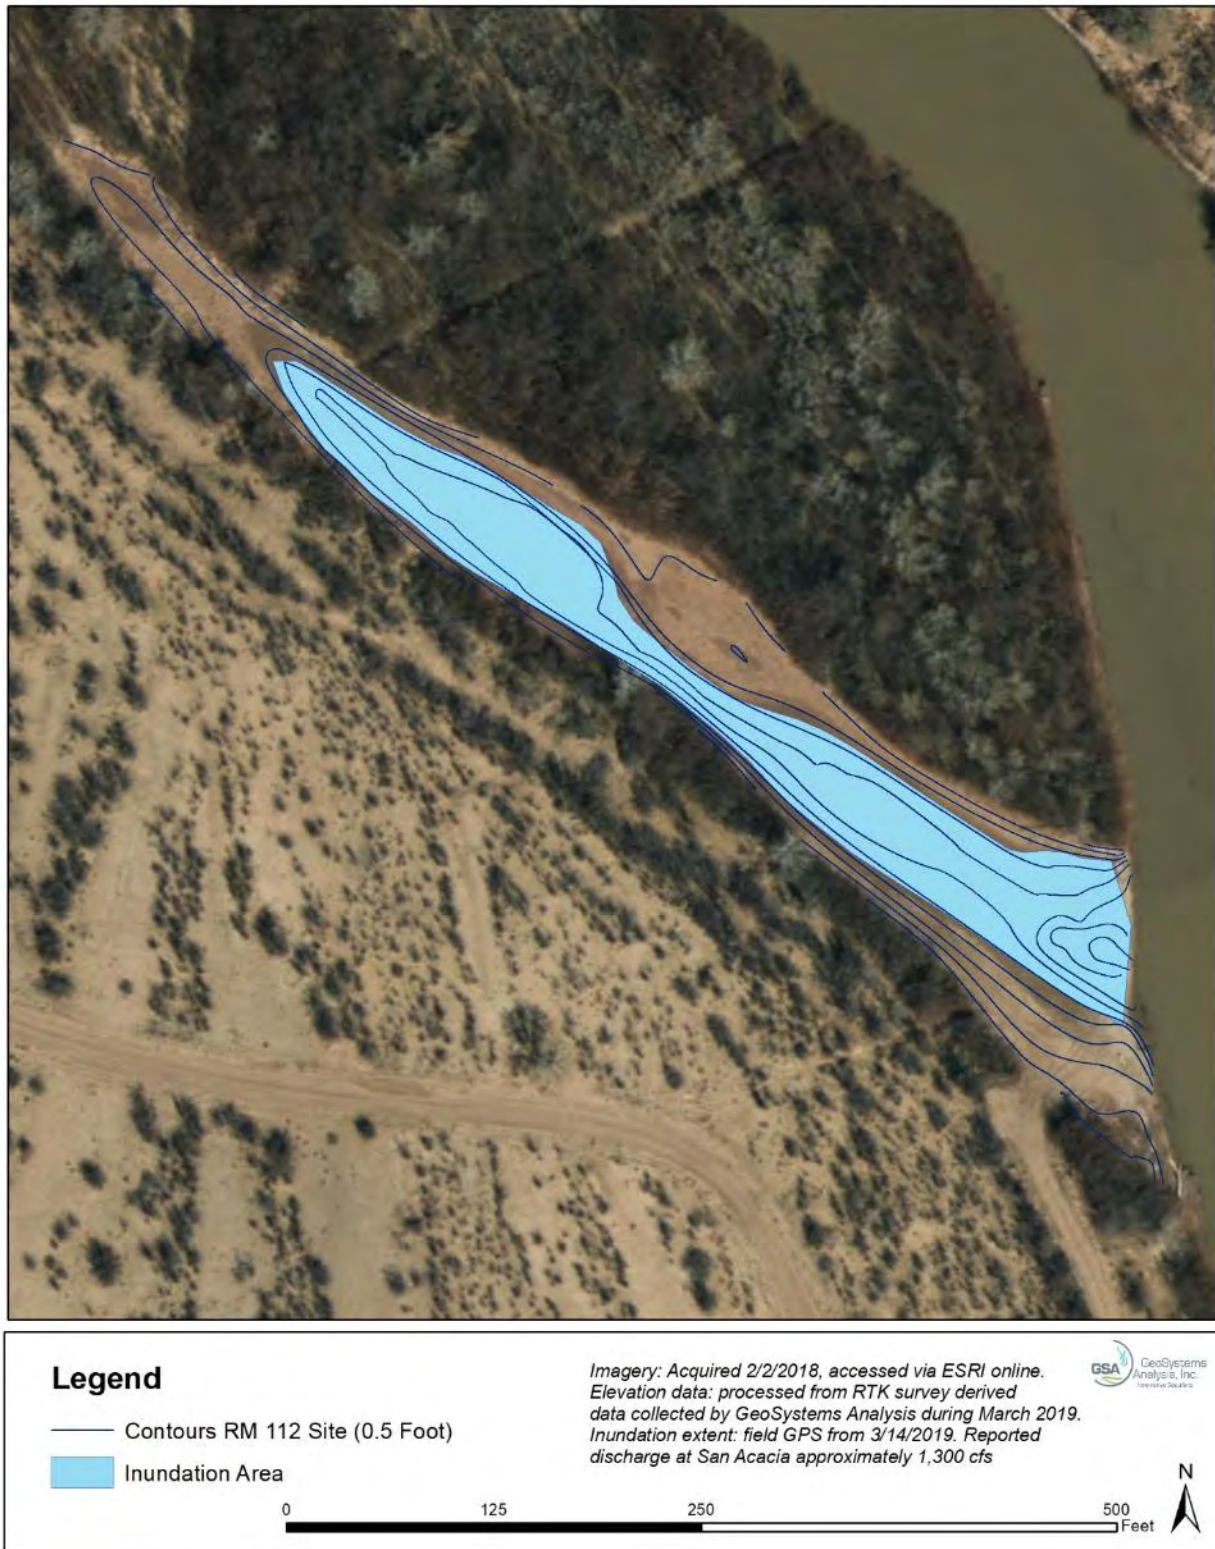
RM 112 March 14, 2019 Inundation Extent

Figure A-3. Inundation extent documented at RM 112 on March 14, 2019. Mean daily discharge at San Acacia gage was 1,310 cfs.

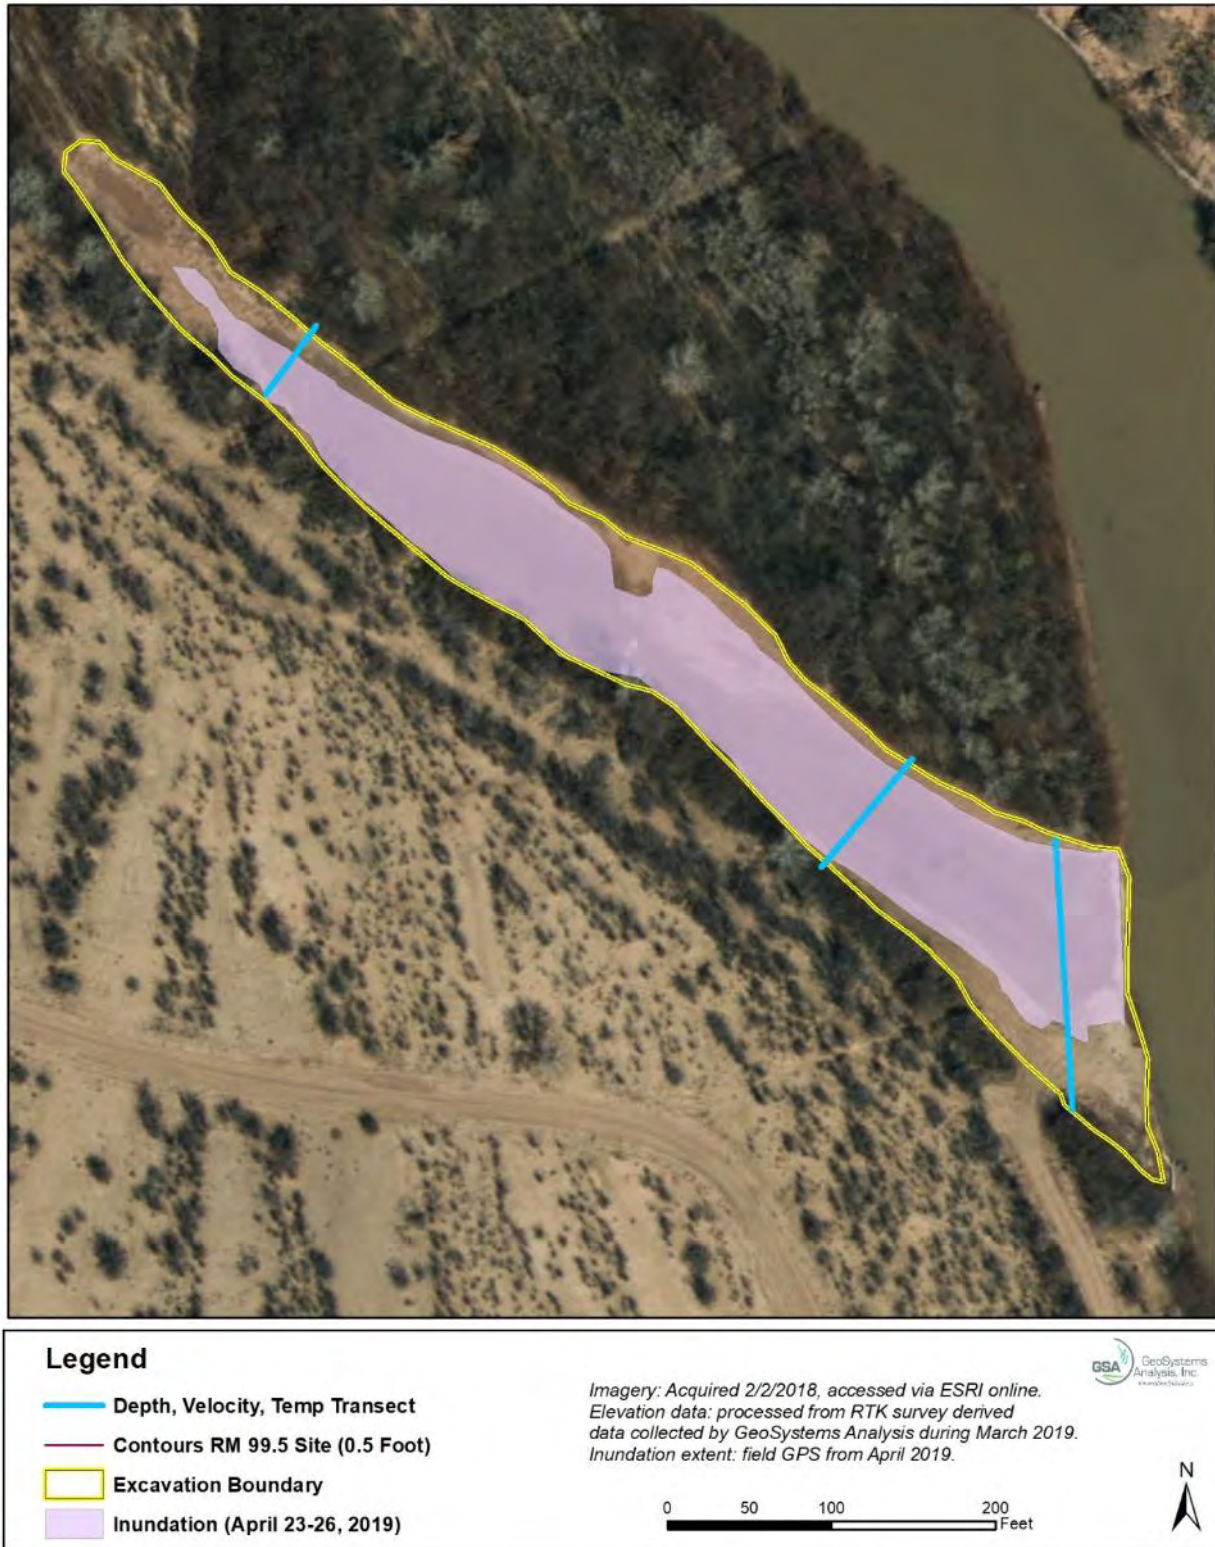
RM 112 April 23, 2019 Inundation Extent

Figure A-4. Inundation extent documented at RM 112 on April 23, 2019. Mean daily discharge at San Acacia gage was 2,530 cfs.

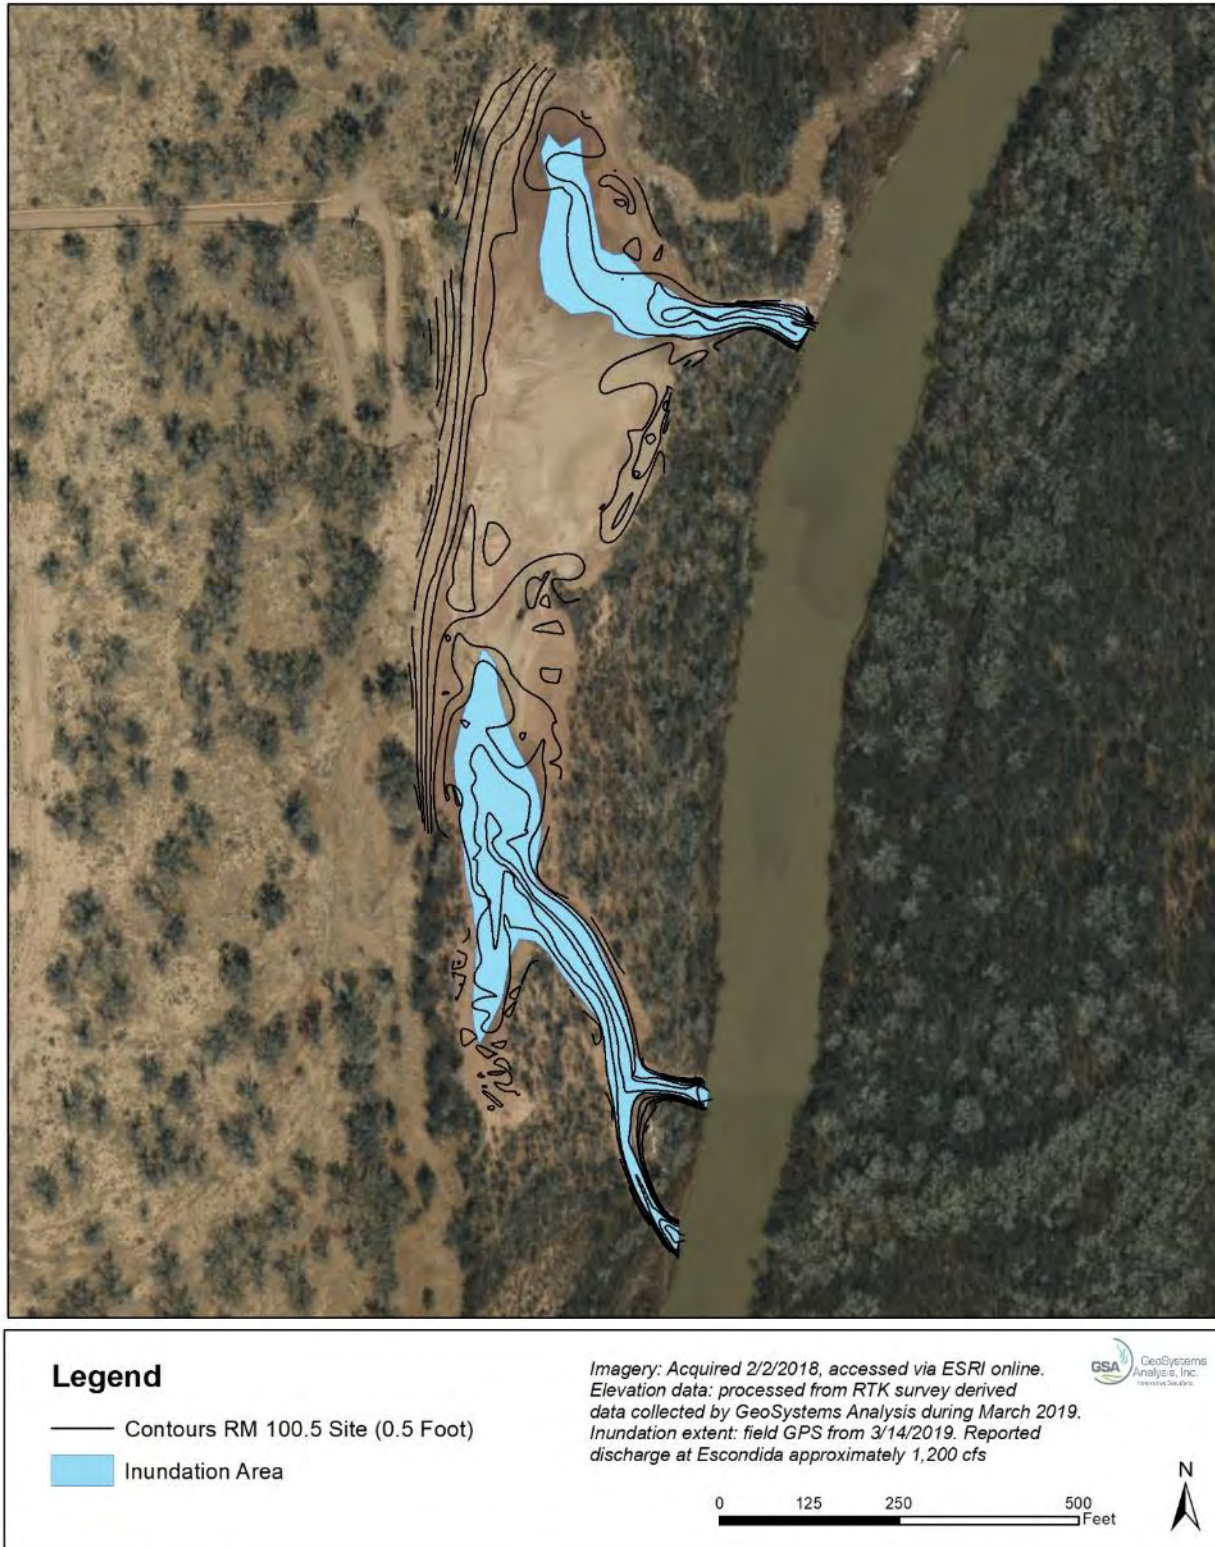
RM 100.5 March 14, 2019 Inundation Extent

Figure A-5. Inundation extent documented at RM 100.5 on March 14, 2019. Mean daily discharge at the Escondida gage was 1,190 cfs.

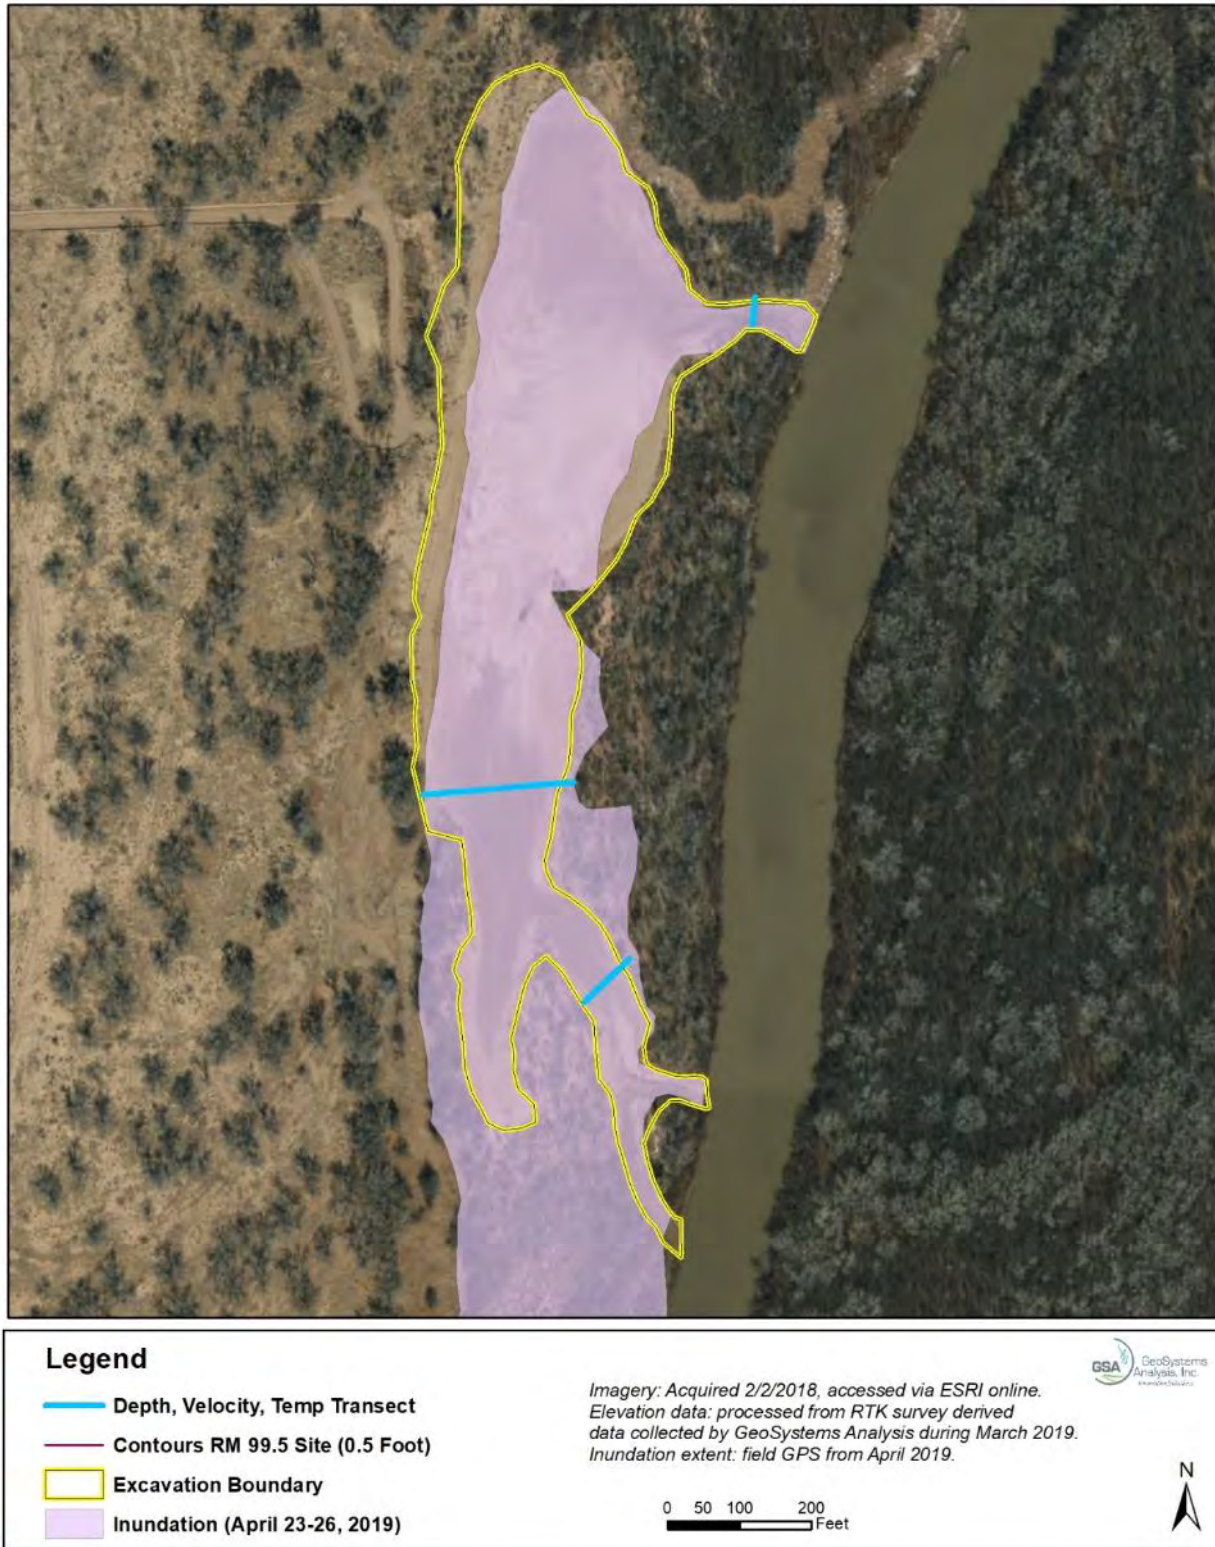
RM 100.5 April 24, 2019 Inundation Extent

Figure A-6. Inundation extent documented at RM 100.5 on April 23, 2019. Mean daily discharge at the Escondida gage was 2,560 cfs.

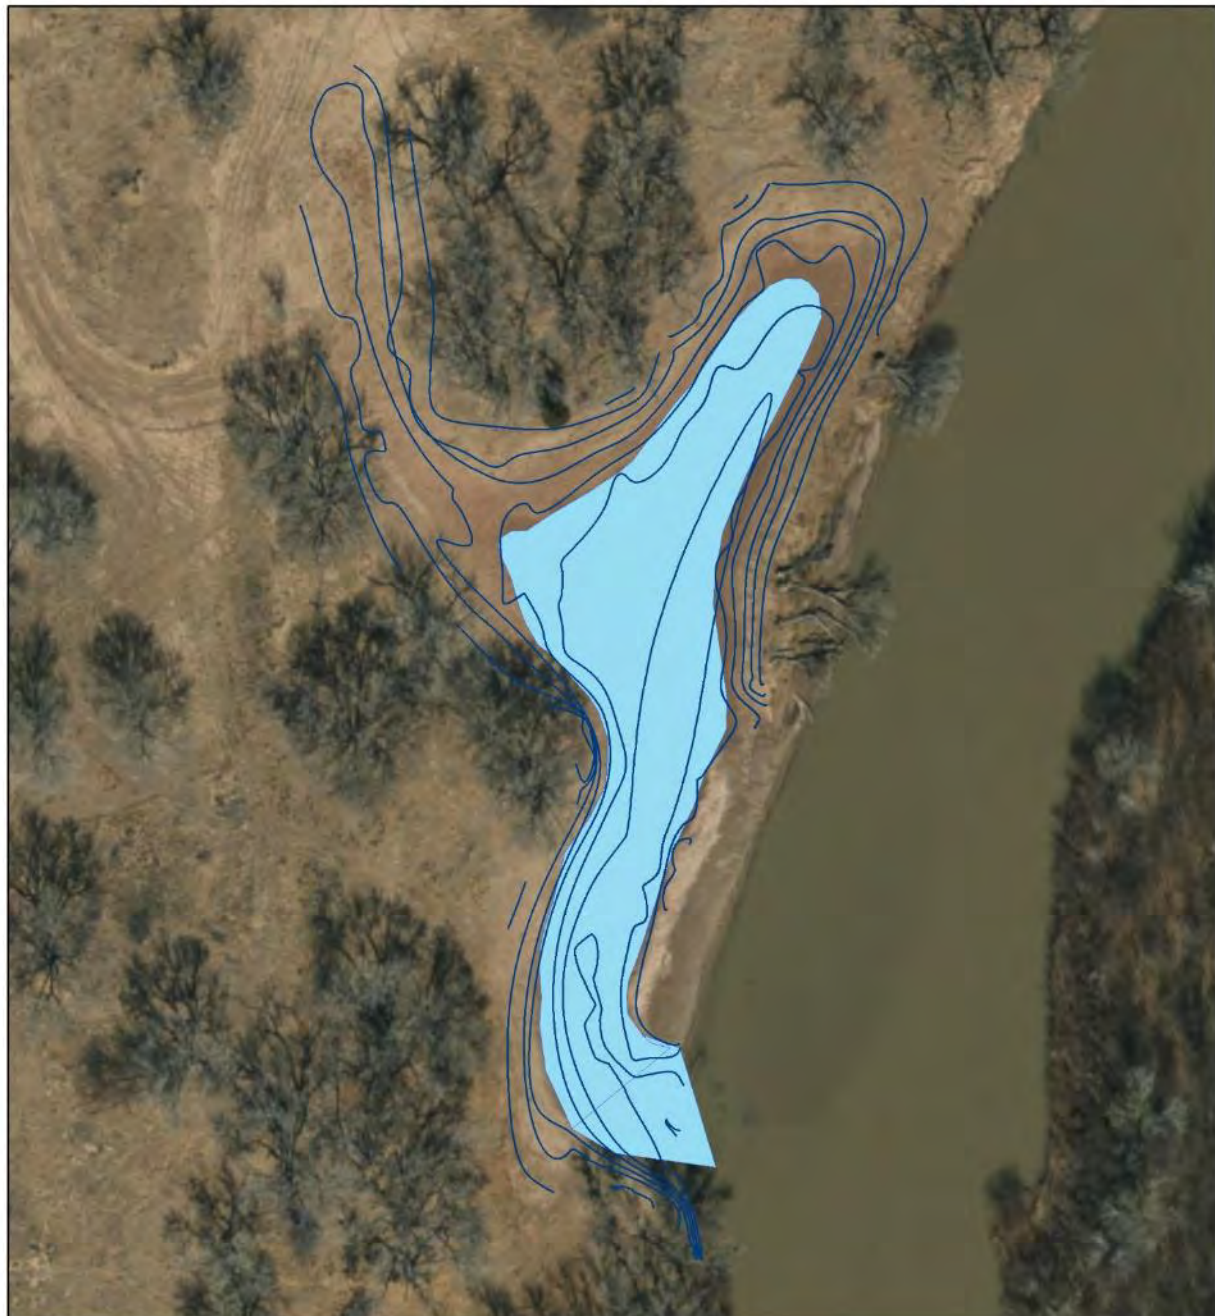
RM 100 March 14, 2019 Inundation Extent

Figure A-7. Inundation extent documented at RM 100 on March 14, 2019. Mean daily discharge at the Escondida gage was 1,190 cfs.

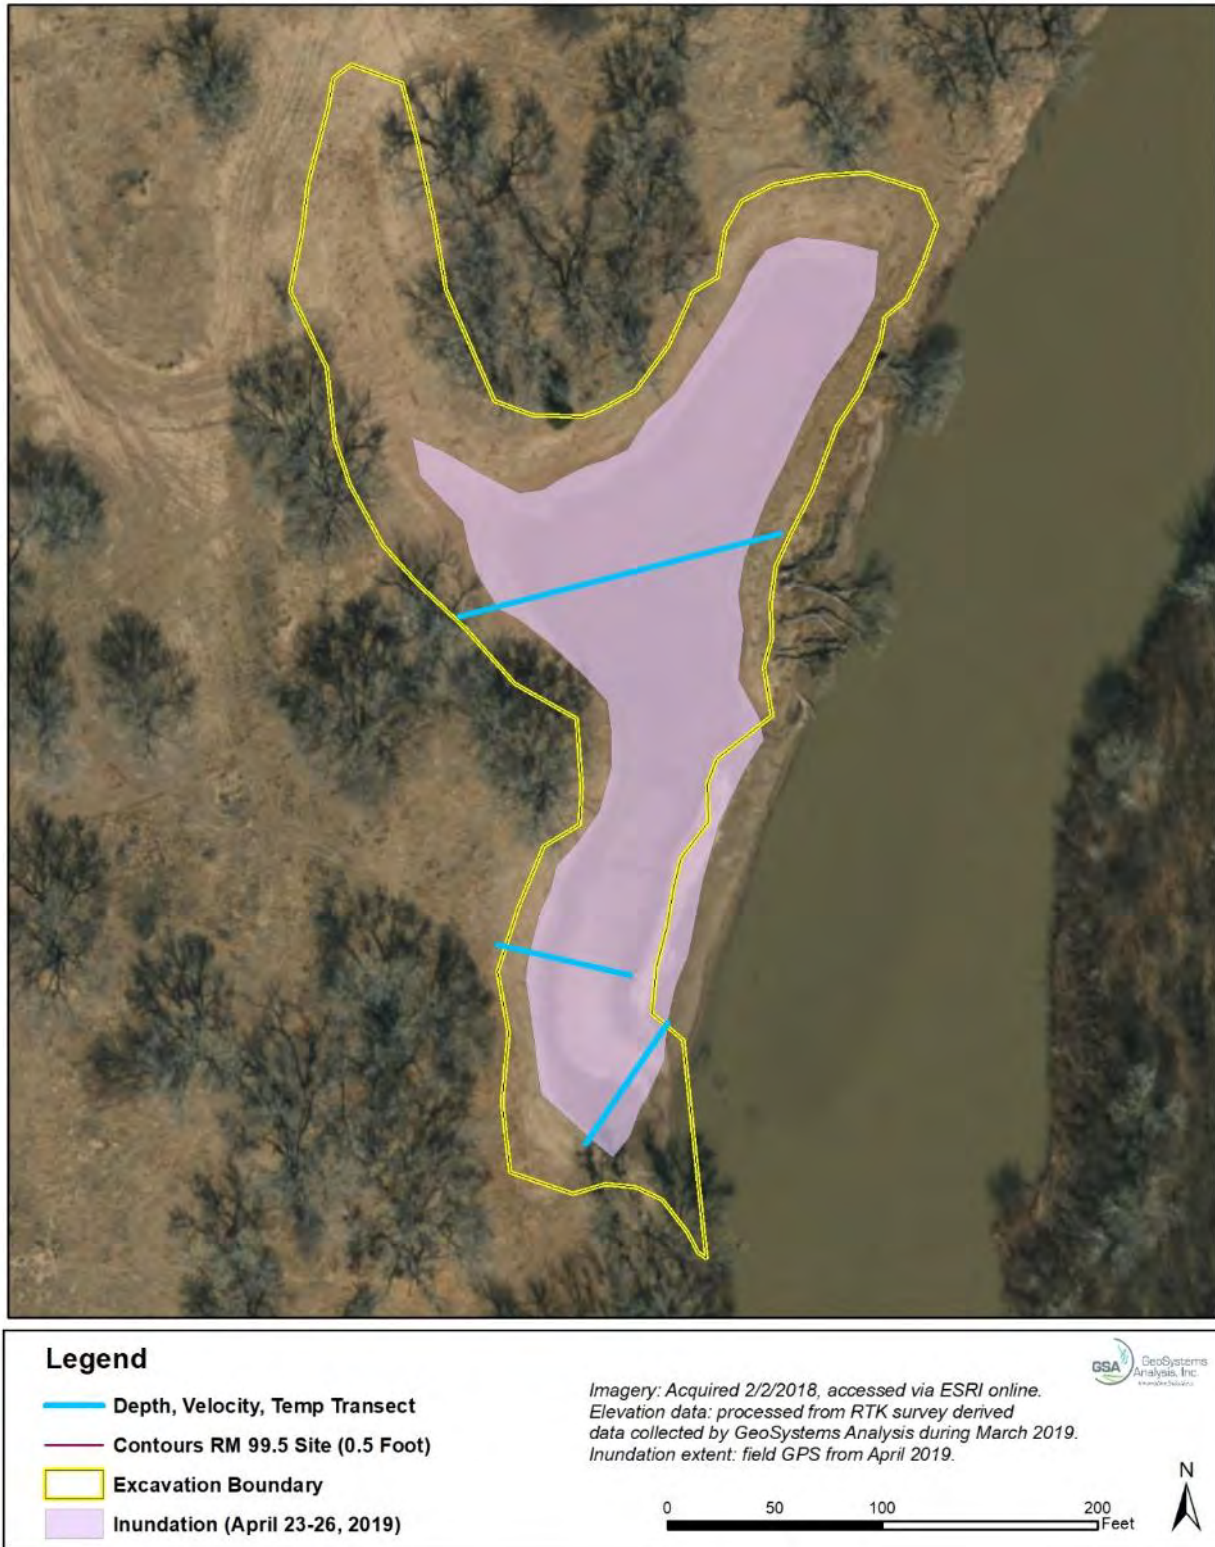
RM 100 April 24, 2019 Inundation Extent

Figure A-8. Inundation extent documented at RM 100 on April 24, 2019. Mean daily discharge at the Escondida gage was 2,740 cfs.

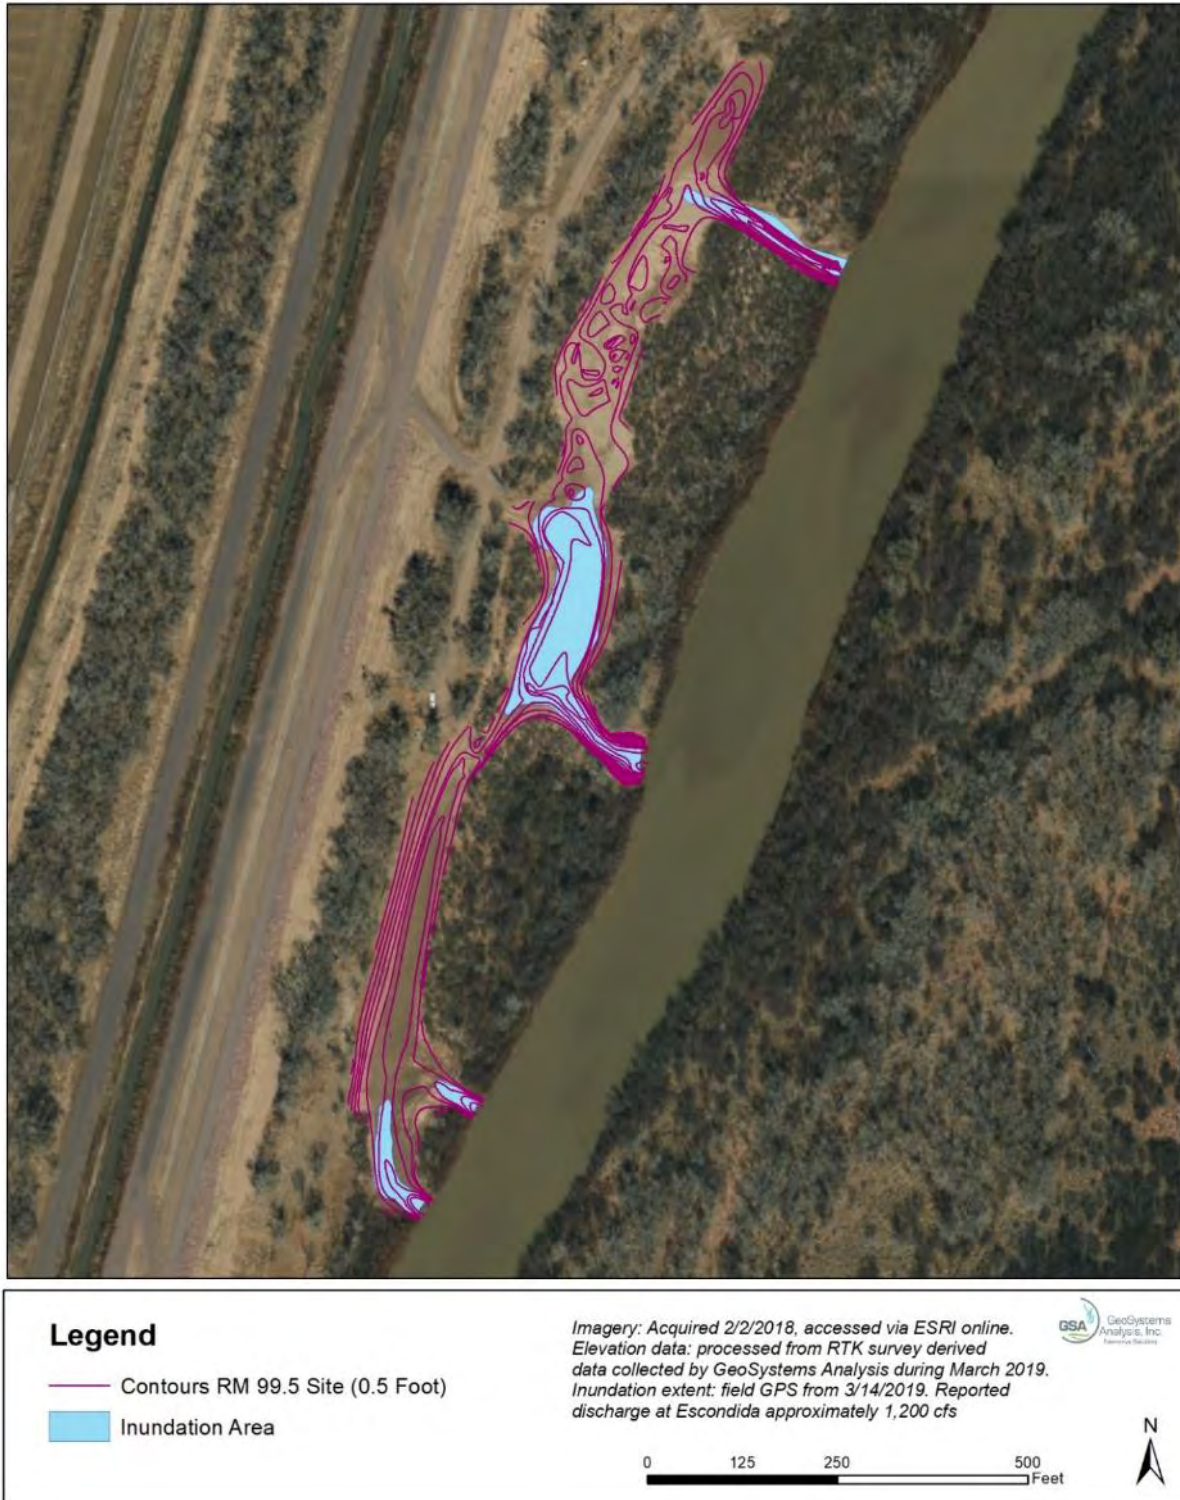
RM 99.5 March 14, 2019 Inundation Extent

Figure A-9. Inundation extent documented at RM 99.5 on March 14, 2019. Mean daily discharge at the Escondida gage was 1,190 cfs.

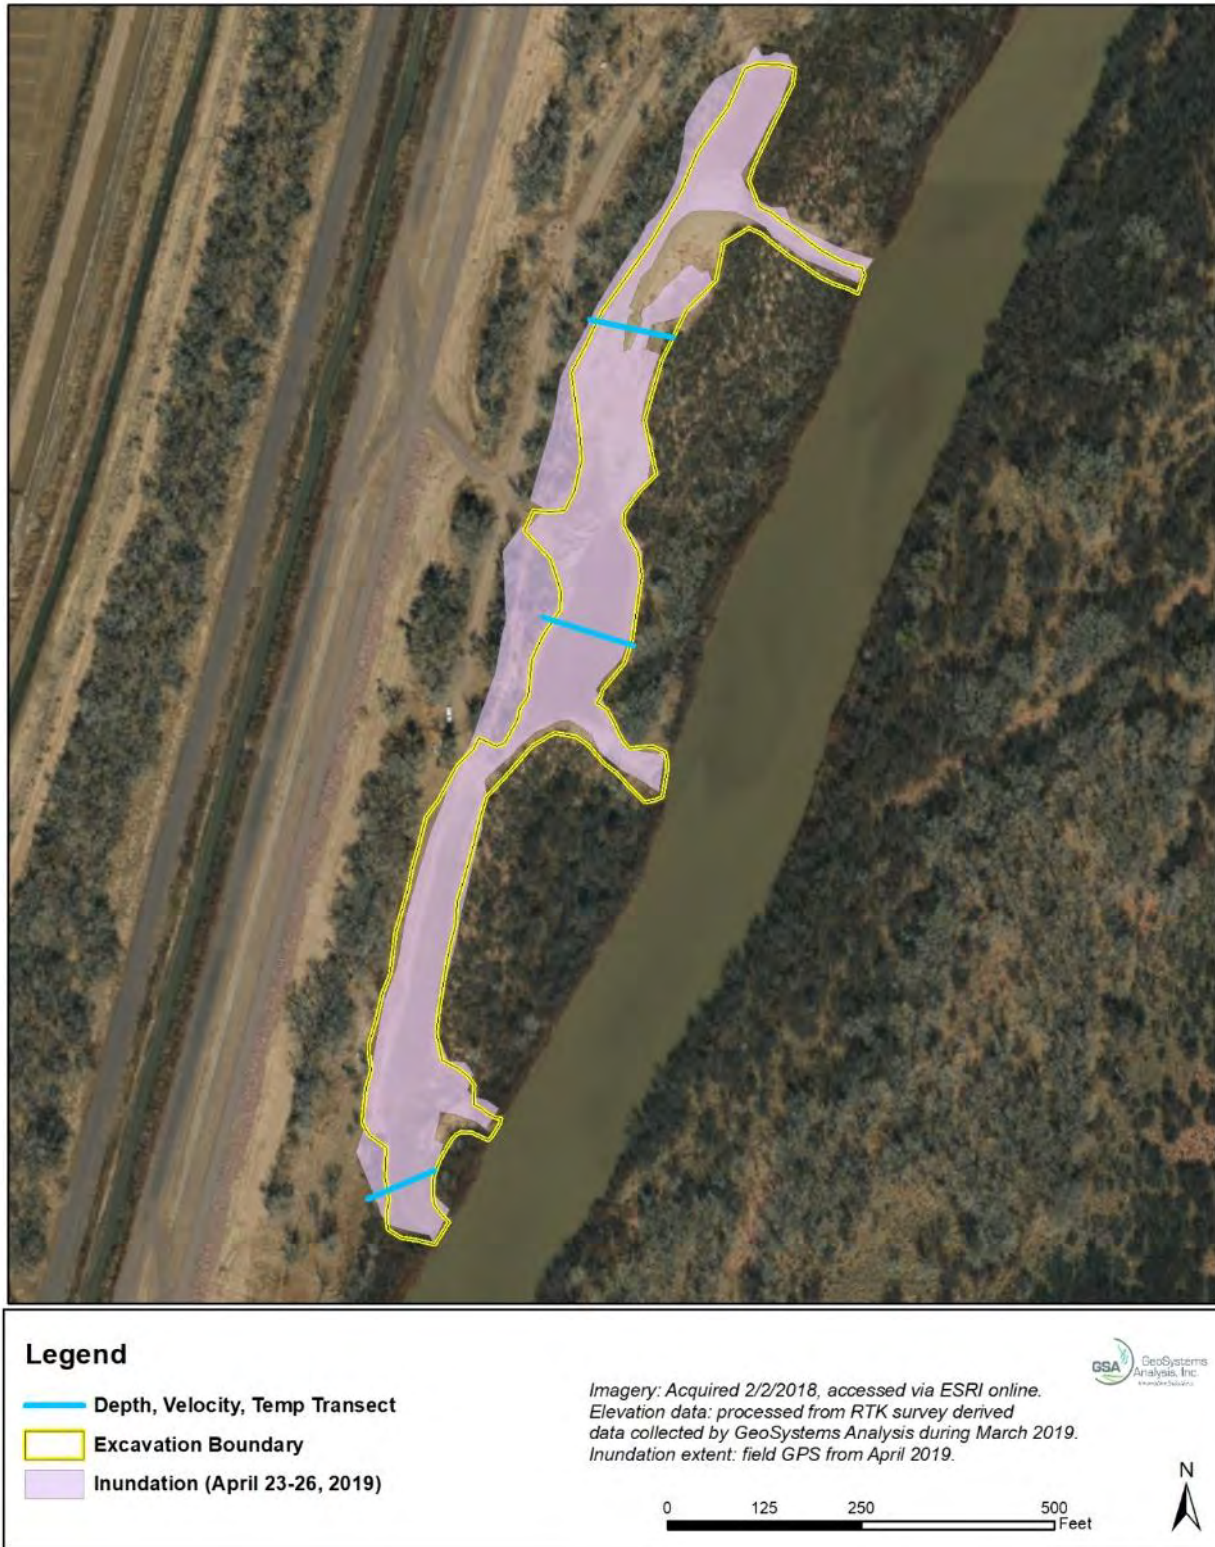
RM 99.5 April 24, 2019 Inundation Extent

Figure A-10. Inundation extent documented at RM 99.5 on April 24, 2019. Mean daily discharge at the Escondida gage was 2,740 cfs.

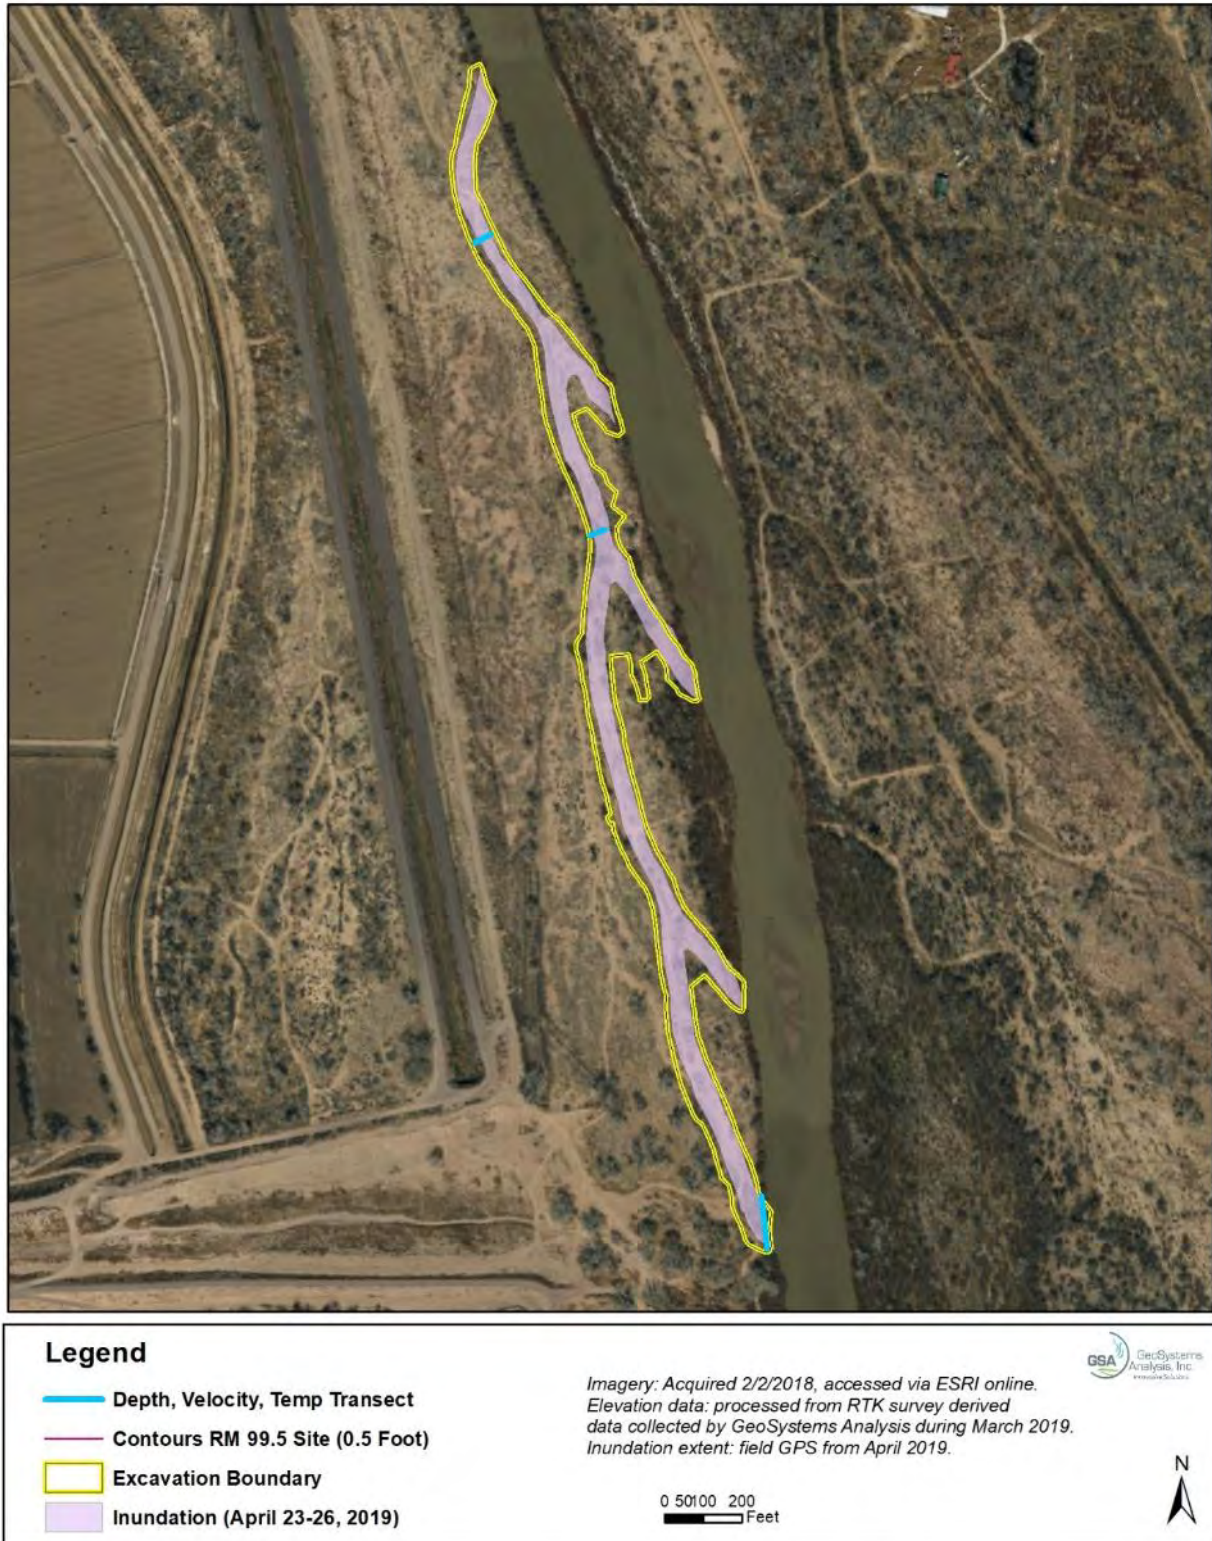
RM 103 April 25, 2019 Inundation Extent

Figure A-12. Inundation extent documented at RM 103 on April 25, 2019. Mean daily discharge at the Escondida gage was 2,830 cfs.

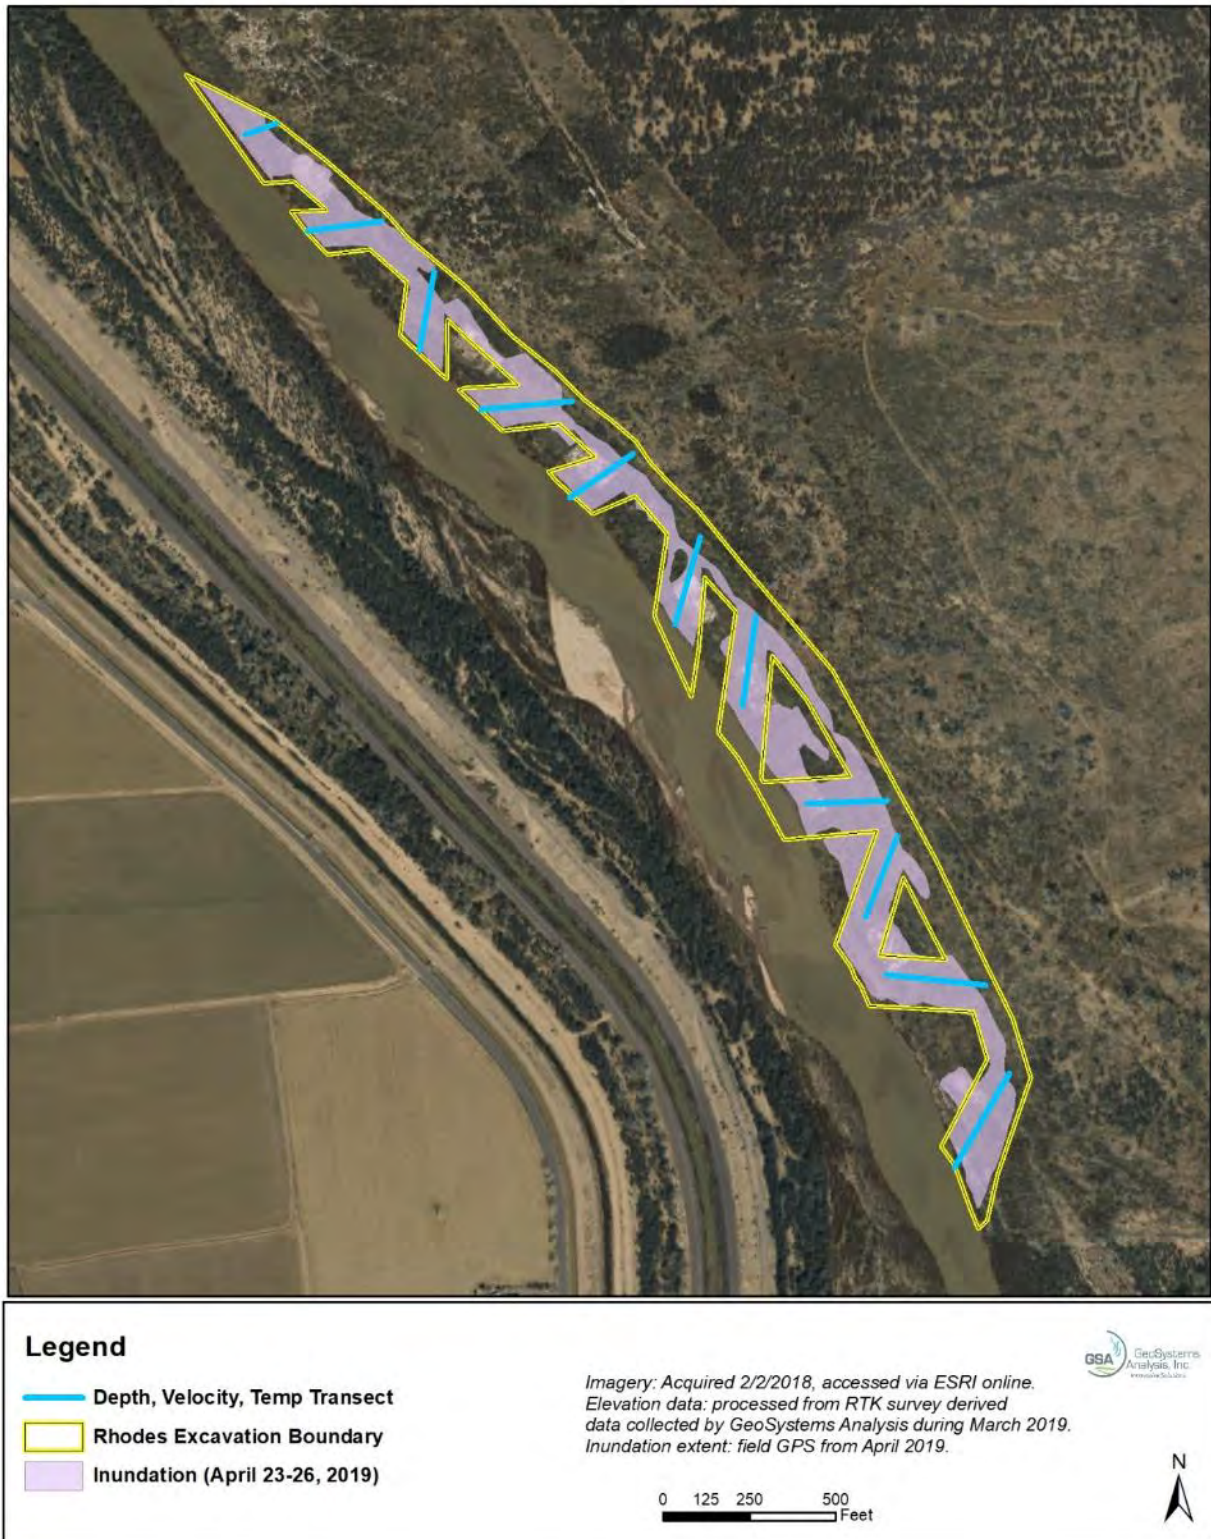
RM 93 April 24, 2019 Inundation Extent

Figure A-13. Inundation extent documented at RM 93 on April 25, 2019. Mean daily discharge at the Escondida gage was 2,830 cfs.
