2019 Annual Monitoring Results and Maintenance Plan for San Acacia Reach Restoration Sites

Prepared for:
New Mexico Interstate Stream Commission
5550 San Antonio
Albuquerque, New Mexico 87109

Prepared by:
GeoSystems Analysis, Inc.
3150 Carlisle Blvd. NE,
Albuquerque, NM 87110
www.gsanalysis.com

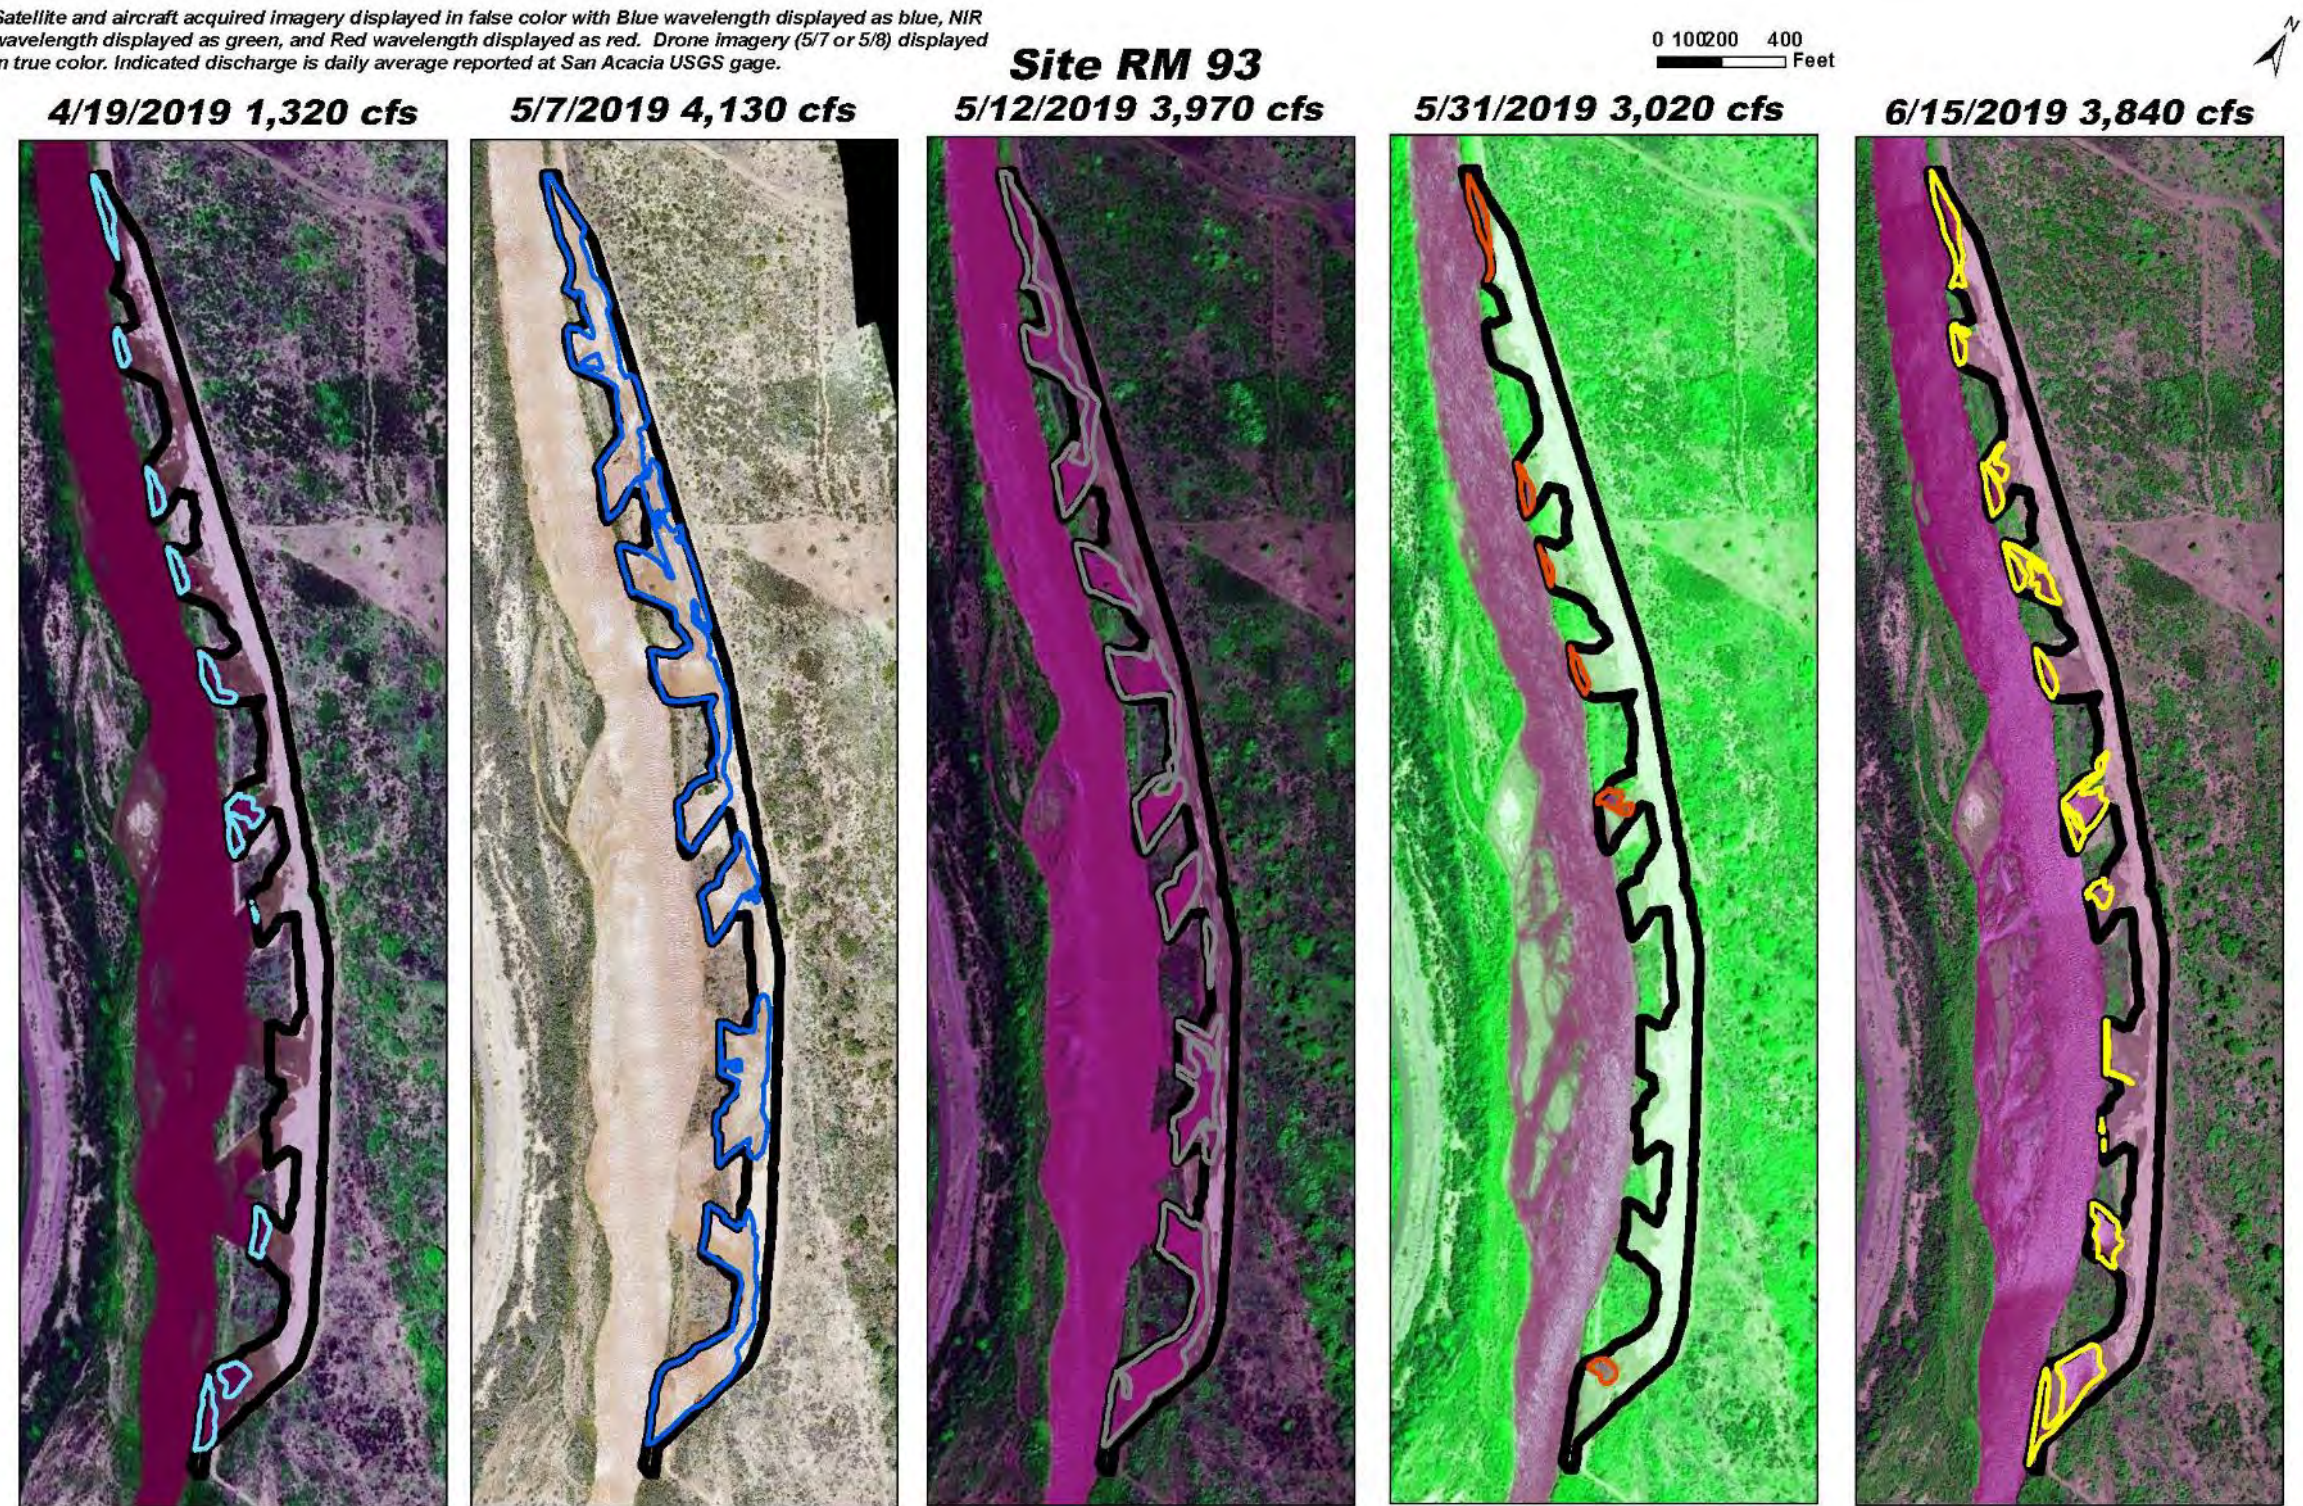
At most sites, the highest inundation percent detected from available imagery was delineated off the June 15 image, when San Acacia reported mean daily discharge of 3,840 cfs. Percent inundation notably declined through the sustained runoff season at RM 93, as only 13% of the excavation area appears inundated on the June 15 orthophotography. Conversely, the percent of area inundated at sites RM 100.5, RM 100 and RM 99.5 notably increased between early-May and mid-June. These dramatic shifts in inundation area indicate dynamic sediment deposition and redistribution processes were occurring throughout the protracted snowmelt runoff period and, with the exception of RM 93, implies that the approximately 1,000 cfs flow spike (from approximately 3,000 to 4,000 cfs -see **Figure 2**) between late-May and mid-June flushed sediment accumulations in many of the channel inlets at different project sites.

Figure B-8. Interpreted inundation area at RM 93 from five different geospatial image sources and dates during 2019 snowmelt runoff. Black polygons indicate project excavation footprint. Different colored polygons represent interpreted inundation areas during “heads-up” digitizing.

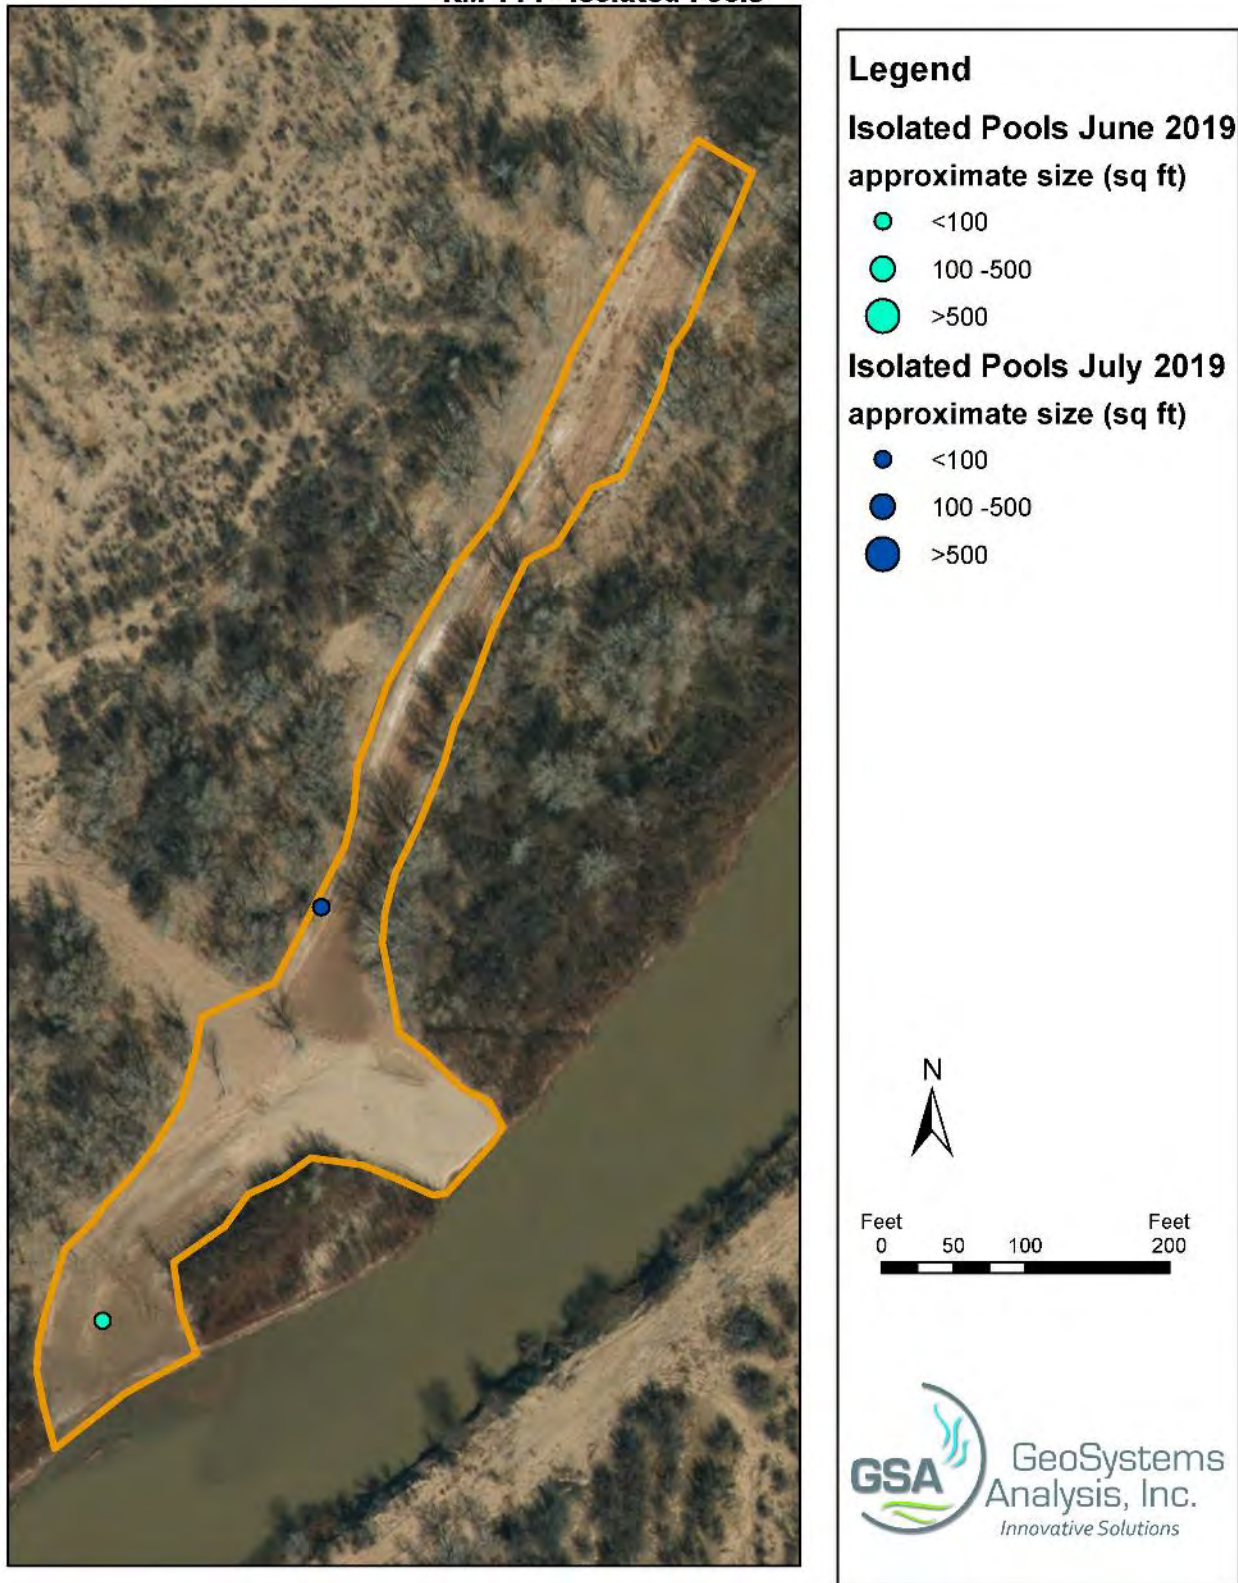
RM 114 - Isolated Pools

Figure C-1. Maps showing location and size class of isolated pools documented at RM 114 in June and July 2019.

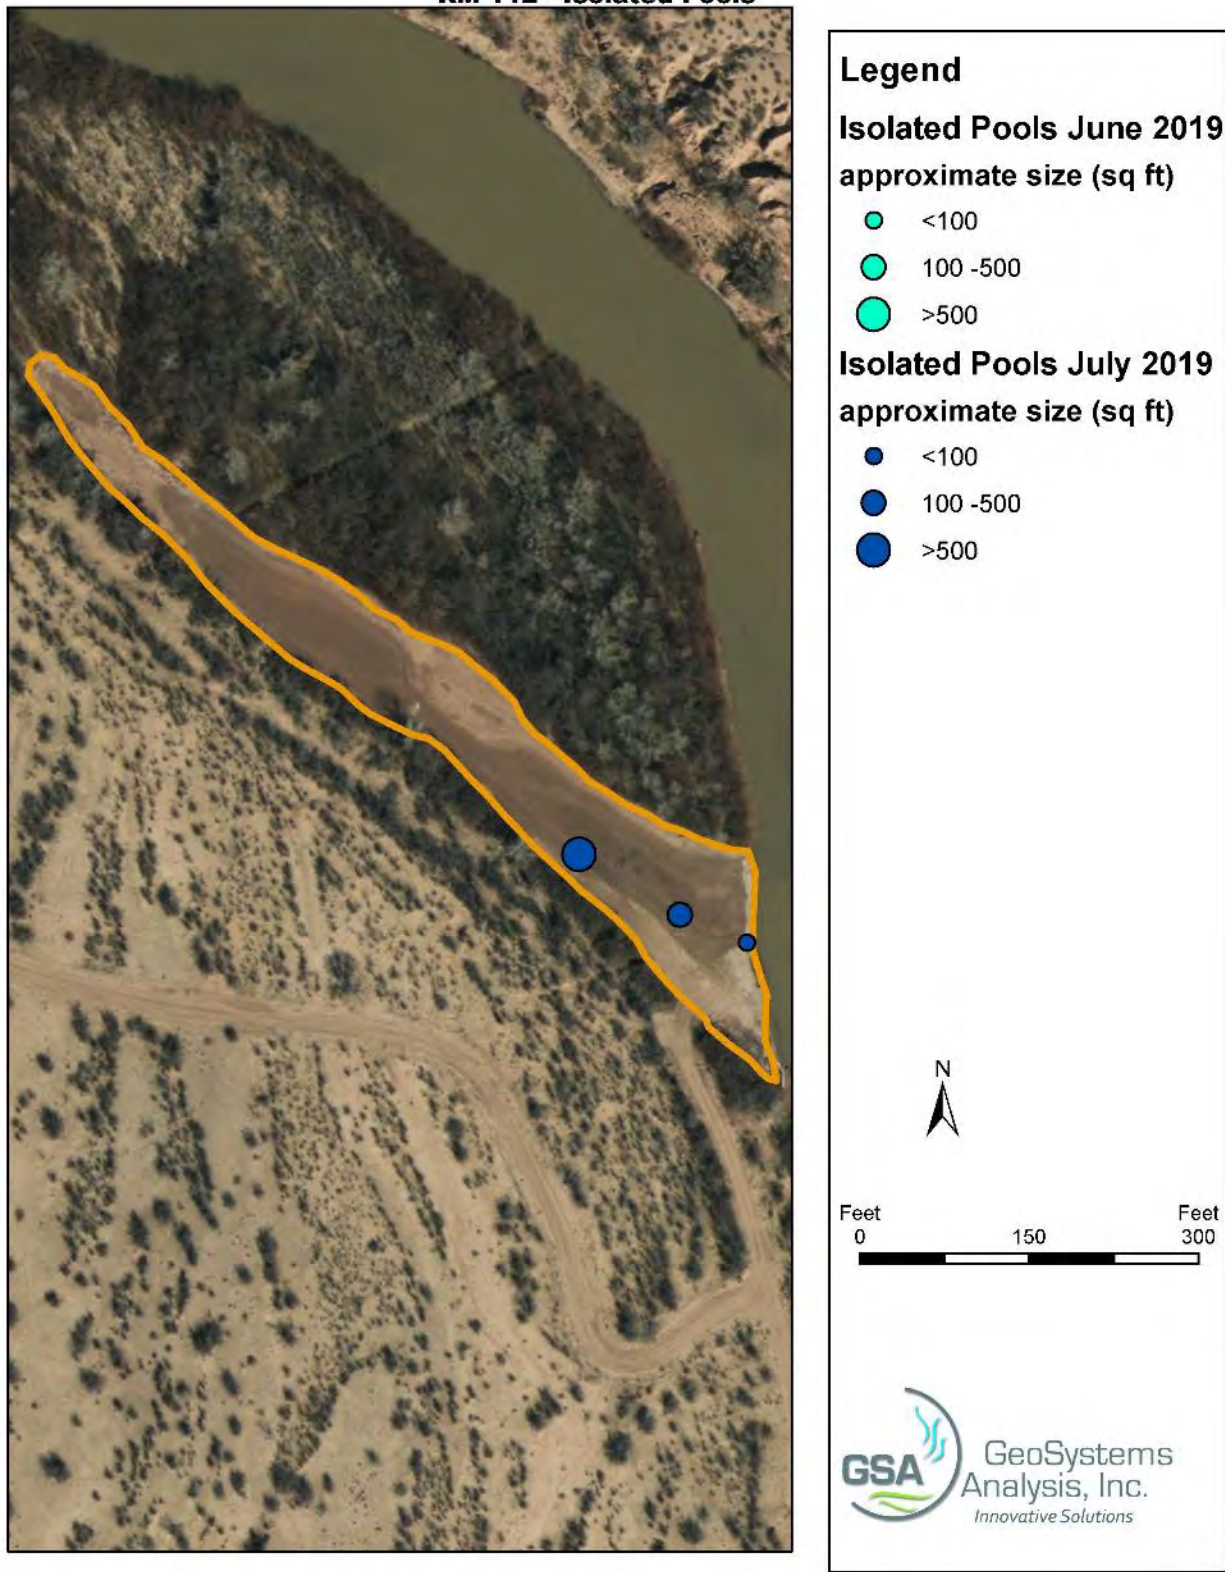
RM 112 - Isolated Pools

Figure C-2. Maps showing location and size class of isolated pools documented at RM 112 in June and July 2019.

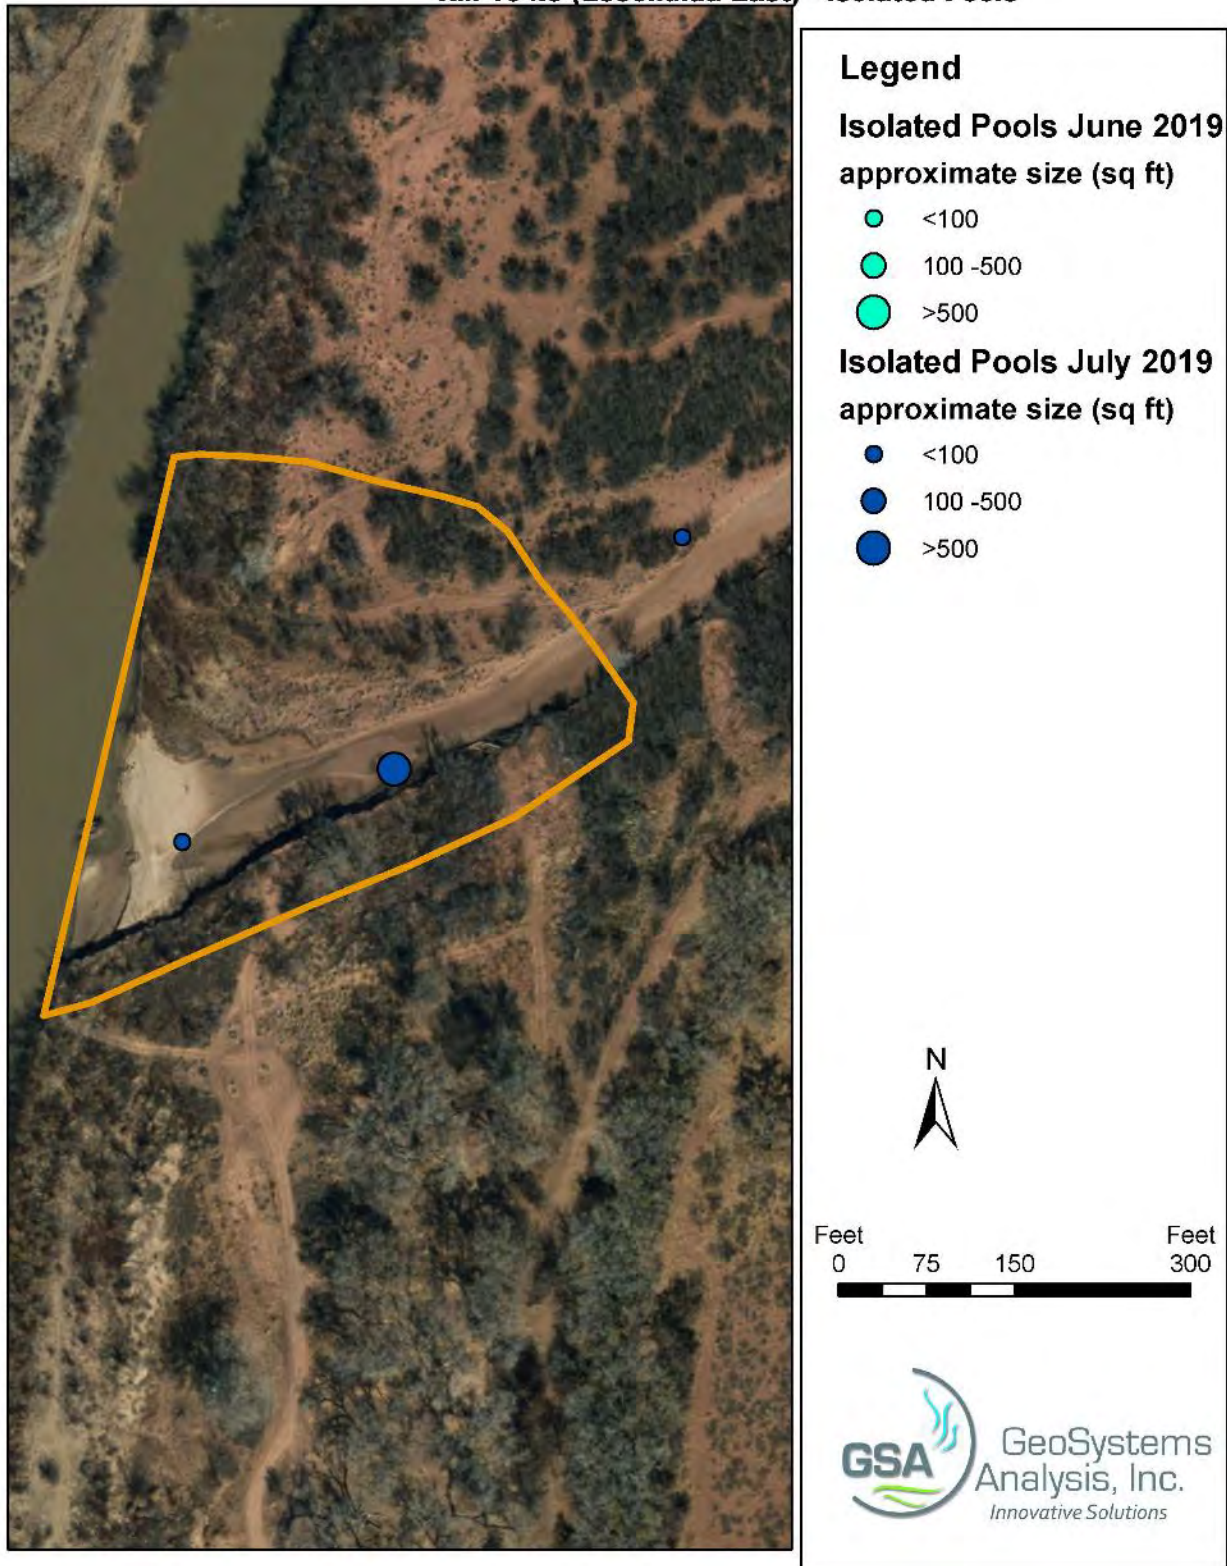
RM 104.5 (Escondida East) - Isolated Pools

Figure C-3. Maps showing location and size class of isolated pools documented at RM 104.5 in June and July 2019.

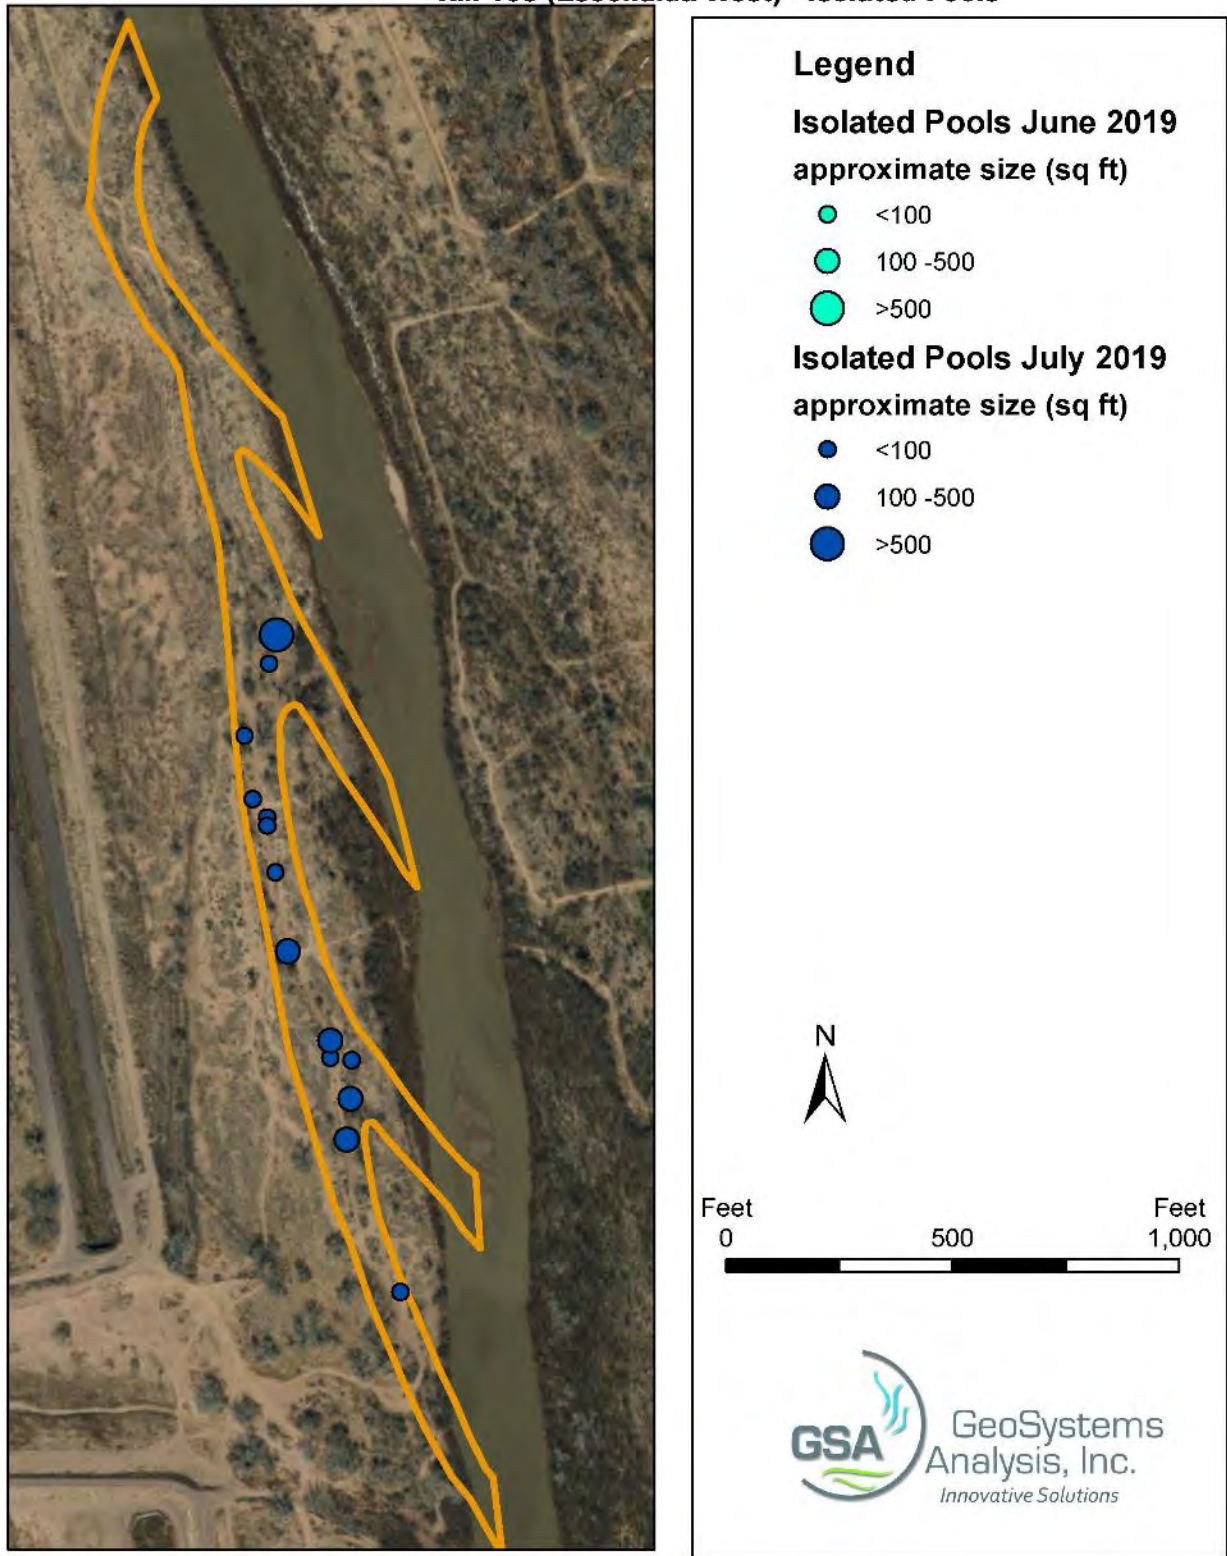
RM 103 (Escondida West) - Isolated Pools

Figure C-4. Maps showing location and size class of isolated pools documented at RM 103 in June and July 2019.

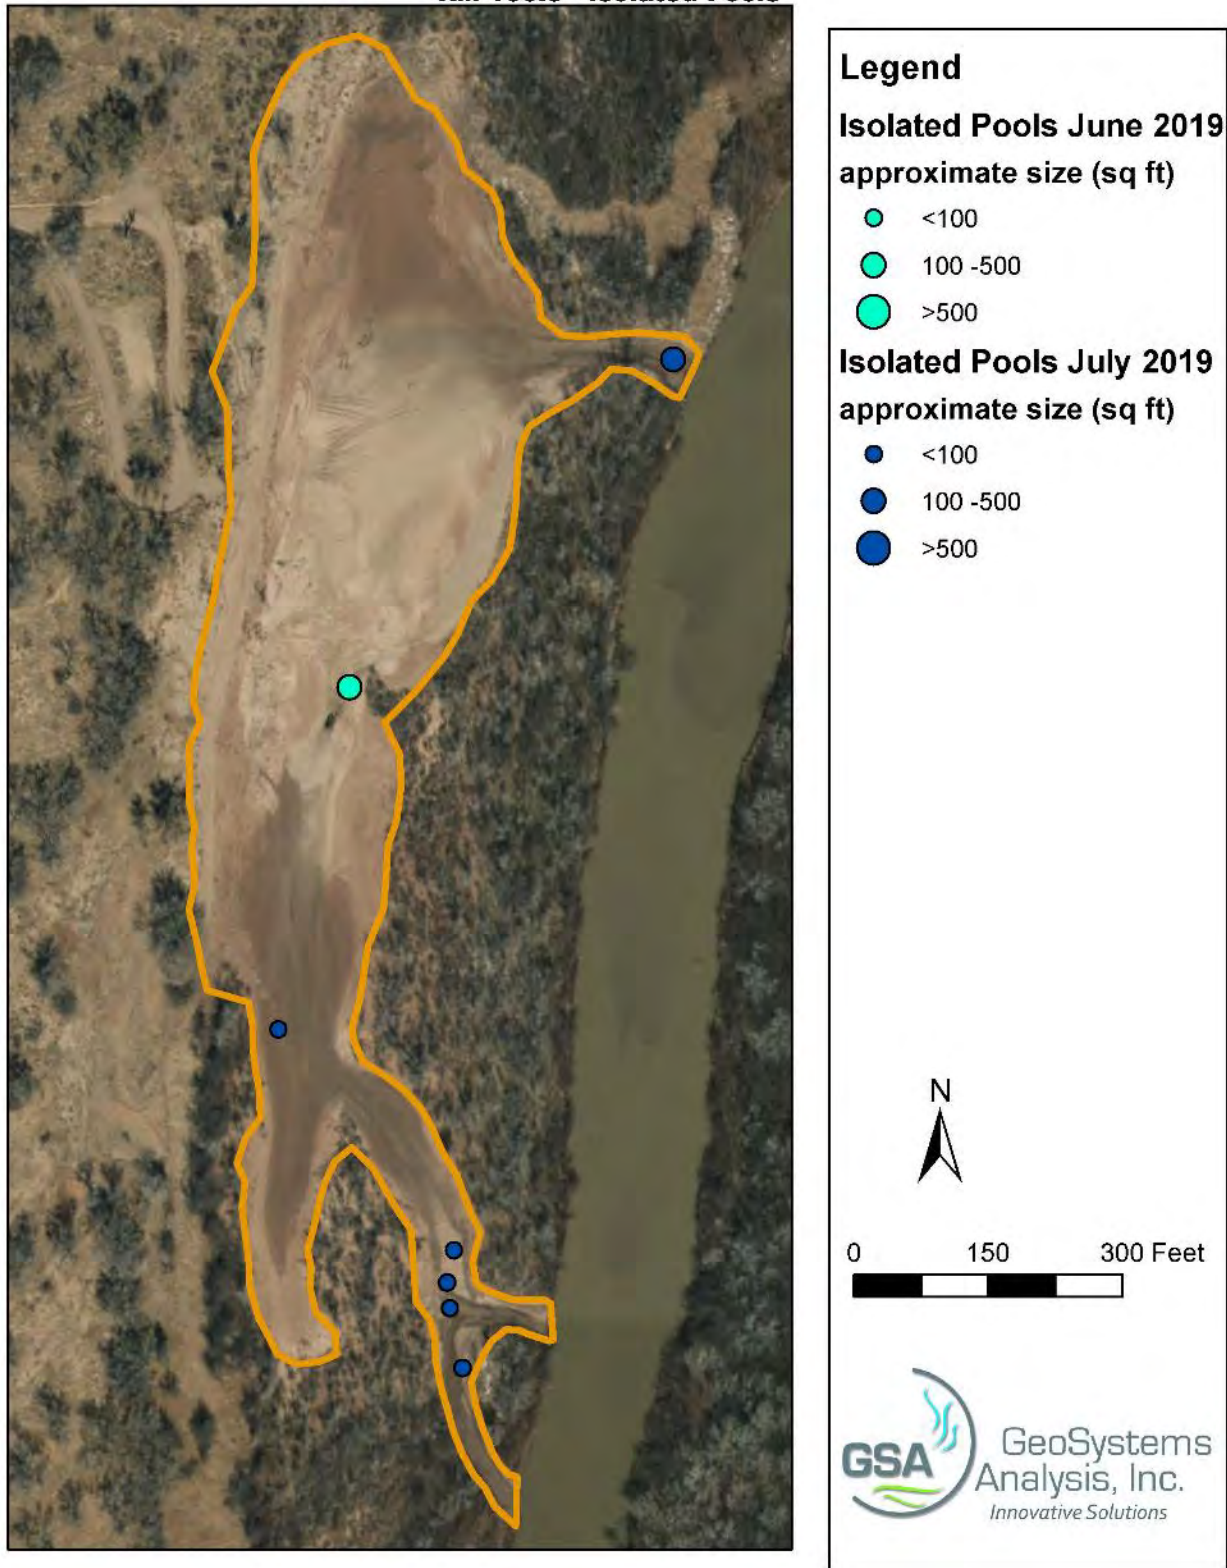
RM 100.5 - Isolated Pools

Figure C-5. Figure B-3. Maps showing location and size class of isolated pools documented at RM 100.5 in June and July 2019.

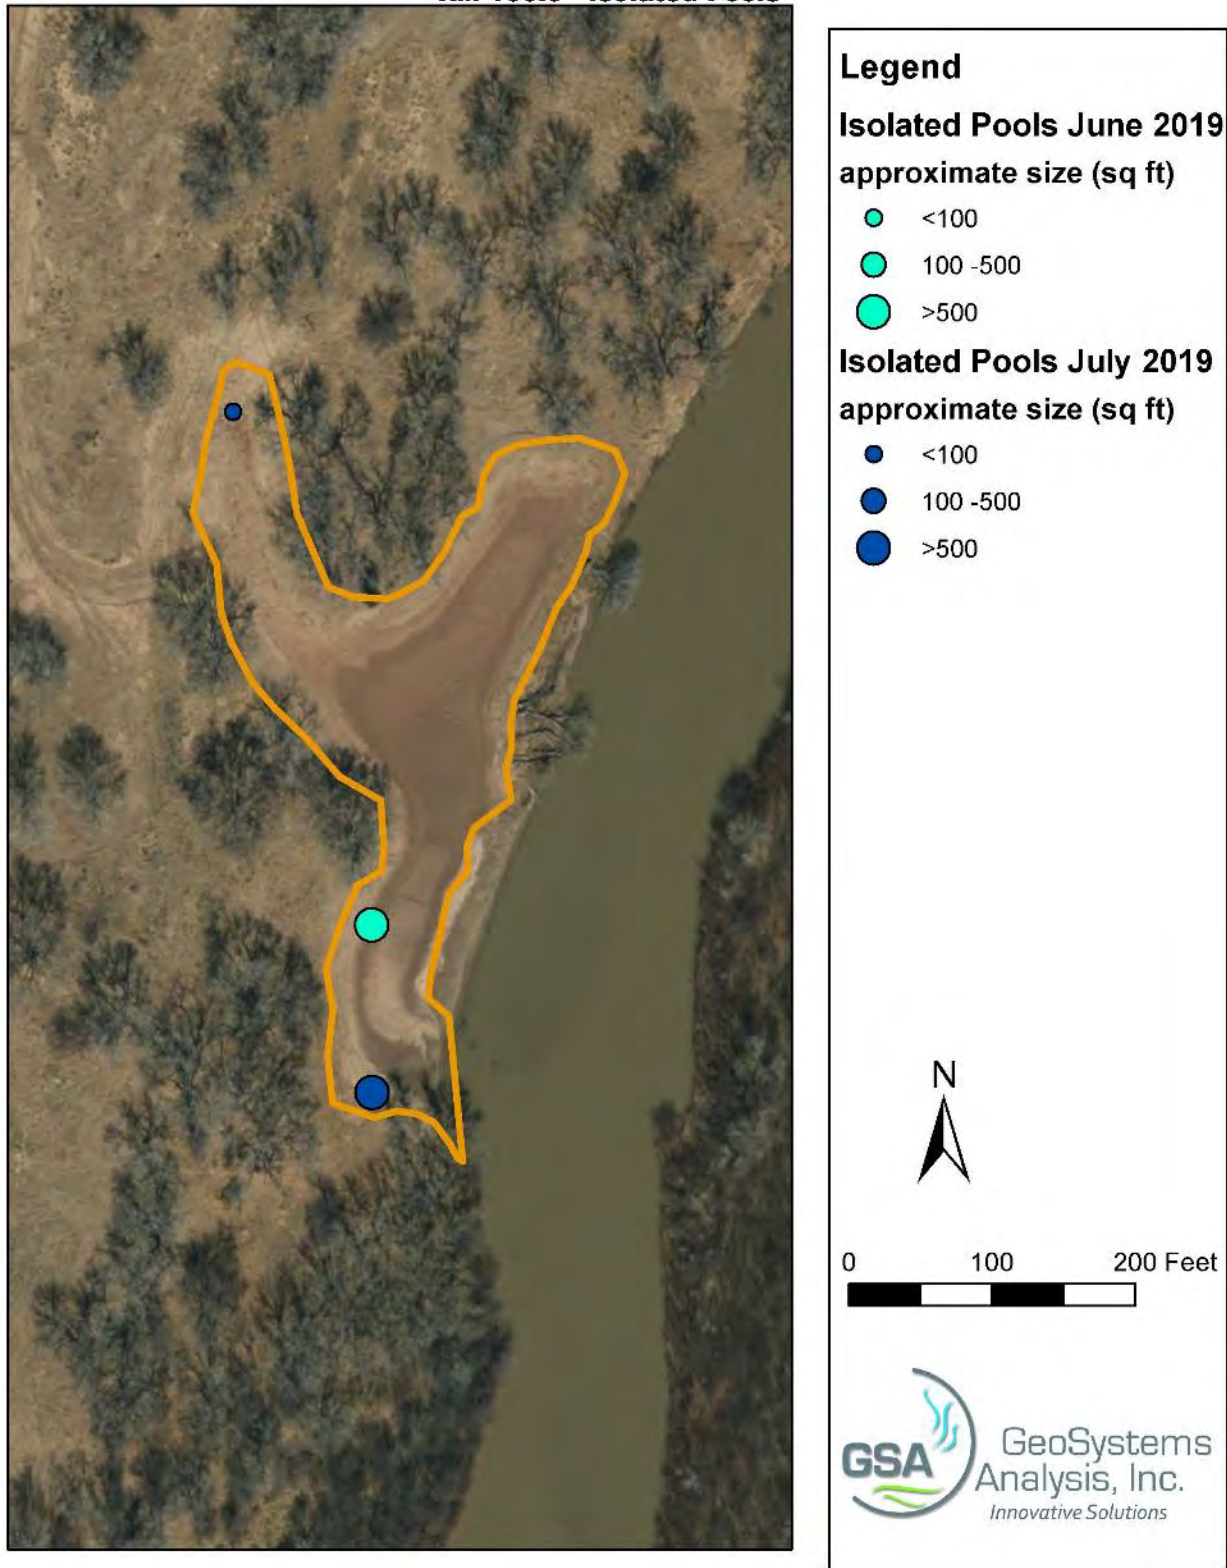
RM 100.0 - Isolated Pools

Figure C-6. Figure B-3. Maps showing location and size class of isolated pools documented at RM 100 in June and July 2019.

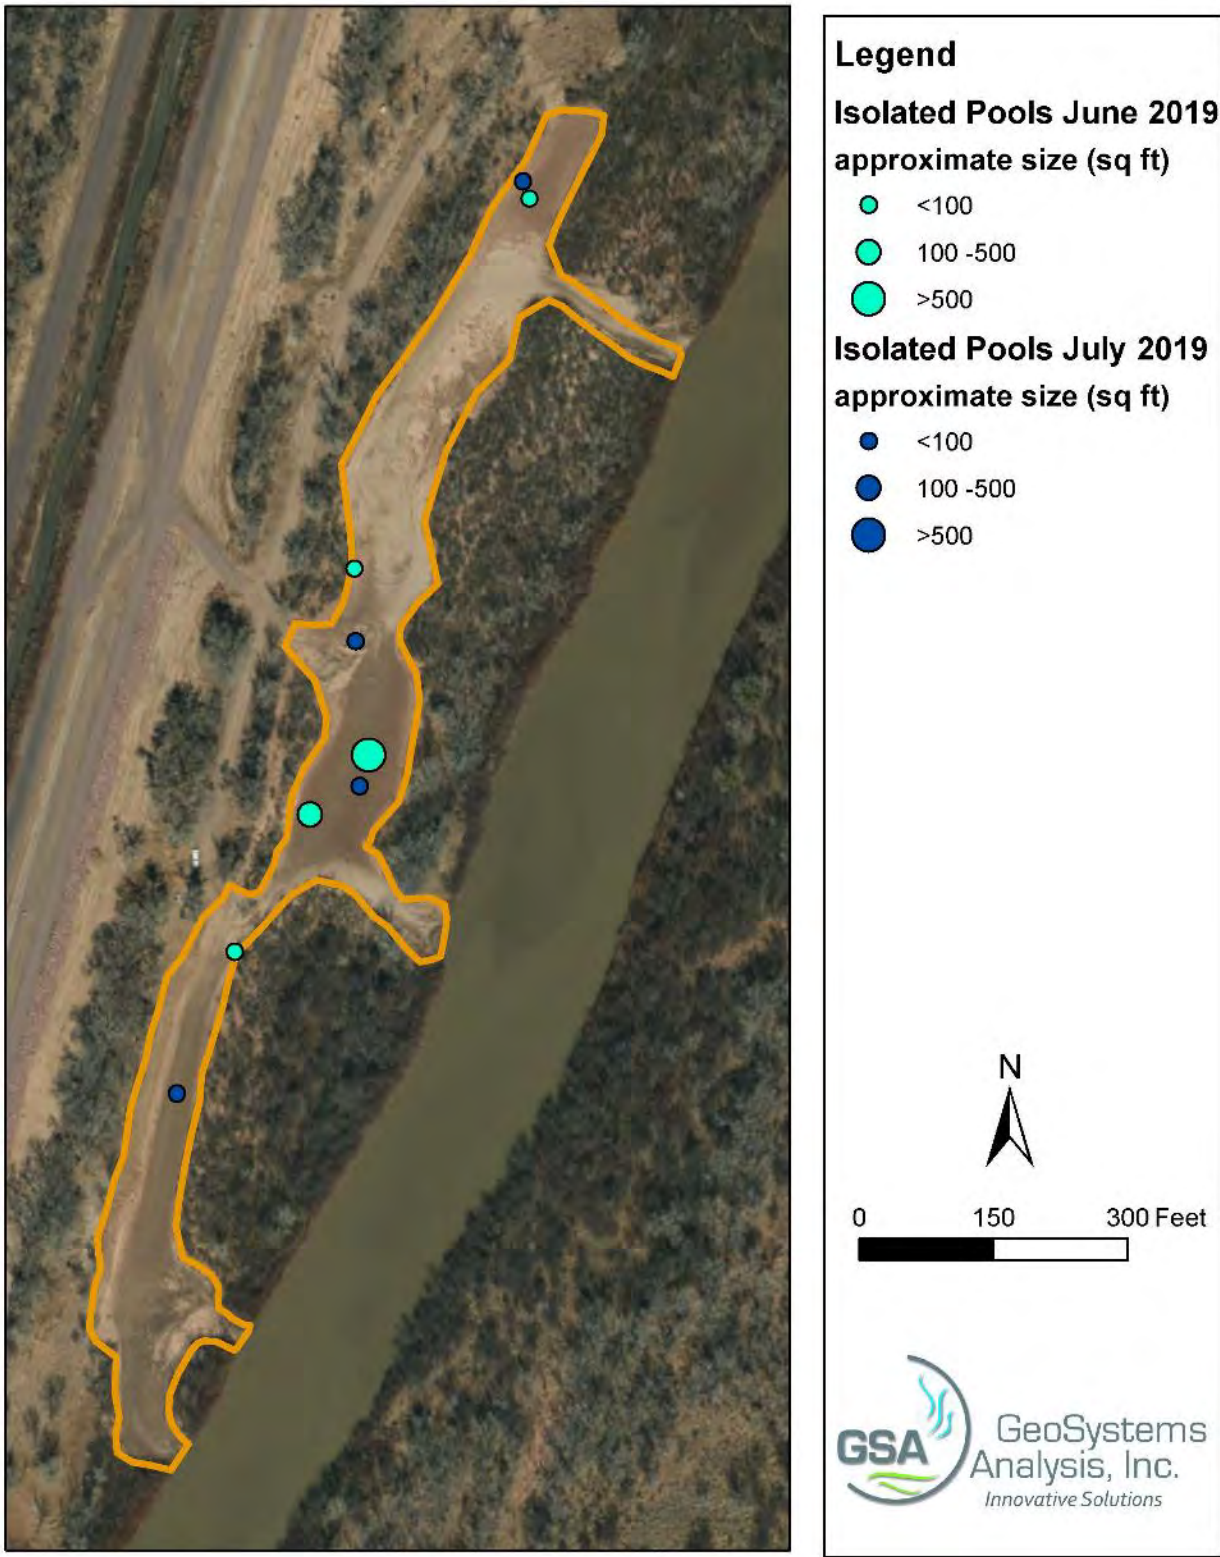
RM 99.5 - Isolated Pools

Figure C-7. Maps showing location and size class of isolated pools documented at RM 99.5 in June and July 2019.

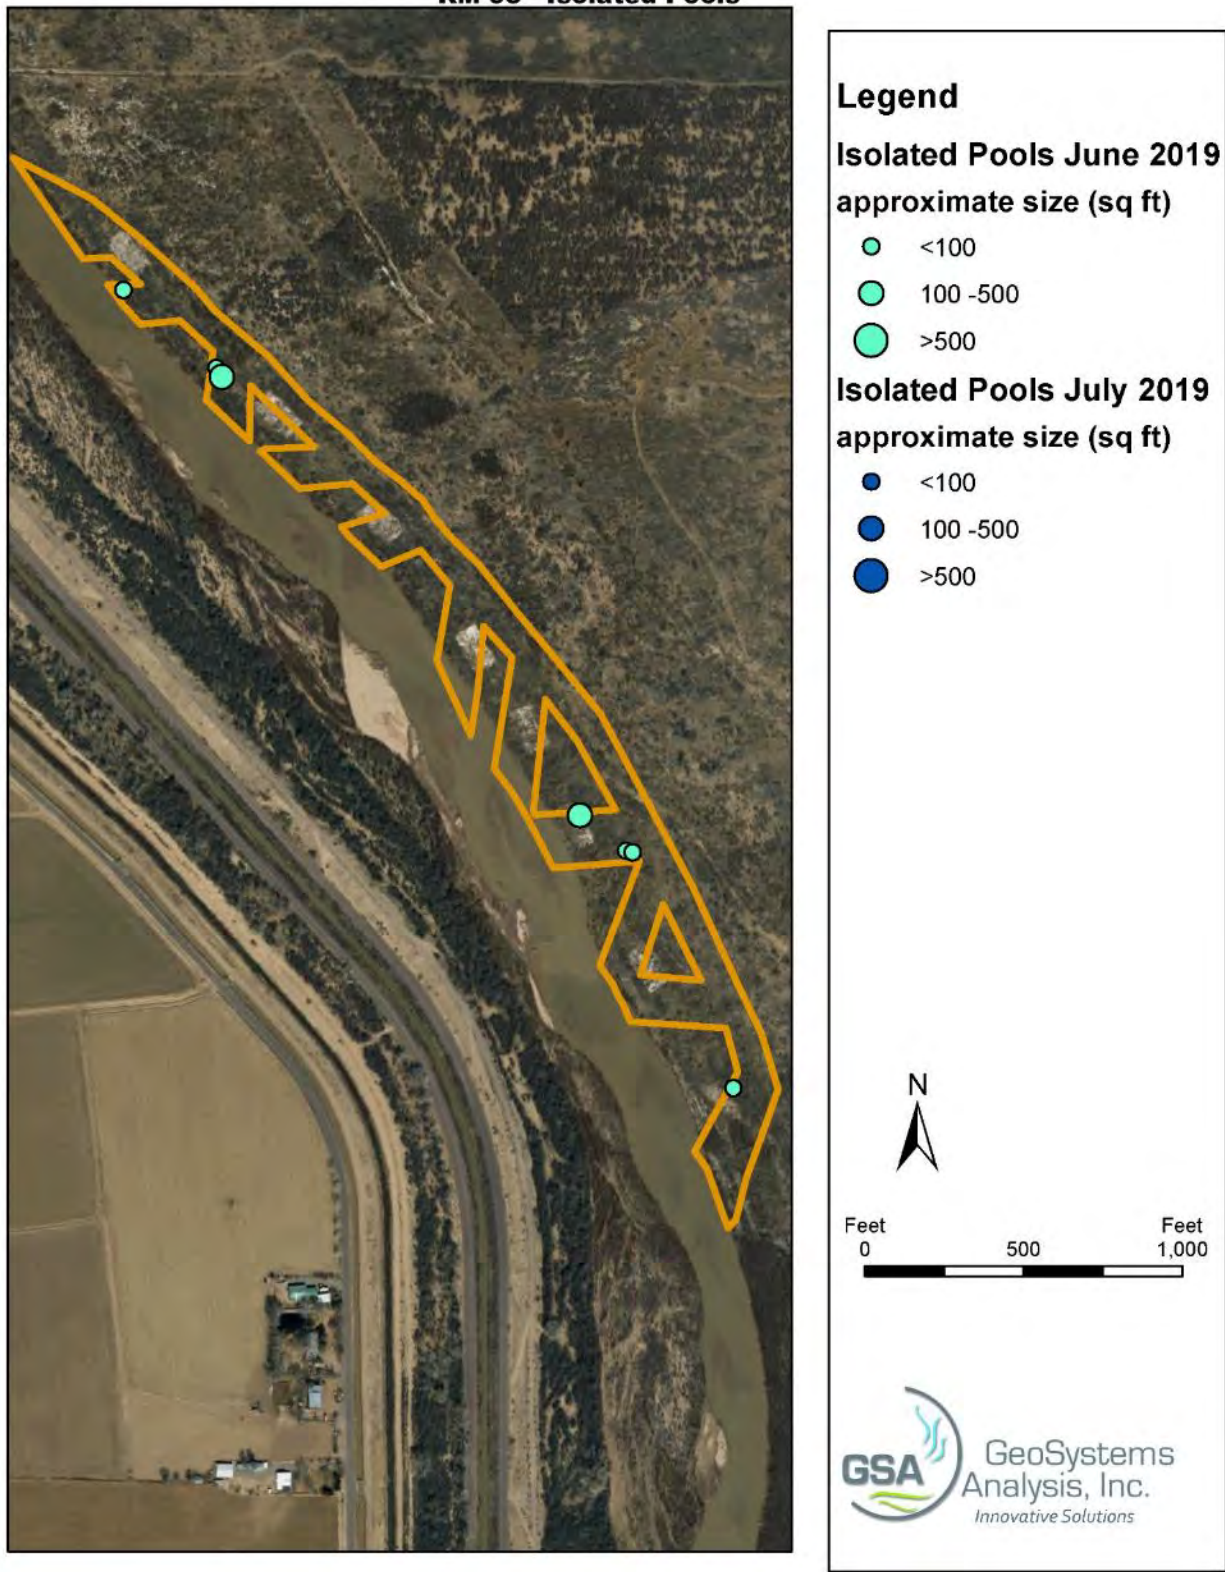
RM 93 - Isolated Pools

Figure C-8. Maps showing location and size class of isolated pools documented at RM 93 in June and July 2019.

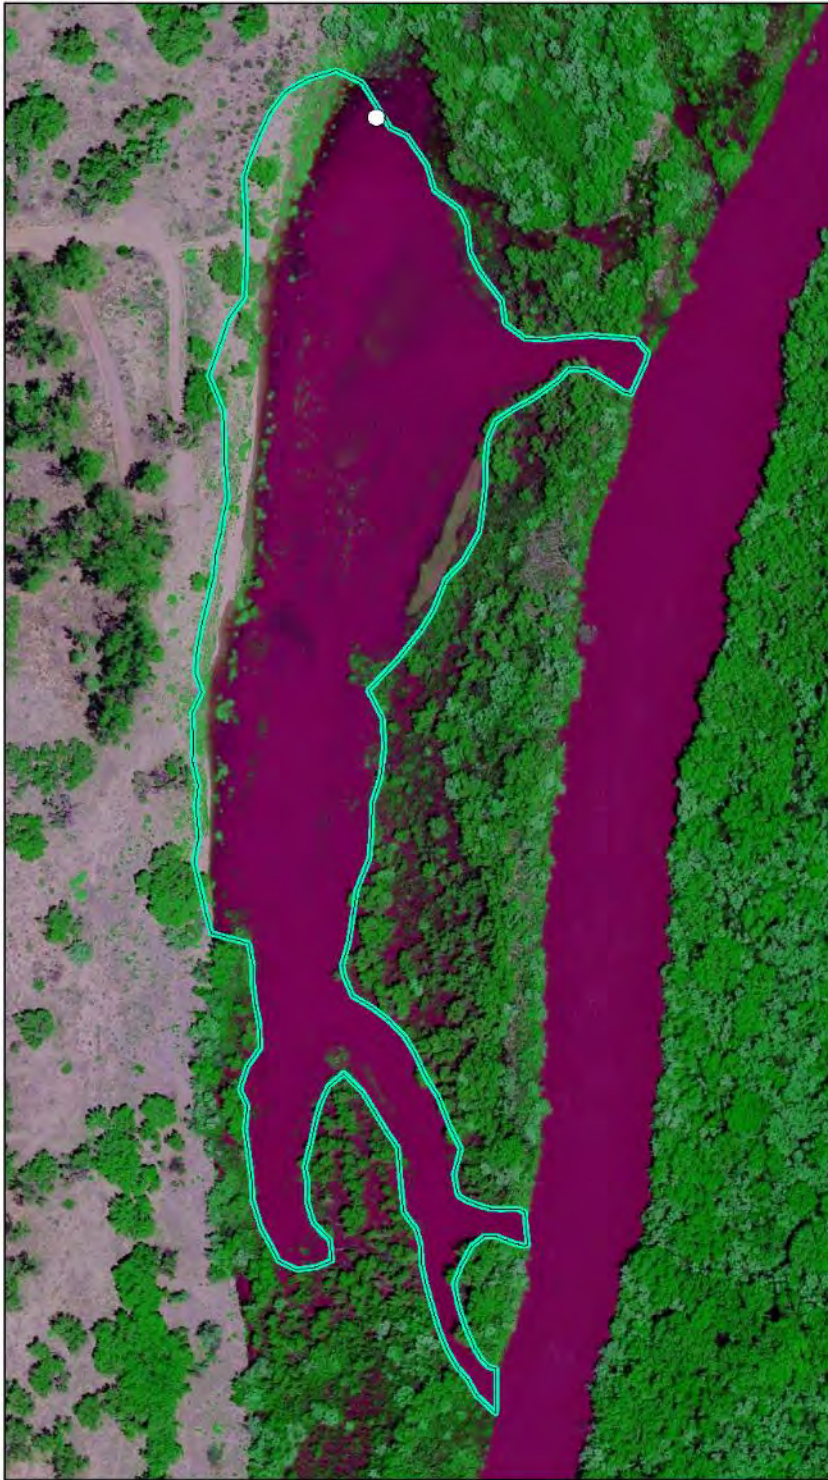
**Noxious Weed Detections through October 2019:
Site RM 100.5**

Figure D-4. Noxious weed species populations documented at RM 100.5.

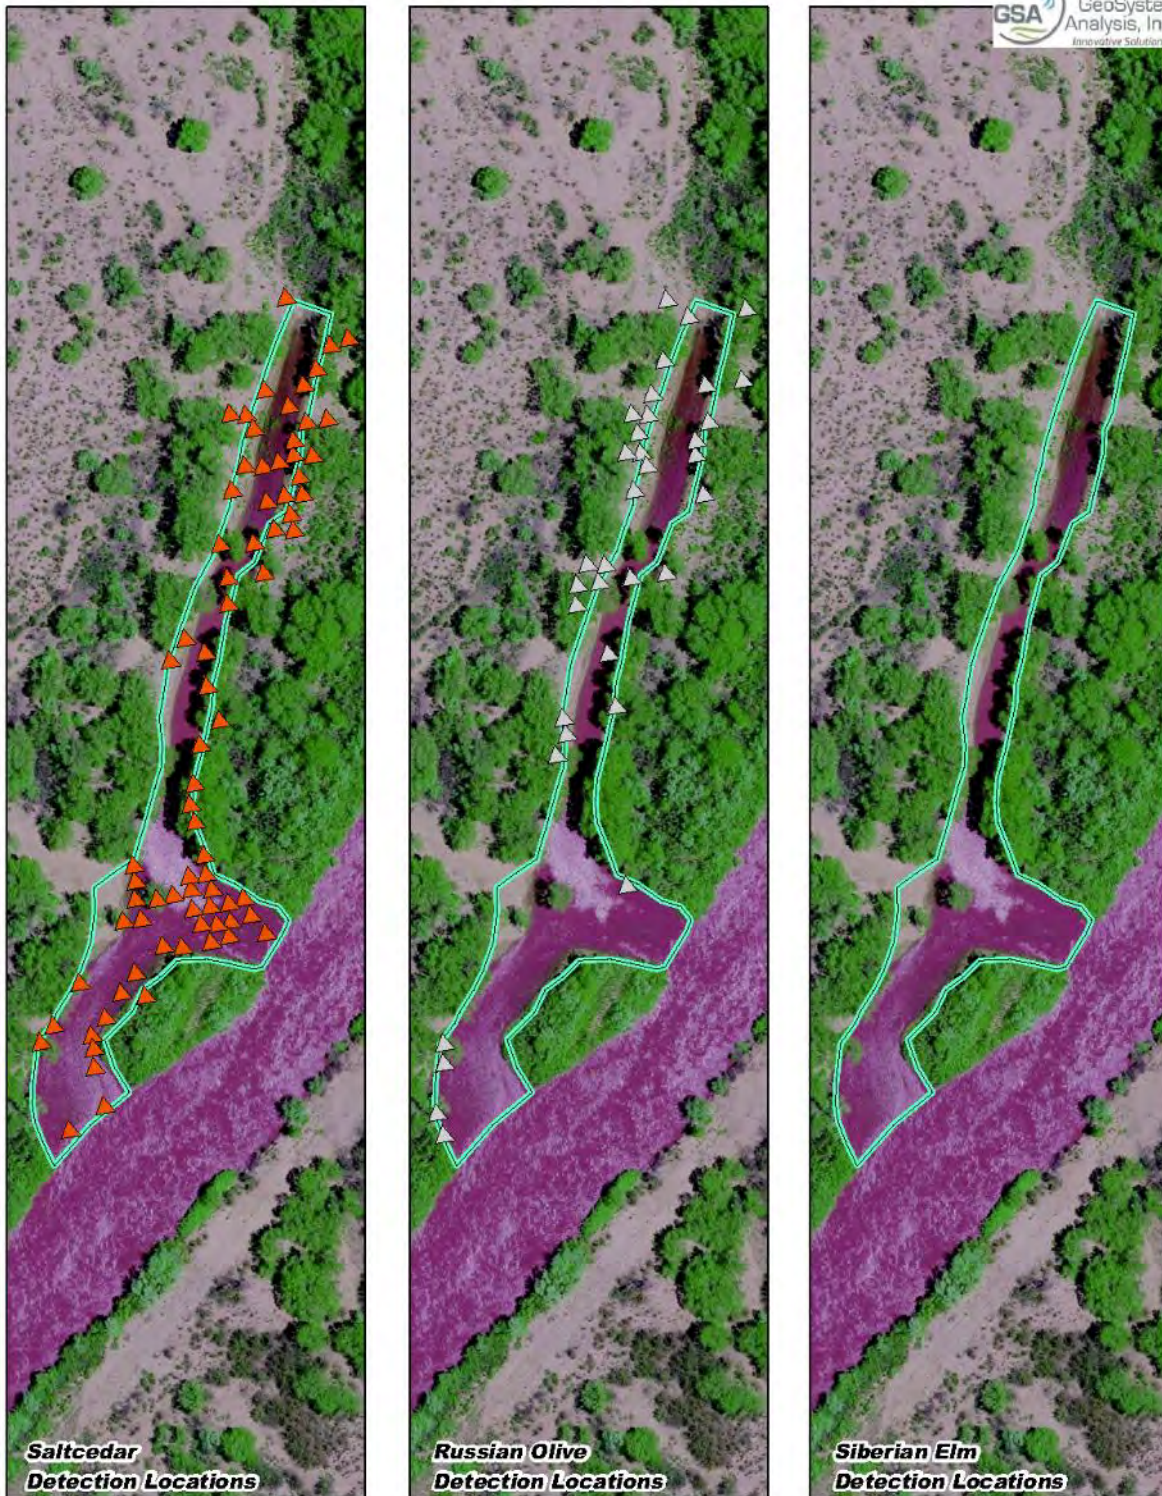
Exotic Woody Spp Distribution: RM 114

Figure F-1. Distribution of non-native saltcedar (left), Russian olive (center) and Siberian elm (right) seedlings recorded at evenly spaced monitoring stations (20 x 20 ft) at RM 114.
