2019 Annual Monitoring Results and Maintenance Plan for San Acacia Reach Restoration Sites

Prepared for:
New Mexico Interstate Stream Commission
5550 San Antonio
Albuquerque, New Mexico 87109

Prepared by:
GeoSystems Analysis, Inc.
3150 Carlisle Blvd. NE,
Albuquerque, NM 87110
www.gsanalysis.com

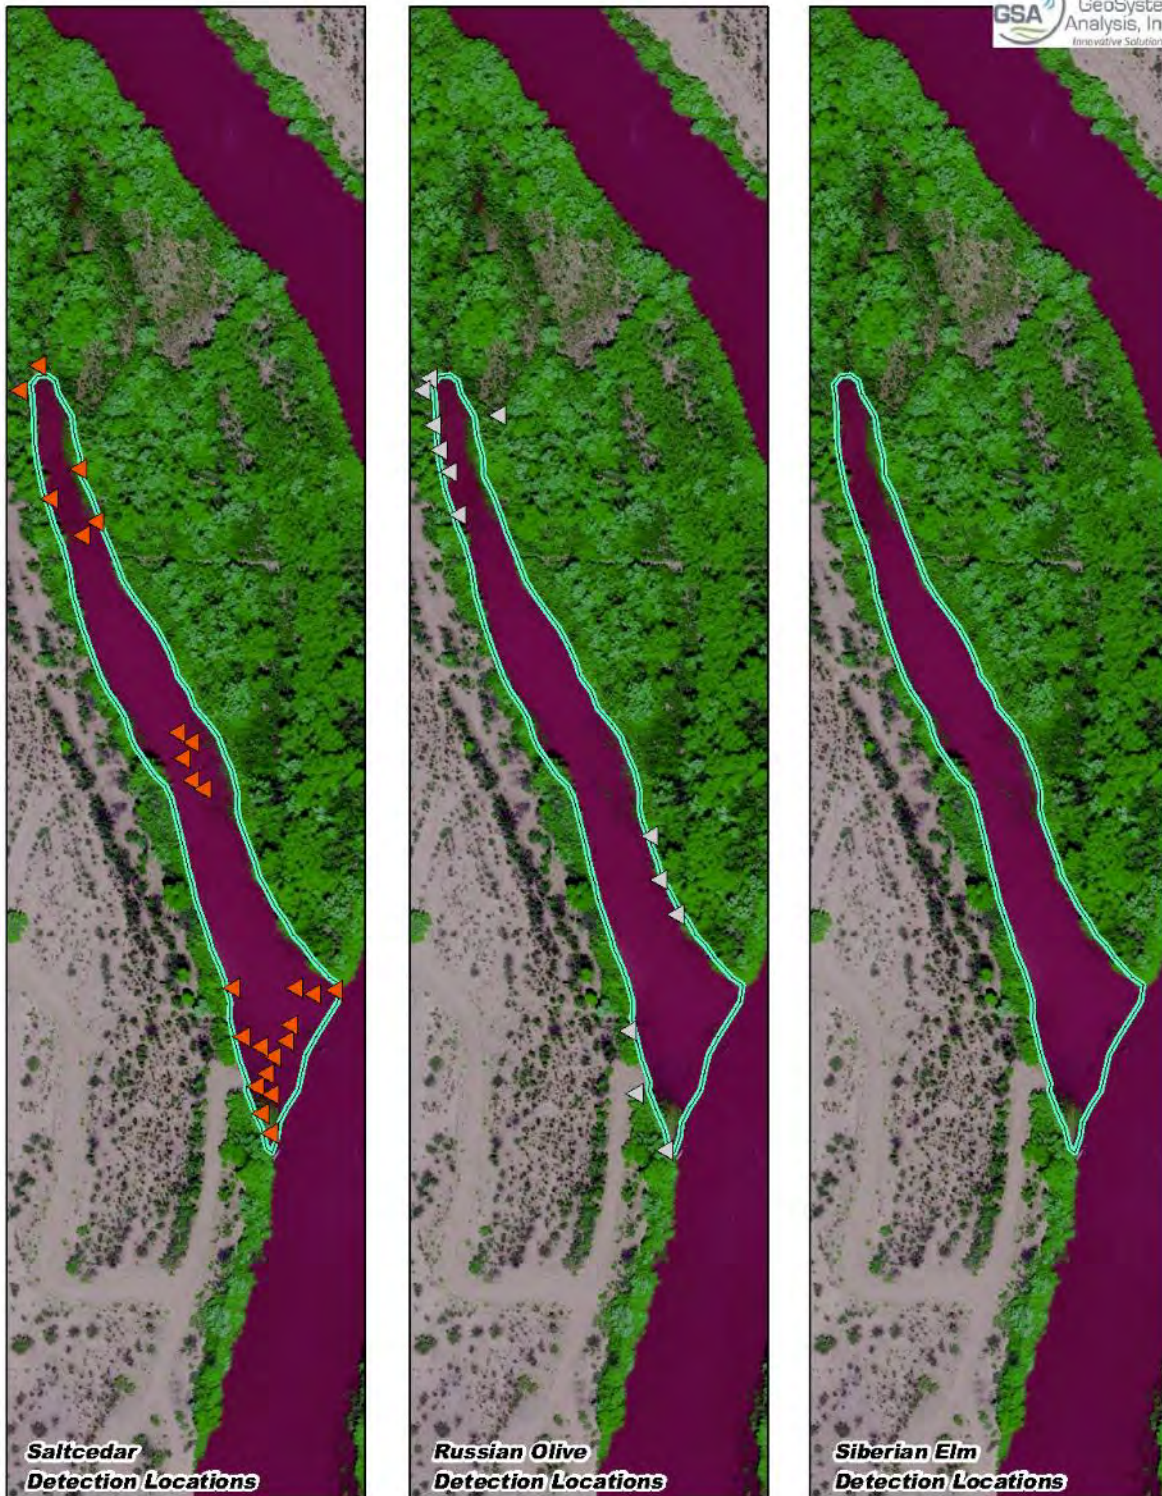
Exotic Woody Spp Distribution: RM 112

Figure F-2. Distribution of non-native saltcedar (left), Russian olive (center) and Siberian elm (right) seedlings recorded at evenly spaced monitoring stations (20 x 20 ft) at RM 112.

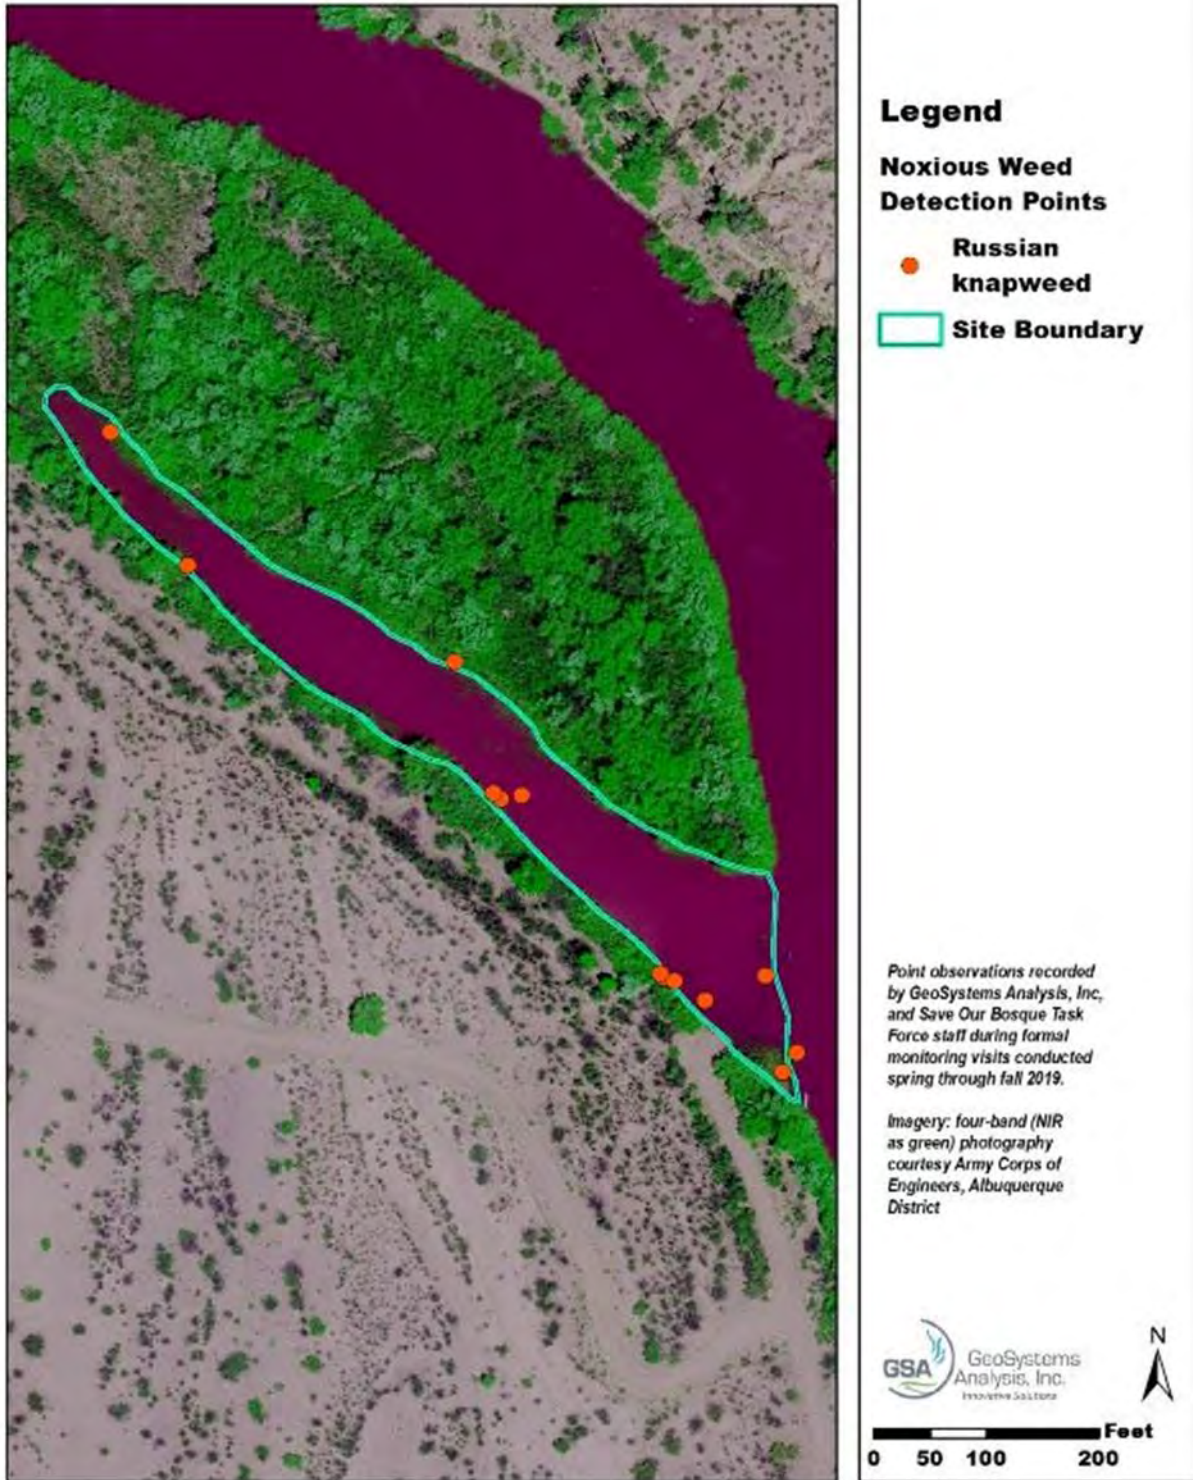
**Noxious Weed Detections through October 2019:
Site RM 112**

Figure 4. Noxious weed species populations documented at RM 112.

STEP 3: Once onsite, open the non-native species distribution map in Avenza Maps. Note that herbaceous noxious weed and non-native woody species detections are shown on separate maps. Avenza Maps will show your current location as a blue dot on the map. In the sample map shown above, monitoring personnel would locate Russian knapweed populations documented at the RM 112 site (shown as red dots on the map) via the Avenza Maps app.

STEP 4: Ensure that crews implementing control treatments follow the species-specific recommended treatment methods and timing described in the *Final Annual Monitoring Results and Maintenance Plan*. When herbicide treatments are recommended, confirm that implementation crews add a blue dye to the specified herbicide formulation so treatment quality can be accurately assessed.

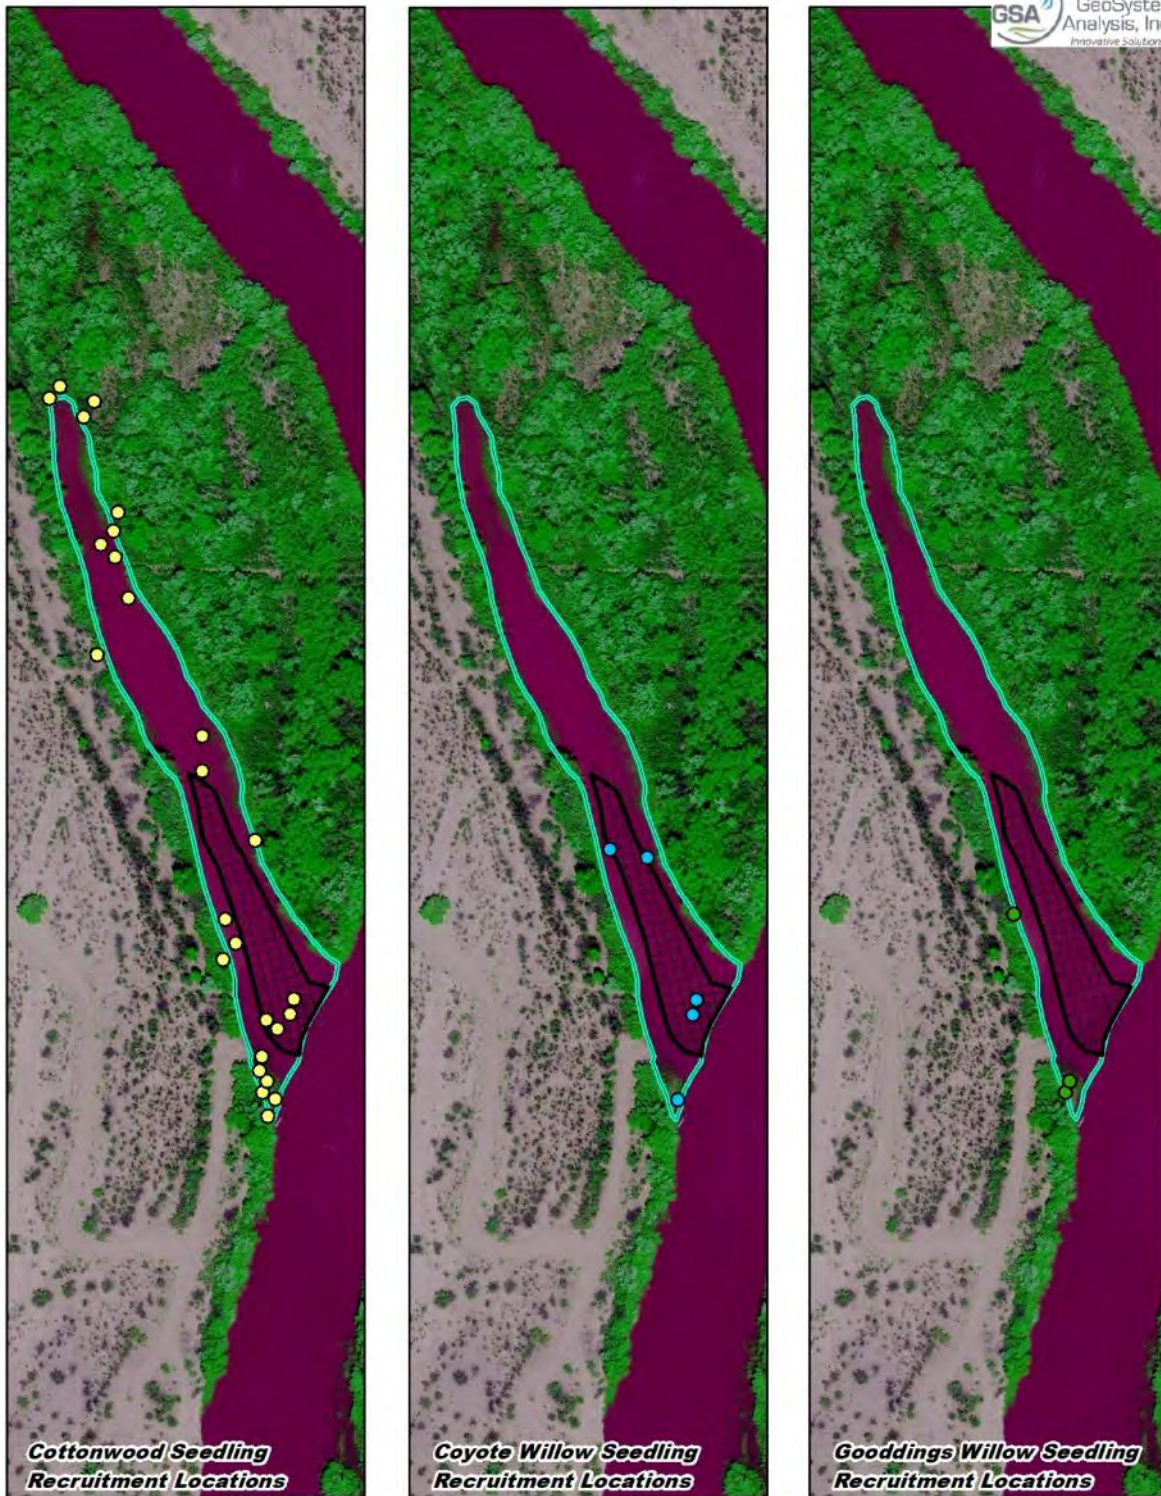
Seedling Distribution: RM 112

Figure 5. Woody vegetation species distribution relative to CMZs at RM 112.

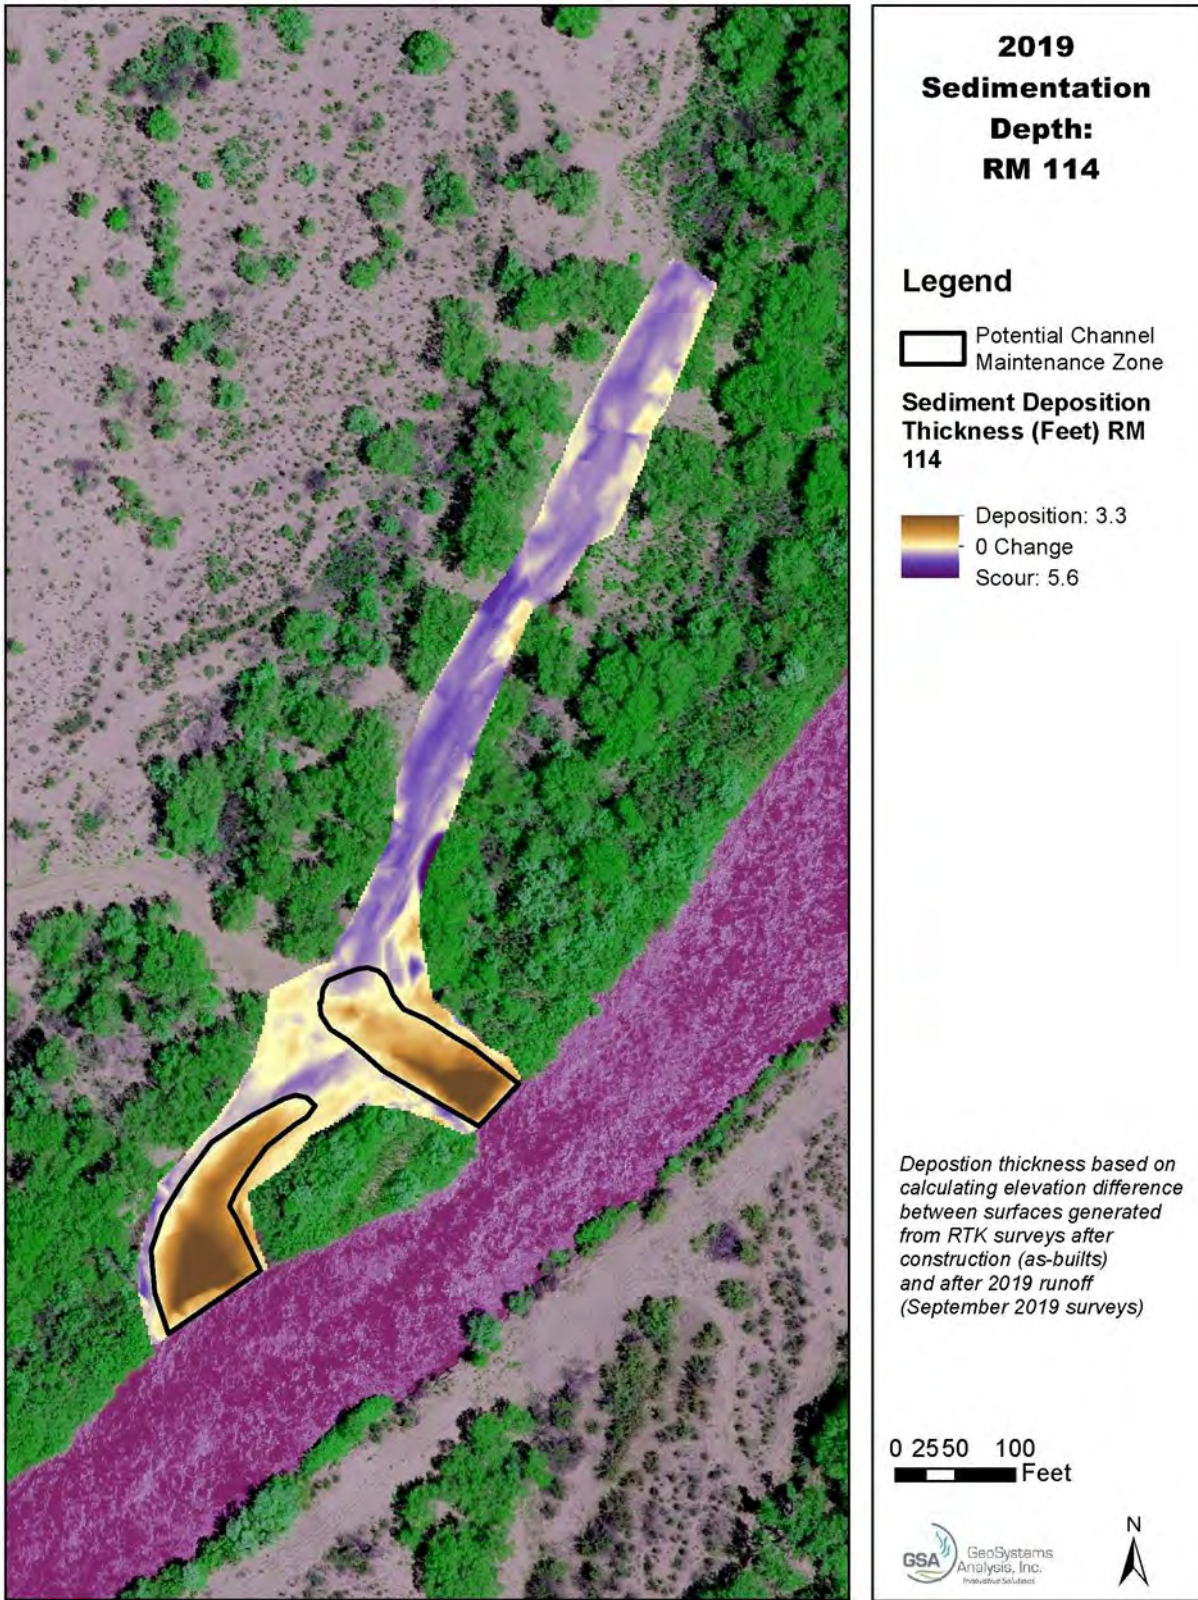
Figure 6. Post-runoff sedimentation and scour at the RM 114 site.

STEP 4: Setup the RTK-GPS base and establish survey controls. Most sites have nearby U.S. Bureau of Reclamation rangeline endpoints or other pre-established survey controls. Initialize the RTK-GPS rover, walk to each inlet, and pound a survey hub in the ground along the river bankline. Spray paint the survey hub to improve visibility. Use the stakeout commands and traditional survey practices to install and label a cut stake at the inlet/river interface. The cut/fill depth should be clearly marked to the nearest 0.1 foot. Use tape flagging and spray paint to improve cut stake visibility. Establish survey offsets and/or additional cut stakes as needed or requested by the heavy equipment operator.
