**INITIAL ISLAND AND BAR GEOMORPHIC SURVEYS FOR THE
RIVERINE HABITAT RESTORATION PROJECT IN THE
ALBUQUERQUE REACH, MIDDLE RIO GRANDE, NEW MEXICO**

NEW MEXICO INTERSTATE STREAM COMMISSION

SWCA[®] ENVIRONMENTAL CONSULTANTS

March 23, 2006

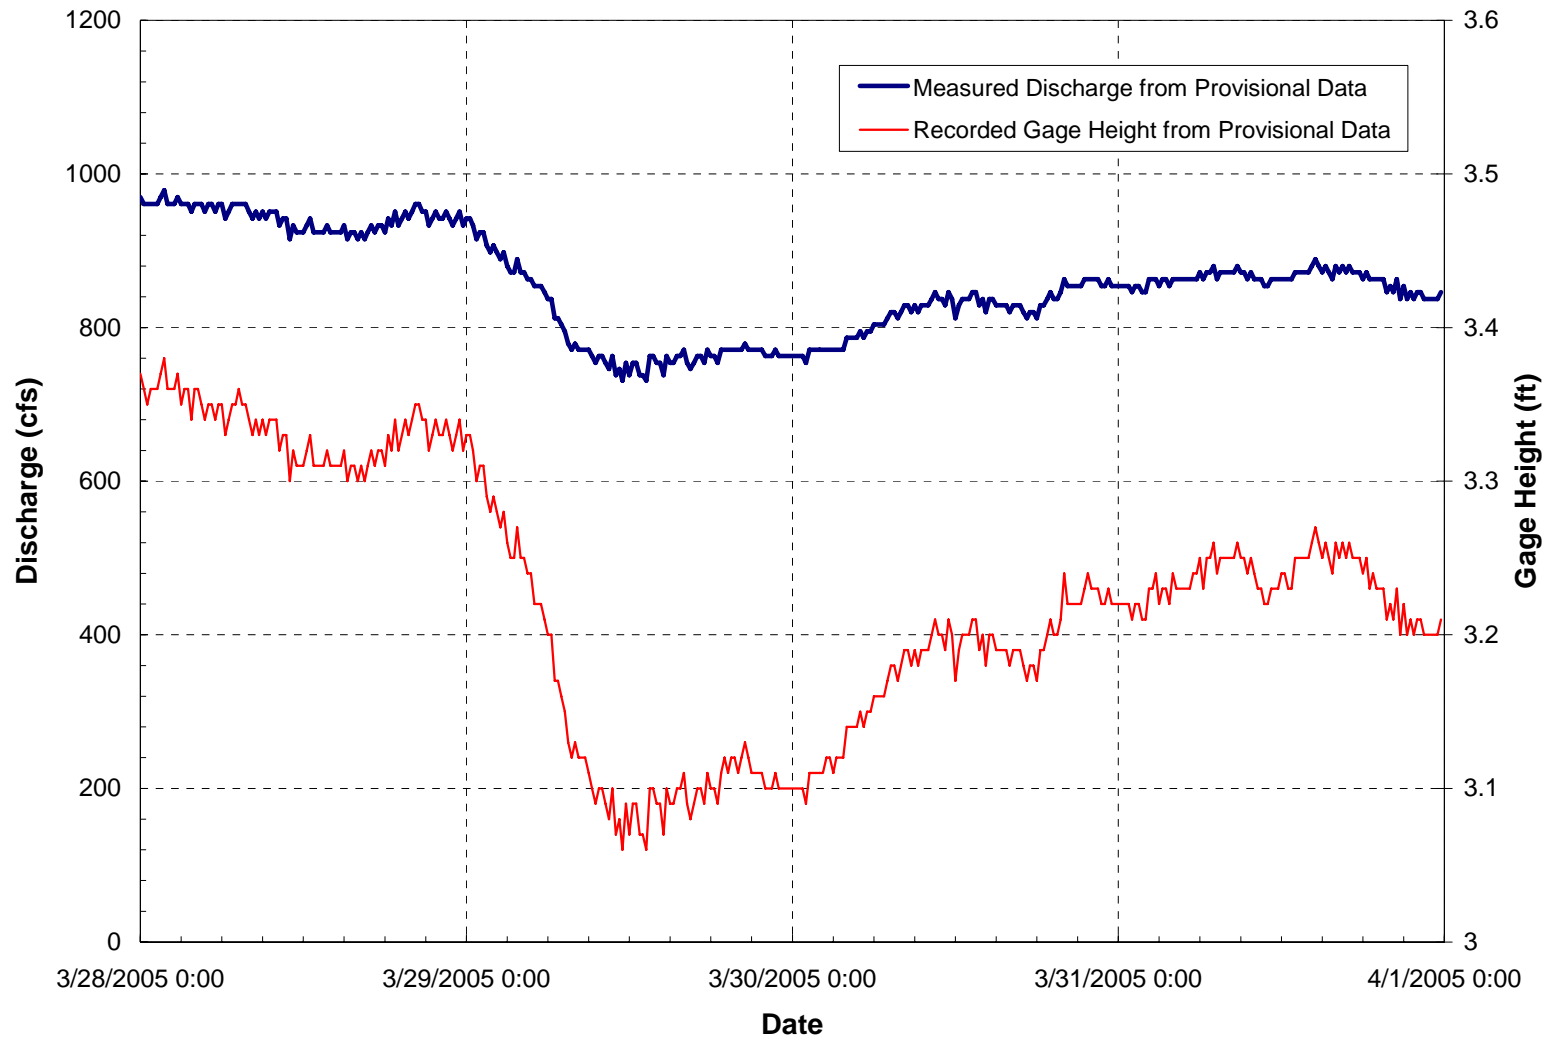
Figure 2. Stage and discharge data for the period between March 28 and April 1, 2005, at the Central Avenue USGS gaging station on the Rio Grande.

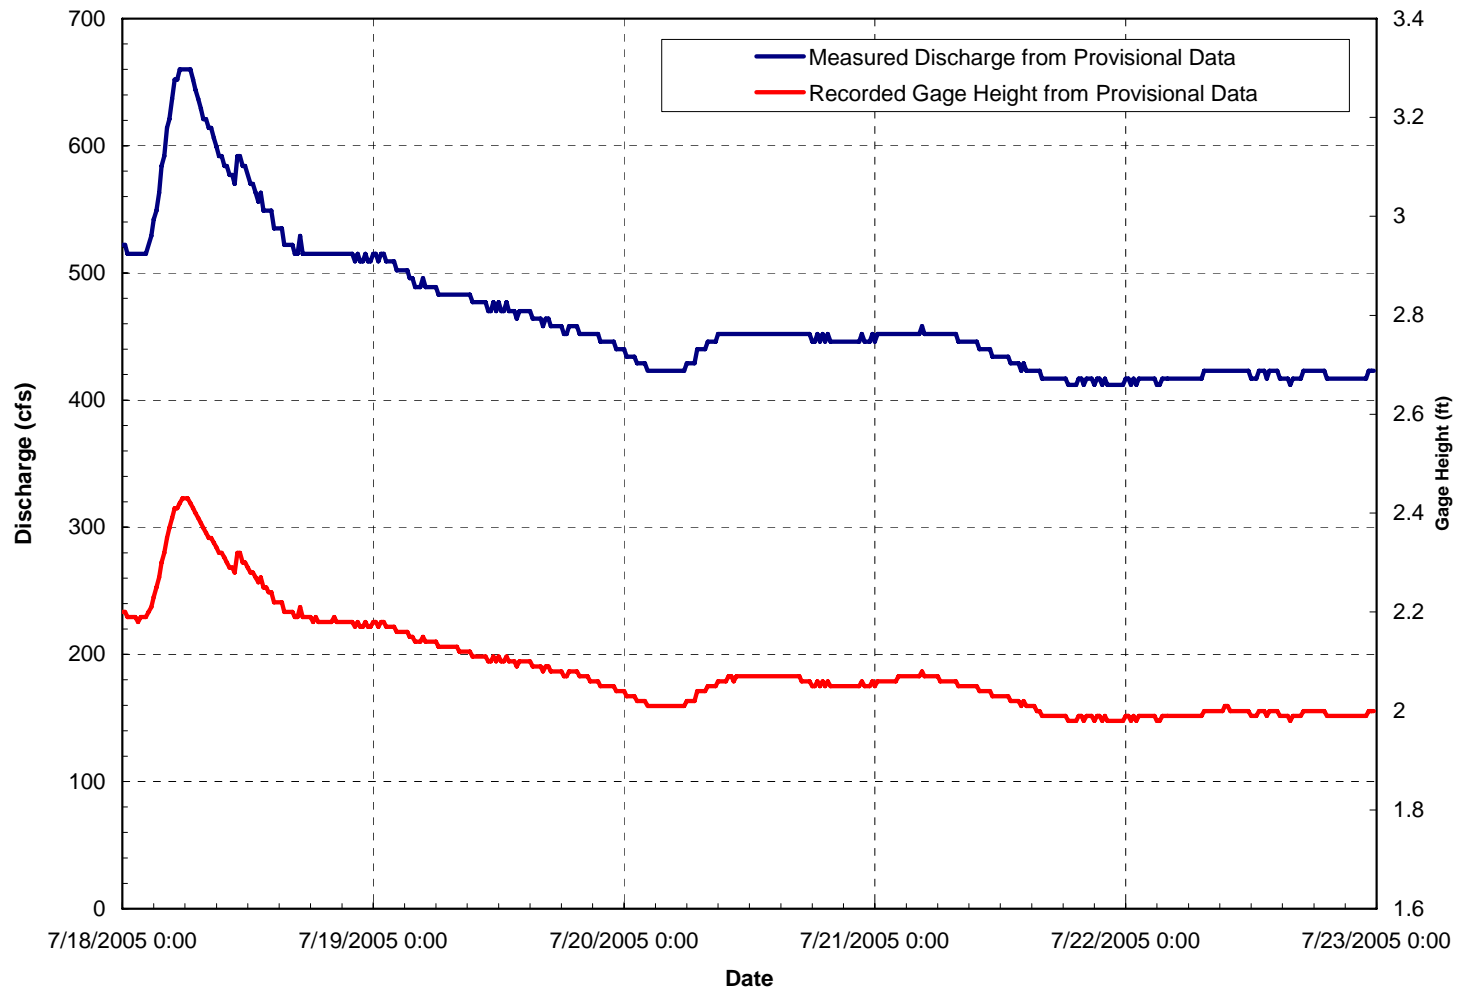
Figure 3. Stage and discharge data for the period July 18 through 23, 2005, at the Central Avenue USGS gaging station on the Rio Grande.

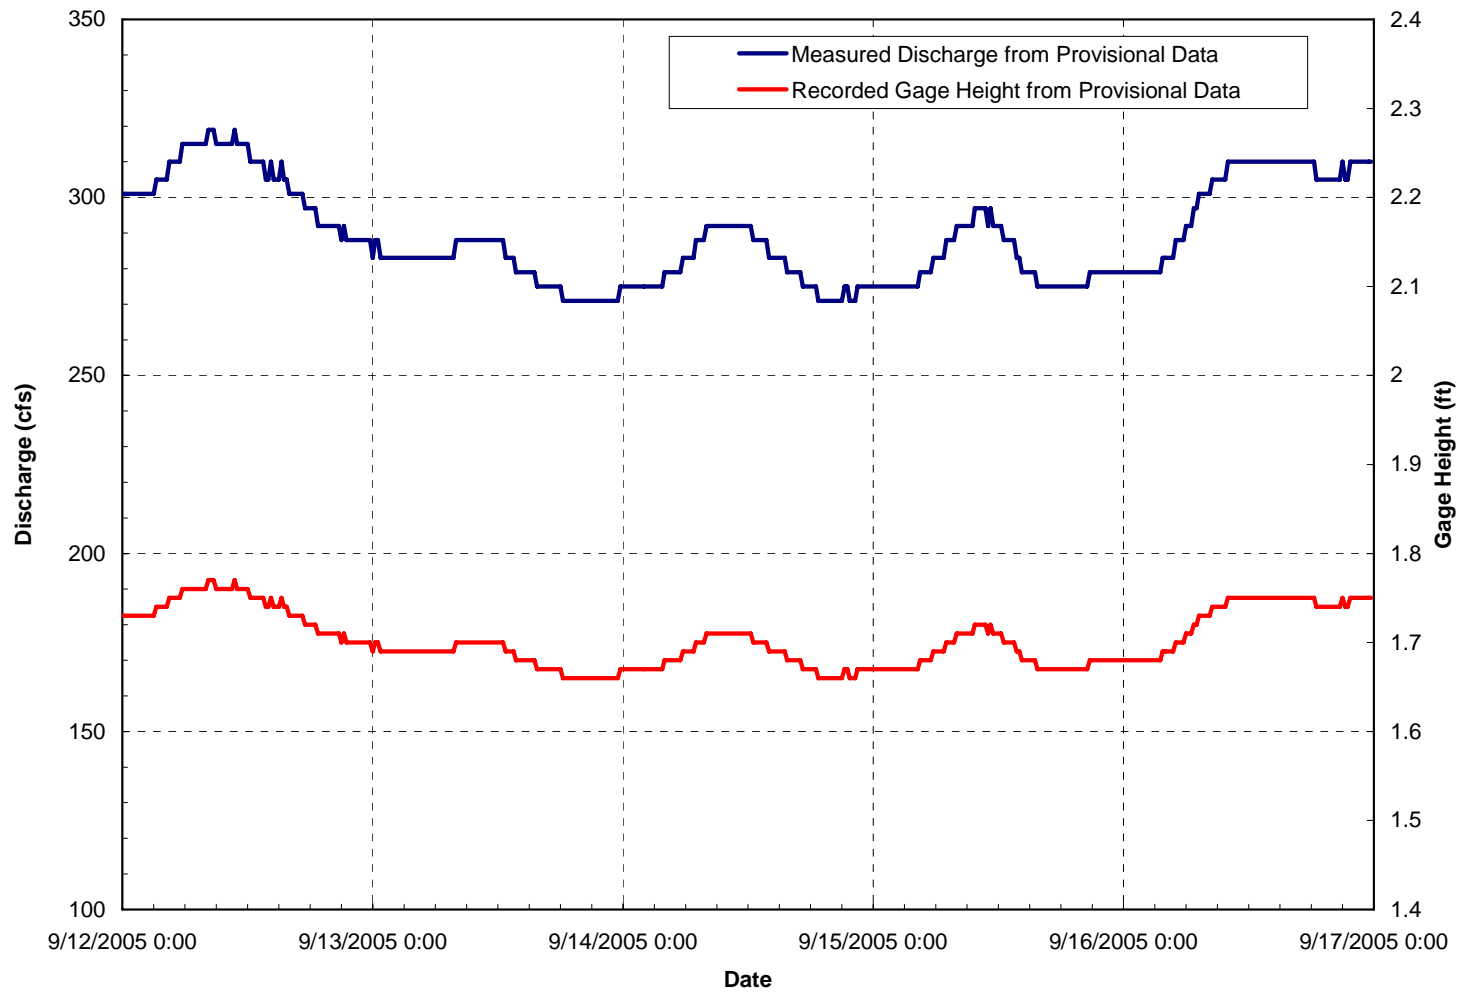
Figure 4. Stage and discharge data for the period September 12 through 17, 2005, at the Central Avenue USGS gaging station on the Rio Grande.

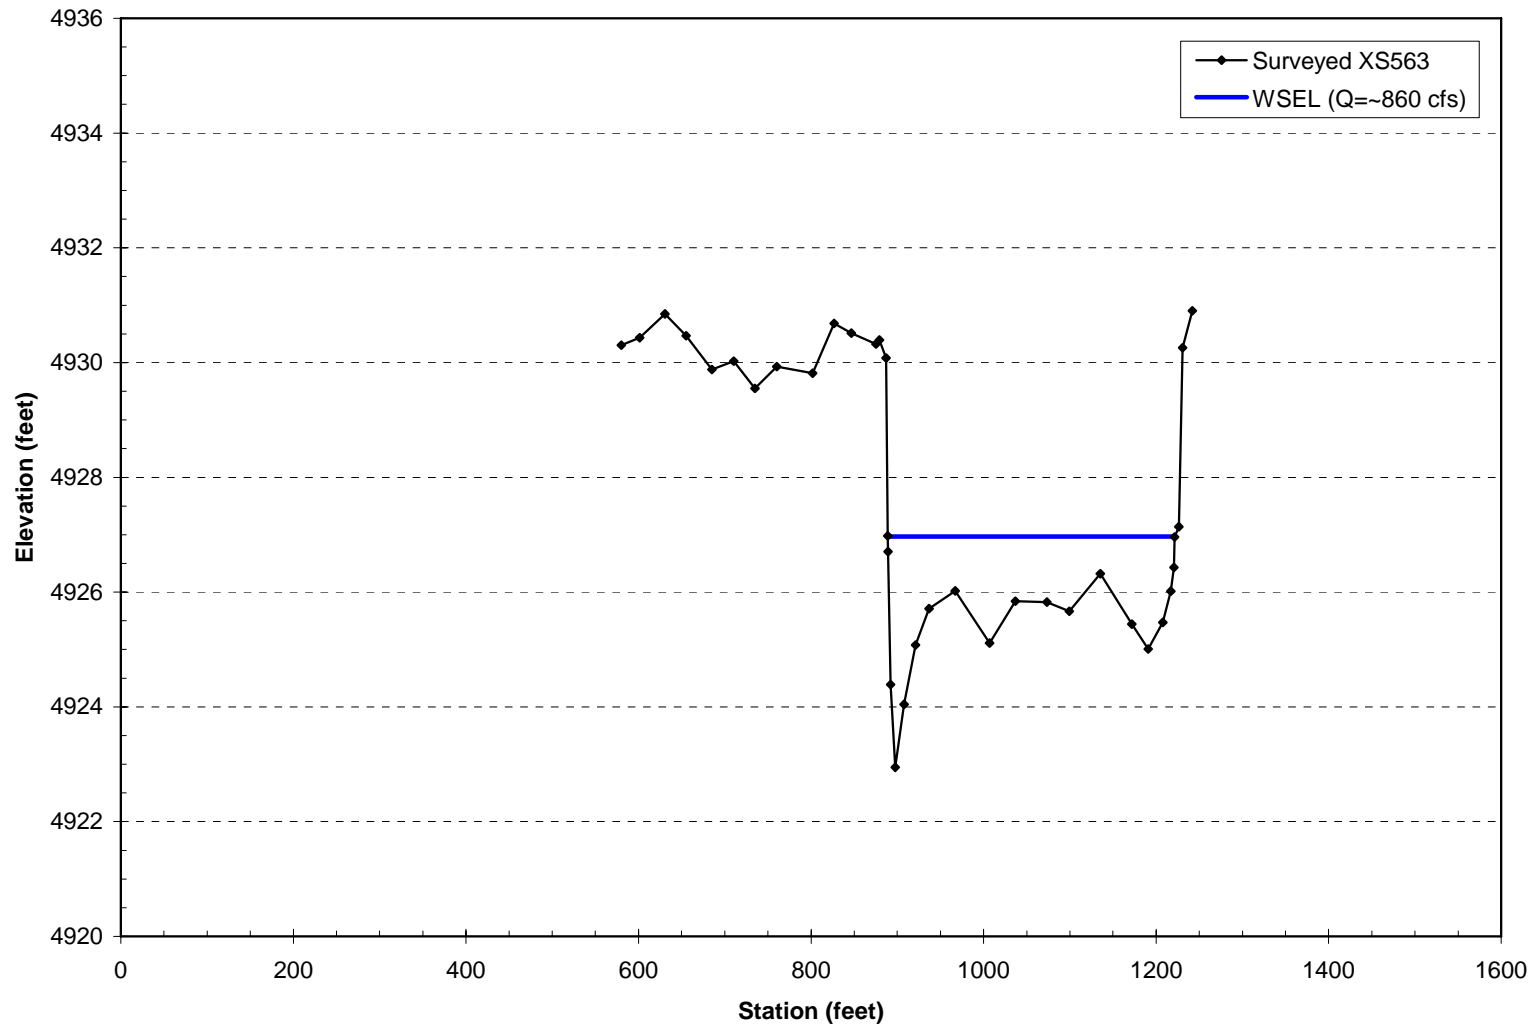
Figure 10. Cross-section profile for XS563 that crosses the upper portion of the bank-attached bar in the South Diversion Channel subreach. The flow in the river was about 860 cfs.

The locations of cross-section profiles that were surveyed in the SDC subreach in March 2005 are shown on Figure 5. Cross-section numbers are related to the U.S. Army Corps of Engineers (USACE) HEC-RAS model and the BOR range line numbering system, and the cross sections are plotted looking downstream. Figure 6 shows the cross-section profile (XS567.5) through the downstream-most mid-channel bar/island. Figure 7 shows the cross-section profile (XS567) through the upstream-most mid-channel bar/island, and Figure 8 shows the cross-section profile (XS566) through the control mid-channel bar/island. Figure 9 shows the cross-section profile (XS564) through the lower portion of the bank-attached bar, and Figure 10 shows the cross-section profile (XS563) through the upper portion of the bank-attached bar.

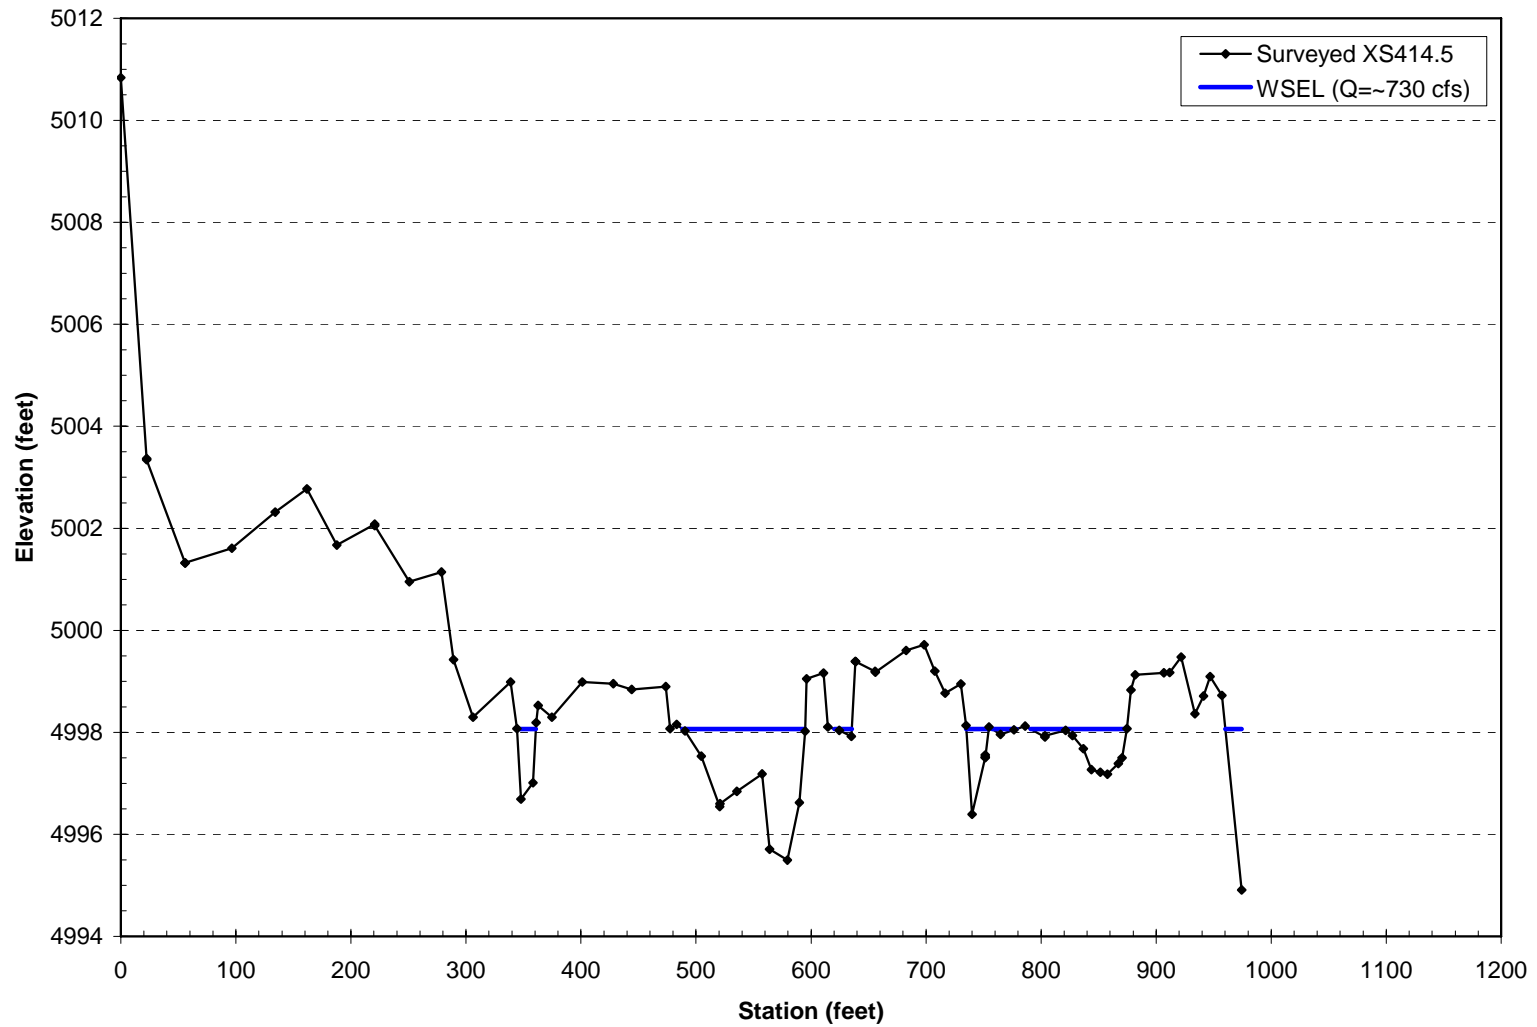
Figure 12. Cross-section profile for XS414.5 that crosses the downstream-most of the restoration mid-channel bars/islands in the North Diversion Channel subreach. The flow in the river was about 730 cfs.

The locations of the surveyed cross-section profiles for the NDC subreach are shown on Figure 11. Cross-section numbers are related to the USACE HEC-RAS model and the BOR range line numbering system, and the cross sections are plotted looking downstream. Figure 12 shows the cross-section profile (XS414.5) through the downstream-most mid-channel bar/island. Figure 13 shows the cross-section profile (XS405.5) through the downstream end of the upstream-most mid-channel bar/island. Figure 14 shows the cross-section profile (XS405) that crosses both the upstream end of the upstream-most mid-channel bar/island and the downstream end of the control mid-channel bar/island. Figure 15 shows the cross-section profile (XS404.5) through the control mid-channel bar/island.

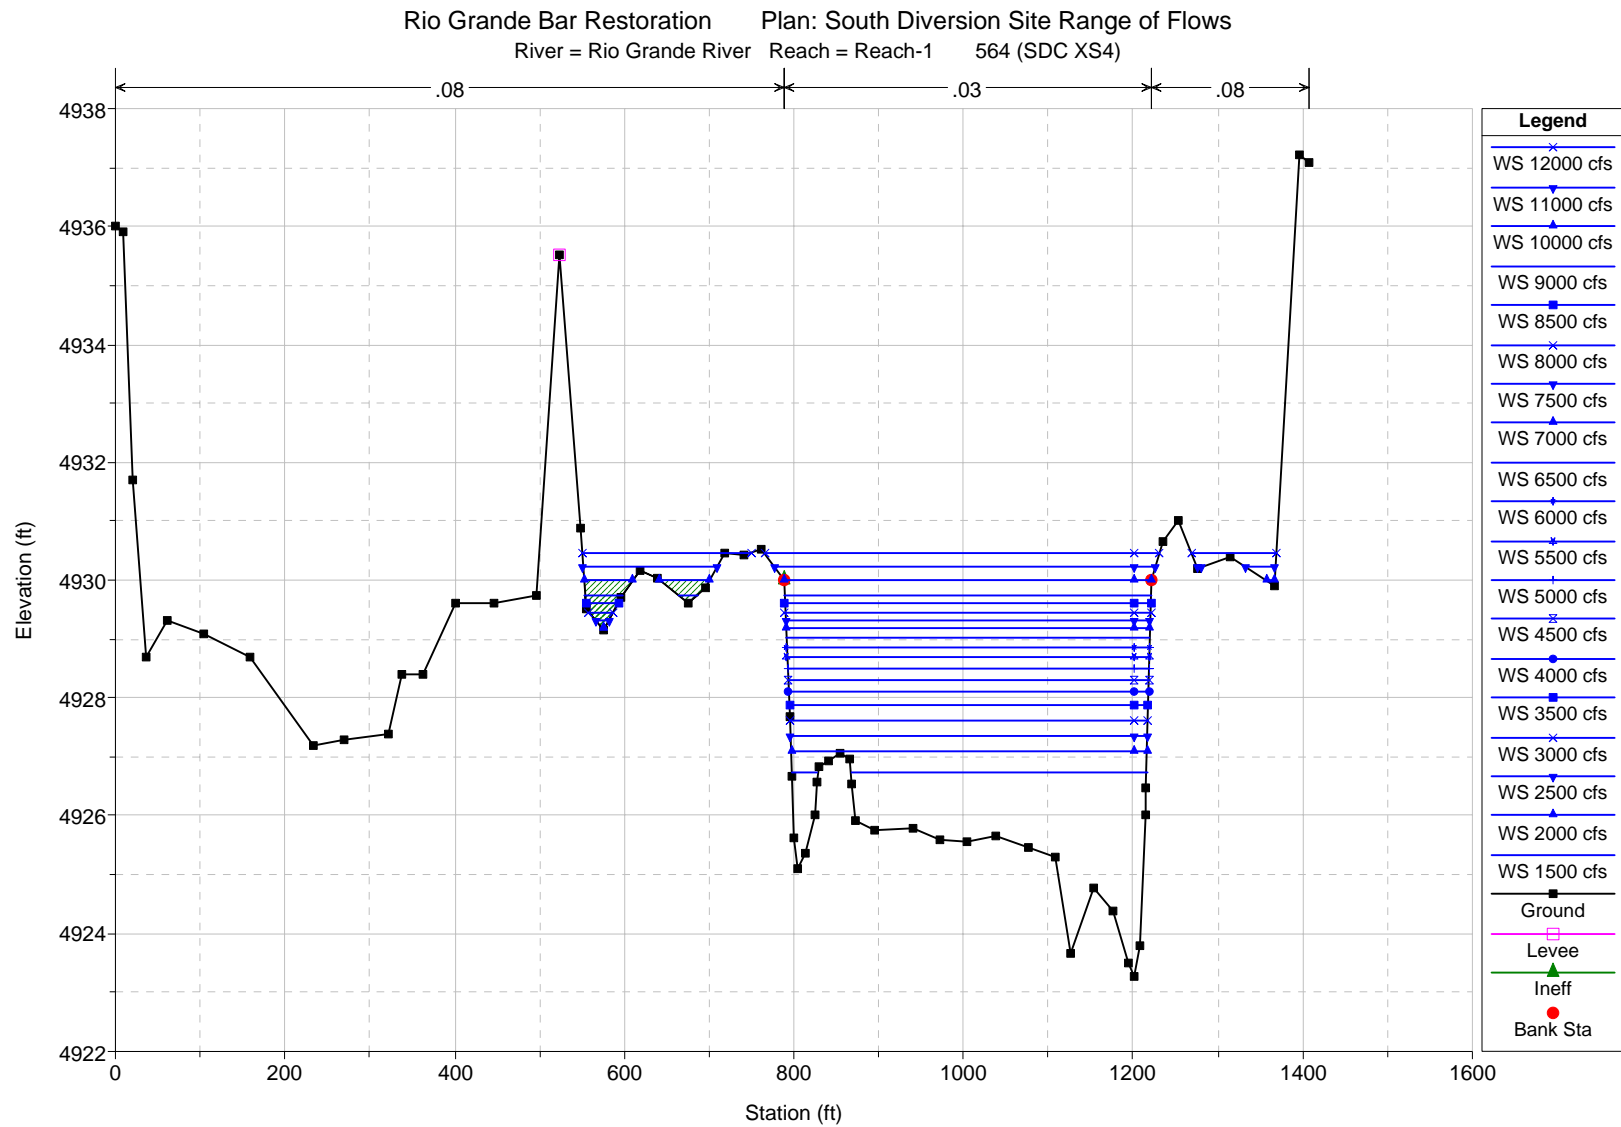
Figure 16. Cross Section 563 showing water-surface elevations for flows between 1,500 and 12,000 cfs at the upstream end of the bank-attached bar.

Figure 17. Cross Section 564 showing water-surface elevations for flows between 1,500 and 12,000 cfs at the downstream end of the bank-attached bar.

Figures 16 and 17 show that the bank-attached bar (XS563 and XS564) should be overtopped at a flow of between 10,000 and 12,000 cfs, which is similar to the 5-year

peak discharge (10,800 cfs) prior to construction of Cochiti Dam (MEI 2002). This discharge is somewhat higher than would be expected for the 2-year peak discharge (about 7,000 cfs) that probably correlated with the floodplain elevation of the Rio Grande prior to the construction of Cochiti Dam. Stage-discharge rating curves for the Central Avenue USGS gage indicate that the channel degraded about 2 feet between 1973 and 1987 (MEI 2002), and this probably explains the greater present channel capacity at the bank-attached bar.

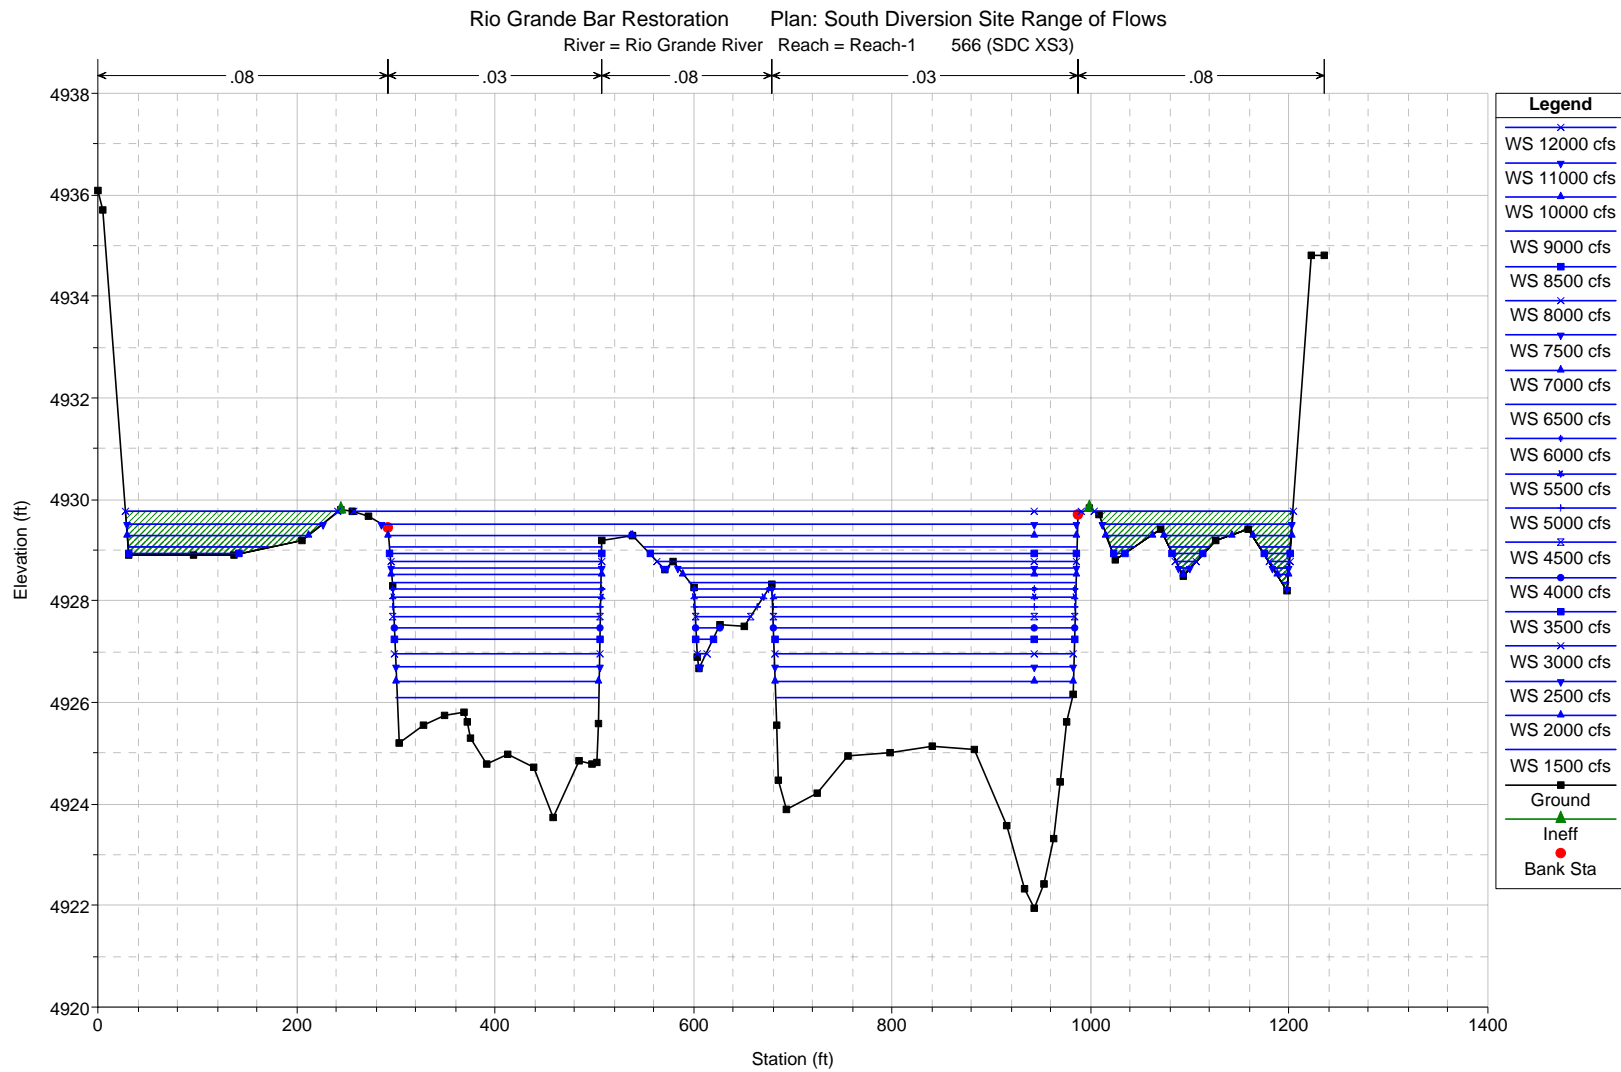
Figure 18. Cross Section 566 showing water-surface elevations for flows between 1,500 and 12,000 cfs at the control mid-channel bar/island.

Figure 18 shows that the highest portions of the control mid-channel bar/island (XS566) will be inundated at a discharge of about 10,000 cfs, whereas other parts of the bar will be inundated at discharges on the order of 5,000 to 6,000 cfs, which is what occurred during the May to June 2005 period of high flows. Figure 19 (XS567) shows that at the upstream-most of the restoration mid-channel bars/islands, the bar will be inundated at a discharge of between 5,000 and 6,500 cfs, which is what occurred in the May to June 2005 period of high flows. The downstream-most of the restoration mid-channel bars/islands (XS567.5) will be inundated at a discharge of between 4,500 and 5,500 cfs (Figure 20), which is what occurred in the May to June 2005 period of high flows. The 2-year peak discharge in the post-Cochiti Dam period is on the order of 5,400 cfs (MEI 2002), and this flow appears to correlate with the mid-channel bar/island surfaces fairly well, which suggests that the mid-channel bars/islands are now functionally equivalent to the present floodplain of the Rio Grande, and the former floodplain surfaces are now terraces that are inundated infrequently (20- to 50-year post-Cochiti Dam peak discharges) (MEI 2002).

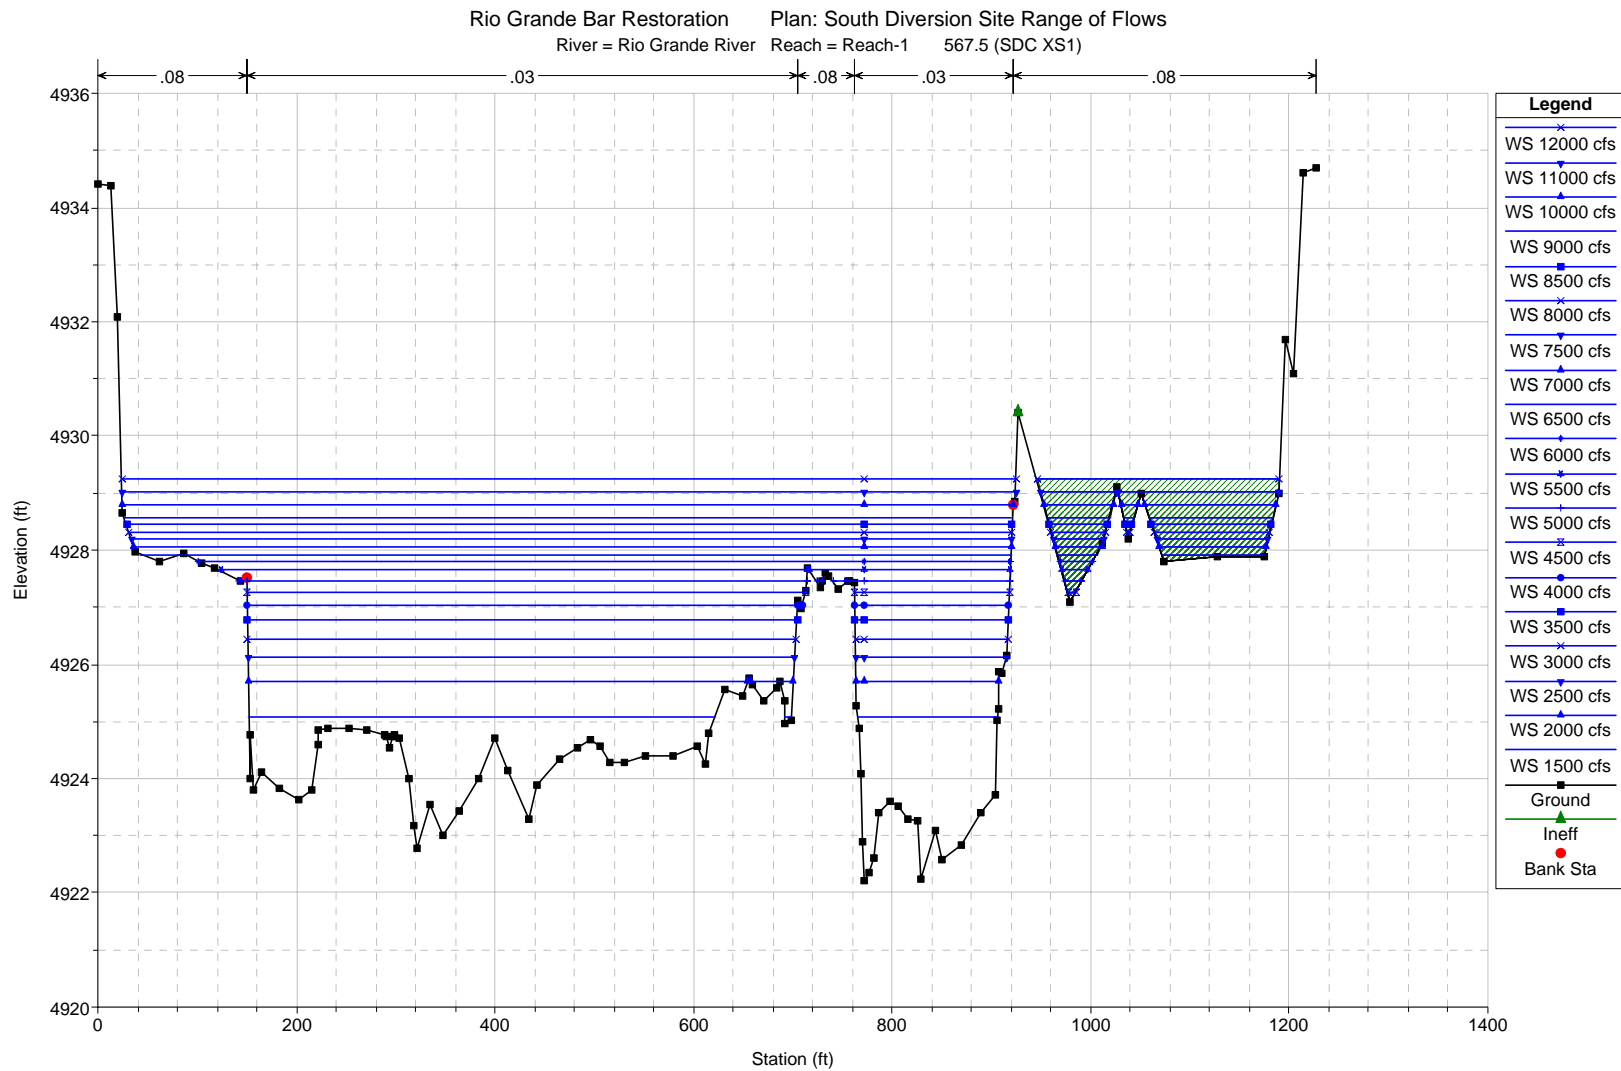
Figure 20. Cross Section 567.5 showing water-surface elevations for flows between 1,500 and 12,000 cfs at the downstream-most of the restoration mid-channel bars/islands.

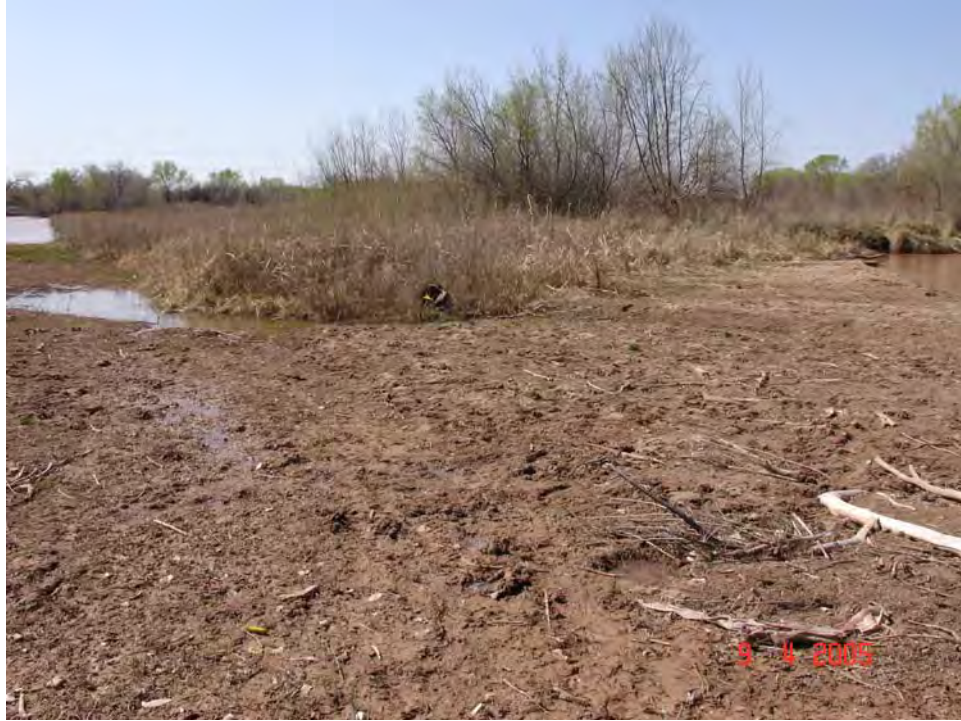
Figure 21. View downstream of the head of the downstream-most mid-channel bar/island in the South Diversion Channel subreach. The low vegetation is on the LI surface, and the Russian olive trees are on the LII surface.

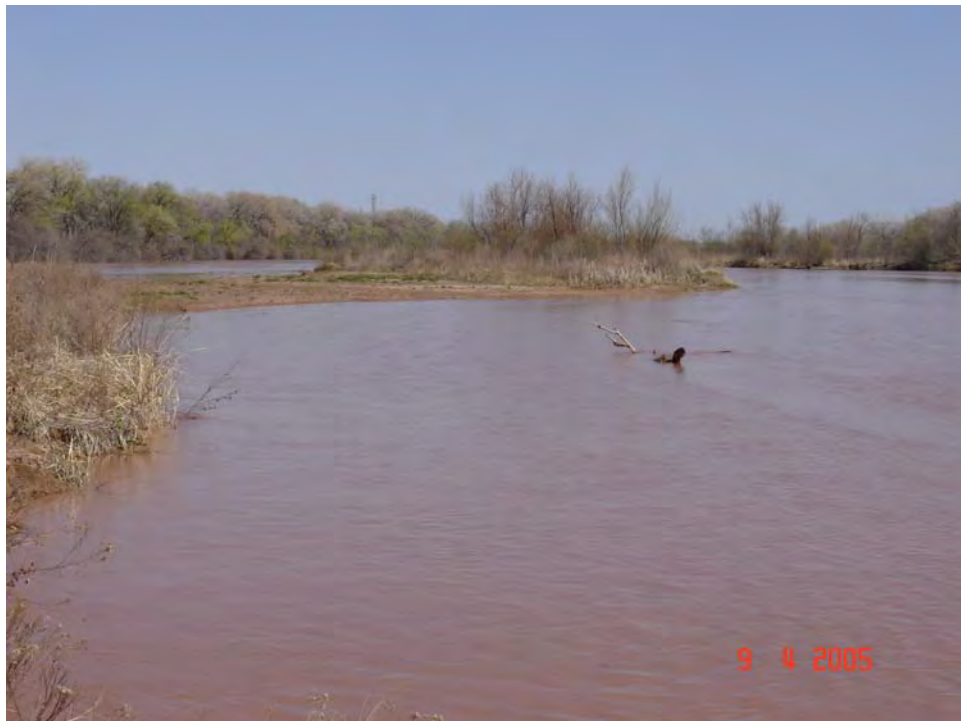
Figure 22. View upstream of the downstream end of the upstream-most of the mid-channel bars/islands in the South Diversion Channel subreach. The lower vegetation is on the LI surface, and the Russian olives are on the LII surface.

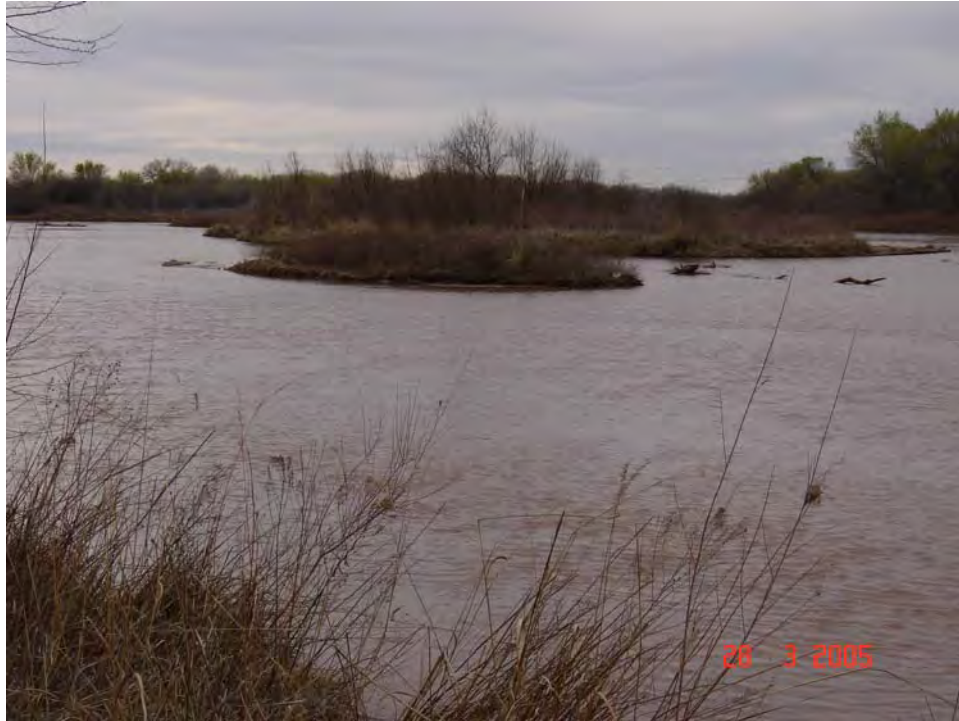
Figure 23. View downstream of the LII mid-channel bar that is the control for the South Diversion Channel subreach.

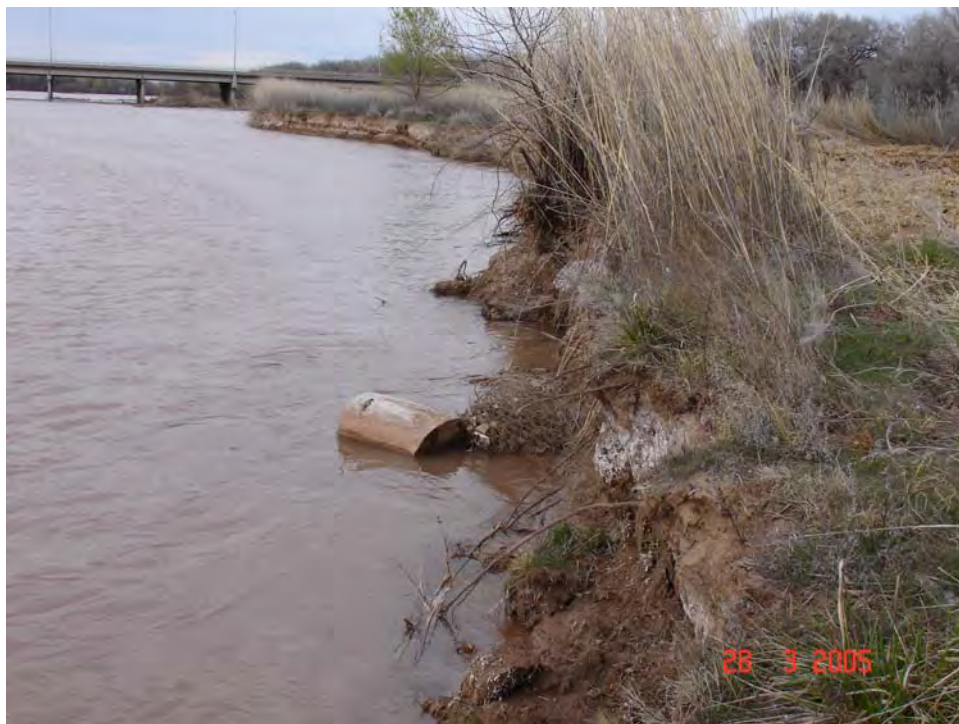
Figure 24. View upstream of the left bank of the bank-attached bar with the Rio Bravo Bridge in the background. The top of the bank represents an LII bank-attached bar.

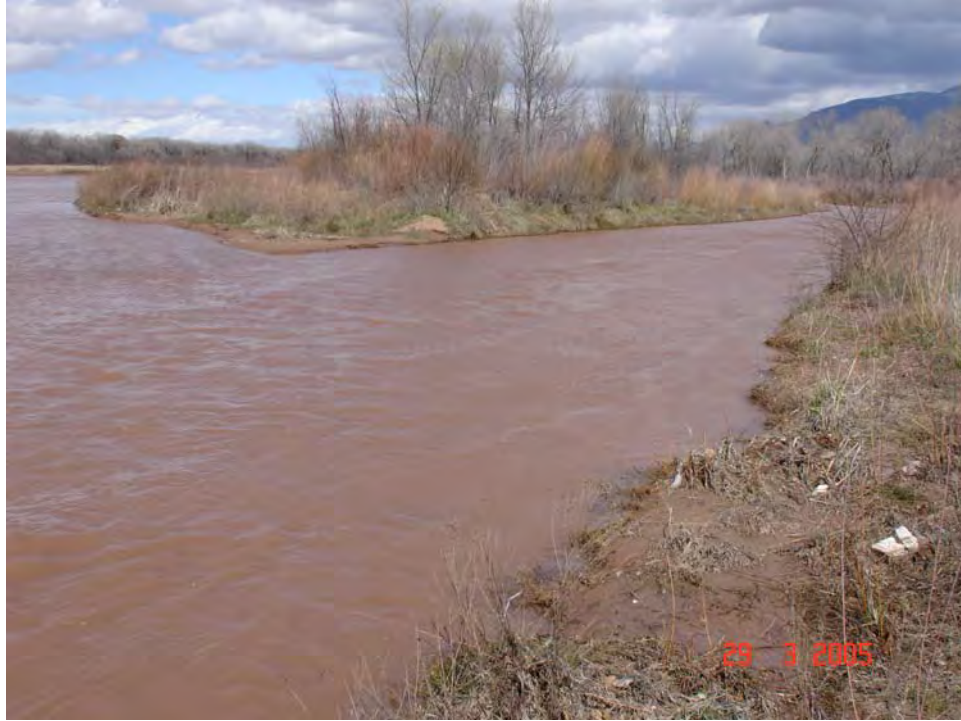
Figure 25. View upstream of the LII mid-channel bar that is the control for the North Diversion Channel subreach. An LI surface is located along the right side of the higher-elevation LII bar.

Within the NDC subreach, the control mid-channel bar/island is classified as an LII mid-channel bar (Figure 25). About one-third of the upstream-most mid-channel bar/island is classified as an LII mid-channel bar, but the remainder of the bar is classified as an LI mid-channel bar that has accreted to the LII bar (Figure 26). Based on the Central Avenue site data, LI mid-channel bars are inundated on average by the 1.5-year peak flow, for about 5 percent of the time (about 18 days per year). The downstream-most of the mid-channel bars/islands is classified as an LI mid-channel bar (Figure 27).

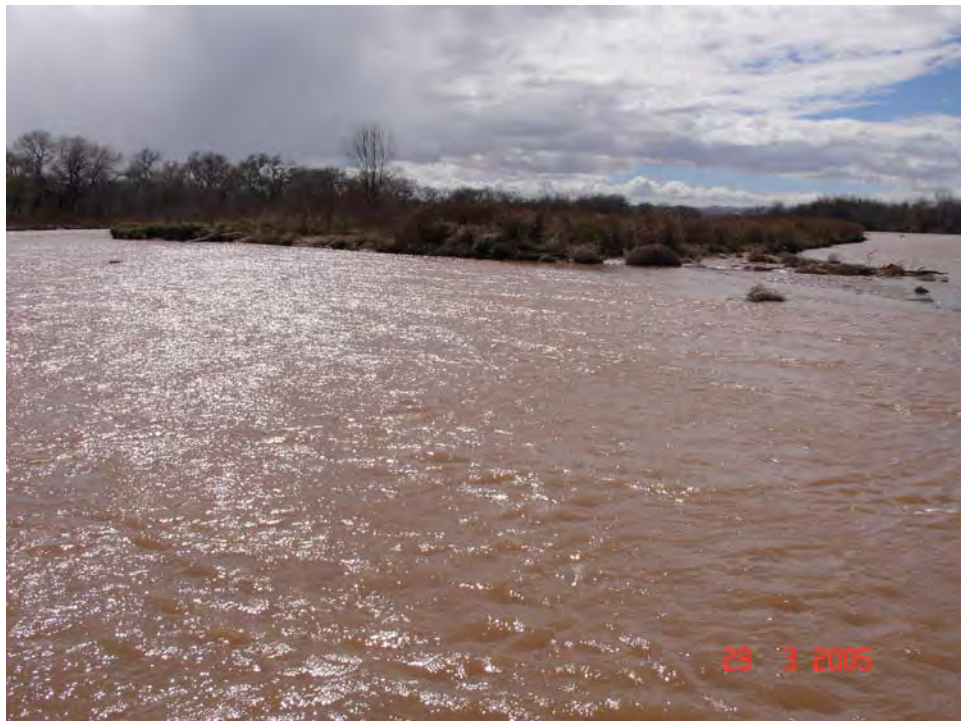
Figure 26. View downstream of the upstream-most of the mid-channel bars/islands in the North Diversion Channel subreach. The right side of the picture shows the LI surface, and the left side shows the LII surface.

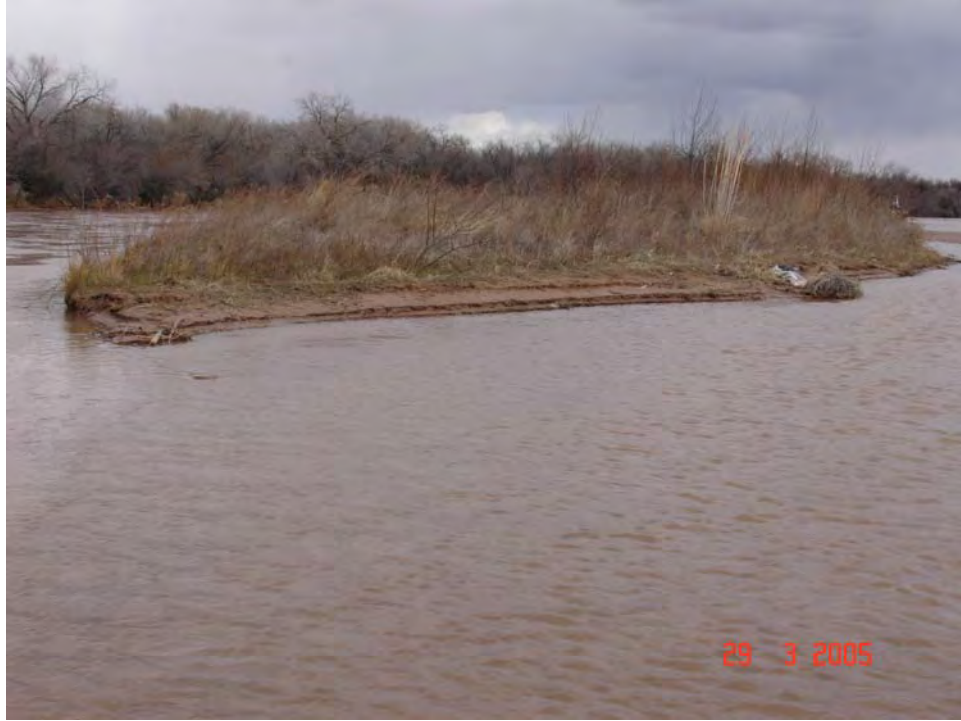
Figure 27. View upstream of the downstream-most mid-channel bar/island in the North Diversion Channel subreach. The entire bar is classified as an LI mid-channel bar.

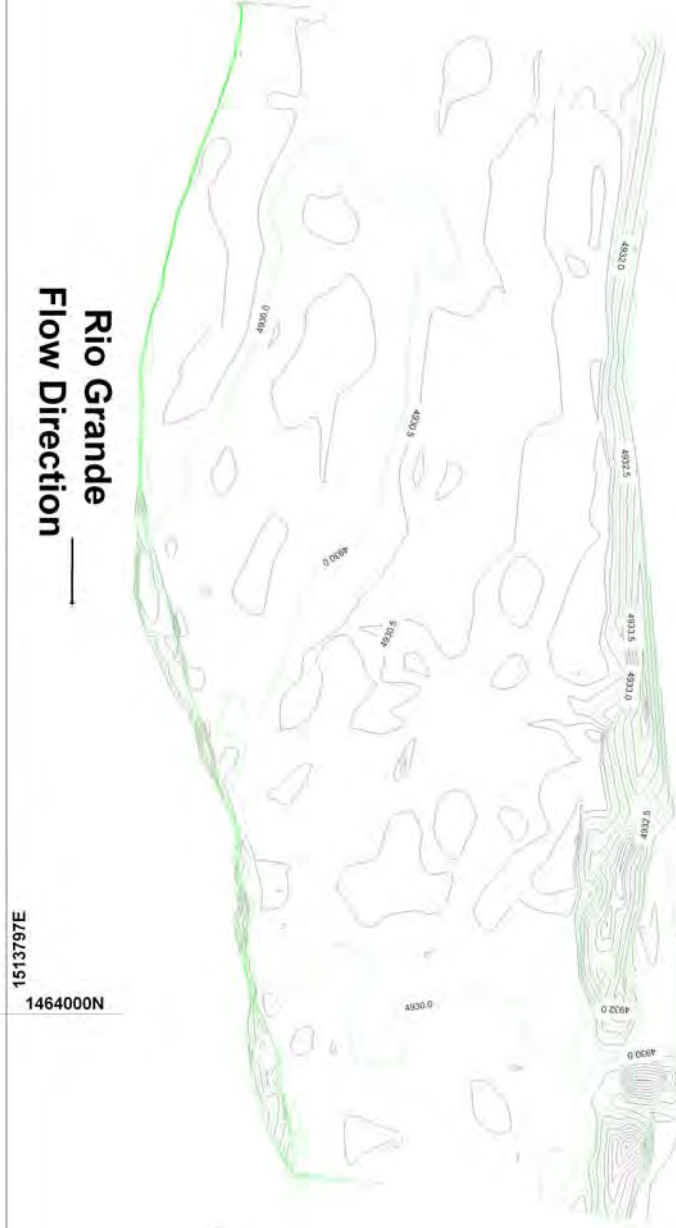
South Diversion Channel
Attached Bar 1

Contour Interval 0.5 ft.

Topographic data from the mid-channel bars/islands and bank-attached bars were reduced to provide 0.5-foot contour interval maps, using the Microstation software. Contour maps for the four mid-channel bars/islands and five bank-attached bars in the SDC subreach are provided in Appendix A. Contour maps for the four mid-channel bars/islands and three bank-attached bars in the Interstate-40/Central Avenue subreach are provided in Appendix B. Contour maps for the five mid-channel bars/islands in the NDC subreach are provided in Appendix C. Contour maps for the resurveyed mid-channel bars/islands in the SDC and NDC subreaches are also included in Appendixes A and C, respectively.

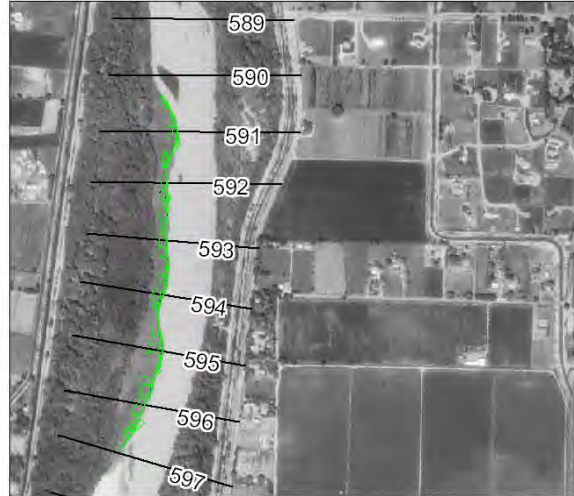
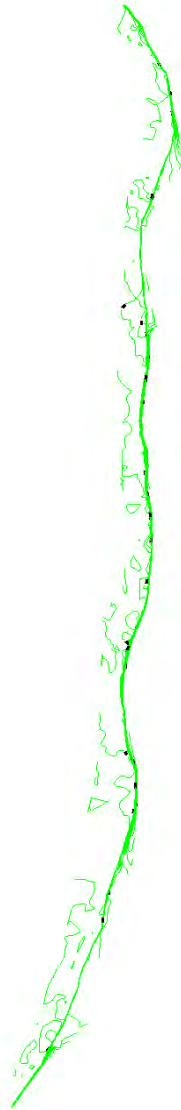
South Diversion Channel Bar 5

Contour Interval 0.5 ft.

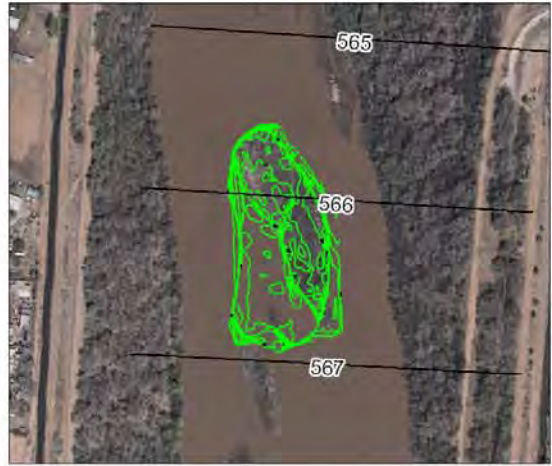
South Diversion Channel
Control Island 1

Contour Interval 0.5 ft.

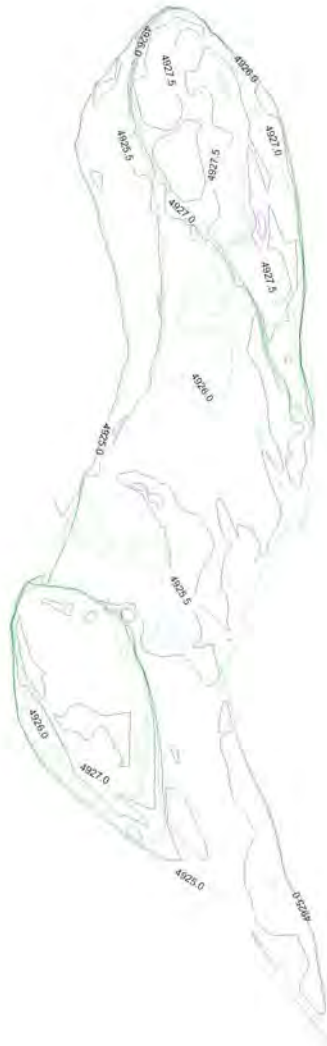
South Diversion Channel Restoration Islands 2 and 3

Contour Interval 0.5 ft.

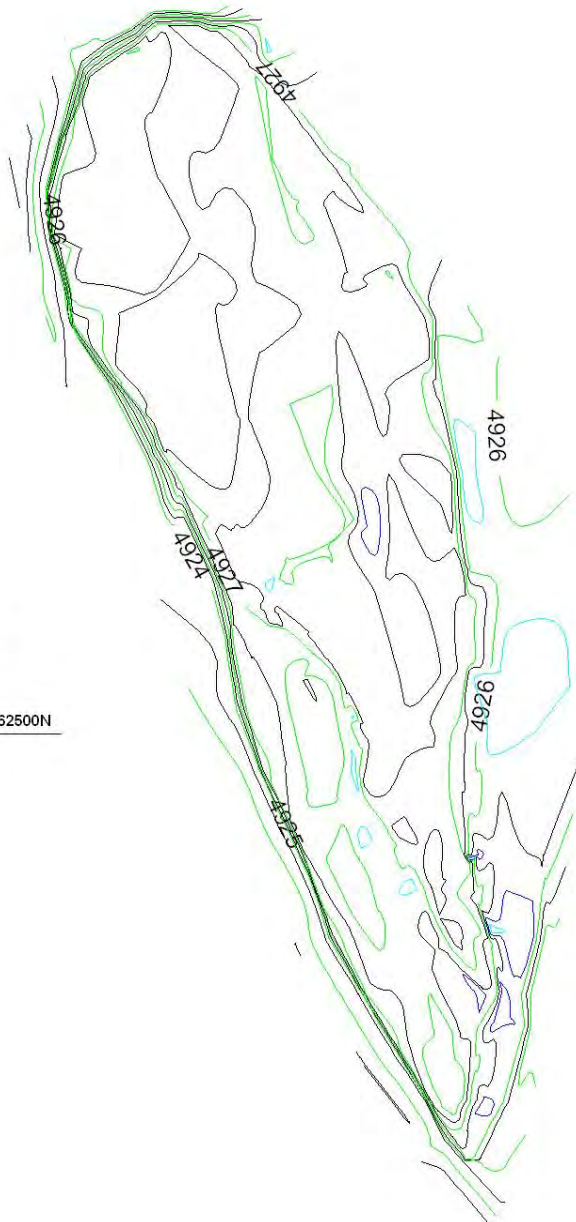
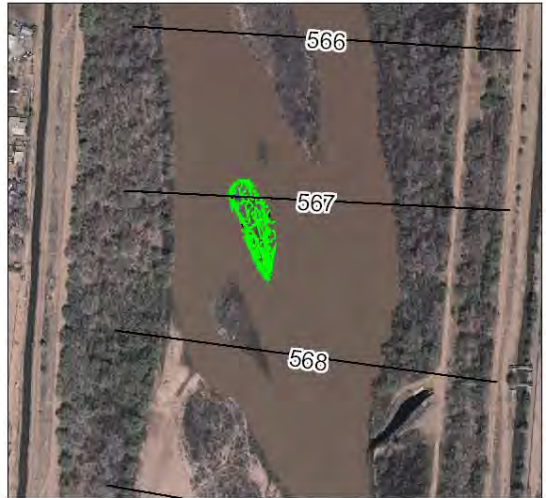
**South Diversion Channel
Restoration Island 2**

Contour Interval 0.5 ft.

Figure 29 is a color-gradient map of the elevation changes at the upstream-most restoration bar/island (No. 2) in the SDC subreach. Most of the island, with the exception of the LII core, was inundated during the high flows between May 12 and June 15, 2005, and therefore there was a significant amount of vertical accretion, from about 0.5 to 2 feet, on the LI surfaces. Degradation along the west (right) side of the bar/island was due to a channel change. Prior to the high flows, the main thread of the river was located to the east, but during the high flows, the main channel switched to the west side.
