**INITIAL ISLAND AND BAR GEOMORPHIC SURVEYS FOR THE
RIVERINE HABITAT RESTORATION PROJECT IN THE
ALBUQUERQUE REACH, MIDDLE RIO GRANDE, NEW MEXICO**

NEW MEXICO INTERSTATE STREAM COMMISSION

SWCA[®] ENVIRONMENTAL CONSULTANTS

March 23, 2006

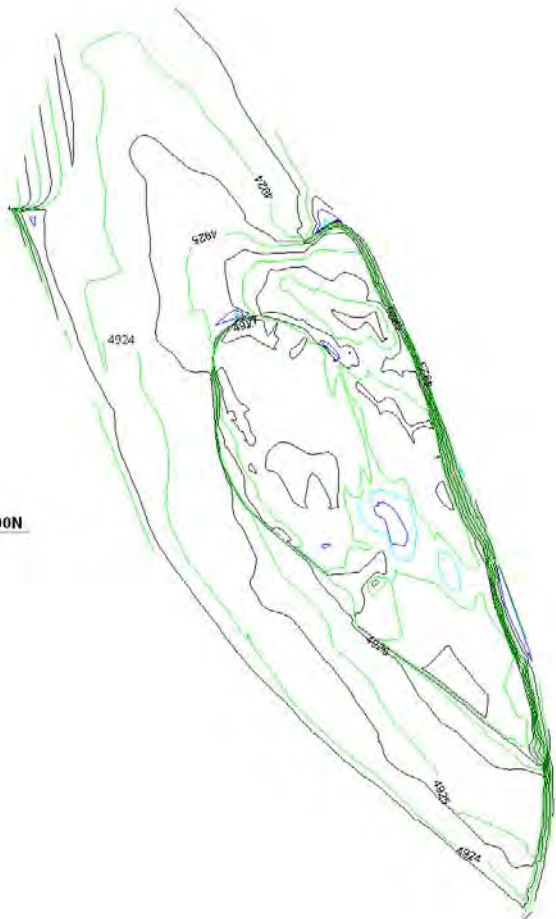
**South Diversion Channel
Restoration Island 3**

Contour Interval 0.5 ft.

The generally lower elevation downstream-most restoration bar/island (No. 3) in the SDC subreach was subjected to considerable vertical accretion on the LI surface between May 12 and June 15, 2005 (Figure 30), from about 0.5 to 2.5 feet. Degradation on the east

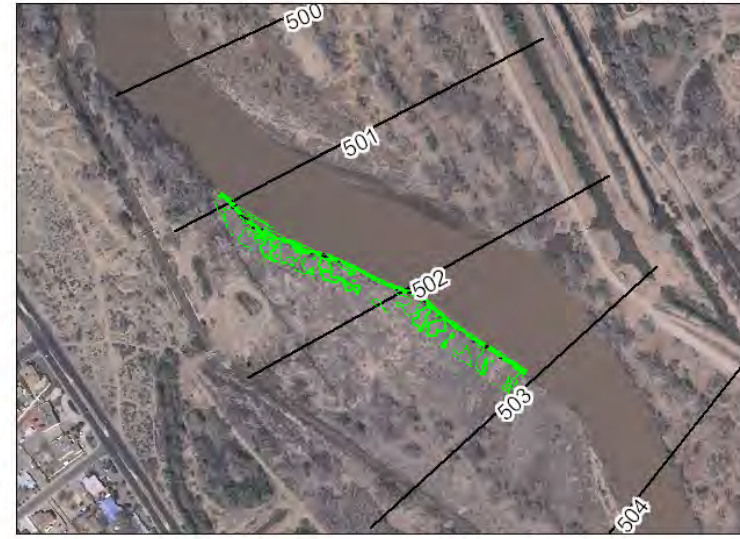
**Central
Bar 2**

Contour Interval 0.5 ft.

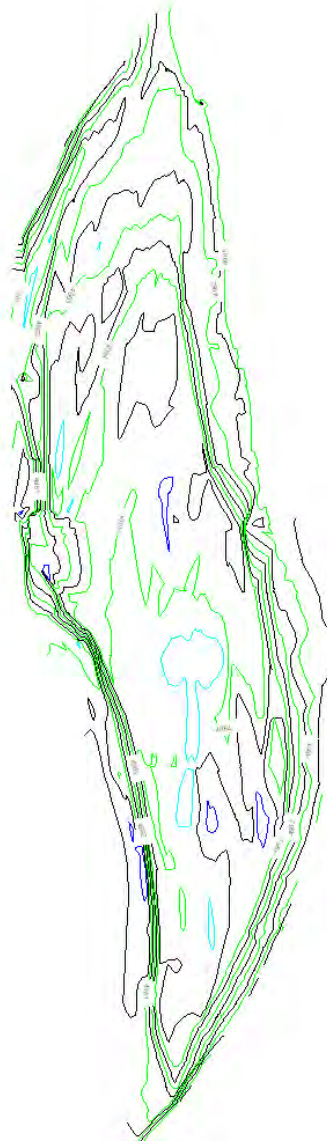
Central Island 1

Contour Interval 0.5 ft.

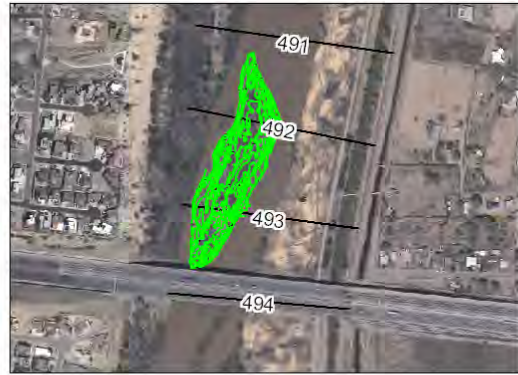
**Central
Island 3**

Contour Interval 0.5 ft.

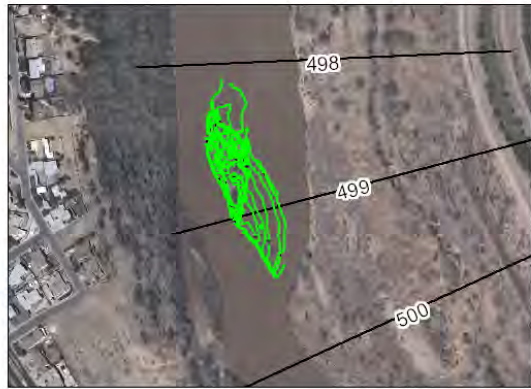
**Central
Island 4**

Contour Interval 0.5 ft.

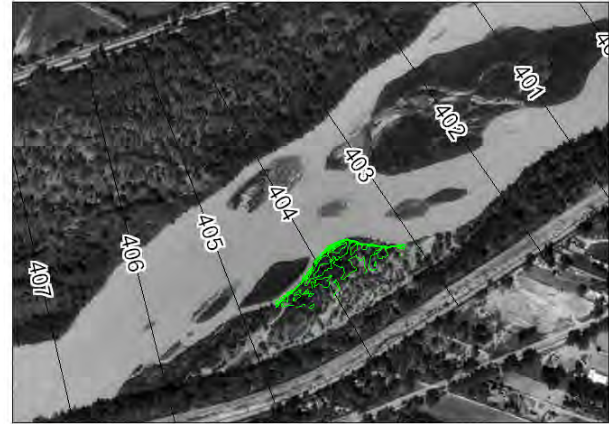
North Diversion Channel
Bar 1

Contour Interval 0.5 ft.

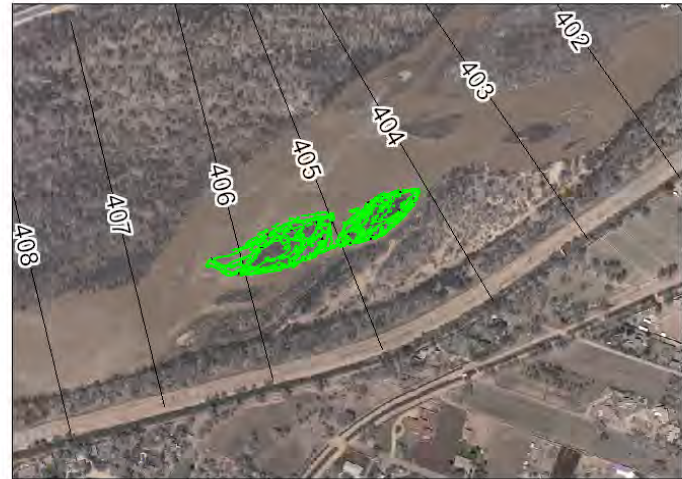
North Diversion Channel
Control Island 1 & Restoration Island 2

Contour Interval 0.5 ft.

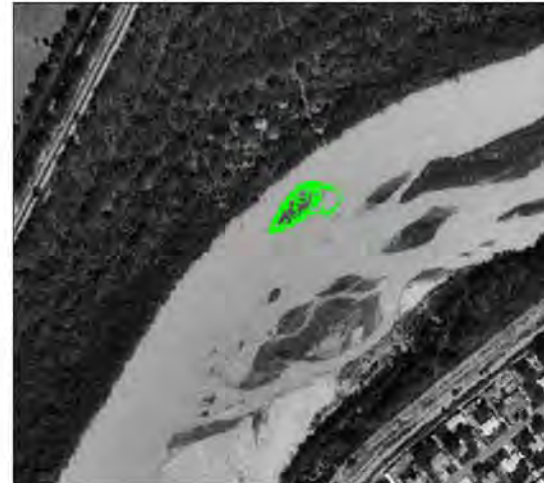
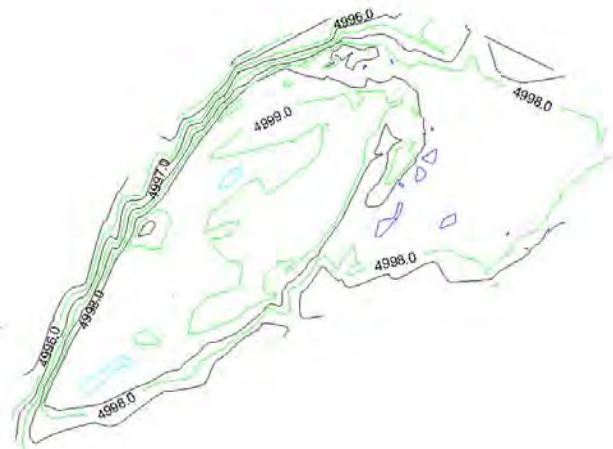
**North Diversion Channel
Restoration Island 3**

Contour Interval 0.5 ft.

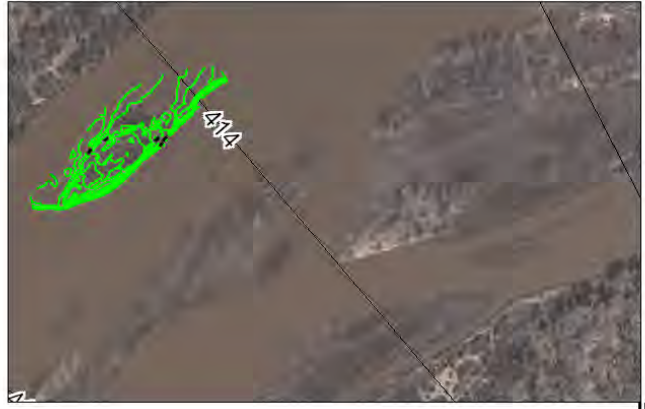
North Diversion Channel Restoration Island 3

Contour Interval 0.5 ft.

Restoration bar/island No. 3 in the NDC subreach consists completely of an LI surface, and as such it experienced significant vertical accretion during the high flows (Figure 32). Vertical accretion on the west (right) side of the bar/island was high because of channel switching during the high-flow event. Prior to the high flows, the main channel was located on the west side of the bar/island, but it switched to the east side during the event, causing some degradation of the bed. On most of the bar/island, vertical accretion ranged from 0.5 to 1.5 feet.

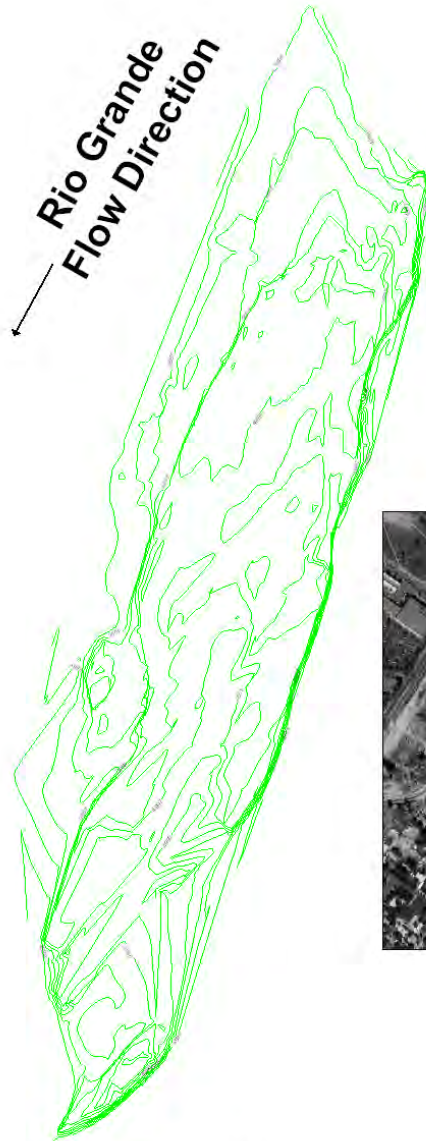
North Diversion Channel
Island 5

Contour Interval 0.5 ft.
