Sediment Erosion Analysis of San Acacia Diversion Dam Removal Alternative – Final Report

San Acacia, NM

U.S. Department of the Interior
Bureau of Reclamation
Technical Service Center

August 2005

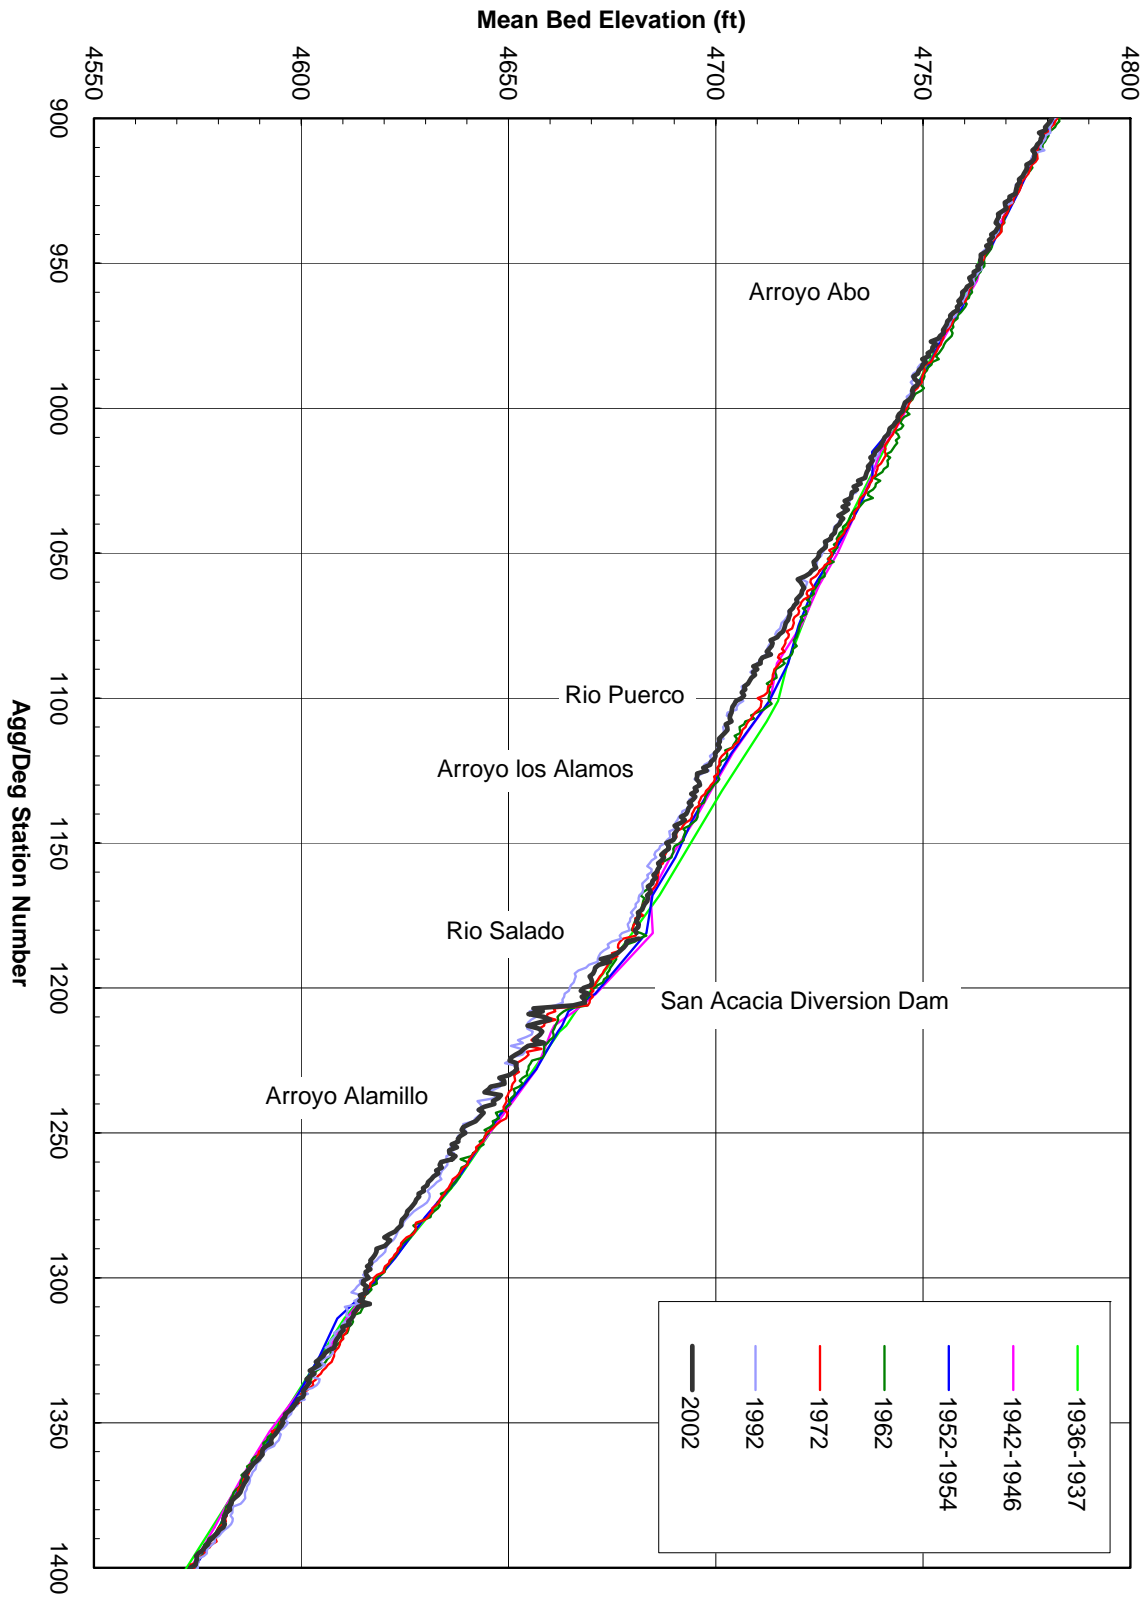
Figure 6. Mean Bed Profiles in Reach since 1936.

Plots of the river bed profile are given in Figure 5 and Figure 6. Figure 5 shows the thalweg profile in 2002, 1992, and 1972. The average stream slope is also shown on the figure. Figure 6 is a plot of the mean bed elevation for several years since 1936.

Some of the sediment eroded from behind San Acacia Dam will deposit in the reach downstream. Based upon the mean bed elevations of Figure 6, the reach downstream of San Acacia Dam has been experiencing erosion since the 1950's. The large supply of sediment upstream of San Acacia Dam may temporarily reverse this trend and aggradation may occur downstream of San Acacia Dam if it is removed. The aggradation is expected to be most significant in the first three years, after which time the reach will be fairly stable for at least 10 years. After 10 years the reach downstream of San Acacia may again start to degrade, but the simulation was only for a period of 10 years and a larger study would have to be conducted to estimate the long term trends in this reach after dam removal. The reach downstream of San Acacia Dam has also become significantly coarser and the simulations indicate that the removal of the San Acacia Dam will at reverse trend for the 10 year simulation period.

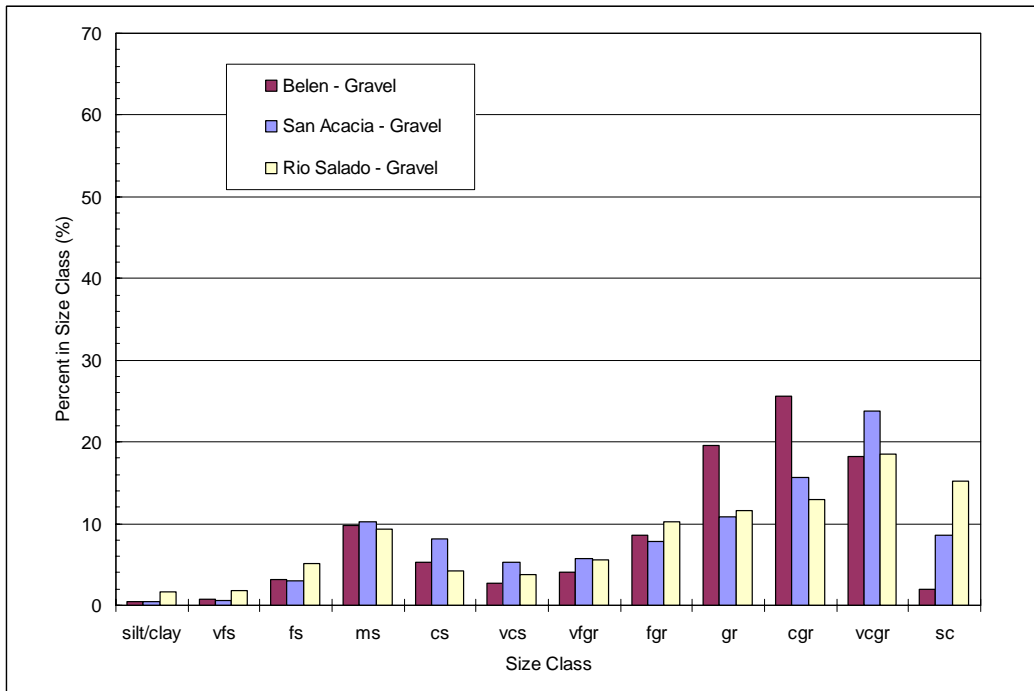
Figure 8. Coarse Bed Material Samples Collected in 2004.

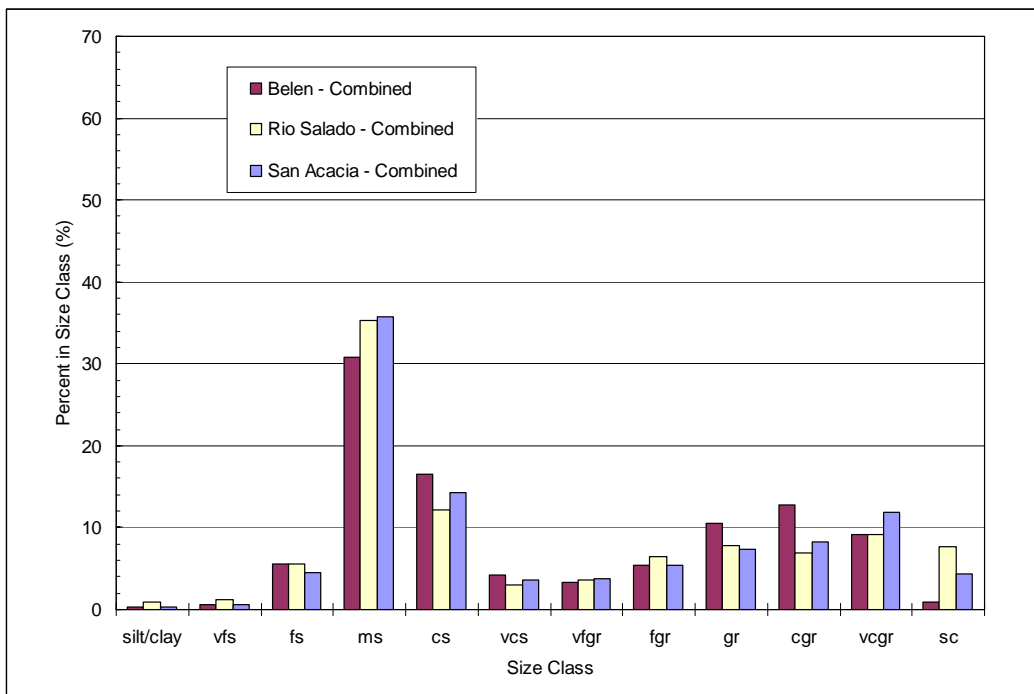
Figure 9. Combination of Coarse Bed Material Samples and Sand Samples (50% of each).

The Engelund-Hansen (1972) transport formula has been used in previous analysis of sediment transport on the Rio Grande (Reclamation, 2005). A comparison between the Engelund-Hansen formula and the measured sand and gravel loads at San Acacia stream gage is given in Figure 11 and Figure 12. HEC-RAS 3.1.1 was used to compute the hydraulic properties in the reach where the gage was present. The average hydraulic properties over a two mile reach downstream of San Acacia Diversion dam were used. The bed material gradations used in the transport capacity computations were taken from the average gradation of the sand and coarse bed material samples of Bauer (2004) found in Figure 9.

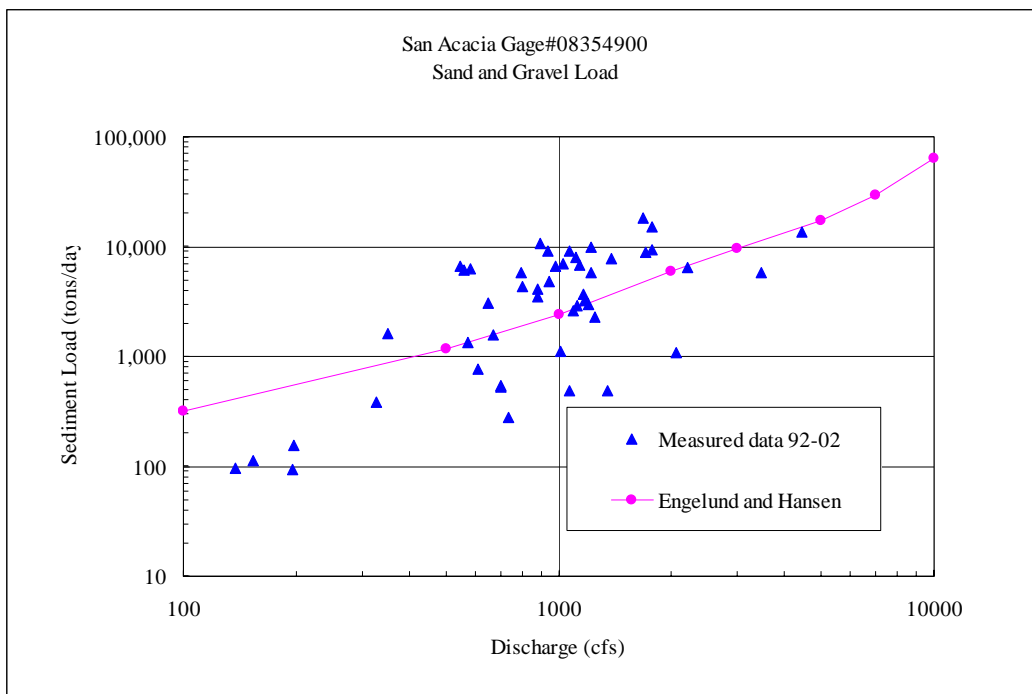
Figure 11. Comparison between predicted and measured sand and gravel load at San Acacia USGS stream gage.

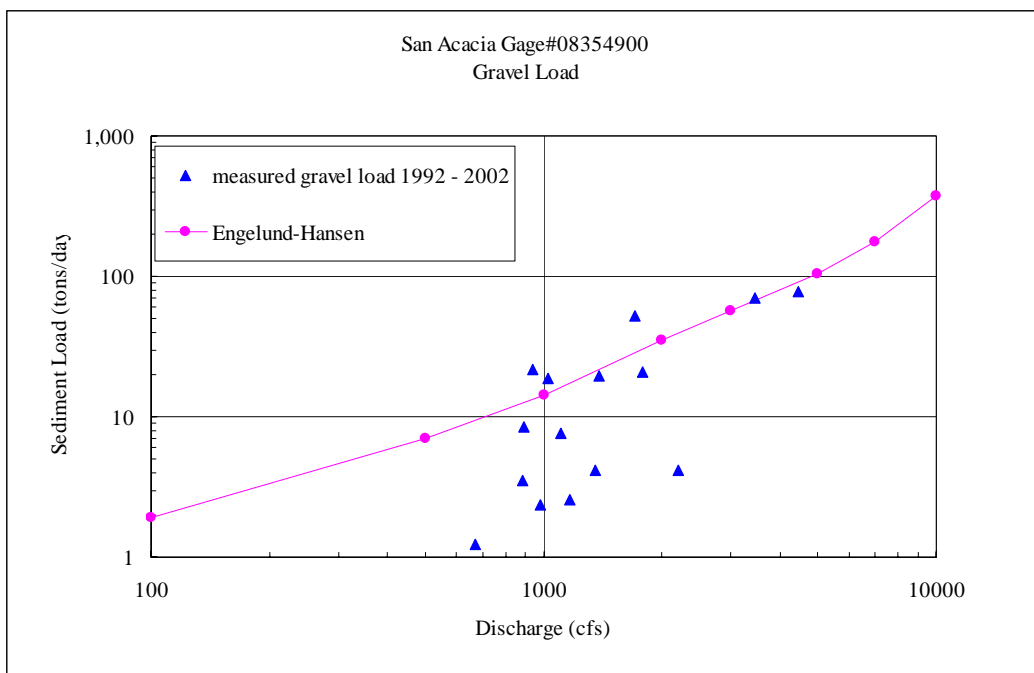
Figure 12. Comparison between predicted and measured gravel load at San Acacia USGS stream gage.

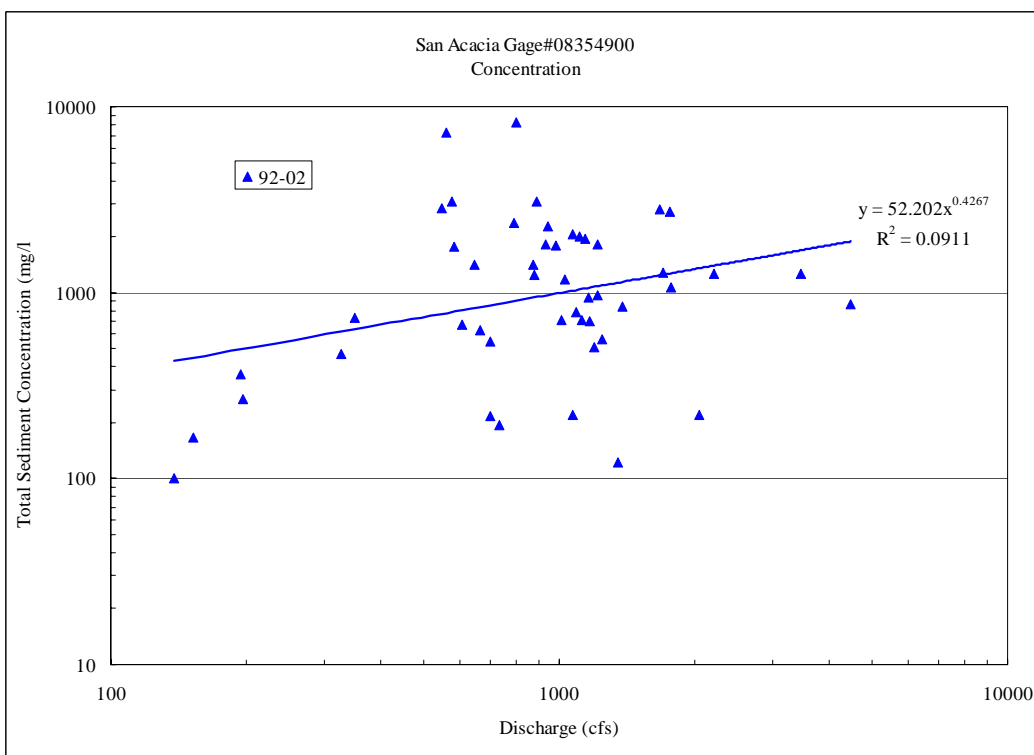
Figure 13. Total sediment concentration at San Acacia Gage for period 1992 to 2002.

The total sediment concentrations plotted against flow rate are given in Figure 13. One can see that the concentrations are not well correlated with flow rate as the R squared value of the fitted power function between concentration and flow has a value of 0.09, indicating that flow explains approximately only 9% of the variation in sediment concentration. Therefore, many other factors affect sediment concentration. Some tributaries, such as the Rio Puerco, supply large amounts of fine-grained sediment, but the flow in the Rio Puerco is not always correlated to large flows in the Rio Grande.

It should be noted that an increase of 1200 mg/l is a relatively minor increase in sediment concentration considering the large natural variability in sediment concentrations (see Figure 13). Sediment concentrations currently vary between 100 and 8000 mg/l.

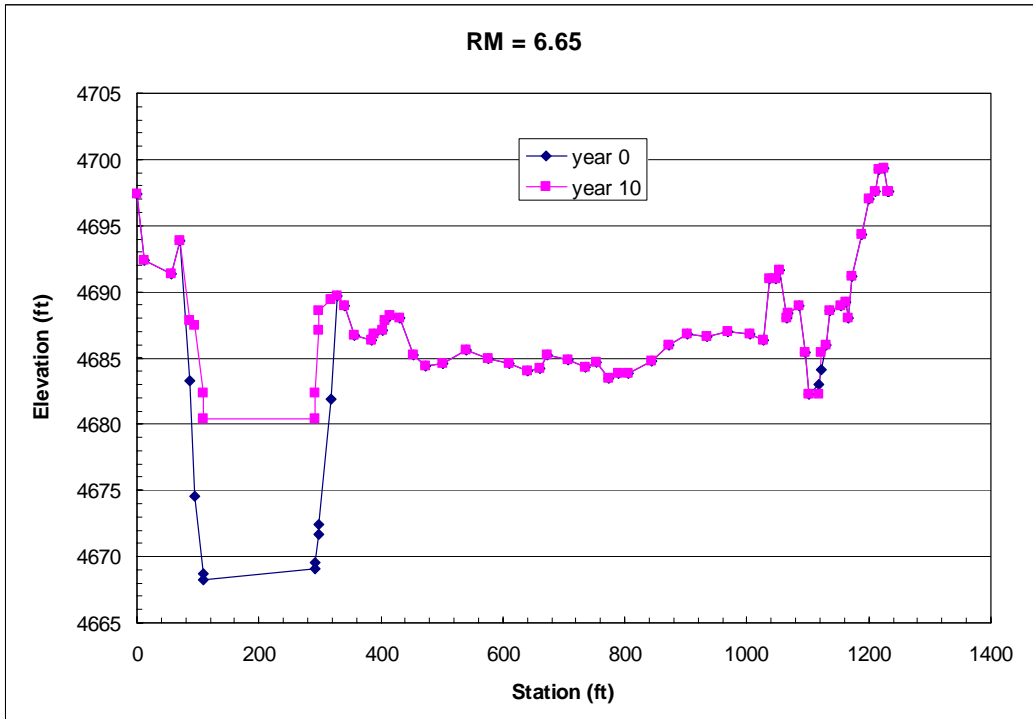
Figure 18. Cross Section geometry at River Mile 6.65, 3 miles upstream of San Acacia Dam, Run 1.

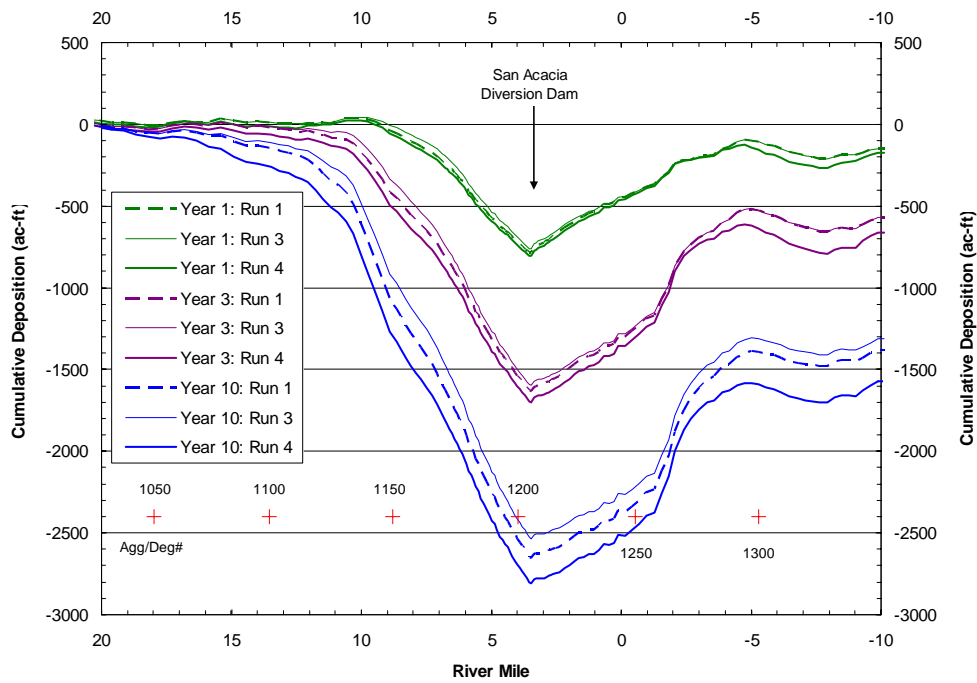
Figure 22. Comparison between Simulated Erosion or Deposition Volumes of Run 1, Run 3, and Run 4.

Two different active layer thickness combinations were simulated to assess model sensitivity to this parameter. Run 3 used an active layer thickness of 1.55 ft throughout the simulated reach. Run 4 used an active layer thickness of 7.4 ft throughout the simulated reach. In general, the model was relatively insensitive to active layer thickness. There was however, slightly less erosion predicted with smaller active layer thicknesses. Overall, the model is not considered sensitive to active layer thickness.

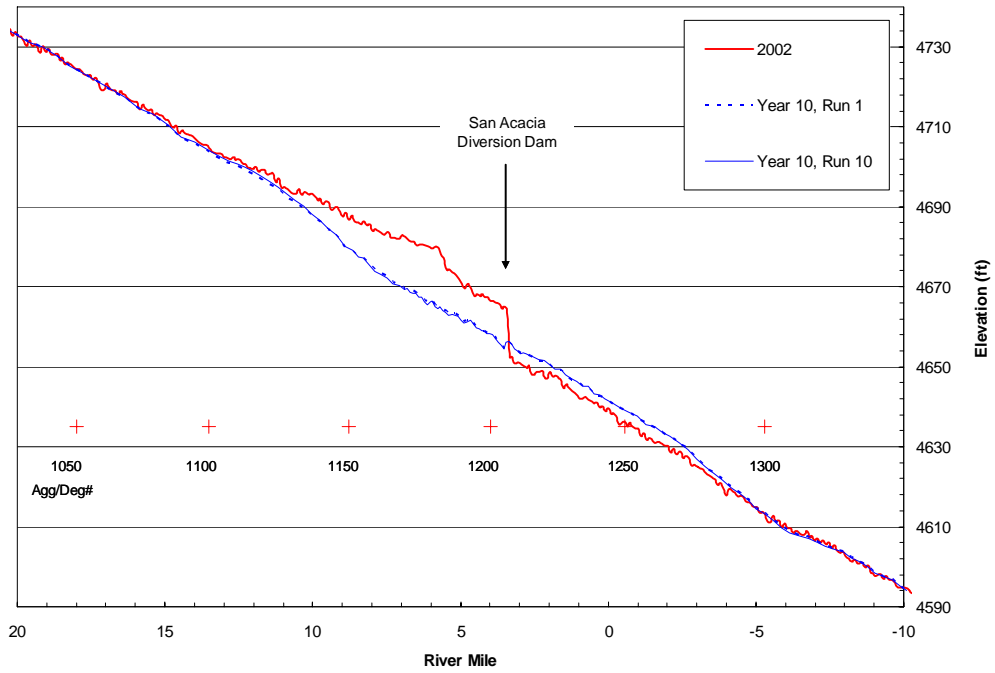
Figure 23. Comparison between Simulated Bed Profiles of Run 1 and Run 10.

The value of Manning's roughness coefficient was increased to 0.025 to test the sensitivity of the model to its value. The profile comparison between the base simulation (Run 1) and the simulation with the increased Manning's roughness coefficient of 0.025 (Run 10) is given in Figure 23. The erosion volume comparison is given in Figure 26. There is slightly less erosion predicted when Manning's roughness coefficient is increased, but the difference is insignificant.

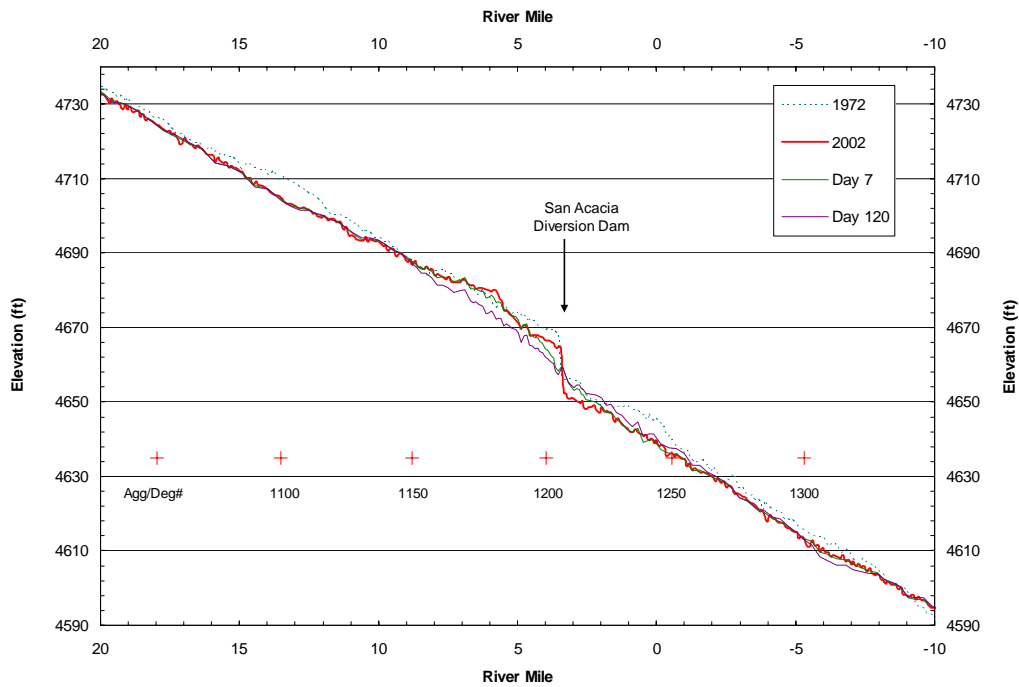
Figure 28. Simulated Bed Profile Assuming a Constant 3000 cfs flow for a period of 120 days.

The erosion zone for the constant flow of 3000 cfs extended approximately 6 miles upstream of the dam, near Agg/Deg #1143 (Figure 28). The constant flow of 3000 cfs eroded approximately twice as much sediment as the 1000 cfs flow (600 ac-ft versus 300 ac-ft, see Figure 29).

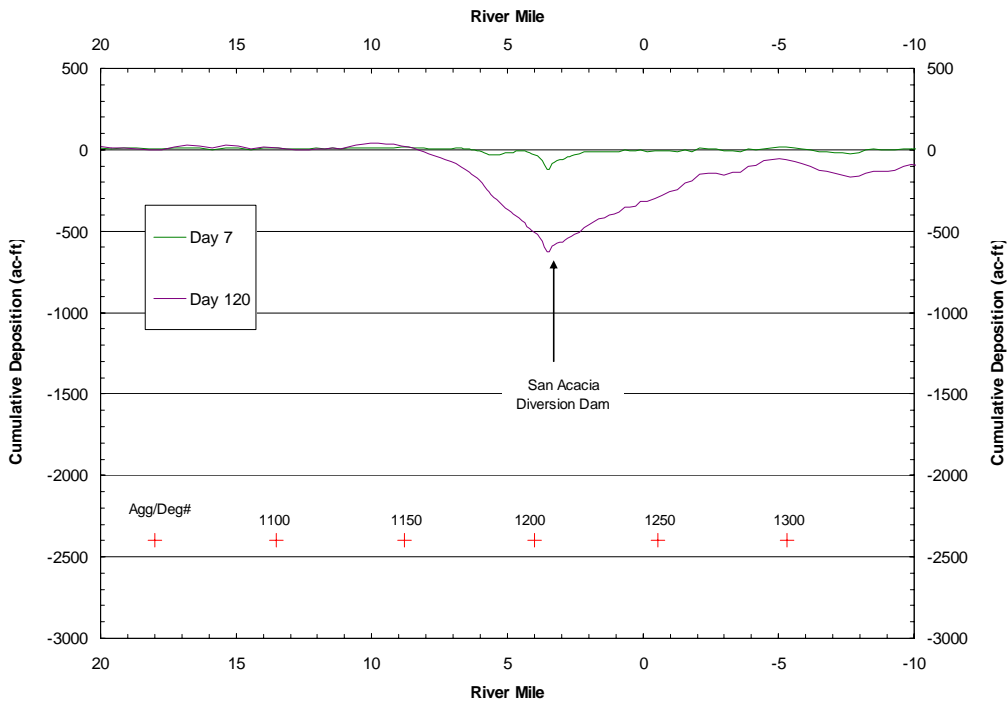
Figure 29. Simulated Cumulative Erosion or Deposition Assuming a Constant 3000 cfs flow for a period of 120 days.

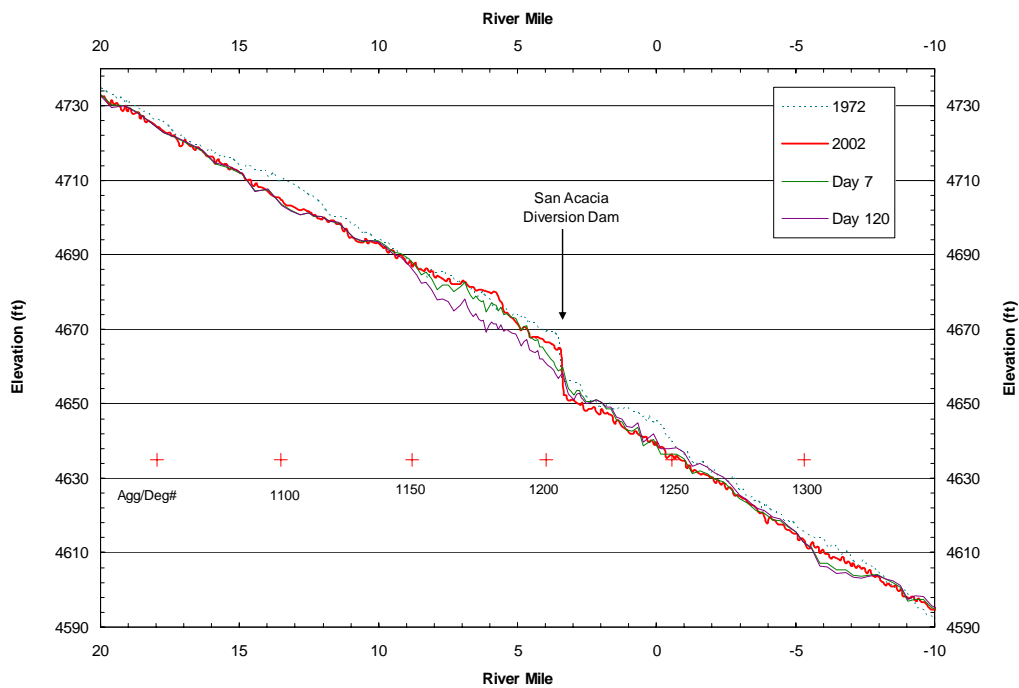
Figure 31. Simulated Bed Profile Assuming a Constant 7000 cfs flow for a period of 120 days.

The erosion zone predicted as the result of a 7000 cfs flow for 120 days extended approximately 6 miles upstream of the dam, near Agg/Deg #1143 (Figure 31). This is a similar erosion distance as predicted for the 3000 cfs flow. However, the volume eroded during the 7000 cfs was much greater, approximately 1400 ac-ft (Figure 32).
