2007 Geomorphic Summary of the Middle Rio Grande *Velarde to Caballo*

Department of the Interior
Bureau of Reclamation
Albuquerque Area Office

January 2007

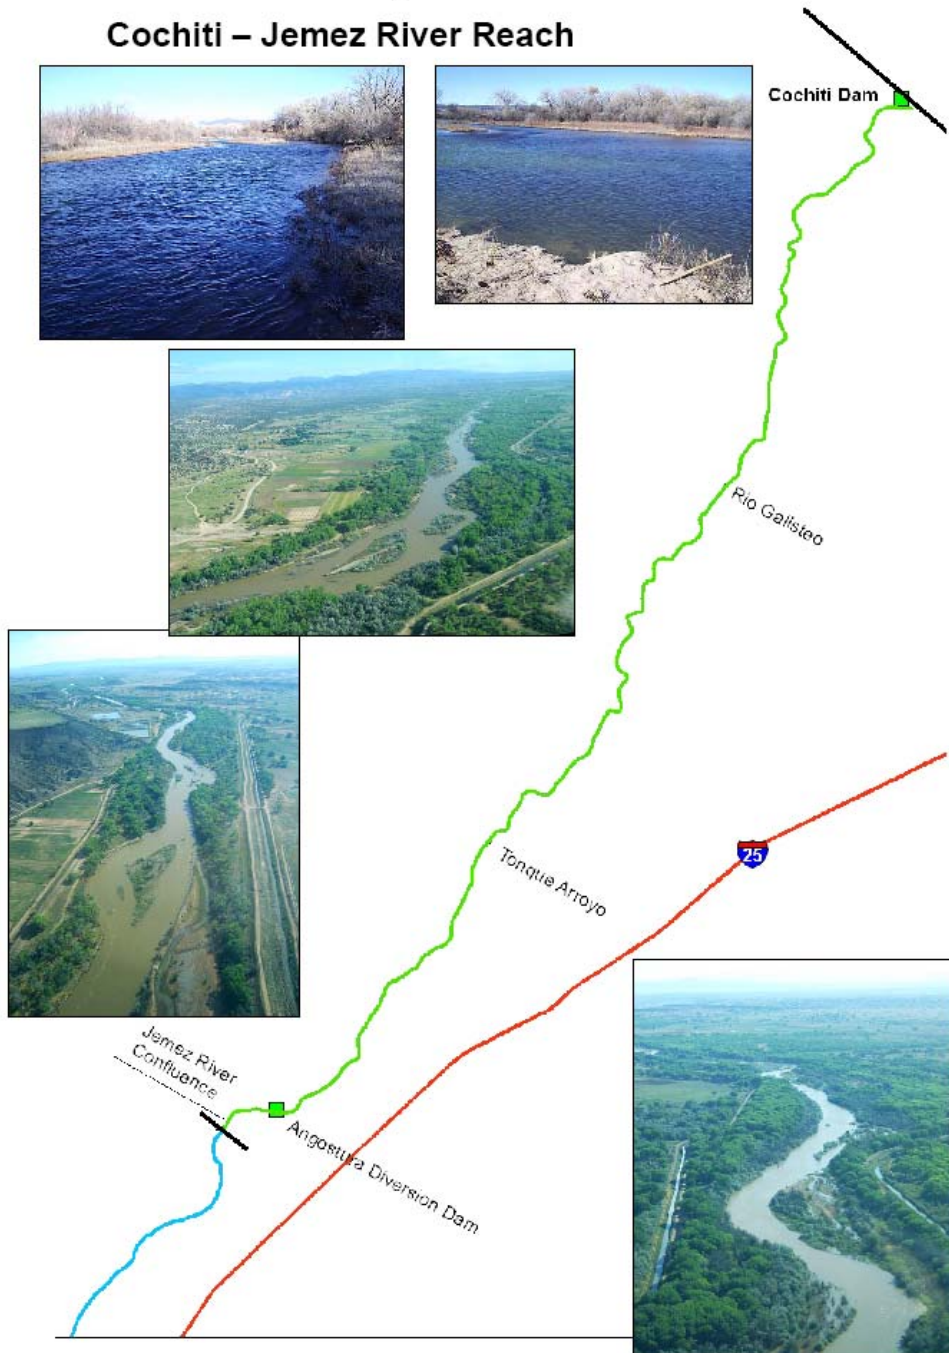
Cochiti – Jemez River Reach

2006 Geomorphic Reaches
Middle Rio Grande Project

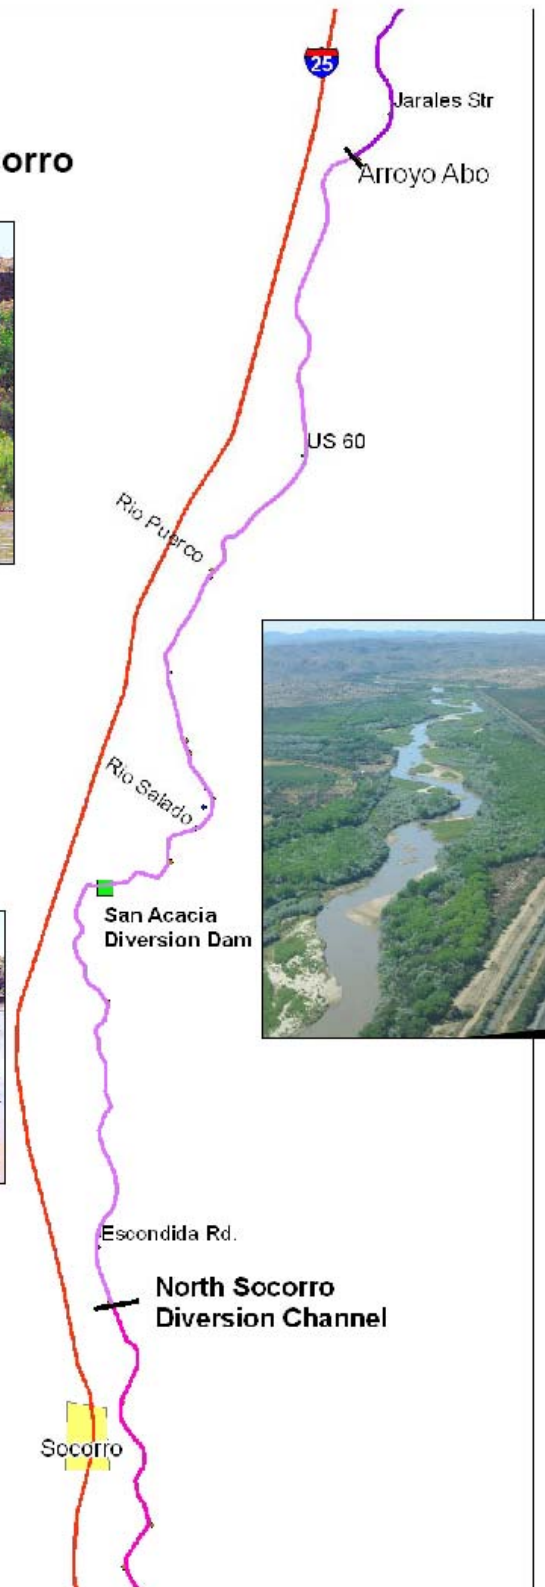
**2006 Geomorphic Reaches
Middle Rio Grande Project
Uplift Reach
Arroyo Abo to North Socorro**

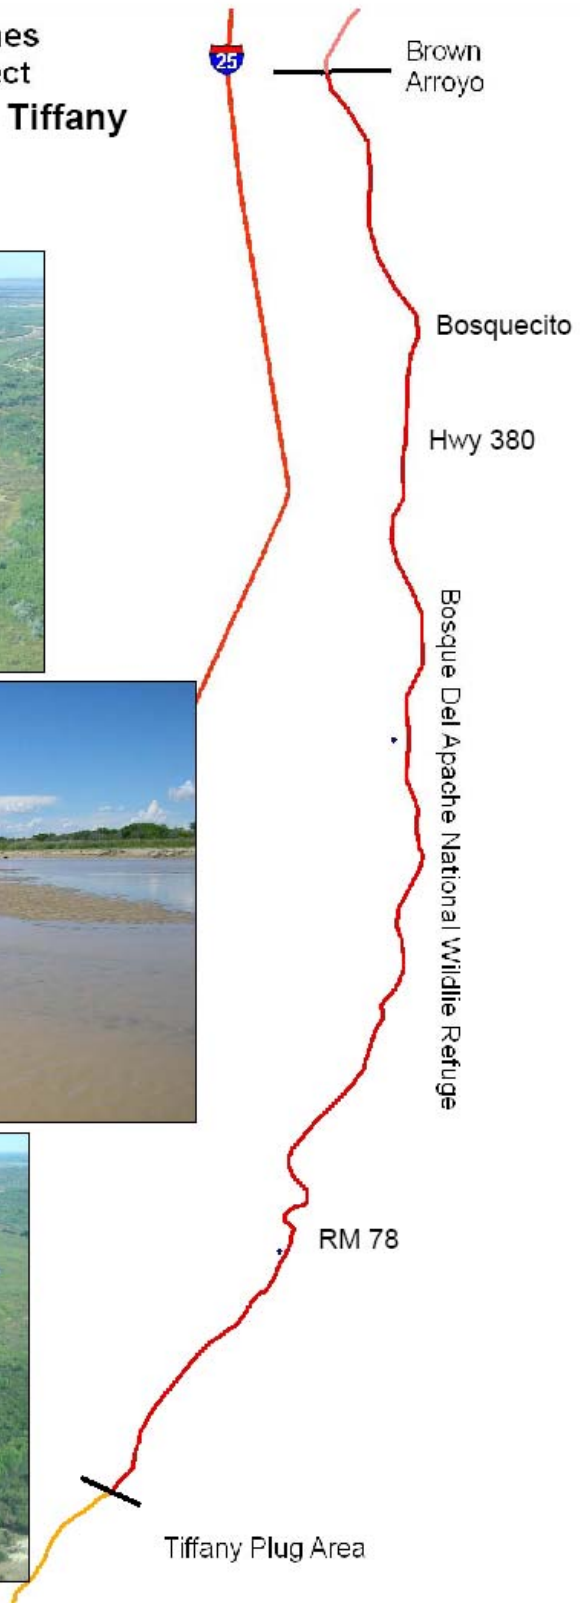
**2006 Geomorphic Reaches
Middle Rio Grande Project
Brown Arroyo to the Tiffany
Plug Area**

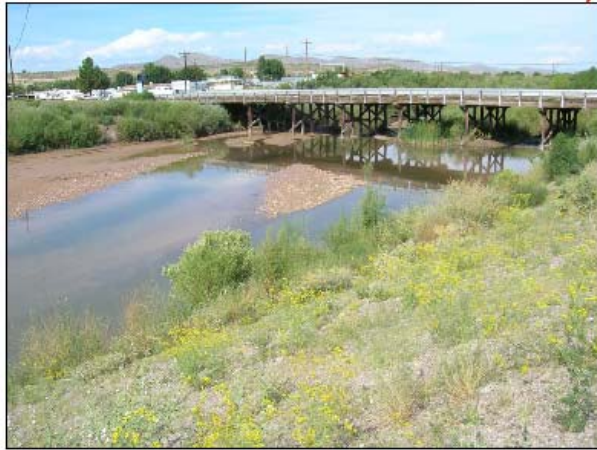
**2006 Geomorphic Reaches
Middle Rio Grande Project
Caballo Geomorphic Reach**

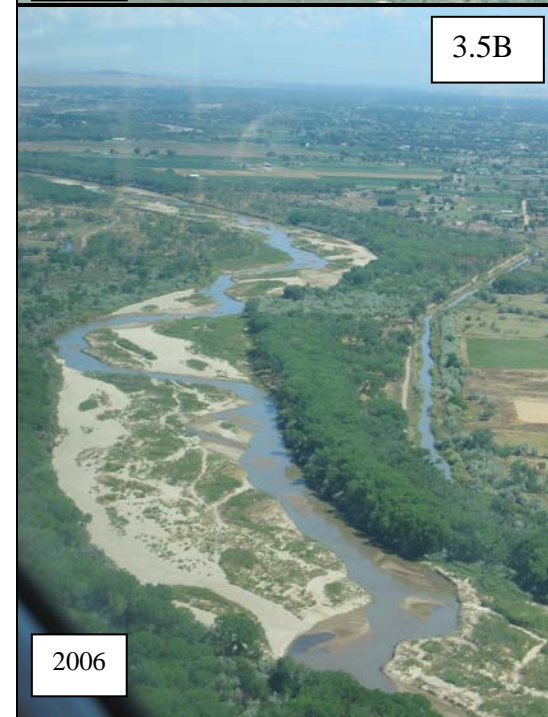
Stage 3.5 is similar to that of Stage 3, however, the main channel begins to incise. Additional narrowing of the single channel may occur. Gravel deposits are becoming wide spread within the main channel and side channels. Riffles or channel spanning gravel patches may exist. Stage 3 and 3.5 may occur at the same time.

Habitat value for in-channel species decreases in this stage, as the channel becomes more incised, higher flows are required to inundate the floodplain, bars, islands and side channels. During low flows, the water is contained within a single channel with a reduced area/perimeter as compared to previous stages. For riparian species, this phase is probably great, since the islands/bars/side channels rapidly vegetate and provide new riparian areas for wildlife.

Stage 4 occurs after the channel has formed a stable single-threaded channel. A slightly sinuous pattern, alternating thalweg may form, however, the channel is still essentially straight (sinuosity is less than 1.5). The channel width may decrease in this stage as the floodplain vegetation encroaches on the active channel. The historical floodplain is mostly abandoned, except in very high flow events. . It appears to get a stable channel, a gravel bed is required, however, this is only observation and could be incorrect. Stages 3.5 and 4 could occur at the same time.

This stage may be the final stage for some sections of the Rio, as the banklines are heavily vegetated, peak flows are controlled and the river is not able to erode the historical floodplain. A good example of this type of channel is just downstream from Cochiti Dam (Figure 4A). Parts of the river channel within the San Acacia reach have evolved from Stages 1-3.5 to this Stage 4. But due to the high incision, these Stage 4 channel are expected to continue to evolve. The Belen reach could get stalled in this Stage, as the riparian vegetation is exceptionally dense, and incision will probably be limited

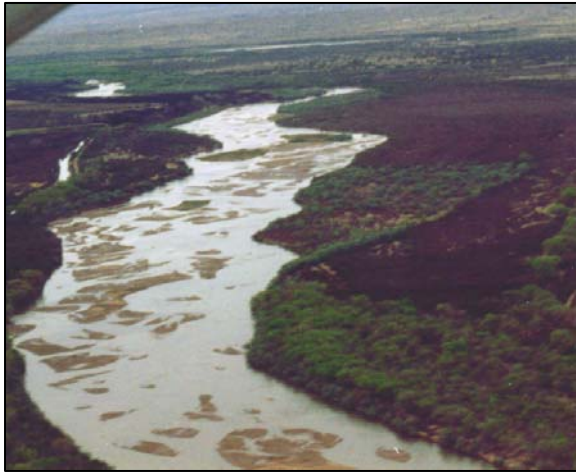
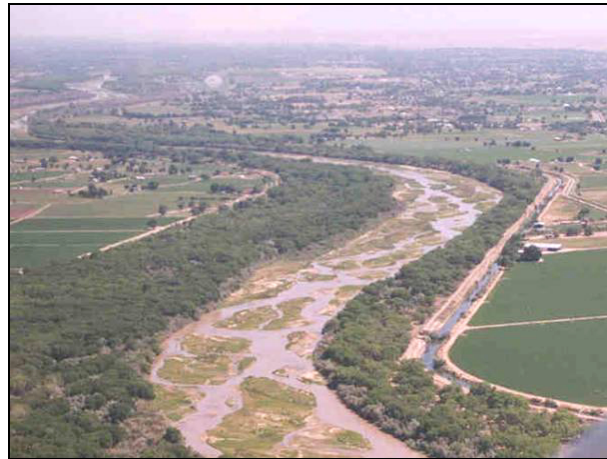
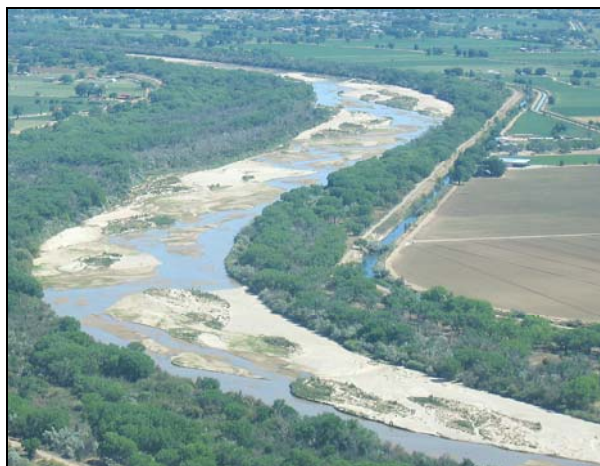
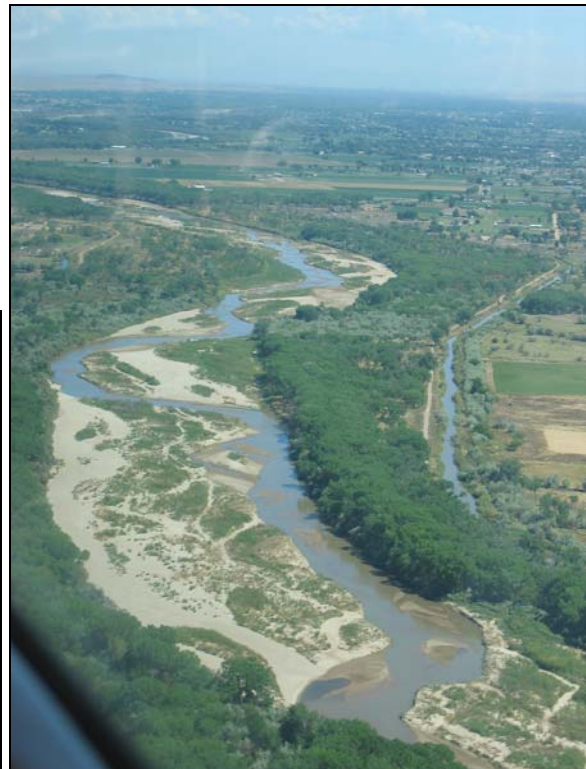
Stage 1 to Stage 3.5

- Sequence observed at the Belen Reach
- Classic example of a high sediment river with a reduced hydrology.

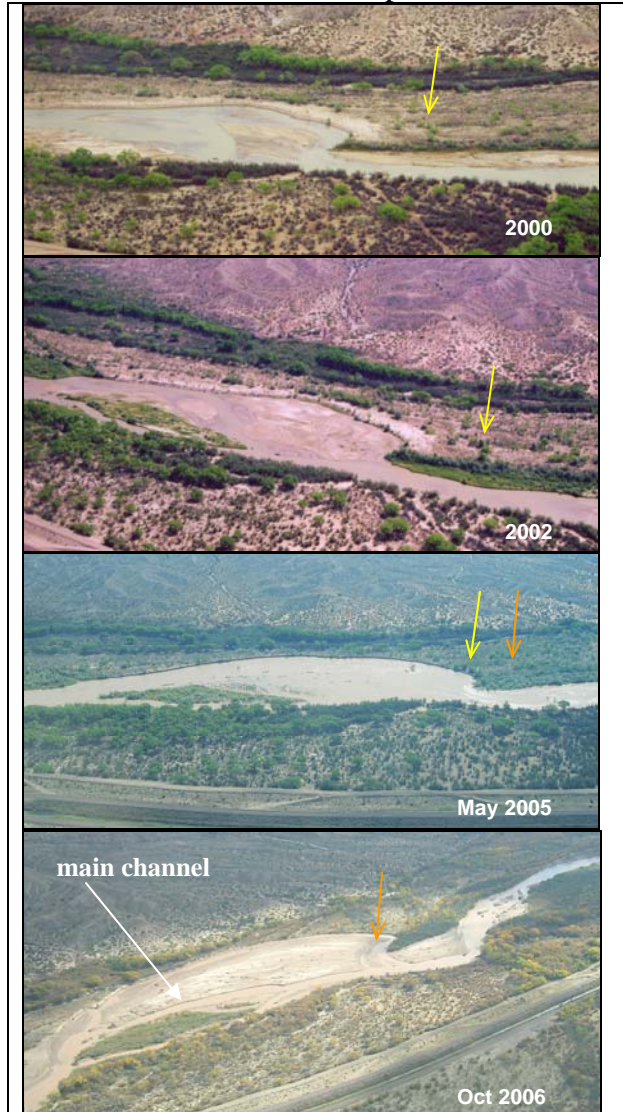
Stages 4-8

- Bend migration sequence observed within the San Acacia Reach at RM 110, bend on east side of the Rio Grande. Downstream is from left to right. The channel was slightly sinuous in the late 1990s, with this hook-shaped bend forming in about 1999.
- Relatively low sediment (Rio Puerco stopped delivering) with a relatively maintained hydrology regime. With more regular hydrology, these stages would likely evolve at a faster rate.
- As of yet, the channel along the outside of the bend has not been abandoned. However the cutoff channel captured the main flow in the summer of 2006.
