2021 RiverEyes Monitoring Report

Prepared for:
US Bureau of Reclamation,
Albuquerque Area Office
555 Broadway NE, Suite 100
Albuquerque, NM 87102

Prepared by:
GeoSystems Analysis
3393 North Dodge Blvd
Tucson, AZ 85716
www.gsanalysis.com

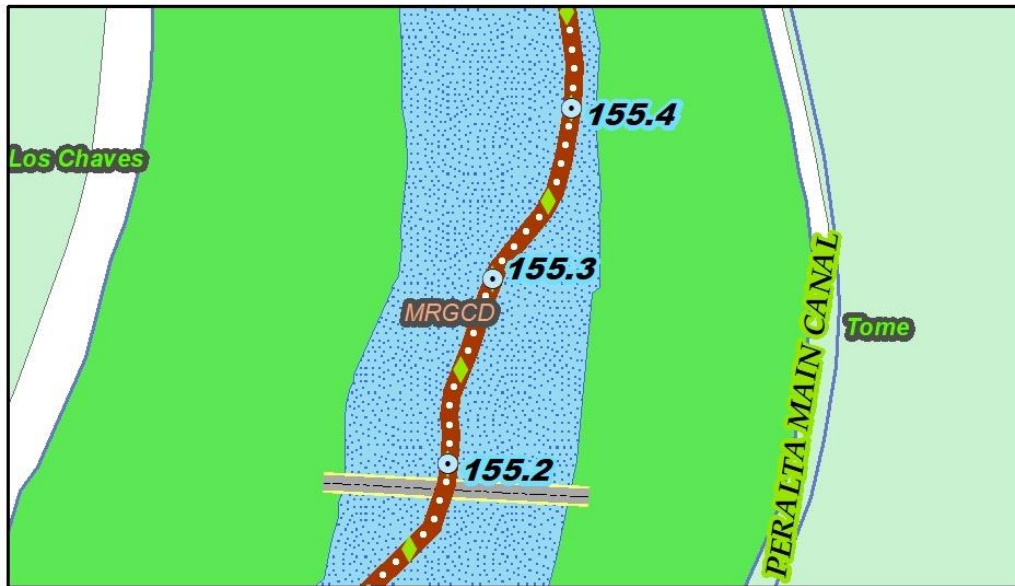
Figure 2. Sample RiverEyes field maps from the 2020 monitoring season. When accessed via the Avenza Maps app, current field location is clearly marked with a large blue dot and the interface allows for panning and zooming.

Figure 2. Sample RiverEyes field maps from the 2020 monitoring season. When accessed via the Avenza Maps app, current field location is clearly marked with a large blue dot and the interface allows for panning and zooming. 8

When field conditions allowed, crews accessed the riverbed with ATVs, since this has historically been the most efficient method of travel to locate the dried extent quickly and confidently. On occasion, reconnaissance was performed on foot when mud, debris, deep holes, or other circumstances blocked access. Due to widespread quicksand, ATVs regularly became temporarily stuck in the riverbed during the 2021 monitoring season. Quicksand was more prominent in 2021 than any year since at least 2017, which was the first year GSA supported Reclamation with RiverEyes monitoring.

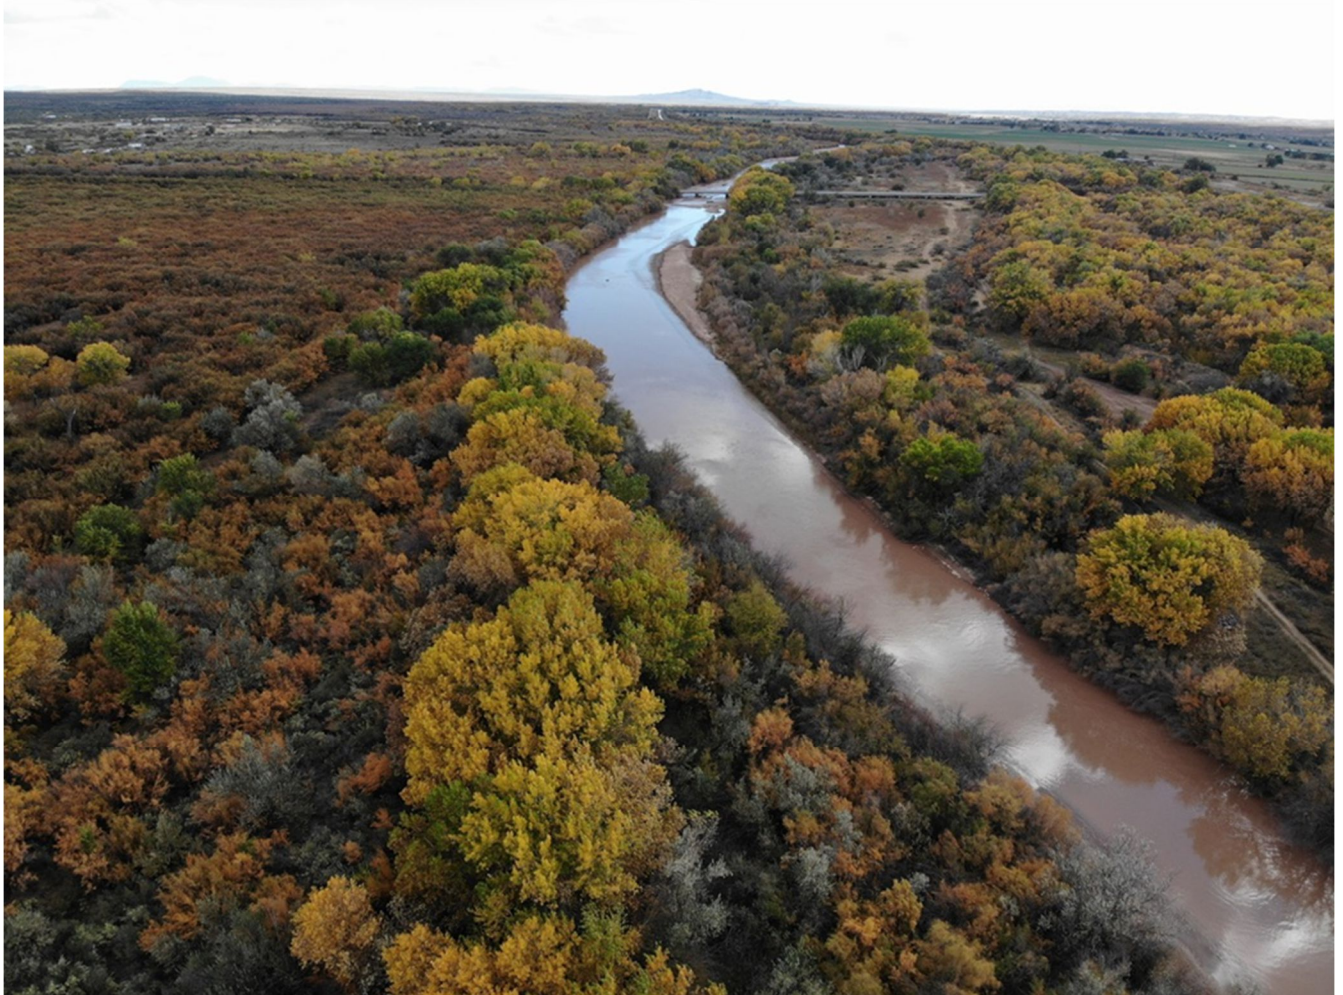
Figure 1: Photo Taken at 150 feet AGL above RM 87.58 Note the US380 bridge 0.46 miles to the south.

- The UAV will be an invaluable tool to support spot checks on foot because the drone can be launched from anywhere on the levee road and not be limited to existing access points and/or rangelines. An observer can easily fly above the brush and check the river in areas where access would be difficult or impossible on foot or ATV. The viewing elevation of the drone also makes it easy to observe relatively large sections of river channel with a single spot check, as demonstrated in Figure 1 below.

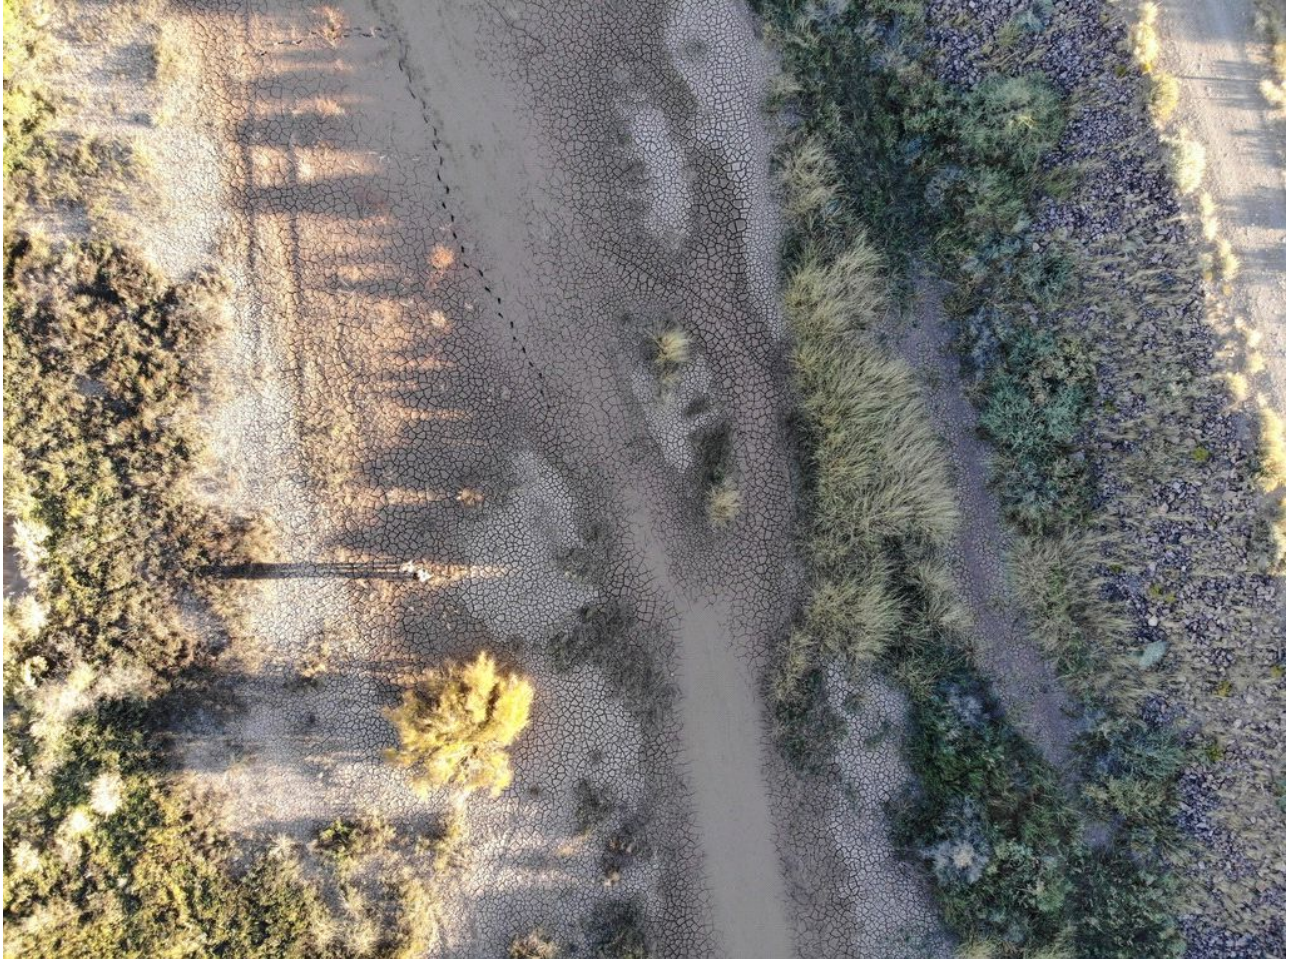
Figure 1: Example of an extent of drying taken at 100' AGL

- For mapping the extent of drying, hovering directly above the suspected extent and taking a photo straight down is a viable technique, particularly if also validated with traditional methods when the location is in question. An example of an extent of drying captured with a drone is shown in Figure 2 below.
