## ***2022 RiverEyes Monitoring Report***

*Prepared for:*  
US Bureau of Reclamation  
Albuquerque Area Office  
555 Broadway NE, Suite 100  
Albuquerque, NM 87102

*Prepared by:*  
GeoSystems Analysis  
3393 North Dodge Blvd  
Tucson, AZ 85716  
[www.gsanalysis.com](http://www.gsanalysis.com)

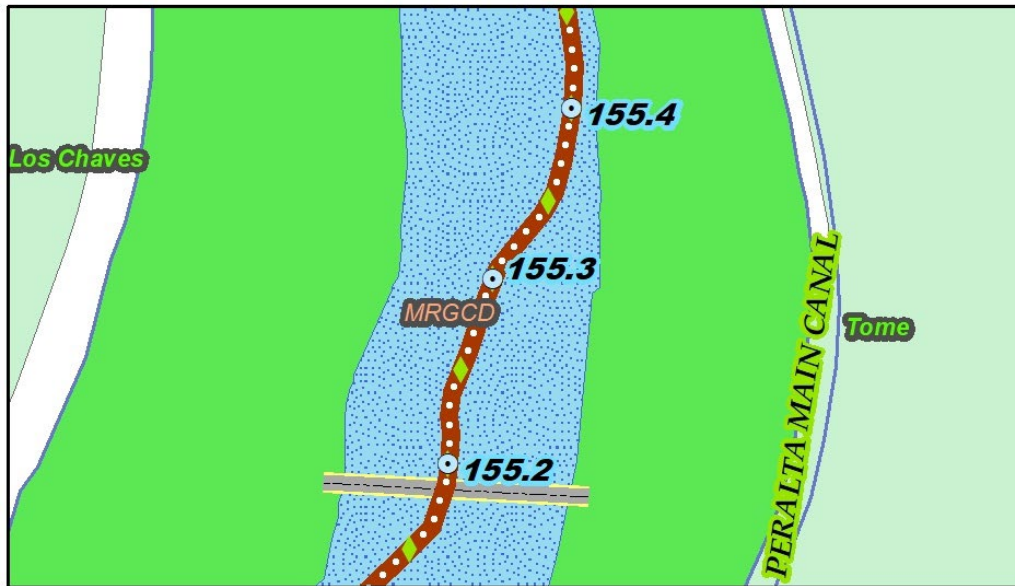
Figure 2. Sample RiverEyes field maps from the 2022 monitoring season. When accessed via the Avenza Maps app, current field location is clearly marked with a large blue dot and the interface allows for panning and zooming.
