**NEW MEXICO INTERSTATE STREAM COMMISSION  
MIDDLE RIO GRANDE  
RIVERINE RESTORATION PROJECT PHASE I  
ANNUAL REPORT**

**NEW MEXICO INTERSTATE STREAM COMMISSION, ALBUQUERQUE OFFICE**  
121 Tijeras N.E., Suite 2000  
Albuquerque, New Mexico 87102

**SWCA<sup>®</sup> ENVIRONMENTAL CONSULTANTS**  
5647 Jefferson Street, NE  
Albuquerque, New Mexico 87109  
Telephone: 505-254-1115, Fax: 505-254-1116  
[www.swca.com](http://www.swca.com)

**MUSSETTER ENGINEERING INC.**  
1730 South College Avenue, St 100  
Fort Collins, CO 80525  
Telephone: 970-224-4612, Fax: 970-472-6062

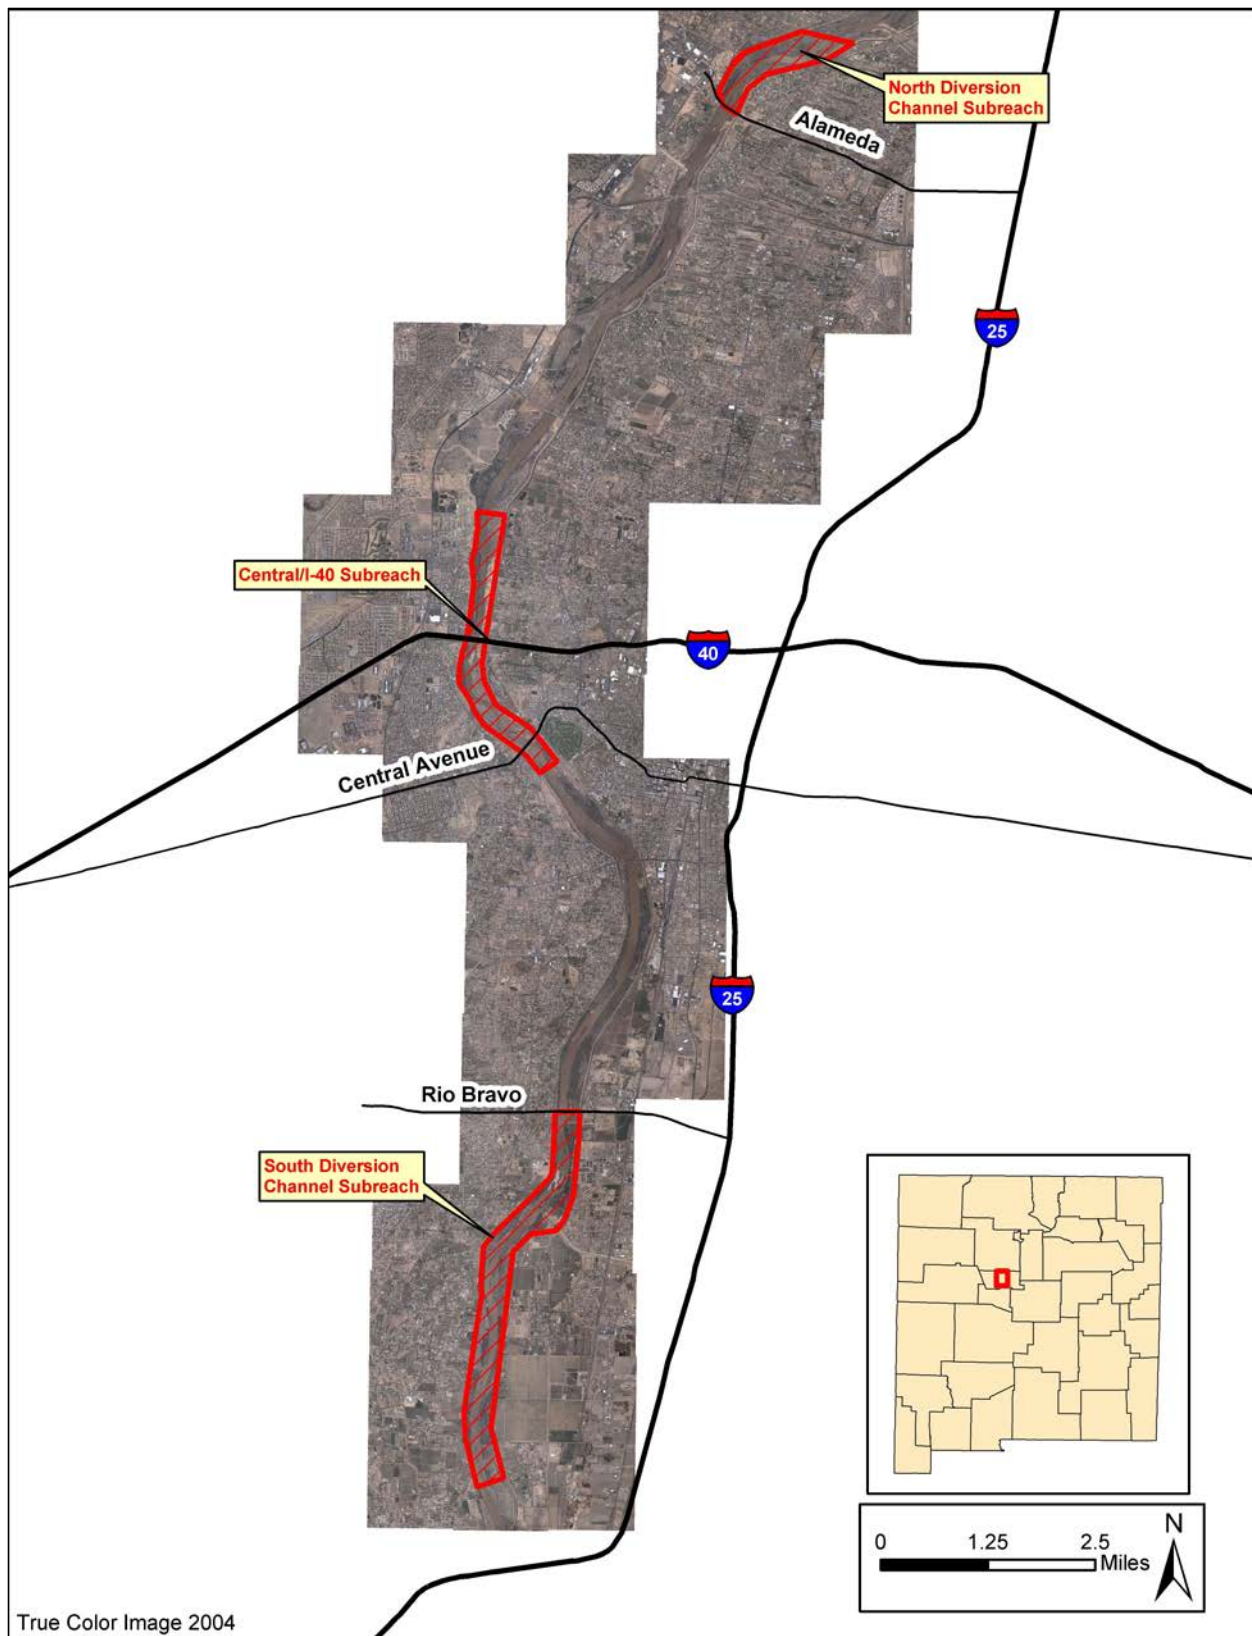
**Figure 1.** Middle Rio Grande riverine HR subreaches.

The project consists of HR techniques designed to create aquatic habitat applied in three subreaches of the Albuquerque Reach of the MRG, which includes the stretch of river east of the Village of Corrales and through the City of Albuquerque (Figure 1). The project comprises several alternative techniques for improving aquatic habitats at an intermediate scale (mesohabitats), as discussed and adapted from the *Habitat Restoration Plan for the MRG* (Tetra Tech 2004). Specific techniques were implemented, monitored, and evaluated, and the HR plans of subsequent phases will be adjusted to increase treatments that are most effective in meeting the habitat needs of silvery minnow. Four primary restoration/rehabilitation techniques (Table 1) were selected in Phase I for their theoretical ability to improve available over-wintering, silvery minnow egg retention, and larval-rearing habitat for the silvery minnow at flows ranging from 500 cfs to 3,500 cfs.

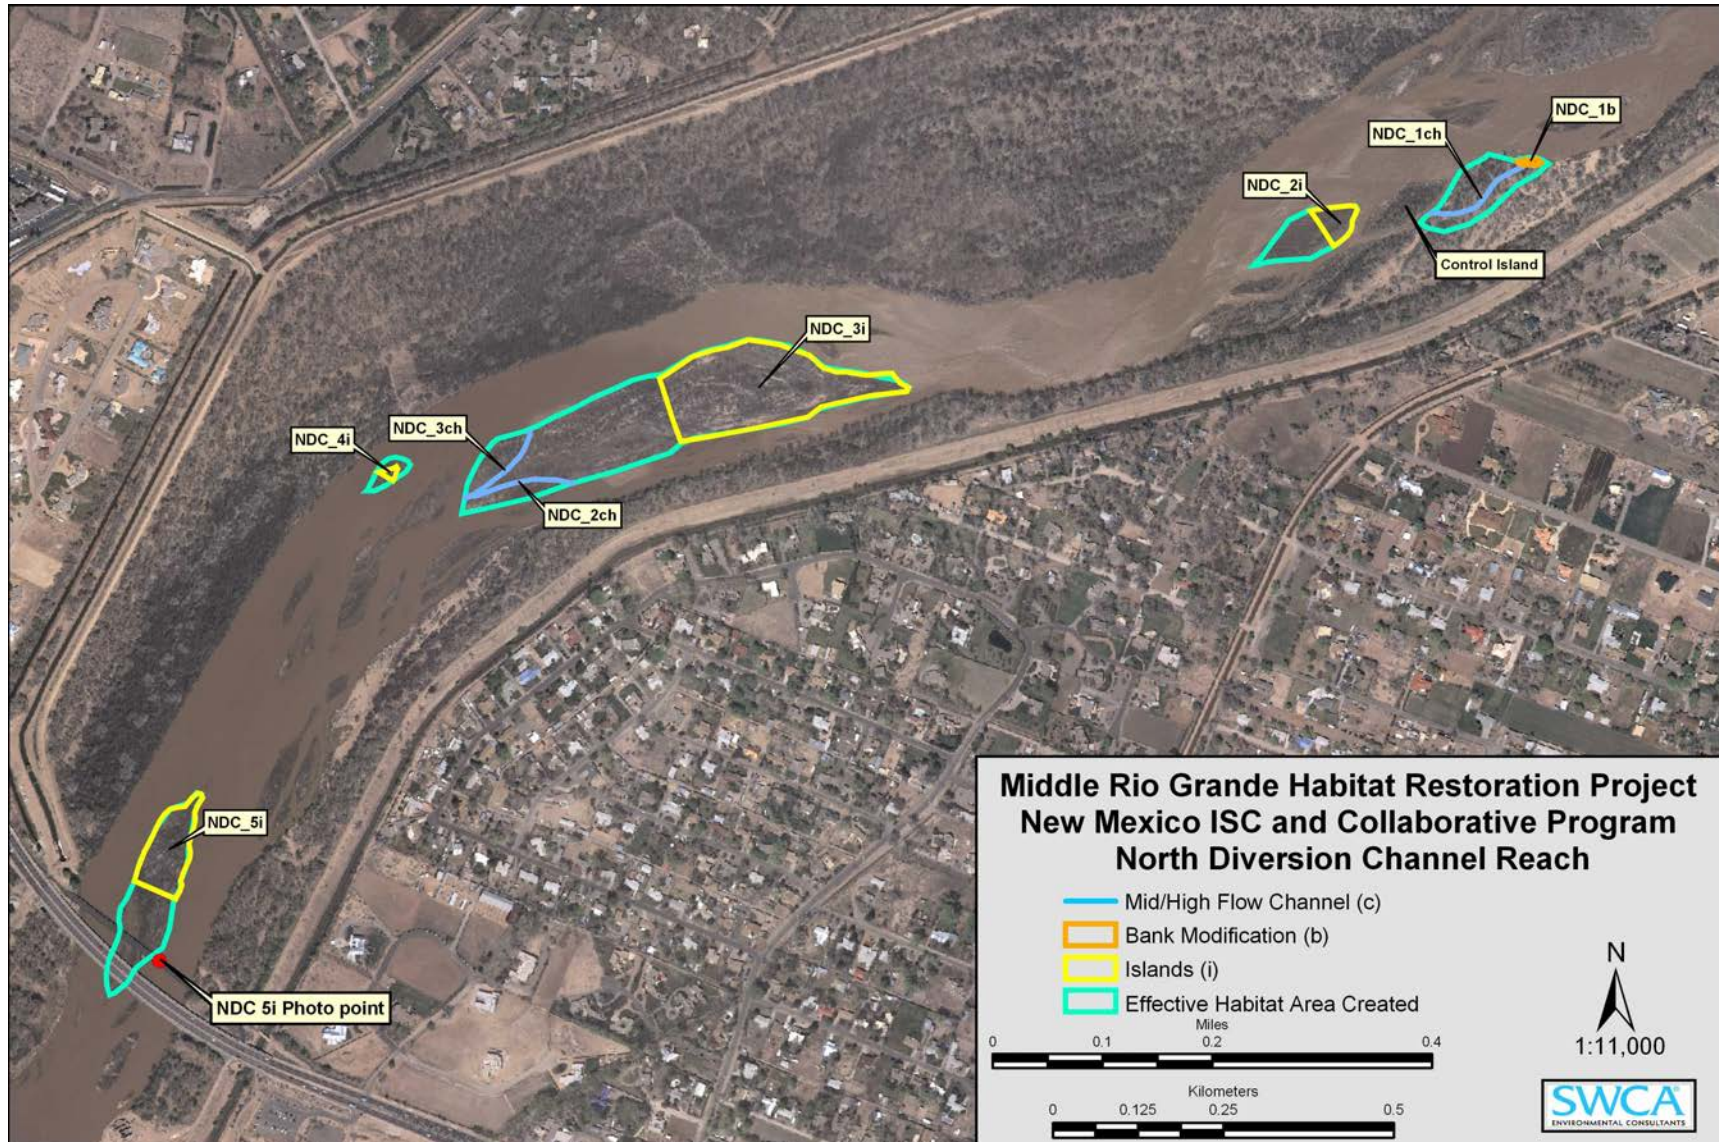
**Figure 2.** Treatment locations for the NDC Subreach.

Four treatment islands were selected for evaluation in the subreach between the NDC and the Alameda Bridge, as shown in Figure 2. In this subreach, three types of island treatments were implemented, and one undisturbed (control) island was mapped for comparison with treatment islands (Figure 3). Of the four treatment islands, one site was selected for bank scouring and scalloping and three ephemeral channels were constructed.

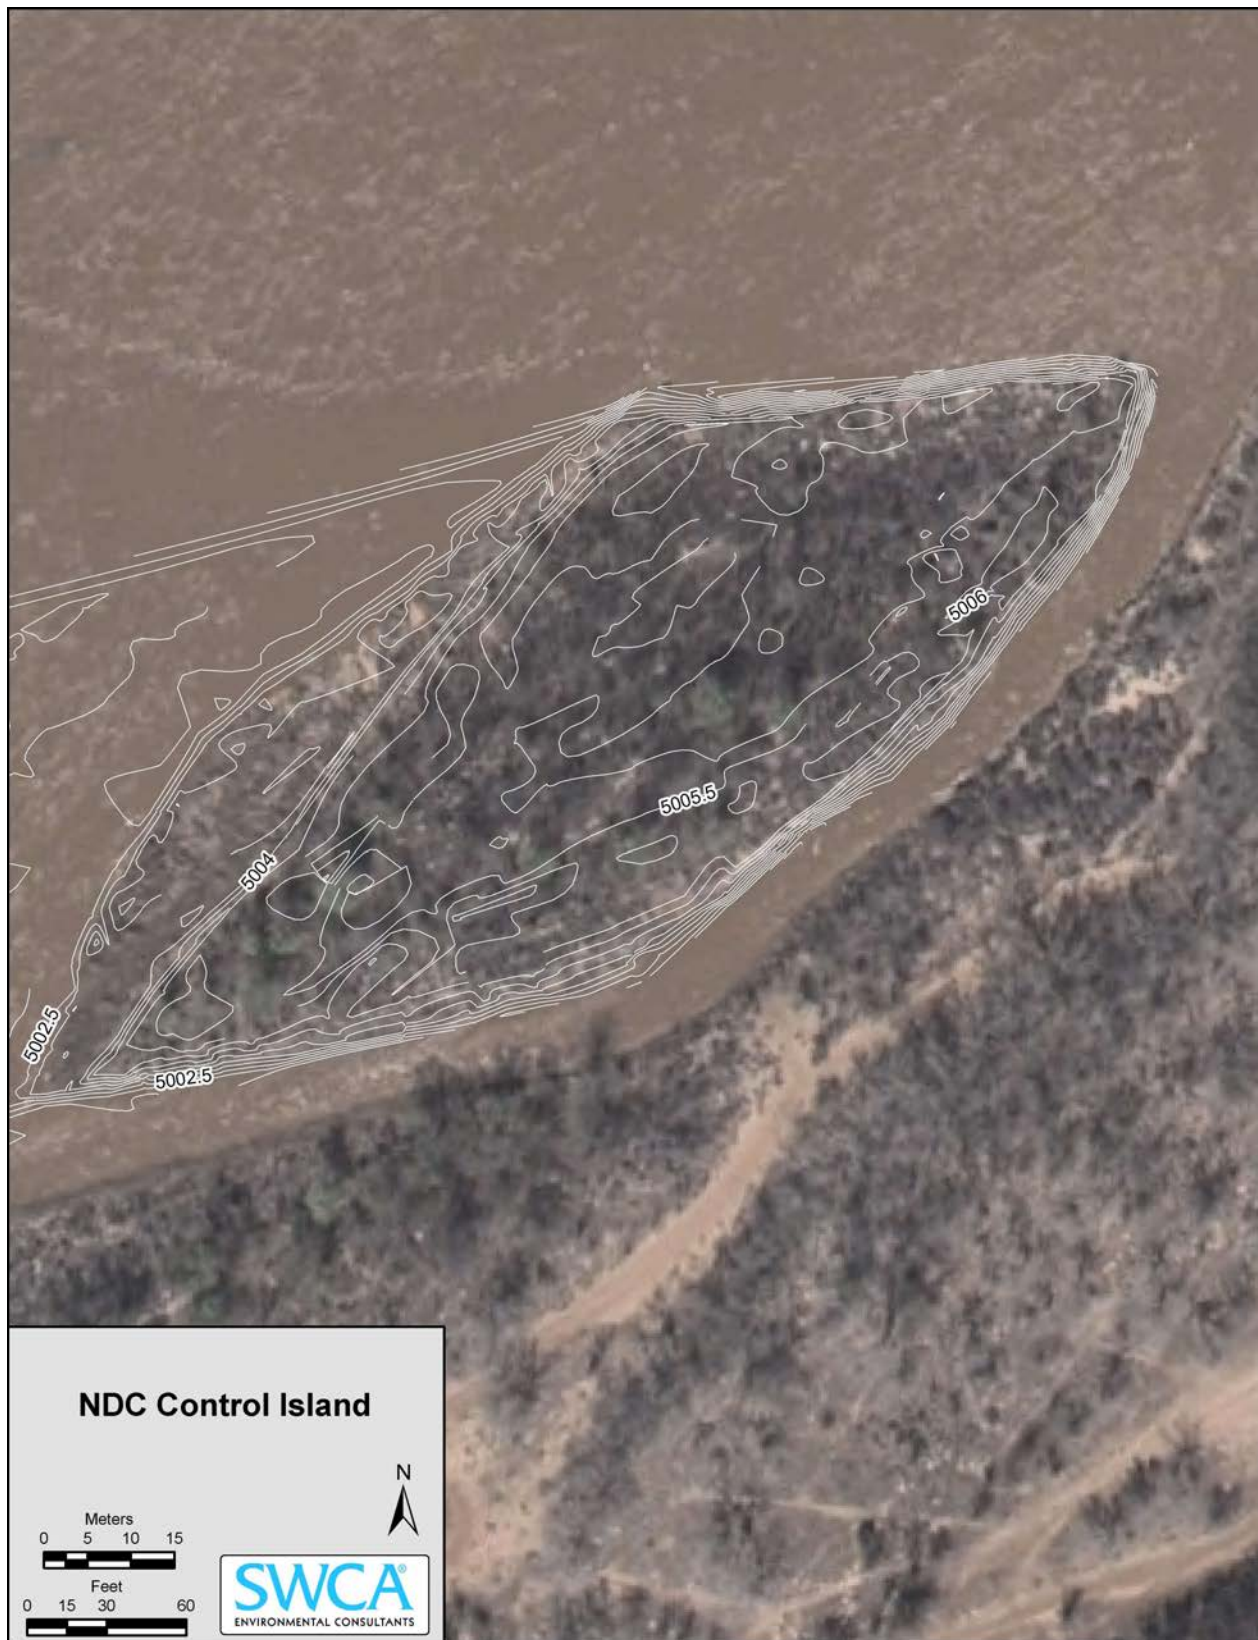
**Figure 3.** NDC Subreach control island with topographic detail.

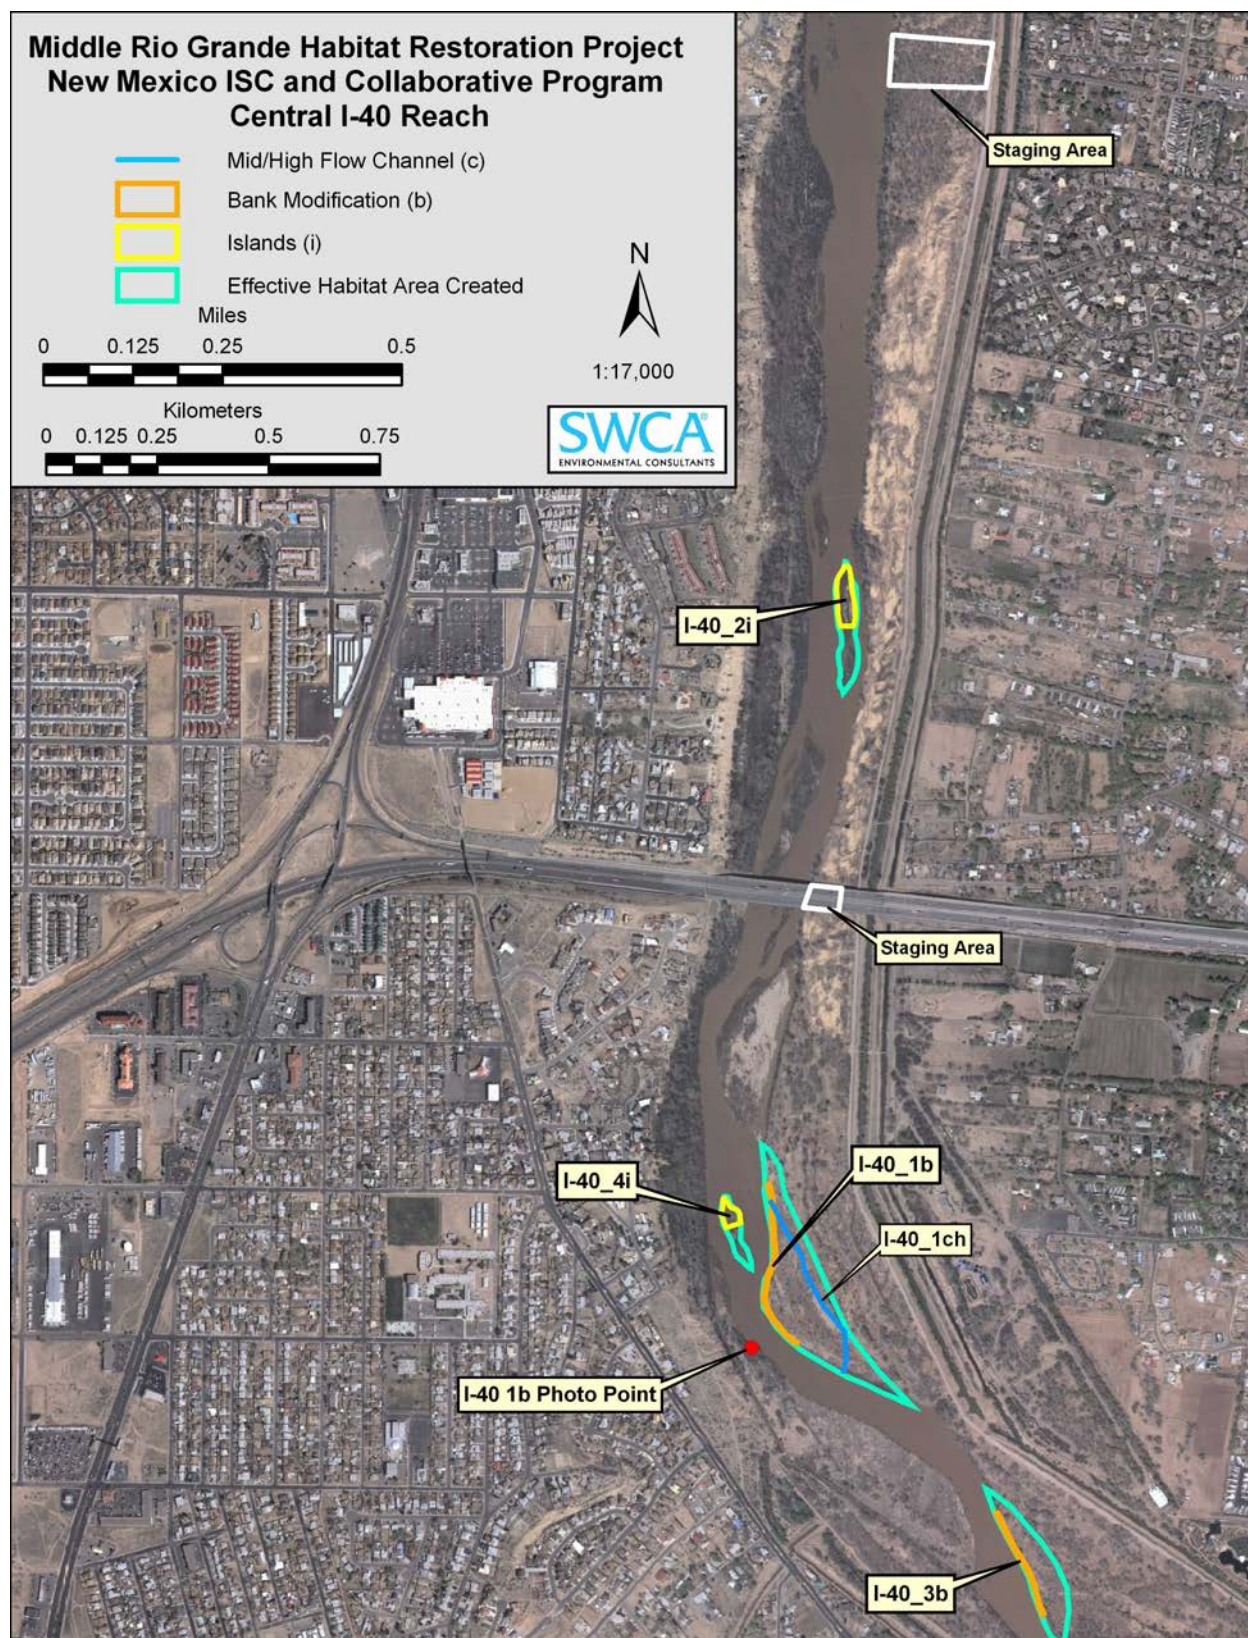
**Figure 4.** Treatment locations for I-40 /Central Subreach.

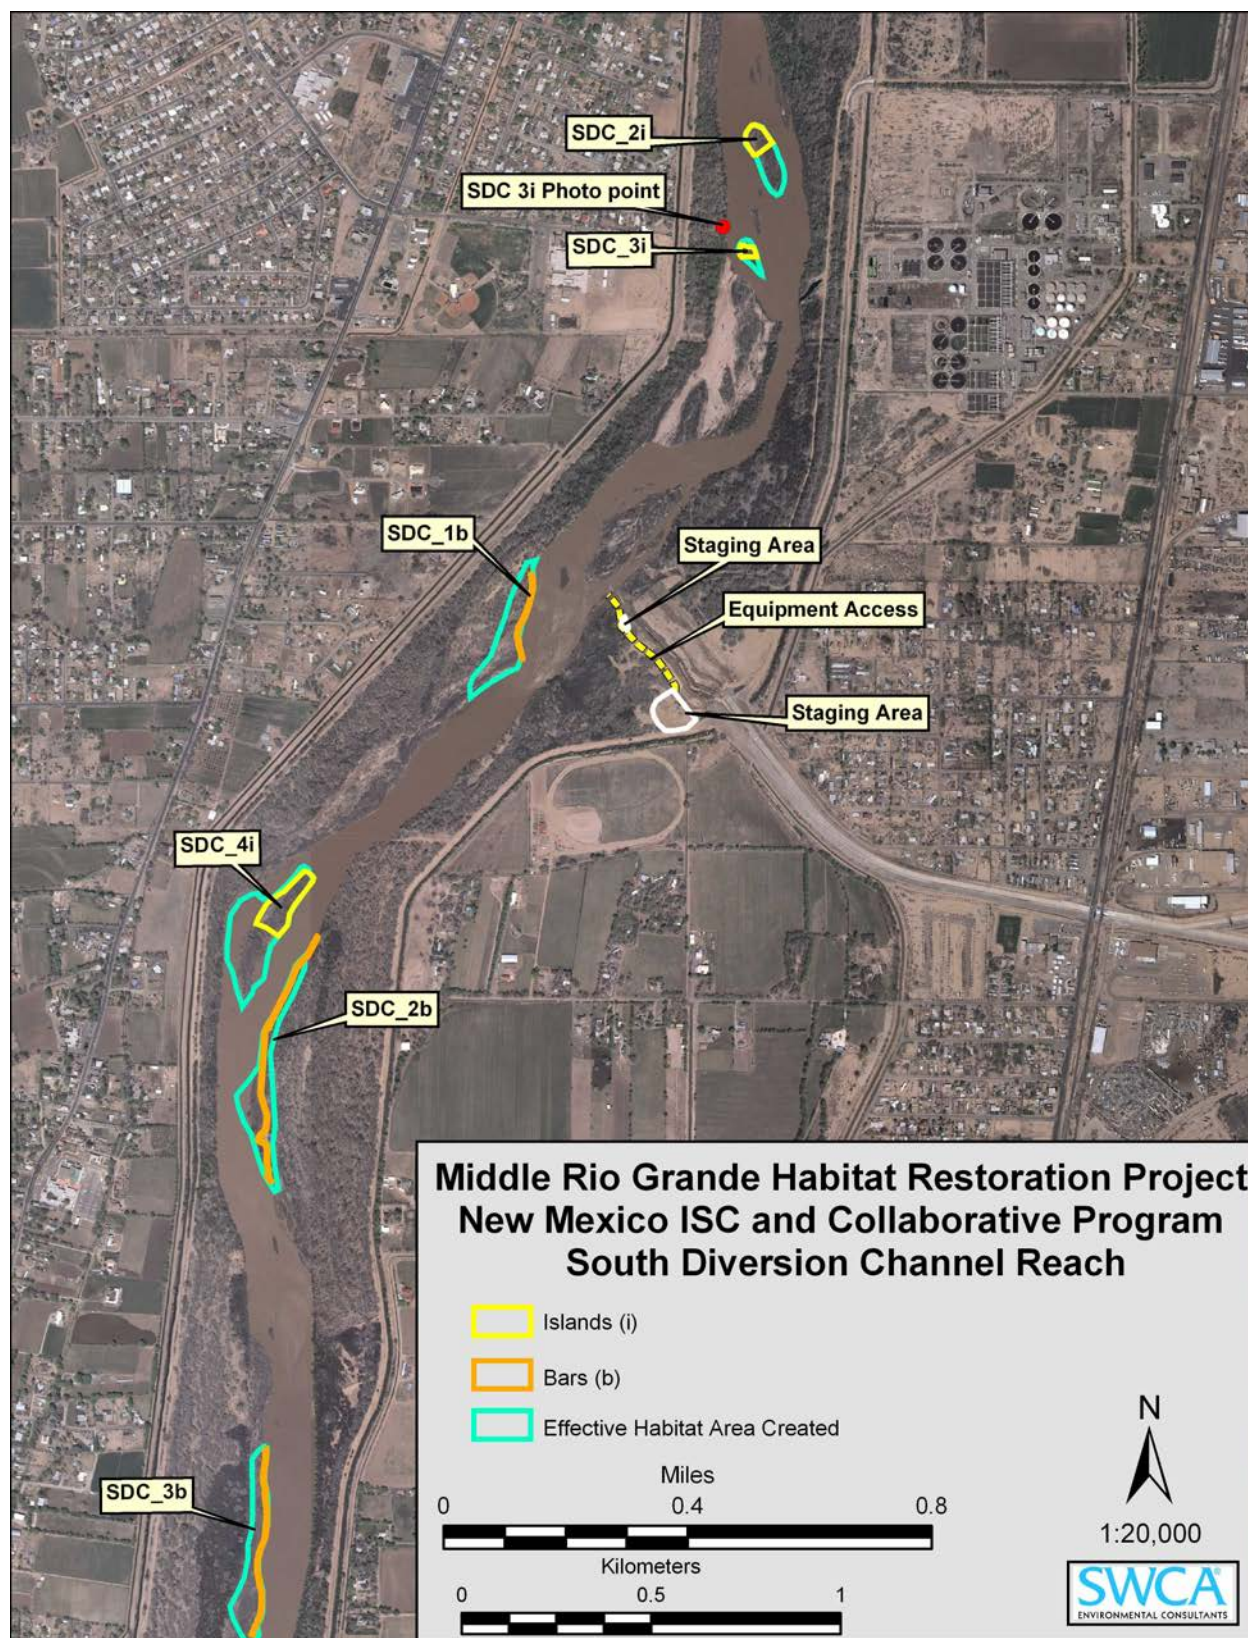
**Figure 5.** Treatment locations for SDC Subreach.

The area between the Rio Bravo Bridge and the SDC consists of three treated islands, as shown in Figure 5. Four ephemeral channels and five bank scours and scallops were implemented in the SDC Subreach. One island in this subreach was left undisturbed as a control island and monitored for comparison with treated islands (Figure 6).

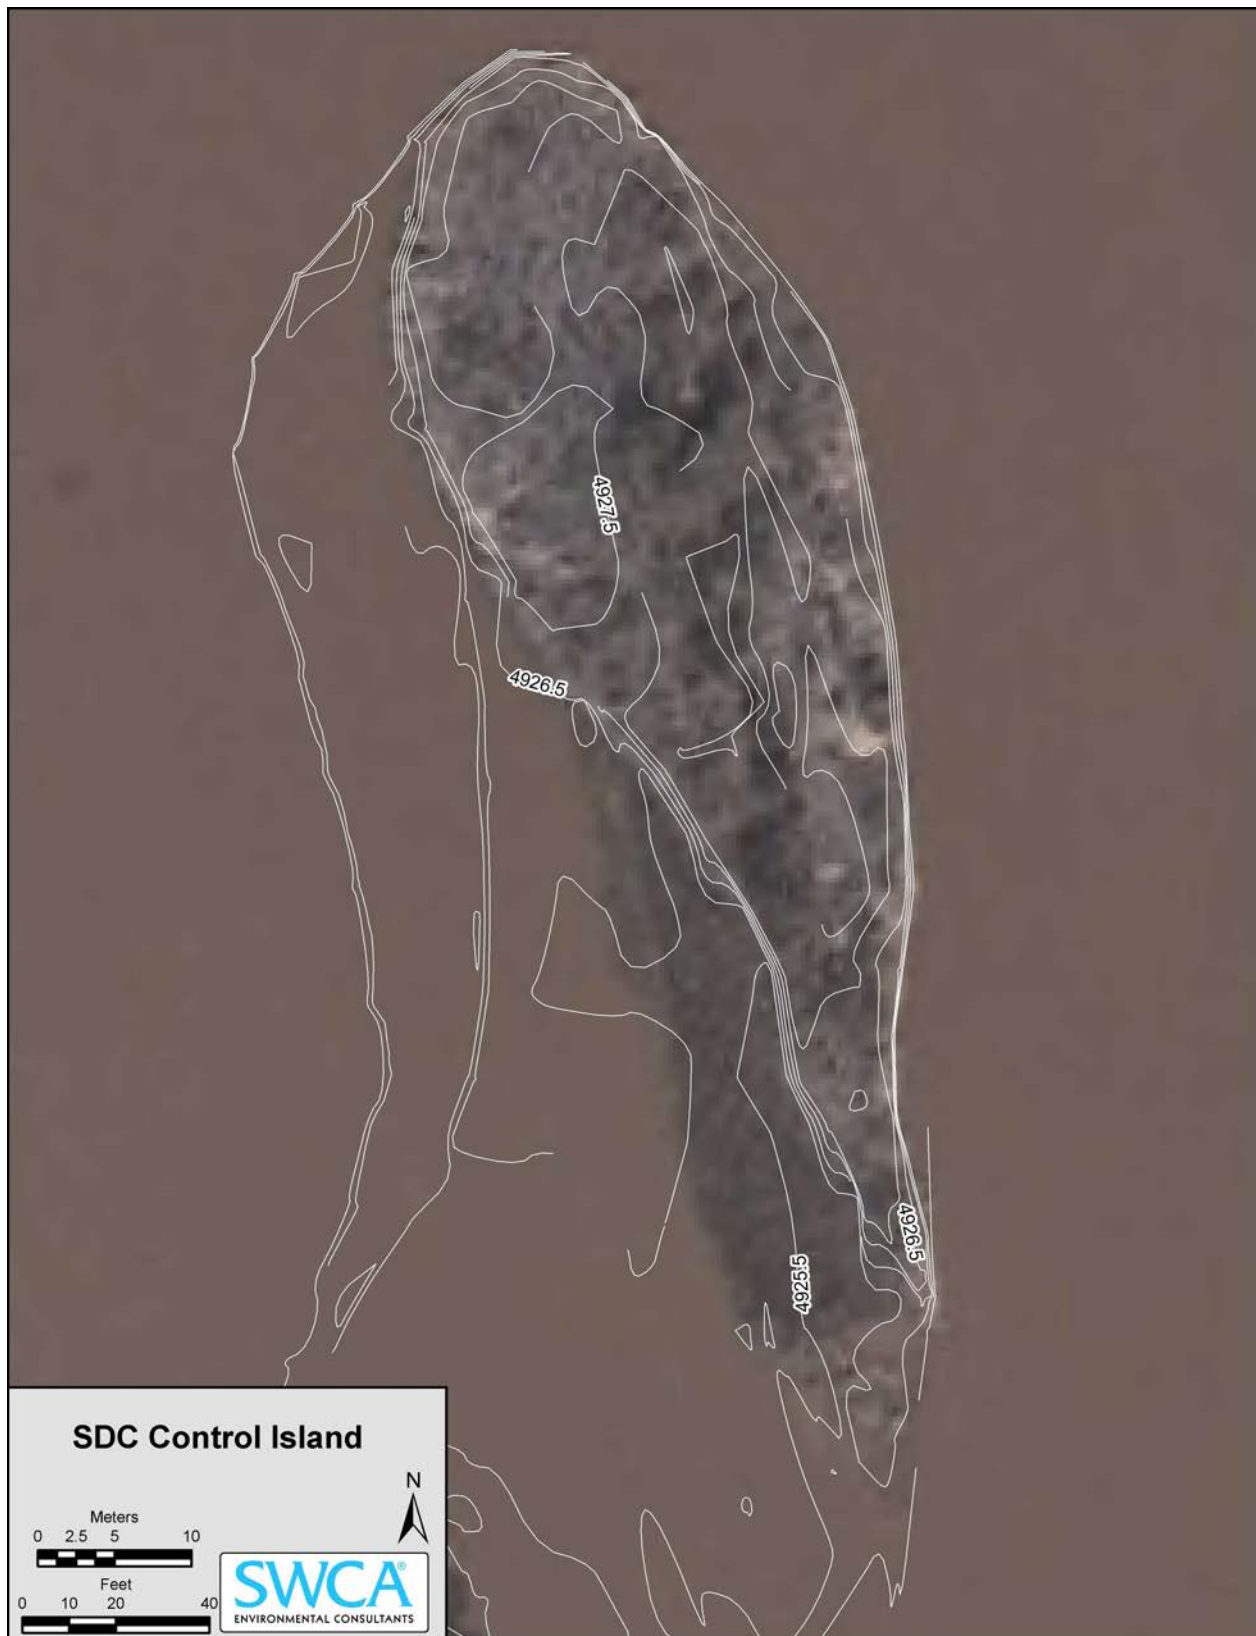
**Figure 6.** SDC Subreach control island detail.

The island has not had much appreciable change since the original 2005 survey. However, the lower elevation areas adjacent to the island that are void of vegetation showed some major changes. There was more than 2 feet of scour over a large area north of the control island; it appears the low-flow channel has shifted and eroded some barren bar features. Also, moderate deposition occurred between the control island and SDC 2i.

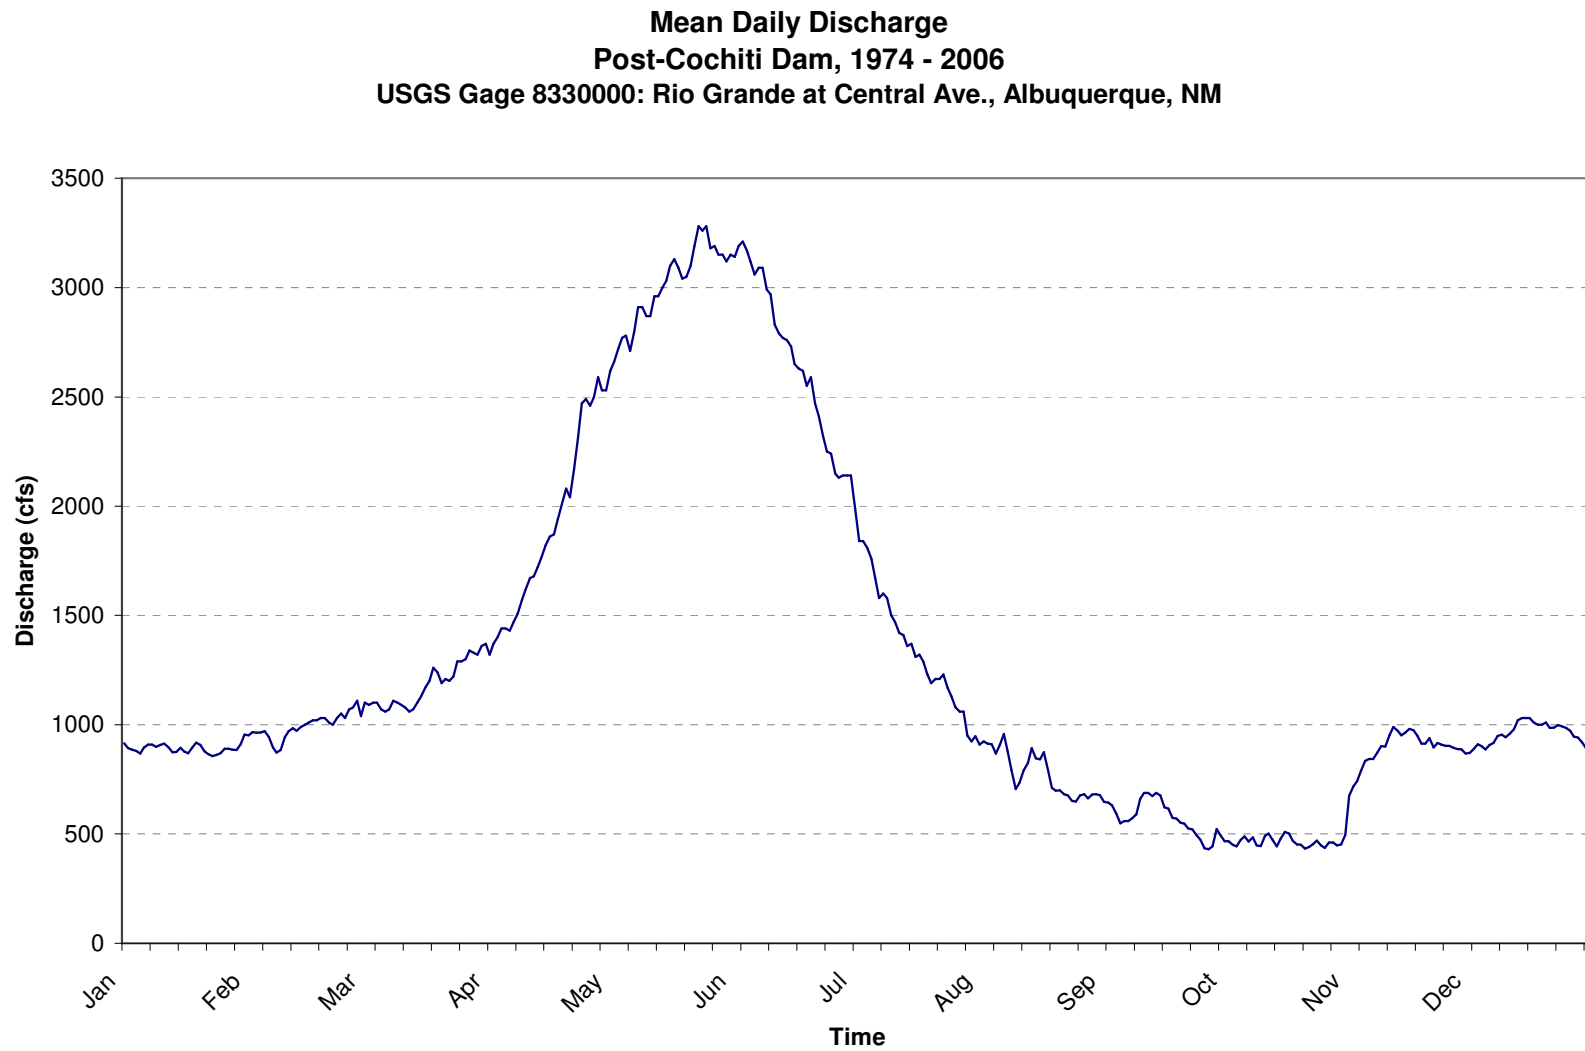
**Figure 7.** Mean Daily Discharge at Albuquerque Gage, 1974-2006.

The construction of Phase I restoration concluded in spring 2006, ahead of the anticipated spring runoff. Typically, runoff commences in the beginning of April when the mountain snow begins to melt and lasts through July (Figure 7). The winter of 2005/2006 was especially dry in the Rio Grande basin. In March, the snow pack was less than 50 percent of the average, so runoff was below recorded average. The late summer and fall monsoon season was quite active as evidenced by the 2006 daily flow hydrograph (Figure 8). Examining the 15-minute data shows that flows at the Albuquerque gage reached 2,000 cfs 8 times between mid-June and mid-October with a peak of 4,027 cfs (Figure 9). These events were very short in duration, lasting less than 10 hours on only 3 occasions. These are still short in duration compared to an average year where flow is greater than 2,500 cfs for approximately 55 days. The ability of these moderately large, short duration flows to alter channel geometry is significantly less than that of a sustained runoff event leading to minimal to moderate changes to the restored features.

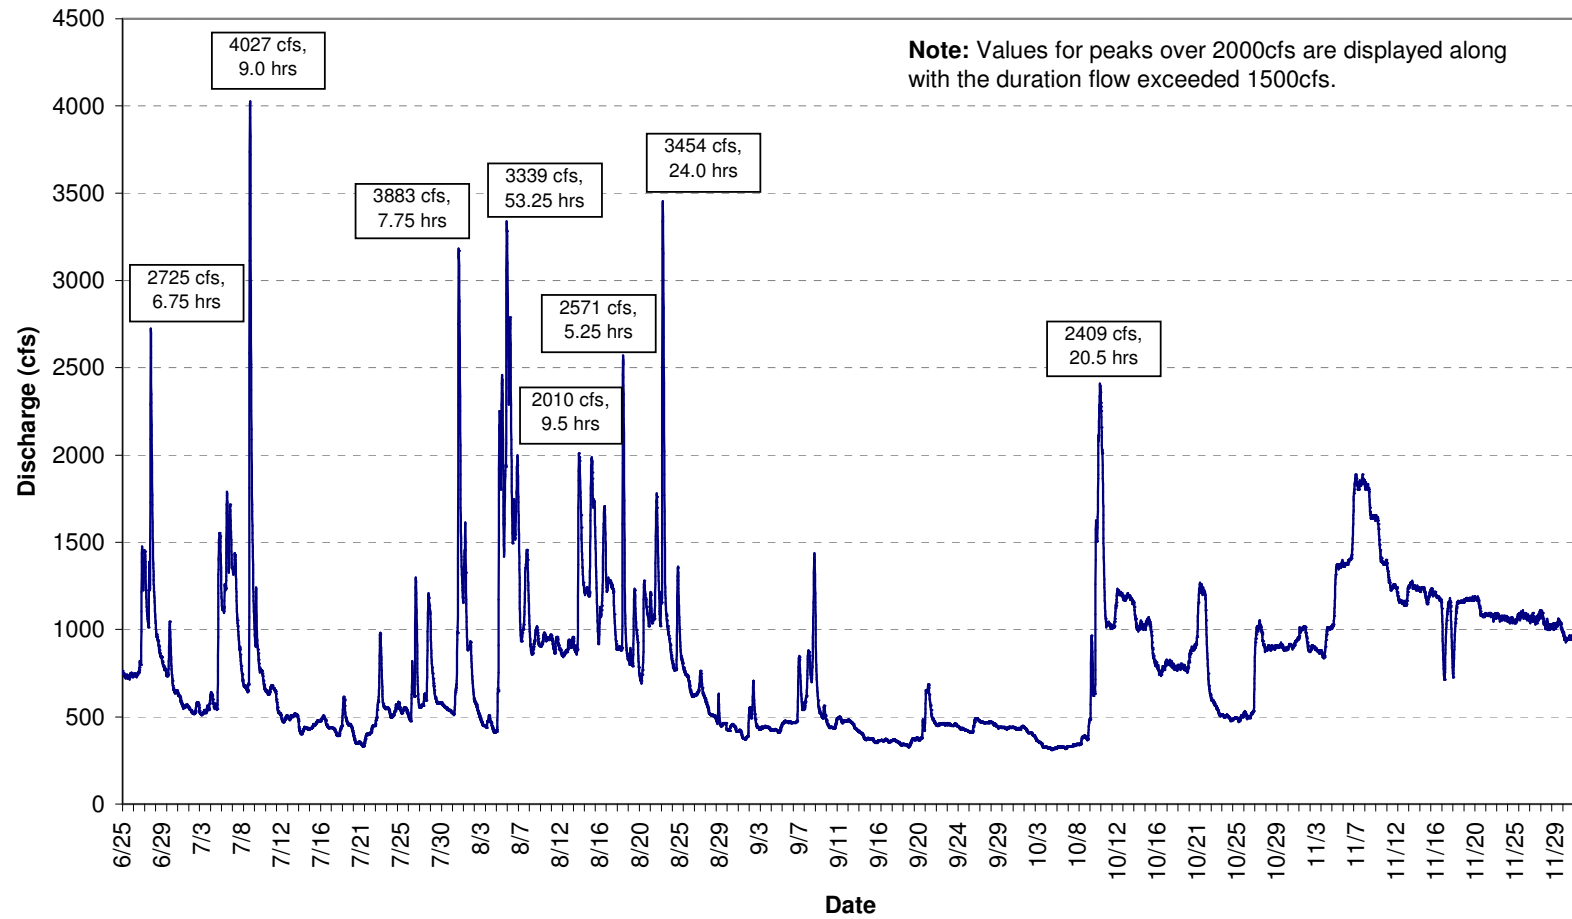
**Figure 9.** 15-minute Discharge at Albuquerque Gage, 06/25/2006-12/01/2006.

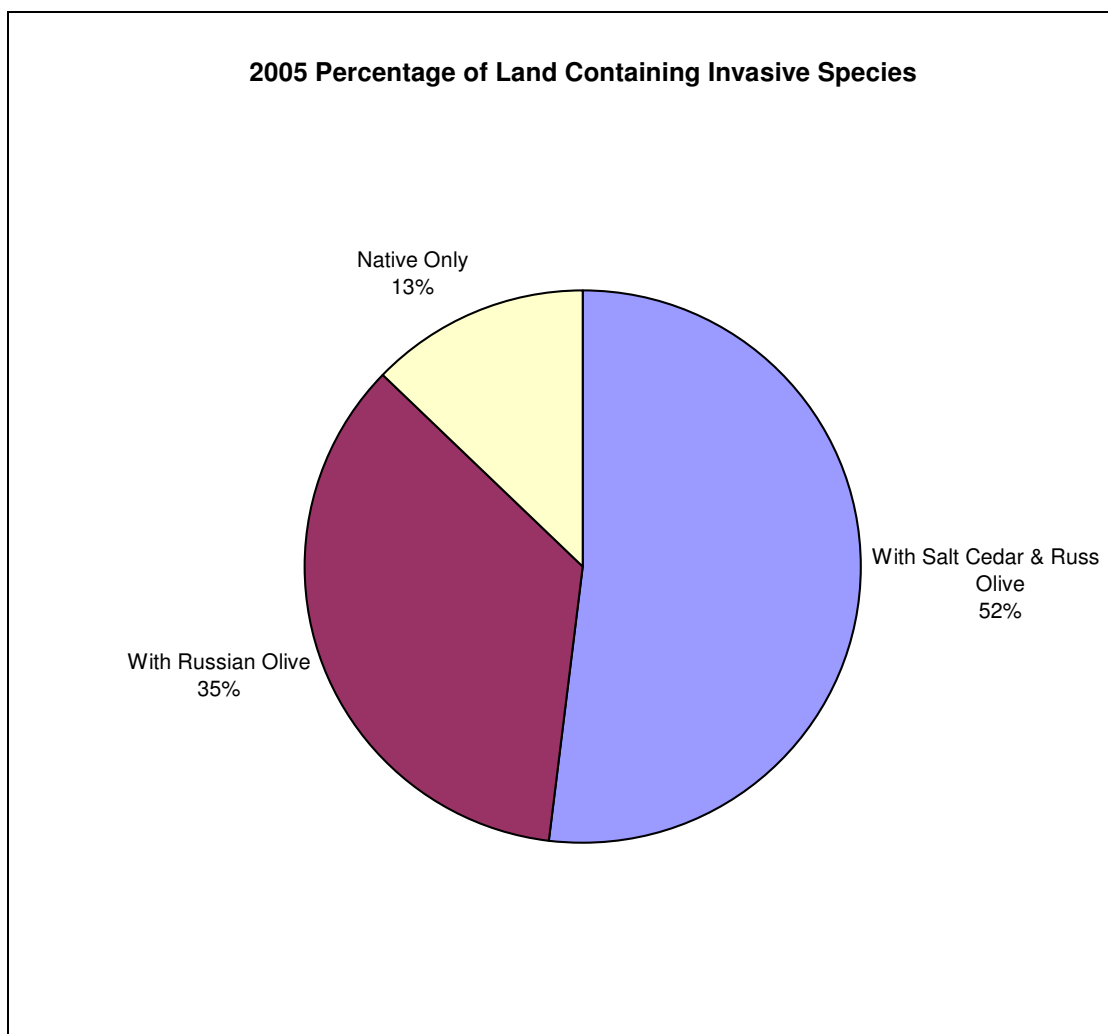
**Figure 10** Percentage of native species vs. the percentage of non-native species within preconstruction restoration sites, 2005.

Vegetation monitoring shows a steep decline in structural classes containing non-native species, such as Russian olive and salt cedar (Figure 10 and Figure 11). The 2005 vegetation structural classification (Table 6) data clearly shows a dominate Russian olive, salt cedar overstory 5 feet to 15 feet in over 80 percent of the Project Area and several structural class 3 habitats dominated by Russian olive and salt cedar. In contrast, the 2006 data (Table 7) shows no Russian olive or salt cedar overstory for structural type 3 in any of the project areas and a significant reduction in salt cedar and Russian olive in structural class 5. Where salt cedar covered 52 percent of the Project Area in 2005, in 2006 it was reduced to 6 percent of the Project Area. In 2006, Russian olive exists within 70 percent of the Project Area; whereas, in 2005 it could be found in 87 percent of the Project Area. Figure 12 is an example of the field data sheet.

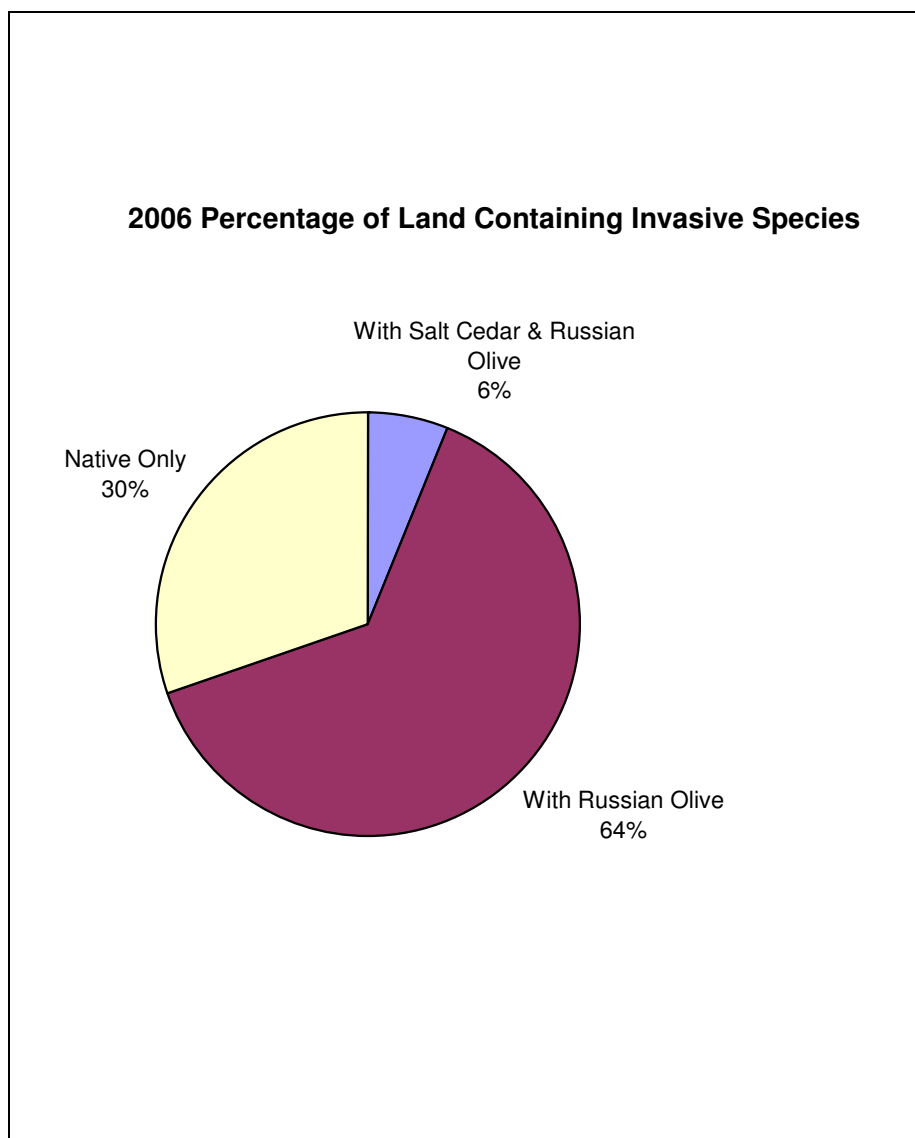
**Figure 11.** Percentage of native species vs. non-native species in post construction restoration sites, 2006.

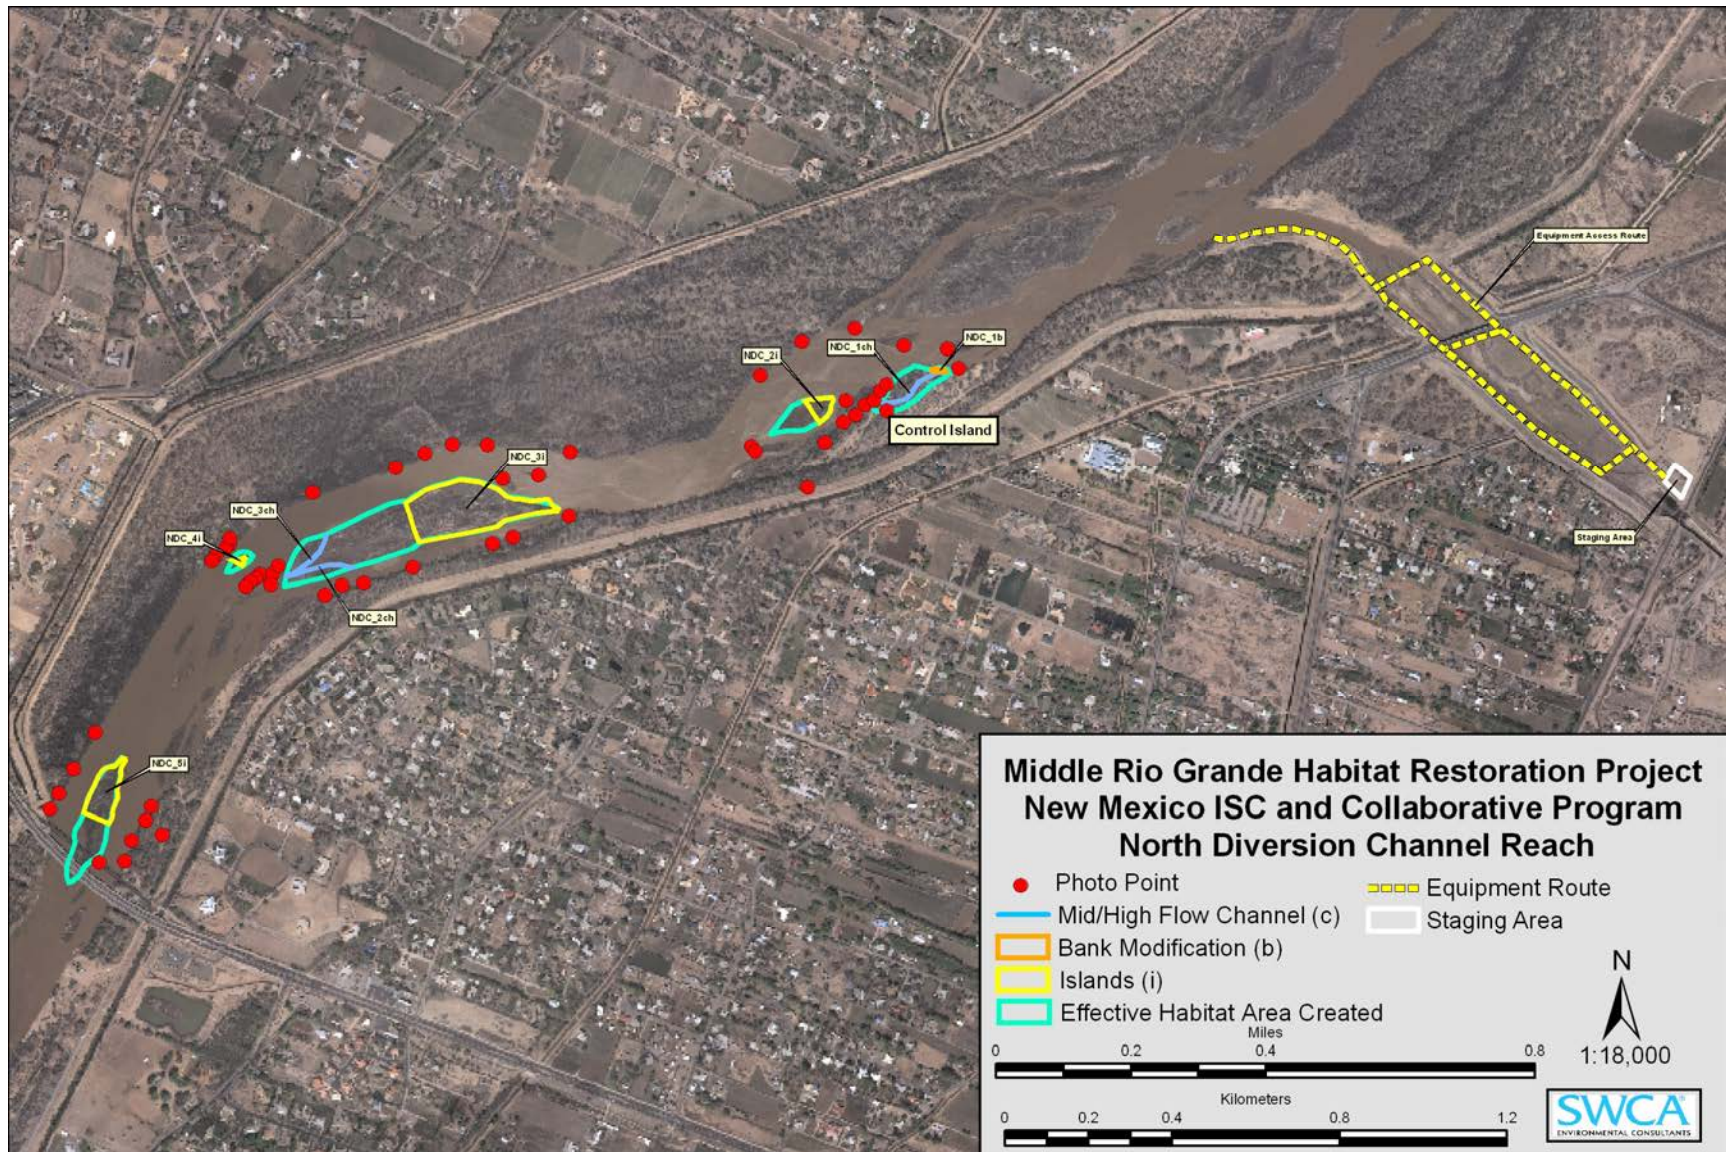
**Figure 1.** North Diversion Channel Subreach photo points and access locations.

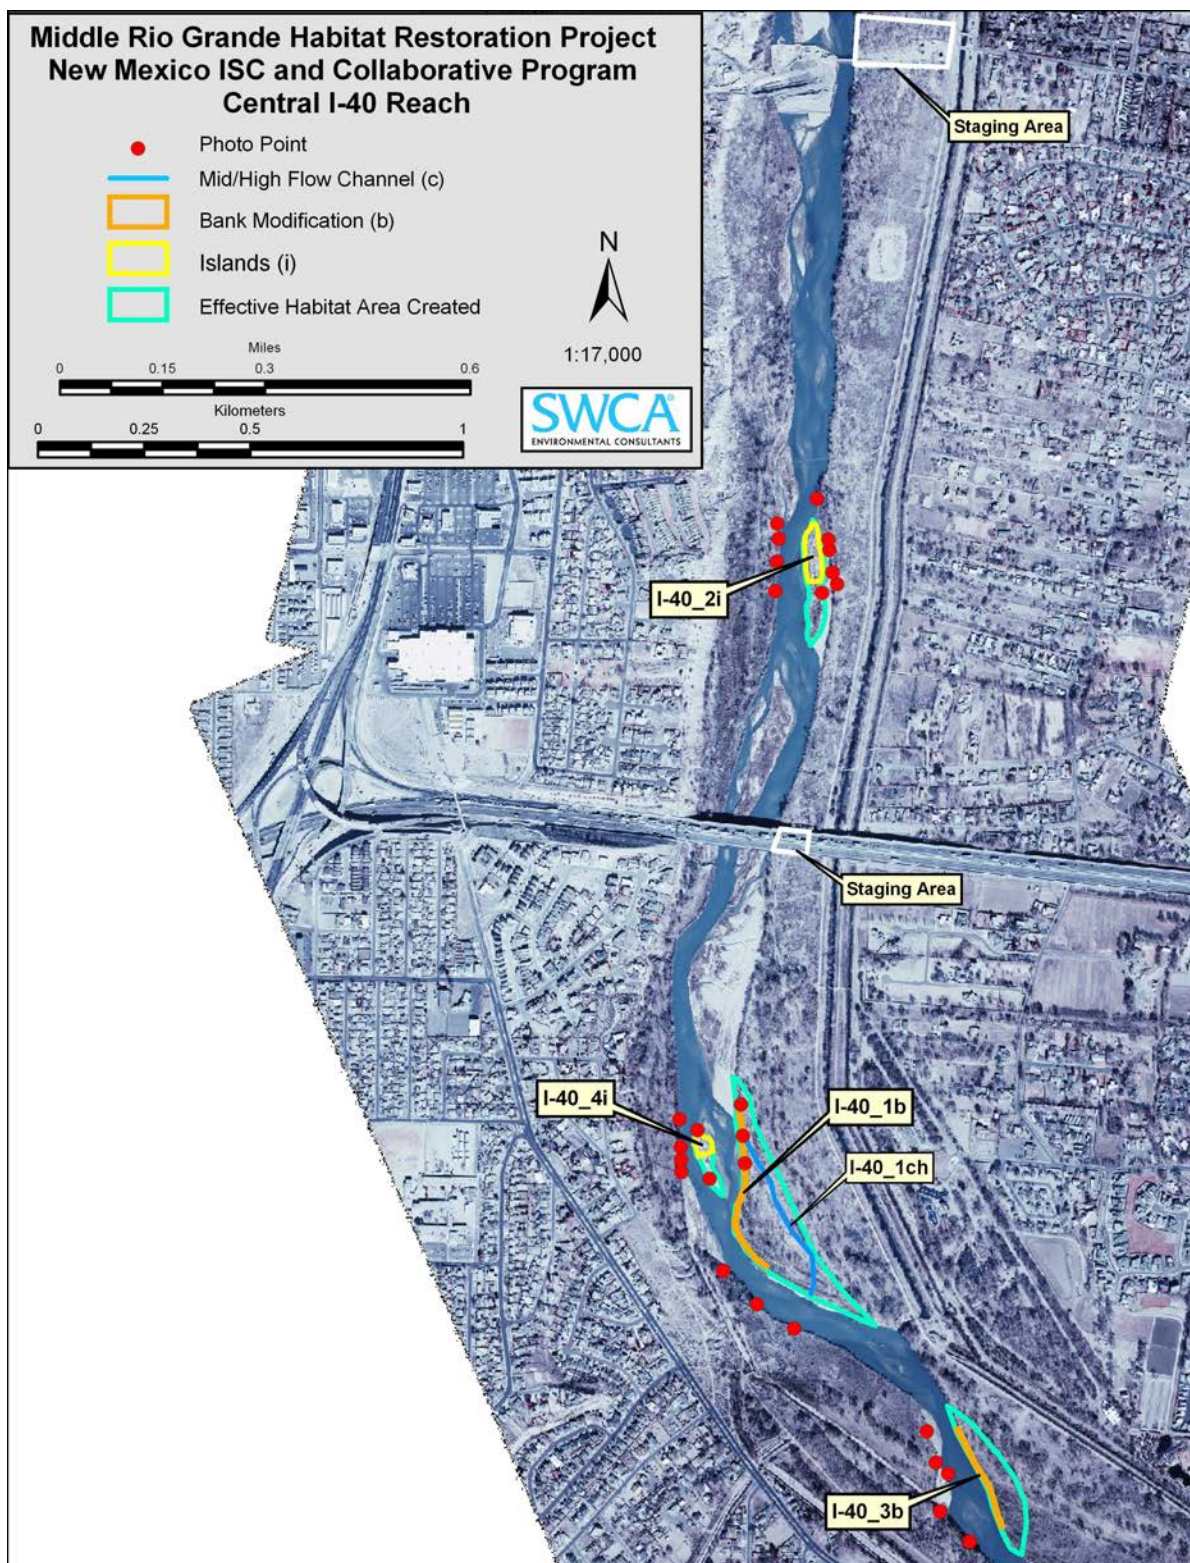
**Figure 2.** I-40 Subreach photo points.
