**NEW MEXICO INTERSTATE STREAM COMMISSION  
MIDDLE RIO GRANDE  
RIVERINE RESTORATION PROJECT PHASE I  
ANNUAL REPORT**

**NEW MEXICO INTERSTATE STREAM COMMISSION, ALBUQUERQUE OFFICE**  
121 Tijeras N.E., Suite 2000  
Albuquerque, New Mexico 87102

**SWCA<sup>®</sup> ENVIRONMENTAL CONSULTANTS**  
5647 Jefferson Street, NE  
Albuquerque, New Mexico 87109  
Telephone: 505-254-1115, Fax: 505-254-1116  
[www.swca.com](http://www.swca.com)

**MUSSETTER ENGINEERING INC.**  
1730 South College Avenue, St 100  
Fort Collins, CO 80525  
Telephone: 970-224-4612, Fax: 970-472-6062

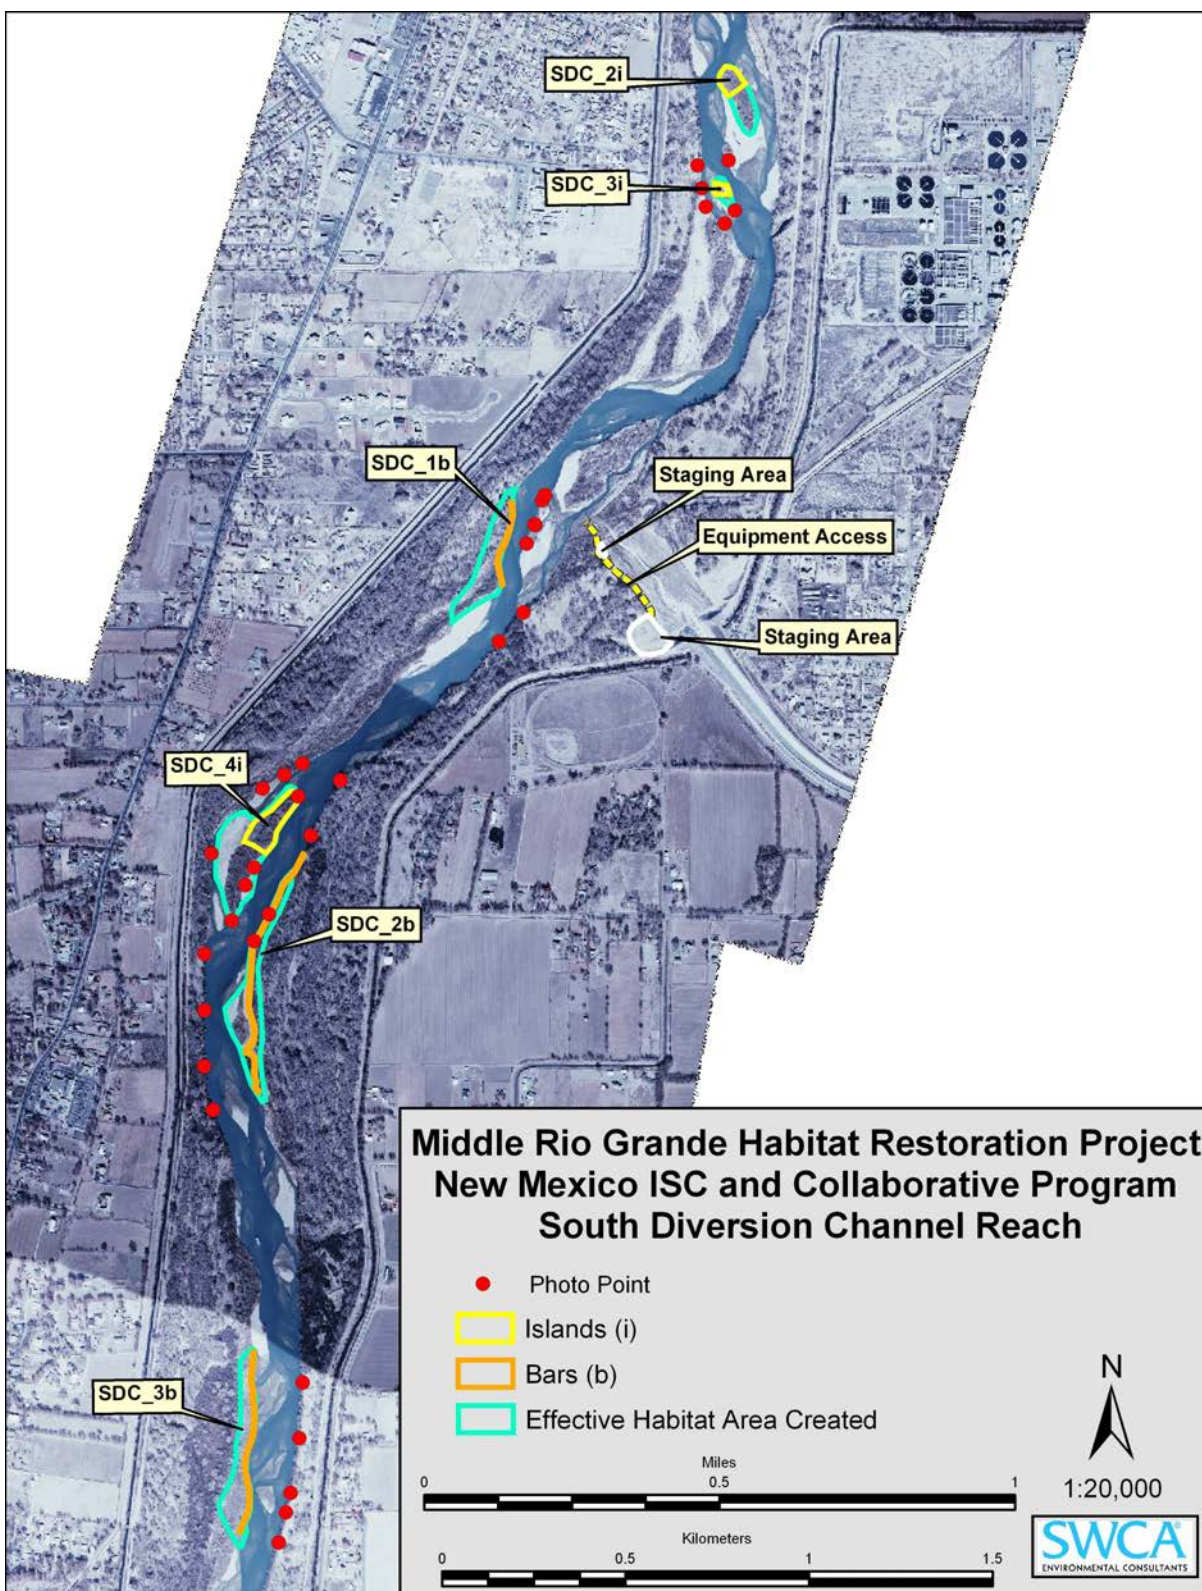
**Figure 3.** South Diversion Channel Subreach photo points and access locations.

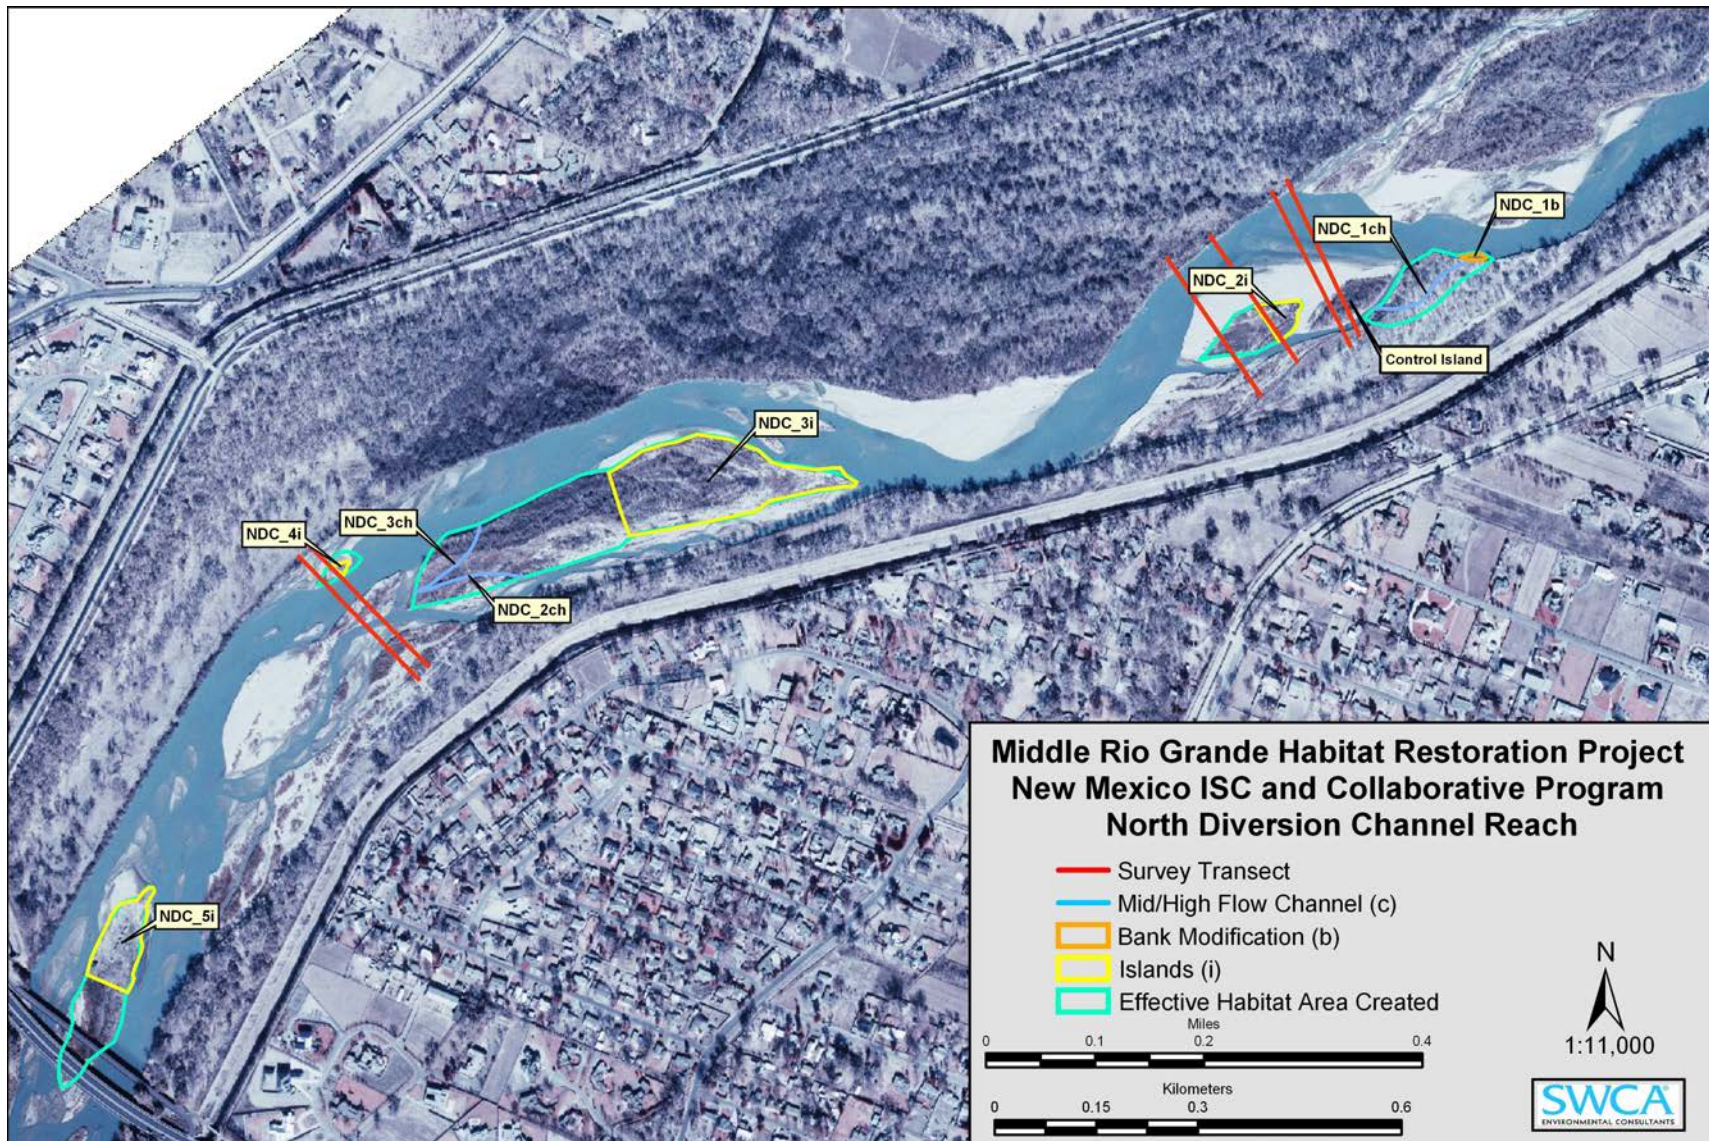
**Figure 4.** North Diversion Channel Subreach survey transects.

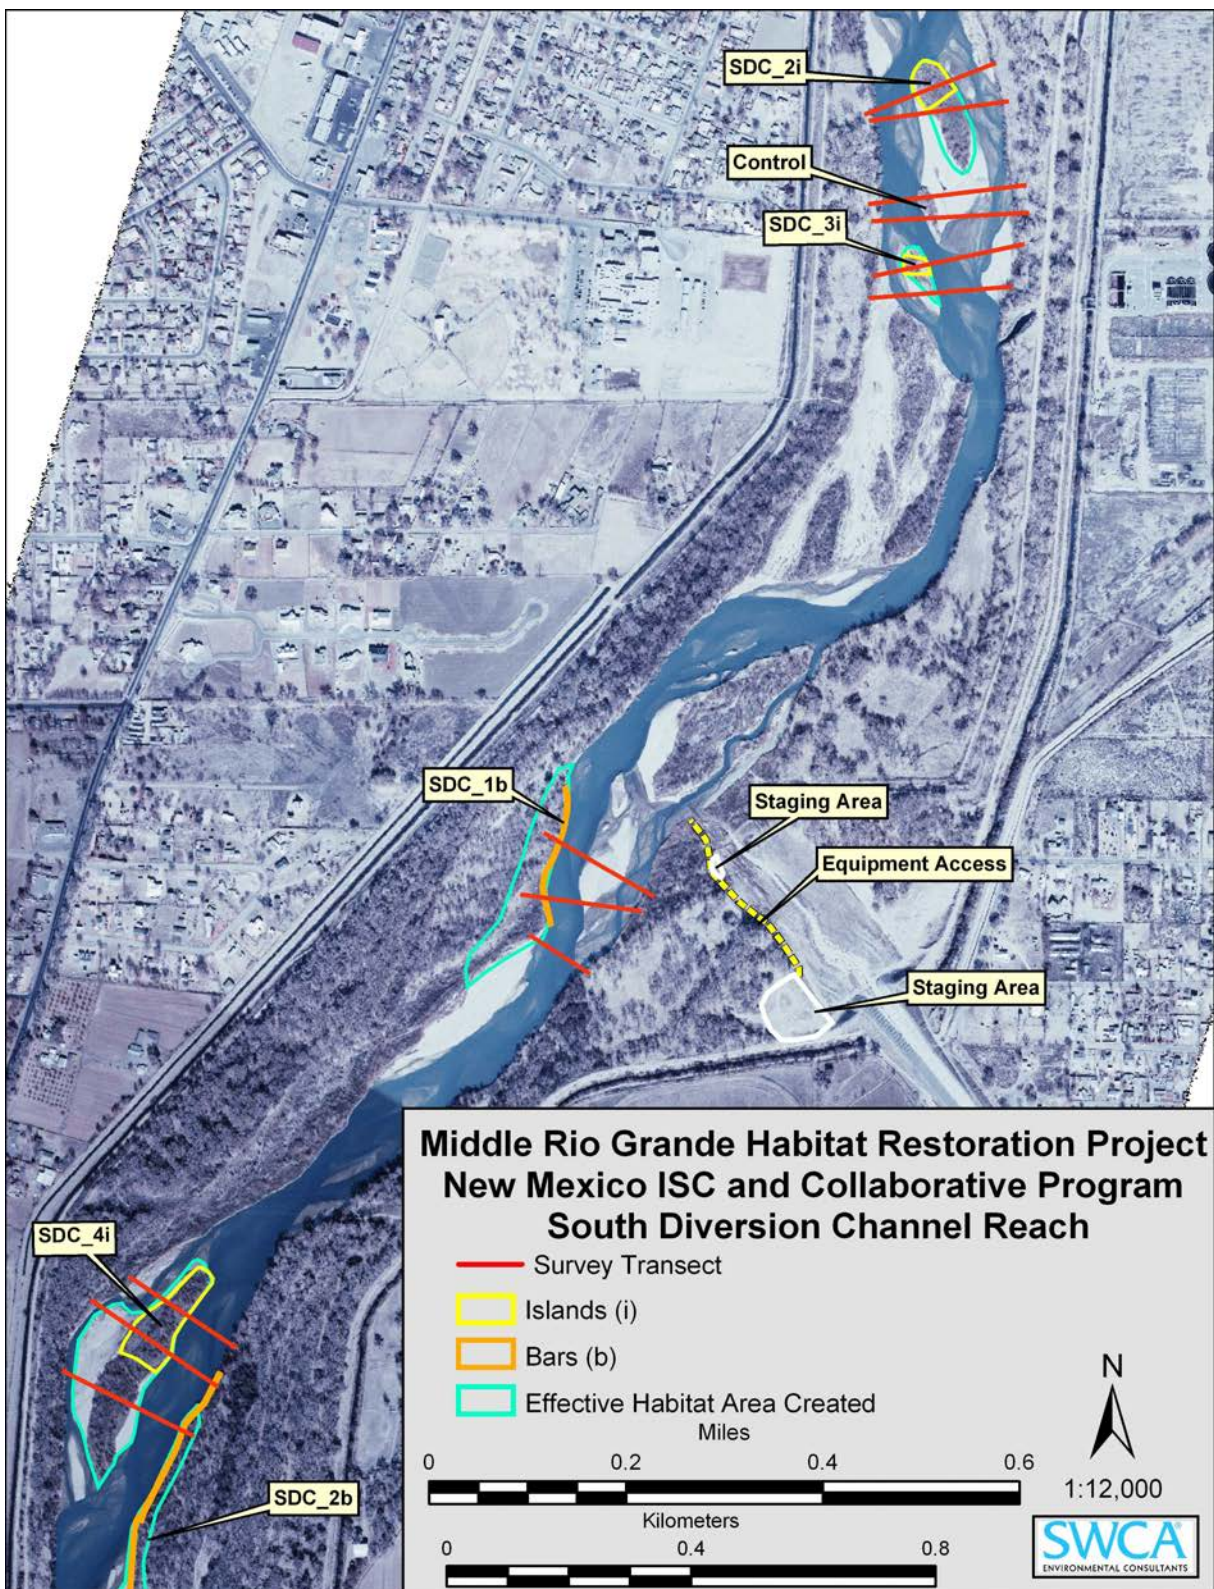
**Figure 5.** South Diversion Channel Subreach survey transects.

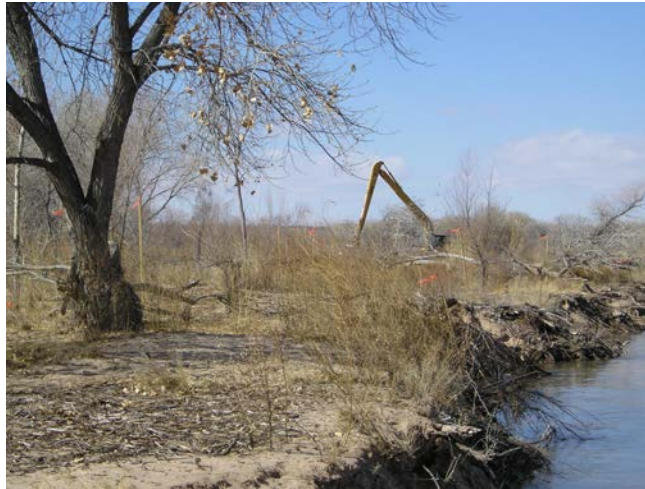
The bank scallop was constructed on the east bank of the Rio Grande, northeast of NDC-2i and north of NDC-1ch. The scallop was constructed as an embayment to function at 1,000 cfs, with an outflow channel (NDC-1ch) that will be inundated and flowing at approximately 1,500 cfs (Figure 1). The channel returns to the Rio Grande downstream within a side channel near NDC-2i. Work started with the excavator moving sediment and spreading the spoil on the bank to the south and east of NDC-1ch. Downed pieces of large woody debris were tagged and placed in the river by the excavator.

**Figure 1.** NDC-1b prior to construction

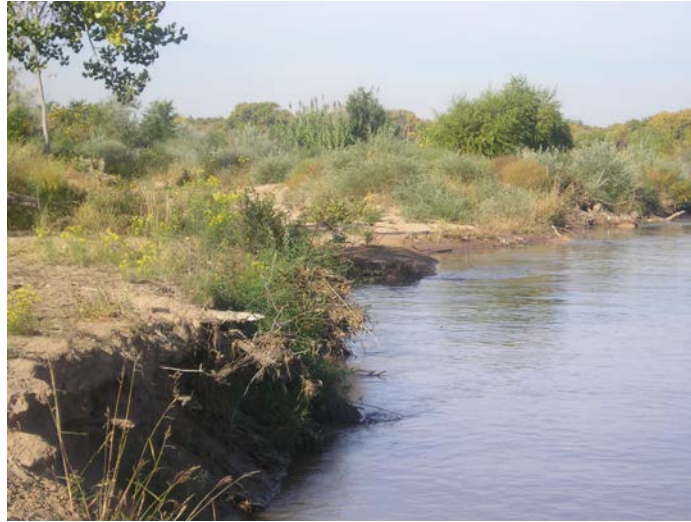
The scallop (and channel inflow) had quite a bit of sediment deposition and developed a shelf along the eastern side (Figure 2). The water level has reached the top level of the scallop and the current water level (829 cfs) was approximately 6 inches below the surface level. Some herbaceous vegetation has grown within the scallop and along the waters edge (Hink and Ohmart C4). Russian thistle, *Salsola tragus*, has also grown quite extensively along the bank of the scallop.

**Figure 2.** NDC-1b after construction

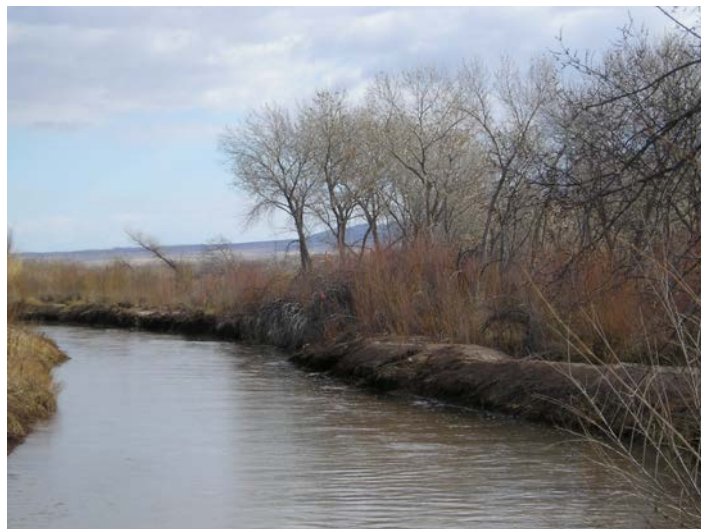
The channel was constructed on the east bank of the Rio Grande, northeast of NDC-2i. It was constructed as an ephemeral channel, about 25 feet wide, with inundation to occur at approximately 1,500 cfs (Figure 3). After the channel was surveyed, construction work started with the excavator digging from the downstream end to the upstream end. Fill material was deposited adjacent to the created channel on the bank.

**Figure 3.** Outflow area of NDC-1ch prior to construction

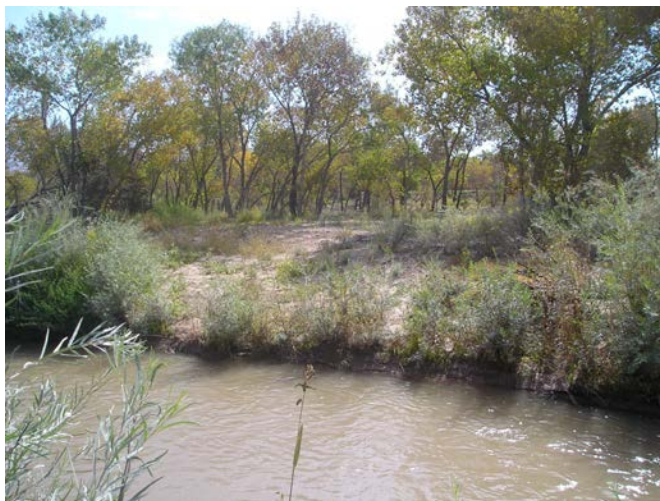
coyote willow saplings as well as herbaceous vegetation has grown within the channel and along the banks where the spoil was spread out (Hink and Ohmart C-CW6). Russian thistle has also grown quite extensively along the banks of the channel. The outflow area also has some sediment deposition and herbaceous vegetation growth just at the water's edge (Figure 4).

**Figure 4.** Outflow area of NDC-1ch after construction

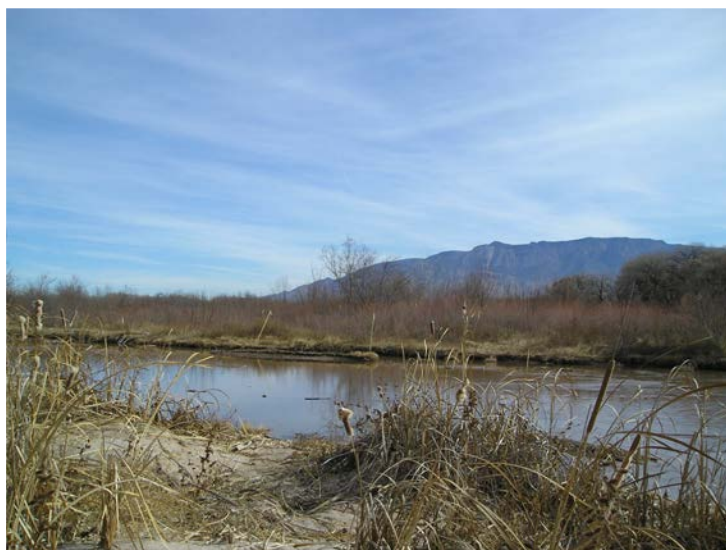
Work started with the excavator constructing NDC-2ch from the upstream end to the downstream end and then constructing NDC-3ch from the downstream end (Figure 5) to the upstream end. The spoil was spread on both sides of the created secondary channels.

**Figure 5.** Outfall of NDC-2ch and NDC-3ch prior to construction

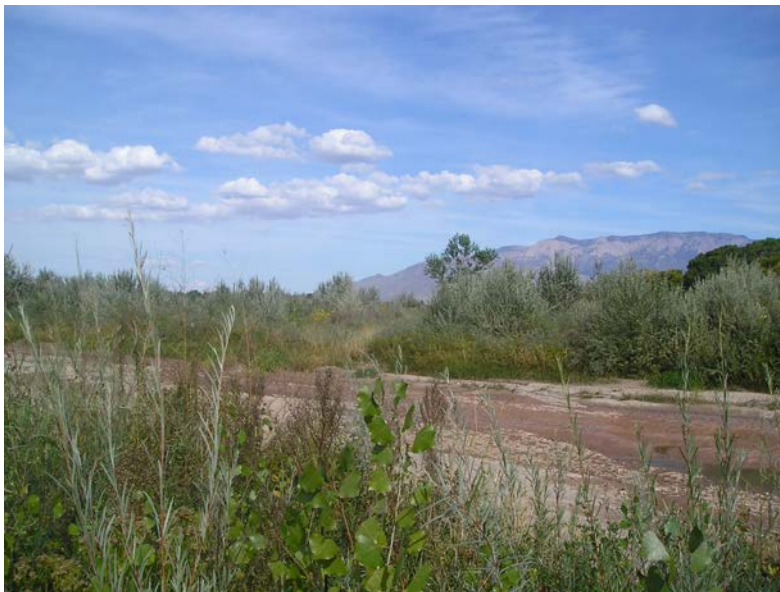
Channel 2ch had sediment deposited at the inflow area, which caused the bank level to be higher. Although, the woody vegetation surrounding the channels remains similar to pre-construction (Hink and Ohmart RO/CW5), the vegetation within the channels is mainly coyote willow and some cottonwood saplings along the banks. A remarkable amount of 5 – 10 foot vegetation (mainly *Salix exigua* and herbaceous) is also present at the inflow of 2ch and extends downstream to approximately the convergence with 3ch. South of the convergence herbaceous vegetation has grown within the channel as well as on the banks where the spoil was spread out. Channel 2ch was inundated with at least 2 – 3 inches throughout most of the channel. The inflow for channel 3ch had also received sediment deposition increasing the bank height. However, the vegetation throughout the channel is approximately 3 ft. tall and is mainly herbaceous. Channel 3ch is also inundated throughout most of the channel, but is deeper than 2ch having up to 1 foot of water. The outflow area (Figure 7) has been blocked by sediment buildup and growing vegetation, and although mainly herbaceous, may anchor and prevent the channel from functioning properly.

**Figure 6.** Outfall of NDC-2ch and NDC-3ch

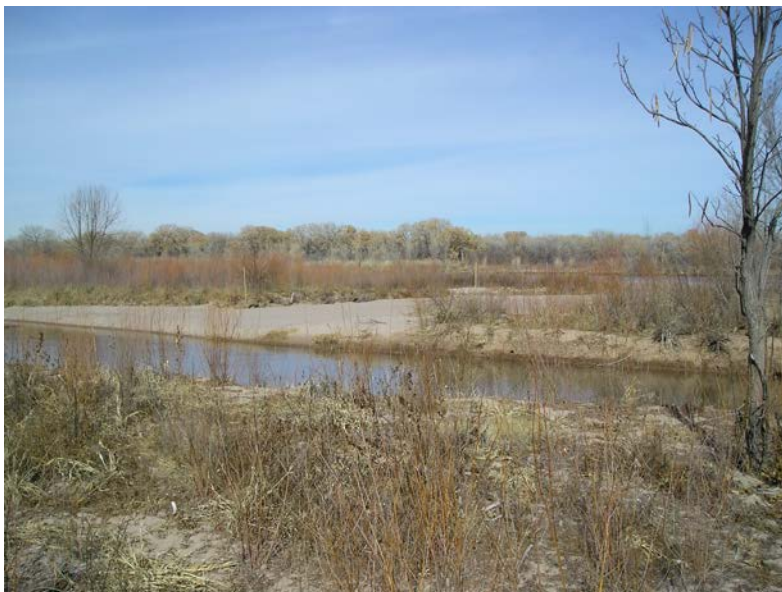
NDC-2i is part of the island destabilization project funded by the Collaborative Program. The upper third of the island was modified (1) to create an elevation at which inundation at approximately 2,000 cfs could support various life stages of the silvery minnow and (2) to test the efficacy of destabilizing an island (Figure 7). The spoil was spread out on the southern end of the island

**Figure 7.** Northeast section of 2i.

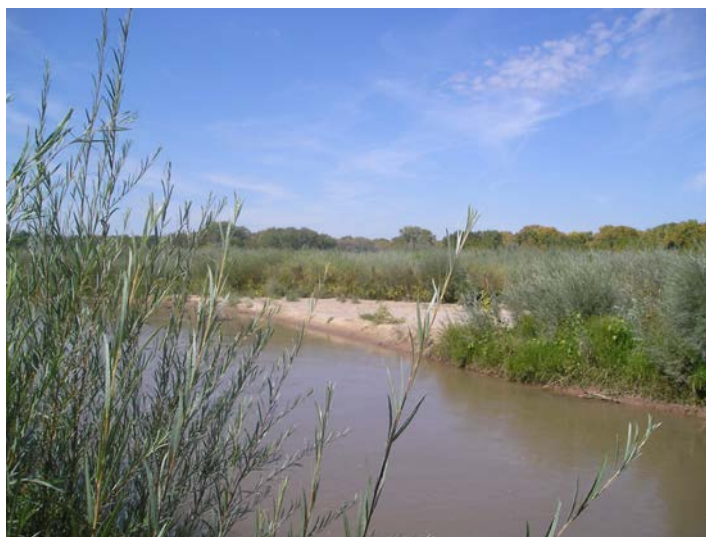
Island 2i has a large amount of sediment deposition on the northern tip of the island where it is connected to a bar (at low flows) that borders the northeastern and western sides of the island (Figure 8). The entire project area had been inundated during high flows and only on the south central section was there water remaining in a few spots. Most of the modified area had *Salix exigua* (5 – 10 ft.) growing back along with some patches of young *Populus deltoides*, [\*Elaeagnus angustifolia\*](#), and *Tamarix ramosissima*, which was primarily restricted to the northern tip of the island (Hink and Ohmart CW5).

**Figure 8.** Northeast section of 2i.

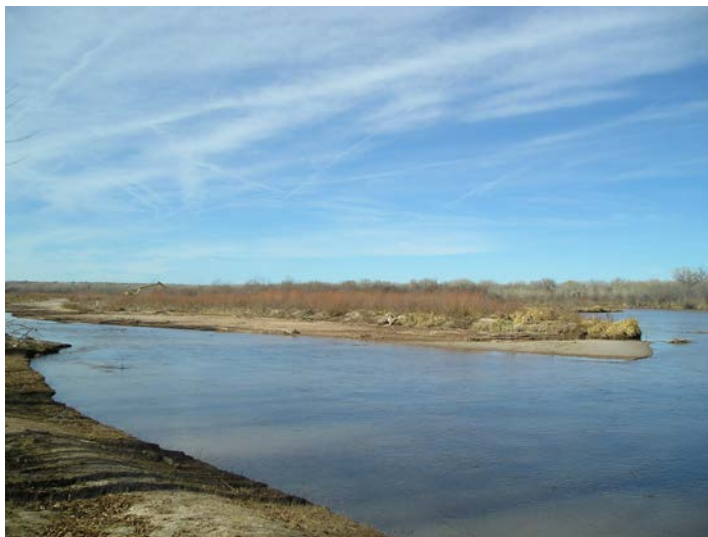
The upstream half of the island was modified to create three terraces at different elevations at which inundation could help support various life stages of the silvery minnow (Figure 9). The terraces will be inundated at approximately 1,500, 2,500, and 3,500 cfs. The original design included construction of an embayment downstream of the silt curtain. Because there was not enough fill material to create an embayment, the material was spread across the different terraces to fill several small depressions. The extra spoil material and vegetation were used as fill for several depressions in the center of the island.

**Figure 9.** Northern tip of 3i prior to construction

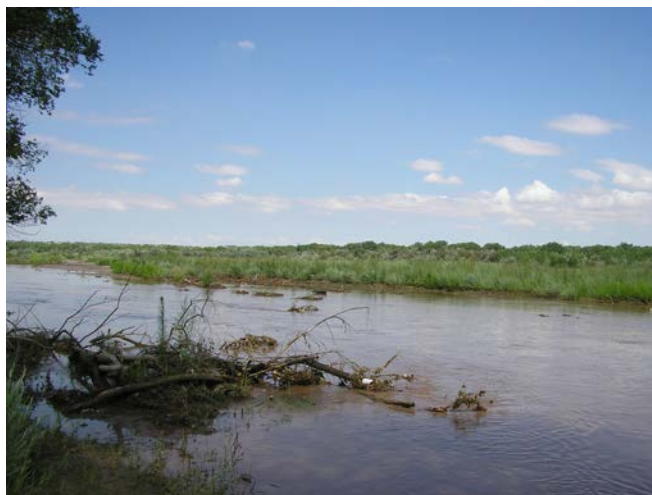
Sediment deposition was extensive on the northern tip of the island as flows pushed in about 20 feet (Figure 10). High flows had sustained inundation on both outer terraces whereas the inner terrace was inundated, but had already begun to dry out in spots. There was some ponding throughout the project area with the majority in the southeast corner, which still had 2 – 3 inches of standing water. The vegetation is mostly *S. exigua* with sparse patches of young *P. deltoides*, [\*Elaeagnus angustifolia\*](#), *Ulmus pumila*, and *Tamarix ramosissima* (Hink and Ohmart CW-C-RO5). Most of the vegetation is approximately 5 – 15 ft tall.

**Figure 10.** Northern tip of 3i after construction

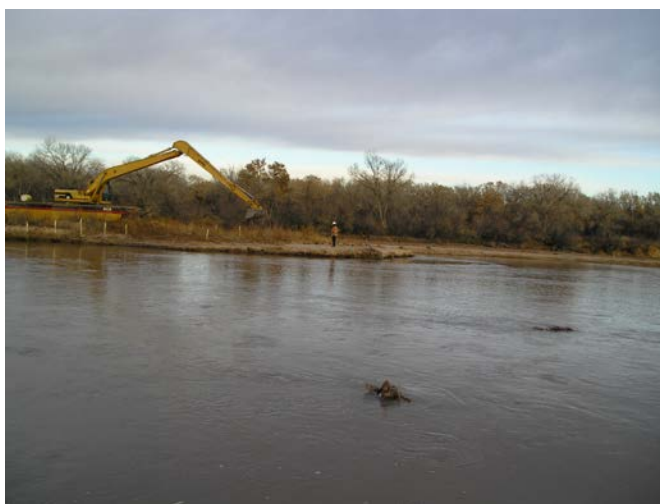
NDC-4i is part of the island destabilization project funded by the Middle Rio Grande Endangered Species Act Collaborative Program (Collaborative Program). The middle third of NDC-4i was modified to create an elevation at which inundation at approximately 2,000 cfs can take place to help support various life stages of the silvery minnow and to test the efficacy of destabilizing an island. The spoil material was then spread out on the island (Figure 11).

**Figure 11.** Eastern bank of NDC-4i prior to construction

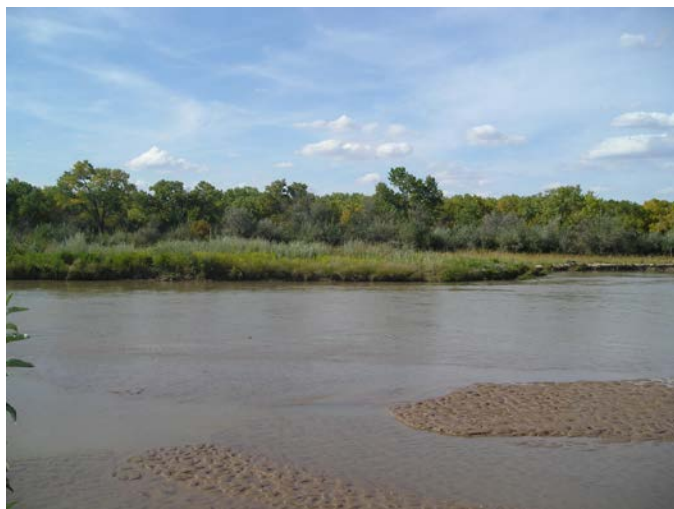
This small island was inundated throughout the project area during high flows and sediment deposition was extensive on the entire island especially along the eastern and western sides of the island (bar connected to the west bank during low flows). The vegetation on this island consists primarily of 5 – 7 foot coyote willow (Hink and Ohmart CW5) with a few Russian olives, but less than 25%. On the northern section of the island, herbaceous plants such as cattails (*Typha angustifolia*) were very abundant (Figure 12).

**Figure 12.** Eastern bank of NDC-4i after construction

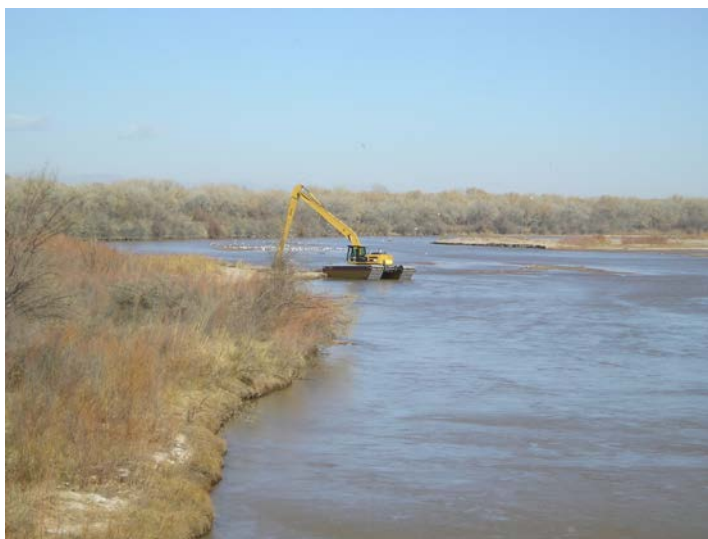
The upstream half of the island was modified to create terraces at different elevations that can be inundated to help support various life stages of the Rio Grande silvery minnow (silvery minnow). The three created terraces will be inundated at approximately 1,500, 2,500, and 3,500 cubic feet per second (cfs) discharge. The embayment created downstream of the silt curtain will be inundated at low flows, to less than 500 cfs (Figure 13). Spoil material from the island was placed on the inside of the silt curtain to secure it, partitioning the river flow to the east of the silt curtain and creating an embayment.

**Figure 13.** NDC-5i creation of silt curtain and embayment.

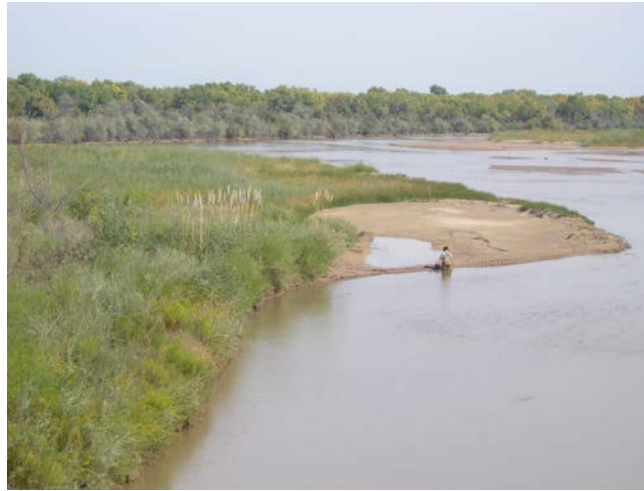
Sediment deposition was significant on the north and eastern sides of the project area. The embayment area is almost entirely filled in and there is only a small amount of water at the southern end. Although the innermost terrace showed little signs of recent inundation (mostly dry), high flows inundated all three terraces and the outer two had sustained inundation with the lowest terrace still very saturated. The vegetation within the modified area consists primarily of 5 – 15 foot coyote willow (Hink and Ohmart CW5) with some cottonwood and Russian olive saplings, but less than 25%. The outer terrace as well as the embayment (Figure 14) area had a considerable amount of herbaceous and wetland vegetation.

**Figure 14:** NDC-5i embayment after construction.

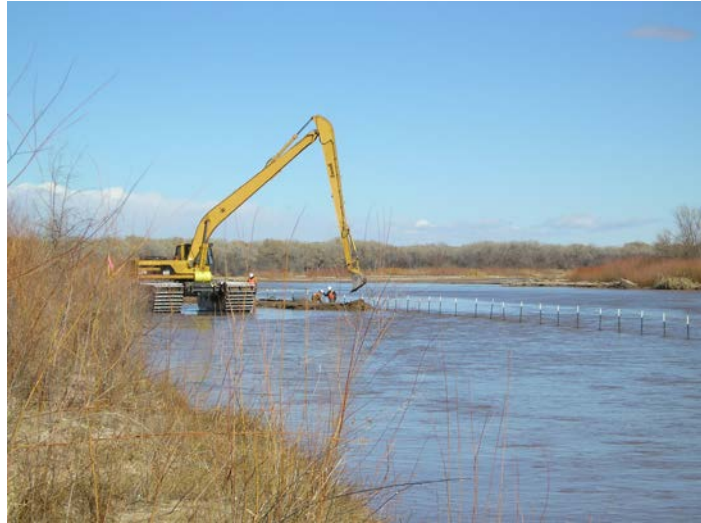
The upstream half of the island was modified to create terraces at different elevations to be inundated in support of various life stages of the Rio Grande silvery minnow. The three created terraces will be inundated at approximately 1500, 2500, and 3500 cubic feet per second (cfs) discharge. The embayment created downstream of the silt curtain will be inundated at low flows, including less than 500 cfs (Figure 1).

Work started on 12 January for NDC-5i in which the survey crew staked out the back-line and then constructed the silt curtain on the east side of the island. The flow of the river was focused to the east of the island, causing the silt curtain to collapse. To secure the silt curtain, spoil material from the island was placed on the inside of the silt curtain. The silt curtain process partitioned the river flow to the east of the silt current and also created an embayment.

**Figure 1:** NDC 5i silt curtain and embayment.

During the course of work on NDC-5i, several silvery minnow were positively identified in the embayment created by the construction crew. The embayment created a slow-velocity habitat different than the relatively deep and constricted mesohabitats predominantly present on the east and west sides of the island. During a cold period in January, three silvery minnow were found dead in semi-frozen water near the embayment. Four other silvery minnows were found stressed but did not die. Two sample seine hauls were accomplished on 25 January 2006 by SWCA and the NMISC in which 56 total fish were caught and identified. Of the 56 capture fish, 52 were identified as silvery minnows and four were fathead minnows. Work concluded on 26 January.

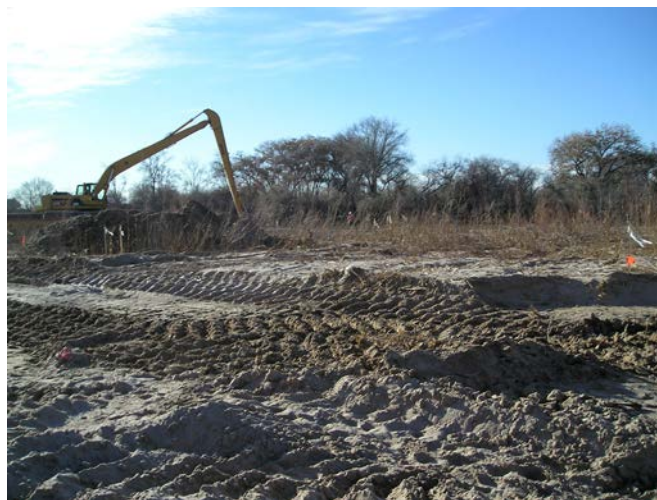
Some survey stakes could not be placed due to dense vegetation. The excavator started grubbing the vegetation and at the same time, survey stakes were being placed after clearing (Figure 2). When the grubbing concluded, the excavator started to create the terraces outlined in the survey and detailed schematics. Excess vegetation gathered during grubbing was used to support the fill area around the embayment. Much of this vegetation was invasive Russian olive or immature tamarisk. Scattered coyote willows or immature cottonwoods were left throughout the modified area.

**Figure 2:** NDC 5i during implementation.

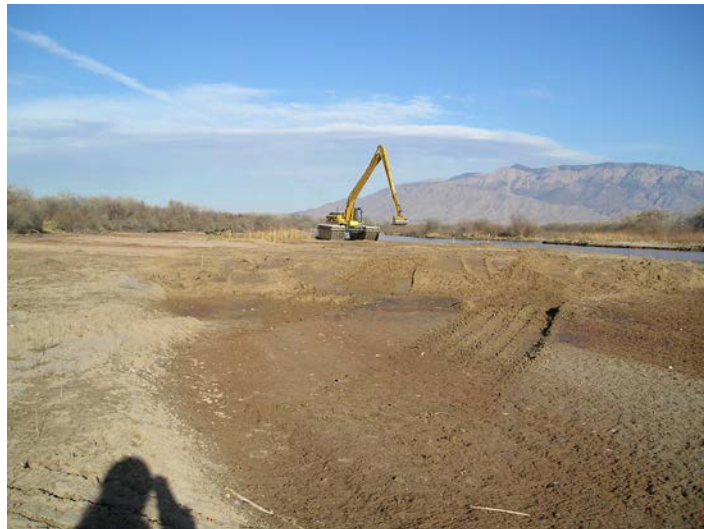
Work started on 27 January with the excavator grubbing the vegetation and grading the contours. The spoil material was spread out on the island (Figure 3). Surveying of the island was completed in advance of the excavator's arrival. Work concluded on 27 January.

**Figure 3:** NDC 4i during implementation.

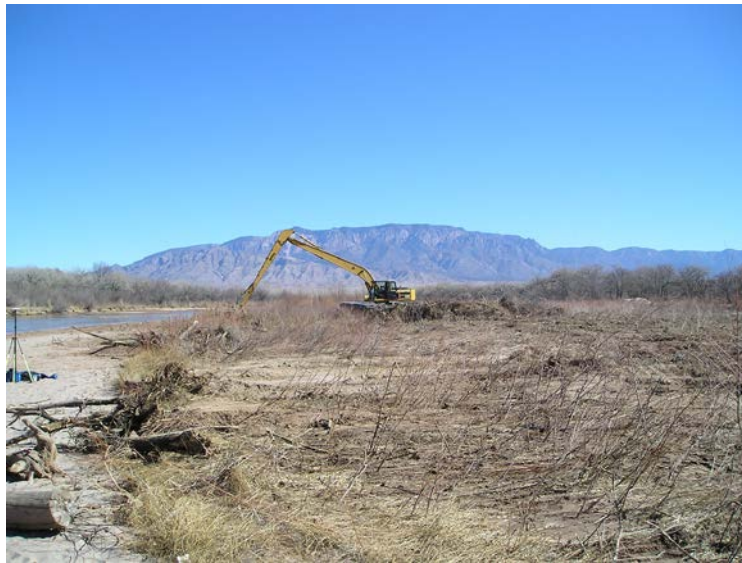
Work started on 30 January with the grubbing of the vegetation (Figure 4). Although the survey crew had previously staked the back-line, it was necessary to remove the excess vegetation before the rest of the island could be staked out. The excavator started grubbing the vegetation and at the same time, survey stakes were placed. When the grubbing concluded, the excavator started to construct the terraces (Figure 5). The extra spoil material and vegetation was used as fill for several depressions in the center of the island. Work concluded on 10 February.

**Figure 4:** NDC 3i looking northeast.

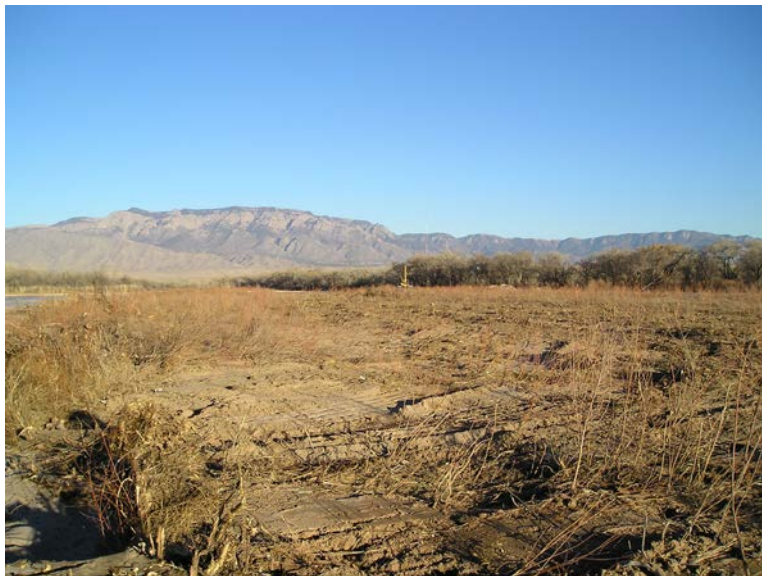
**Figure 5:** NDC 3i after the vegetation has been grubbed.

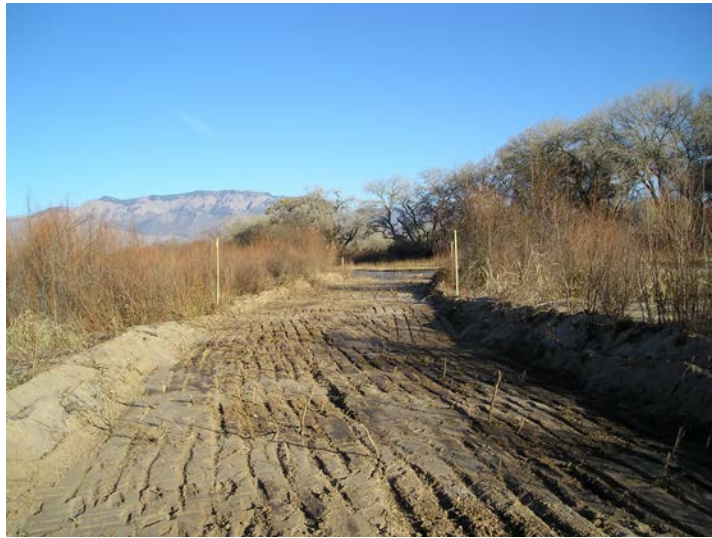
Work started on 10 February with the excavator constructing NDC-2ch (Figure 6) from the upstream end to downstream end and then constructing NDC-3ch (Figure 7) from the downstream end to upstream end. The spoil was spread on both sides of the created secondary channels. Surveying of the island was completed in advance of the excavator's arrival. Work concluded on 14 February.

**Figure 6:** NDC 2ch looking east, northeast.

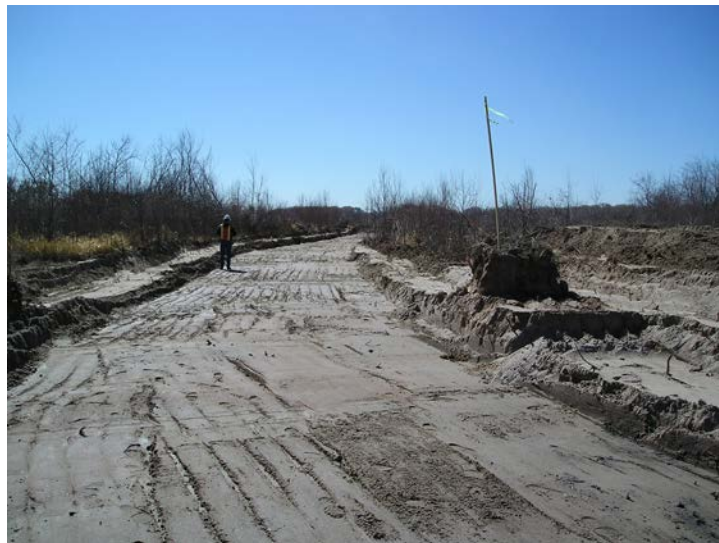
**Figure 7:** NDC 3ch after construction.

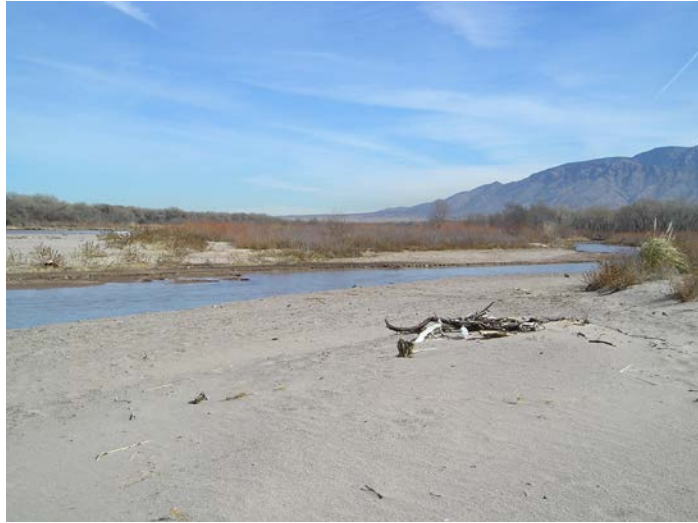
Work started on 14 February with the grubbing of the vegetation. The spoil was spread out on the southern end of the island (Figure 8). Surveying of the island was completed in advance of the excavator's arrival. Work concluded on 16 February.

**Figure 8:** NDC 2i looking north, northwest.

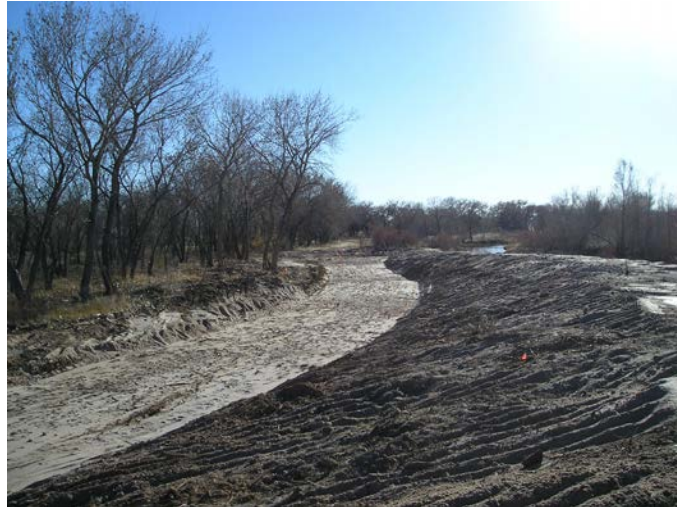
The channel was constructed on the east bank of the Rio Grande, northeast of island 2i. The channel has been constructed as an ephemeral channel, with inundation to occur at approximately 1500 cfs. Fill material was deposited adjacent to the created channel on the bank and then spread evenly (Figure 9). The channel is about twenty-five feet wide.

**Figure 9:** NDC 1ch, looking south.

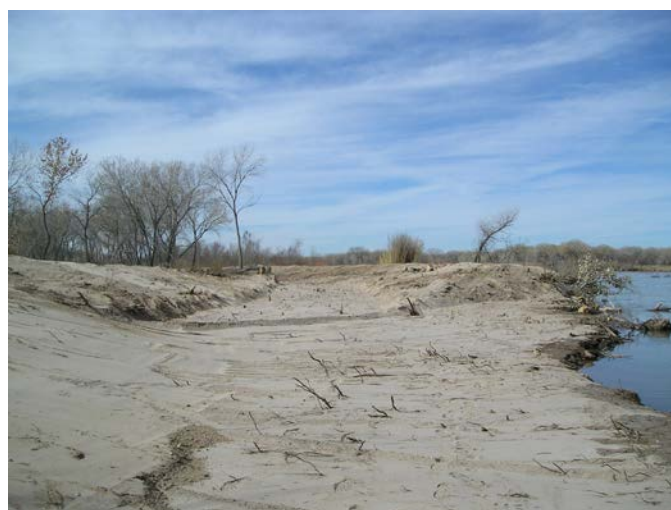
Work started on 21 February with the excavator moving sediment and spreading the spoil on the bank to the south and to the east of NDC-1ch (Figure 10). Downed, large woody debris was tagged and placed in the river by the excavator as part of the NMISC's Large Woody Debris project. A GPS point, physical measurements, and identification information were recorded. Surveying of the channel was completed in advance of the excavator's arrival. Work concluded on 22 February.

**Figure 10:** NDC 1b during construction.

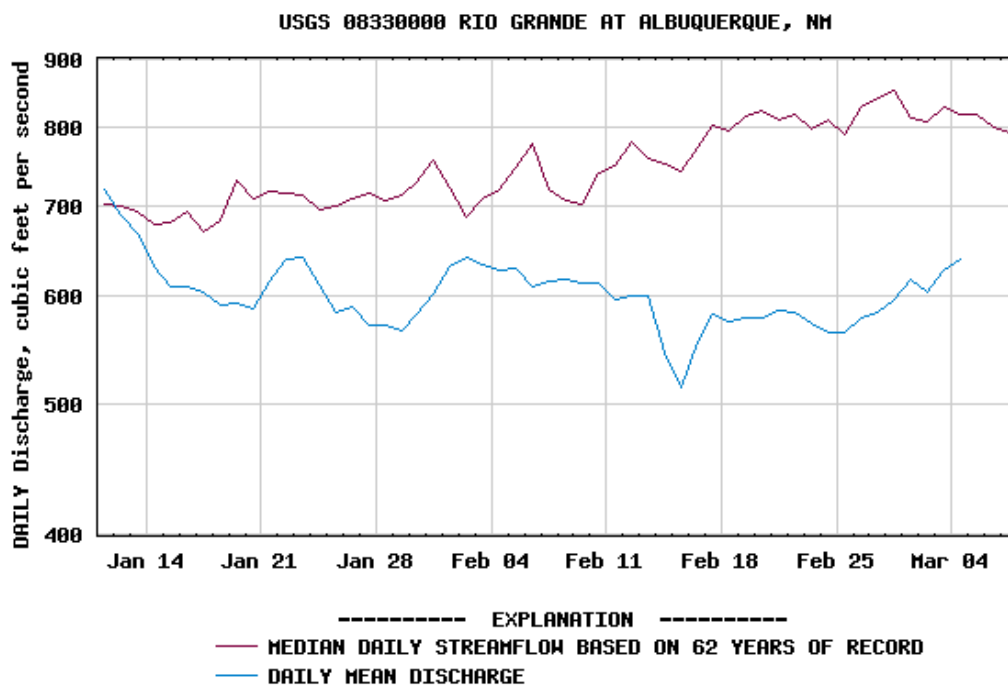
**Discharge:** The USGS gage near Alameda Boulevard was out of commission for most of the project period. The Central and North Floodway gages were used to track discharge instead. The maximum average daily flow at the Central Gage was 721 cfs on January 11<sup>th</sup>. The minimum average daily flow occurred on February 15<sup>th</sup> with 514 cfs being recorded (Figure 11). The maximum average daily flow at the North Floodway Gage was

**Figure 11.** Central Gage discharge during project implementation.

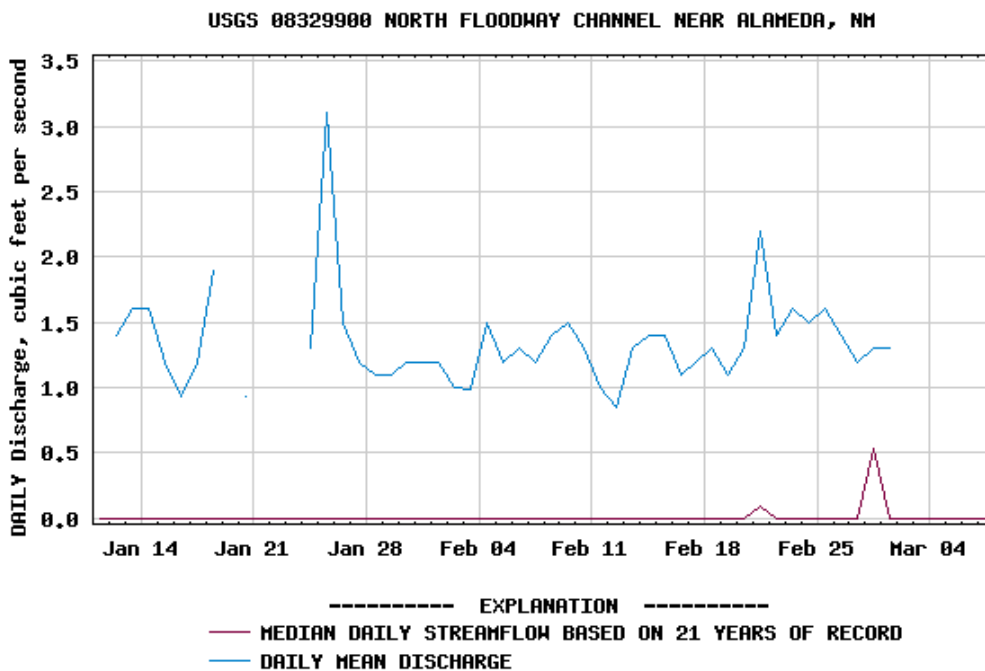
3.1 cfs on January 25<sup>th</sup>. The minimum average daily flow was 0.0 cfs, which occurred on numerous occasions (Figure 12). Please note median daily streamflow (discharge) on the hydrographs below.

**Figure 12.** North Floodway Gage discharge during project implementation.

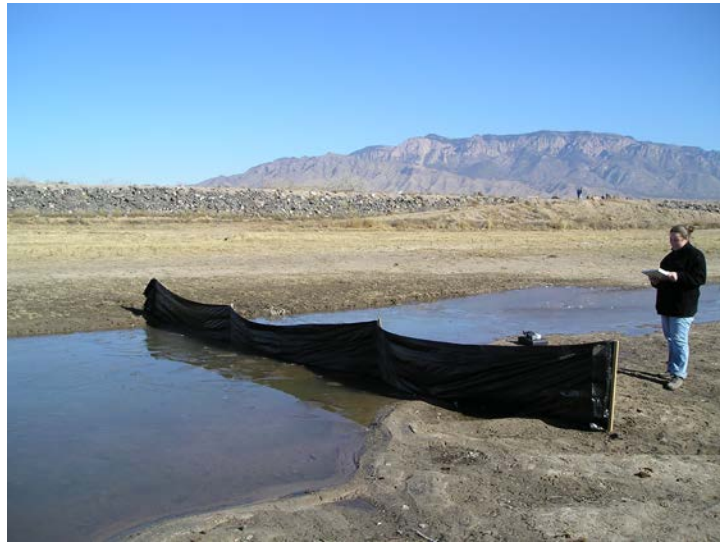
**Demobilization/mobilization:** On January 11<sup>th</sup>, SWCA and Wilco crews met at the North Diversion Channel on Sandia lands to prepare for the arrival of the excavator and mobilize into the Rio Grande via the North AMAFCA Floodway and Pueblo of Sandia lands (Figures 13 and 14). On February 23<sup>rd</sup>, the excavator tracked upstream to the launch site for demobilization to travel to the South Diversion Channel subreach. Silt fences were used during both the mobilization and demobilization process and water quality samples were taken accordingly.

**Figure 13.** Silt fencing used while crossing the North Floodway Channel.

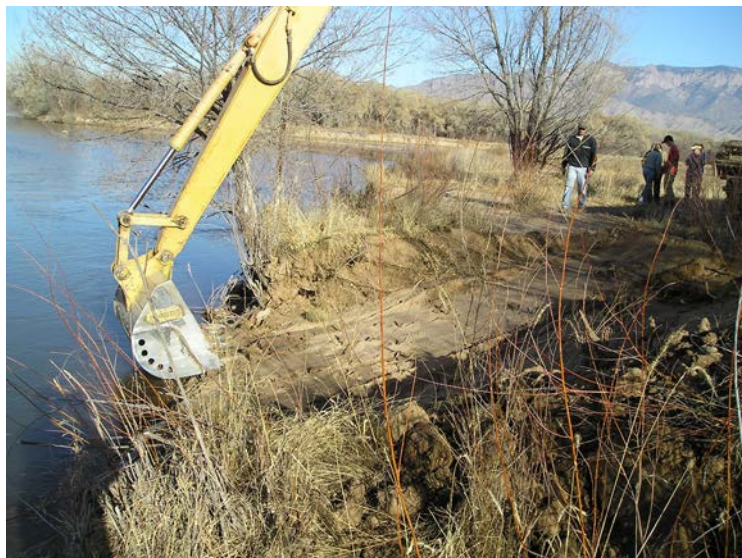
**Figure 14.** Construction of a ramp to access the Rio Grande from Sandia lands.
