**NEW MEXICO INTERSTATE STREAM COMMISSION  
MIDDLE RIO GRANDE  
RIVERINE RESTORATION PROJECT PHASE I  
ANNUAL REPORT**

**NEW MEXICO INTERSTATE STREAM COMMISSION, ALBUQUERQUE OFFICE**  
121 Tijeras N.E., Suite 2000  
Albuquerque, New Mexico 87102

**SWCA<sup>®</sup> ENVIRONMENTAL CONSULTANTS**  
5647 Jefferson Street, NE  
Albuquerque, New Mexico 87109  
Telephone: 505-254-1115, Fax: 505-254-1116  
[www.swca.com](http://www.swca.com)

**MUSSETTER ENGINEERING INC.**  
1730 South College Avenue, St 100  
Fort Collins, CO 80525  
Telephone: 970-224-4612, Fax: 970-472-6062

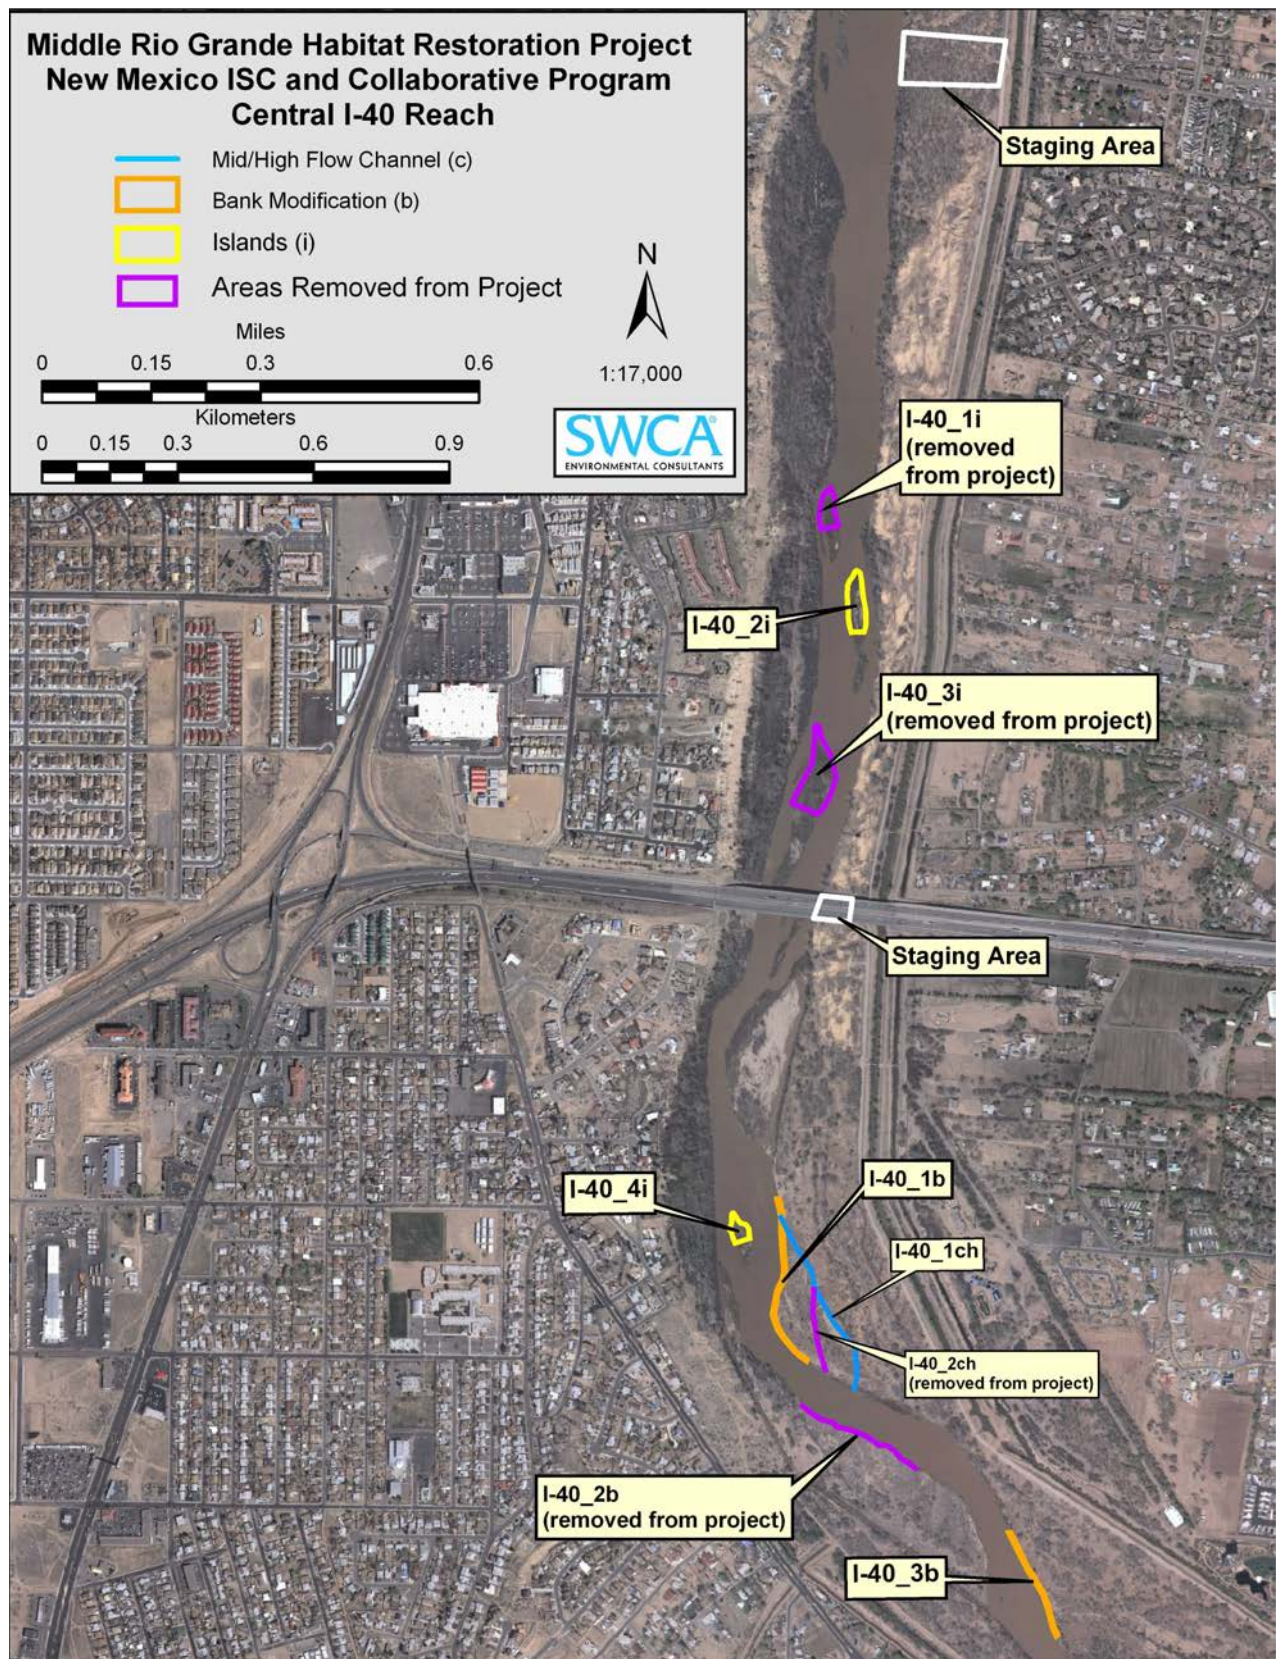
**Figure 1.** I-40/Central subreach with restoration sites and staging area.

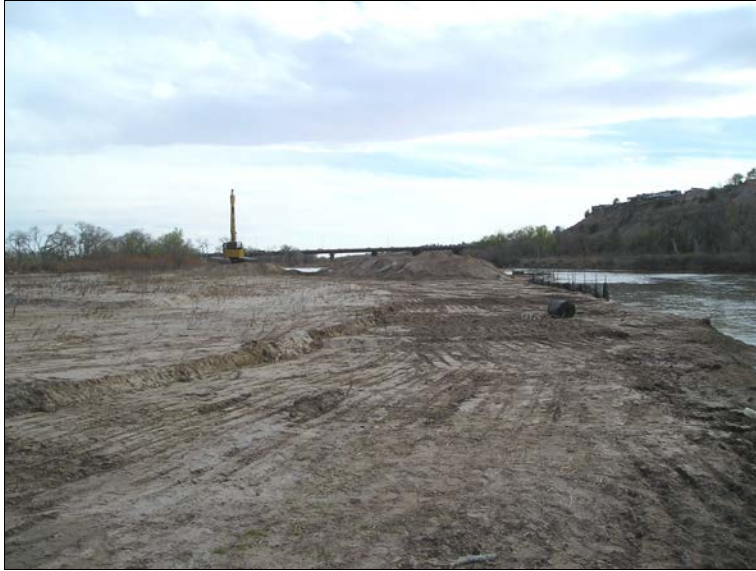
The upstream half of the island was modified to create terraces at different elevations at which inundation could occur to help support various life stages of the Rio Grande silvery minnow. The three created terraces will be inundated at approximately 1500, 2500, and 3500 cubic feet per second (cfs) discharge. The embayment created downstream of the silt curtain will be inundated at low flows, including less than 500 cfs (Figure 2).

**Figure 2.** Excavator moving spoil into embayment at I-40-2i.

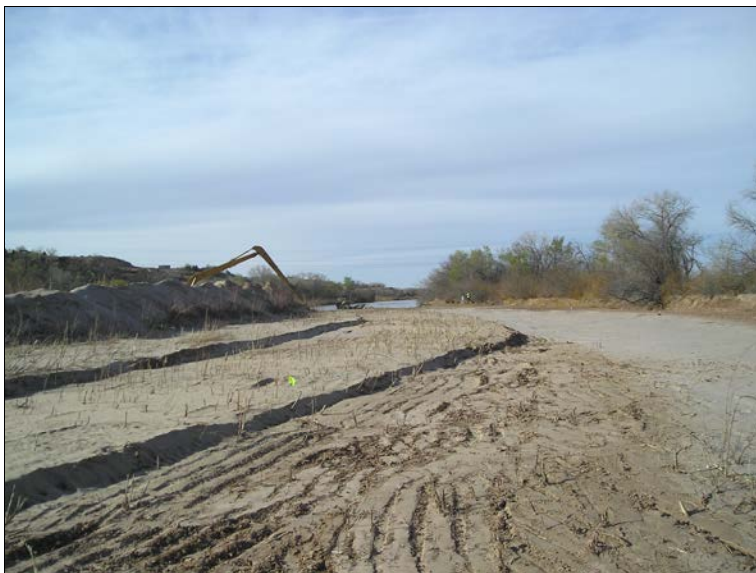
Work started on 29 March, after the island was surveyed, with the excavator grubbing the vegetation and then creating the terraces (Figure 3). To secure the silt curtain, spoil material from the island was placed on the inside of the silt curtain. The silt curtain process partitioned the river flow to the west of the silt curtain. Work concluded on 5 April.

**Figure 3.** Excavator creating terraces at I-40-2i.

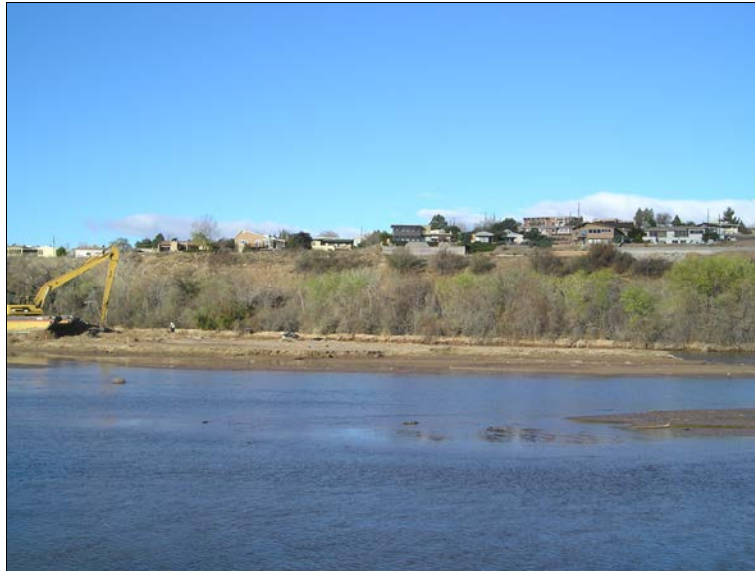
Work started on 5 April, after the island was surveyed, with the grubbing of the vegetation and creating the terraces. Work concluded on 6 April.

**Figure 4.** Moving spoil and creating terraces at I-40-4i.

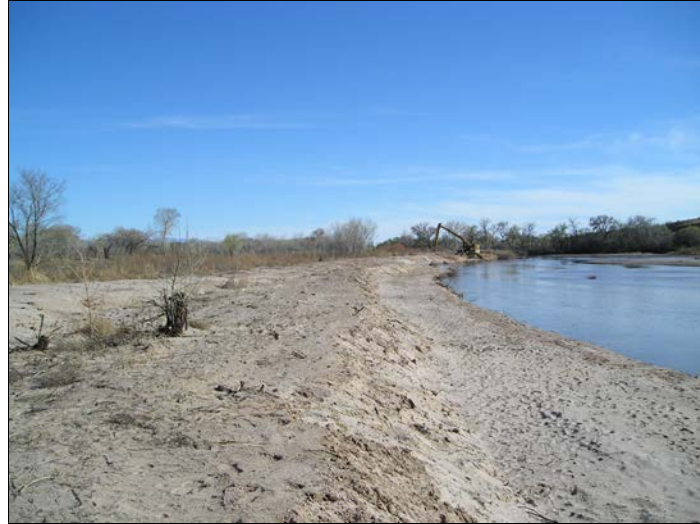
This bank modification was constructed on the east bank of the Rio Grande east-southeast of island 4i. The bank modification was cut with the elevation dropping 0.0009 feet per linear foot from the upstream to downstream end. Inundation of this modification should occur at approximately 2000 cfs.

Work started on 6 April, after the bank modification was surveyed, with the excavator cutting the bank and moving the spoil material to the east of the bank modification. Work concluded on 10 April (Figure 5).

**Figure 5.** Moving spoil material from the bank modification at I-40-1b.

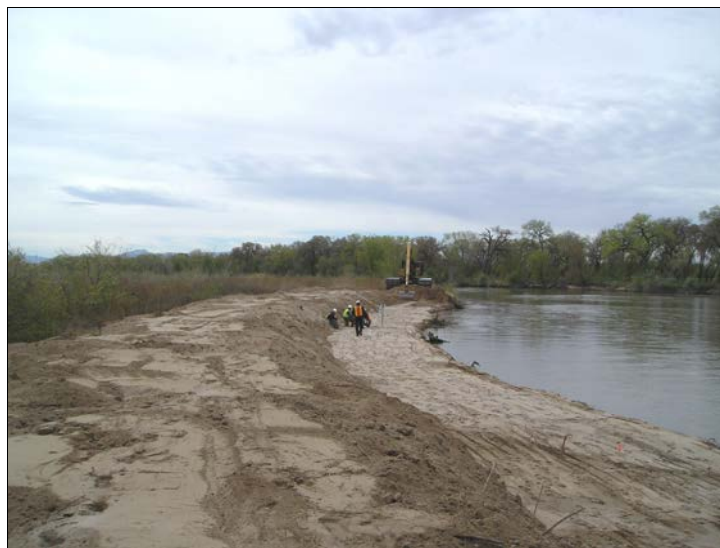
This bank modification was constructed on the east bank of the Rio Grande downstream of I-40-1ch. The bank modification was cut with the elevation dropping 0.0009 feet per linear foot from the upstream to downstream end. Inundation of this modification should occur at approximately 2000 cfs.

Work started on 13 April, after the bank modification was surveyed, with the excavator cutting the bank and moving the spoil material east of the bank modification (Figure 6). The spoil material was spread evenly in the bosque. Work concluded on 14 April.

**Figure 6.** I-40-3b looking south.

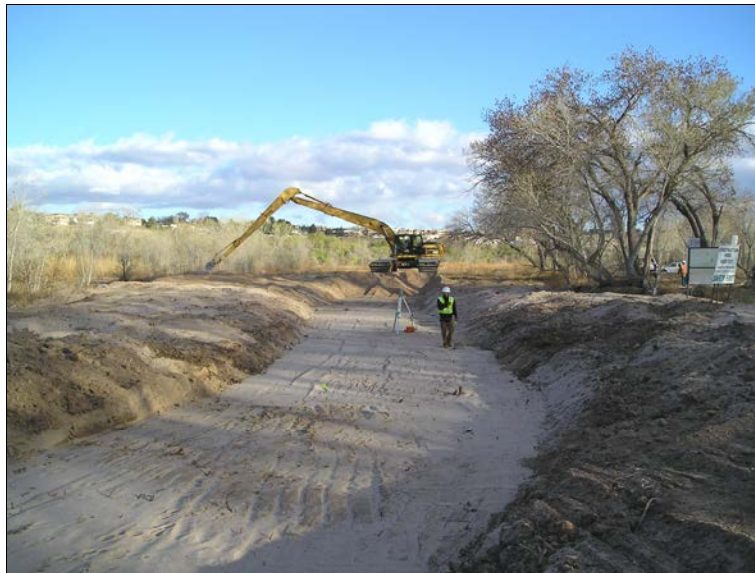
This channel is located just east of bank modification 1b and also starts at the northern end of bank modification 1b (just east of island 4i). The channel has been constructed as an ephemeral channel 25 feet wide, with inundation to occur at approximately 2000 cfs. Fill material was deposited on both sides of the created channel.

Work started on 10 April, after the channel was surveyed, with the excavator working (Figure 7) from the downstream end to upstream end. Work concluded on 13 April.

**Figure 7.** I-40-1ch looking north.

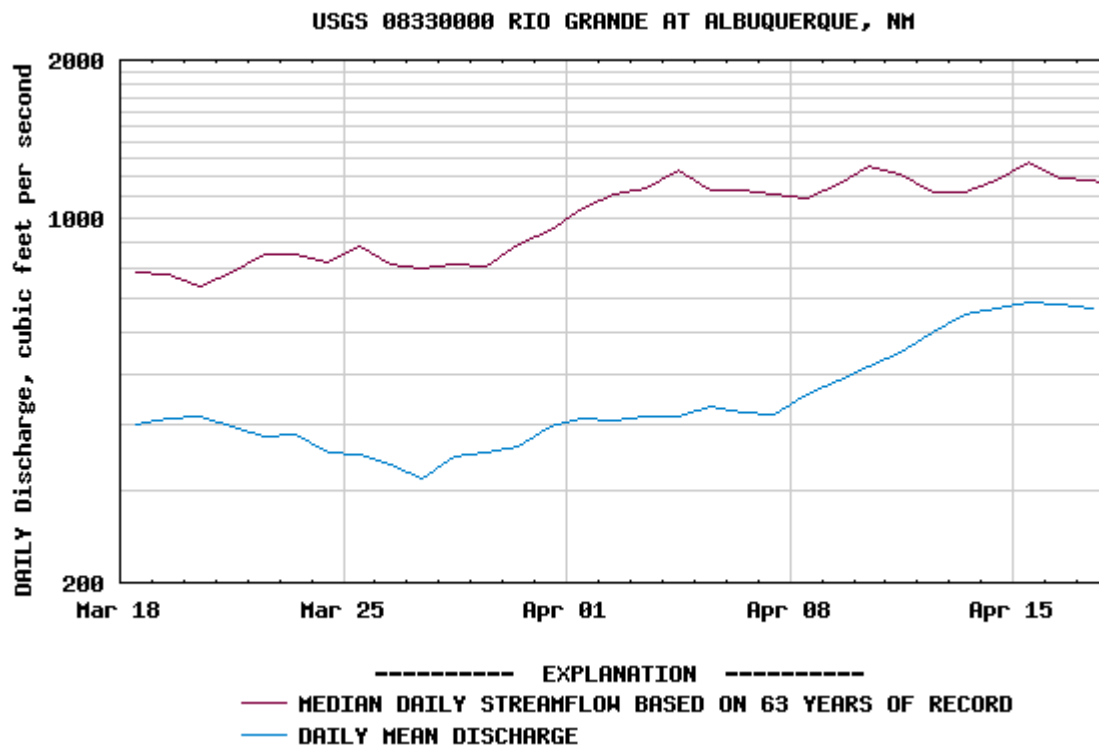
**Discharge:** The Central gage was used to track discharge during construction at the I-40/Central subreach. The maximum average daily flow at the Central Gage was 666 cfs on 15 April. The minimum average daily flow occurred was 190 cfs on 30 March (Figure 8). Please note median daily streamflow (discharge) on the hydrograph below.

**Figure 8.** Central Gage discharge during project implementation.

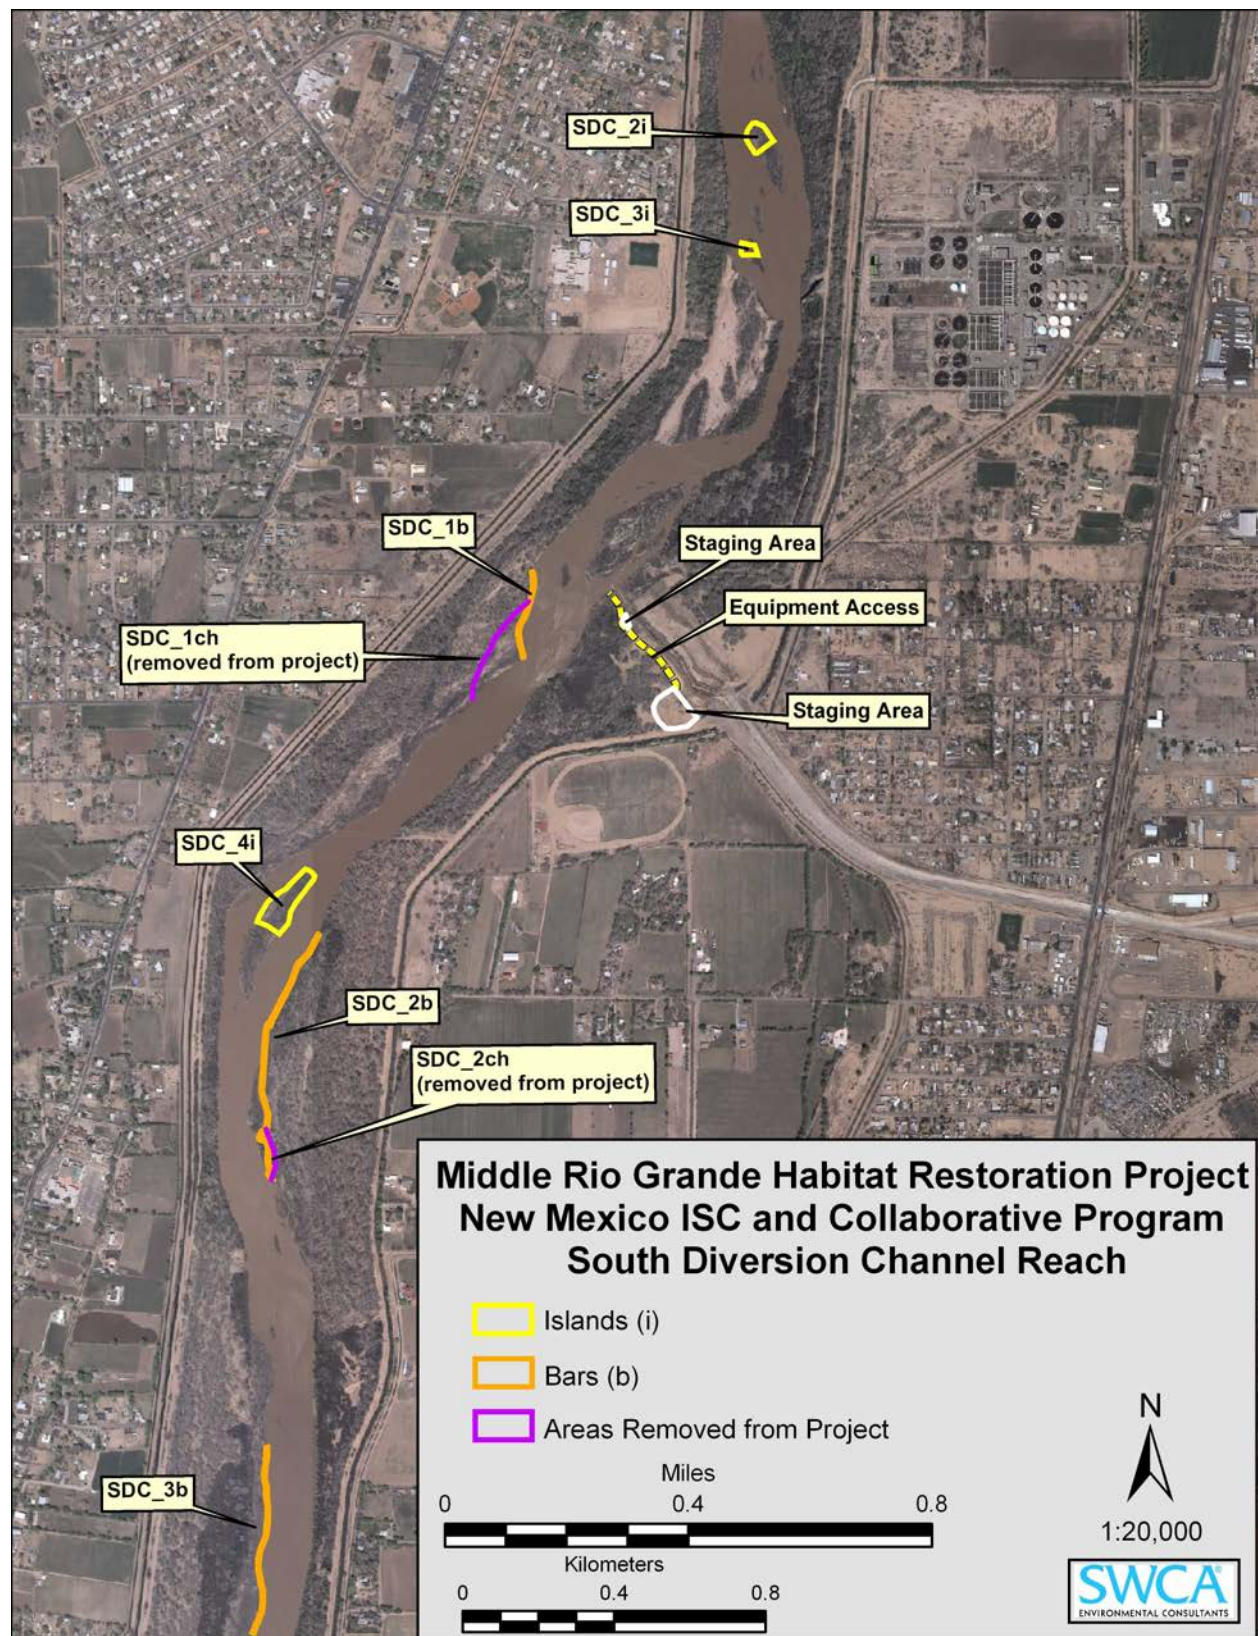
**Figure 1.** SDC subreach with restoration sites and staging area.

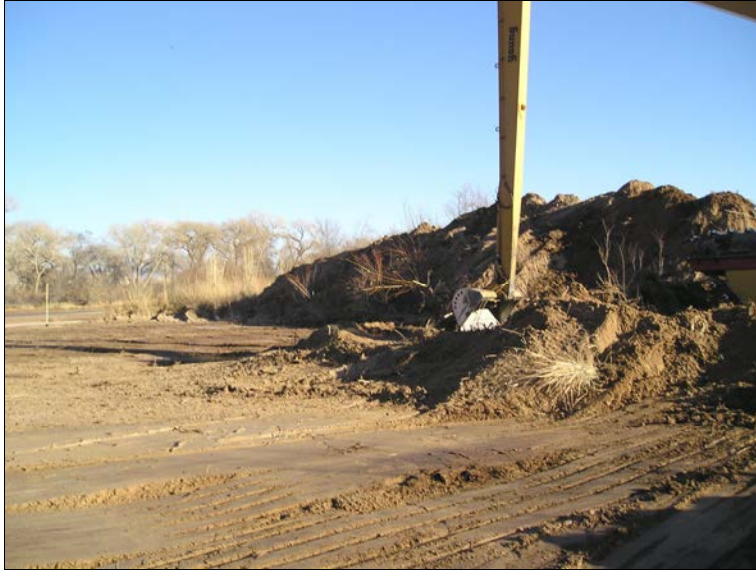
The upper third of the island was modified to create an elevation at which inundation could occur at approximately 2000 cubic feet per second (cfs); this will help support various life stages of the silvery minnow and test the efficacy of destabilizing an island. SDC-2i is part of the island destabilization project funded by the Collaborative Program.

Work started on 24 February, after the island was surveyed, with the excavator grubbing the vegetation and grading the contours. The spoil material was spread out on the island (Figure 2). Work concluded on 2 March.

**Figure 2.** Excavator moving spoil and creating contours at SDC-2i.

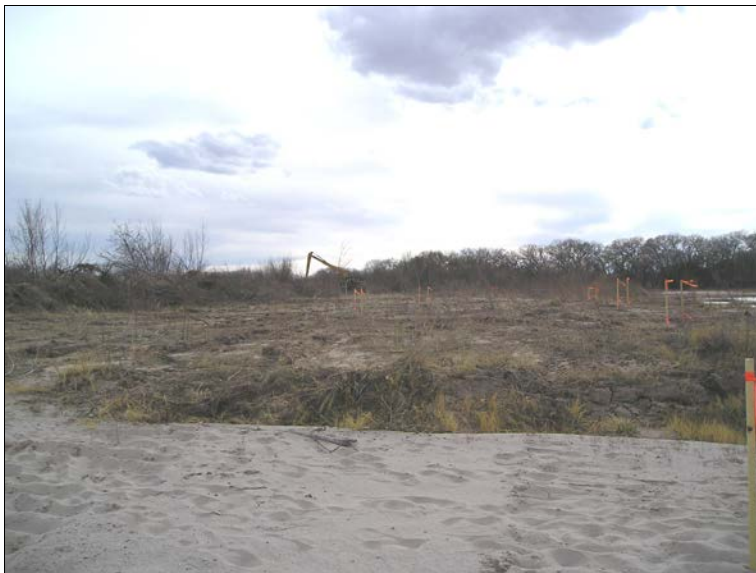
The middle third of the island was modified to create an elevation at which inundation could occur at approximately 2000 cfs; this will help support various life stages of the silvery minnow and test the efficacy of destabilizing an island. SDC-3i is part of the island destabilization project funded by the Collaborative Program.

Work started on 2 March, after the island was surveyed, with the excavator grubbing the vegetation and grading the contours (Figure 3). The spoil material was spread out on the downstream end of the island. Work concluded on 3 March.

**Figure 3.** Moving spoil and grading contours at SDC-3i.

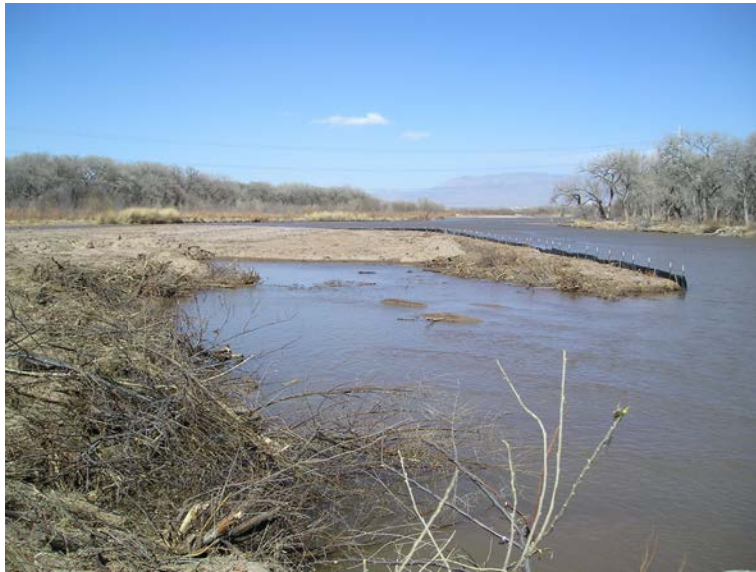
The upstream half of the island was modified to create terraces at different elevations at which inundation could occur to help support various life stages of silvery minnow. The three created terraces will be inundated at approximately 1500, 2500, and 3500 cfs. The embayment (Figure 4) created downstream of the silt curtain will be inundated at low flows, including less than 500 cfs. To secure the silt curtain, spoil material from the island was placed on the inside of the silt curtain. The silt curtain process partitioned the river flow to the east of the silt current.

**Figure 4.** SDC-4i embayment.

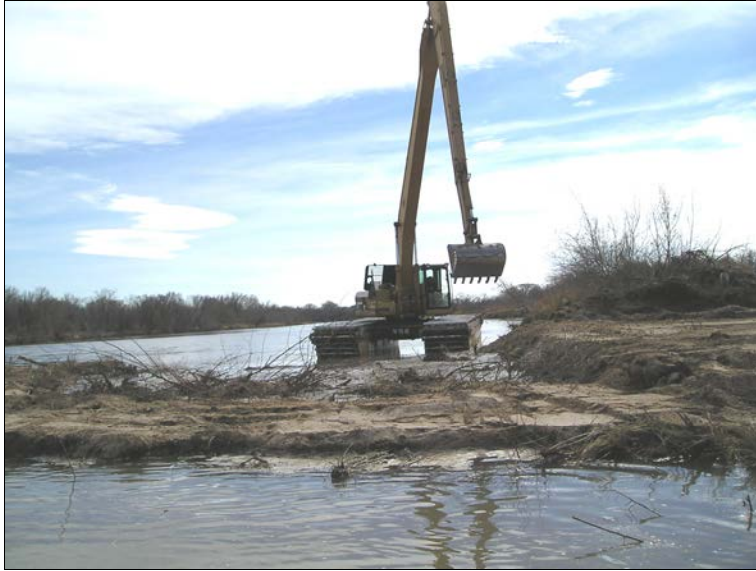
**Figure 5.** Excavator moving spoil and excess vegetation to build silt curtain at SDC-4i.

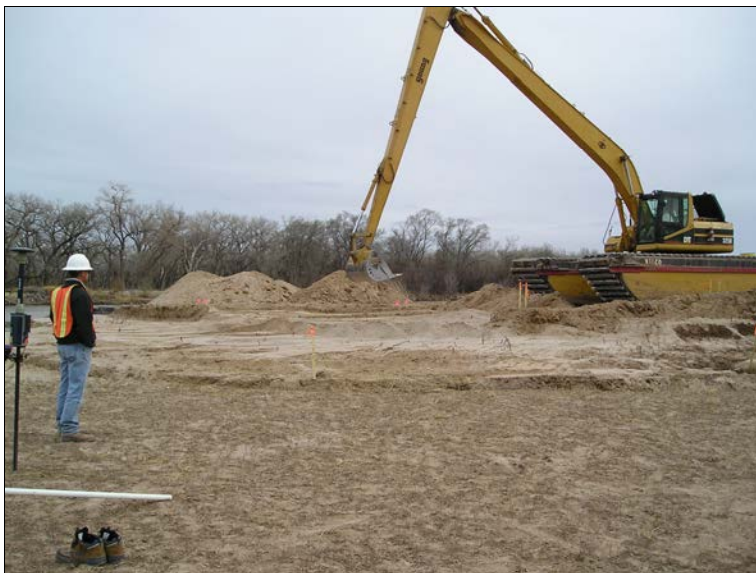
**Figure 6.** Excavator moving spoil to create terraces at SDC-4i.

Although the survey crew had previously staked the back-line, it was necessary to remove the excess vegetation before the rest of the island could be staked out. Beginning on 3 March, survey stakes were placed directly after the excavator grubbed the vegetation. Excess vegetation gathered during grubbing was used to support the fill area around the embayment (Figure 5). Much of this vegetation was invasive Russian olive (*Elaeagnus angustifolia*) or immature salt cedar (*Tamarix spp.*). Scattered coyote willows (*Salix exigua*) or immature cottonwoods (*Populus deltoides*) were left throughout the modified area. When the grubbing concluded, the excavator started to construct the terraces (Figure 6). Work concluded on 18 March.

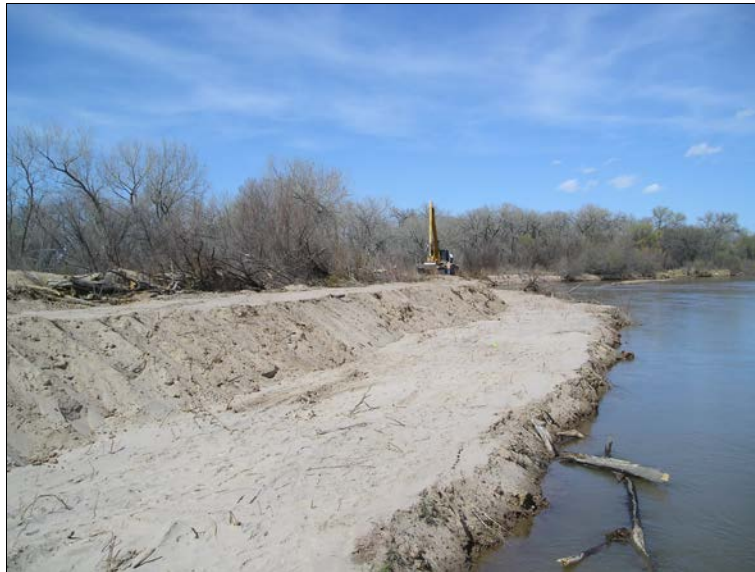
**Figure 7.** SDC-1b looking north.

This bank modification was constructed on west bank of the Rio Grande north-northeast of island 4i and spanned 369 meters. The bank modification was cut with the elevation dropping 0.0009 feet per linear foot from northern to southern end. Inundation of this modification should occur at approximately 2000 cfs. Work started on 25 March, after the bank modification was surveyed, with the excavator cutting the bank and moving the spoil material to the west of the bank modification (Figure 7). Work concluded on 27 March.

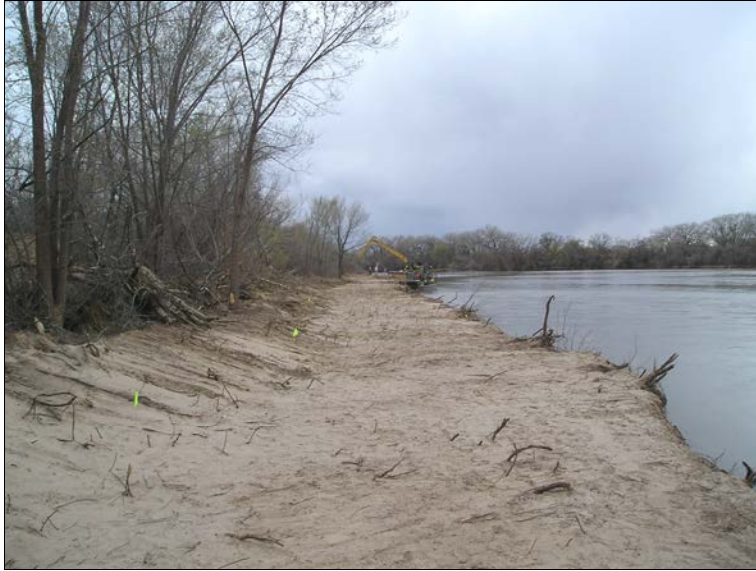
**Figure 8.** SDC-2b looking south.

This bank modification was constructed on east bank of the Rio Grande just east-southeast of island 4i and spanned 635 meters. The bank modification was cut with the elevation dropping 0.0009 feet per linear foot from northern to southern end. Inundation of this modification should occur at approximately 2000 cfs.

Work started on 18 March, after the bank modification was surveyed, with the excavator cutting the bank and moving the spoil material to the east of the bank modification (Figure 8). Work concluded on 20 March.

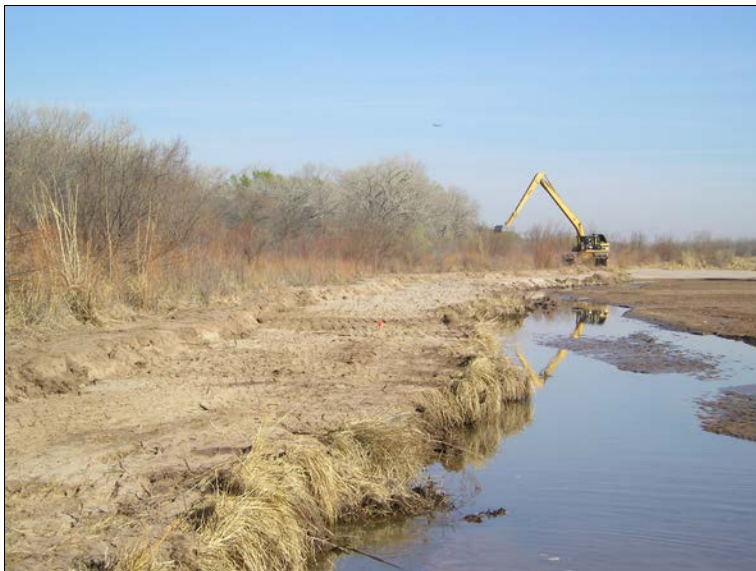
**Figure 9.** SDC-3b looking north.

This bank modification was constructed on the west bank of the Rio Grande, south of bank modification 2b, and spanned 504 meters. The bank modification was cut with the elevation dropping 0.0009 feet per linear foot from northern to southern end. Inundation of this modification should occur at approximately 2000 cfs.

Work started on 20 March, after the bank modification was surveyed, with the excavator cutting the bank and moving the spoil material to the west of the bank modification (Figure 9). Work concluded on 24 March.

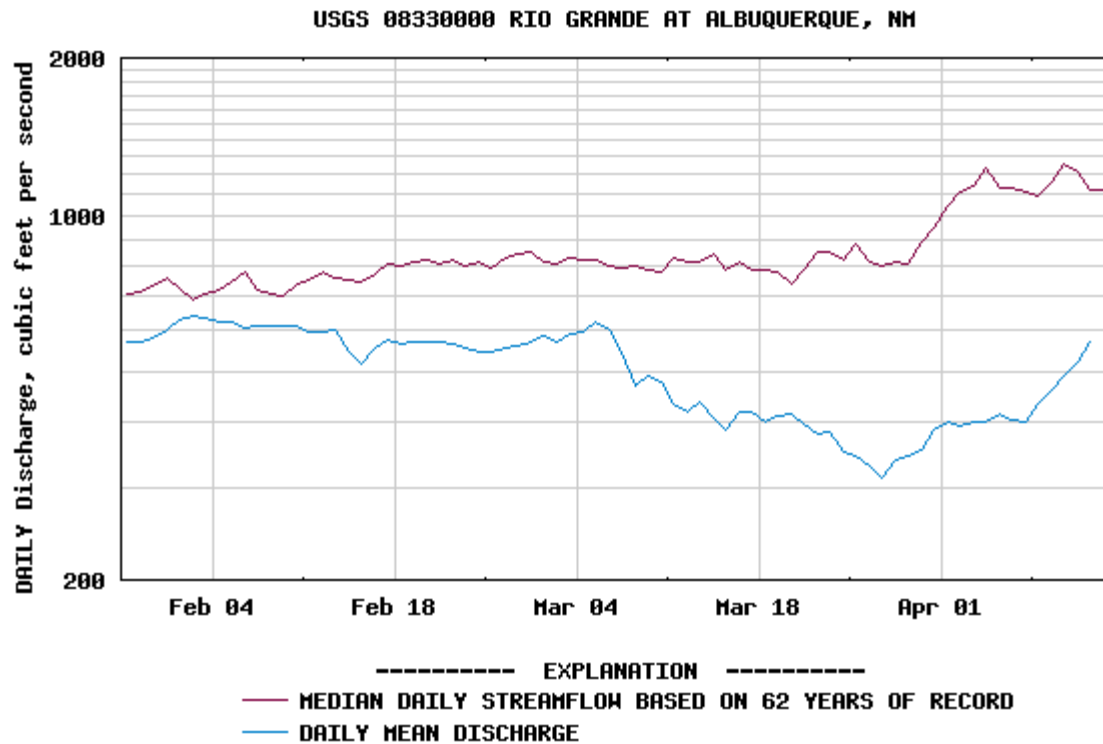
**Figure 10.** Central Gage discharge during project implementation.

**Discharge:** The Central and Tijeras gages were used to track discharge at the SDC subreach. At the Central Gage, the maximum average daily flow was 679 cfs on 6 March, and the minimum average daily flow was 366 cfs on 27 March (Figure 10). The Tijeras Gage had no reportable daily flows (0.0 cfs) during the duration of the project at the South Diversion Channel subreach. Please note median daily streamflow (discharge) on the hydrograph below.

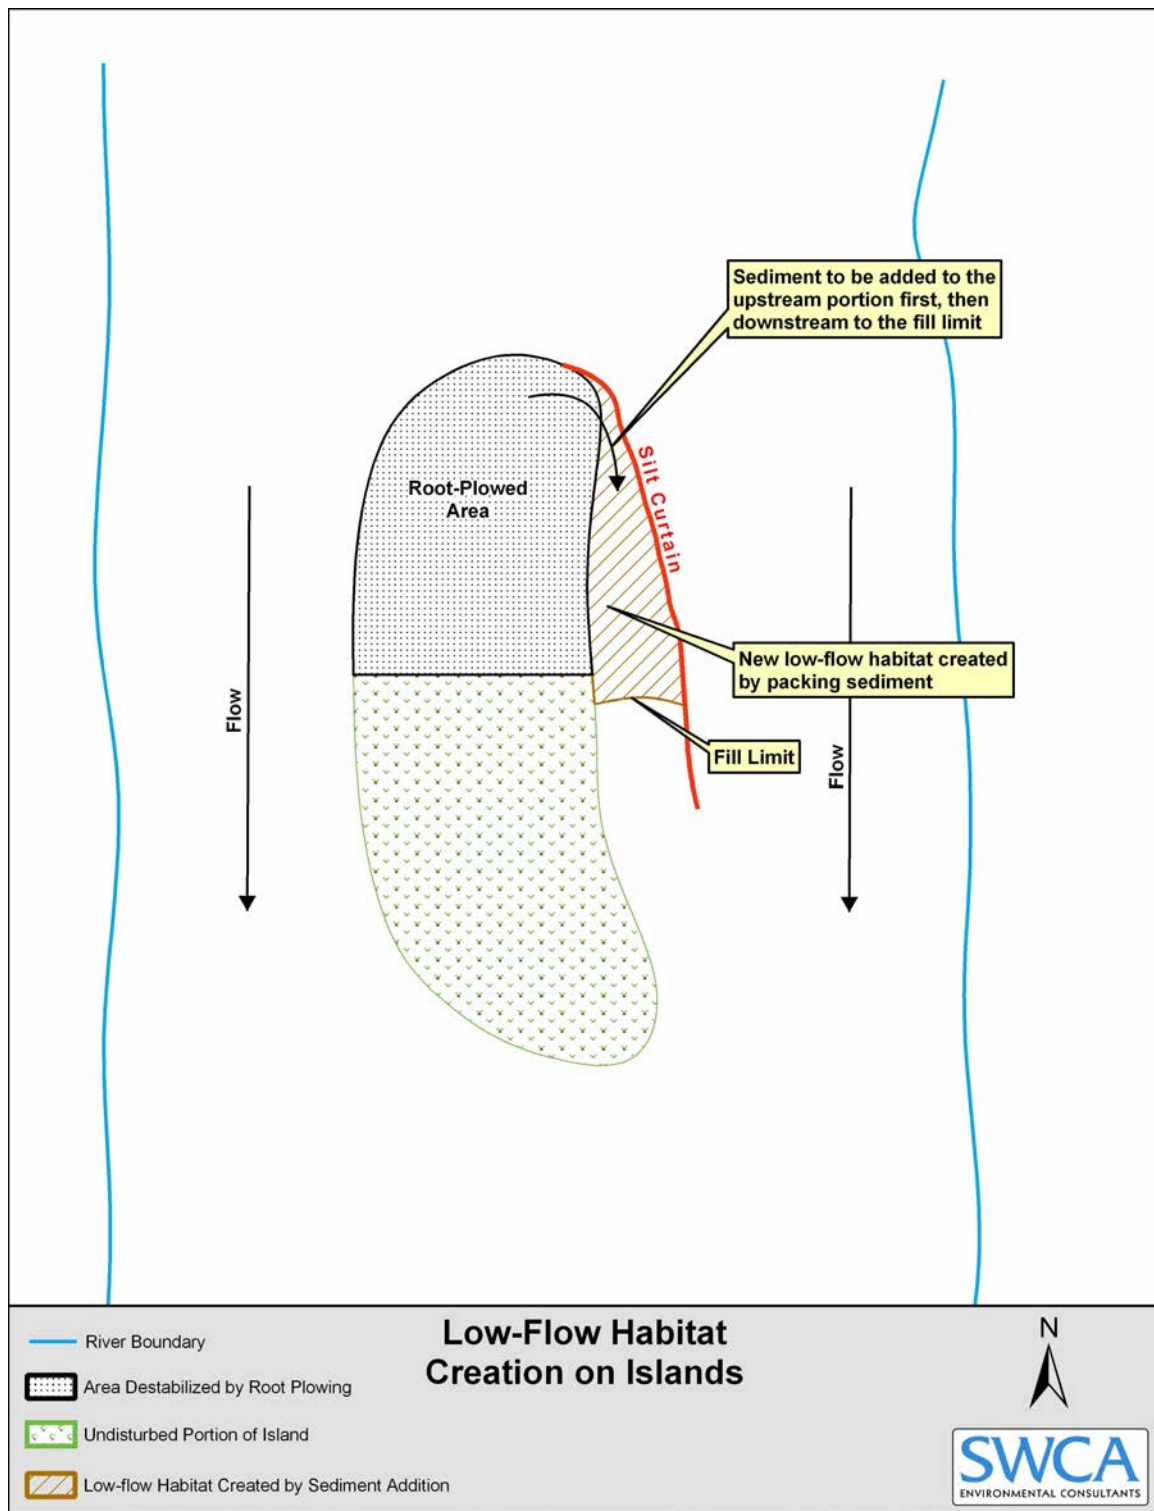
**Figure 3.** Hypothetical design for island modification and creating embayments within the Rio Grande.

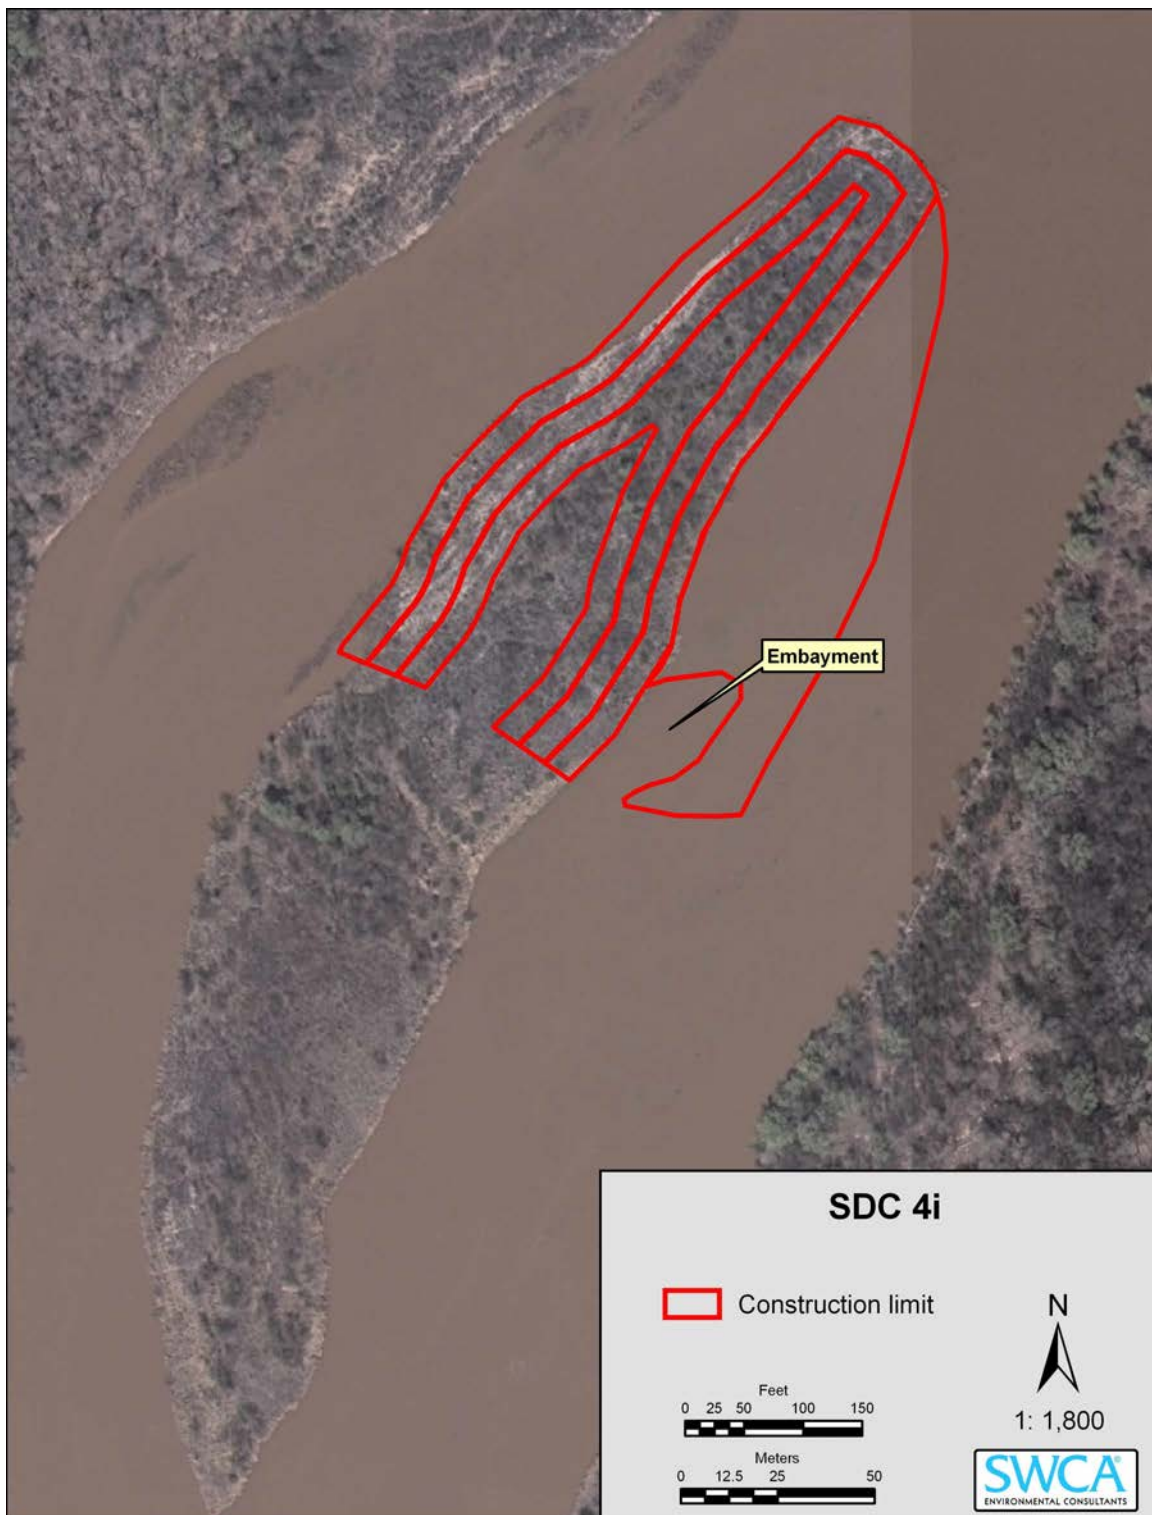
**Figure 5.** Constructed embayment at South Diversion Channel site.

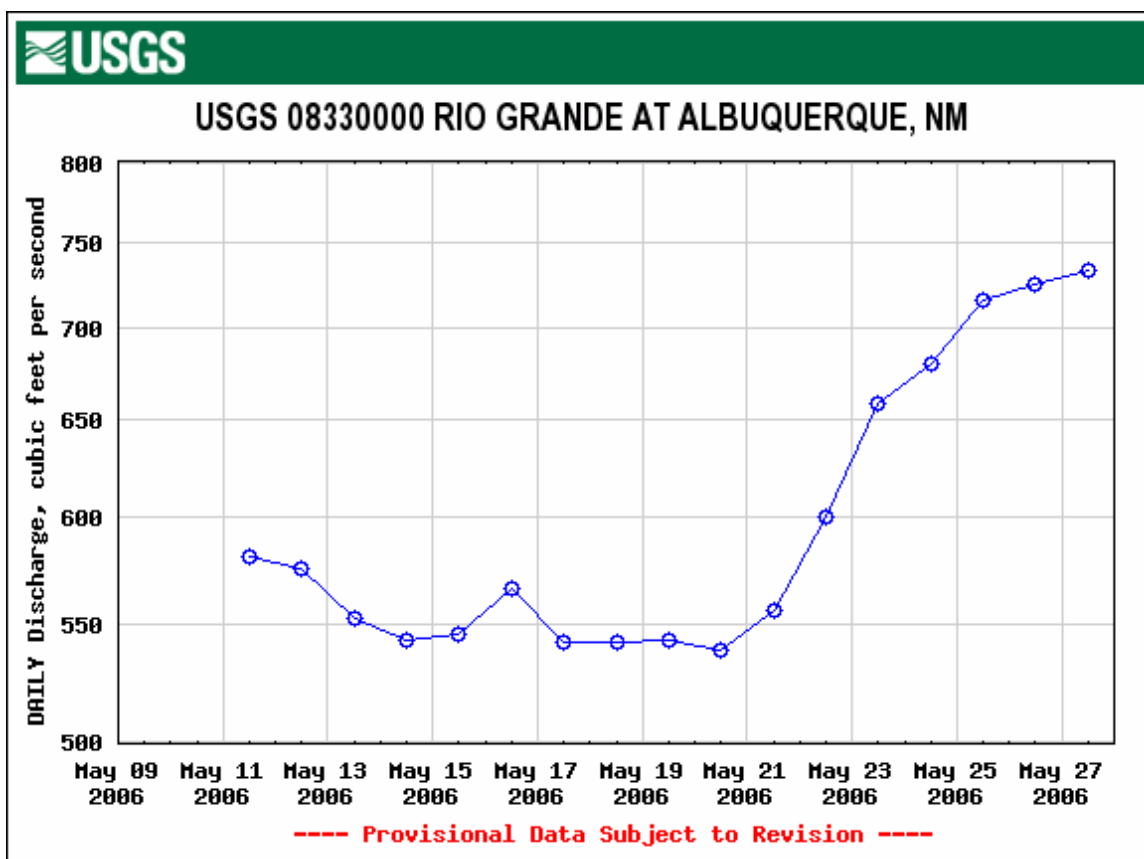
**Figure 6.** USGS hydrograph for the gage at Central Avenue for the study period.

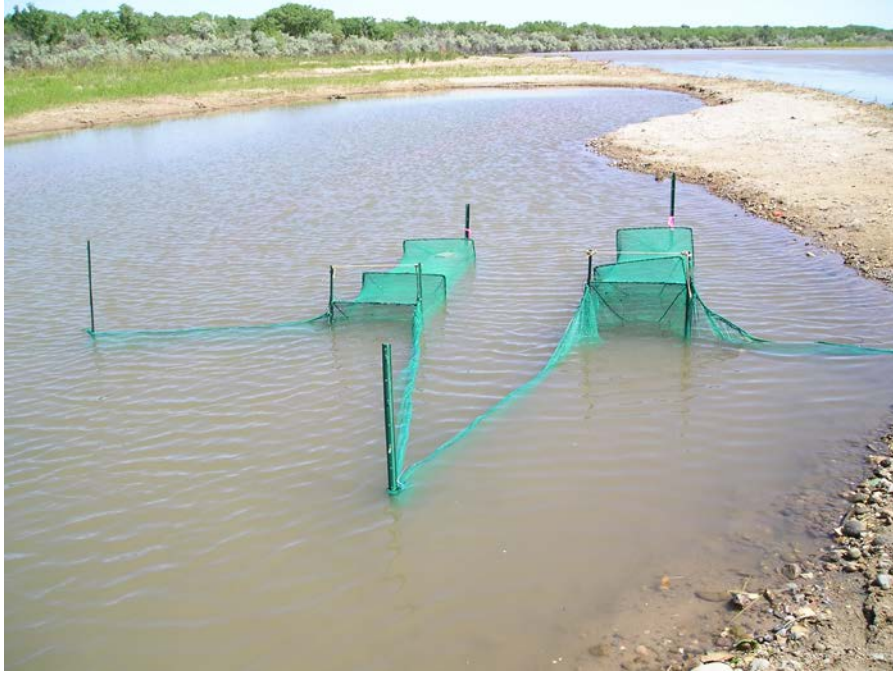
**Figure A.1.** Hoop net set up within the constructed embayment at Alameda. The hoop net on the left contains a nylon bag of hay, while the hoop net on the right does not. The main channel of the Rio Grande is on the right side, and the photograph was taken looking upstream.

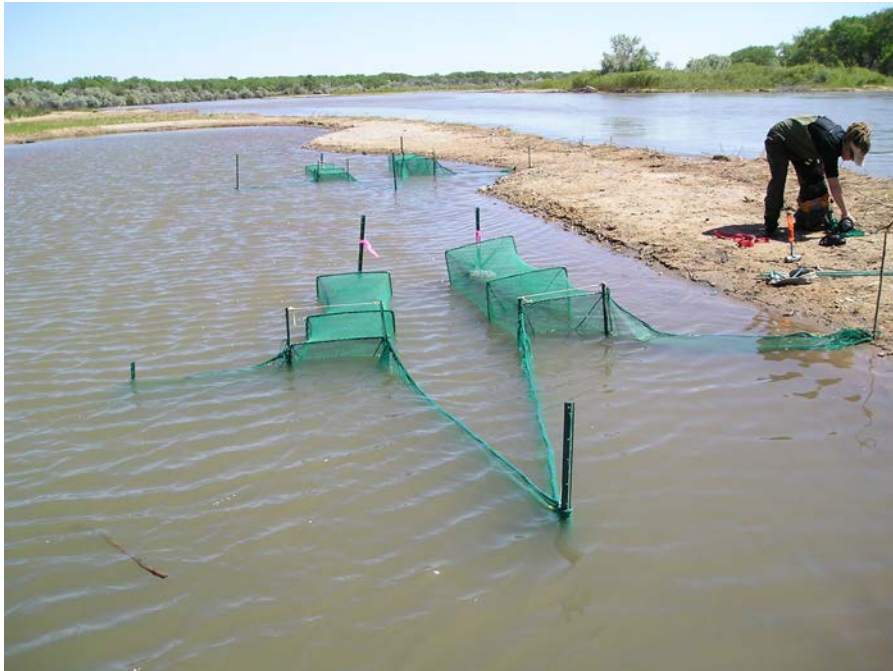
**Figure A.2.** Both set-ups within the constructed embayment at Alameda.

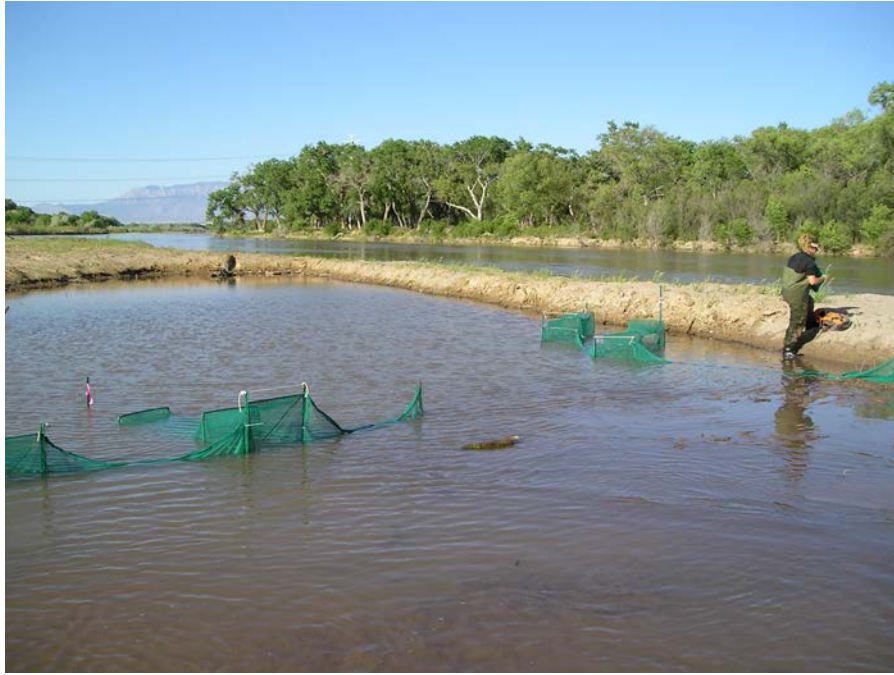
**Figure A.3.** Both hoop net set-ups within constructed embayment at South Diversion Channel. The main channel of the Rio Grande is in the back half of the photograph, and the river is flowing from left to right.

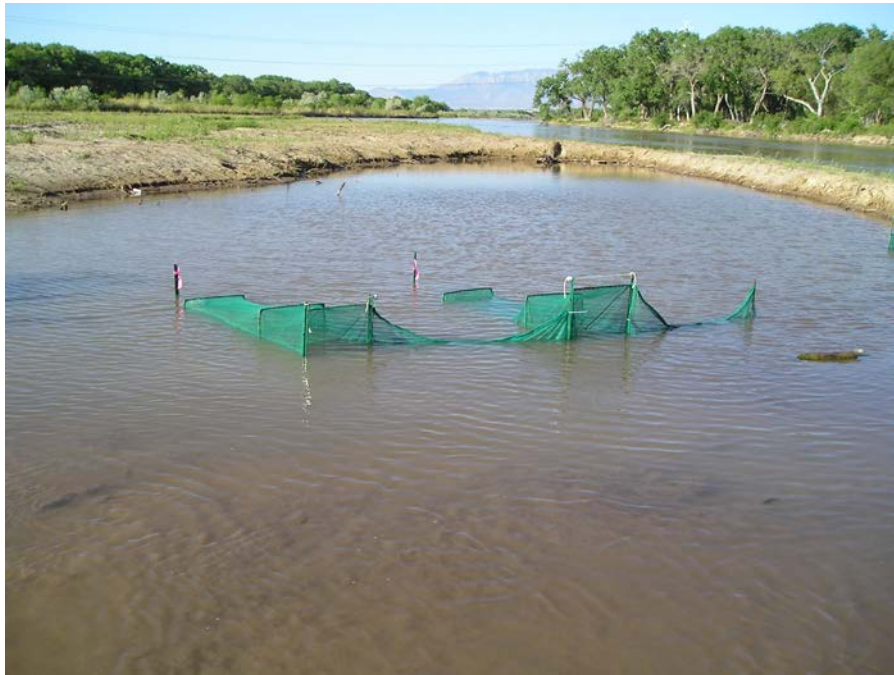
**Figure A.4.** Westernmost set-up at South Diversion Channel. A medial sandbar has been deposited across the mouth of the embayment, and the water becomes substantially deeper behind the hoop nets.

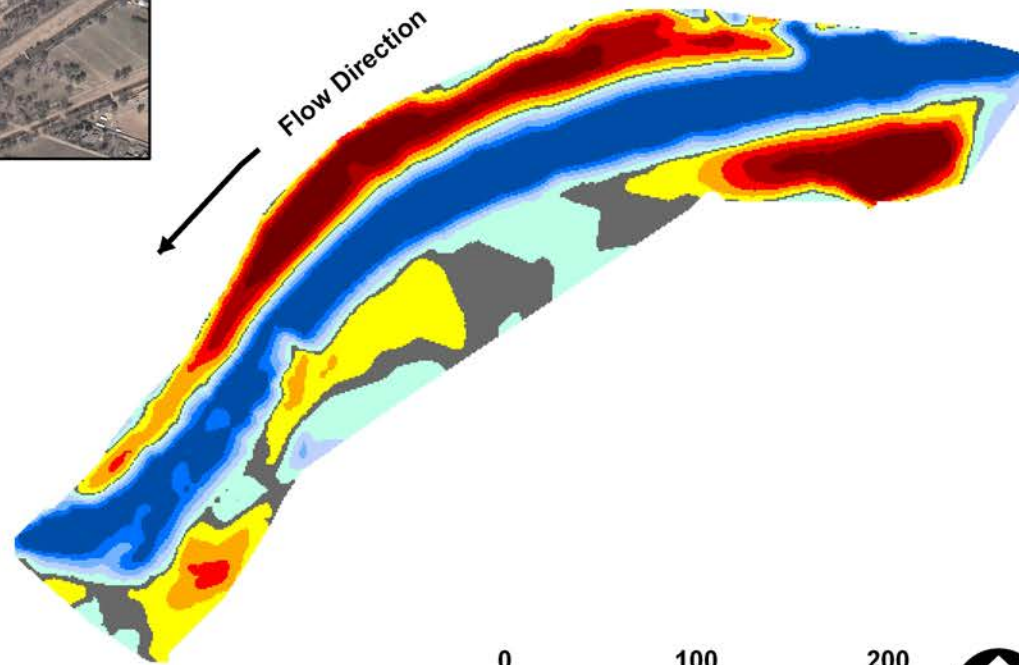
NDC 1b & 1ch

**Comparison of Original Surface  
and As-Built Condition**

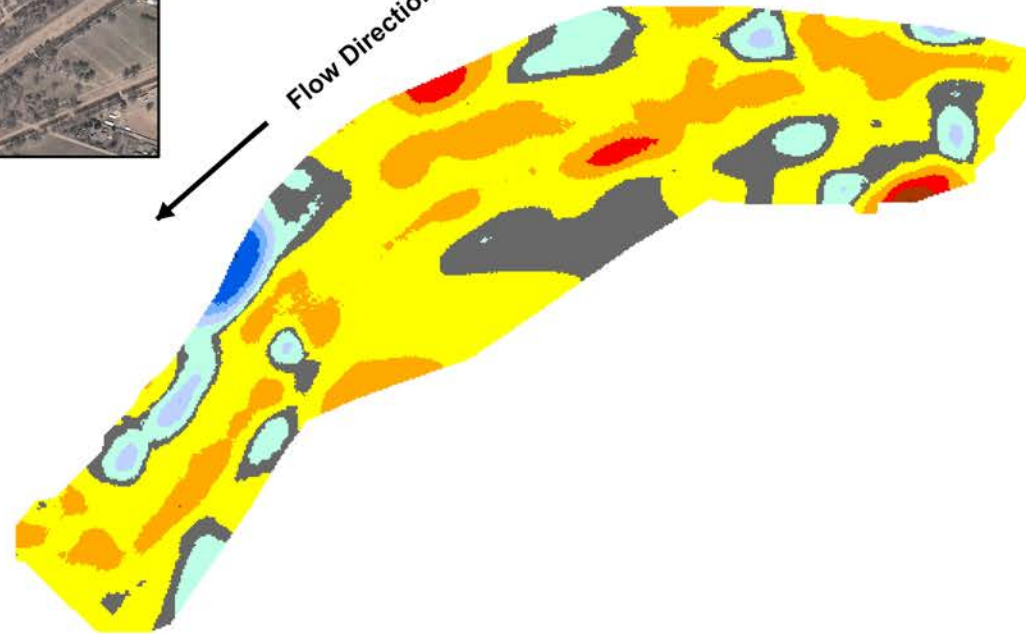
NDC 1b & 1ch

**Comparison of As-Built  
and December 2006 Surveys**

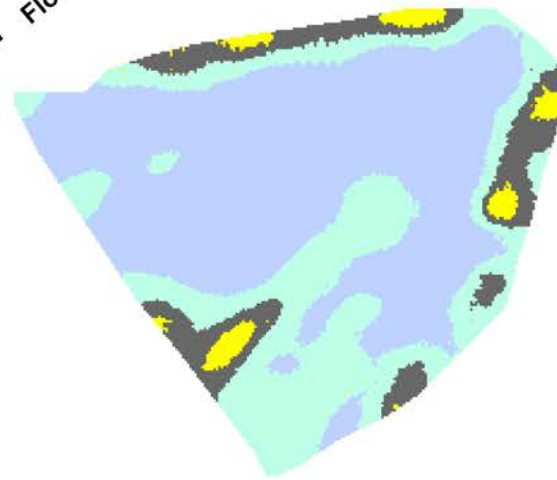
NDC 2i

## Comparison of Original Surface and As-Built Condition
