**NEW MEXICO INTERSTATE STREAM COMMISSION  
MIDDLE RIO GRANDE  
RIVERINE RESTORATION PROJECT PHASE I  
ANNUAL REPORT**

**NEW MEXICO INTERSTATE STREAM COMMISSION, ALBUQUERQUE OFFICE**  
121 Tijeras N.E., Suite 2000  
Albuquerque, New Mexico 87102

**SWCA<sup>®</sup> ENVIRONMENTAL CONSULTANTS**  
5647 Jefferson Street, NE  
Albuquerque, New Mexico 87109  
Telephone: 505-254-1115, Fax: 505-254-1116  
[www.swca.com](http://www.swca.com)

**MUSSETTER ENGINEERING INC.**  
1730 South College Avenue, St 100  
Fort Collins, CO 80525  
Telephone: 970-224-4612, Fax: 970-472-6062

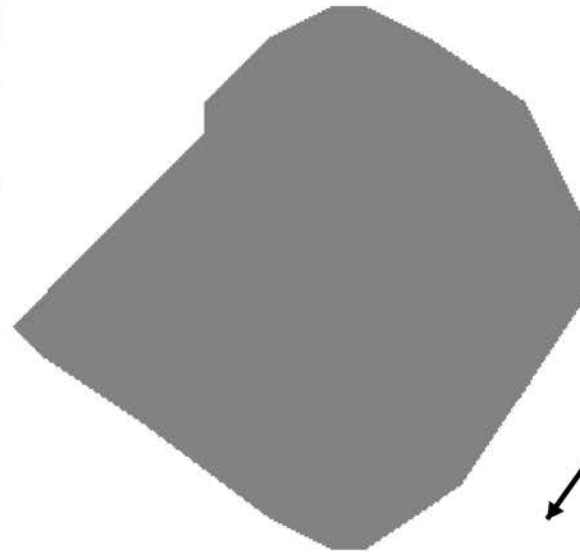
NDC 4i

## Comparison of Original Surface and As-Built Condition

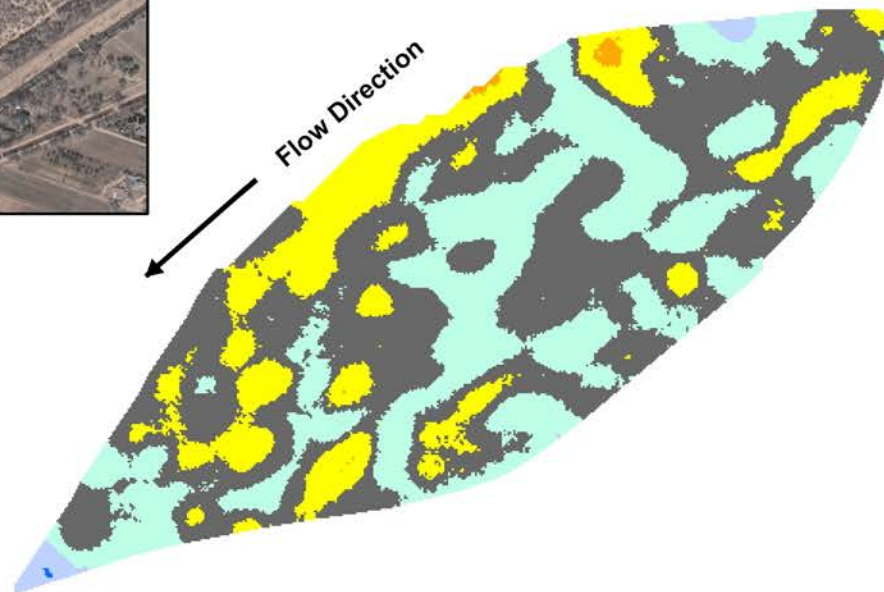
## NDC Control Island

### Change in Elevation (feet)

## Natural Changes - Comparison of September 2005 and December 2006

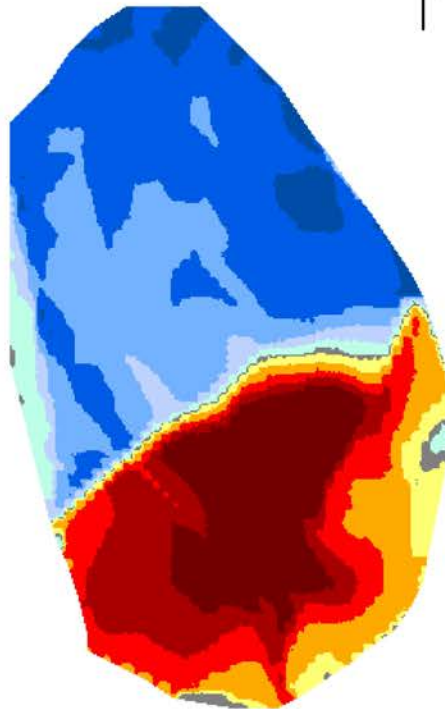
SDC 2i

**Comparison of Original Surface  
and As-Built Condition**

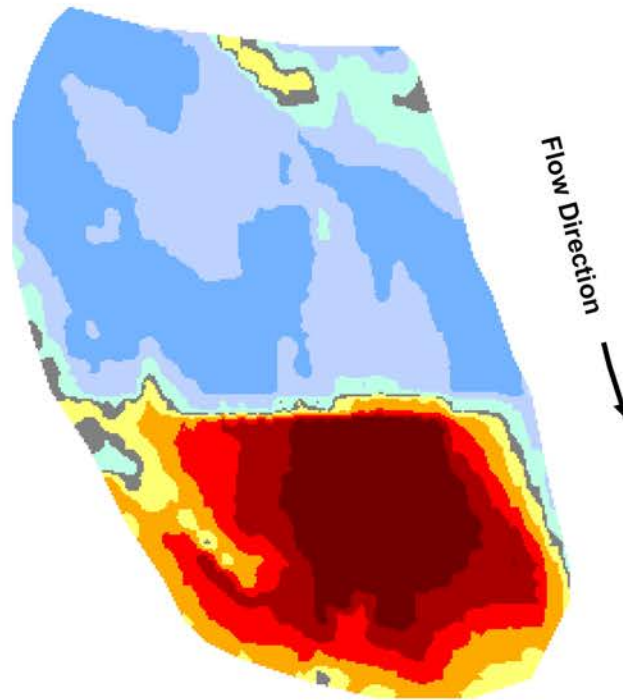
SDC 3i

## Comparison of As-Built and December 2006 Surveys

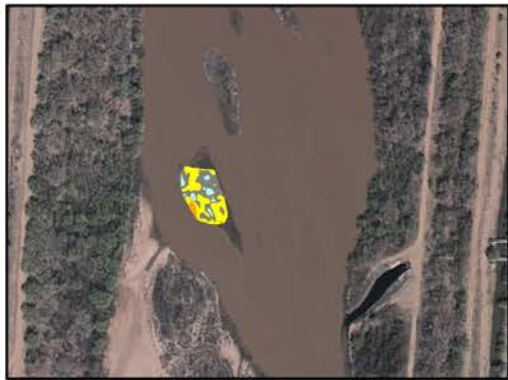
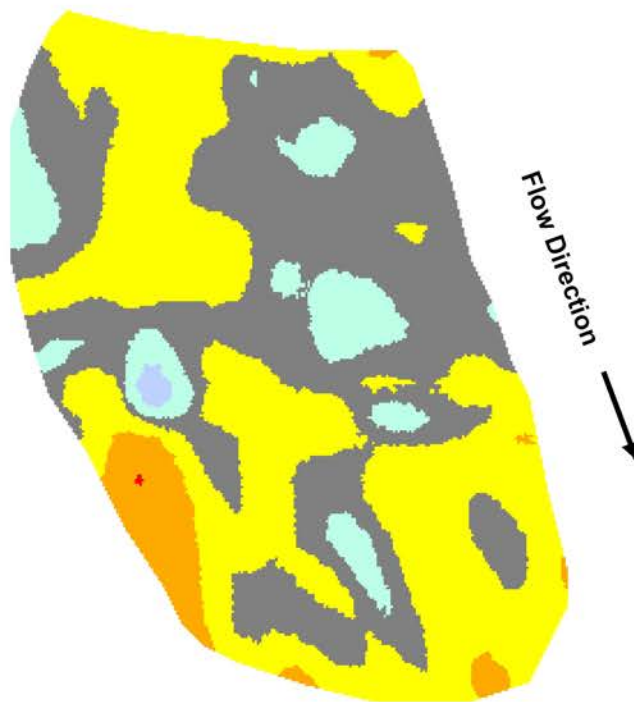
SDC 3i

## Comparison of Original Surface and As-Built Condition

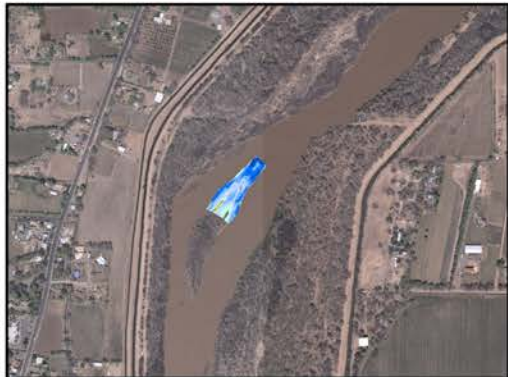
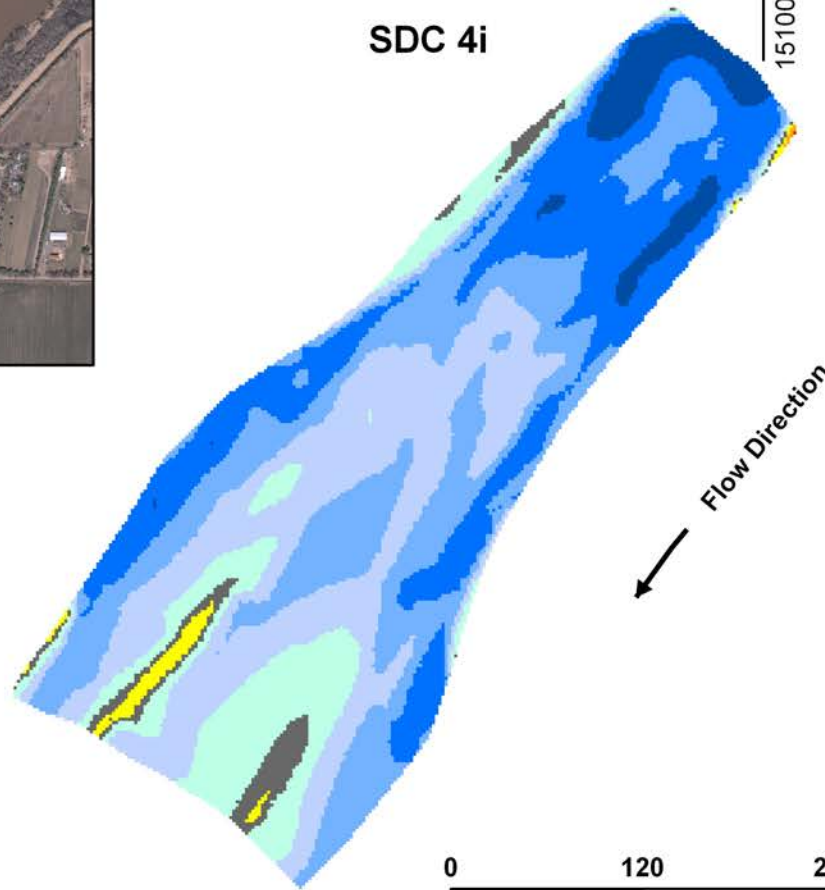
SDC 4i

**Comparison of As-Built  
and December 2006 Surveys**

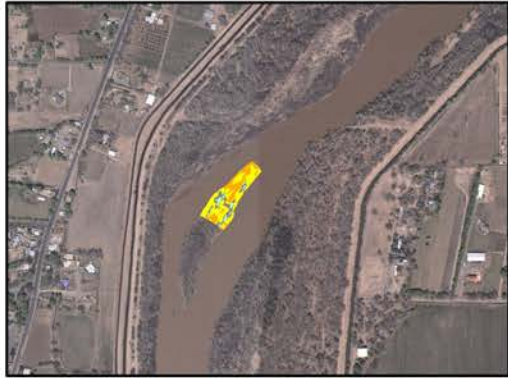
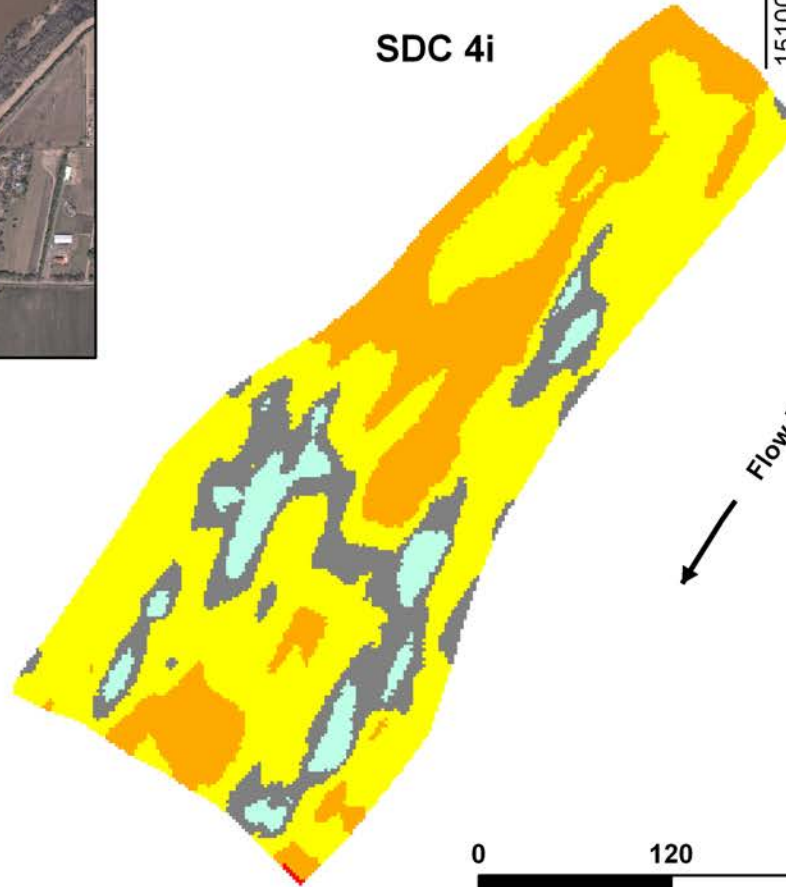
SDC 4i

## Comparison of Original Surface and As-Built Condition

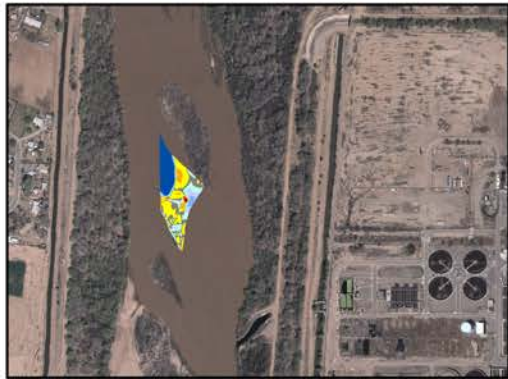
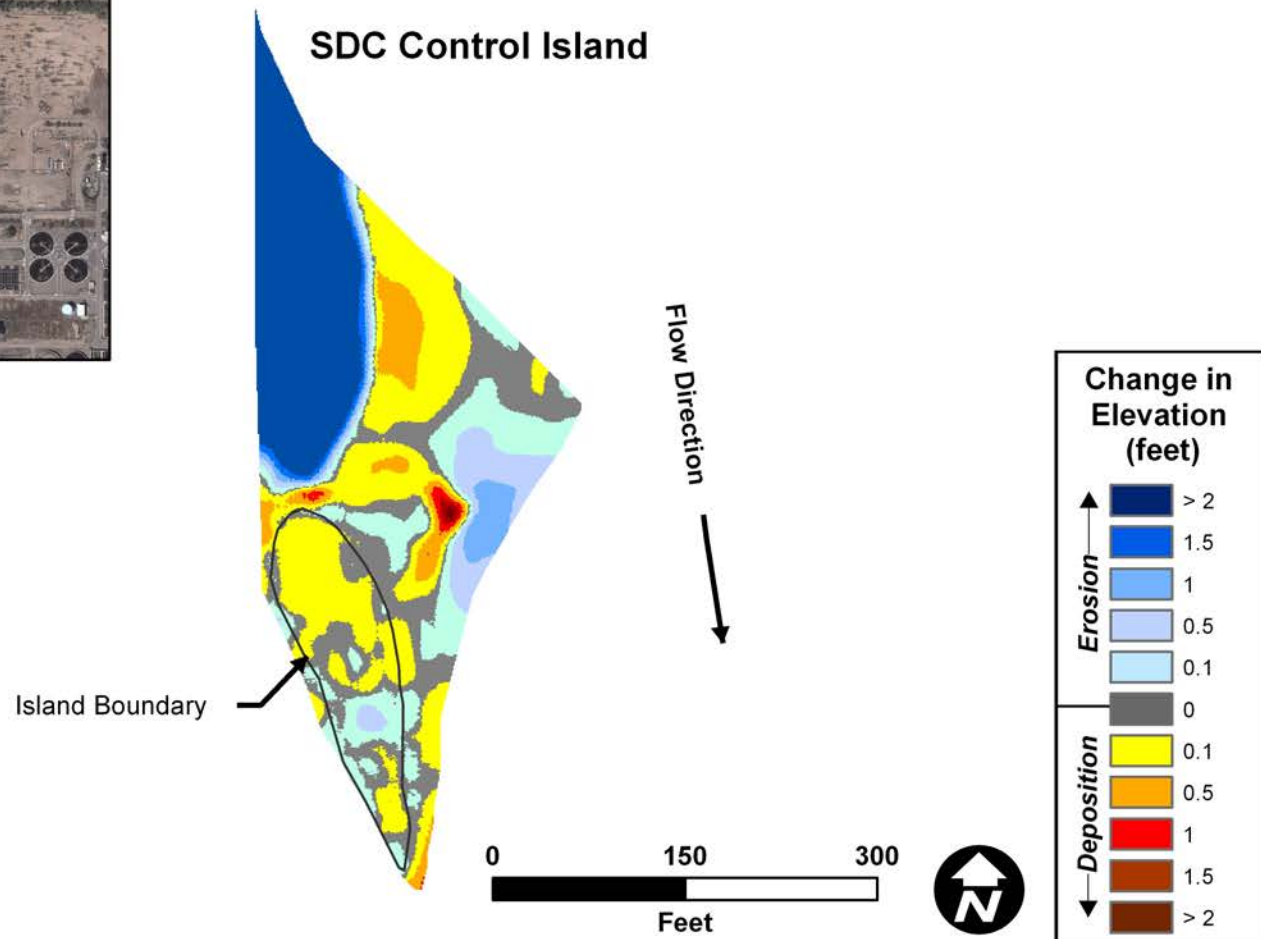
## Comparison of As-Built and December 2006 Surveys

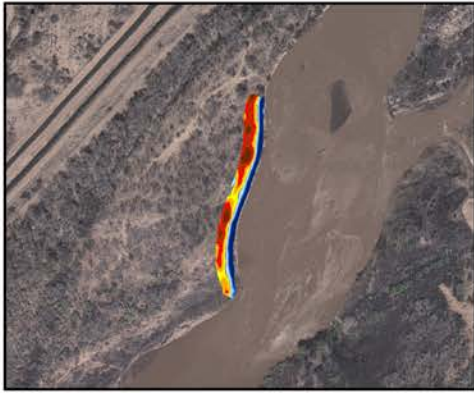
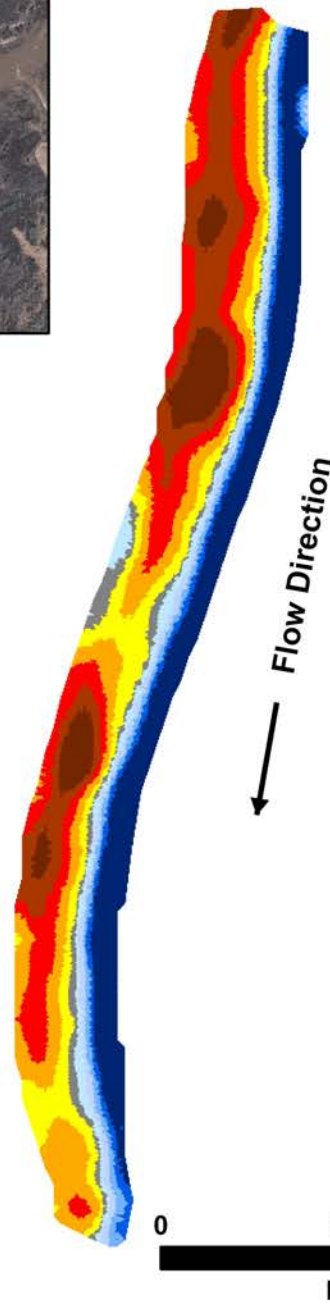
SDC 1b

## Natural Changes - Comparison of September 2005 and December 2006

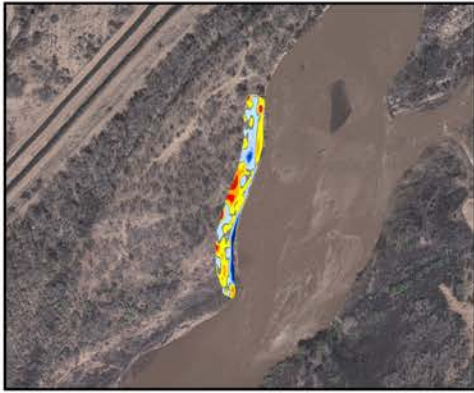
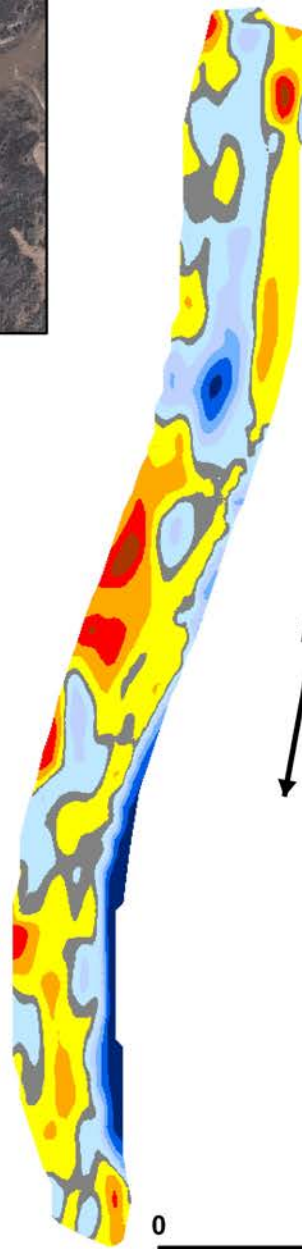
SDC 1b

**Comparison of Original Surface  
and As-Built Condition**
