***Development of Rio Grande Silvery Minnow Refugia at Drain Outfalls in the  
Isleta Reach of the middle Rio Grande, New Mexico***

**Project Completion Report on  
Grant Agreement No. 05-FG-40-2436**

**February 2010**

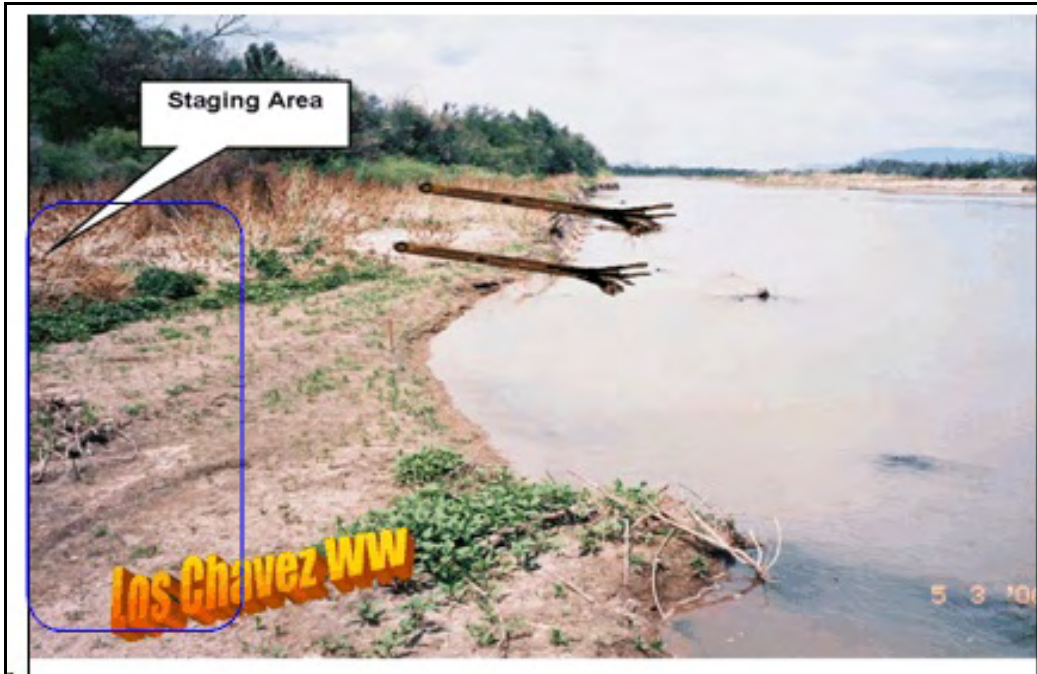
Figure 5. Close up of the staging area used at the Los Chavez Wasteway outfall.

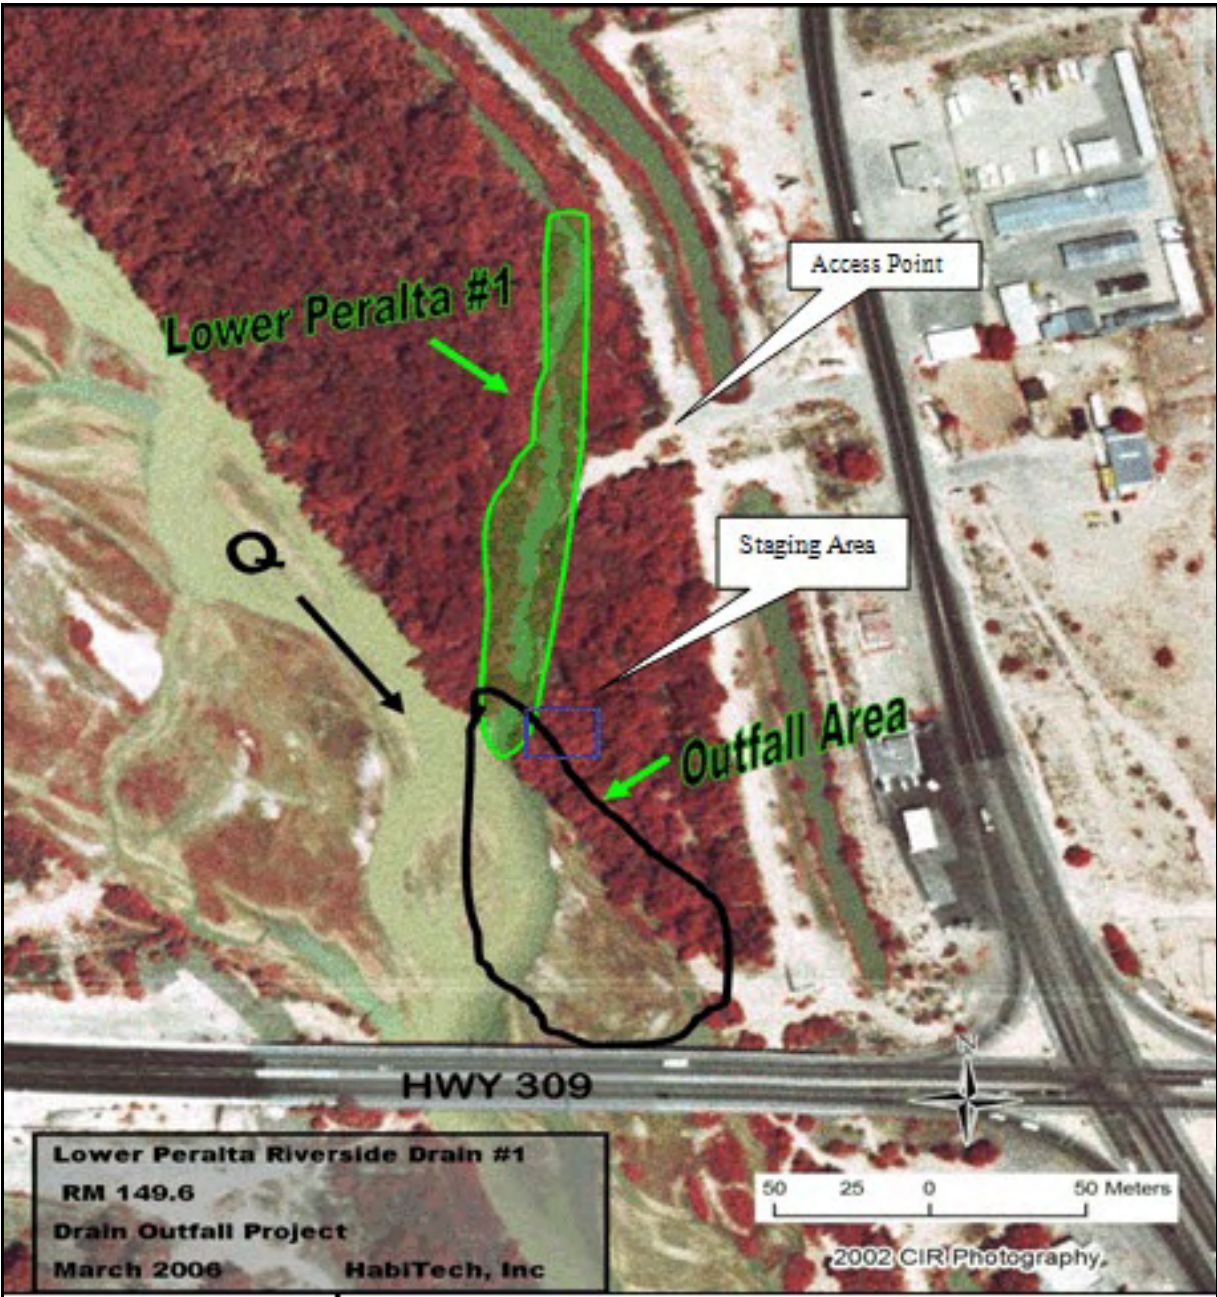
Figure 11. Aerial photo of Lower Peralta #1 Drain showing access and drain outfall area.

The LP1DR site is located at RM 149.6 at latitude 34° 39' 12.54"N, longitude 106° 44' 22.29"W at an elevation of about 4790 ft. above msl. The relationship of the outfall to the main river channel, as well as the location of the access road and staging area is shown in the aerial view of the site presented in Figure 11. The site plan is presented in Figure 12 with the location and configuration of the seven cottonwood snags installed at or near the mouth of the outfall. The well-developed access road, used primarily for recreation use and water management activities, and staging area are shown in Figure 13.

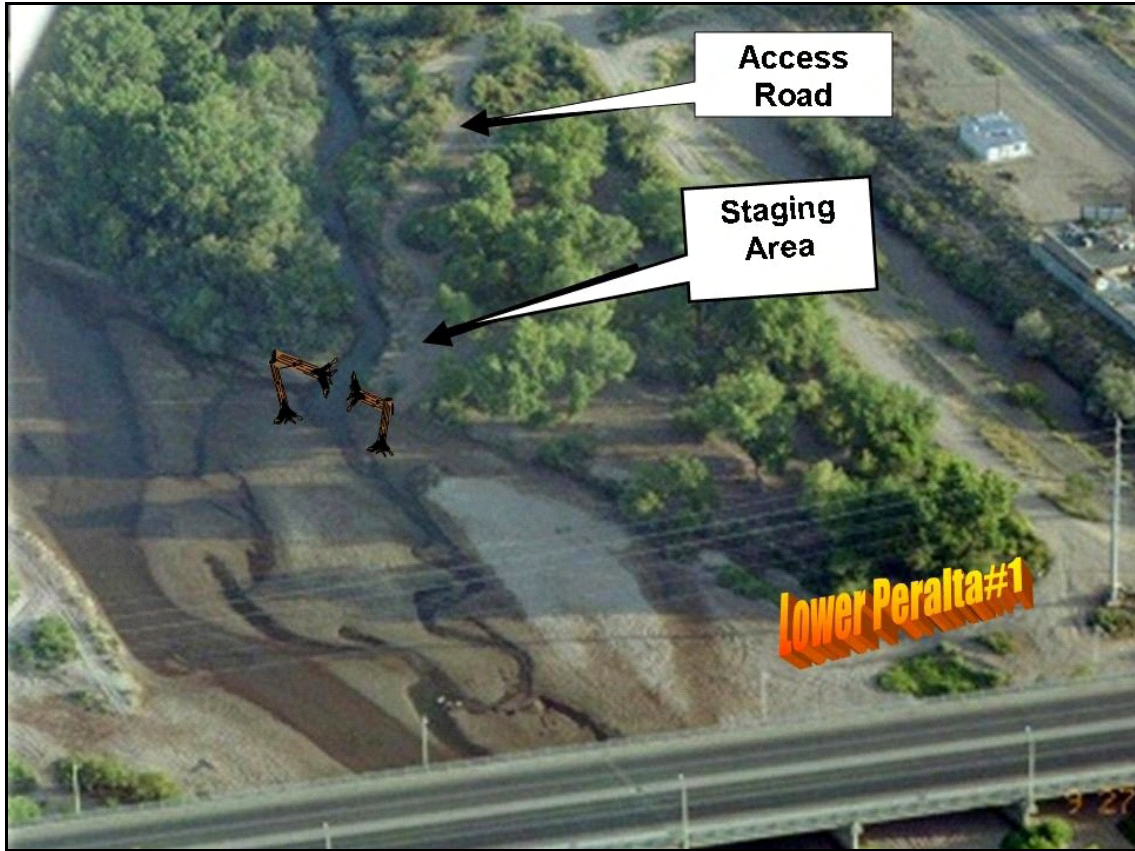
Figure 13. Location of the access and staging area used for construction of cottonwood snags at Lower Peralta #1 Drain.

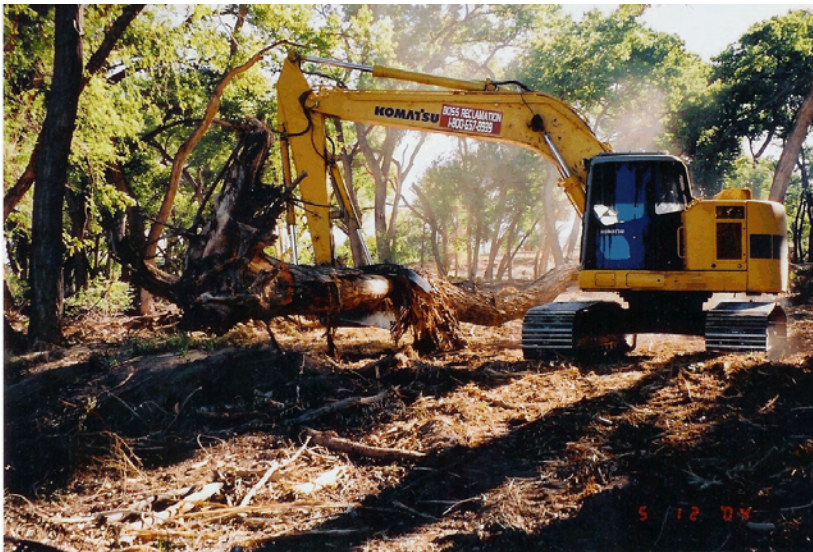
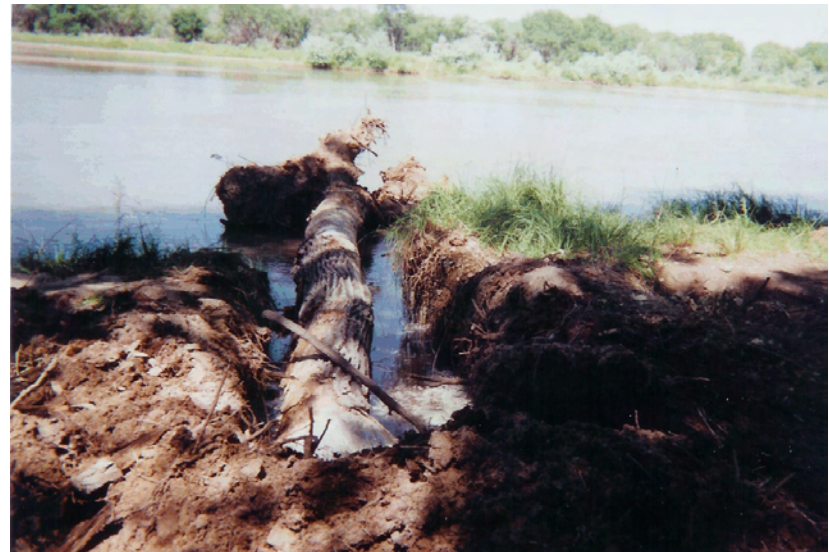
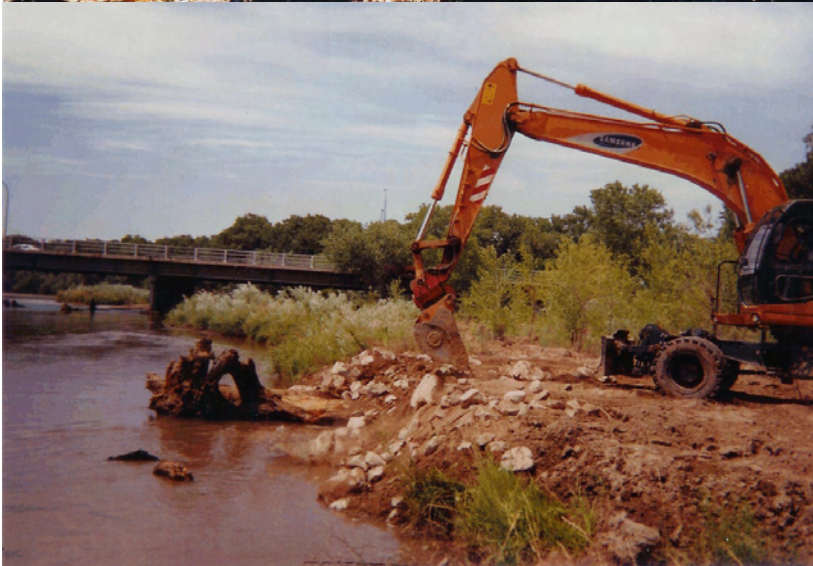
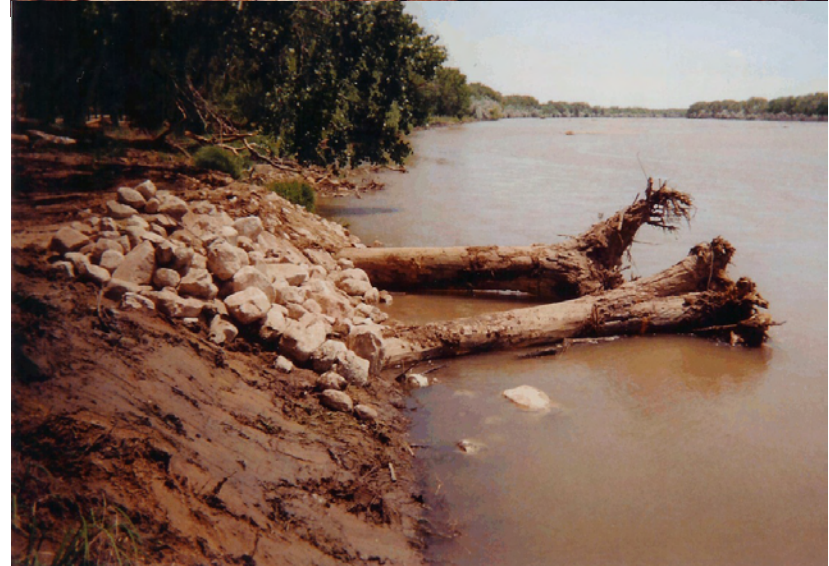
Figure 14. Installation of cottonwood snag structures. Top Left: Snag is uprooted and transported to stream bank. Top Right: Snag placed in excavated trench with rootwad streamside. Bottom Left: Trench is re-filled with soil and rock. Bottom Right : Banks are re-sloped and rock armor placed. Site is ready for revegetation.

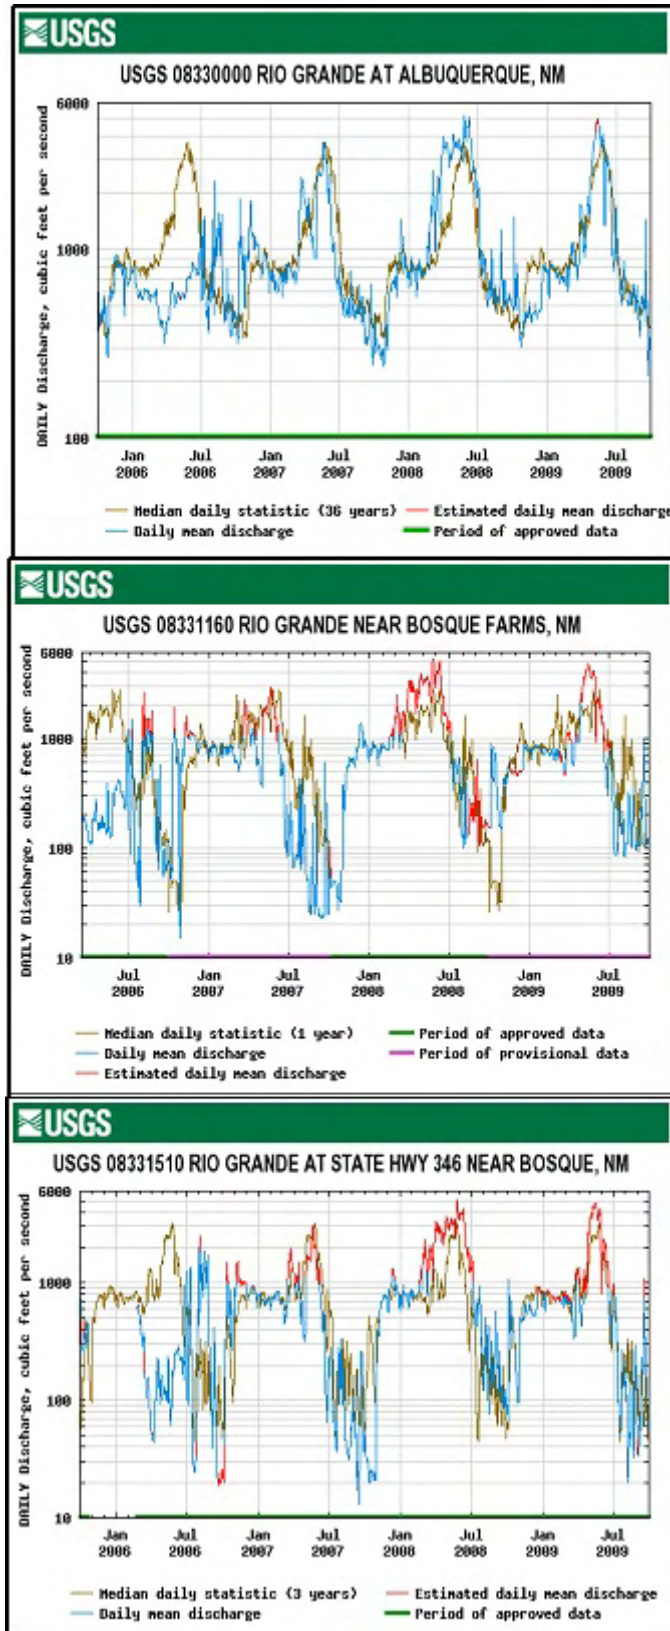
Figure 15. Streamflow hydrographs for 2006-2009 from three U.S. Geological Survey gage stations on the Rio Grande in the vicinity of the three drain outfall project sites.

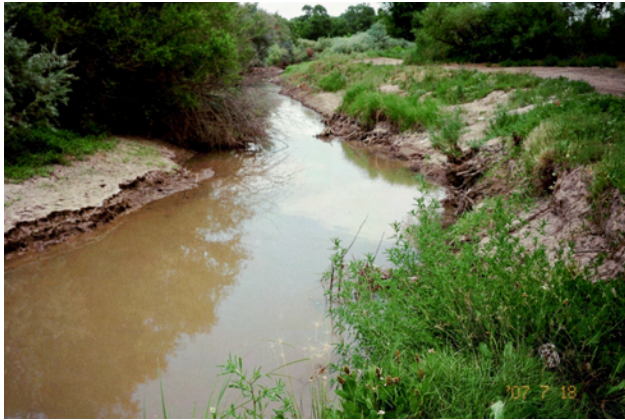
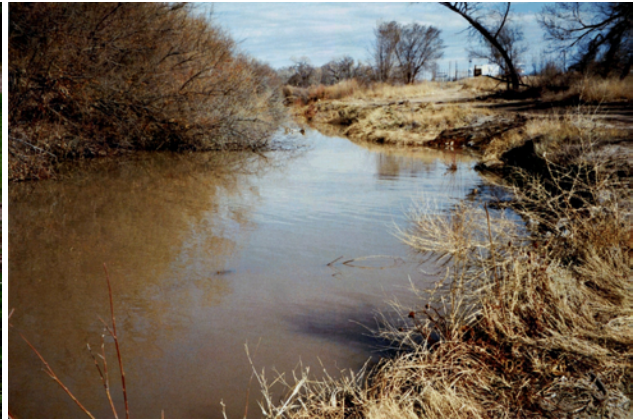
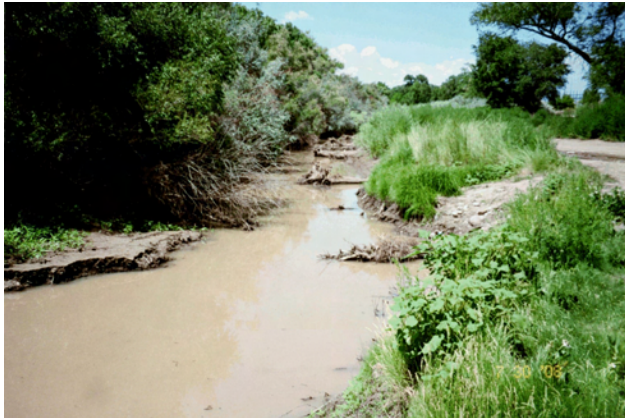
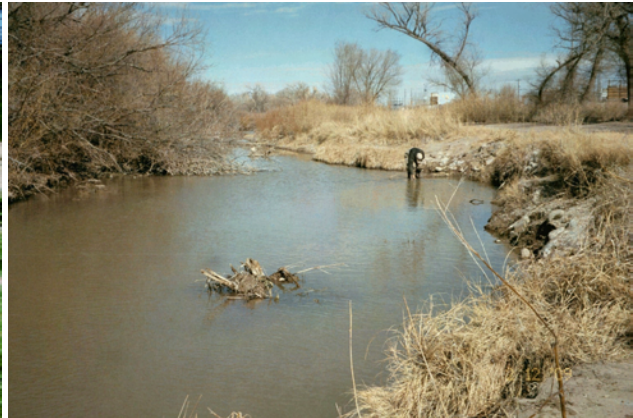
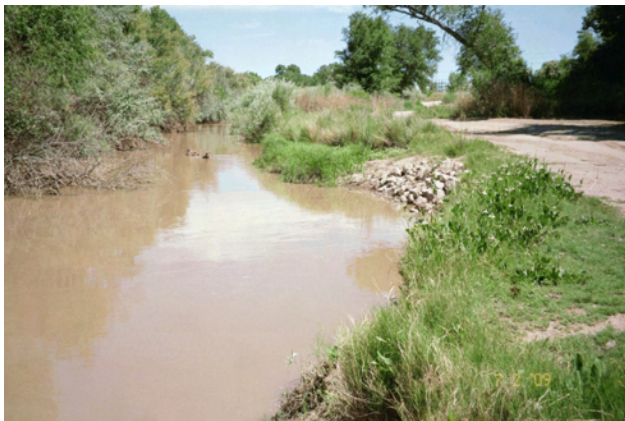
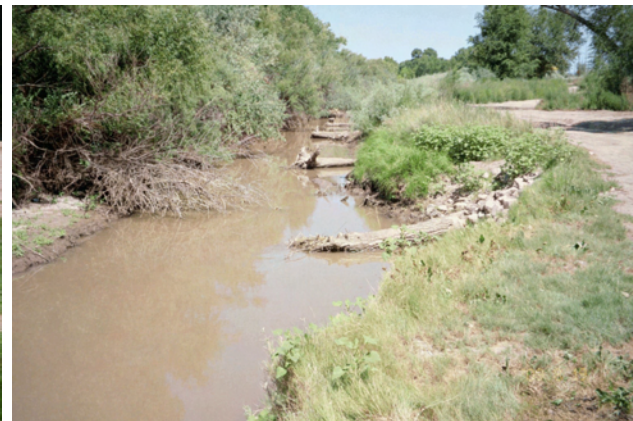
Figure 16. Monitoring photographs sequence for the Lower Peralta #1 Drain outfall project site. July 2007 (upper left) is pre-construction.

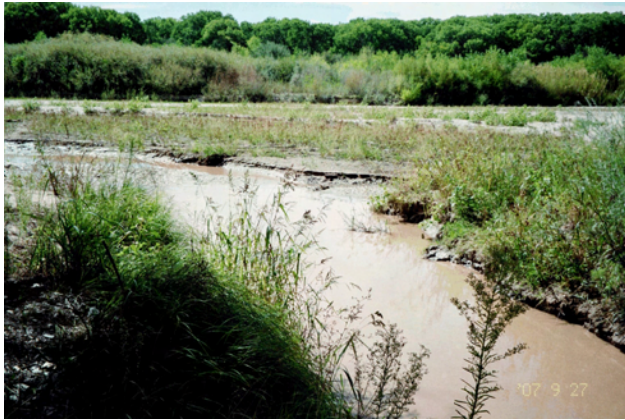
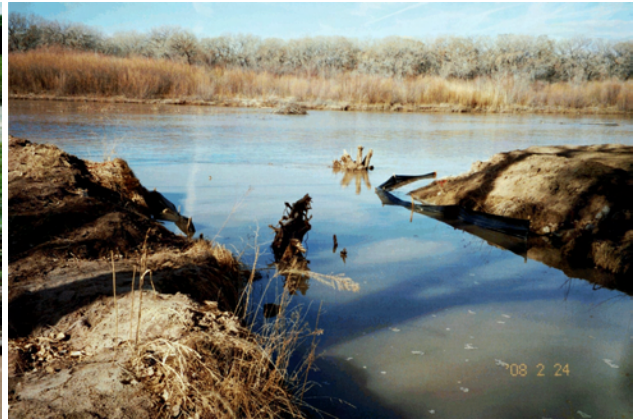
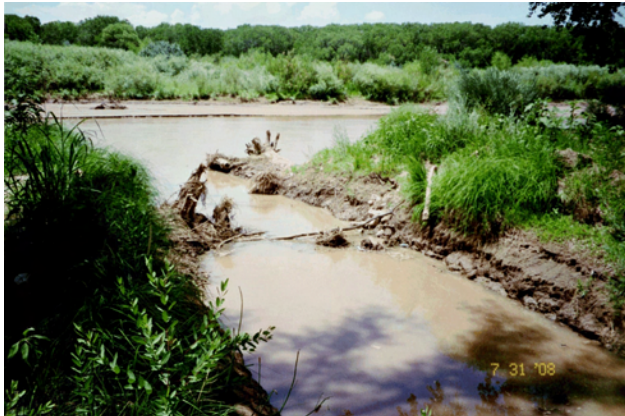
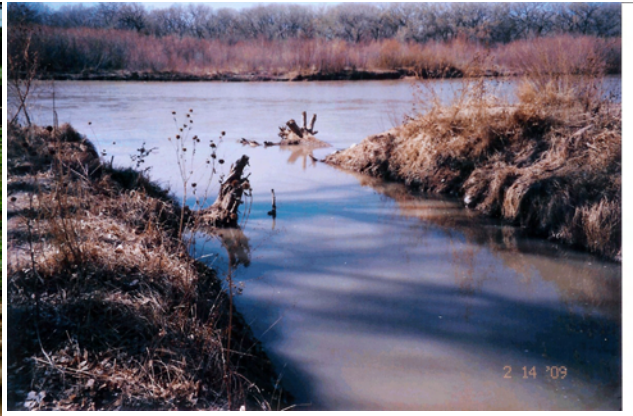
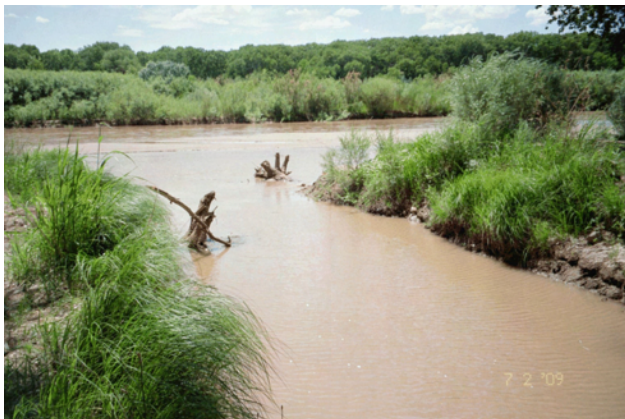
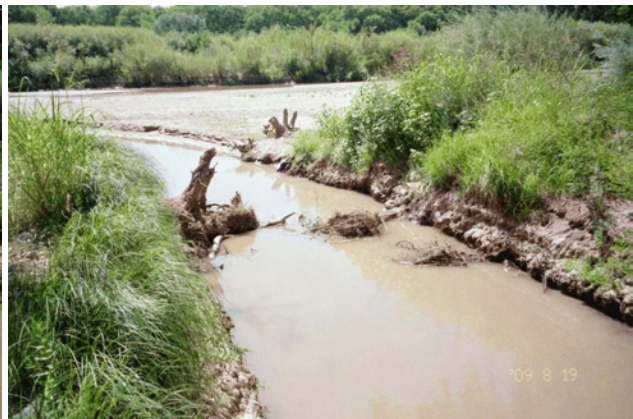
Figure 17. Monitoring photographs sequence for the Peralta Wasteway project site at the confluence of the outfall with the Rio Grande. July 2007 (upper left) is pre-construction.

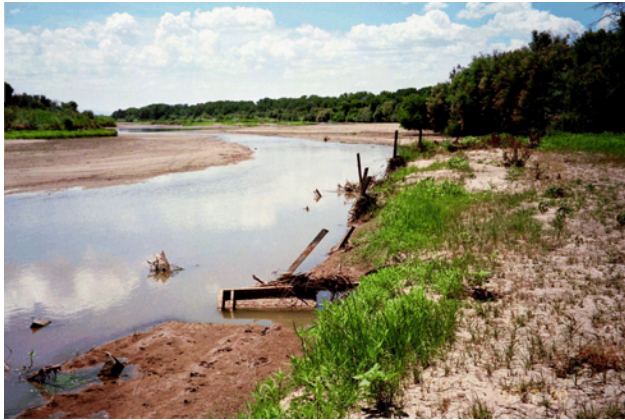
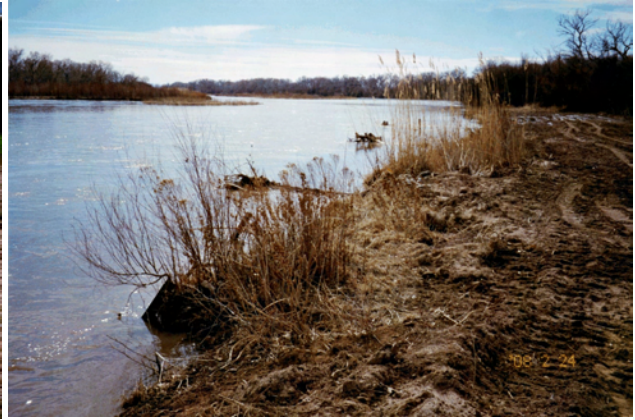
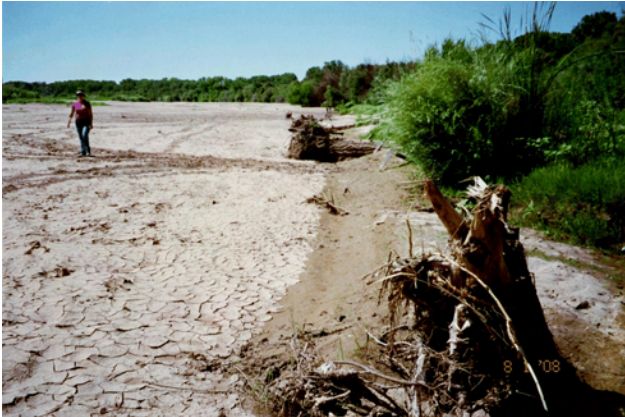
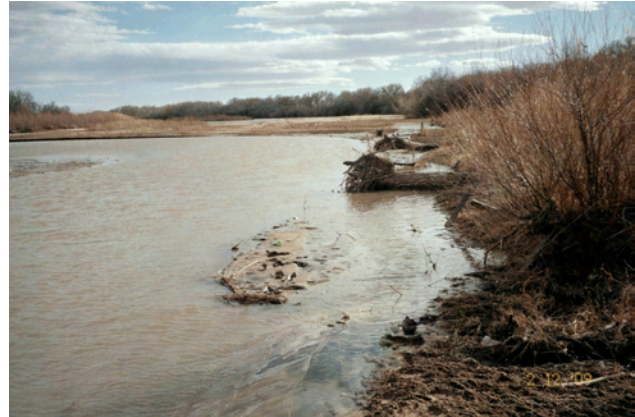
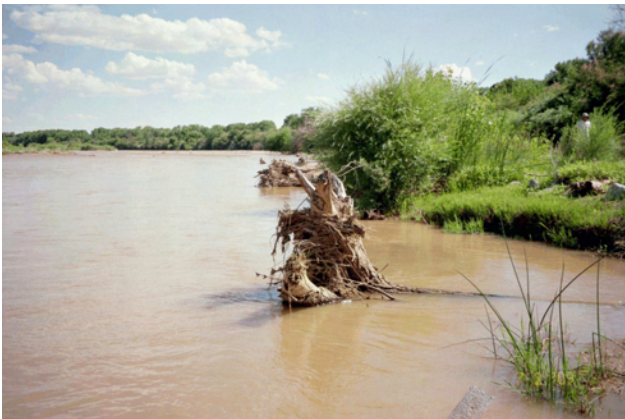
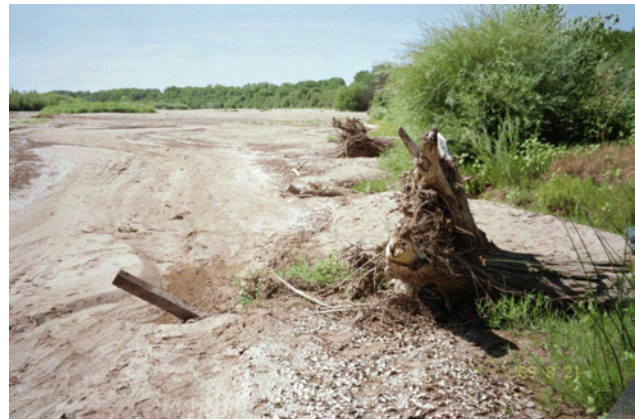
Figure 18. Monitoring photographs sequence for the Los Chavez Wasteway outfall project site. July 2007 (upper left) is pre-construction.

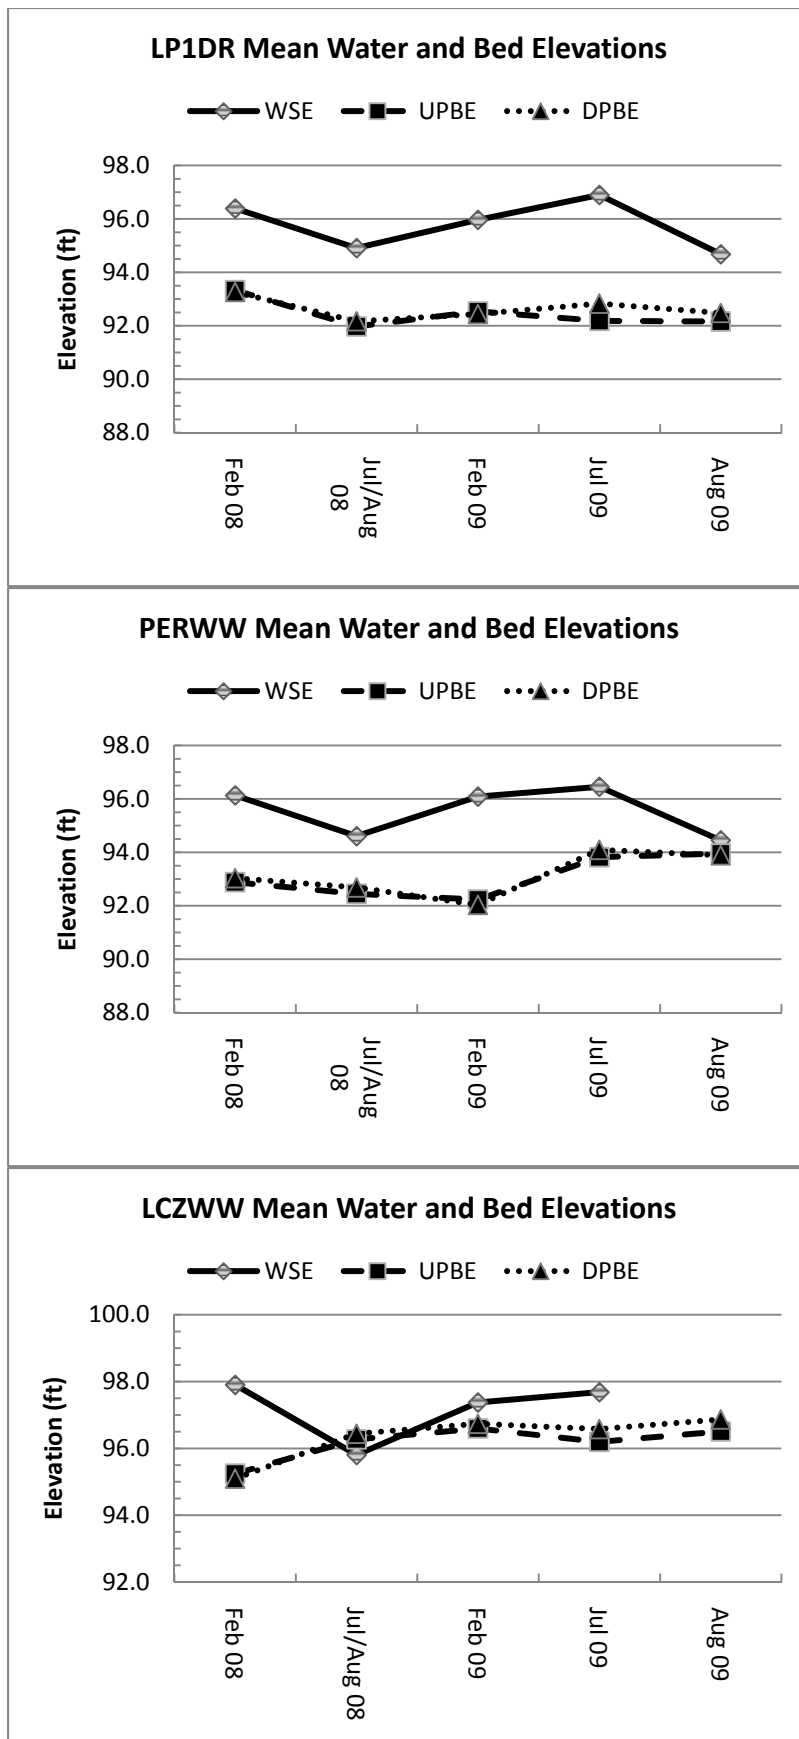
Figure 22. Relation of mean water surface (WSE) to mean upstream and downstream pool bed elevations (UPBE, DPBE) at the three drain outfall sites over the monitoring period.

Structural performance was evaluated primarily on a structure's ability to maintain pool bed elevations, both immediately upstream and downstream of the snag, at adequate levels in relation to the water surface elevation for the snag to remain wetted and functioning over a range of flow conditions. Water surface and pool bed elevations for each treatment, site and monitoring time are presented in Table 3 and Figures 19, 20, and 21. A summary plot of mean elevations for each site over time is provided in Figure 22.

Structural performance at LCZWW was severely hampered by the lack of flow through the drain outfall during the monitoring period as well as a shift in the river's thalweg above the site to the opposite side of the floodplain, similar to that observed at PERWW (Table 3; Figures 21 and 22). As a result, the river "bermed off" the mouth of the outfall with sediment deposits several feet high during spring runoff 2008, leaving Snags #1 Left and Right buried in sediment and dry for the remainder of the monitoring period. The remainder of the snags, all located along the right bank of the main river channel, functioned intermittently from July 2008 to August 2009. Snags #2, #3, #5 and #6 were wetted on two of four monitoring dates during this period, while Snag #4 was functioning on three of four occasions. Excluding February 2008, mean maximum pool depths ranged from 0.0 ft in August 2009 to 1.51 ft in July 2009, while the maximum pool depth measured was 2.83 ft at Snag #4 in July 2009. Until MRGCD is able to provide flow more routinely into the LCZWW, structural performance will remain well below potential at this site.

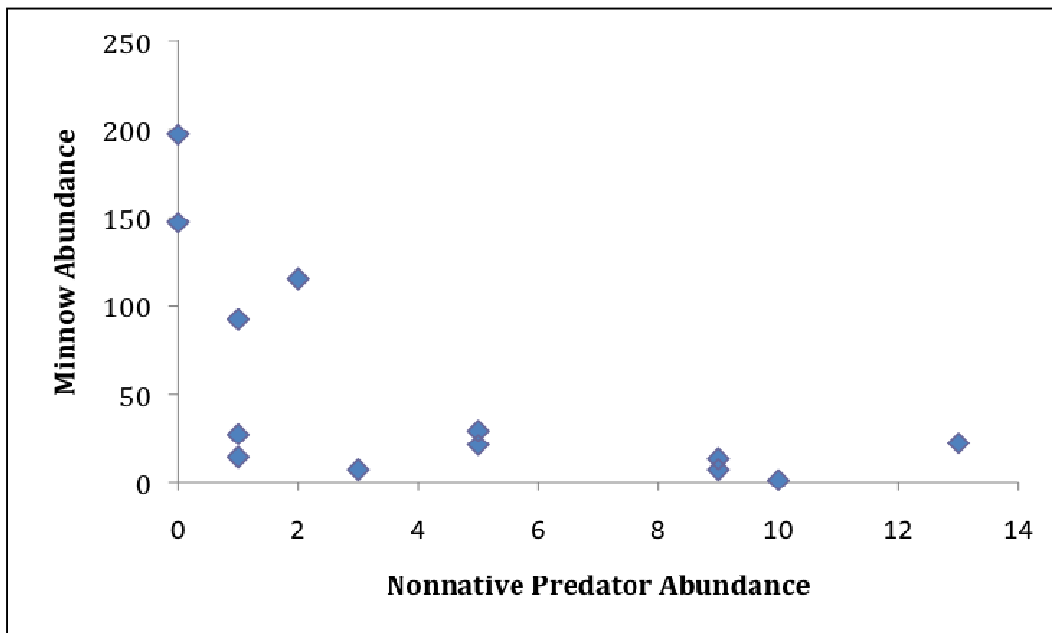
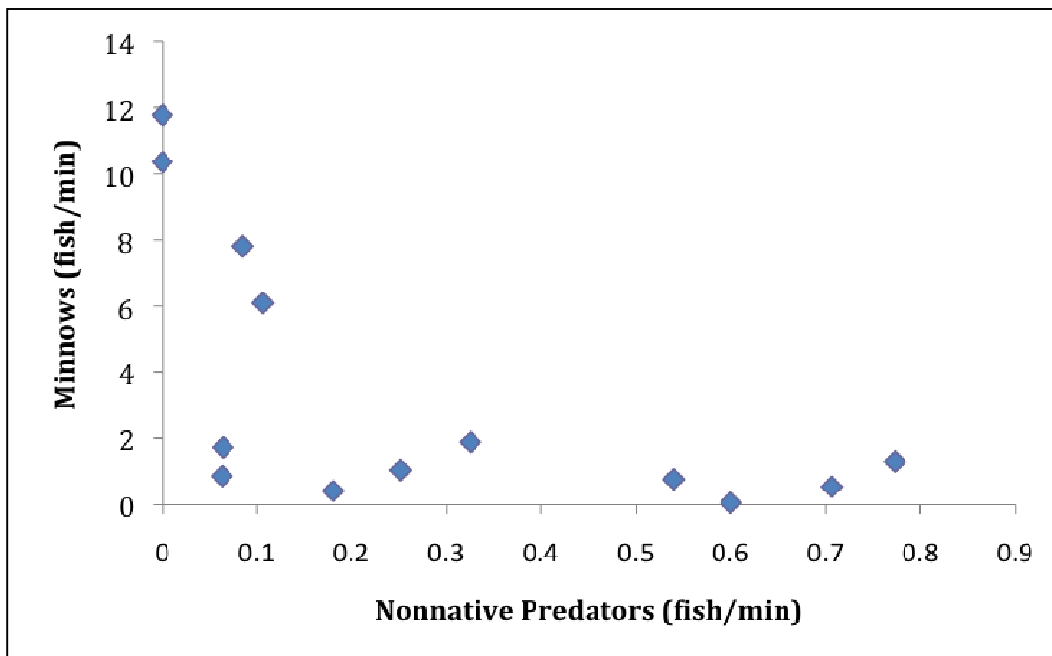
(a)

(b)

Figure 23. Abundance (a) and catch per minute (b) of minnows relative to nonnative predators across three drain outfall sites and across all samples.

The abundance and catch per minute for minnows (*C. lutrensis*, *H. amarus*, *P. promelas*, *P. vigilax*, and *P. gracilis*) were plotted against comparable values for nonnative predators (Figure 23). In general, samples containing more nonnative predators had substantially fewer numbers of minnows whereas samples with few or no nonnative predators had abundant minnow populations. The relationship between minnows and nonnative predators was nonlinear and clearly negative.
