Southwestern Willow Flycatcher and Western Yellow-billed Cuckoo use at Restoration Sites in the Albuquerque Reach of the Middle Rio Grande

Middle Rio Grande Endangered Species Collaborative Program Symposium

Ondrea Hummel and Alaina Pershall

December 4, 2019

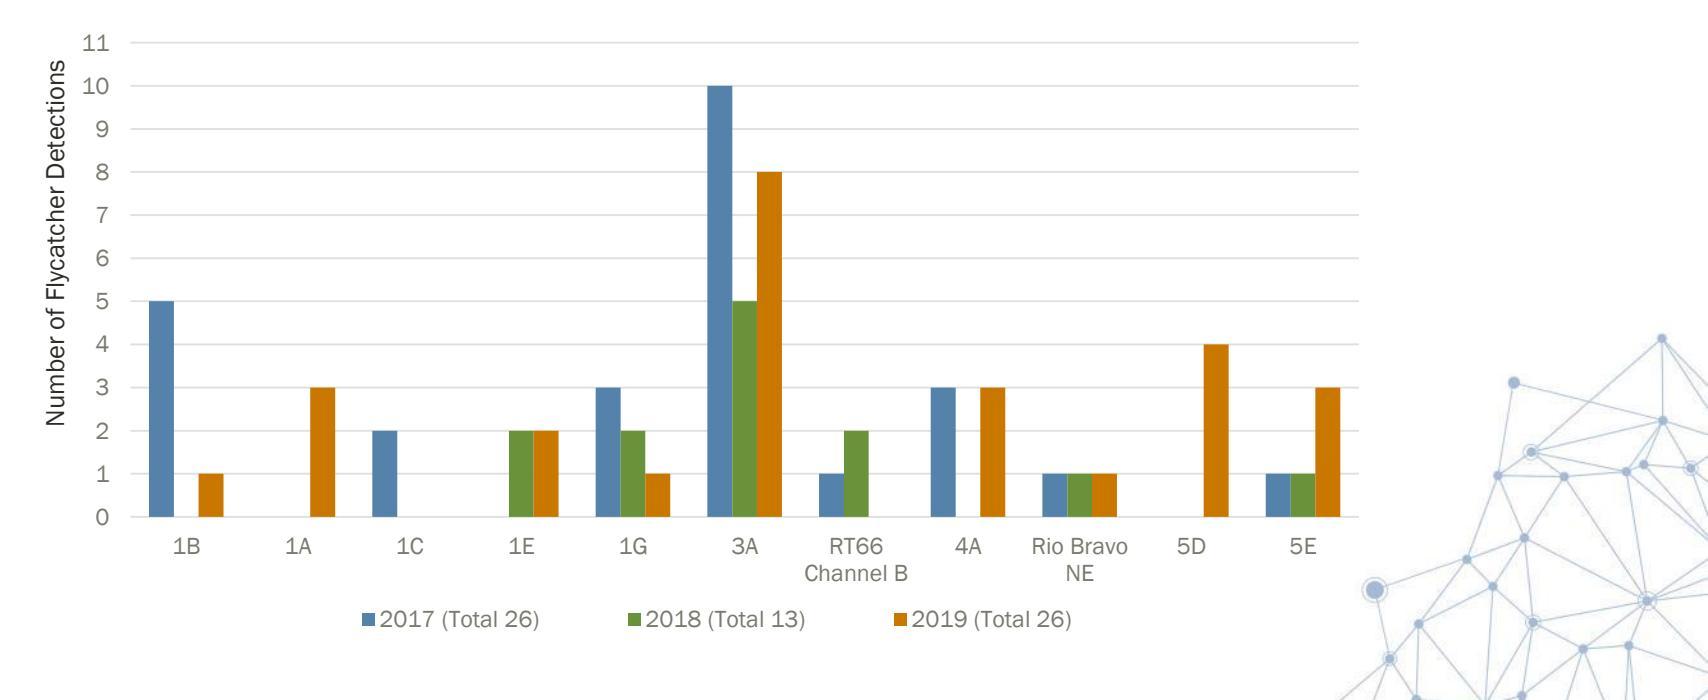
May Flycatcher Detections by Restoration Site

Generally more detections in mature coyote willow that inundates during high flows

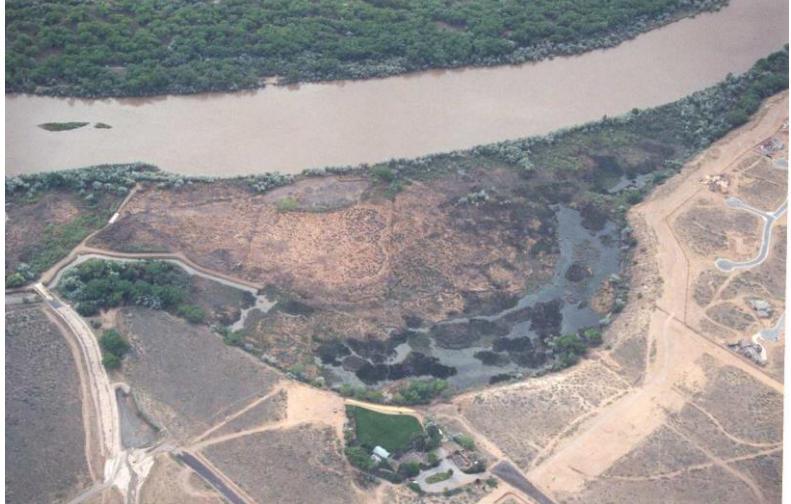
MRG Restoration Site 3A/Oxbow

- Change in habitat:
 - 1998 San Antonio Arroyo restructuring
 - 'dead zone'
 - 2002 South berm extension
 - 2013 MRG Restoration project
- Link with 'natural' habitat

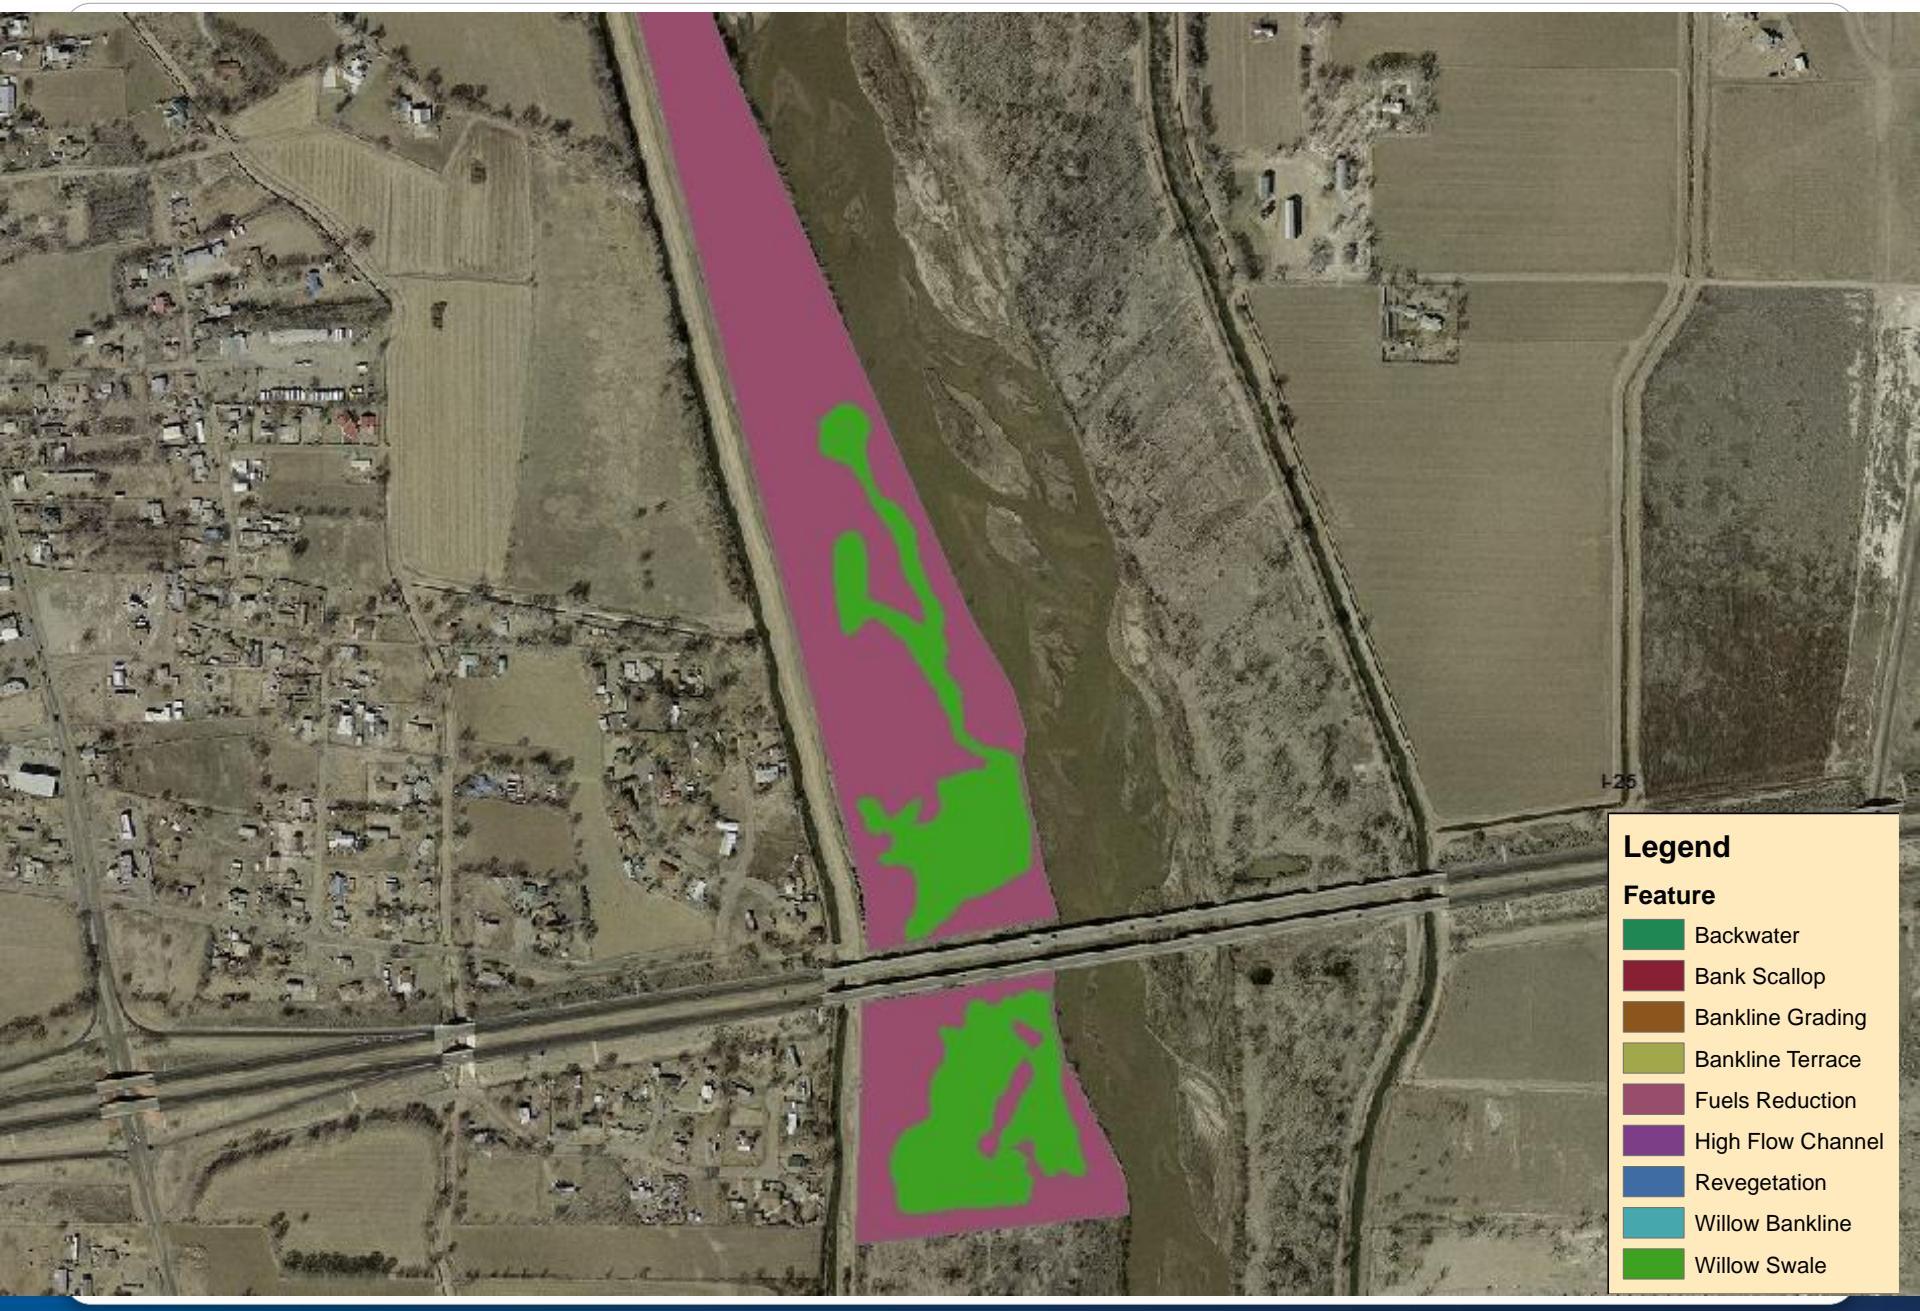
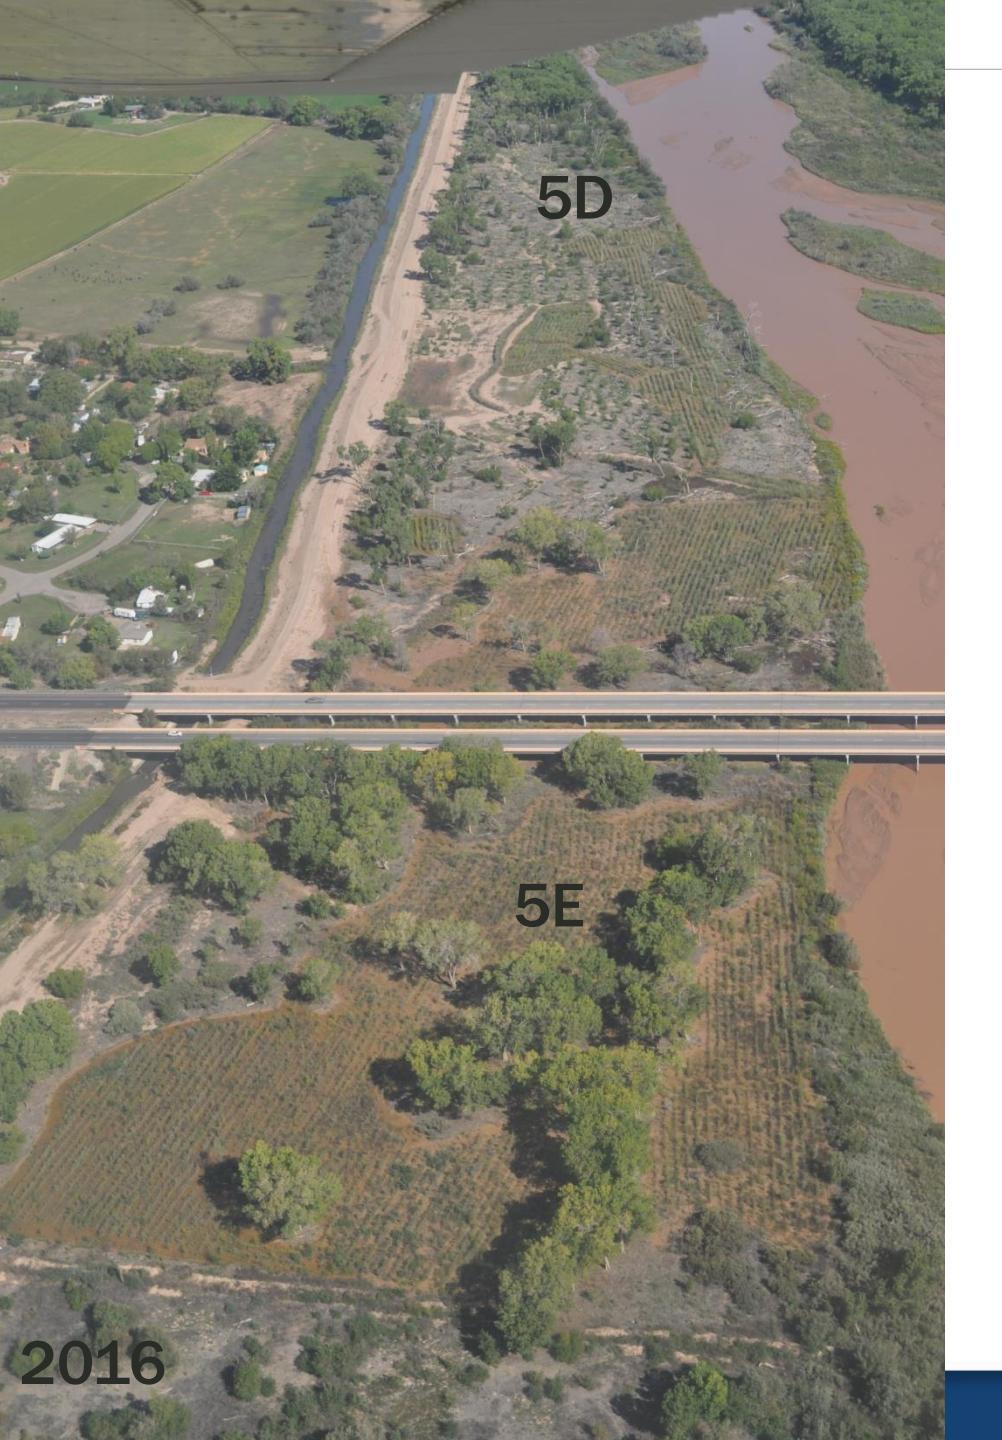
MRG Restoration Sites 5D and 5E

Flycatcher Detections in May		
	2017 - 2018		At least 1
	2019	0 in May	
	2019	2	7/8/19
	2019	1	7/17/19
