FILE: KAY COUNTY FLOOD FILE

THESE PICTURES WERE TAKEN AT THE BRAMAN INTERCHANGE OF I-35 & FAS ROUTE 3109 APPROX. 0.75 MILE WEST OF BRAMAN, KAY, COUNTY. FLOOD OCCURRED ON NOVEMBER 17, 1964. PICTURES WERE TAKEN APPROX. 2:50 PM 11/17/64. FLOODING WAS CAUSED BY DRY CREEK OVERFLOW. ALL FOUR QUADRANTS OF INTERCHANGE WERE PARTIALLY INUNDATED. HIGHWATER VIEWED BY G.H. STOUT, O.C. CURNUTT AND R.C. POAGE.

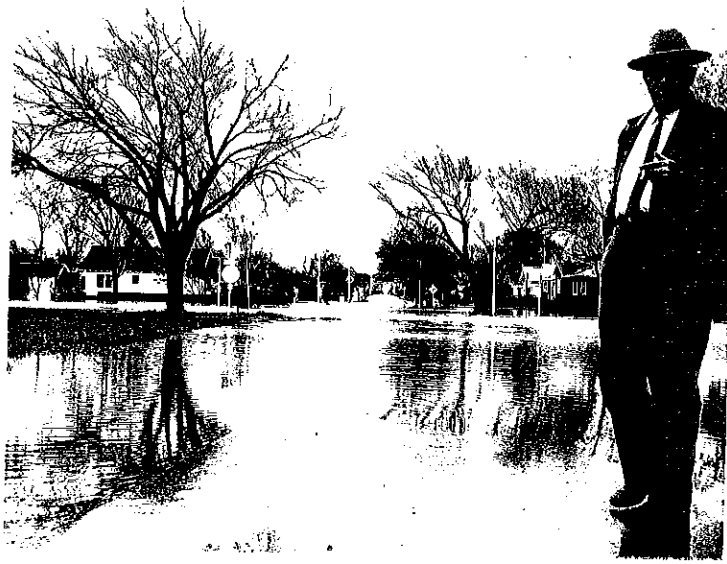
LOOKING EAST ON SH 11 IN CITY OF BLACKWELL, KAY  
COUNTY. STREET INTERSECTION IN PICTURE IS EAST  
BLACKWELL AVENUE AND SOUTH "F" STREET.  
NOTE: CHICKASKIA RIVER BRIDGE.

WATER WAS ON CENTER LINE OF STREET APPROX. 100' WEST  
OF INTERSECTION AT STA. 1+75.0, FAP 62(A). FLOOD  
WATER HAD BEGUN TO RESIDE AND WAS APPROX. 1.0 FEET  
BELOW MAXIMUM. PICTURE WAS TAKEN AT 1:30 PM NOV. 17,  
1964. HIGHWATER VIEWED BY G. H. STOUT, O.C. CURNUTT,  
AND R.C. POAGE. GENTLEMAN IN PICTURE IS G.H. STOUT,  
SURVEY ENGINEER.

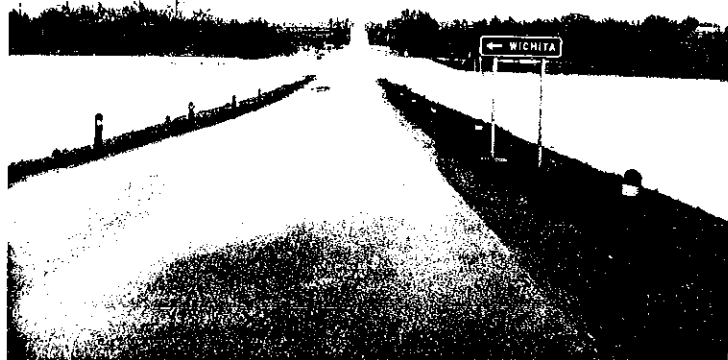
THIS VIEW LOOKING EAST ON FAS ROUTE 3109 TOWARD BRAMAN FROM TOP OF GRADE SEPARATION STRUCTURE OVER I-35 OVERLOOKING DRY CREEK. NOTE SILT ON PAVEMENT. WATER HAD RESIDED APPROX. 2.5' FROM MAXIMUM - PICTURE TAKEN APPROX. 2:50 PM.

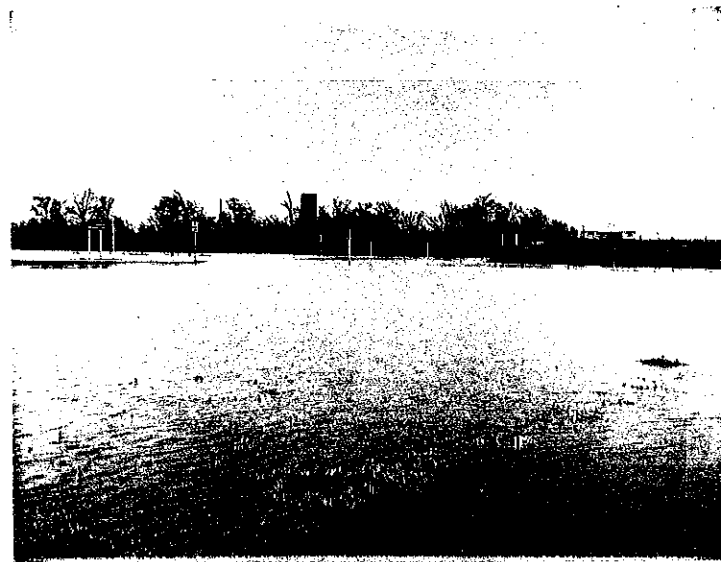
THIS VIEW LOOKING NORTH 45° E± FROM RAMP IN S.E. QUADRANT OF INTERCHANGE.

INTERCHANGE WAS CONSTRUCTED AS 1456(4) & (5) INTERSECTION STATION 715+30.72.

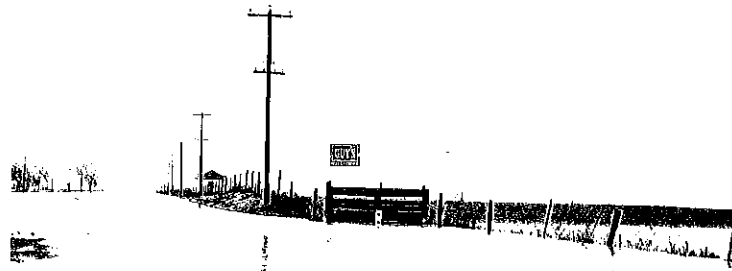
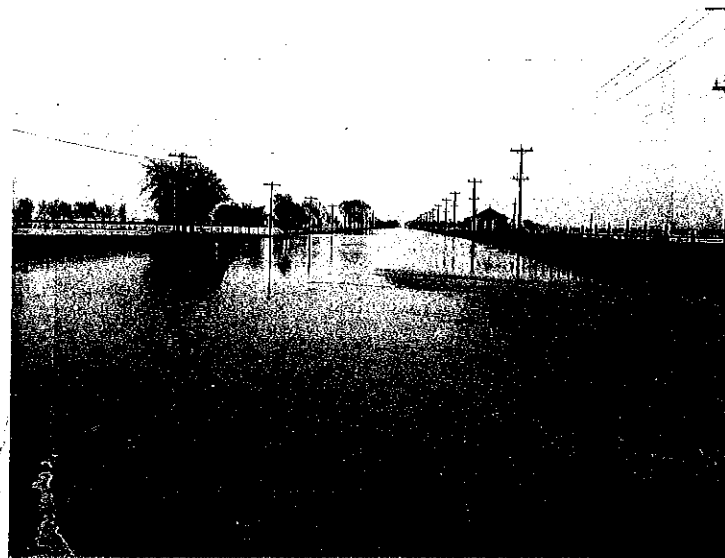
LOOKING EAST ON US 60 APPROX. 2.0 MI. E. OF TONKAWA, KAY COUNTY. HIGHWATER IS FROM CHICKASKIA RIVER OVERFLOW. THESE SCENES ARE BOTH TAKEN FROM APPROX. 800' EAST OF CHICKASKIA RIVER BRIDGE. NOTE R/W JOG IN LT. PICTURE ON RT. THIS IS END OF FAP 287(A) STATION 74+52. HIGHWATER WAS ON CENTER LINE PAVEMENT TO APPROX. 74+00.

EMPLOYEES OF THE CITY OF TONKAWA WATER DEPARTMENT, WHO WERE AT THE SCENE, REPORTED THAT WATER HAD NOT REACHED ITS PEAK AT THE TIME PICTURE WAS TAKEN, WHICH WAS 1:30 PM ON NOVEMBER 17, 1964. HIGHWATER VIEWED BY G. H. STOUT, O.C. CURNUTT AND R. C. POAGE.

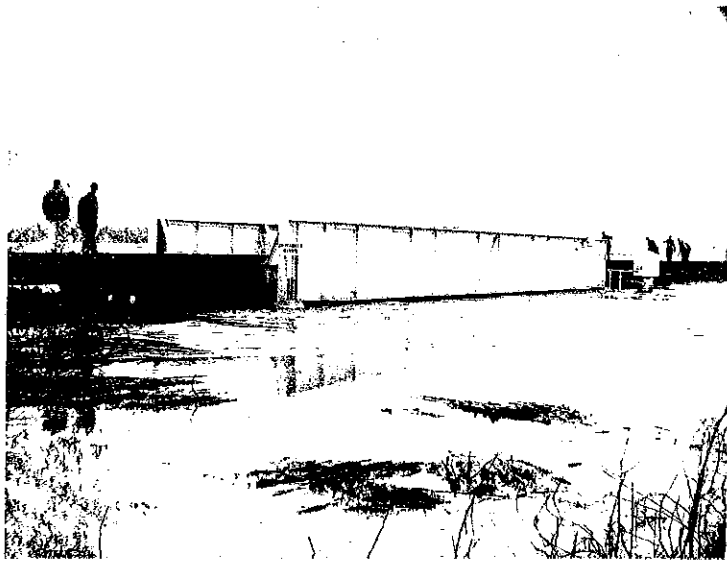
LOOKING N 65° E ± FROM NORTH D ST. AND  
S.L. & S.F. RR AT N.E. COR OF BLACKWELL,  
KAY COUNTY. WATER HAD RESIDED APPROX 1.5'  
FROM MAXIMUM HEIGHT AS REPORTED BY R.R.  
WORKMAN CLEARING DEBRIS FROM BRIDGE.  
THIS BRIDGE IS APPROX 1200' DOWNSTREAM  
FROM OUR PROPOSED FUTURE CROSSING OF  
CHICKASKI RIVER WITH SH 11 AS SURVEYED  
SWO 2299 (1). NOTE USGS GAGE ON BRIDGE  
AT RT. OF PICTURE. SEE PAGE 40 OF  
"FLOODS IN OKLAHOMA MAGNITUDE AND  
FREQUENCY", PUBLISHED BY USGS. IN  
COOPERATION WITH STATE HIGHWAY DEPT. &  
BUREAU OF PUBLIC ROADS FOR OTHER FLOOD  
INFORMATION. DATE OF THIS FLOOD AND  
PICTURE; 11/17/64, TIME 2:00 PM  
VIEWED BY G.H. STOUT, O.C. CURNUTT &  
R.C. POAGE.

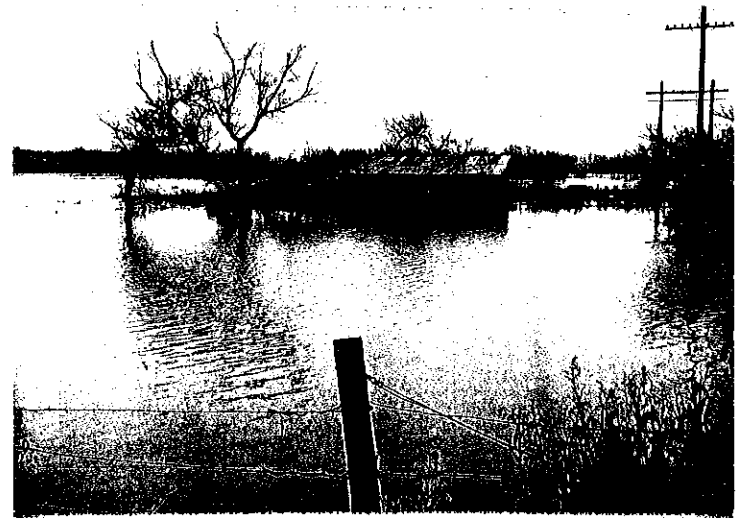
LOOKING N 75° E ± FROM NORTH B STREET AND DOOLIN AVE  
AT N.E. COR. OF BLACKWELL, KAY COUNTY. HIGHWATER  
HAD RESIDED APPROX 1.5' FROM MAXIMUM. HIGHWATER  
OCCURRED 11/17/64, PICTURE TAKEN 11/17/64 APPROX. 2:15PM  
FRAME SHED IN VIEW IS 57' LT. OF STATION 2724 ± 20  
SWO 2299 (1). HIGHWATER VIEWED BY GAINES H. STOUT,  
O.C. CURNUTT, R.C. POAGE.

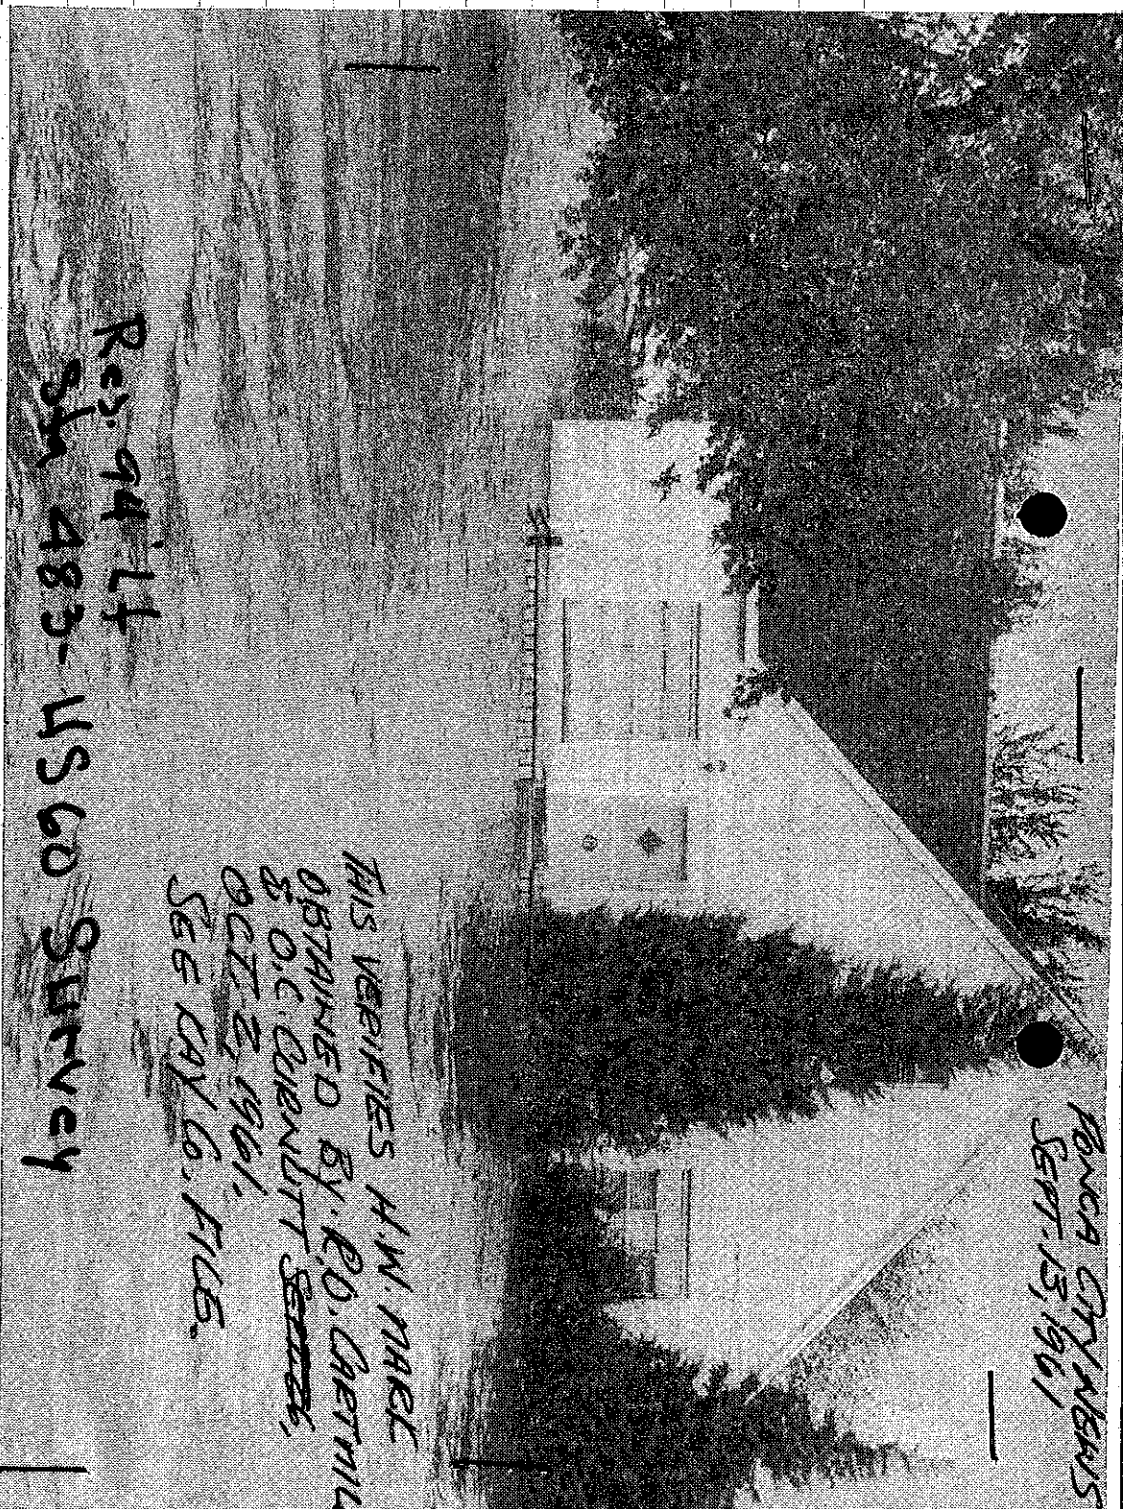
THIS VERIFIES H.W. MARK  
OBTAINED BY R.D. CRETWILL  
801 C. QUENLITT ~~SEPT. 22,~~  
OCT. 2, 1961.  
SEE CAY CO. FILES.

WATER ROSE to the windowills of the W. H. Ginn farmhouse  
near Bois d'Arc Creek early this morning in the flash flooding along

U.S. 60-77, but was receding by 10 a.m. when this picture was taken.

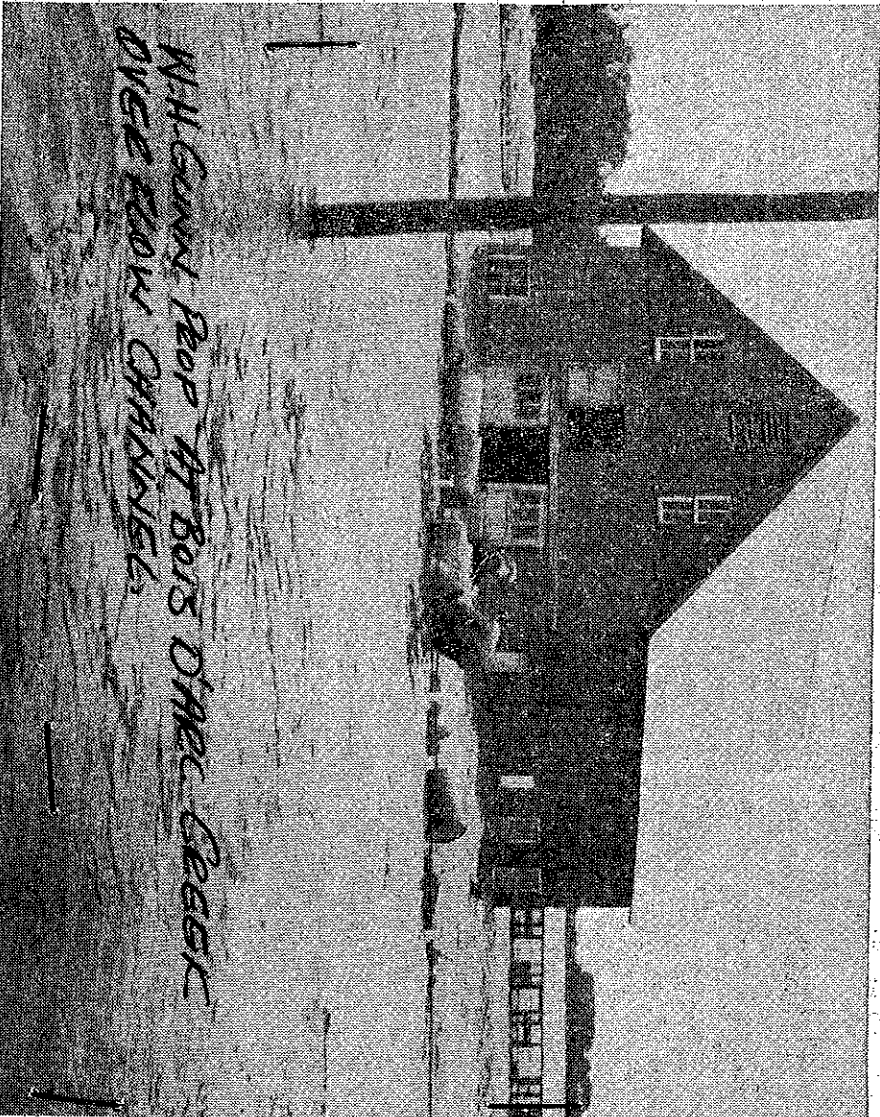
W.H. GINN'S POOP AT BOIS D'ARC CREEK  
DICE FLOW CHANNEL.

FILES: FLOOD  
RFD: Cay Co.  
FOR ELEV.  
SEE SWD: 33230

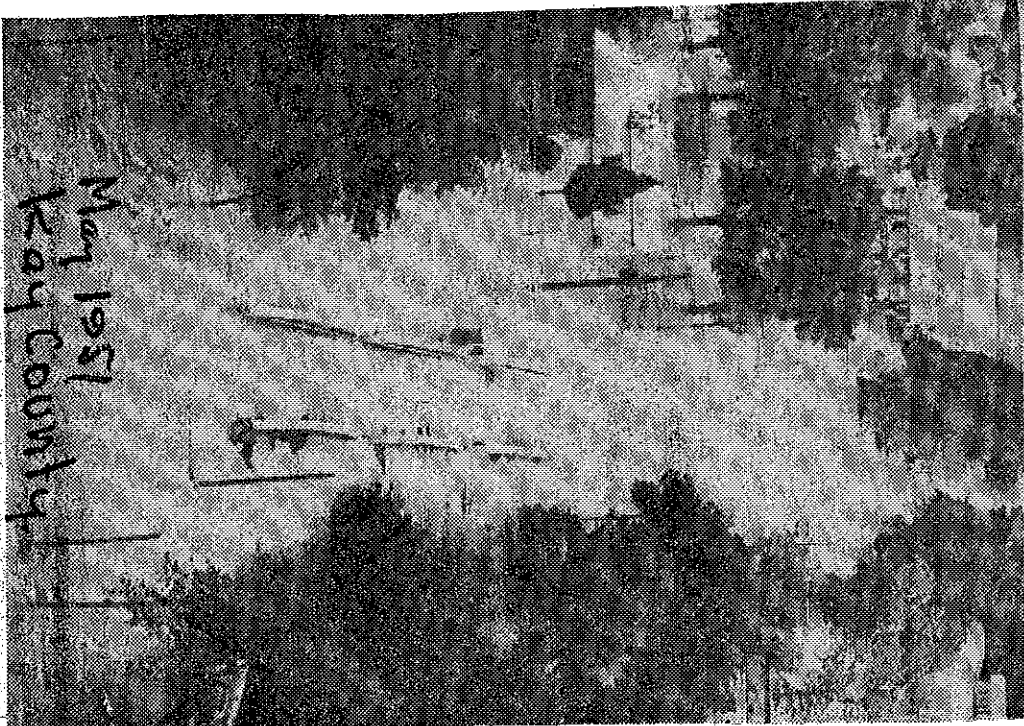
The Chikaskia river at Blackwell was falling slowly Saturday morning as the stream poured into the Salt Fork of the Arkansas south of Tonkawa. The Salt Fork was out south of Ponca City closing U. S. 77. Above is a view of the U. S. 81 bridge on the north edge of Blackwell and of the flood that caused 100 families to be evacuated. (More Photos, Page 6.)
