STATE OF OKLAHOMA  
DEPARTMENT OF HIGHWAYS  
SURVEY DIVISION

THIS FORM IS FOR IDENTIFYING, EXPLAINING  
AND RECORDING INFORMATIVE PHOTOGRAPHS.

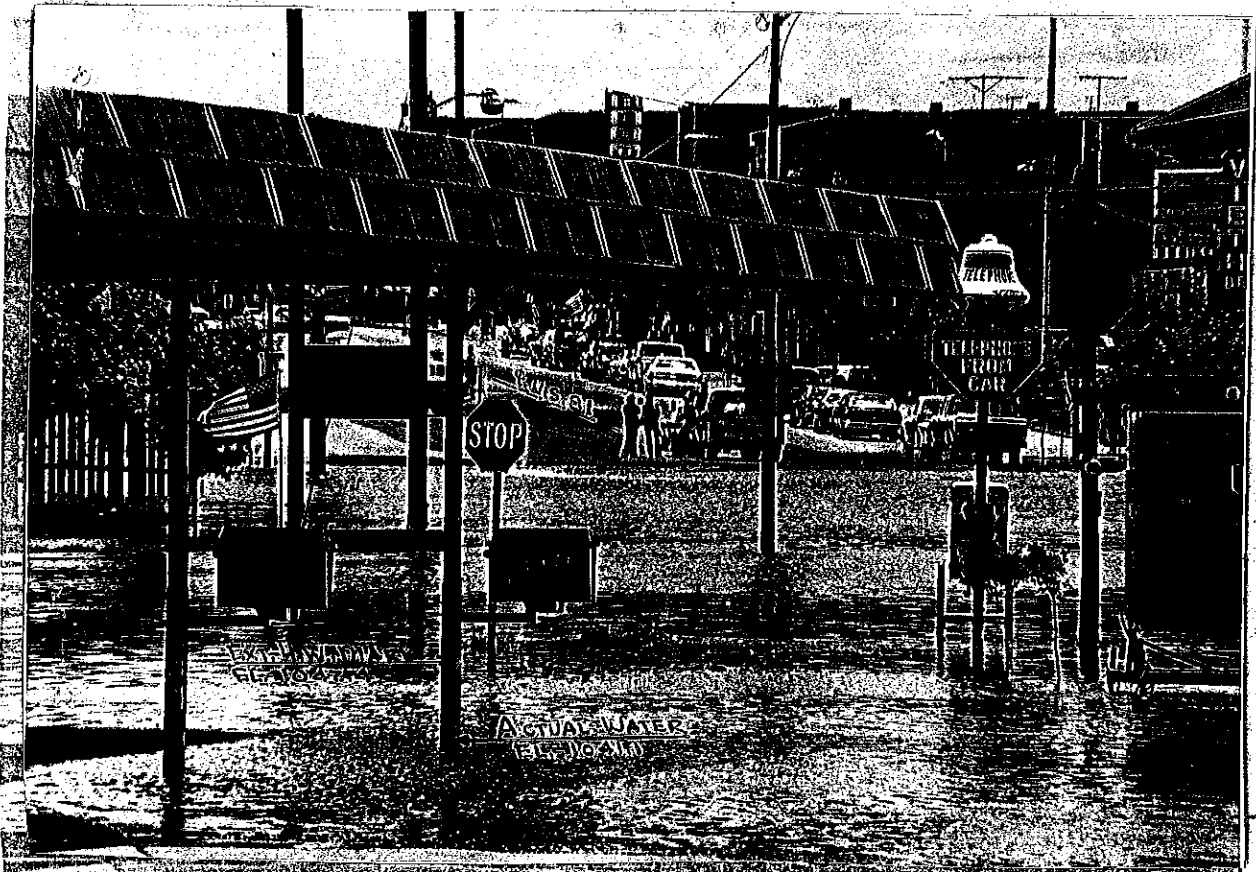
Location No. 6

1. Location KINGFISHER, OKLAHOMA 198' SOUTH AND 69' EAST OF INTERSEC-  
TION ON MAIN STREET & "C" AVENUE (AT MUG AND JUG DRIVE-IN, AT POST  
SUPPORTING OVERHANG)
2. Subject EXTREME HIGHWATER IN KINGFISHER CRESTED AT 4:00 PM MAY 21,  
1977, HIGHWATER FROM KINGFISHER CREEK.
3. Purpose NOTE: THIS HIGHWATER WAS CAUSED FROM 4" TO 8" RAINS IN AND  
AROUND KINGFISHER OVERNIGHT ON MAY 20, 1977.
4. For Use KINGFISHER COUNTY'S FREE PRESS NEWSPAPER TOOK PHOTOGRAPH  
AT 2:30 PM MAY 21, 1977. WATER ELEV: 1041.1
5. History and Explanations HIGHWATER REACHED CREST STAGE AT 4:00 PM  
MAY 21, 1977. CREST ELEV. 1042.4  
(LEVEL DATUM FROM S.A.P. NO. 927(2) - U.S. 81 PLANS)

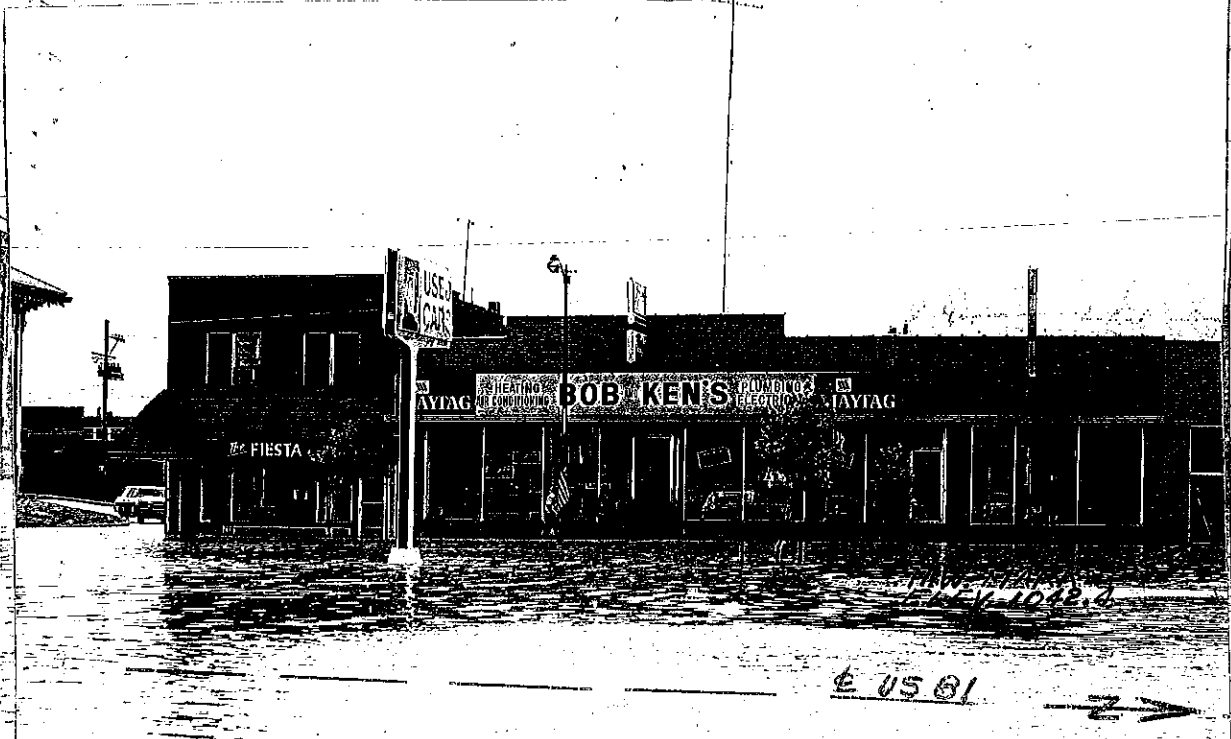
Location No. 6

1. Location KINGFISHER, OKLAHOMA 85' SOUTH AND 50' WEST OF INTERSECTION OF "A" AVENUE & MAIN STREET (AT WINDOW SILL OF OWENS SUPPLY COMPANY)
2. Subject EXTREME HIGHWATER IN KINGFISHER CRESTED AT 4:00 PM MAY 21, 1977. HIGHWATER FROM KINGFISHER CREEK.
3. Purpose NOTE: THIS HIGHWATER WAS CAUSED FROM 4" TO 8" RAINS IN AND AROUND KINGFISHER OVERNIGHT ON MAY 20, 1977.
4. For Use KINGFISHER COUNTY'S FREE PRESS NEWSPAPER TOOK PHOTOGRAPH AT 3:00 PM MAY 21, 1977. WATER ELEV. 1042.0
5. History and Explanations HIGHWATER REACHED CREST STAGE AT 4:00 PM MAY 21, 1977. CREST ELEV. 1042.4 NOTE: E U.S. 81 IS AT ITS LOWEST POINT IN FRONT OF BUILDING WHERE H.W. MARK IS INDICATED AND HIGHWATER WAS 1.4' OVER E U.S. 81.  
(LEVEL DATUM FROM S.A.P. NO. 927(2) - U.S. 81 PLANS)
