DESIGN IMPROVEMENTS FOR CONSTRUCTED RIO GRANDE SILVERY MINNOW NURSERY HABITAT

U.S. Department of the Interior
Bureau of Reclamation

September 2004

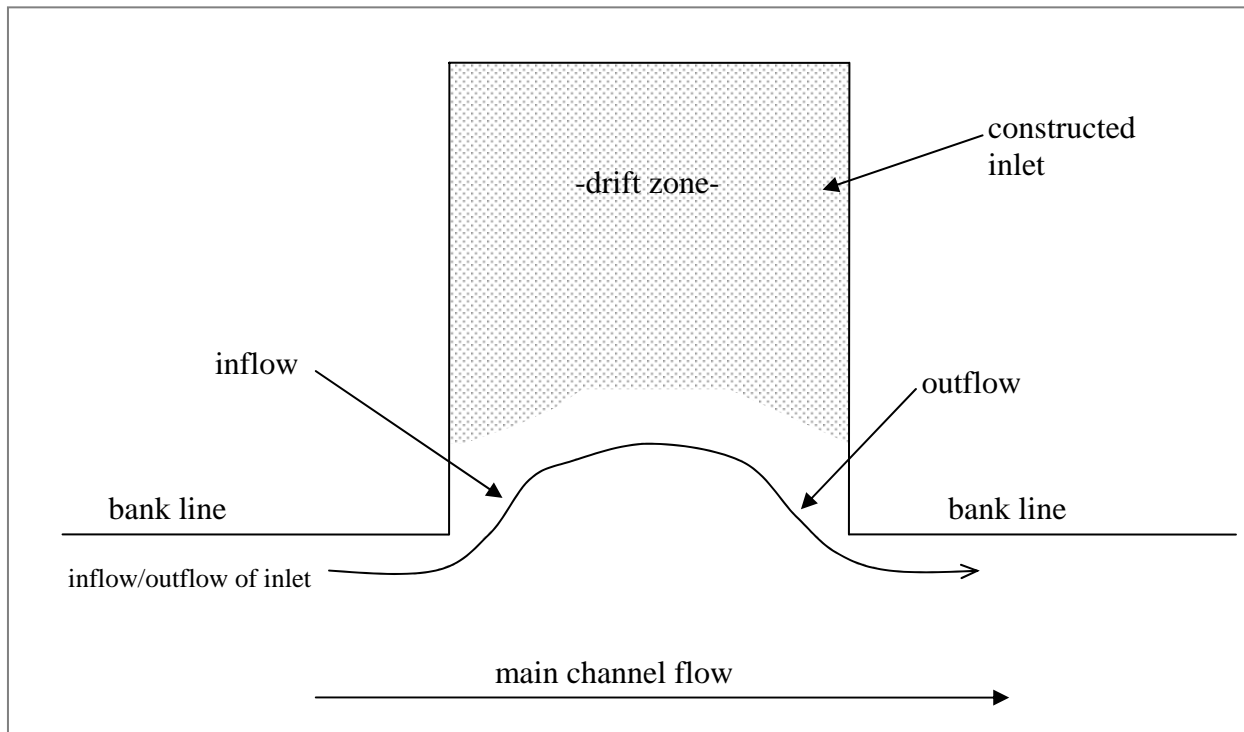
Figure 1. Generalized plan view of the constructed inlets in 2003 at the Channel Widening Restoration Project at Bosque del Apache National Wildlife Refuge (BDA) on the Rio Grande.

This research uses a landscape ecology approach (Forman 1995) to evaluate habitat and life history needs for the silvery minnow. Channel incision resulting from upstream dams has isolated floodplain habitat during years with reduced runoff discharge (Porter and Massong 2005). The importance of edge habitat along the river bank for fulfilling critical life history components of the silvery minnow has not received much attention. In previous studies, we documented that constructed inlets adjacent to the main flow in the channel retained silvery minnow eggs and attracted a variety of free-swimming fish. The primary features in successful inlets for egg retention appeared to be both the formation of a ‘drift zone’ within the inlet, but also substantial inflow and outflow at the inlet mouth (Figure 1). The drift zone is defined as the inundated area with an un-measurable low water velocity that occurs farther back in the inlet.

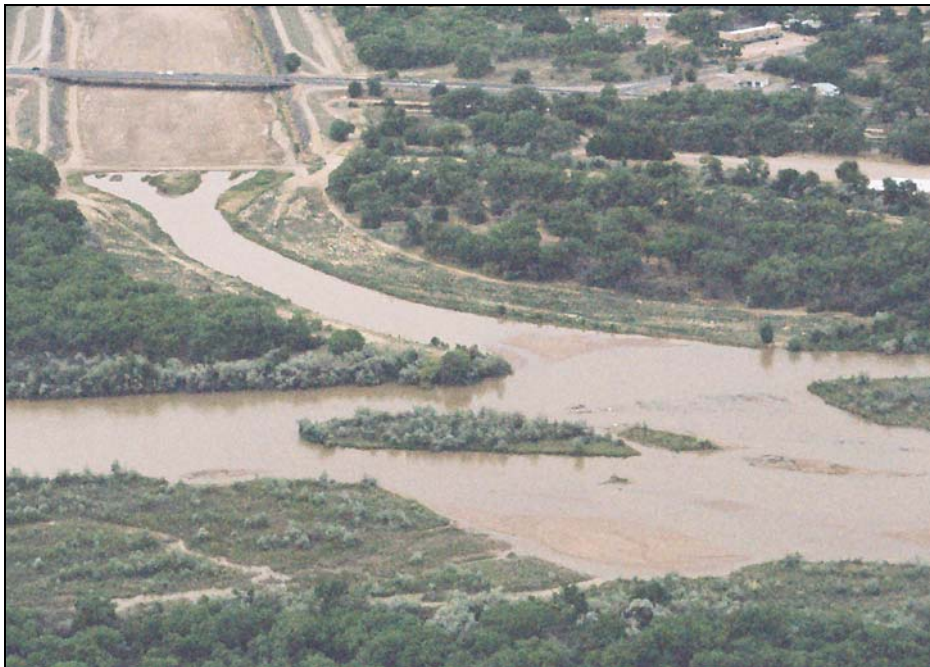
Figure 3. N AMAFCA confluence (May 2004) with the Rio Grande forming an inlet that remains wet year round. The Rio Grande in the foreground is flowing from left to right; north is to the left of the picture.

A set of bars and islands partially blocked the inlet mouth during both the 2003 and 2004 field studies (Figures 3 and 4). In 2003, a wide, shallow inflow channel formed on the upstream side of the confluence with the deeper outflow channel on the downstream side of the inlet. The

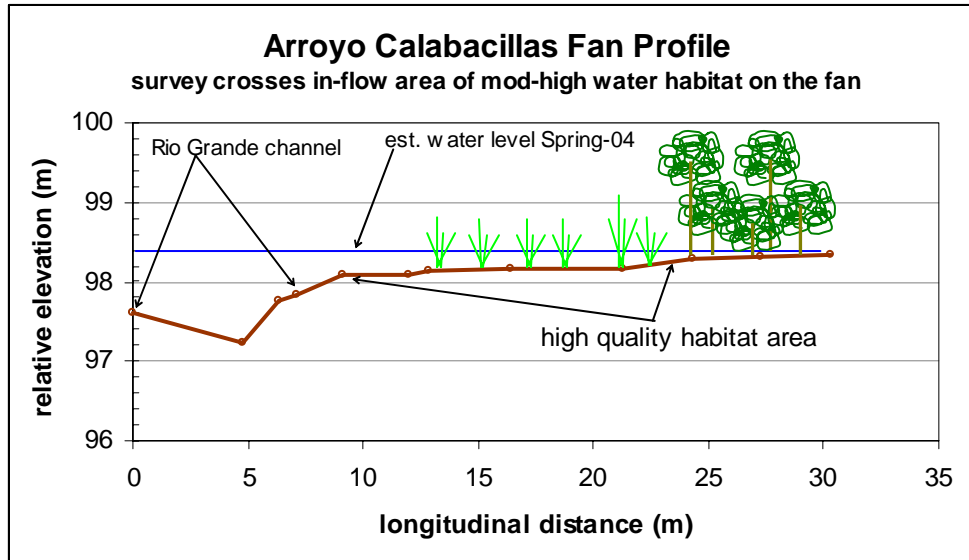
Figure 6. Long profile #1 through the high quality habitat area at the Arroyo Calabacillas confluence/fan. Data collected in June 2004.

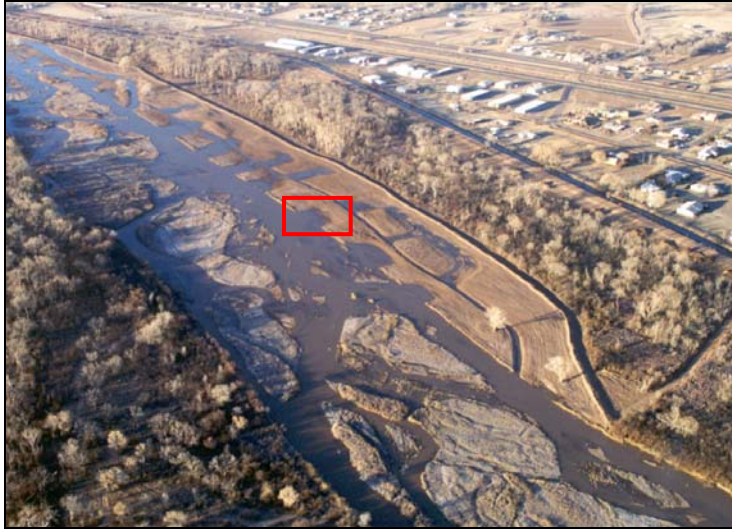
Figure 7. Los Lunas Habitat Restoration Site in January 2003. Red square denotes the inlet #3 studied in May 2003. Photo by AAO-River Analysis Team.

Inlet #3 was chosen in 2003 for the egg retention study, as it had a well defined inflow, outflow and drift zone. During the 2003 study, 57 beads were retained, along with one silvery minnow egg. The real egg was found on quadrats within a slightly vegetated area. During field reconnaissance in spring 2004, a large mid-channel bar was discovered in inlet #3, dominantly filling the inlet (Figure 8). With the higher spring flows in 2004, the inlet routed Rio Grande flow around the bar, essentially creating a side channel and reducing the drift zone area. This inlet is approximately 75 meters wide and 20 meters in length.

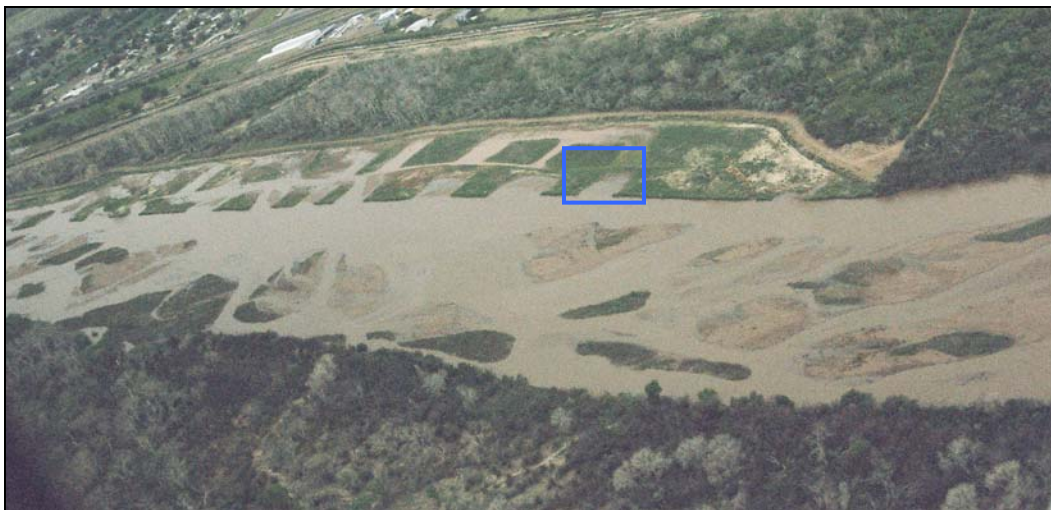
Figure 8. Los Lunas Habitat Restoration Site in May 2004. Blue square denotes the inlet #1 studied in May 2004.

Inlet #1 was considered too small/unsuitable in 2003 to retain eggs as no-drift zone had established at 500 cfs. However with higher flows in 2004, the wetted area within the inlet extended nearly to the constructed high flow channel. This larger wetted area in the inlet created a drift zone. However, egg retention data indicated only minimal effectiveness. This inlet is

Inlet #4, the inlet located downstream of inlet #3 was sampled for only a short time in 2003. Sampling ceased when slightly increased flows created an outflow channel at the back of the inlet, draining into the constructed high flow channel in the floodplain. This flow scenario created a flow-through channel eliminating the drift zone that had originally formed. Monitoring data collected in 2004 revealed that a distinct channel formed between the Rio Grande and the high flow channel, and that the remainder of the inlet filled with sediment (Figure 8).

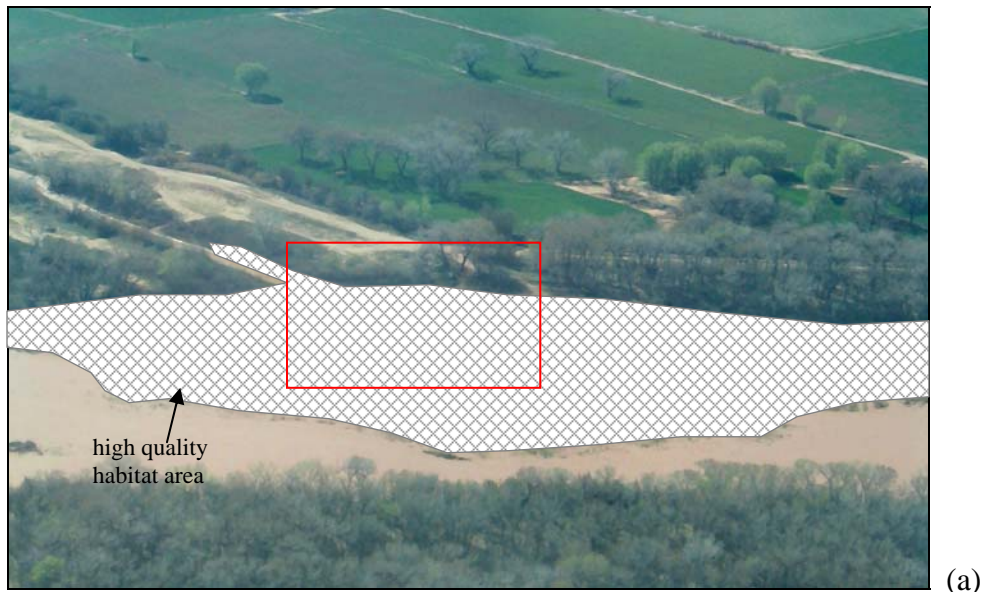
Figure 9. Arroyo Abo confluence with the Rio Grande in April 2004 (a) and May 2004 (b). The April 2004 photo (a) is taken from the west side of the Rio Grande towards Arroyo Abo, while the May 2004 photo was taken from the east side of the Rio Grande looking down Arroyo Abo towards the Rio Grande. Red square on (b) denotes the section of the confluence studied in May 2004.

Unlike Arroyo Calabacillas, the Arroyo Abo fan is closer in elevation to the low flow Rio Grande active channel bed. As observed in May 2004, a large portion of the fan was submerged with a modest flow of 2000 cfs in the Rio Grande. These submerged fan deposits supported a variety of vegetation, similar to those found at Arroyo Calabacillas. The inundated fan appeared to contain high quality habitat for larval fish, as this area contained a relatively high density of the fish.

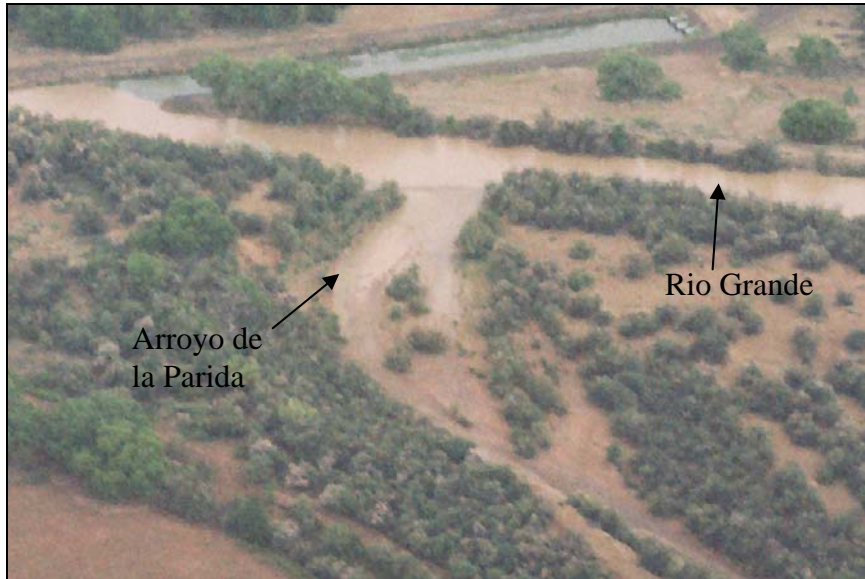
Figure 13. The confluence of Arroyo de la Parida with the Rio Grande on May 26, 2004 (1,150 cfs in the Rio Grande). The Rio Grande is flowing from right to left in the upper portion of the photograph; Low Flow Conveyance Channel Outfall at top of photo.

At present one main Arroyo de la Parida channel meets the Rio Grande. This channel was inundated at a 2,000 cfs Rio Grande flow and stayed wet until flows decreased to less than 1,500 cfs (Figure 13). The confluence angle is rotated downstream 5-10 degrees. The width of the confluence is approximately 25 meters. Although the sediment fan is just beginning to form downstream of the confluence, it doesn’t appear to be forming quality habitat. A moderate number of beads, and low number of fish larvae were collected in seven days of sampling (Porter and Massong 2004).

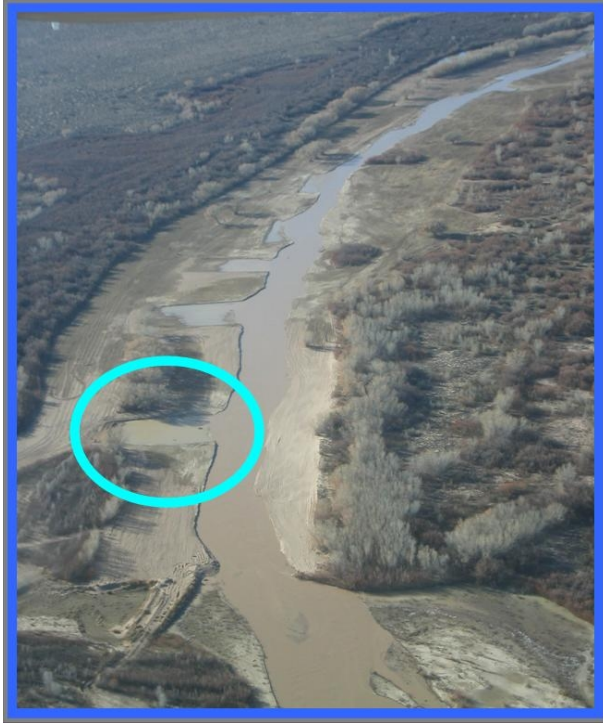
Figure 14. Constructed inlets in the Bosque del Apache NWR Channel Widening Project area in 2003. Inlet #1 is circled in red adjacent to the newly constructed Rio Grande Channel. The previous Rio Grande channel is to the left of the inlets. Photo by R. Doster.

The BDA nursery habitat site is located at RM 36 and is the most southern site in this study. Nursery habitat inlets were created to facilitate widening of the Rio Grande at this restoration site, therefore their lifespan as nursery habitat were designed to be temporary. The created inlets were approximately 40 m wide with a length of 45 m and were perpendicular to the constructed Rio Grande channel. The inflow from the Rio Grande traveled approximately 12 m into the inlet in 2003, while the remaining 33 m of inlet was driftzone. At the time of construction, the inlet mouth was level with the pilot channel bed. In 2003, a moderate number of silvery minnow eggs and beads were collected within the constructed inlet (inlet #1) during three two-hour sampling periods (Figure 14).

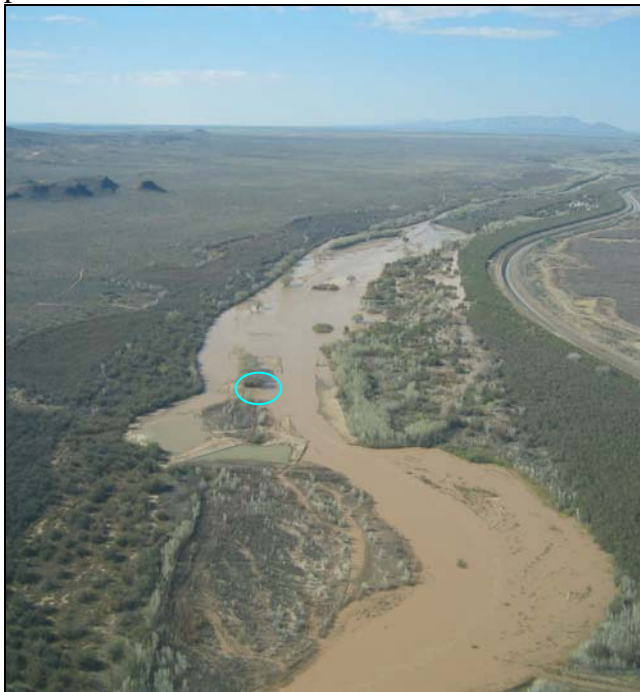
Figure 15. The Bosque del Apache NWR Channel Widening Project area in April 2004 with 2,800 cfs flowing in the Rio Grande. Inlet #1 is circled in red. Photo from River Analysis Archives.

In April 2004, a relatively large flow (about 2,800 cfs) inundated much of the project area (Figure 15), including the inlets. As a consequence, filling with fine sediments occurred in the inlets, with significant growth of a bar at the mouth of three inlets (Figure 16). Scouring at inlet #1 reduced the length about 50% from the former bankline. The runoff flows in May 2004 peaked at only 1,600 cfs, which were too low to flow over the bars at the mouth of the inlets. No sampling for egg retention occurred at this site in 2004.

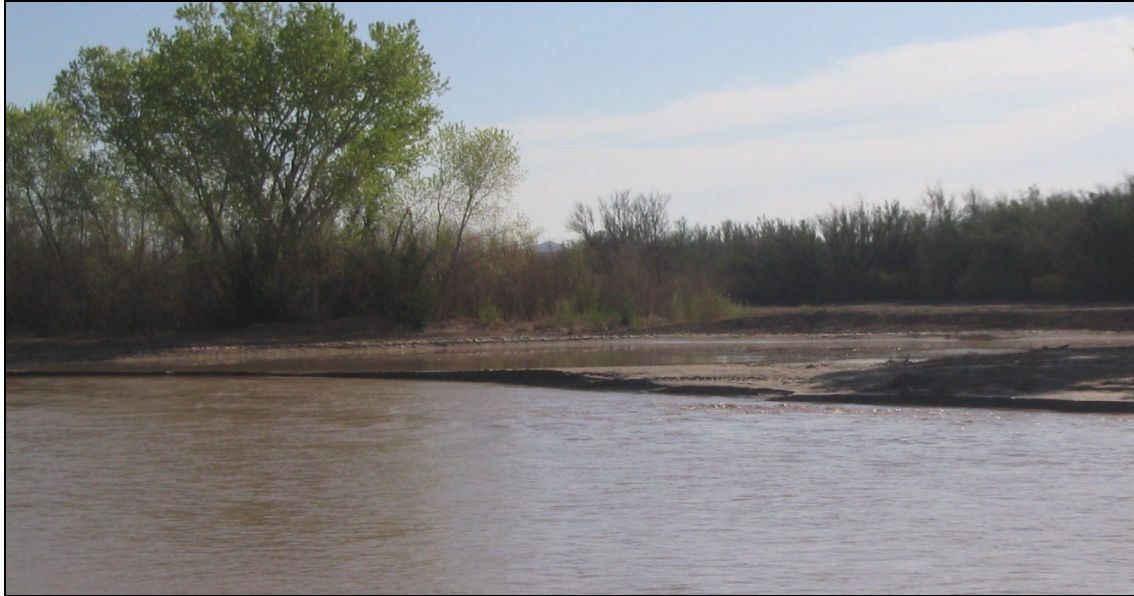
Figure 16. Looking east across the Rio Grande toward ponded water in Inlet #2 downstream of inlet #1 (May 2004). The inlet filled with sediment during high flows in April 2004. Photo by M.D. Porter.

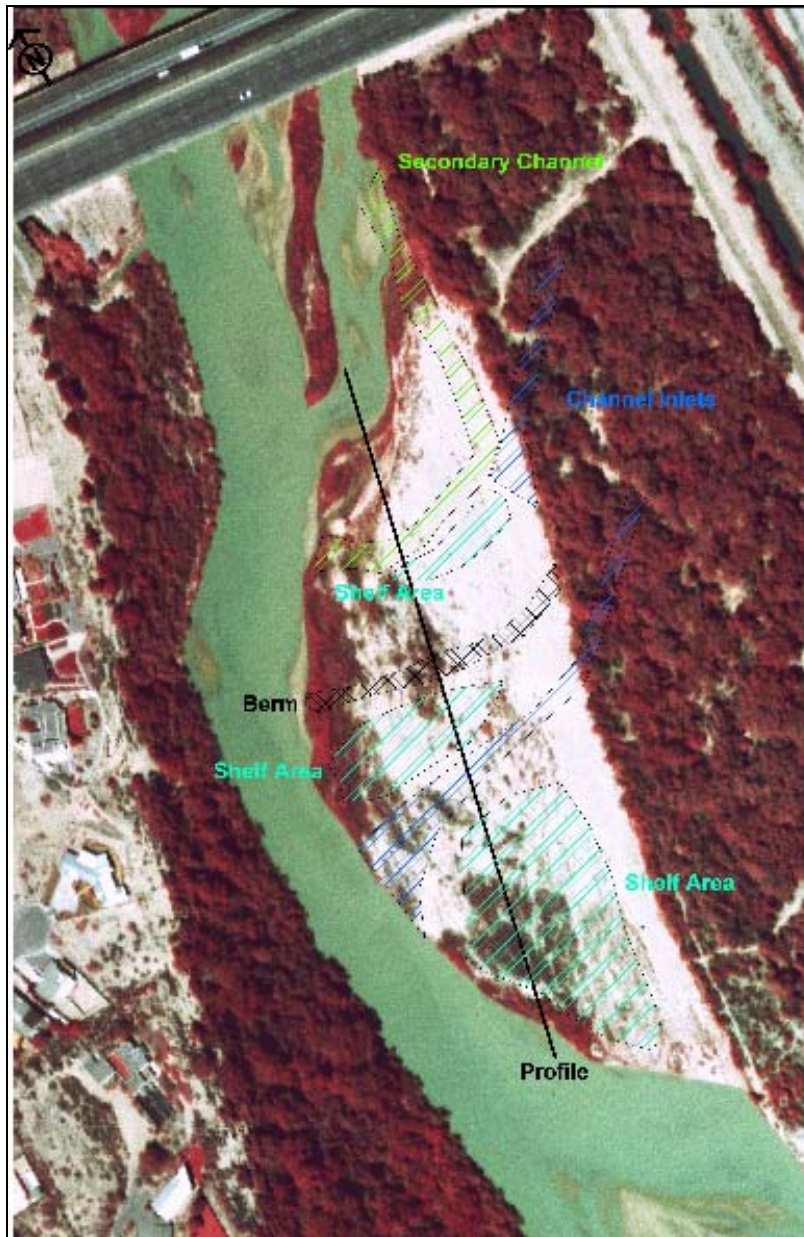
Figure 19. Sketched modifications to a point bar on the Rio Grande immediately downstream of Interstate-40 bridge crossing. The modifications shown include: 1) introduction of a side channel into the bar sediments with connected inlet and shelf area; 2) bar-spanning berm to hinder very high Rio Grande flows that overtop the bar; 3) inlets connected to surface runoff channels; and 4) lower bar elevation to create a directly connected shelf area on the downstream section of the bar.

In their current configuration, most bars/islands do not appear to have the correct structure and surface topography to first retain eggs and then function as nursery habitat. However, the surfaces of these in-channel features could be modified to possess important nursery habitat features that have been identified in this study. Four habitat features could easily be added to these channel features (Figures 19 and 20): 1) lowered surfaces along the active river's edge to simulate connected shelf areas; 2) shelf areas within the point bar connected to the river via small side channels; 3) constructed inlets connected to the river either directly or via a side channel; and 4) constructed inlets that are connected to the river but also convey surface water runoff or riverside drain water to the Rio Grande. The key process for the constructed inlet conveying water, feature #4, is that the periodic flow of water through the entire inlet would 'flush' fine sediments that have accumulated. As sedimentation in constructed inlets is a concern, these flushing flows would better maintain the inlet structure.
