Preliminary Geomorphic Assessment of the Bernalillo- Albuquerque Reach

Middle Rio Grande near Albuquerque, New Mexico
July 2003

Report prepared by:
Richard M. Ortiz

University of New Mexico
Department of Earth and Planetary Sciences
Albuquerque, New Mexico

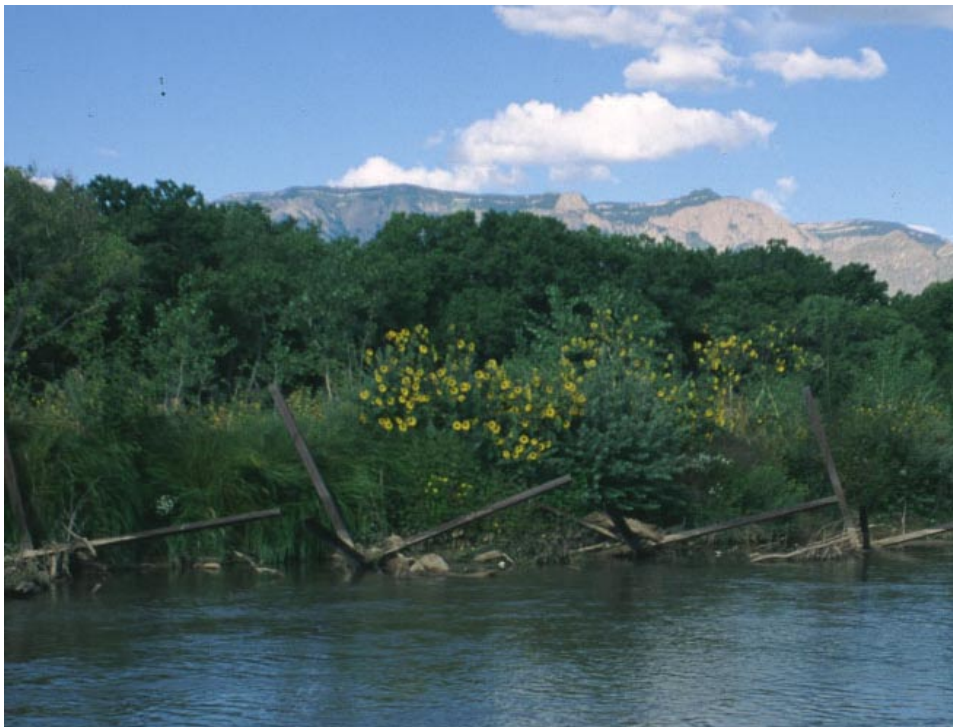
Figure 3. Photo of Kellner Jetty Jacks along the eastern bank of the Rio Grande. Banks have remained stable since jetty jack installation during the late 1940s to early 1950s

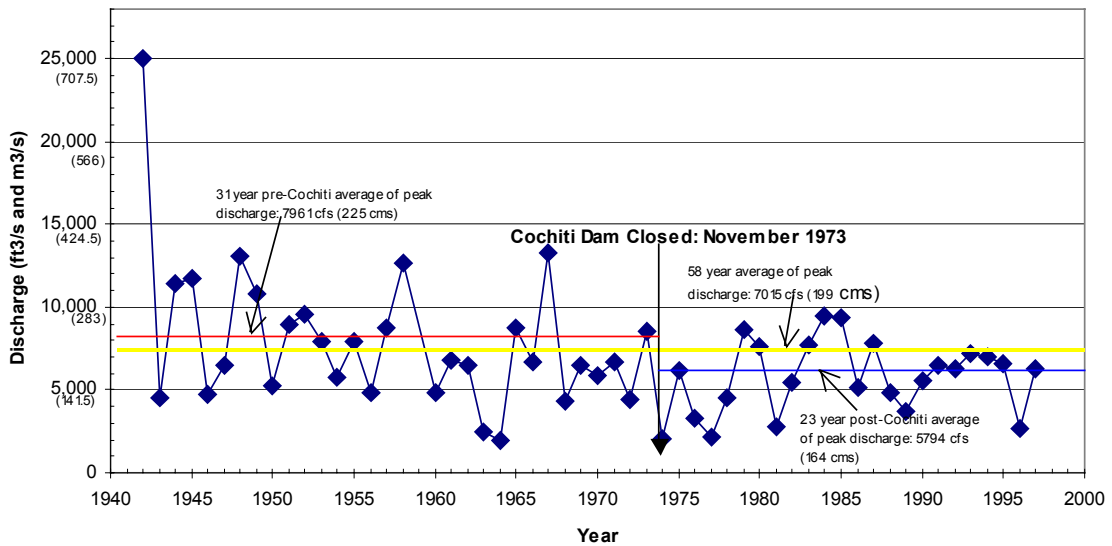
Figure 4. Plot of the annual peak discharges for the 58 year USGS gage record of the Rio Grande at Albuquerque (gage ID: 08330000). Lines indicate the average discharge for the entire record, as well as pre and post-Cochiti average discharges.

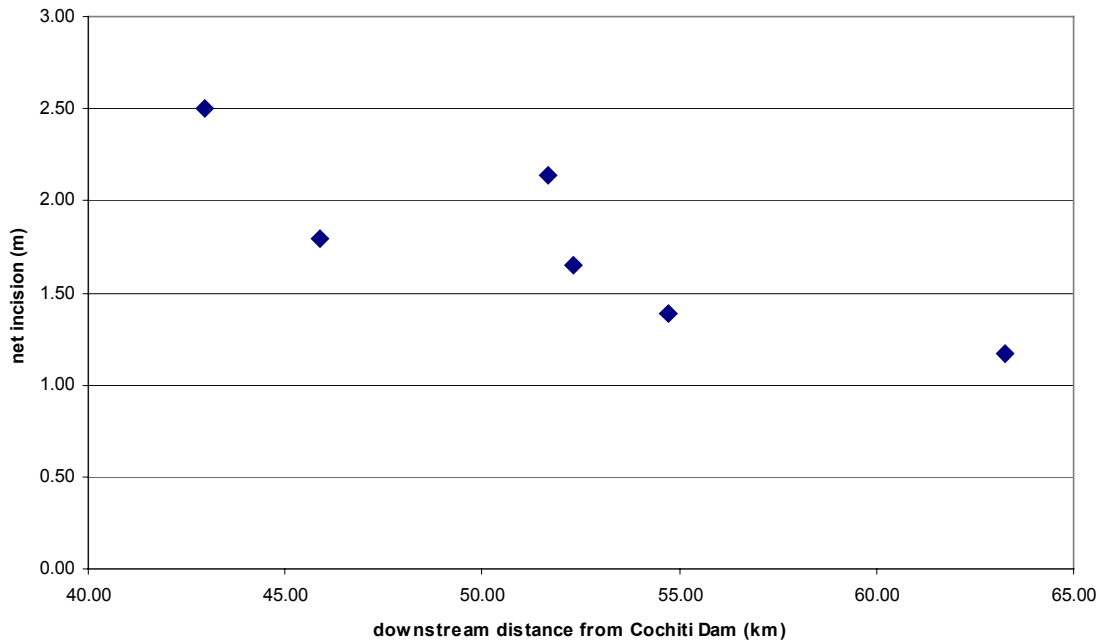
Figure 6. Net incision of study reach downstream from Cochiti Dam. Differences between 1972 average bed elevation and 2001 average bed elevation at Bureau of Reclamation cross-section lines were calculated to determine amount of net incision.

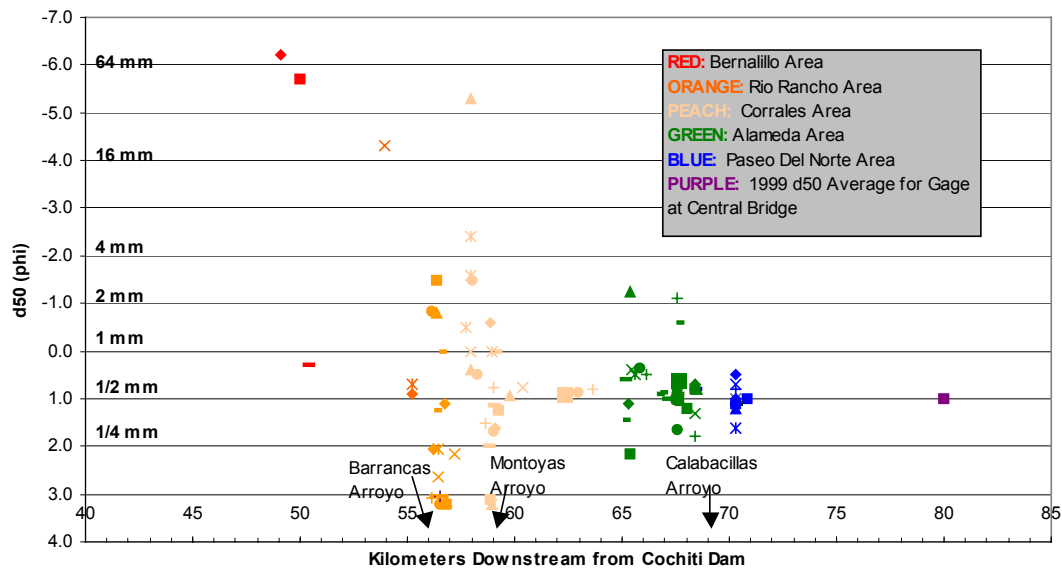
Figure 7. Median grain size values for study reach showing downstream fining trend and decrease in median size variability through transition zone between Arroyo de las Barrancas and Arroyo de las Montoyas. Grain sizes in the study reach range from fine-sands to large cobbles.

A total of 104 bed sediment samples were collected along the length of the study reach. Sediment size terminology used here follows the Wentworth classification (Table 1). Sampling was particularly focused in and around the apparent transition zone between pebble and cobble gravel bed sediments (2-128 mm) dominant in the upper reach and fine to coarse-grained sands (0.125-1 mm) in the lower reach (Fig. 7).

Another trend observed in the grain size data is a reduction in variability of median grain sizes within sub-reaches downstream. The most upstream sub-reach around the U.S. 550 Bridge has a range of median grain sizes from 1-64 mm, whereas the most downstream sub-reach south of Paseo del Norte has a range from 0.25-1 mm. Although the most upstream sample areas contain the coarsest grained material, the largest variability with the study reach occurs around the transition zone. Specifically, the areas of highest variability are found around the two major arroyos currently sampled (Fig. 7).

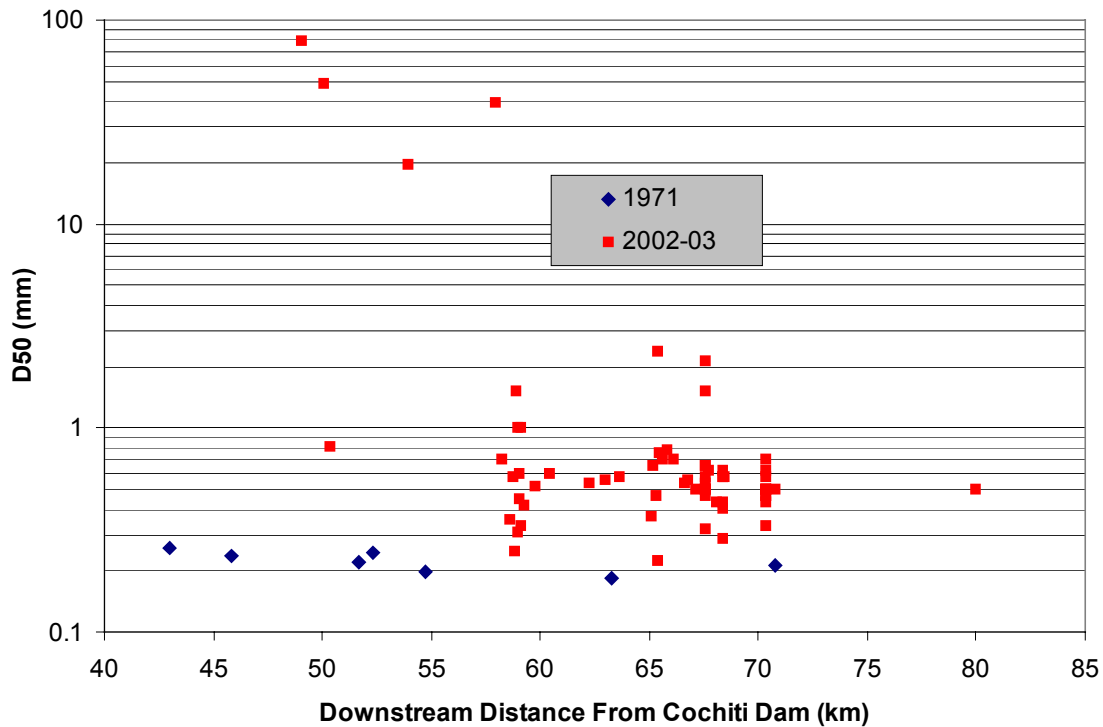
Figure 9. Variation in median grain size of bed sediments over the study reach in 1971 (pre-Cochiti dam) compared to those sampled in this study (2002-2003)

Comparison of averaged median grain size data collected in this study with historical data provided by the Bureau of Reclamation show that prior to dam closure, bed sediments were sand with little variability in median grain size throughout the reach (0.21 to 0.27 mm). Present downstream variation in median grain sizes is large (0.44 to 79 mm) (Fig. 9).

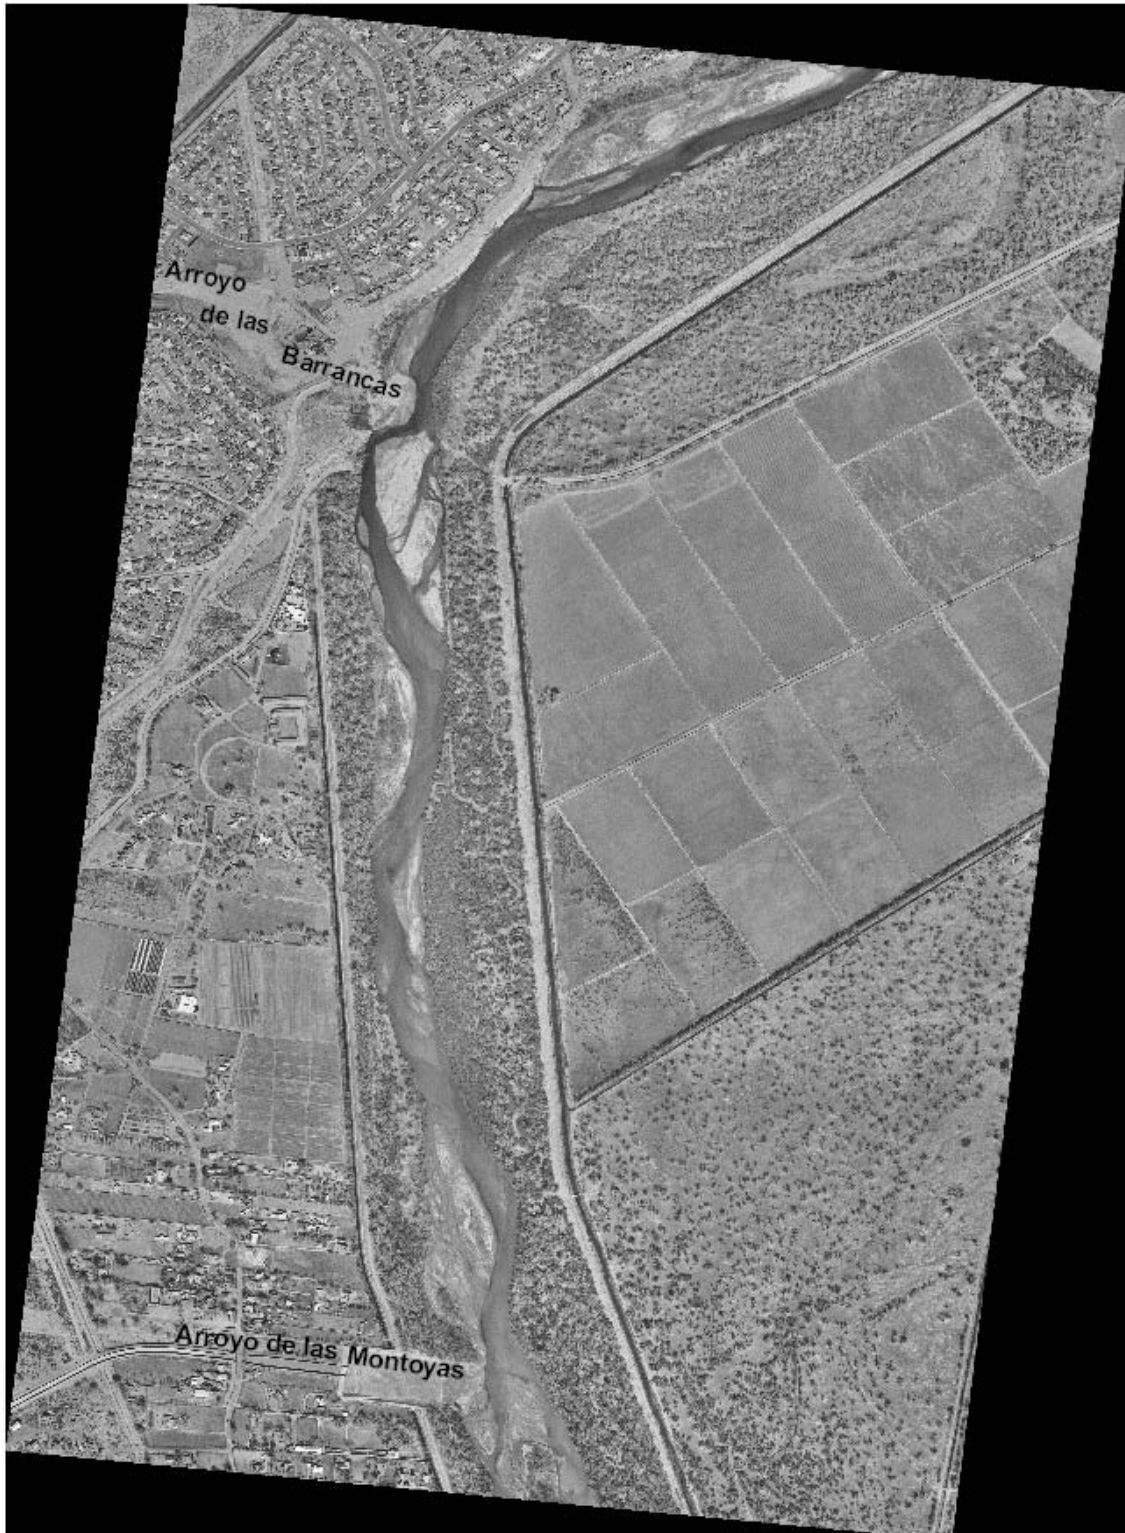
Figure 12. Visible channel planform transition zone from a single-threaded, locally island-braided channel with a deep, fast flowing thalweg (upstream of Barrancas Arroyo) undergoes a transition into a wider, multi-threaded, island and bar-braided channel with shallow, slower-flowing multiple thalwegs (downstream of Montoyas Arroyo).

Between the Arroyo de las Barrancas and the Arroyo de las Montoyas there is an observable change in channel morphology. A single-threaded, locally island-braided channel with a deep, fast flowing thalweg undergoes a transition into a wider, multi-threaded, island and bar braided channel with shallow, slower-flowing multiple thalwegs (Fig. 12). Upstream, low discharges below 2000 ft³/s (57 m³/s) create the dominant single threaded, island-braided planform. With increased discharges, various elevated channels become activated and create a multi-threaded, island-braided planform. Below Arroyo de las Montoyas the multi-threaded island- and bar-braided planform does not change as dramatically with discharge. At flows < 400 ft³/s (11 m³/s), more sand bars become exposed and increase the number of channels present within the downstream section of the reach. Flows above 400 ft³/s combine some of these minor channels, but

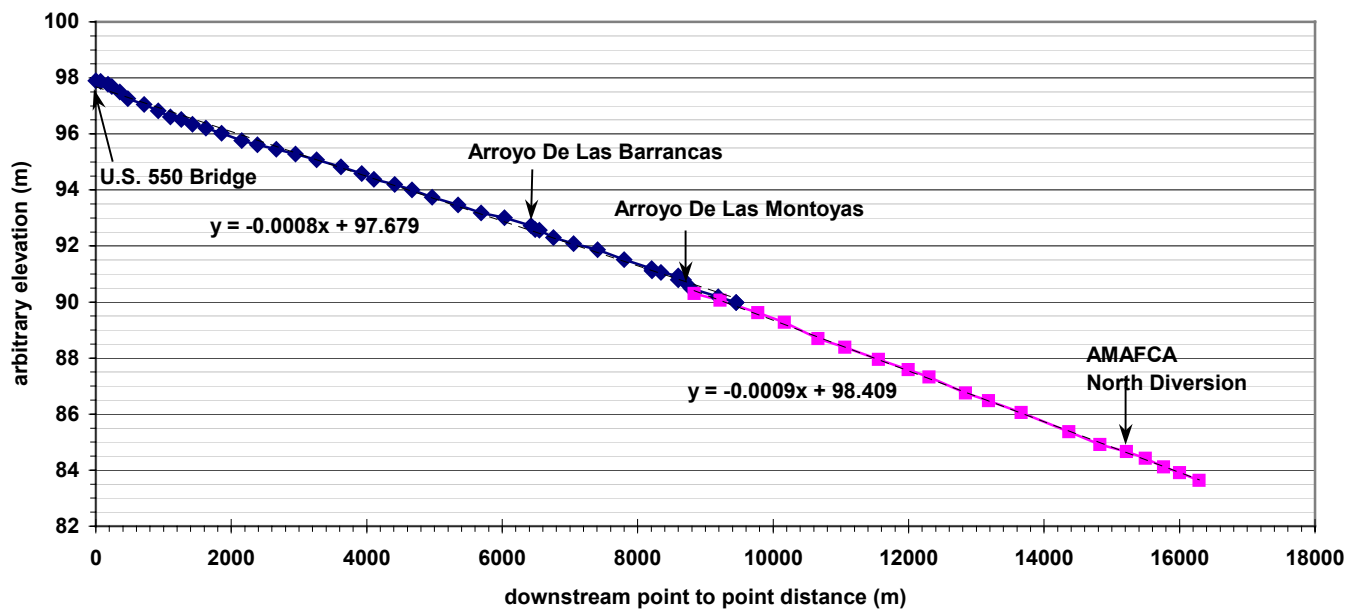
Figure 13. Long profile of study reach created from water surface survey data. Primary survey (blue line) locations were recorded using a differential GPS unit with sub-meter accuracy. Secondary survey (pink line) locations were recorded using a handheld Garmin GPS 12 unit with meter accuracy.

The build up of sediment at the arroyo mouths is observed within the water surface profile as the changing of the slope at both arroyo locations (Fig. 13). The slope changes at the Arroyo de las Barrancas and the Arroyo de las Montoyas indicates that coarse sediment input remains near the arroyo mouths and locally controls slope. At current discharges ($< 1500 \text{ ft}^3/\text{s}$) the system is unable to remove the coarser fraction of introduced sediment, causing reduction of slope above the tributary fan. Downstream of the sediment sources water surface slope increases as water flows over the coarse sediment accumulation.
